Investigating serviceability issues related to thermal movement accommodation in bridges

Conor Duffy
Iowa State University

MASTER OF SCIENCE

Major: Civil Engineering (Structural Engineering)

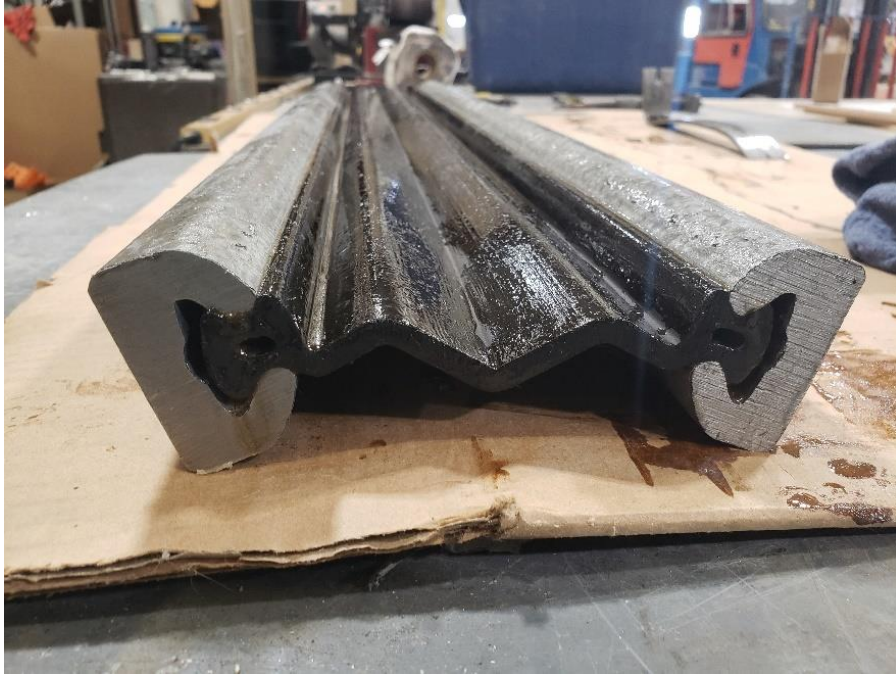
Figure 6: Assembled Strip Seal Cross-Section

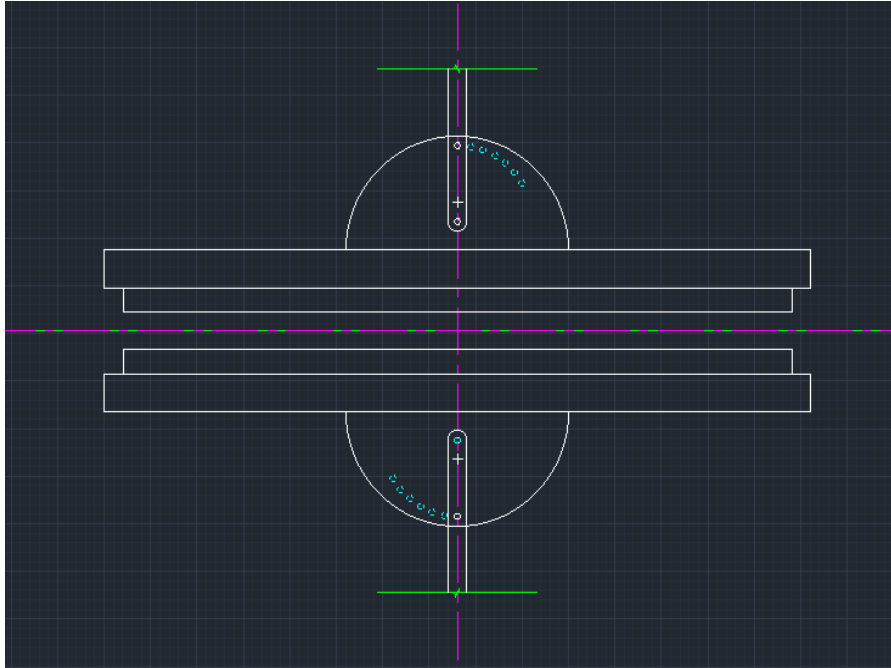
In order to simulate the behavior of a strip seal throughout a range of skew angles, a testing frame was designed and fabricated to allow each specimen to be both expanded and contracted via a continuously braced load applied along each railing. This load was provided from the top of the testing frame, and a load cell was connected to the bottom railing to monitor the applied load. A rotational disk with a semi-circle bolt pattern was utilized to allow the test specimen to rotate in 10° increments while maintaining a load in the direction of the theoretical “centerline” of the bridge. Two string potentiometers were used to measure both the perpendicular displacement and the displacement in the direction of loading (the theoretical “centerline of bridge” in the direction of traffic).

Figure 7: Test Frame Concept

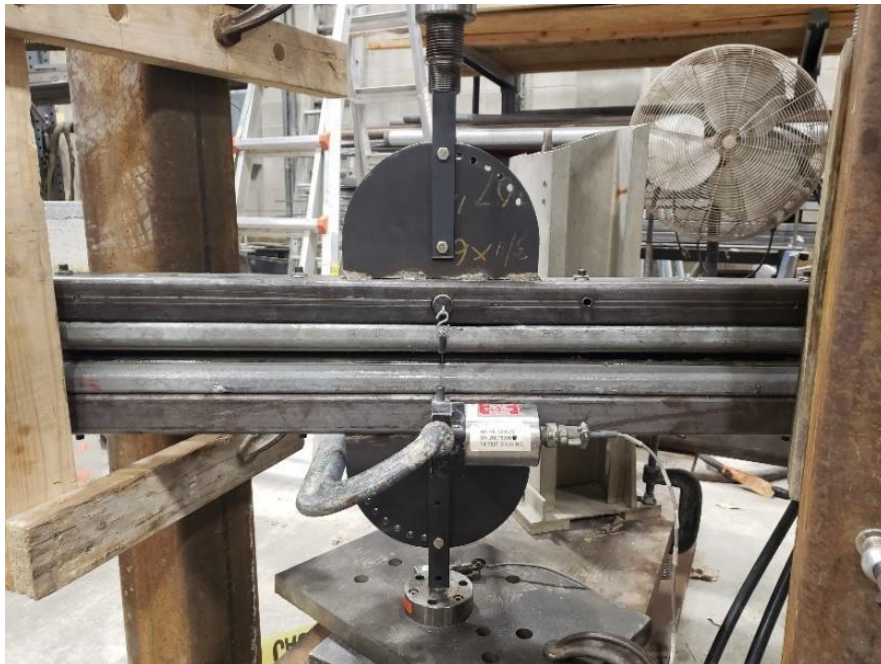
Figure 8: Test Frame

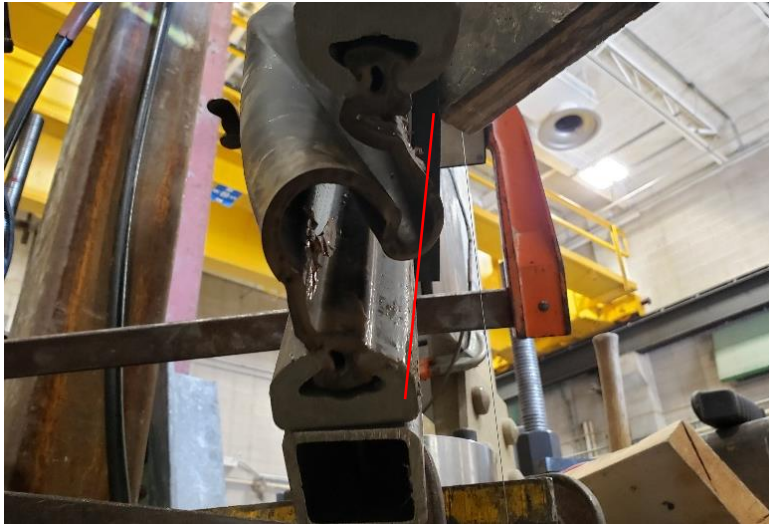
Figure 10: Typical Failure (Entrance into Roadway)

- The specimen was compressed until it either a) reached the manufacturer's recommended minimum opening distance or b) showed obvious signs of failure (excessive flexure, excessive load, torsional bending, or entrance into the path of traffic). This distance was recorded, and pictures were taken to document strip seal behavior.

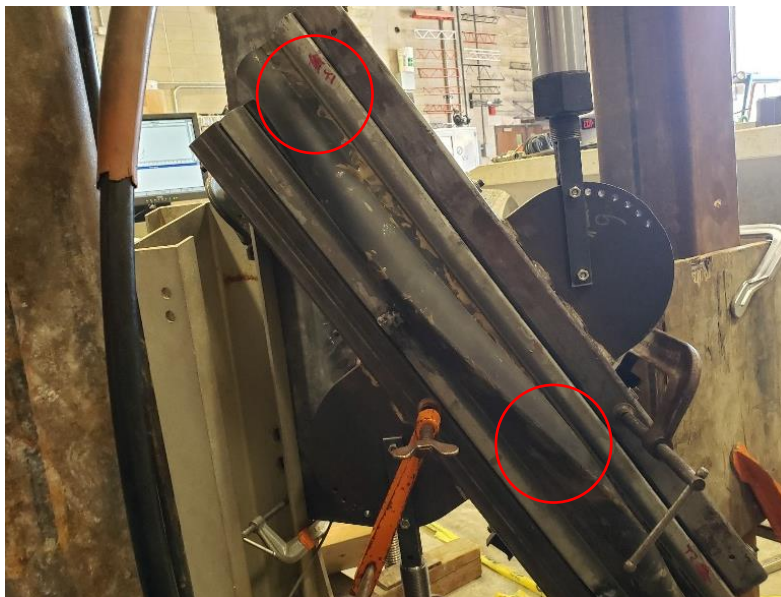
Figure 11: Typical Failure (Excessive Flexure)

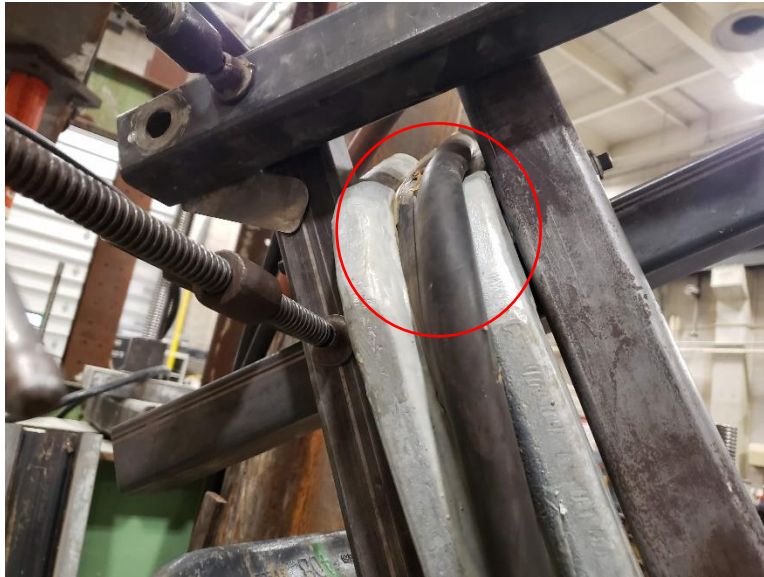
Figure 12: Closure Limit Due to Sealant Bending

In addition, it was noted that the two 30-degree bends in the railing termination create this bending behavior regardless of skew, although this behavior is increased as the skew angle is increased. It was possible to reduce this behavior's impact on the joint's performance by

For the A2R-400 test sections, it was determined that they will comfortably move throughout their full range of motion for all tested skews given high quality installation conditions. The only shortcoming of this specimen came in compression at the upturned sections, which were unable to completely close due to the significant amount of bending in the neoprene sealing material underneath the railing.

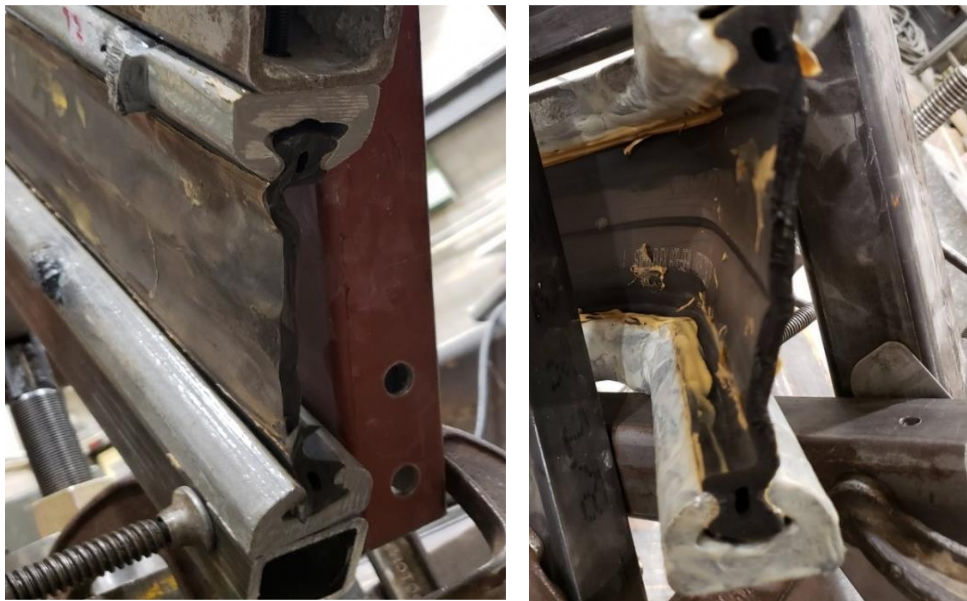
In general, both specimens demonstrated a slight drop-off in total centerline movement for lower skew angles, but this value increased as the skew angle was raised. Even at the highest skew angles, there appeared to be no signs of pull-out or unusual entrance into the vehicle pathway (Figure 15).

Figure 15: Typical A2R-400 Behavior in Extension

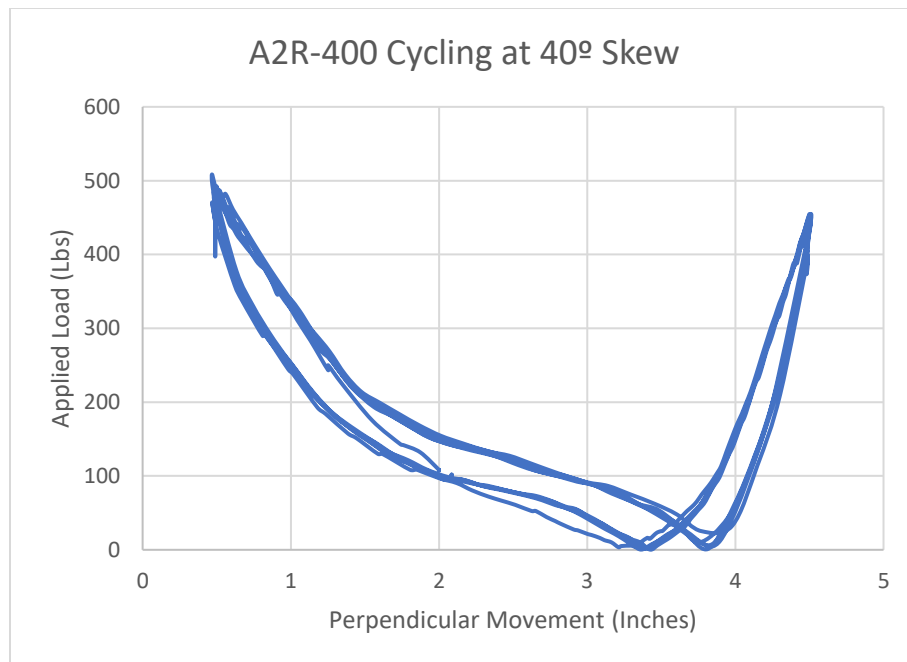
Throughout the cycling process for each specimen at each of the seven test angles, the behavior was noted to be completely elastic, showing no signs of sustained deformation. This behavior is demonstrated below in Figure 17. As the expansion device reached the maximum range of its motion, whether in extension or compression, a correlating increase in load was noted. Upon relaxing the joint back to its initial position, this load decreased back to its installation value. Each cycle followed a similar load pattern, with no observable change in required load at the maximum movement range.

Figure 16: Typical Cycling Behavior

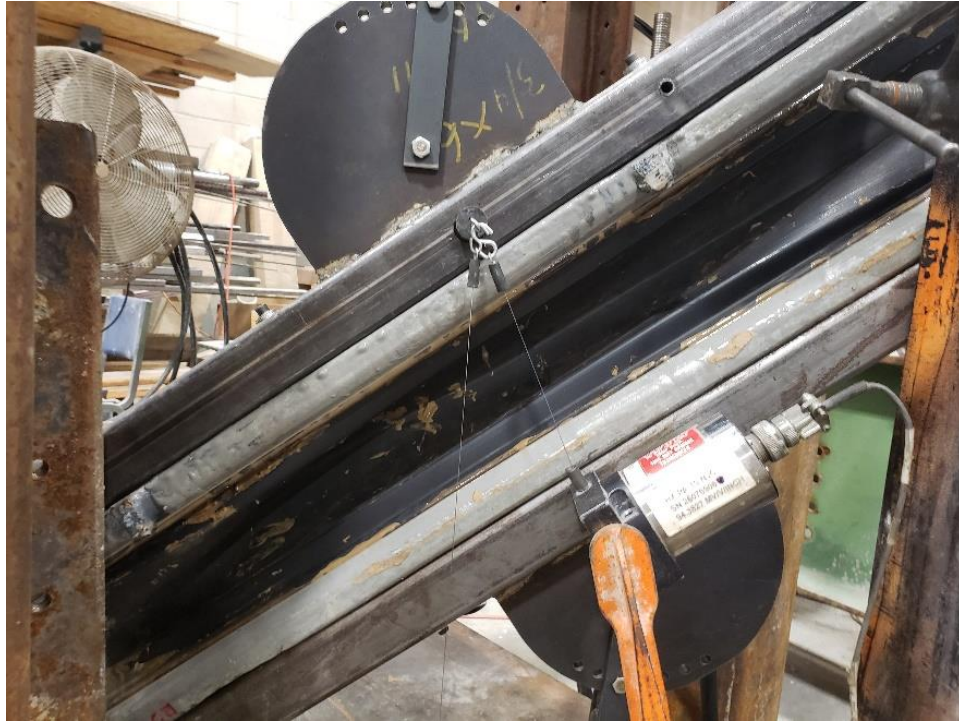
Compared to the A2R-400, the A2R-XTRA exhibited more obvious signs of failure prior to reaching the manufacturer's purported perpendicular movement range. Premature failures occurred in both extension and compression, and clearly became more pronounced as the skew angle was increased. In extension, the joints exhibited a clear amount of rippling and unusual bending (Figures 18 & 19). This movement above the railing would position the joint in the path of traffic, drastically increasing the likelihood that the seal would fail prematurely (Figure 20). This behavior ceased for the straight specimen once the joint was subsequently closed.

Figure 17: Rippling Effect in Extension (Front View)

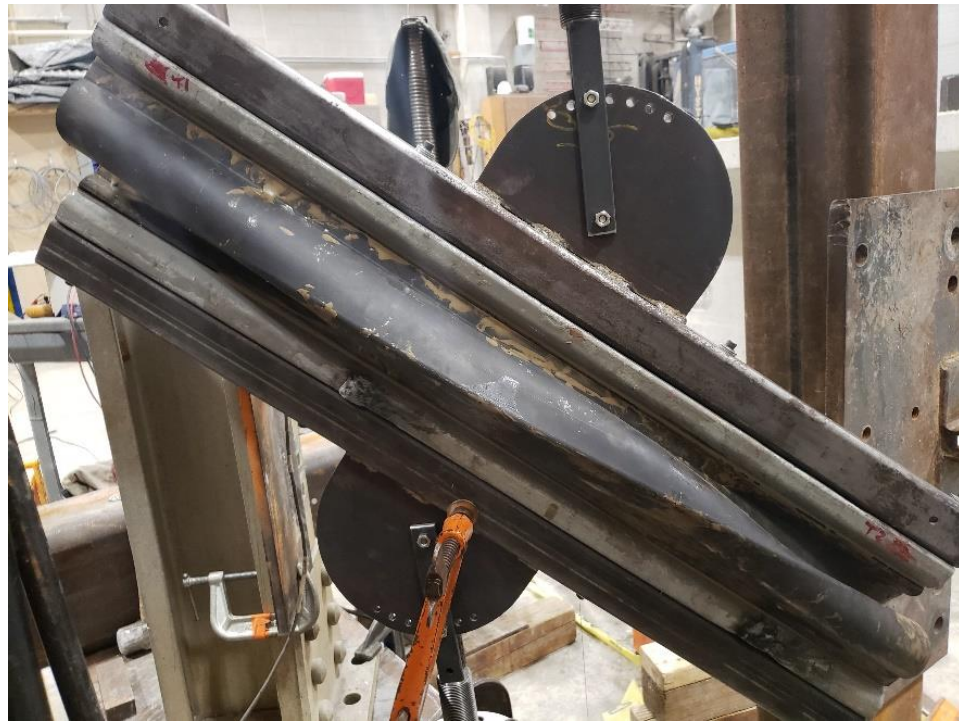
Figure 18: Rippling Effect in Extension (Rear View)

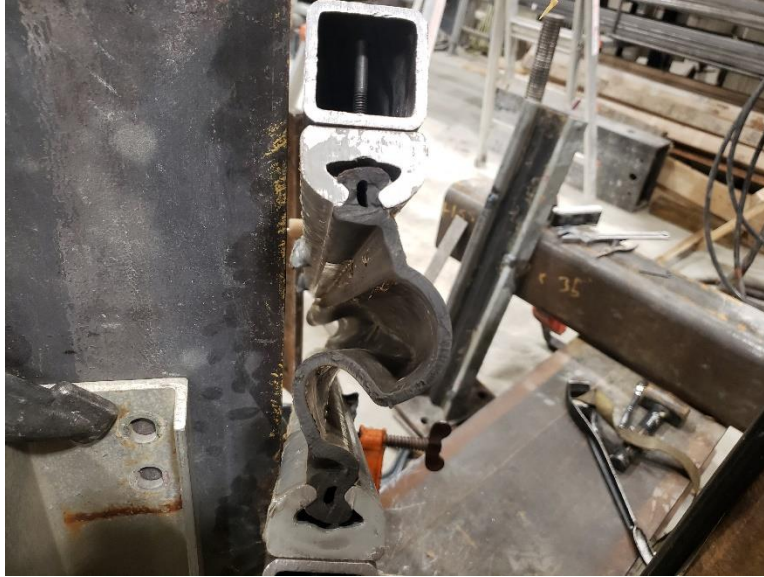
Figure 19: Failure Due to Entrance into Roadway

Compared to the A2R-400 strip seal, the A2R-XTRA showed a marked decrease in movement as the skew angle was increased. The most common cause for failure came in extension for both the straight and upturned sections when the sealing material became warped and pushed above the railing. The upturned A2R-XTRA section also exhibited a consistent

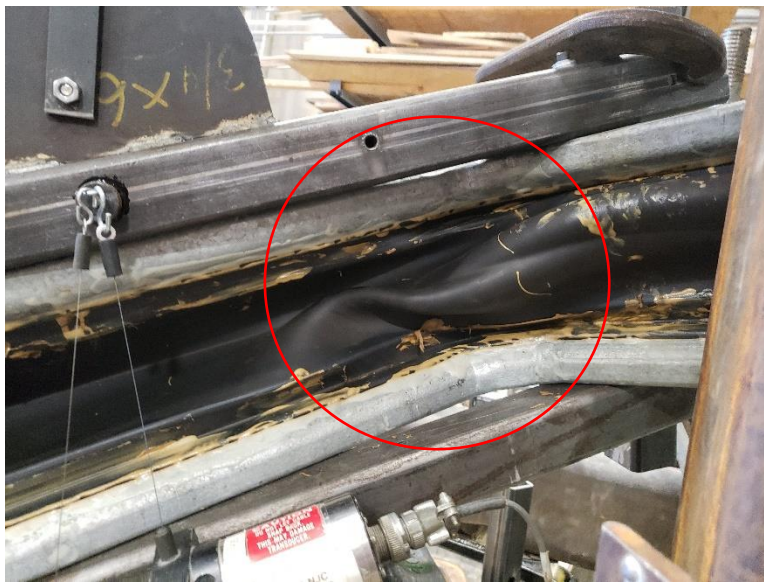
However, it was noted that, for the upturned specimen, this rippling effect did not dissipate upon closure, causing the seal to bend up and above the railing when closed (Figure 21). This behavior became worse as the joint was cycled and the only way to remove this failure was to manually force the joint back below the railing.

Figure 20: Upturned Section Failing in Closure Following Extension

limitation in compression due to the excess material forced between the two railings at the 30-degree bends. Further, the failure the upturned section experienced in extension did not dissipate upon closure at any skew higher than 10-degrees, and this limitation would likely be problematic in the field.

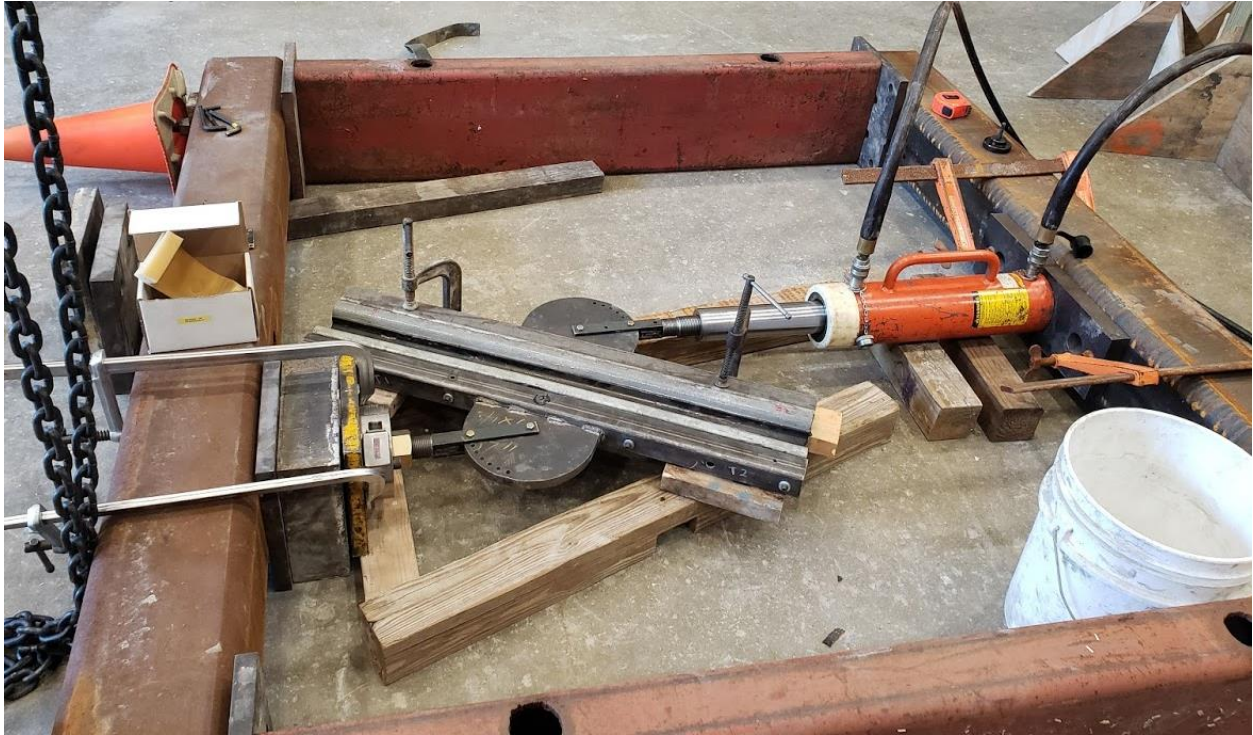
For the debris testing, a modified version of the vertical test setup was used. In order to allow loose debris to easily stay within the confines of the railing, the test setup was reset horizontally (Figure 23). Three skews (0° , 30° , 60°) of A2R-400 strip seal were tested to model a broad range of skew situations. In addition, three levels of debris amount (no fill, half-full, and completely full) were used to note any differences in behavior.

Figure 22: Horizontal Test Rig

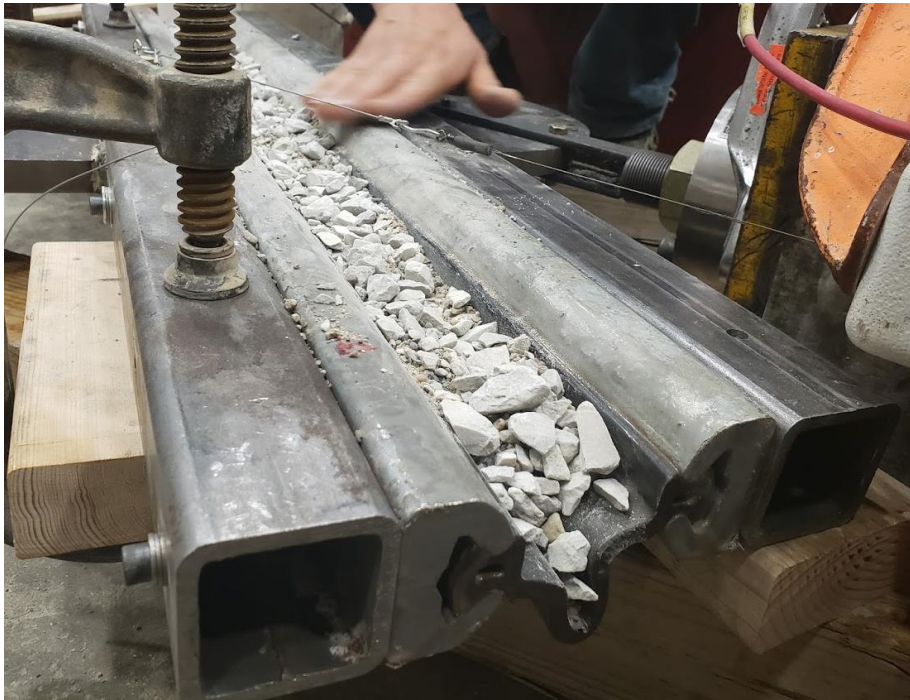
Figure 23: Half-Full Condition

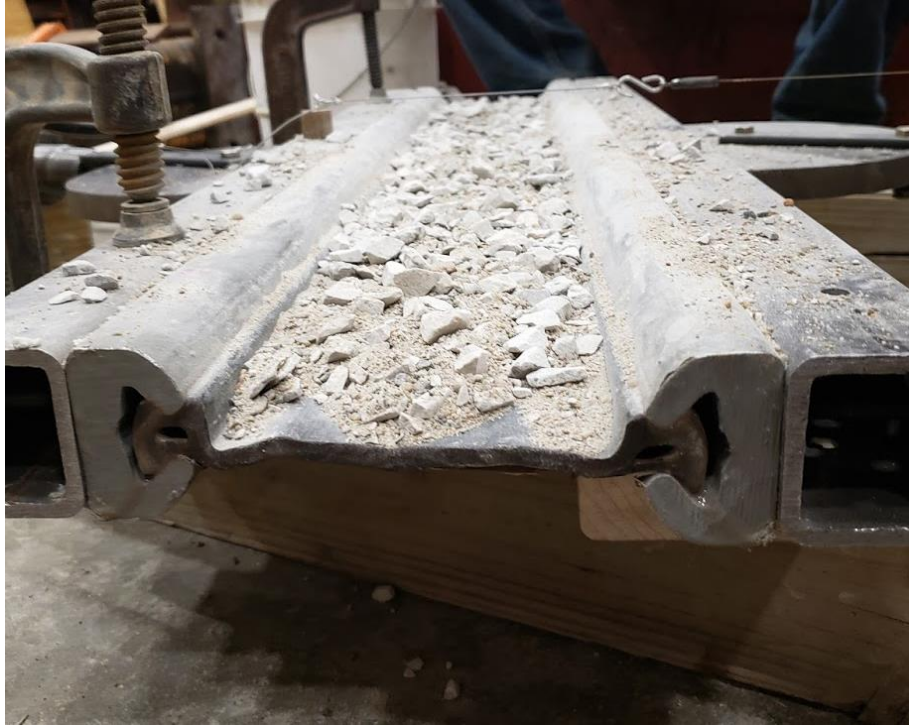
- The specimen was then reset at a 2.0” perpendicular opening width and filled with debris until flush with the top of the railing; this represented the “half-full” condition (Figure 24)

Figure 24: Half-Full Condition (Open)

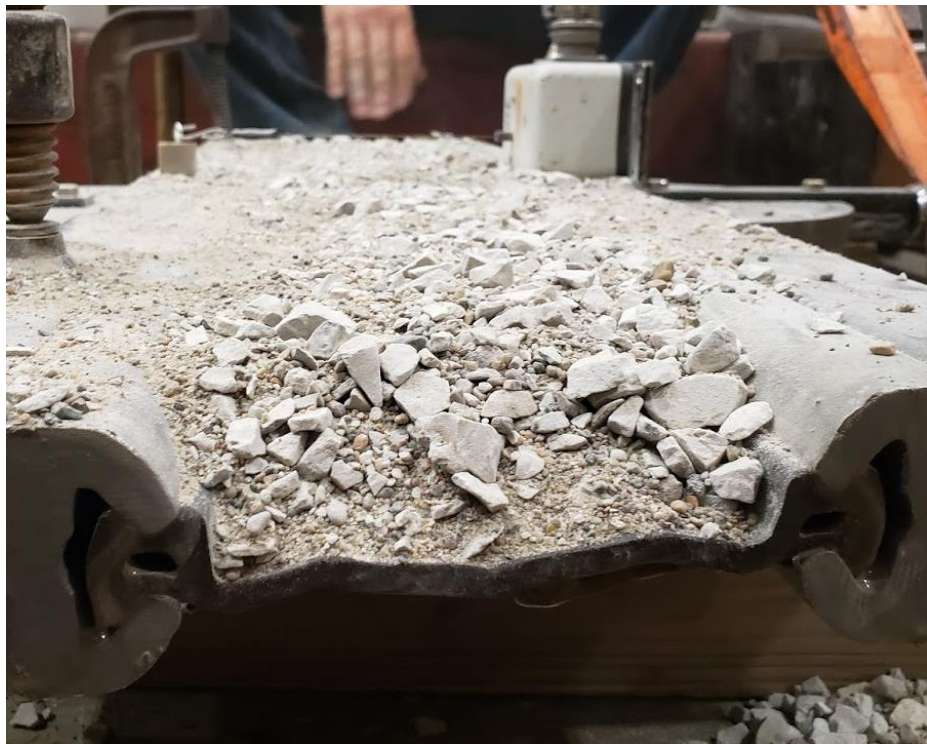
Figure 25: Full Condition

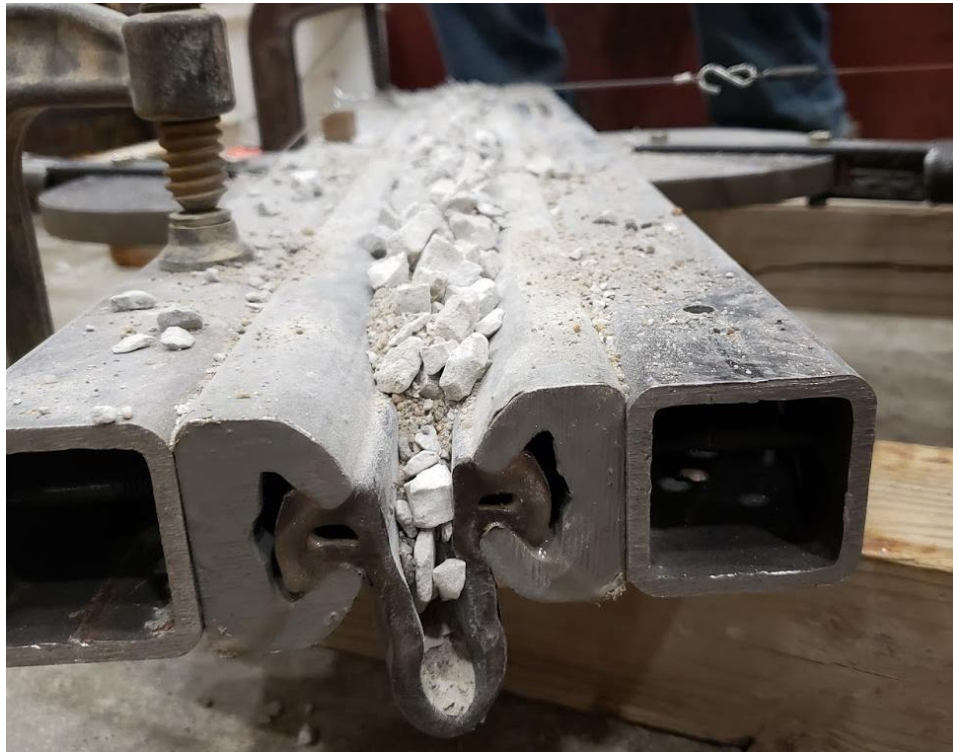
Figure 26: Restricted Closure Due to Debris (Typ.)

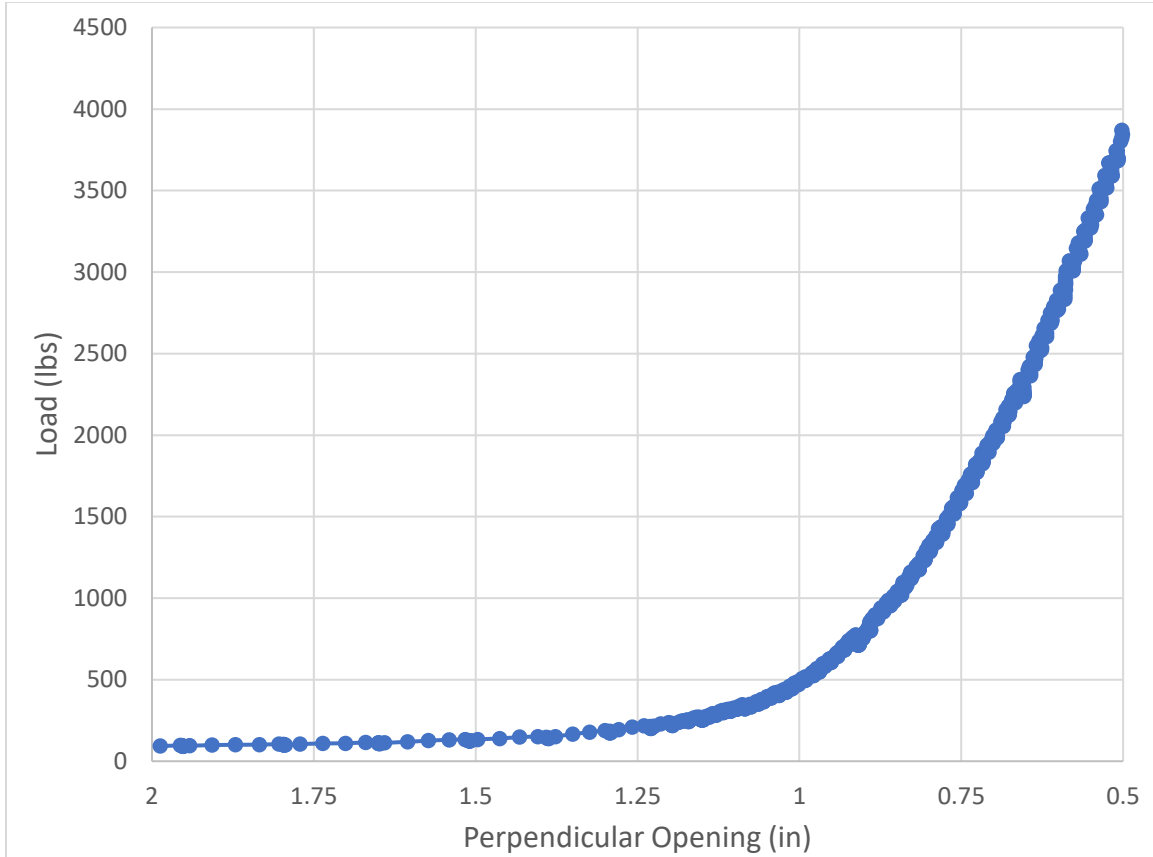
Figure 29: Zero-Degree Skew Full-Capacity Compression Data

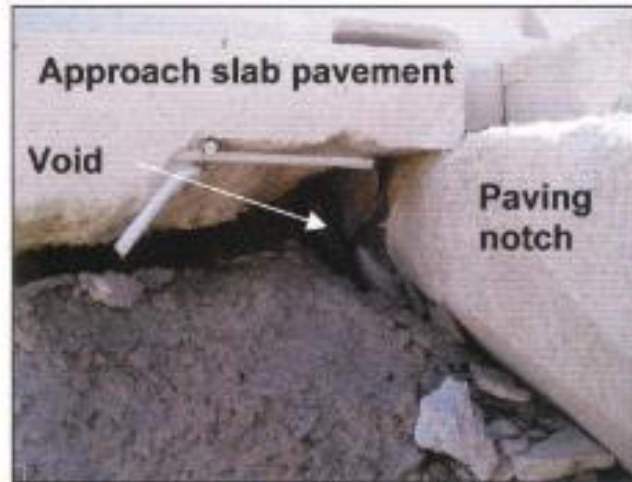
The findings presented above by Yasrobi et al. (2015) have been echoed by previous research. In a series of studies performed by White et al. (2005 & 2007) that investigated 74 Iowa bridges to quantify common issues with failed approach slabs, it was determined that severe voids had developed under 25% of the inspected bridge approaches. In addition, severe erosion was present at 40% of the bridges and 60% of the bridges had ineffective runoff. Majority of the bridges exceeded the recommended 1/200 slope proposed by Wahls (1990) and Long et al. (1998), and differential settlement of 2 to 6 inches was common at the end of the abutment wingwall. Runoff and erosion often accompany one another, as excess runoff typically leads to increased erosion underneath the approach slab. The erosion was found to typically leave a void ranging 6 inches to 12 inches between the base of the slab and the geotextile reinforced subbase (Figure 31).

Figure 30: Voiding Under Approach Slab (White, 2007)

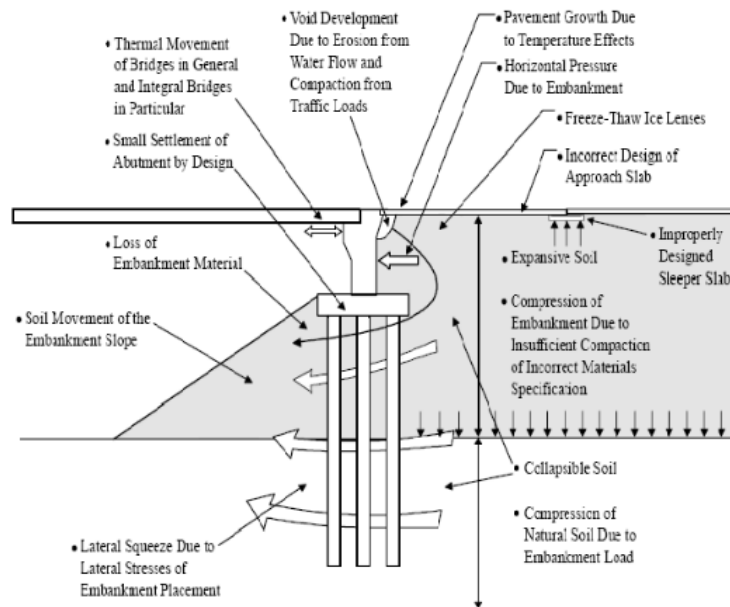
Figure 33: Problems Leading to the Formation of the Bump (Briaud et al., 1997)

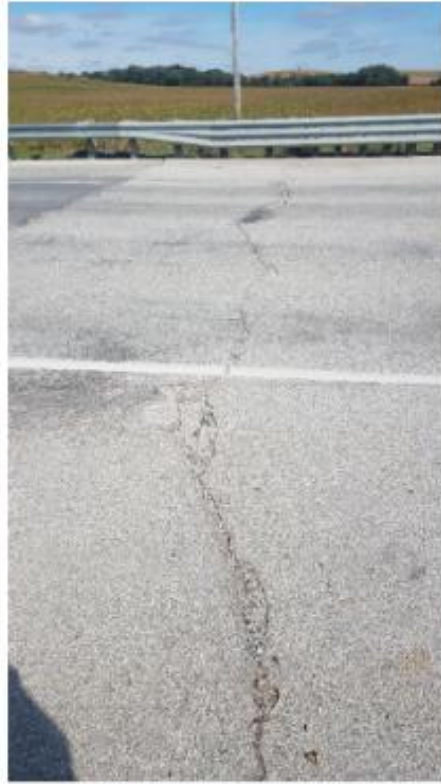
Figure 34: Transverse Cracking of Approach (Krapf, 2019)

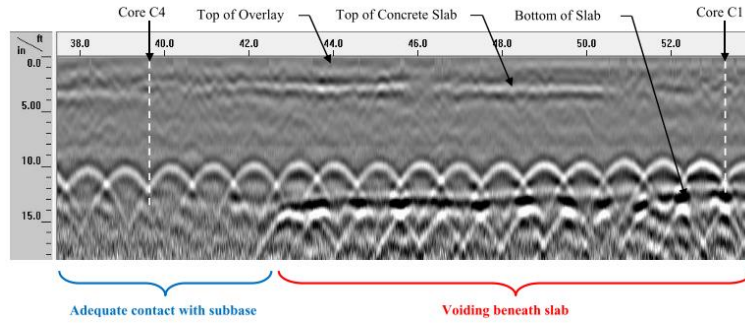
In an effort to determine how widespread the settlement and voiding situation in Iowa approach slabs was, the Iowa DOT contracted Wiss Janney Elstner Associates to perform two empirical surveys of slab performance in the state (Rende and Donnelly, 2011). The first study, performed in 2011 in the wake of a large amount of Missouri River flooding in western Iowa, utilized ground penetrating radar (GPR) and impulse-response (IR). In addition to these two forms of non-destructive evaluation, coring was performed to verify the accuracy of the acquired data. In total, 22 bridges (44 individual reinforced approach slabs) were investigated for voiding and vertical settlement, and the coring verification determined that GPR was a reliable way to scan and detect deficiencies in the soil beneath the approach slab.

Figure 35: WJE GPR Voiding Sample (WJE, 2011)

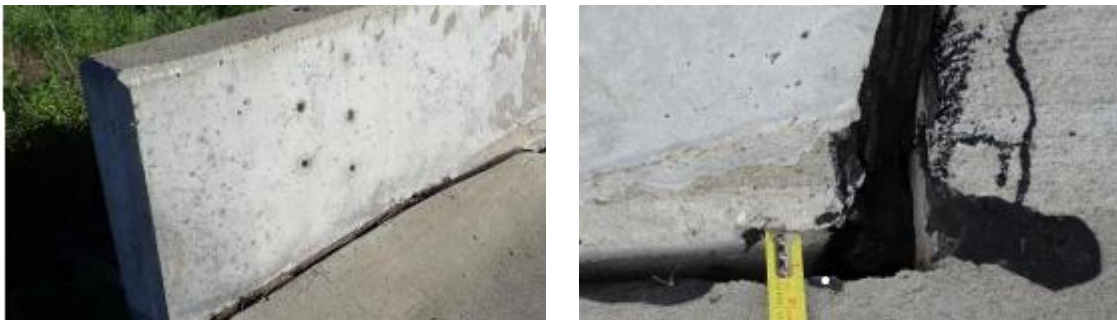
A second study with a similar intent was again conducted by WJE in 2018. In this case, the goal was to investigate the performance of 12 Iowa approach slabs with stub and integral abutments constructed between 2006 and 2015 following the implementation of design recommendations proposed by White et al. (2005). This second survey consisted of visual inspections and GPR and was supplemented by coring and borescope investigations to confirm the presence and extent of voiding. Similar to the visual inspections later performed by Krapf in 2019, a large majority of the connection joints and expansion joints had fared poorly, differing from the design plans in opening width by as much as 3 inches. The GPR and borescope inspections revealed similar performance of that observed in the 2011 report—the bridges with integral abutments displayed large voids adjacent to the abutment, likely from repeated thermal expansion and contraction. The approach slabs on these bridges are likely more susceptible to further erosion and damage as a result of these movement voids. However, it was recorded that many of these bridges were performing well structurally, although several did show signs of transverse cracking and pavement spalling. The maximum settlement and differential settlement were recorded as 1 inch and 0.4 inch, respectively. Investigation of the stub abutment bridges displayed a stark contrast to the performance of the integrally connected bridges, showing much less voiding in general.

Figure 37: Examples of Voiding at Integral Abutment Bridges (IDOT)

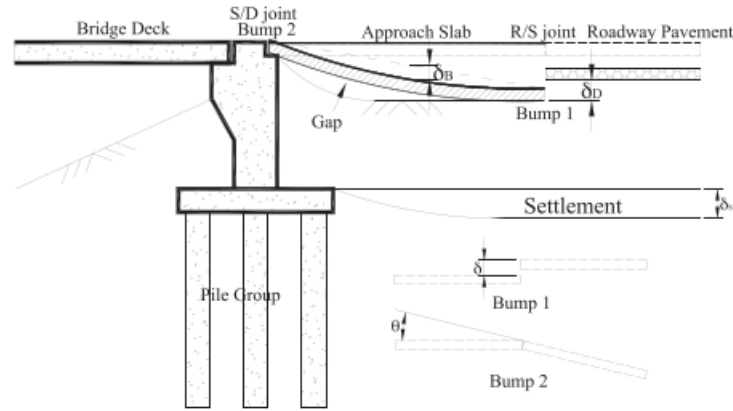
Figure 38: Approach Settlement Away from Abutment (Chen and Abu-Farsakh, 2016)

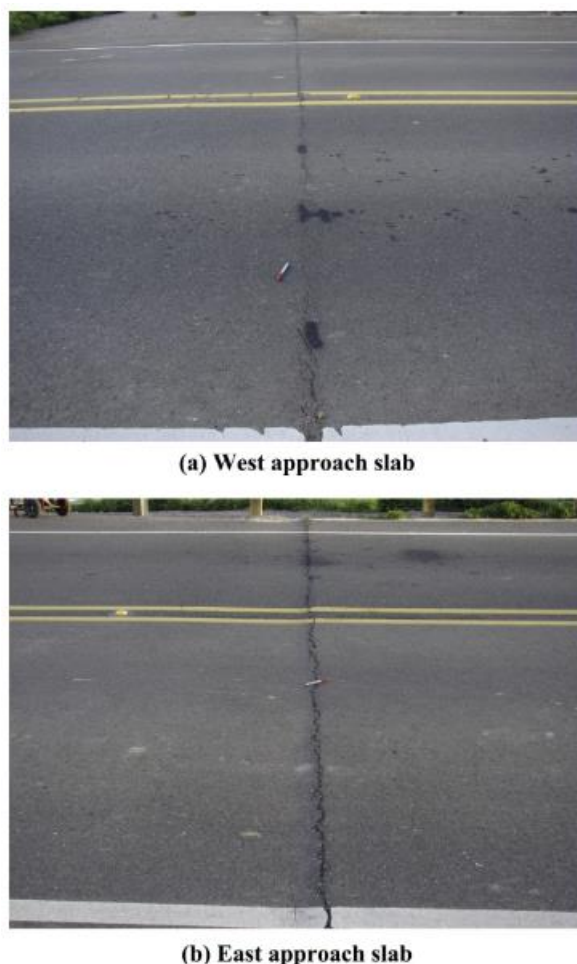
2008). It was clearly observed that an increased slab thickness and higher reinforcement ratio in the West approach slab led to significantly less cracking and reduced tensile strain values.

Figure 39: Effects of Increasing Slab Thickness and Reinforcement Ratio (Chen and Abu-Farsakh, 2016)

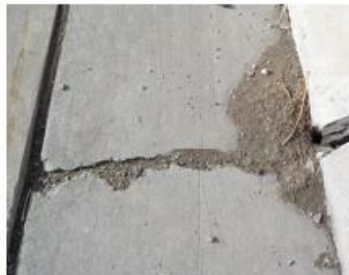
Far Approach Panel 1 Cracking

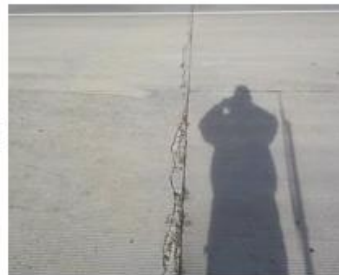
Near Approach Panel 2 Cracking

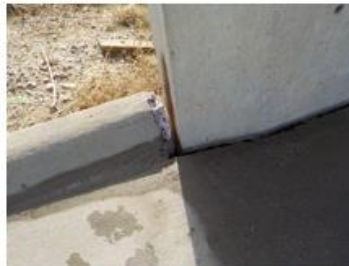
Barrier Diff Settlement/Cause of Drainage

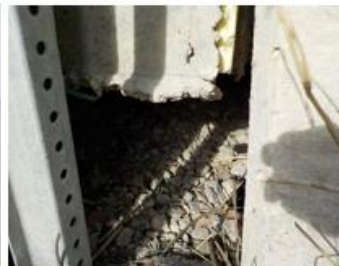
Erosion, thickness = 2 ft.

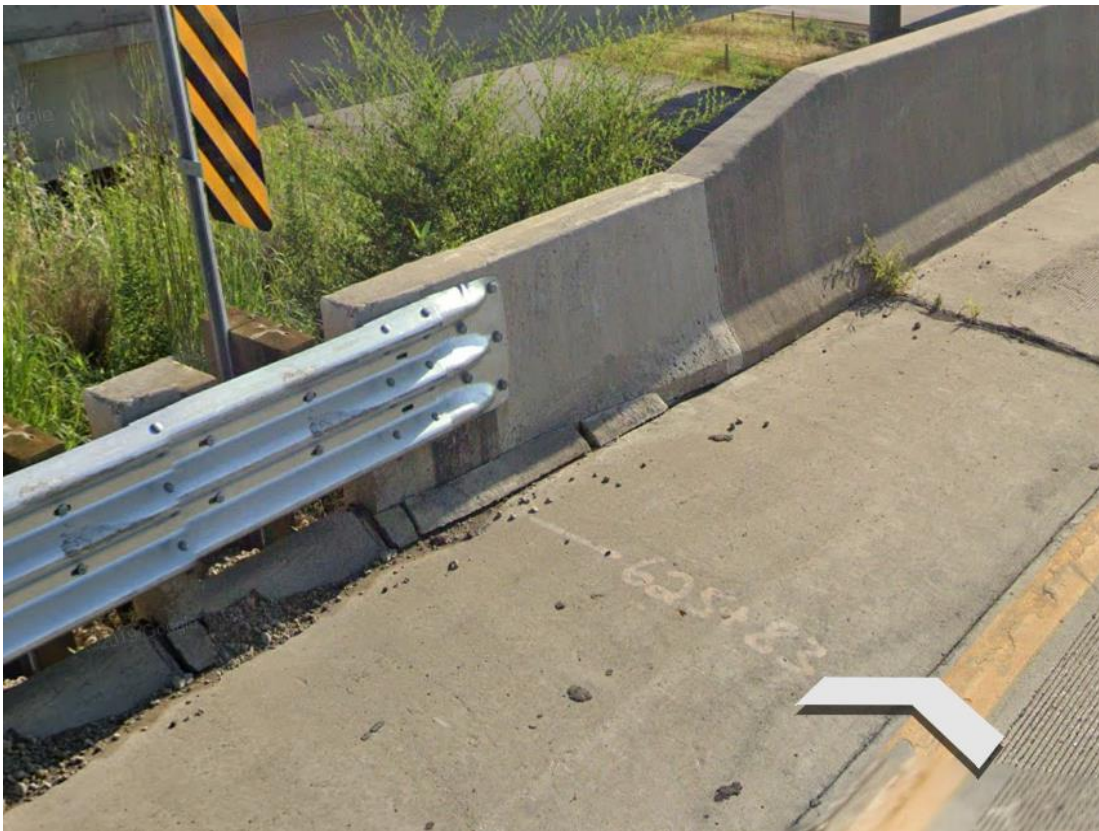
Of the ten approach slabs investigated as a part of this brief study, settlement appeared to likely be present in eight of the subjects. The most obvious sign of this settlement was the presence of cracking between the barrier rail and the approach slab shoulder, indicating that the slab had displaced vertically downward from its original position. This displacement is believed to create tensile cracking between the railing and the shoulder surface. Another obvious sign of differential settlement was the distinct difference in the height of adjacent approach slabs. Settlement appeared to be more prevalent and obvious in the approach slabs constructed prior to 2014.

Figure 40: Cracking at Barrier Rail Indicating Settlement

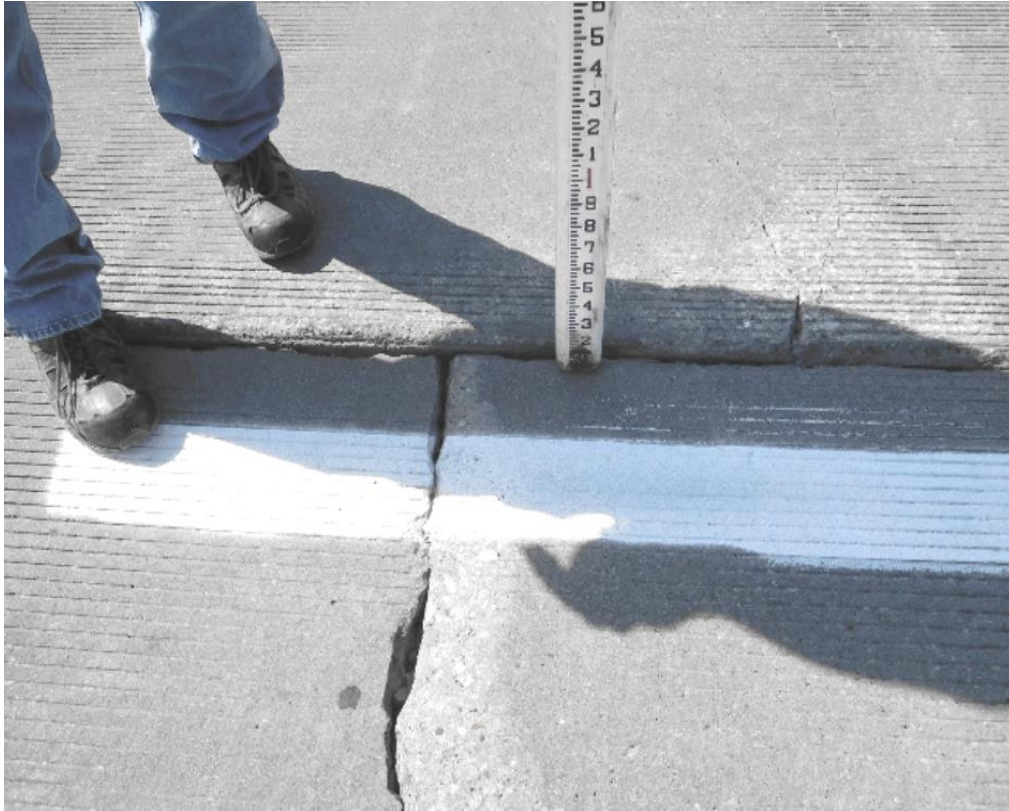
Figure 41: Differences in Slab Height Indicating Settlement

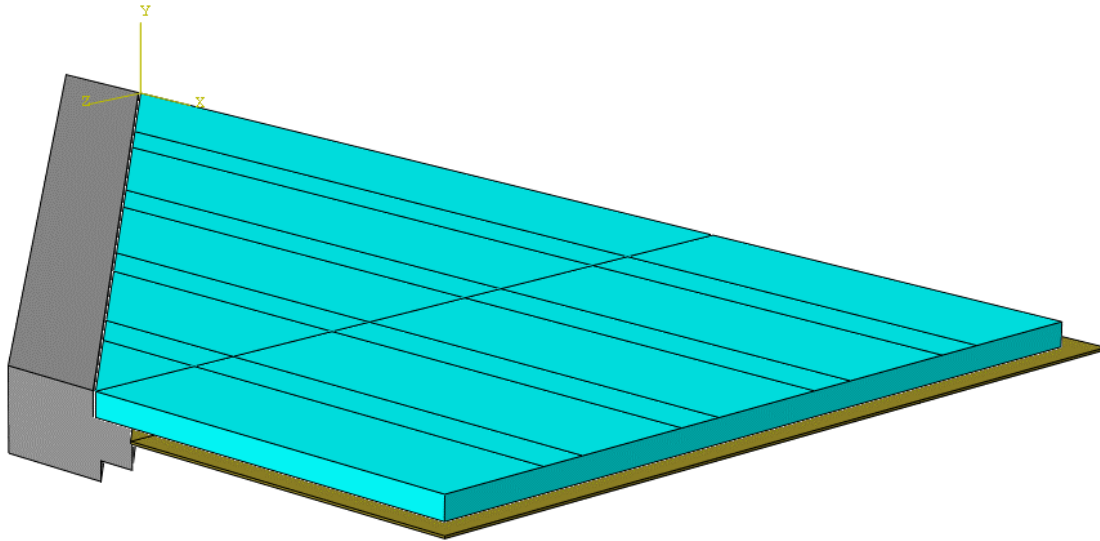
elements with spacing and bar orientation taken from the plan sets for each bridge. Paving notch connection dowel placement and angle were taken from a combination of plan sets and IDOT design standards.

Figure 42: Jasper FE Assembly

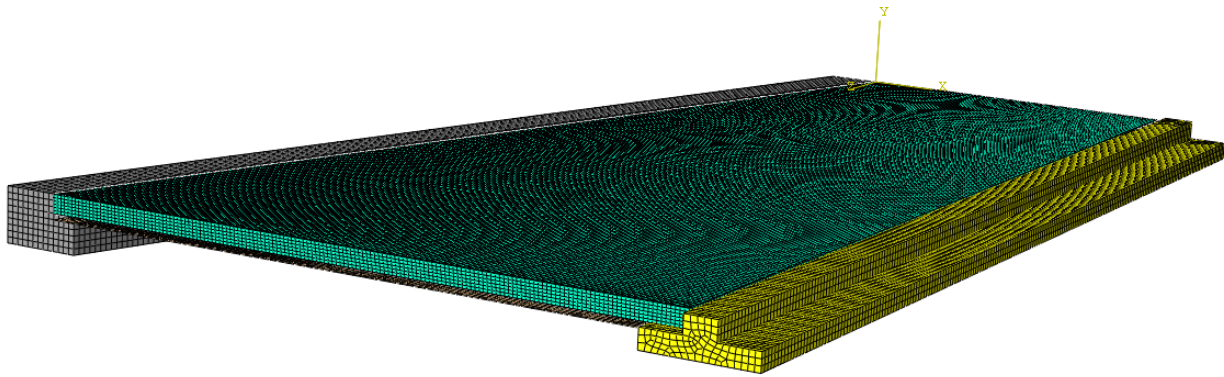
Figure 43: Story FE Assembly and Mesh

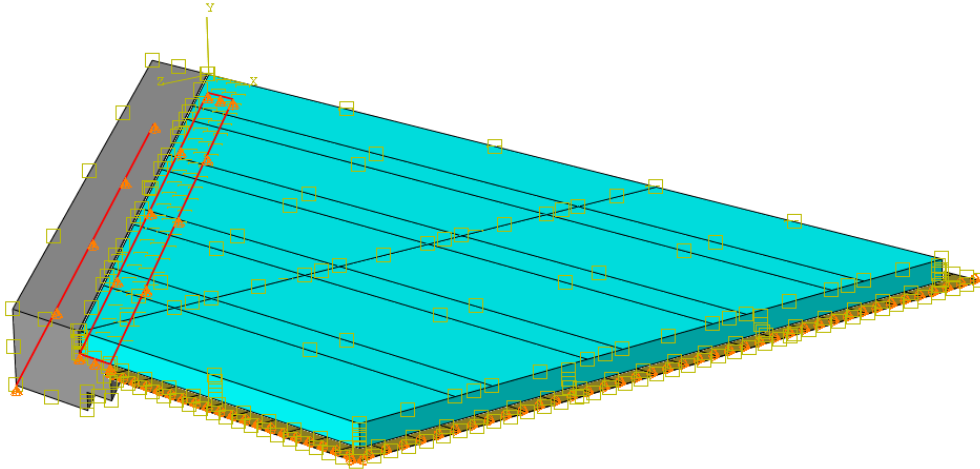
Boundary conditions for these models were modified from earlier research to allow for accurate representation of approach slab settlement. The entirety of the abutment was not modeled as it would needlessly increase the complexity and runtime of the models. Instead, the top portion of the abutment was modeled to provide support for the approach slab as it would in the field bridge. The portion of the abutment that was removed was replaced with a roller to represent the "moveable" abutment condition. Non-vertical movement of the soil condition was restricted to represent soil support surrounding the modeled soil block. No explicit boundary conditions were placed on the approach slab, but it was supported by the abutment, soil and springs, and sleeper slab in the case of the Story County bridge.

Figure 44: Jasper Boundary Conditions

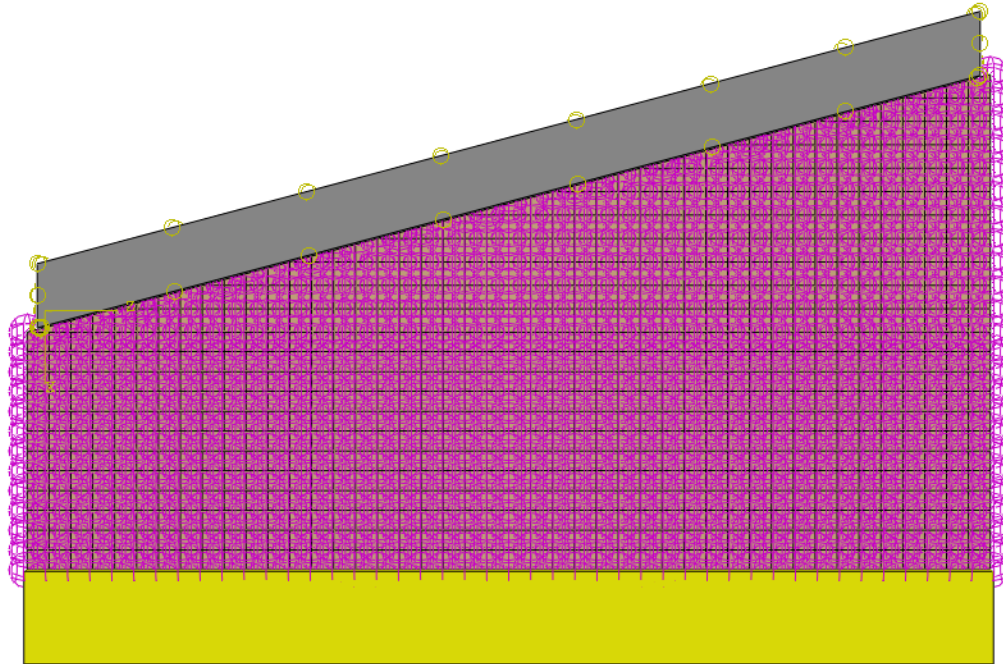
To ensure that the loading and spring scenarios in each of the two models were accurate and would appropriately model the anticipated settlement once loading was applied, a calibration model was also originated. Set in a simpler configuration than the two models mentioned previously, the parts for the test model consisted of a 10-foot by 10-foot by 10-inch concrete slab resting on a thin of soil and a linear spring grid. As this model was to verify the effects of gravity and settlement, no additional support conditions were applied, and no abutments or sleeper slabs were added. Accounting for the volume of concrete and the load applied to the slab, hand-calculations were performed to and a theoretical settlement of one inch was calculated. The model analysis was run and correctly displaced one inch vertically in the negative Y direction, indicating that the slab had settled as expected. This verified that the material properties, load application, and spring linear springs were performing as intended with no unusual irregularities.

Figure 45: Story FE Model Spring Layout

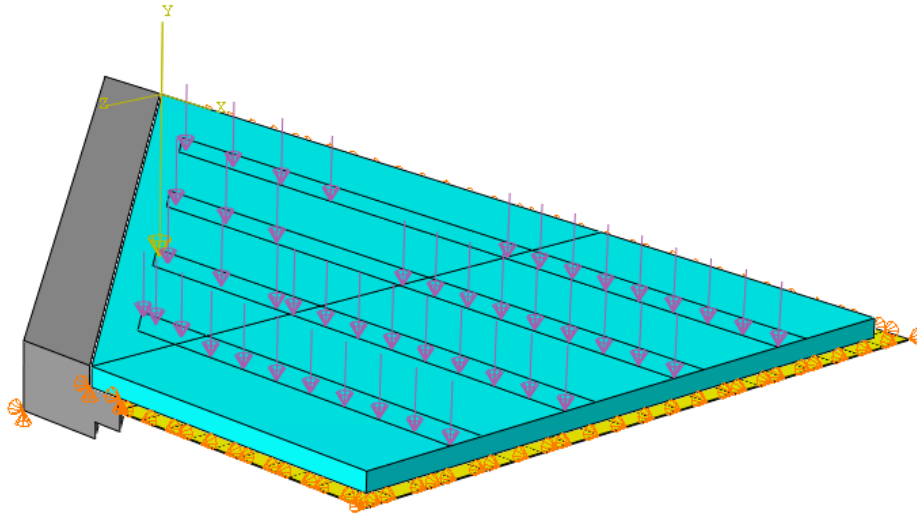
Loading for the model consisted of the self-weight of the slab coupled with expected loading from truck traffic. Per the normal strength concrete used in these approach slabs, the material density for the slab concrete was set as 0.087 with the gravity set to -1; this produced an end weight of 150 pounds per cubic foot of self-weight. The weight of HL-93 design trucks was used to simulate field loading, and the number of trucks simulated on each approach slab was determined by the number of available lanes. As the purpose of this study was to determine the effects of gradual settlement of the slab, it was deemed reasonable to model the total load of each truck as two distributed tire loads running in the direction of traffic. One truck's worth of load was applied for each traffic lane present on the approach slab. In the case of the Jasper model, a maximum loading scenario consisted of two trucks crossing the bridge simultaneously. As the Story County bridge is expected to accommodate three traffic lanes in the future, it was modeled with the weight of three truck paths.

Figure 46: Jasper FE Model Loading

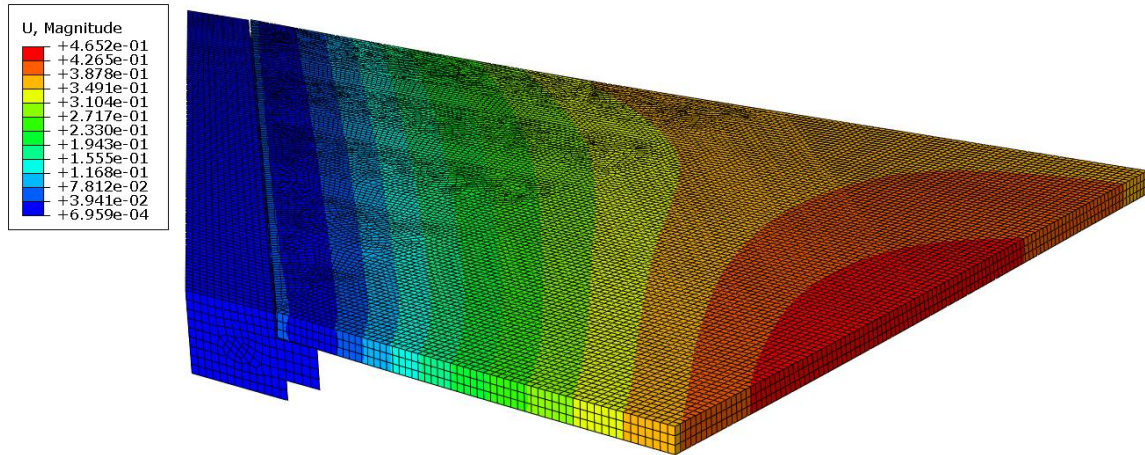
Figure 47: Jasper Base Displacement
