Investigating serviceability issues related to thermal movement accommodation in bridges

Conor Duffy
Iowa State University

MASTER OF SCIENCE

Major: Civil Engineering (Structural Engineering)

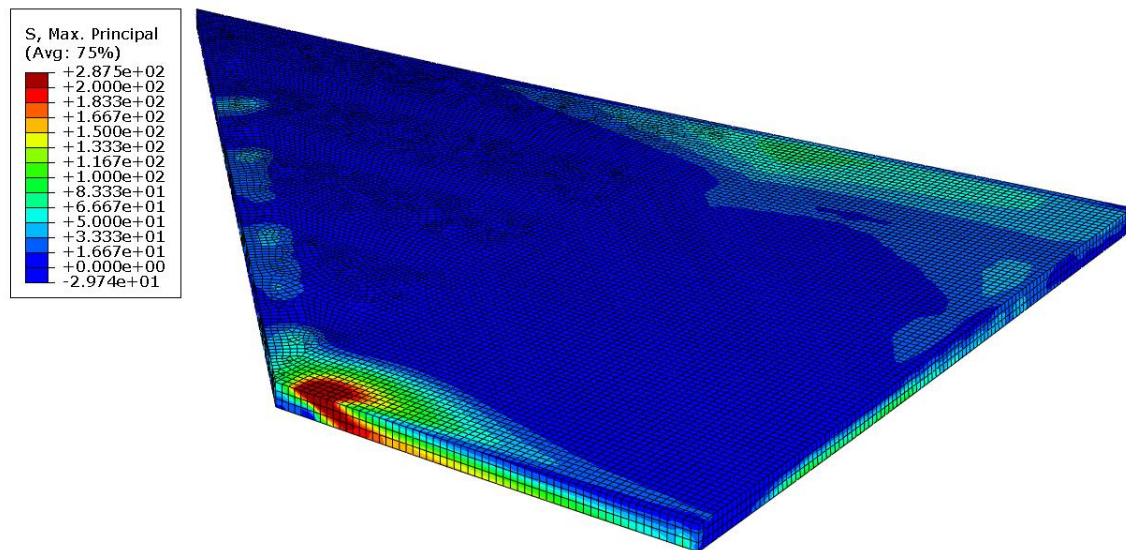
edge of the paving notch. These high tensile stress values likely occur due to the rotation occurring on either side of this point, creating an area of high flexure in the top of the slab. High tensile stresses were also noted on the underside of the approach slab due to the abutment supporting on end of the slab while the other end displaces vertically, creating flexure in the bottom of the slab. The highest of these stresses was recorded as 230 psi.

Figure 48: Jasper Base Model Stress Distribution (Top)

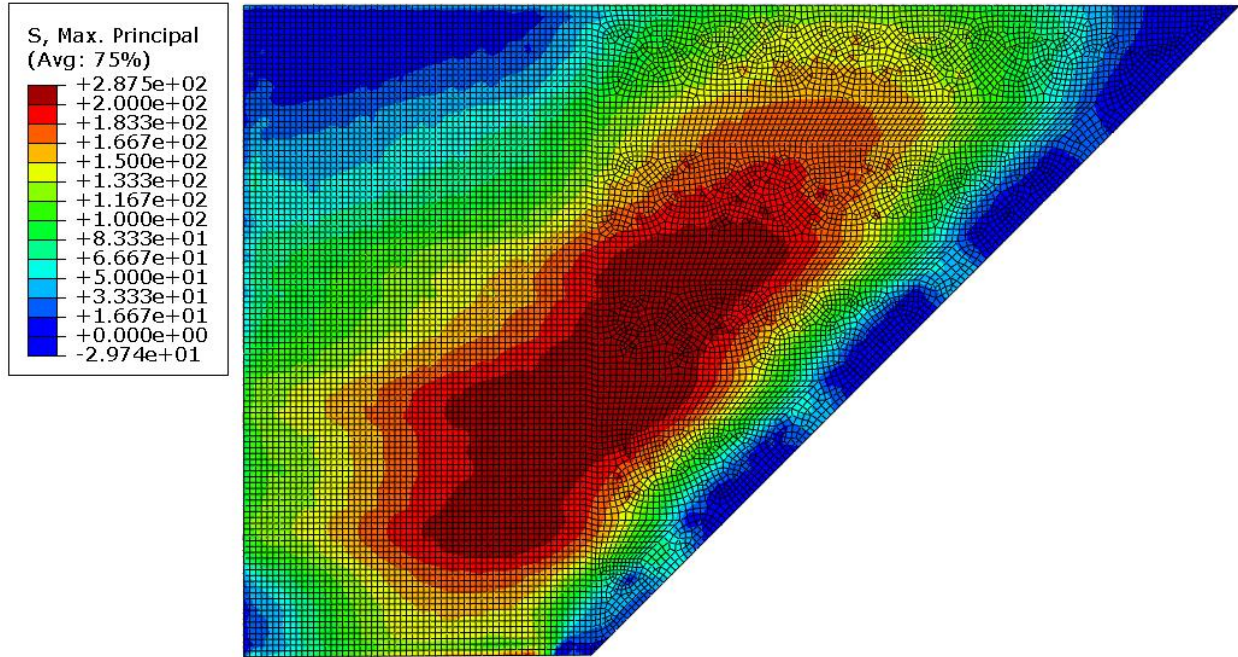
Figure 49: Jasper Base Model Stress Distribution (Bottom)

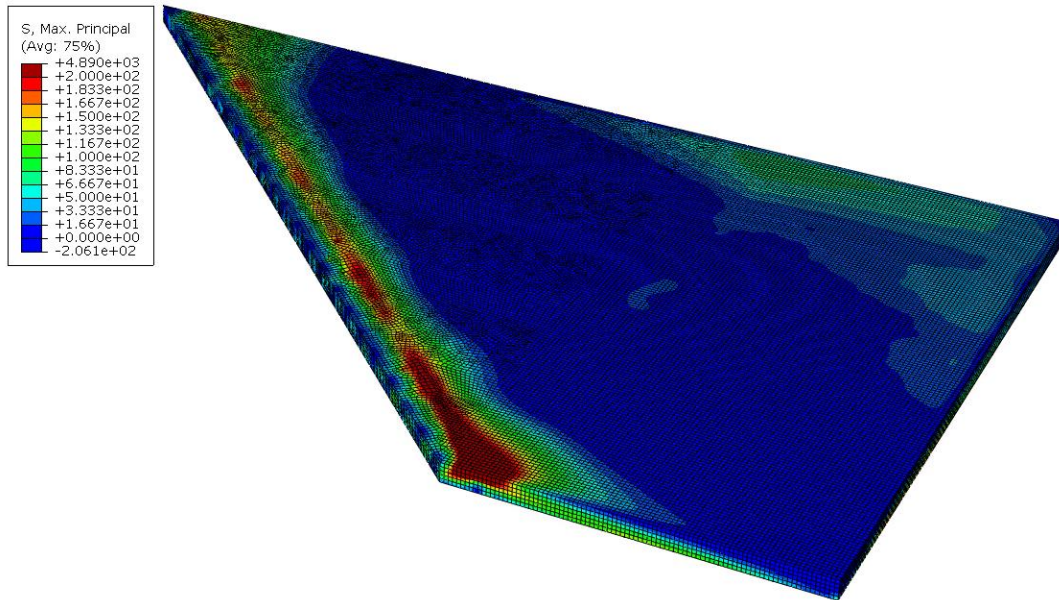
Removing the damage parameters removed any convergence issues, and the model completed running without any additional errors. While this is a less-accurate view of determining how and when the model would fail, it does provide a general view of how the stresses in the model would develop past the point of initial failure in the connection joint. Similar to the original Jasper model, the area with the highest stress values occurs at the obtuse corner in the top of the slab. However, the stress value in this area at one half inch of settlement was now recorded as 440 psi, as opposed to the 287 psi noted in the original model. This indicates that the rotation restriction introduced by the connection dowels results in increased amounts of tensile stress along the top portion of the slab about the connection joint.

Figure 50: Linearly-Elastic Jasper Model Stress Distribution

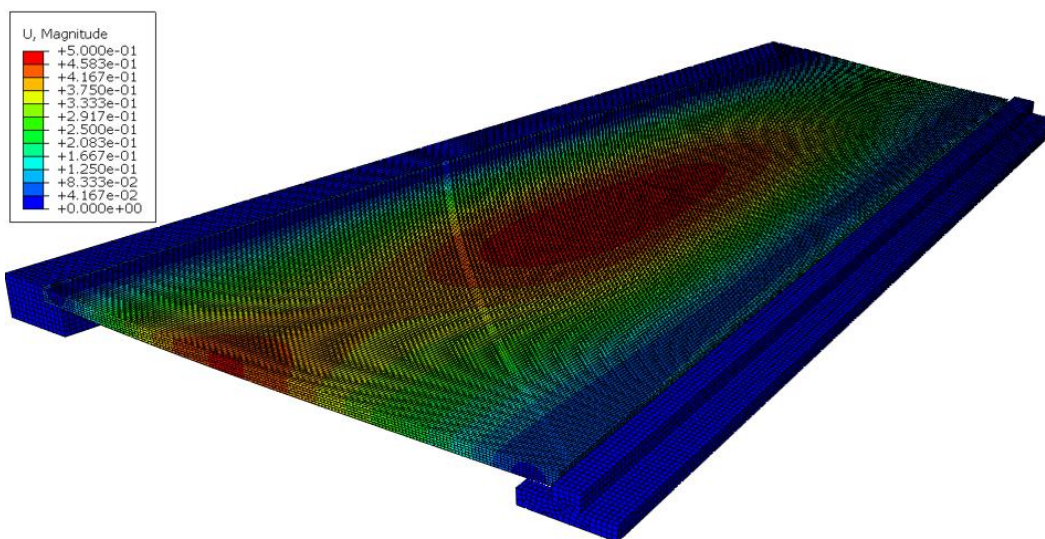
An initial model with no erosion or voiding was run to gain insight into how the approach slab would behave in a best-case scenario. Again, this version adapted the thermal movement models from previous research to account vertical displacement due to settlement. Initially, adequately stiff soil was used to create a base model with a minor amount of settlement. As expected, the slab was supported on each end by the abutment seat and sleeper slab, resulting in a max displacement 0.0673 inches roughly near the middle of the slab. Based on this flexural behavior, it follows that the tensile stresses in the bottom of the slab were much higher than those in the top—161 psi compared to 27 psi, respectively. The highest stress values were observed in the concrete surrounding the embedded connection dowels with a peak value of 270 psi. This is likely a result of the dowel being pulled away from the abutment as the approach slab attempts to rotate at the abutment seat due to settlement. It is important to note that the boundary conditions of this model operate under the assumption that the sleeper slab undergoes no settlement. This is to ensure that the model focus is on whether the approach slab has been designed to adequately span the distance between the abutment and sleeper slab should a full loss of soil support occur.

Figure 51: Initial Vertical Settlement for Story County Approach Slab

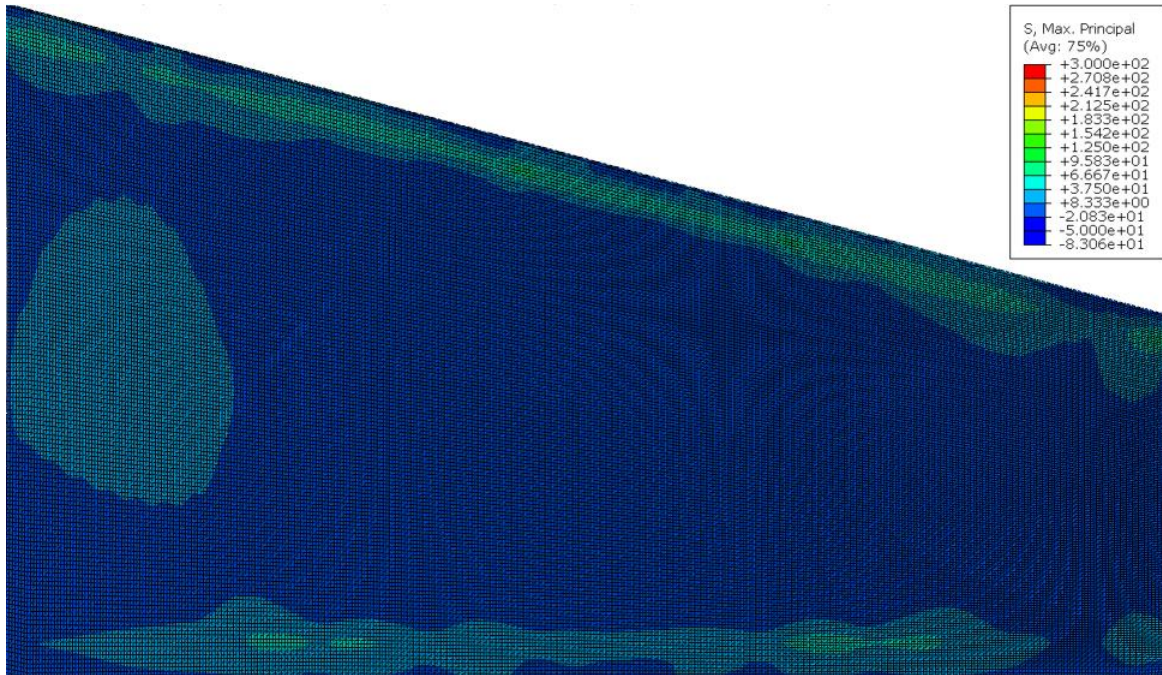
Figure 52: Initial Stress Values for Story Model (Top)

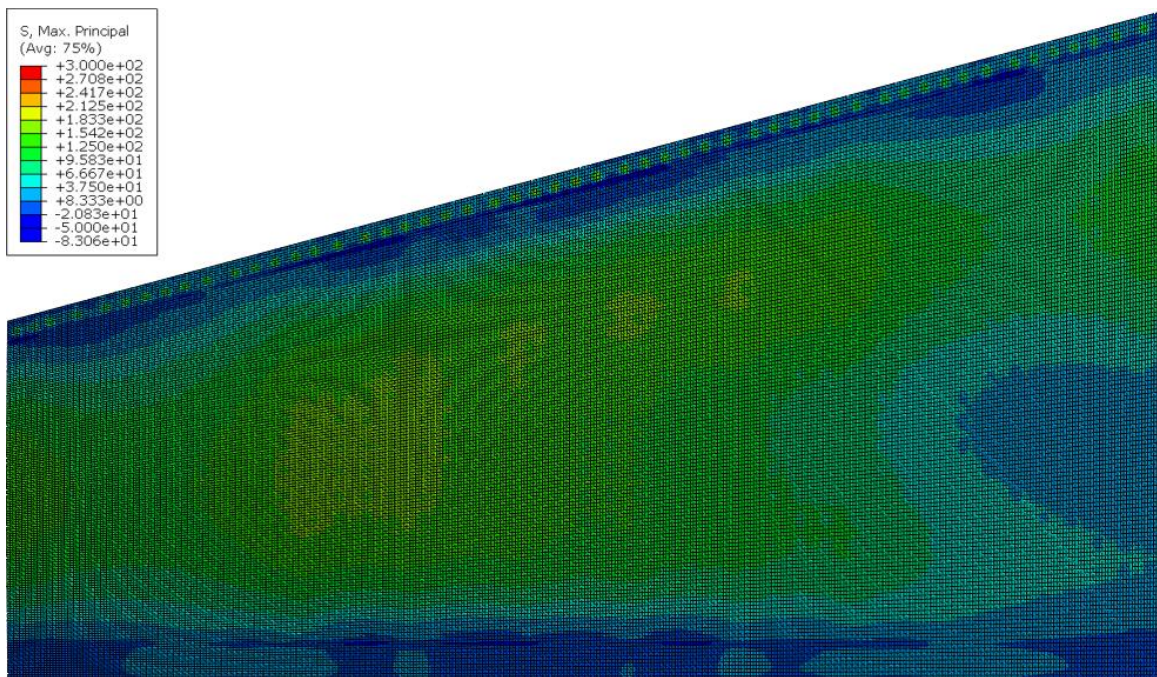
Figure 53: Initial Stress Values for Story Model (Bottom)

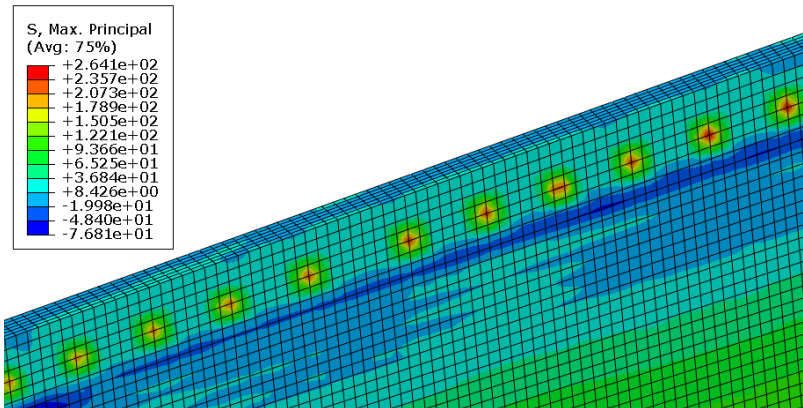
Figure 54: Stress Concentrations at Dowel Connection

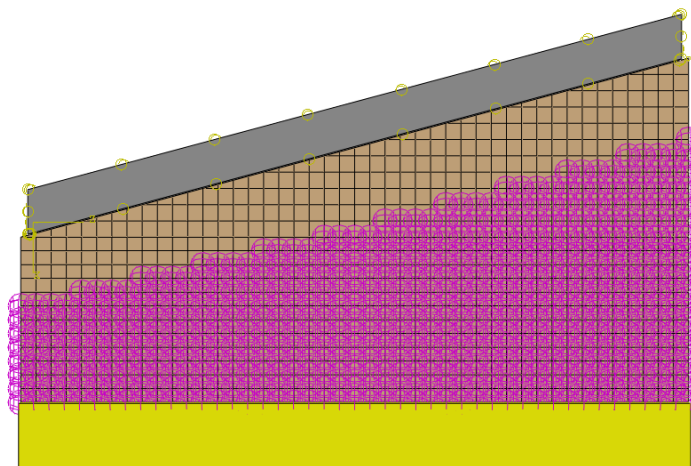
Following a similar approach to those performed by Nassif (2002) and Oliva (2011) on similar projects, voids due to erosion were modeled by removing the soil springs directly adjacent to the abutment in varying lengths. The lengths and patterns of voiding scenarios were modeled based on those observed in the two WJE research reports (2011, 2018), which indicated that voiding generally follows the same skew angle as the abutment. An example of the spring layout for an 8-foot simulated void is given in Figure 53. Test models were run for voids of 5, 8, 10, 13, and 16-feet to determine the point where the structural rigidity of the approach slab would be compromised begin to excessively deflect and show signs of cracking.

Figure 55: Story County 8-Foot Void Scenario

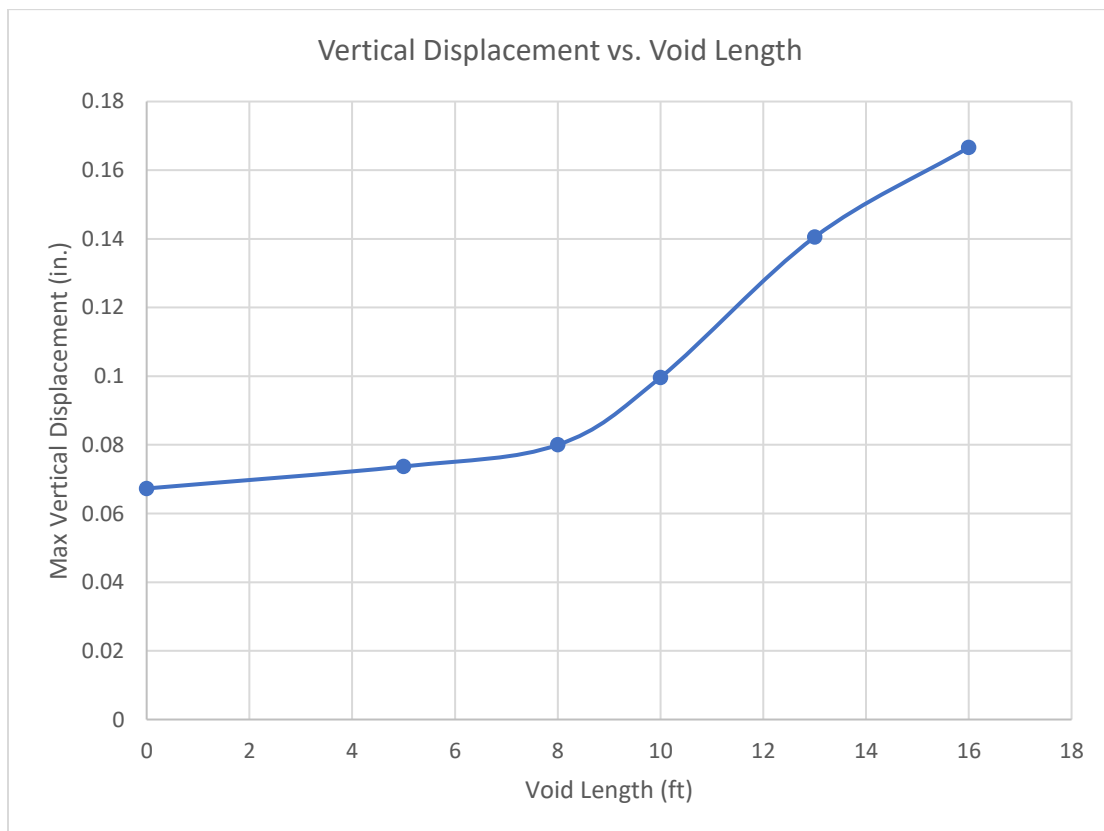
the tensile cracking stress for 4 ksi concrete is roughly 474 psi. It is in this range that the concrete at the connection joint begins to fail, beginning to crack around 474 psi at a deflection of 0.13 inches. The peak stress observed in the connection joint was recorded at 461 psi prior to the failure of the concrete in the joint for both the 13-foot and 16-foot models, and it appears that the concrete in the connection joint may be susceptible cracking at a void length of around 11 feet. Once the concrete in the connection joint begins to fail, it is anticipated that the displacement of the slab will become more drastic as the dowels will no longer be able to transfer force through the broken concrete in the slab. Once this occurs, the slab will begin to sink into the erosion void below, creating a “bump” between the approach slab and the abutment.

Figure 56: Max Vertical Displacement vs. Void Length

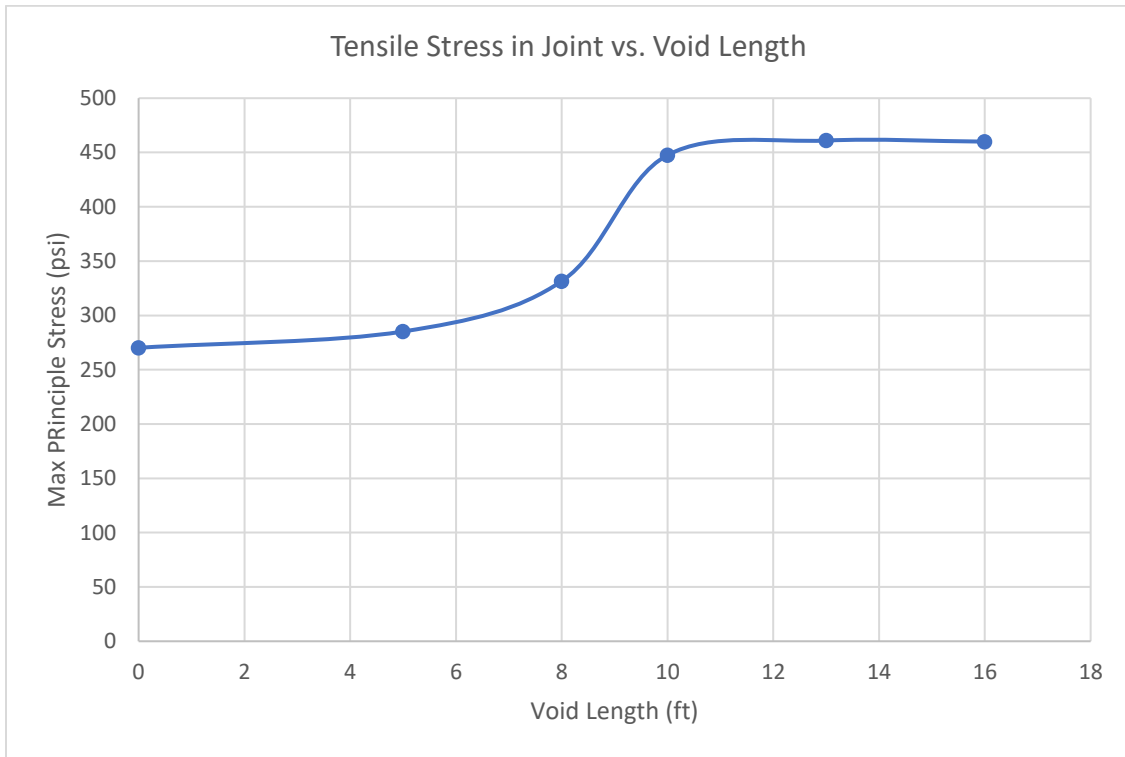
Figure 57: Concrete Tensile Stress in Joint vs. Void Length

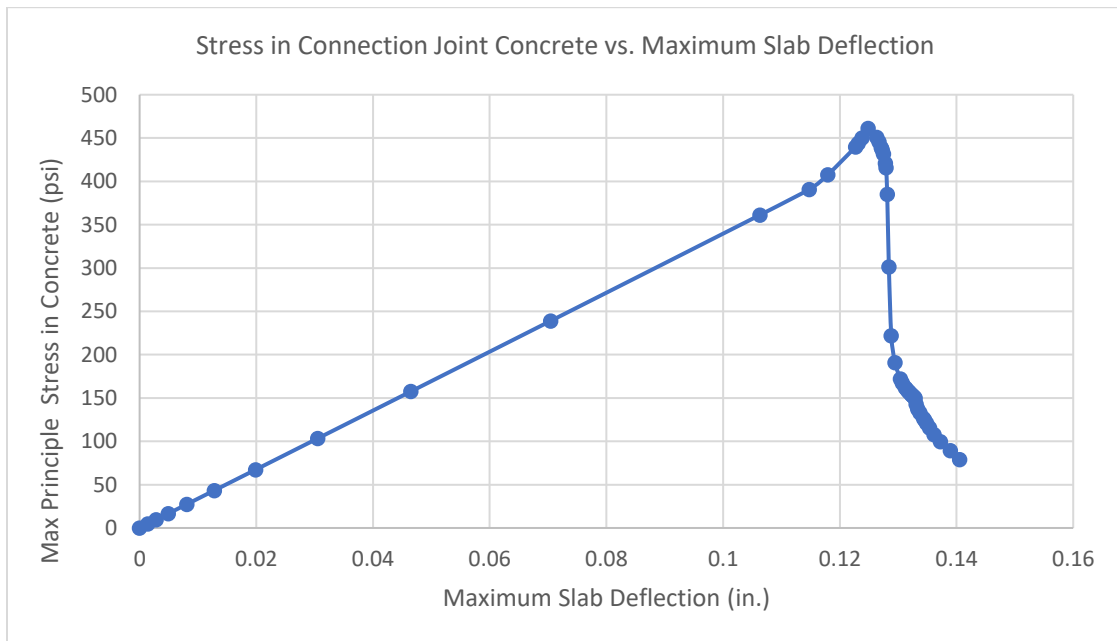
Figure 58: Tensile Stresses in Connection Joint (13-foot void)

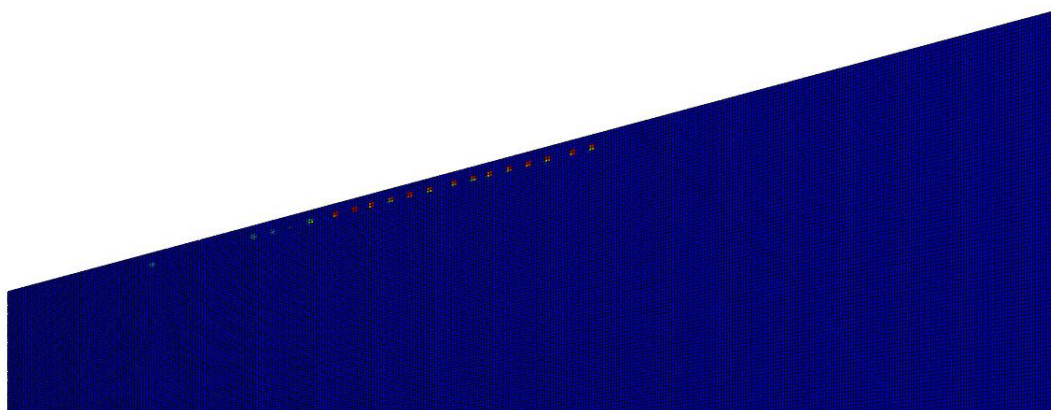
Figure 59: Locations of Damage-Based Failure in 16-Foot Void Model

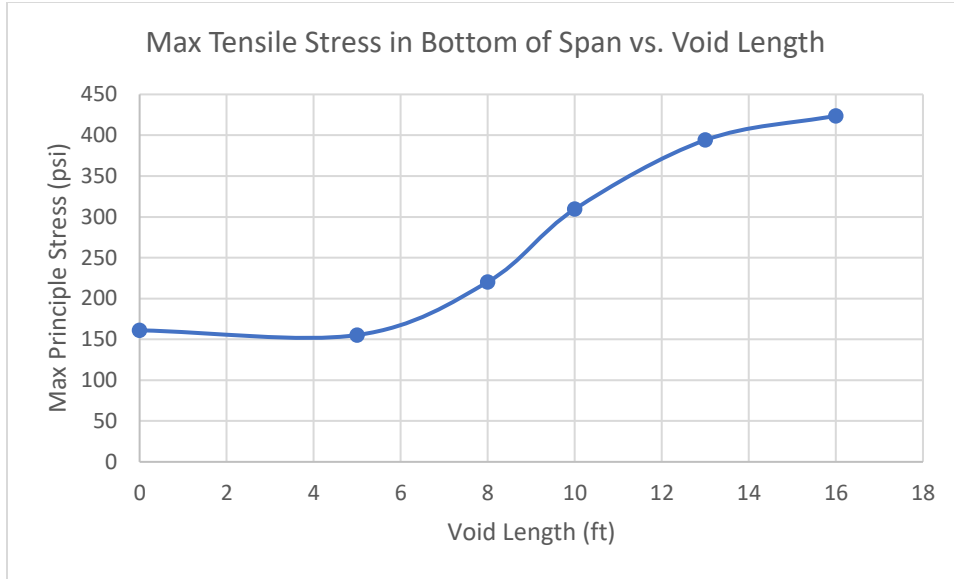
Between the base model and the model with the 5-foot void, tensile stresses in the area with the most vertical settlement remained around 157 psi. As with the stress increases observed in the connection joint, the tensile stresses mid-void begins to increase between the 5-foot and 8-foot void models, reaching a maximum value of 220 psi. This value increases again for the 10-foot model, reaching a maximum stress of 309 psi. For the 13-foot and 16-foot models, stresses continue to increase at the middle of the erosion void, reaching 394 psi and 424 psi, respectively.

Figure 60: Max Tensile Stress in Bottom of Span vs. Void Length

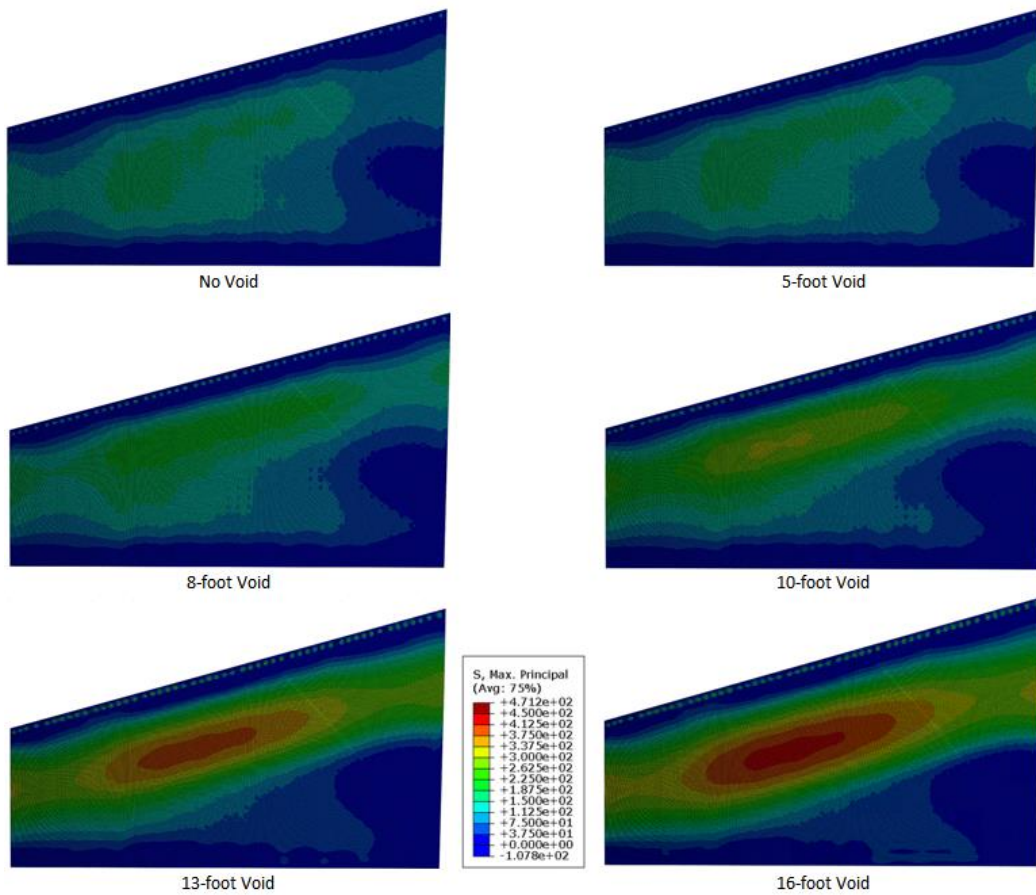
Figure 61: Maximum Principle Stress in Each Model

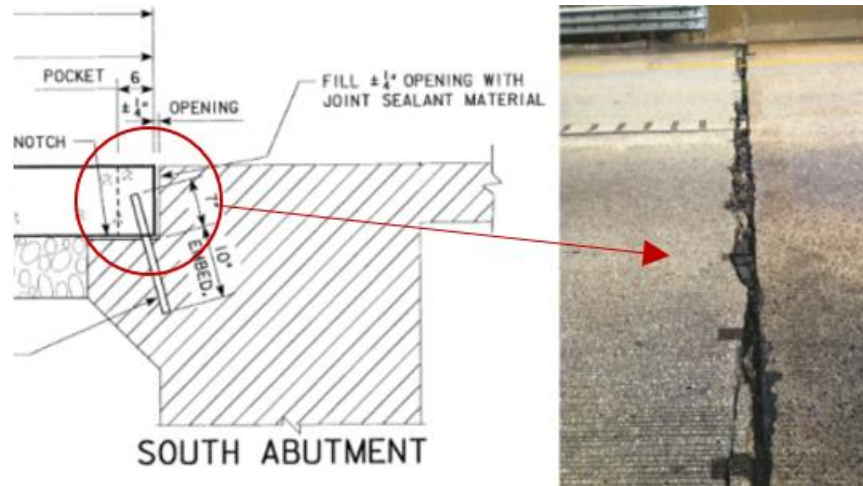
An important aspect to determining future design detail changes is the review and monitoring of previously-built structures. During the routine inspections performed each year on Iowa's bridges, it was noted that a specific bridge in Washington County, Iowa, was experiencing a particularly poor aging of each of its approach slabs. As this bridge, which consists of precast approach slabs tied to an integral abutment, fits the scope outlined for this project, it was identified as a useful subject for further inspection. As shown in the figure below, the approach slabs for this bridge experienced severe spalling directly above the tied connection dowels between the abutment and the approach slab.

Figure 62: South Approach Slab Spalling Location

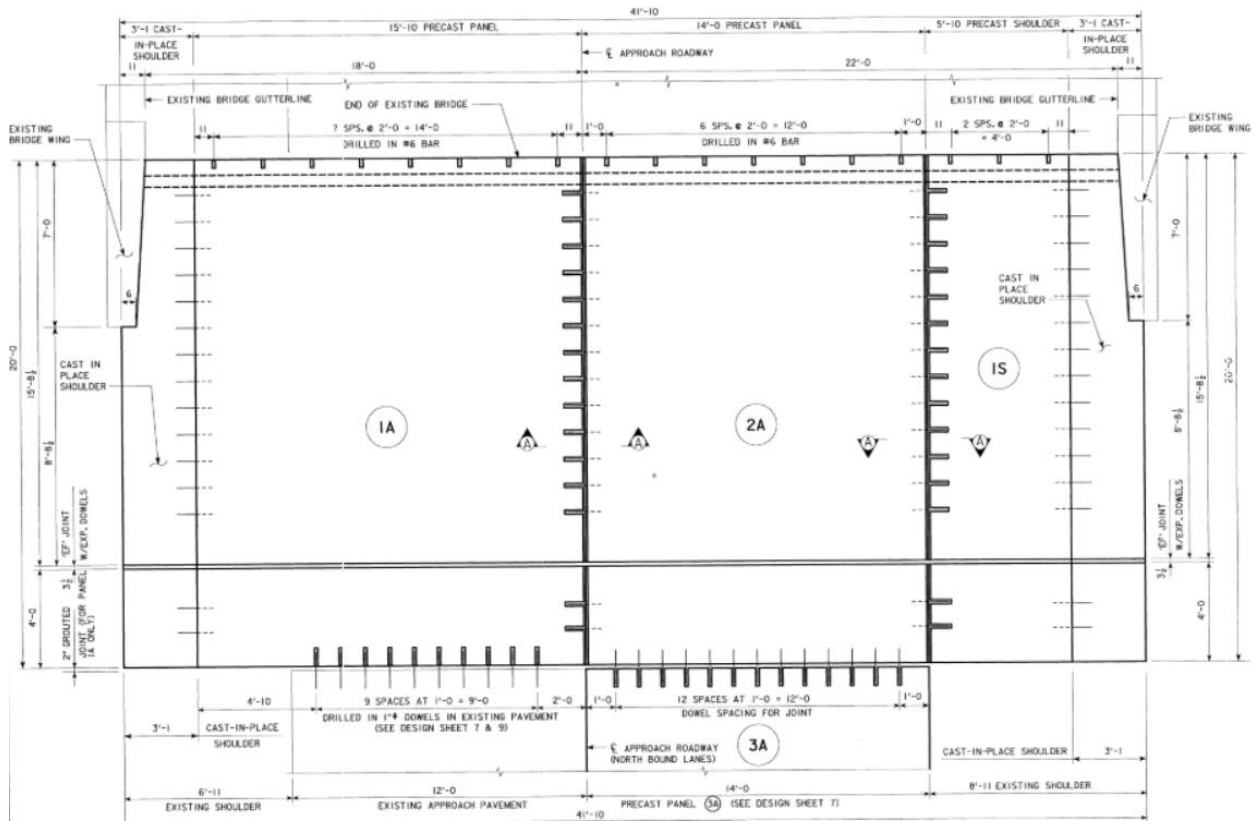
Figure 65: Layout of Precast Panels at Abutment

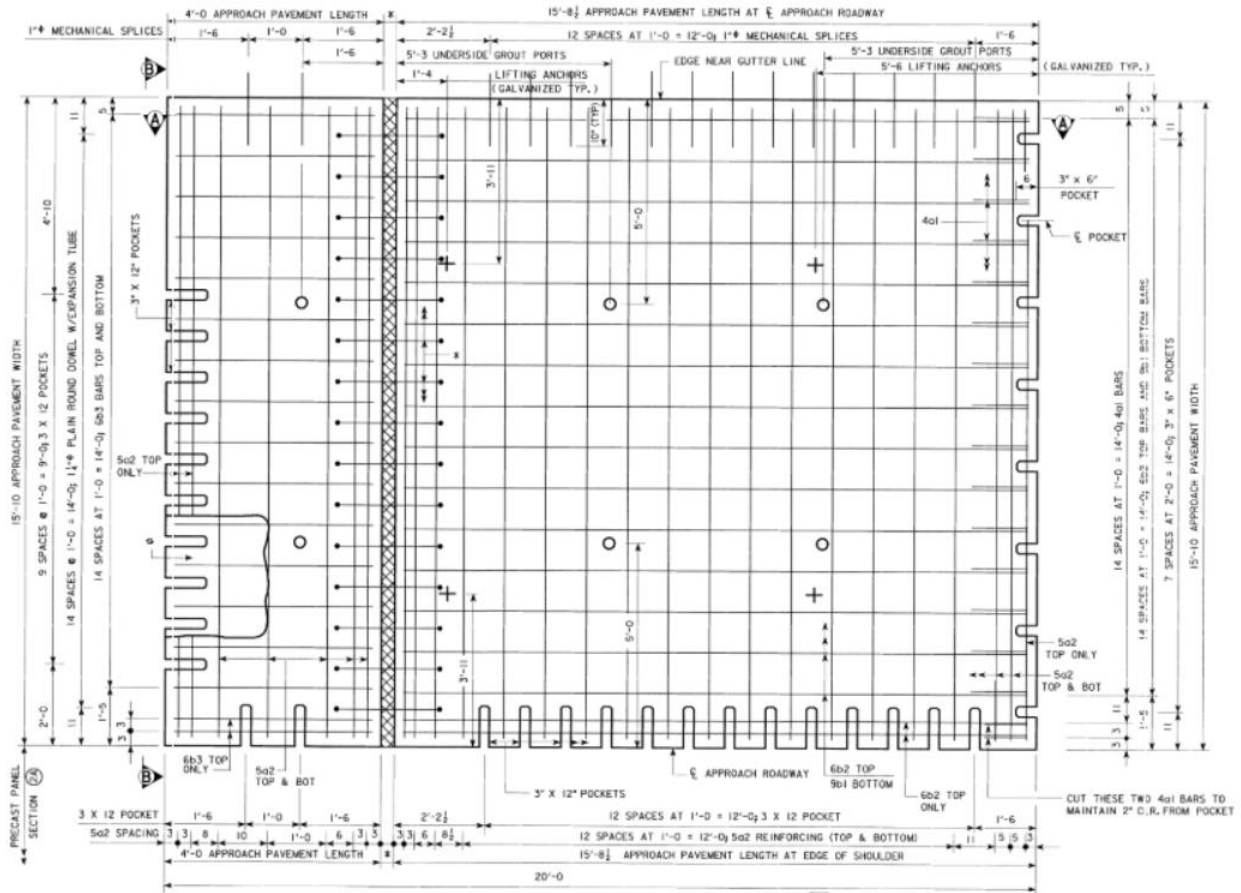
Figure 67: Rebar Layout for Panel 1A

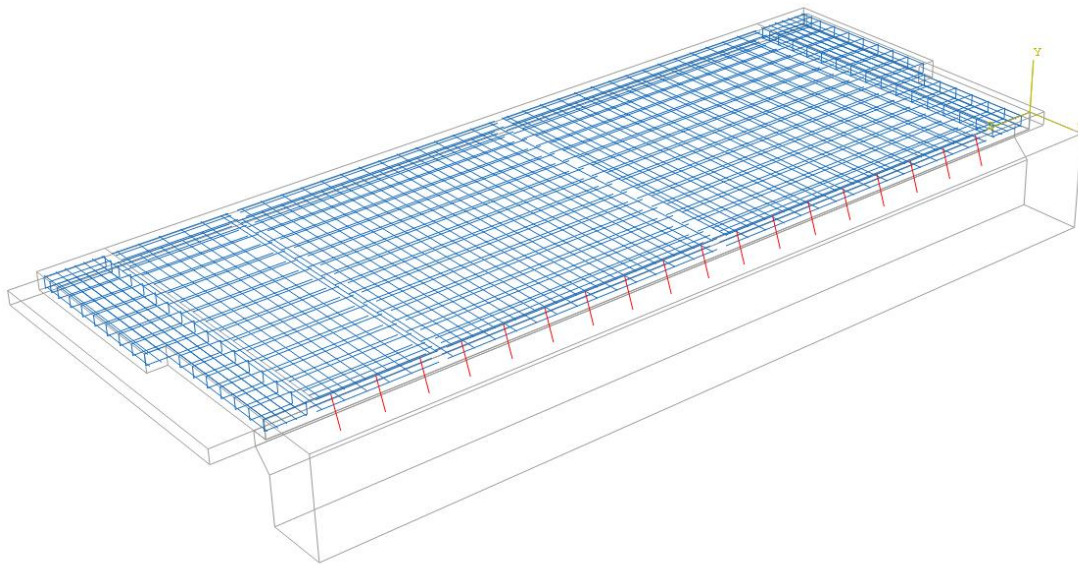
Figure 68: Washington Rebar and Connection Dowels

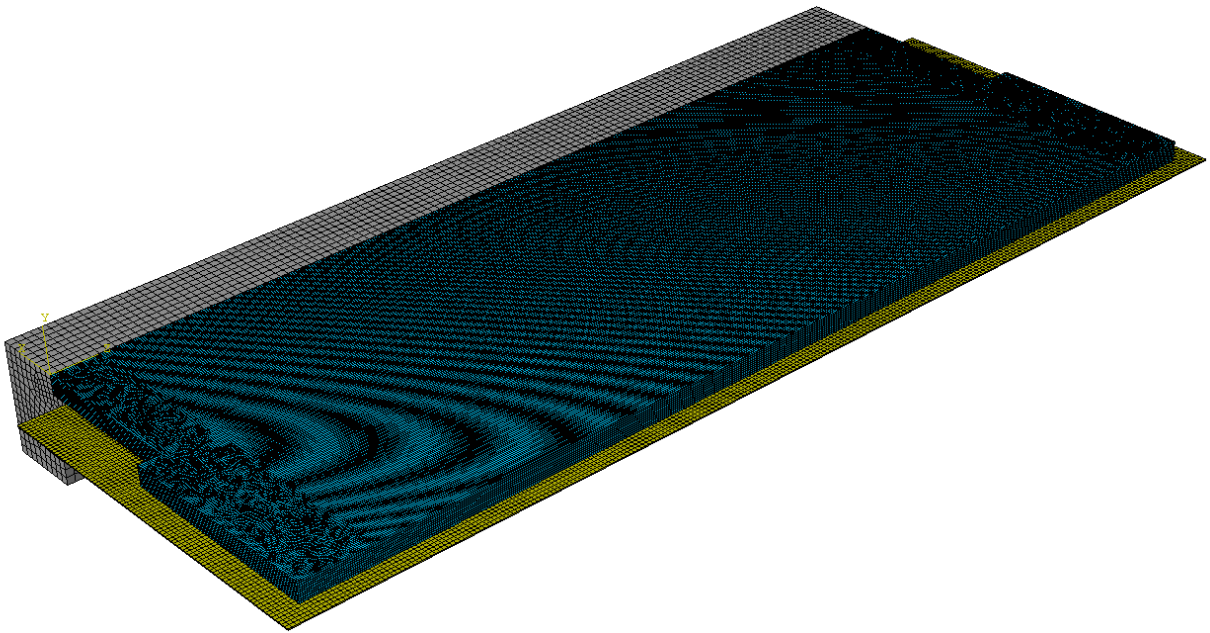
Figure 69: 606890 Model Meshing

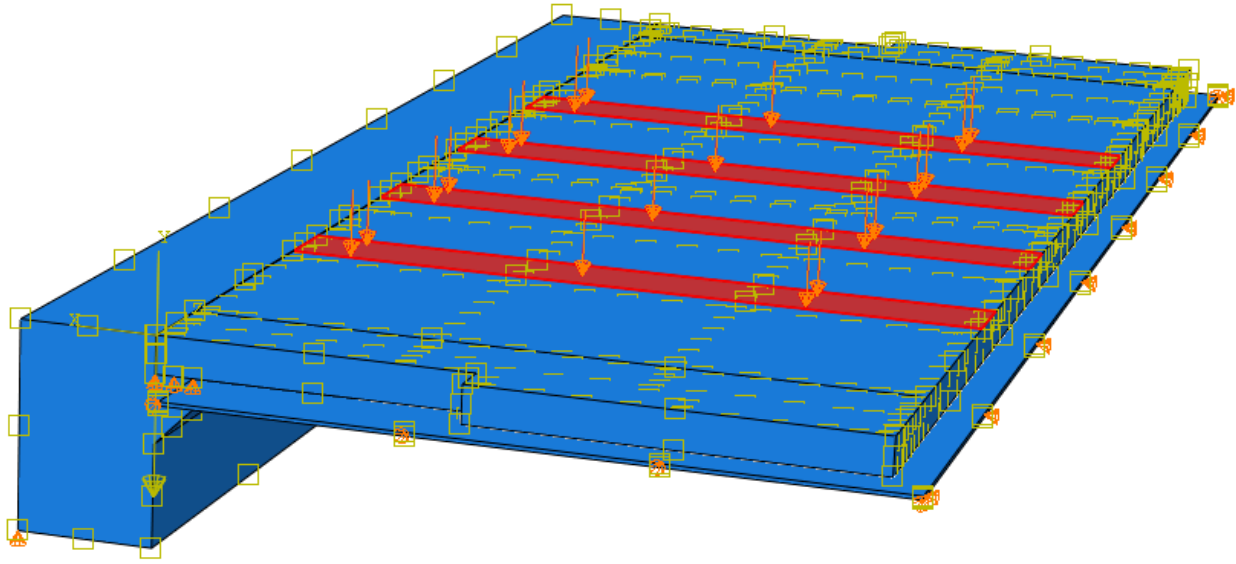
Figure 70: Washington County Loading Scenario

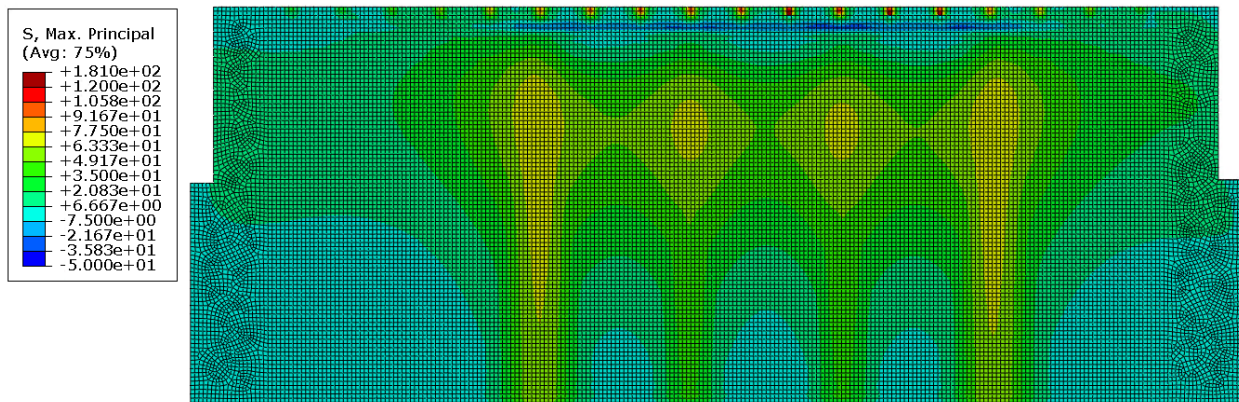
Figure 71: Stress Concentrations on Bottom of Slab

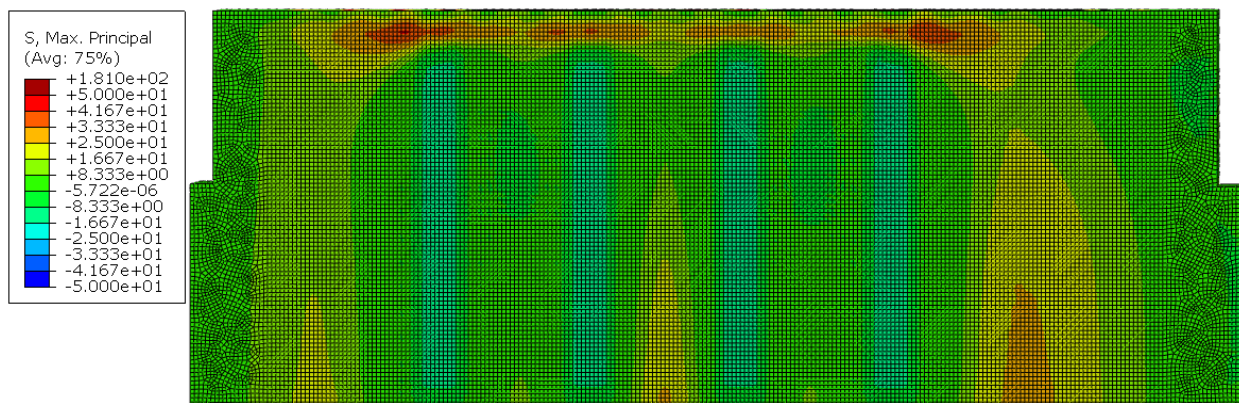
Figure 72: Areas of Tensile Stress on Top Surface of Approach Slab

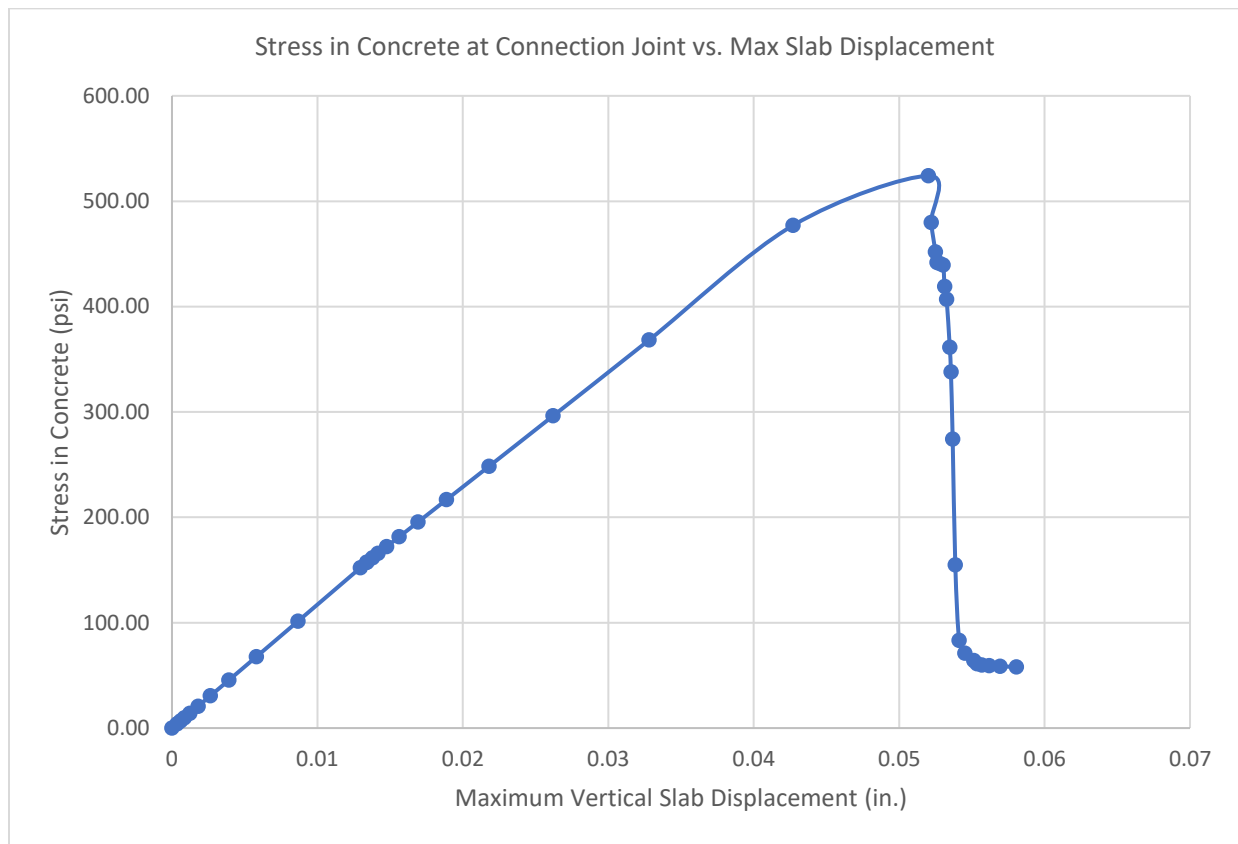
Figure 73: Concrete Failure in Washington Connection Joint

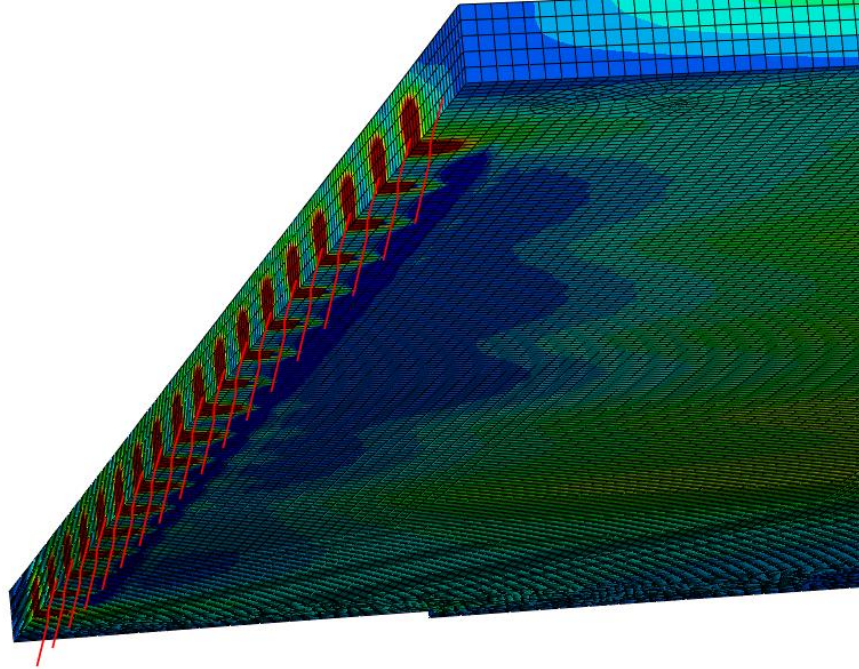
Figure 74: Stress Concentrations at Connection Joint

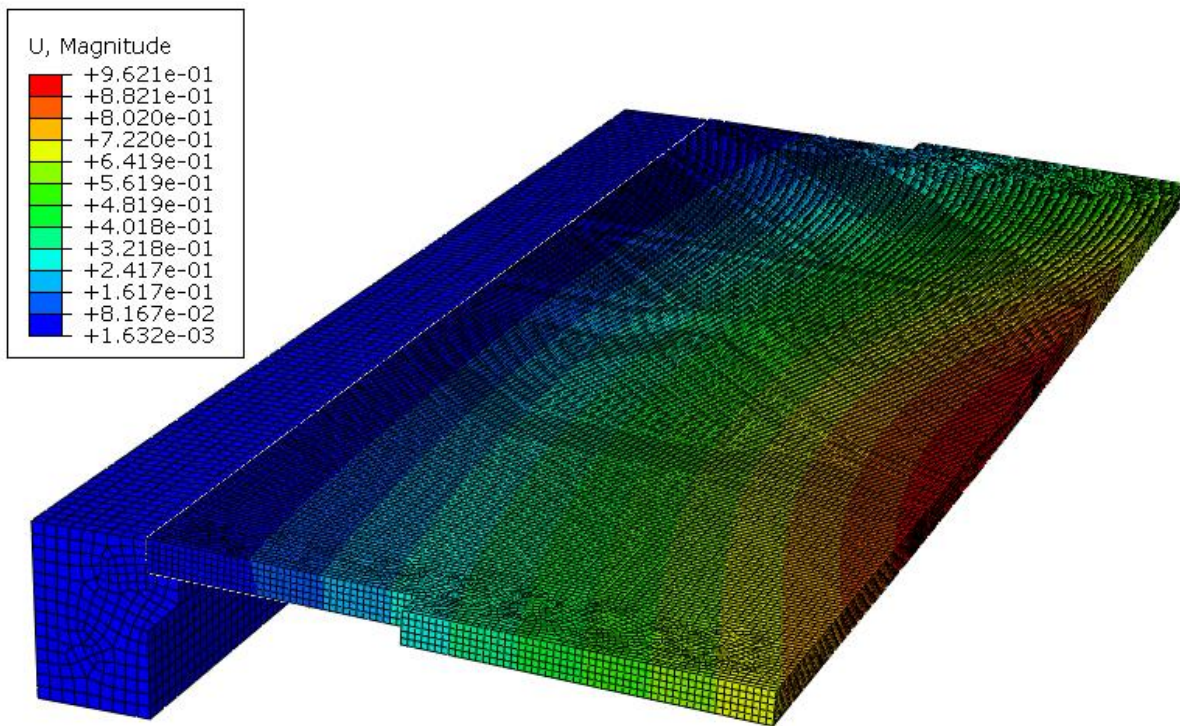
Figure 75: Washington Approach Slab Settlement

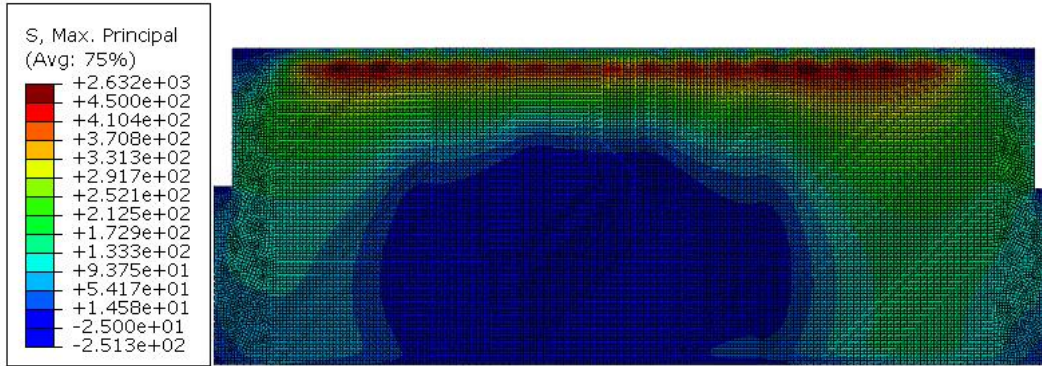
Figure 76: Max Principle Stresses in Washington Slab (Top)
