# Investigation of deterioration of joints in concrete pavements

**Investigation of deterioration of joints in concrete pavements**

Major: Civil Engineering (Geotechnical Engineering)

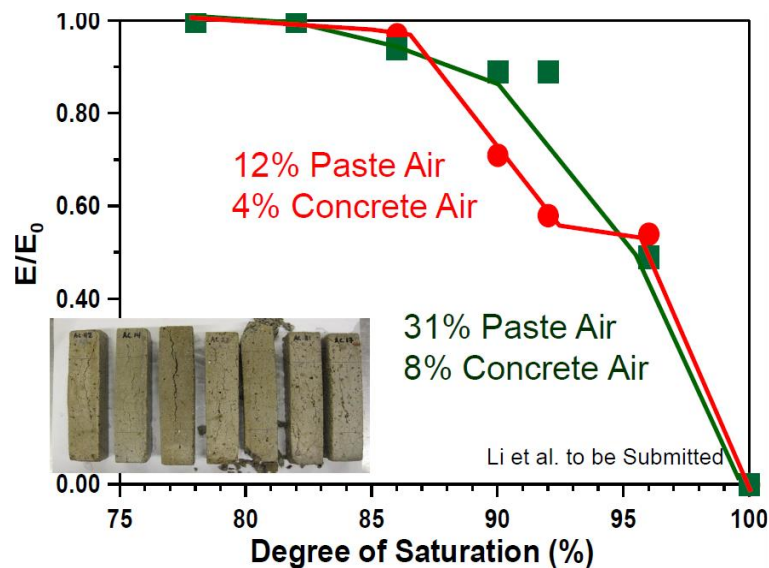
Figure 4. Relationship between degree of saturation and freeze-thaw durability (reproduced Li et al. 2012)

Degree of saturation is an important factor that affects freeze thaw damage in concrete. Closed systems with at least 91.7% saturation experience pressure on capillary pore walls and damage occurs (Page and Page 2007). Li et al. (2012) demonstrated that concrete specimens with a degree of saturation greater than the 86-88% exhibiting damage during freeze-thaw cycles (Figure 4). This critical degree of saturation appears to be independent of the air content. However, concrete that reaches or exceeds the critical degree of saturation is damaged after a few freeze-thaw cycles irrespective of the air content.

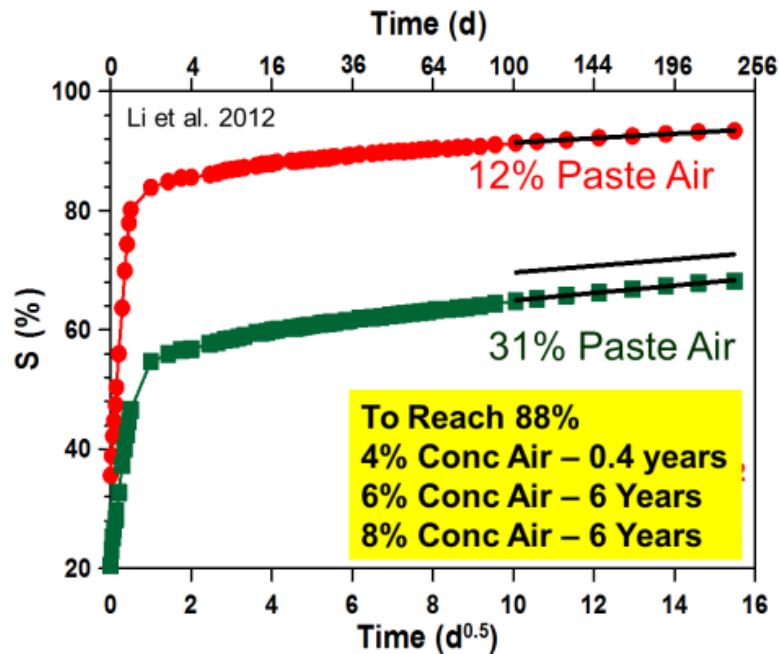
Figure 7. Time to reach the critical degree of saturation for concrete with different air contents (Li et al. 2012)

(Figure 7) (Li et al. 2012). Figure 8 shows how air voids in concrete provide space to release the hydraulic pressure generated during freezing and also increases the time for concrete to reach a critical degree of saturation (Li et al. 2012; Corr et al. 2002; and Taylor et al. 2006).

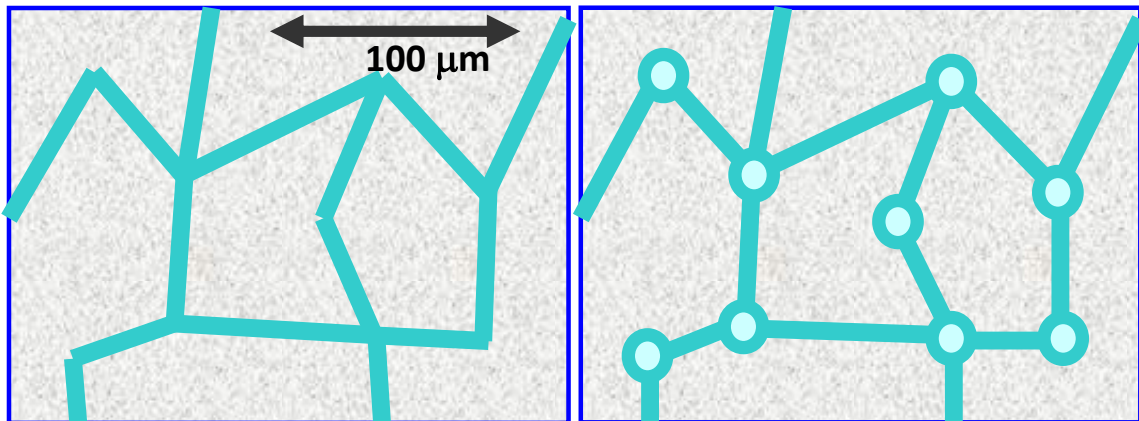
Figure 8. Air voids provide a place for expanding water to move into as it freezes  
Spacing factor ( $L$ ) is another key parameter that affect concrete freeze thaw durability, and it is the distance that water can flow from freezing site to the surrounding

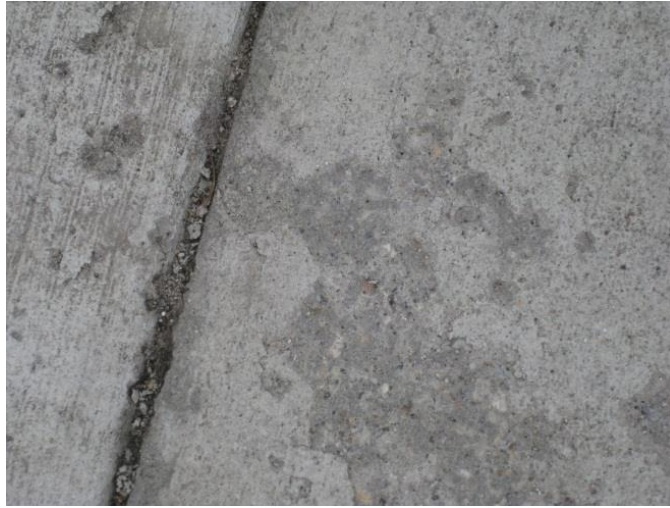
Figure 10. Salt scaled concrete sidewalk

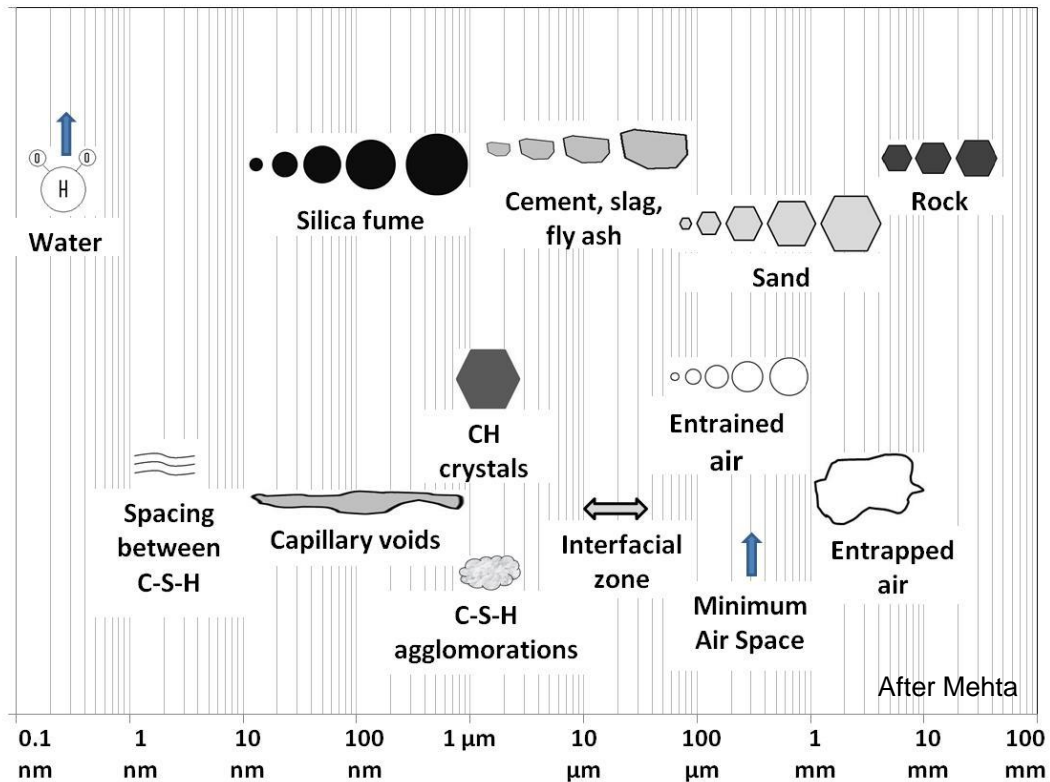
Figure 17. Size of elements in hardened concrete (after Mehta)

Hardened concrete contains several types of voids that influence the properties of the concrete. The typical pore sizes in hardened concrete are shown in Figure 17 (Mehta 1986).

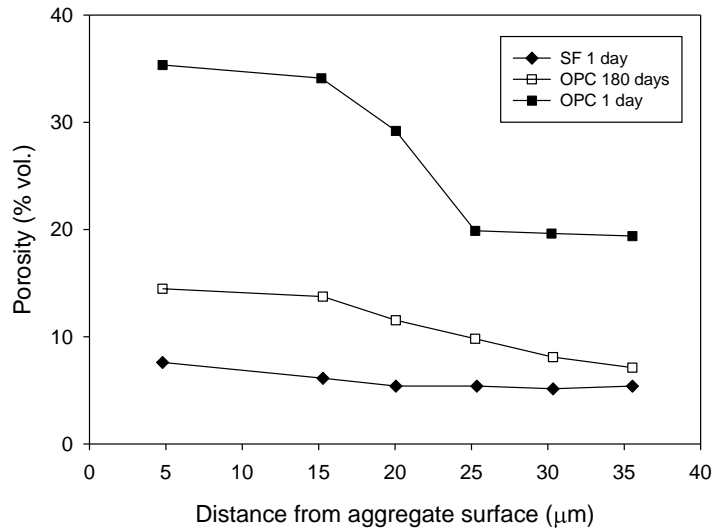
Figure 25. Effect of age and silica fume on the porosity in the ITZ (reproduced from Scrivener et al 1988)

High porosity of ITZ is an important factor to concrete durability, because the ITZ affects water transport in concrete (Cwirzen and Penttala 2005). The concrete ITZ includes large flat  $\text{Ca}(\text{OH})_2$  crystals which perpendicular to the surface of aggregate grains, which makes ITZ a highly porous region in concrete. Such structure favors the formation of microcracks within this layer and the propagation of microcracks under load (Prokopski and Halbiniak 2000). The diffusion coefficient of chloride ions in the ITZ can be 6–12 times higher than bulk paste, and the porosity of the ITZ is not constant, which depends on the mortar composition and the degree of hydration (Bourdette et al. 1995). The porosity of ITZ can be significantly improved by adding silica fume (Figure 25) (Scrivener et al. 1988).

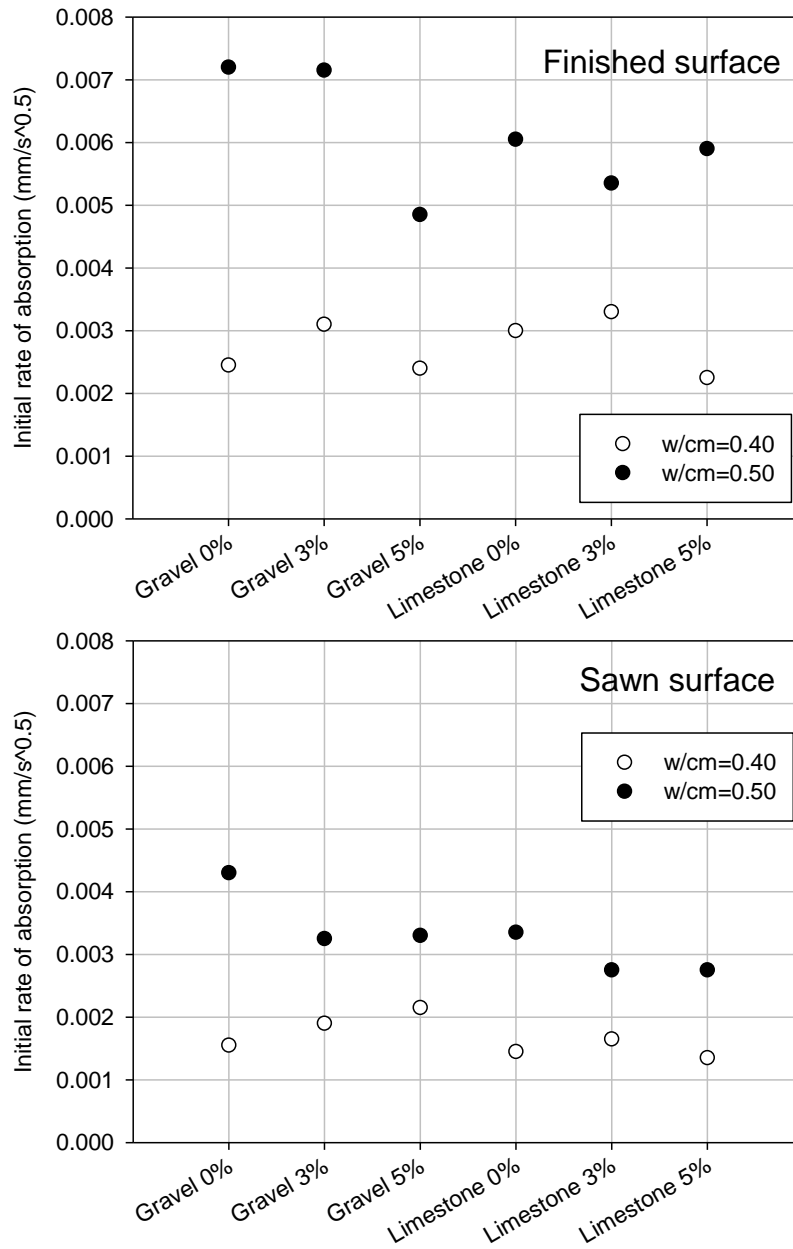
Figure 28. Initial rate of absorption for finished surface samples and sawn surface samples

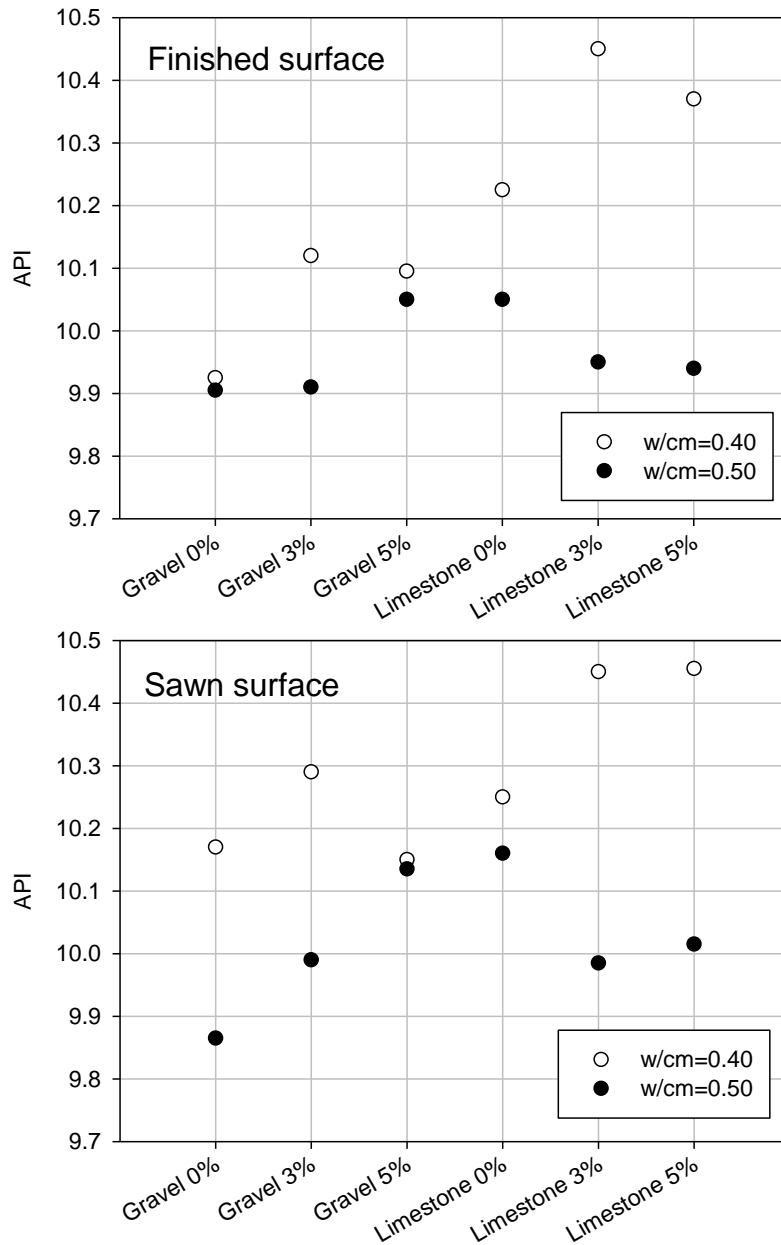
Figure 30. API of the finished surface samples and sawn surface samples

gravel. The sawn surface samples indicate slight lower permeability than the finished surface samples, and that may due to the finished surface samples were obtained from the upper portion of the cylinder, which result in less dense than the sawn surface samples.

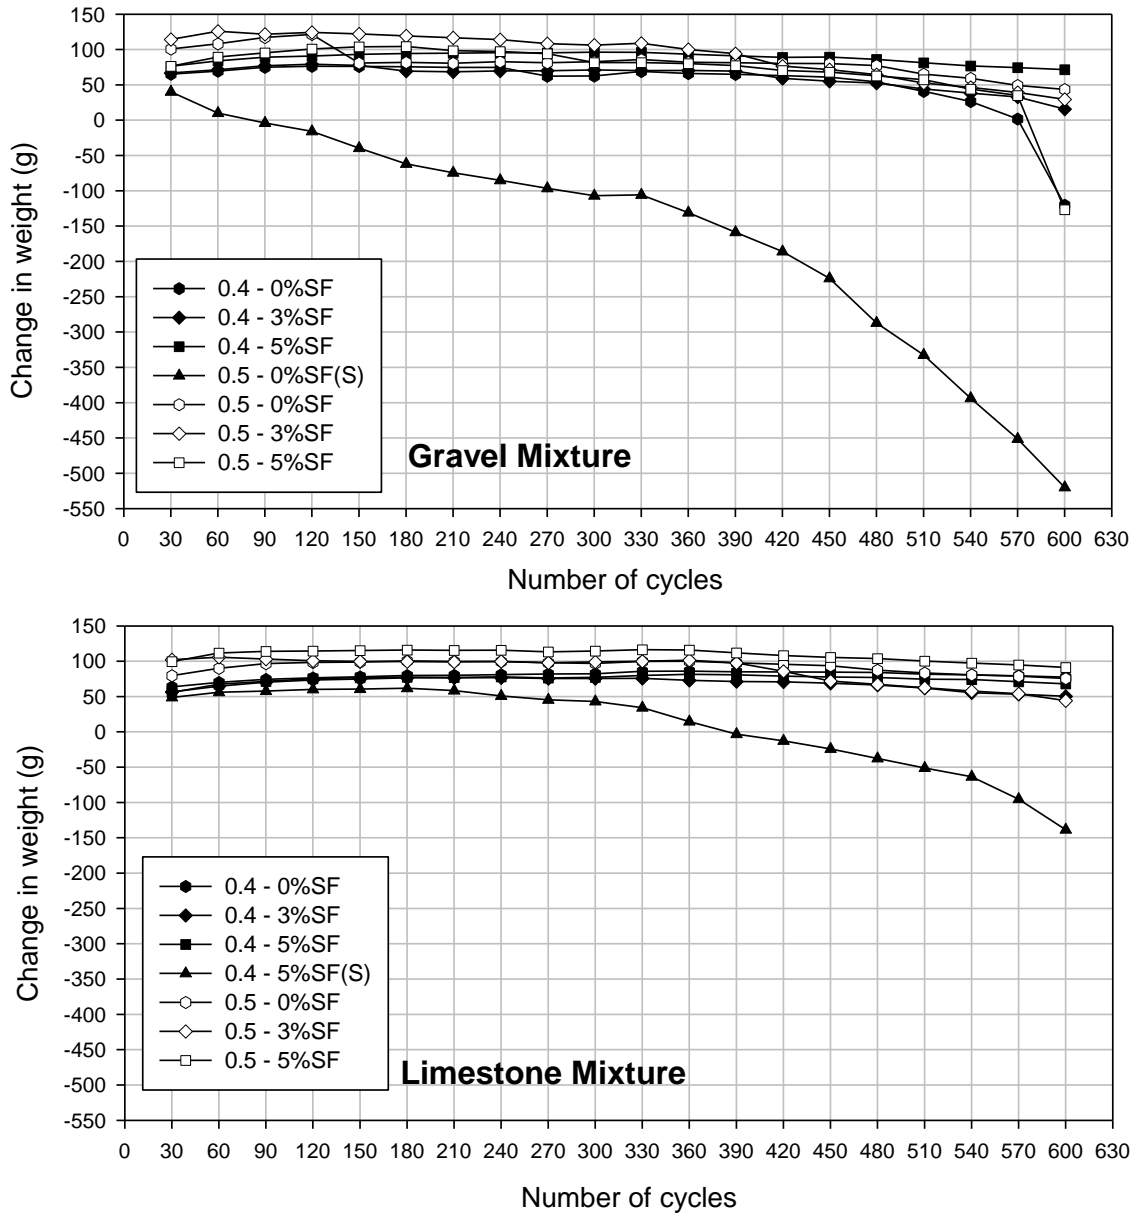
Figure 31. Weight change on the beams for 600 freezing and thawing cycles (0.4-0%SF: w/cm=0.4 with 0% silica fume; 0.4-5%SF(S): w/cm=0.4 with 5% silica fume under salt solution)

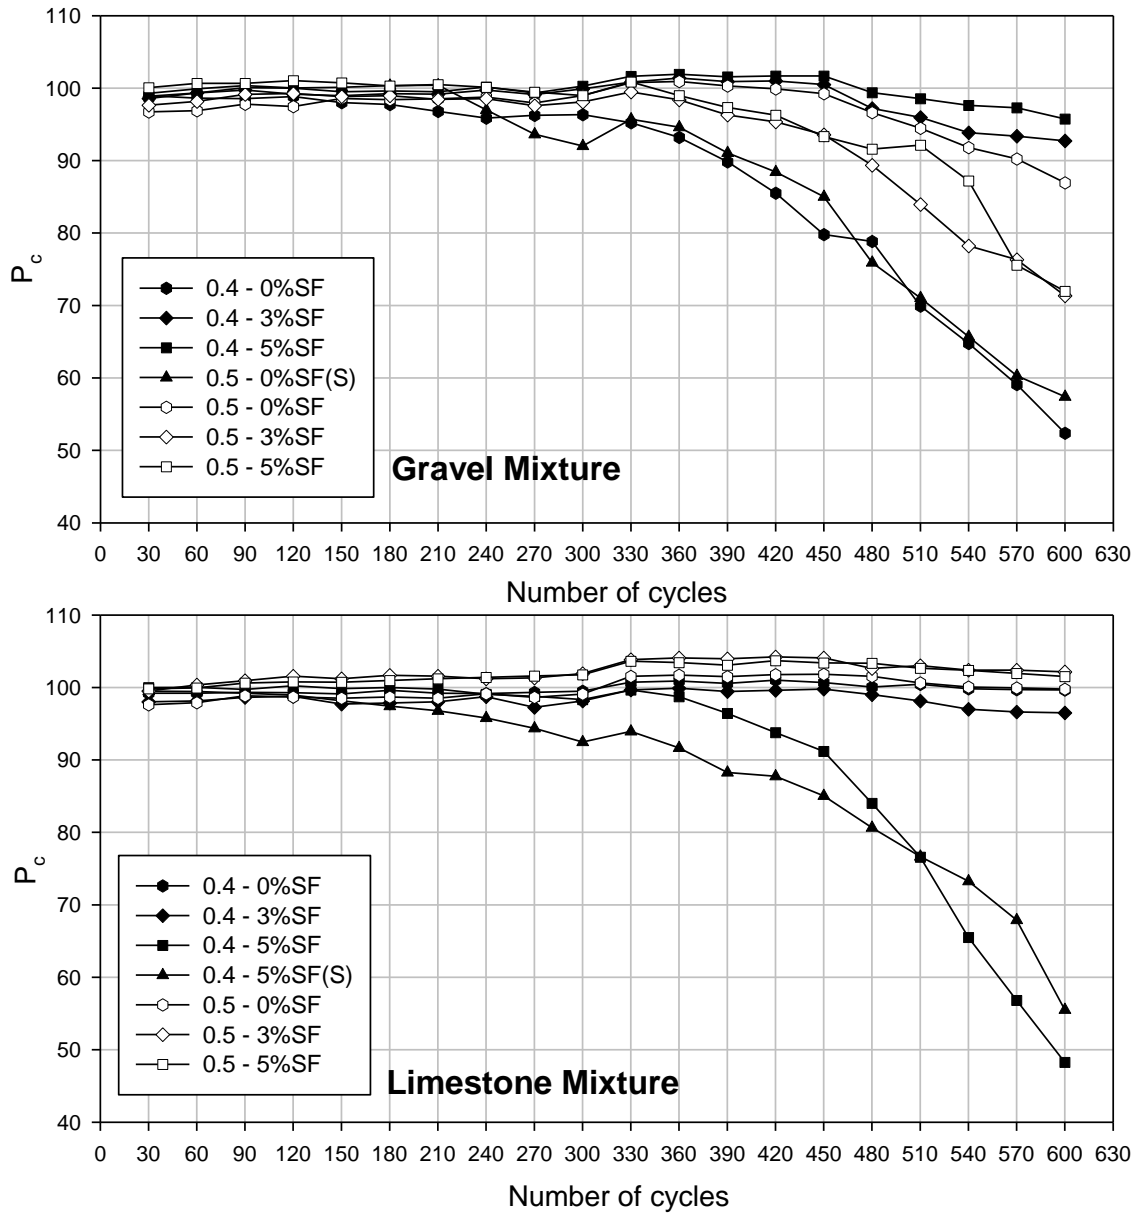
Figure 32. Relative dynamic modulus of elasticity on the beams for 600 freezing and thawing cycles (0.4-0%SF: w/cm=0.4 with 0% silica fume; 0.4-5%SF(S): w/cm=0.4 with 5% silica fume under salt solution)

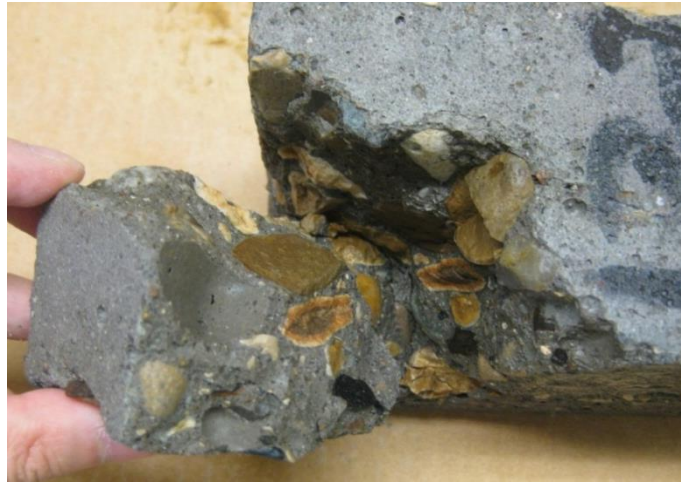
Figure 33. Laboratory observation of distress related to the ITZ during freezing and thawing cycle

In some cases, the failure surfaces go around aggregate which is consistent with the hypothesis.

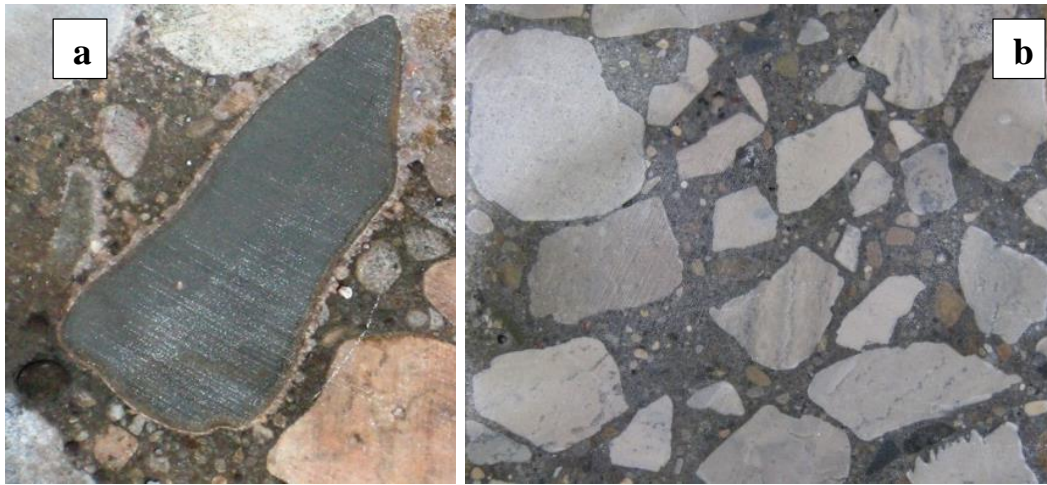
Figure 34. Silver nitrate sprayed samples for mapping chloride (a: concrete mixture using gravel; b: concrete mixture using limestone)

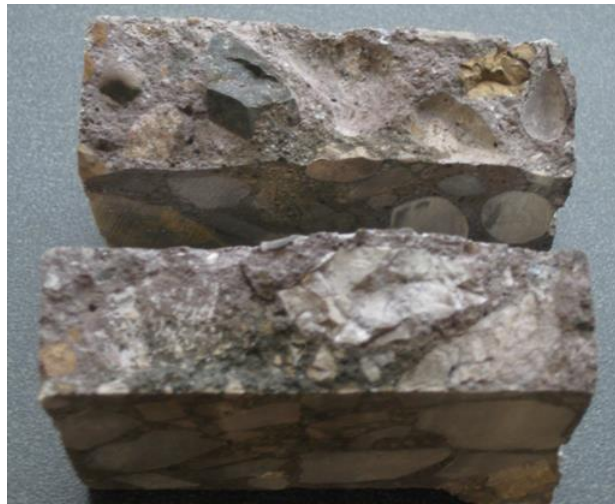
Figure 35. Fracture surface of silver nitrate sprayed samples

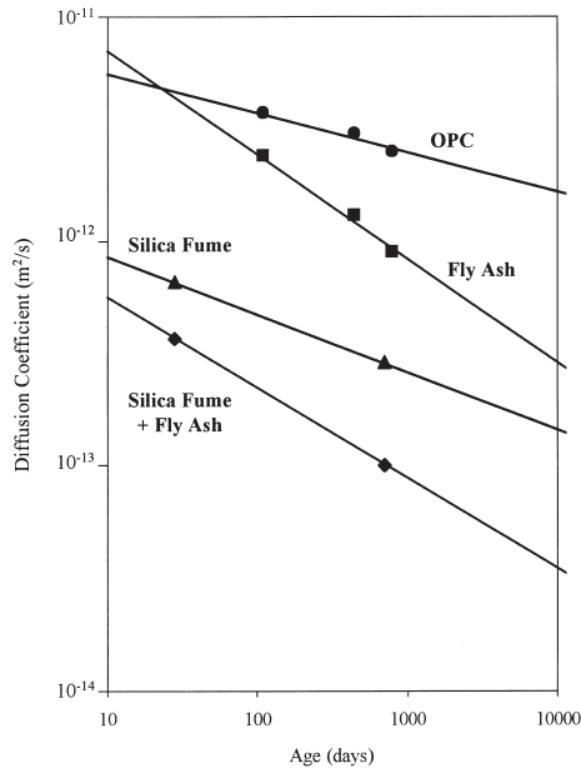
Figure 37. Effect of silica fume on concrete chloride diffusivity (Thomas et al. 1999)

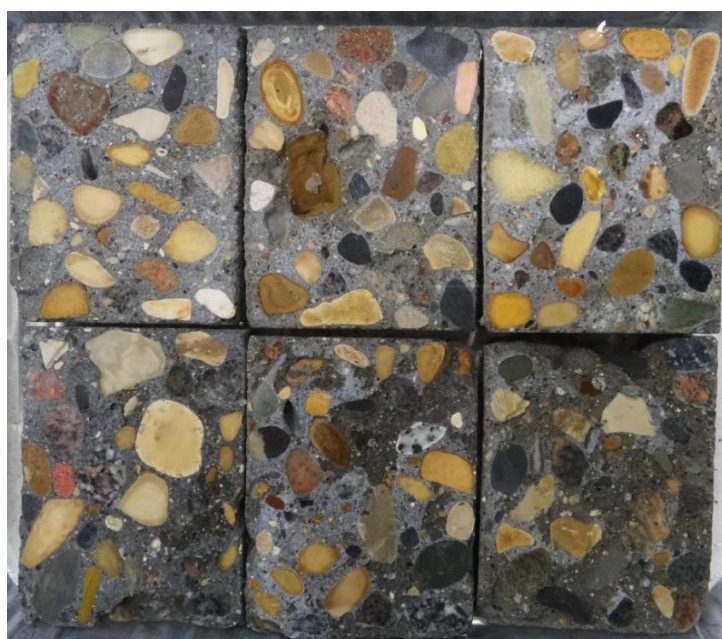
Red: <10 cycles, Green: >20 cycles to 1% mass loss

Figure 38. Sample exposed MgCl<sub>2</sub> solution during freezing and thawing (Top row: w/cm=0.38, bottom row: w/cm=0.45; left to right: silica fume contents are 10%, 5%, and 0%)

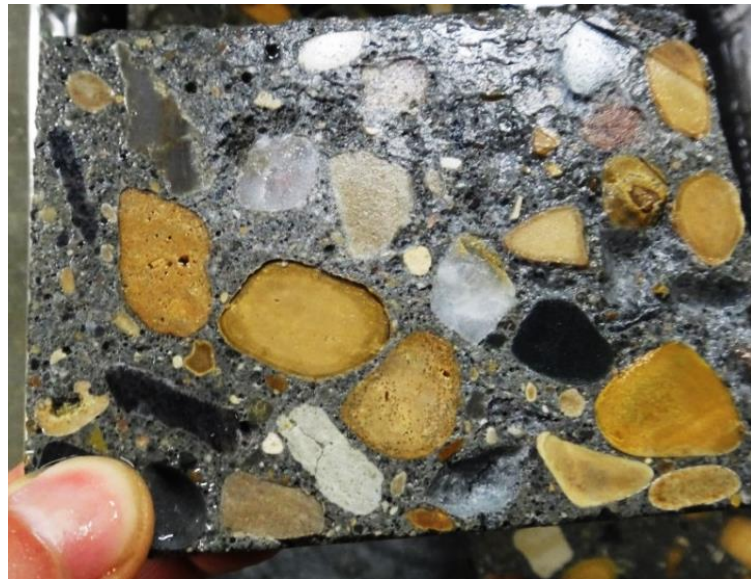
Figure 39. Sample exposed in water during freezing and thawing showing paste pushed above the aggregate

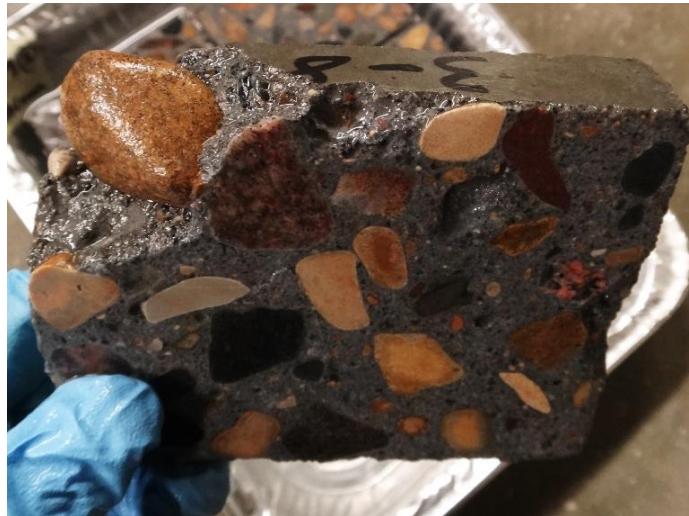
Figure 40. Sample exposed in 3% NaCl solution shown washed aggregate on concrete

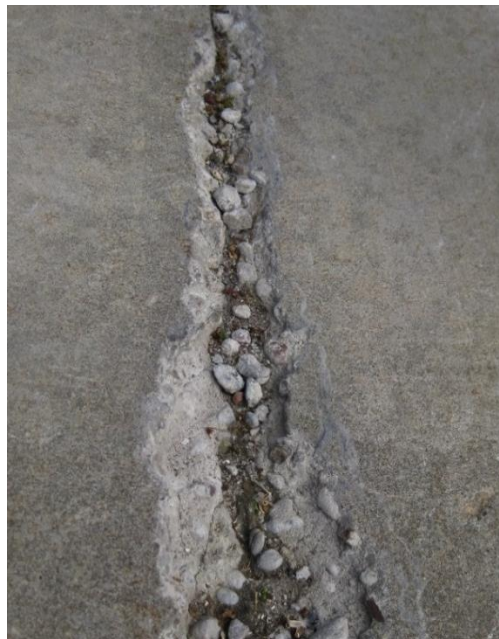
Figure 41. Field observation of joint deterioration

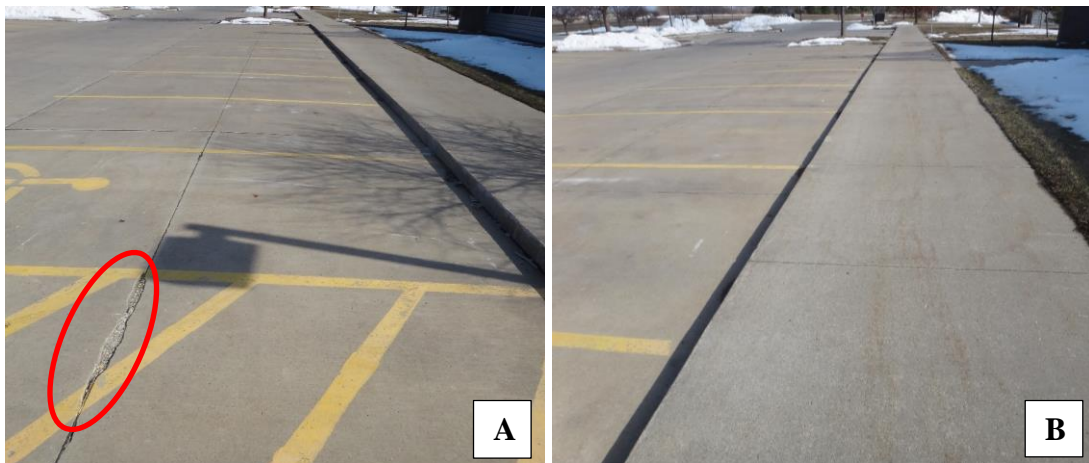
Figure 42. Field observation showing sidewalk performances better than parking lot (A: distressed parking lot, B: undamaged sidewalk)

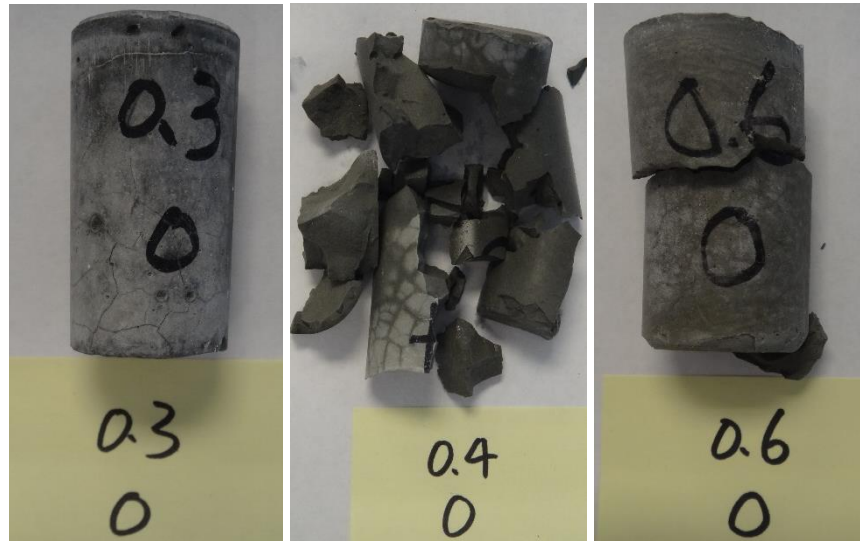
Figure 47. Oven dried paste samples with different w/cm ratios after one freeze thaw cycle

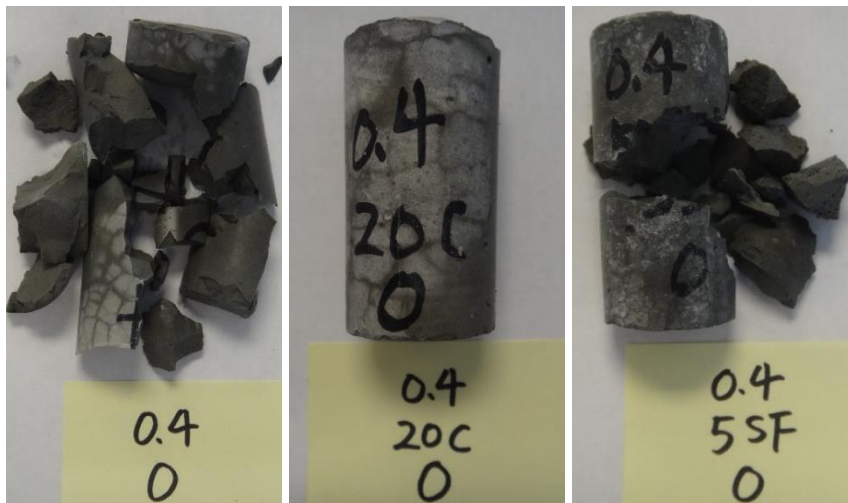
Figure 50. Oven dried paste samples with different SCMs after one freeze thaw cycle

Figure 49. Comparison of the pore size diameter of pastes with different SCMs  
 Photographs of similar samples subjected to one freeze thaw cycle are shown in  
 Figure 50. The plain sample has the most distress, and sample containing 20% C fly ash has  
 the least distress. However, the pore size distribution data on the three hardened paste  
 samples do not show significant differences. It is possible that there is damage caused by the  
 oven dry treatment which is not detected by the MIP test.

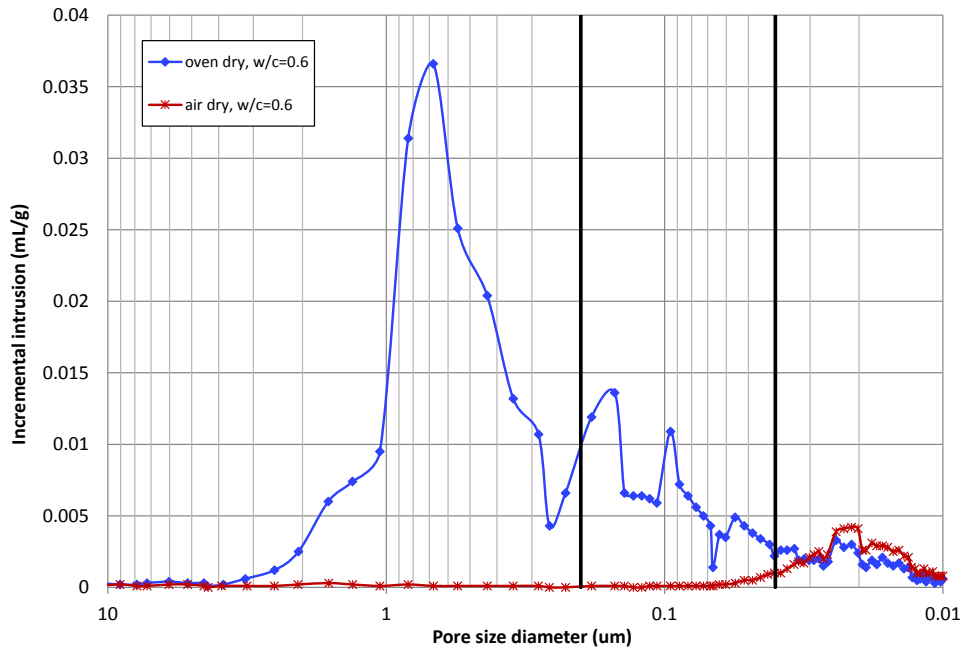
Figure 51. Comparison of reported pore sizes for oven dried and air dried samples with w/cm of 0.60

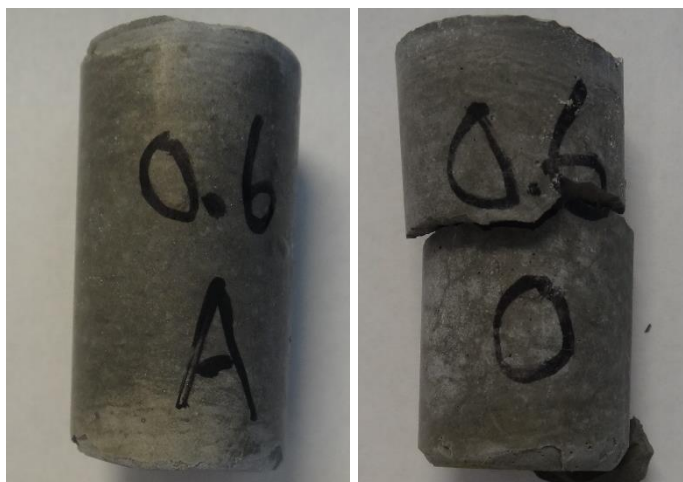
Figure 52. Comparison of freezing and thawing resistance for paste samples treated with different drying conditions

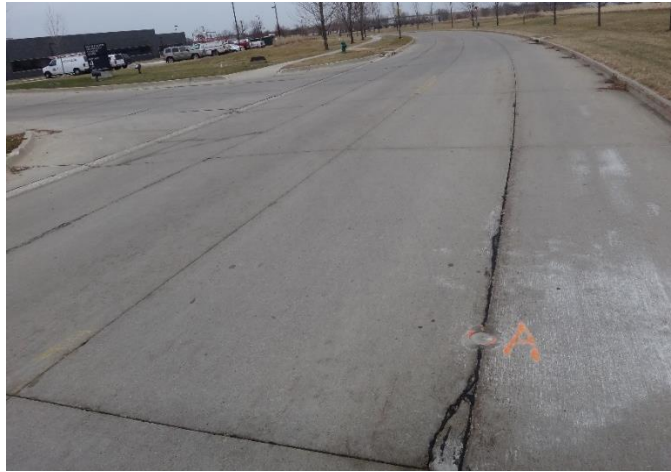
Figure 57. Field view of core 4 location showing joint distress

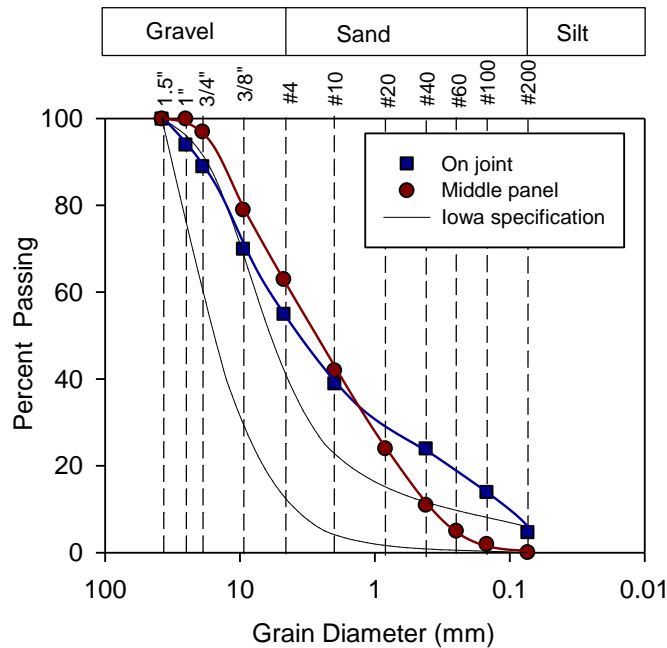
Figure 63. Gradation of base material

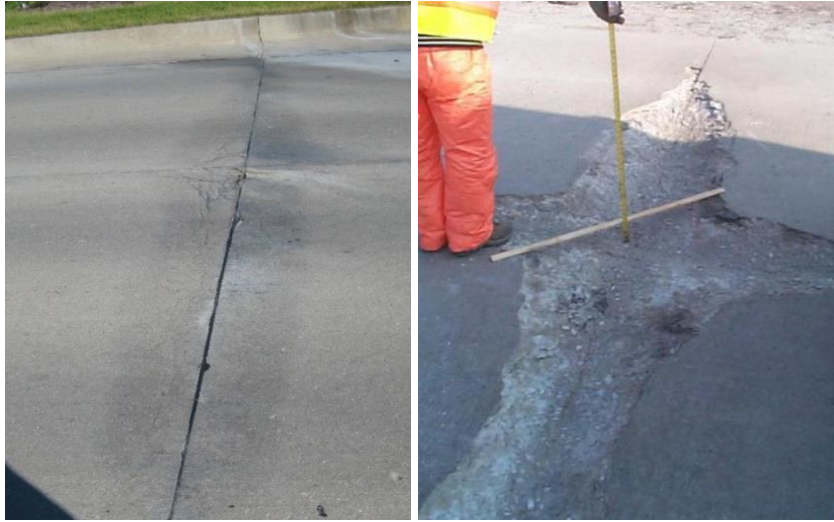
Figure 69. Deteriorated joint in concrete pavement

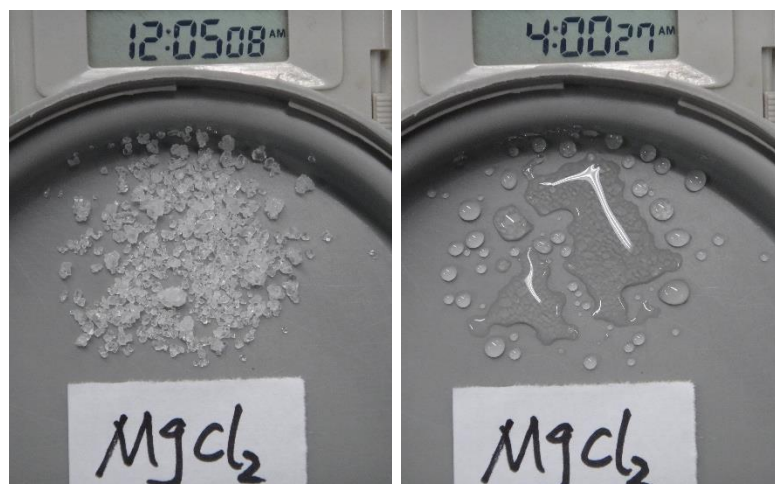
Figure 73. Melting of  $MgCl_2$  by attracting water from atmosphere

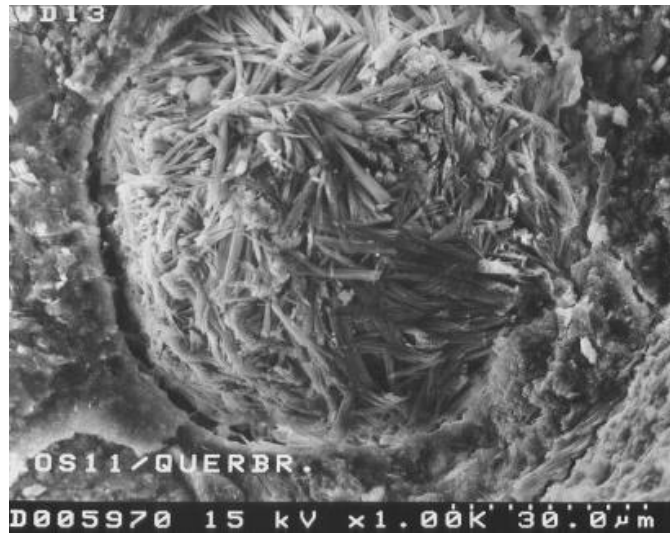
Figure 74. Air voids filled with ettringite in a damaged concrete pavement (Stark and Bollmann 2000)

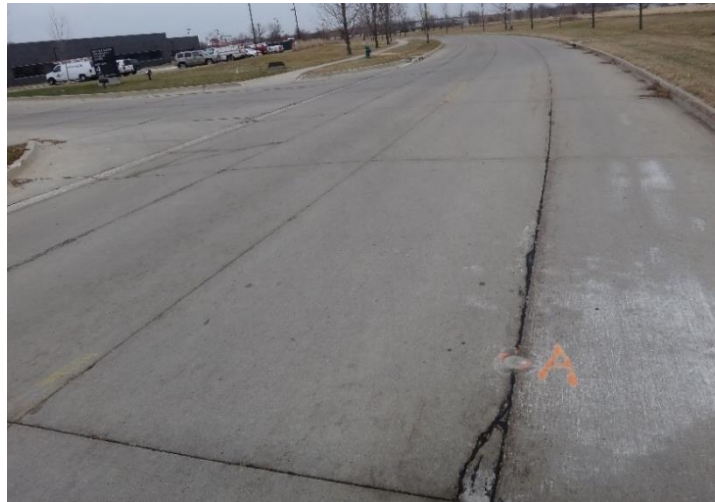
Figure 80. Field view of distressed joint

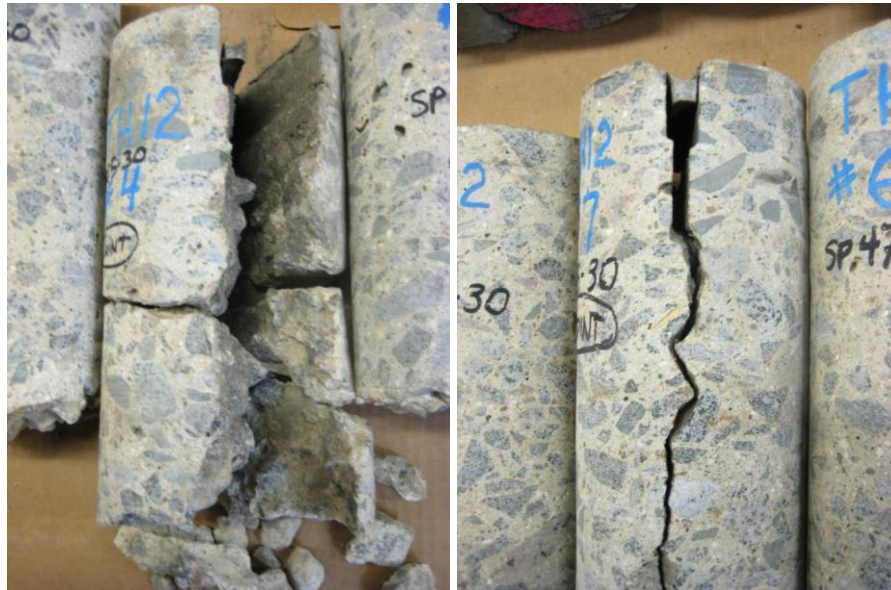
Figure 81. Core samples from Meeker County, Minnesota
