Investigation of electrical and impact properties of carbon fiber textile composites

A thesis submitted in partial fulfillment
of the requirements for the Master of
Science degree in Mechanical Engineering
in the Graduate College of
The University of Iowa

May 2014

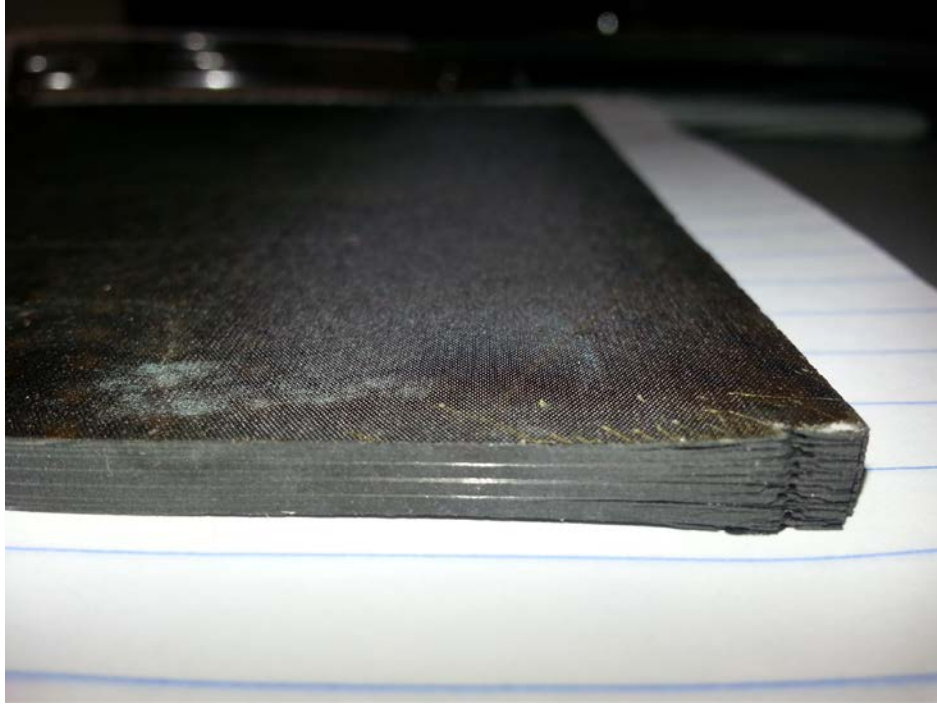
Figure 2.4: Delamination in One of the Samples

To track the samples a two number identification system was used. The first number represents the panel, from which the sample was cut, and the second contained the sample number. An identification number and an arrow indicating the fiber direction were written on each sample. The samples were cut into horizontal beams and square plates with the use of a water jet. The water jet is chosen for its ability to produce finished edges (Hill, 2012); however, due to poor gripping of the panels upon cutting, some of the samples had rough and uncut edges with some delamination. The condition of each sample from both panel 1 and panel 2 is summarized in Table 1 and seen in Figure 2.4

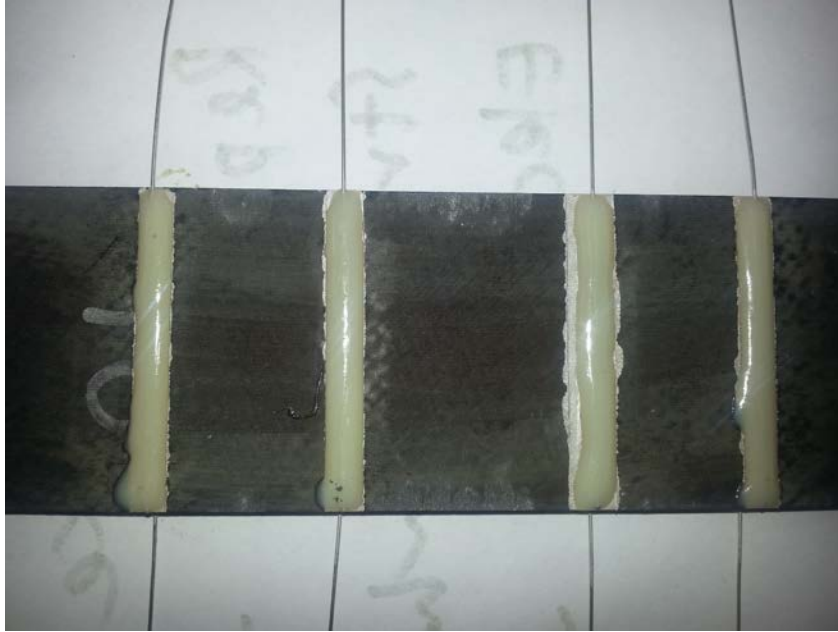
Figure 2.7: Prepared Sample

Figure 2.7 shows the finished and prepared sample.

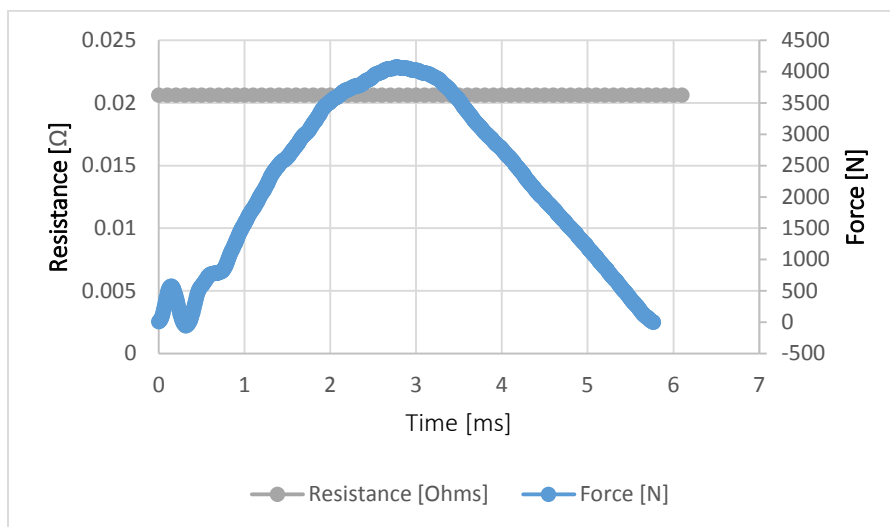
Figure 4.10: Force vs. Time, 7th Impact, Sample 2-8

Figure 4.11: Deflection vs. Time, 7th Impact, Sample 2-8

Figure 4.12: Force vs. Deflection, 7th Impact, Sample 2-8

Figure 4.13: Force and Resistance vs. Time, 7th Impact, Sample 2-8

The load vs. time graph in Figure 4.6 shows that some deflection is detected and is seen after the 7th attempt and the results are seen in Figures 4.10-4.13. Figure 4.13 shows the impact load and resistance plotted together to detect changes in resistance correlated with impact.

that the 7th attempt shows a decrease in force from 10000 to 4000 N, which indicates that there may be some damage even though it is not visible on the laminate. Top and bottom surfaces of sample 2-8 with no visible damage after 7 impacts are shown in Figures 4.14 and 4.15.

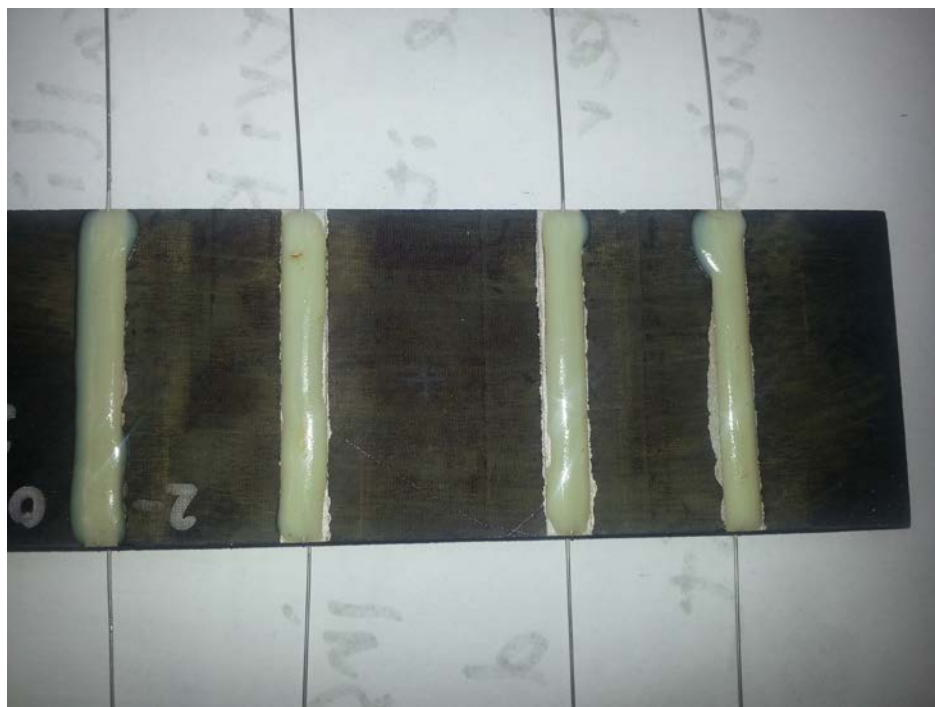
Figure 4.14: Sample 2-8 Top Surface

Figure 4.15: Sample 2-8 Bottom Surface

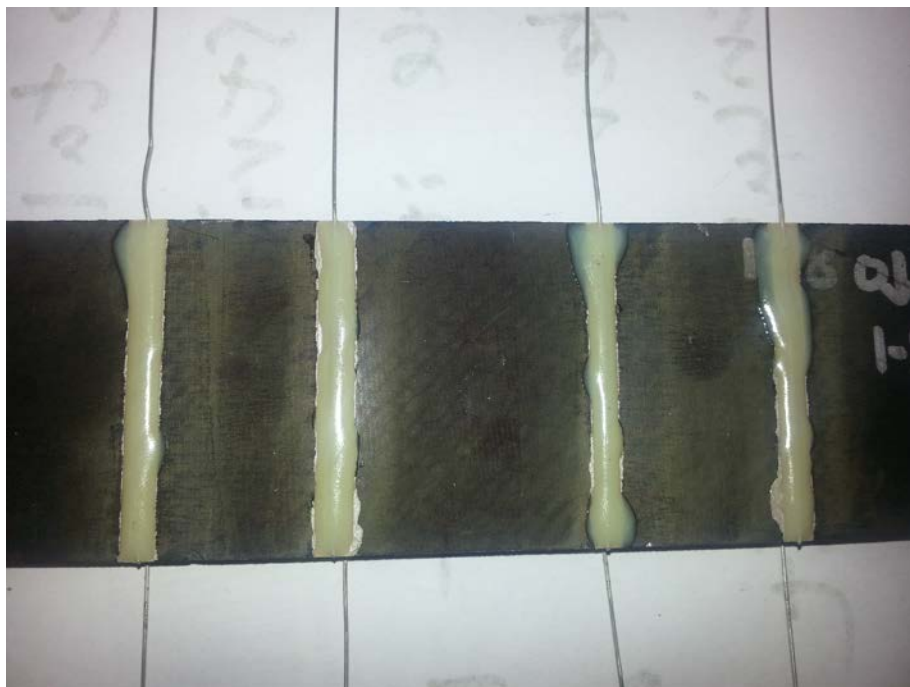
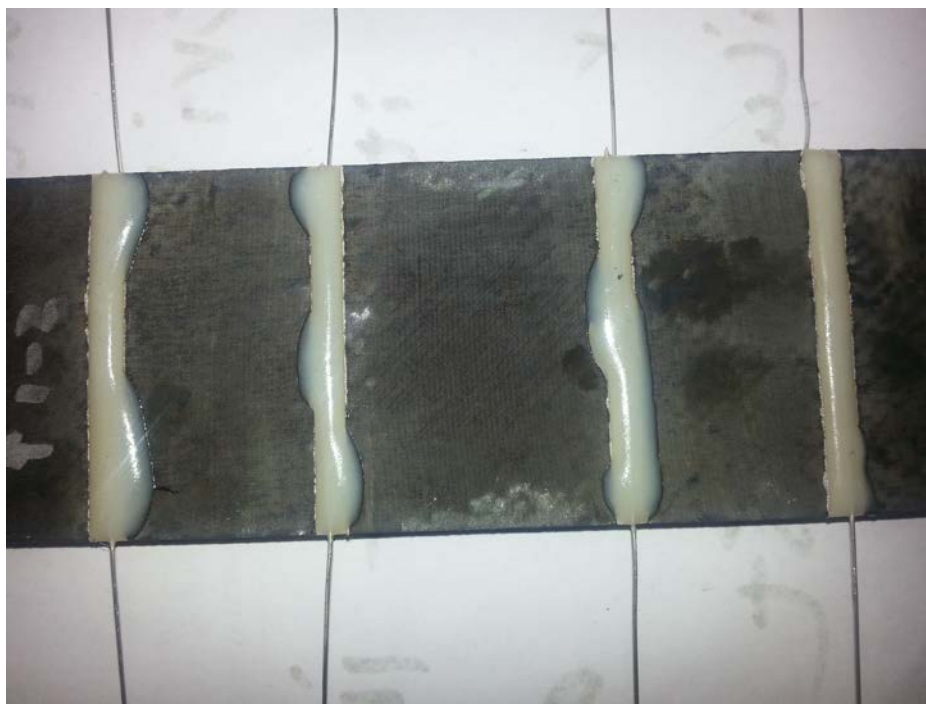
Figure 4.23: Sample 1-8 Top Surface after 2nd Impact

Figure 4.24: Sample 1-8 Bottom Surface after 2nd Impact

Despite of the reduction in the maximum impact load, there was no visible damage observed on the surface of the sample 1-8 after two impacts (see Figures 4.23 and 4.24).

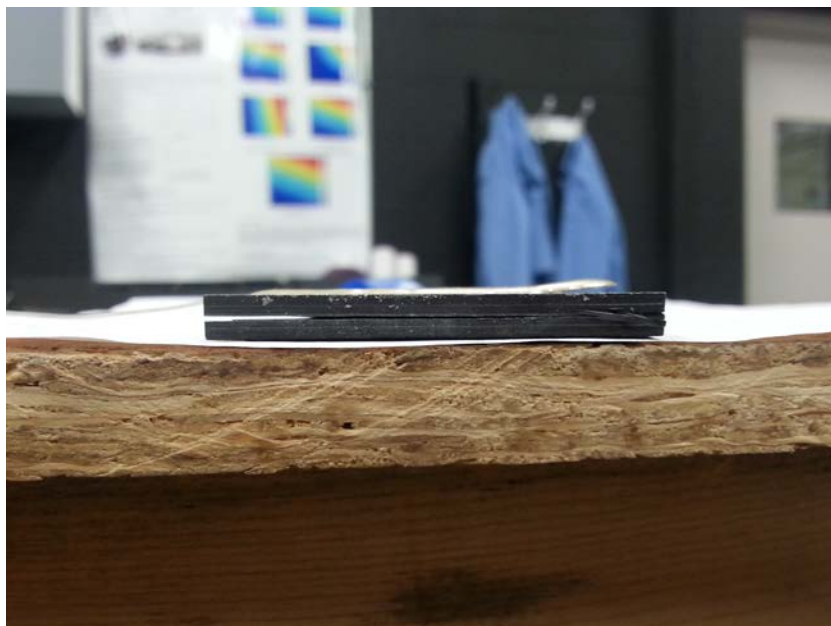
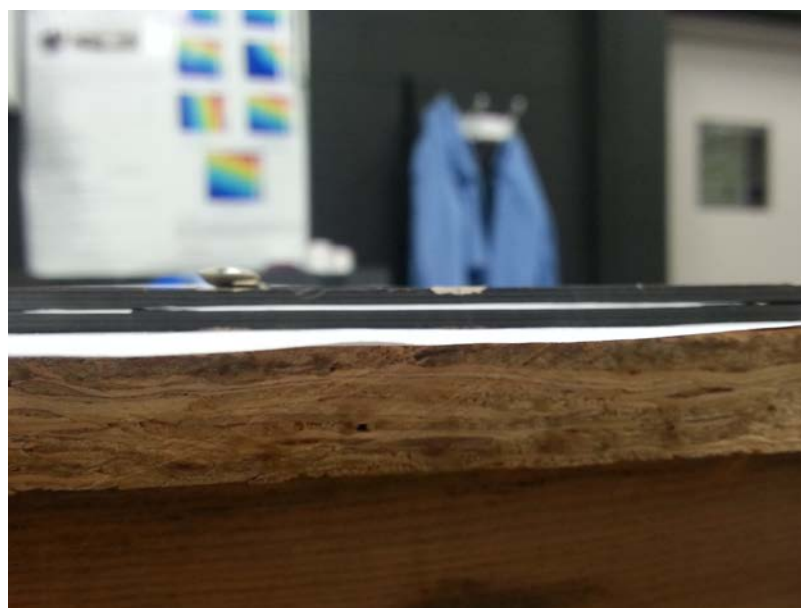
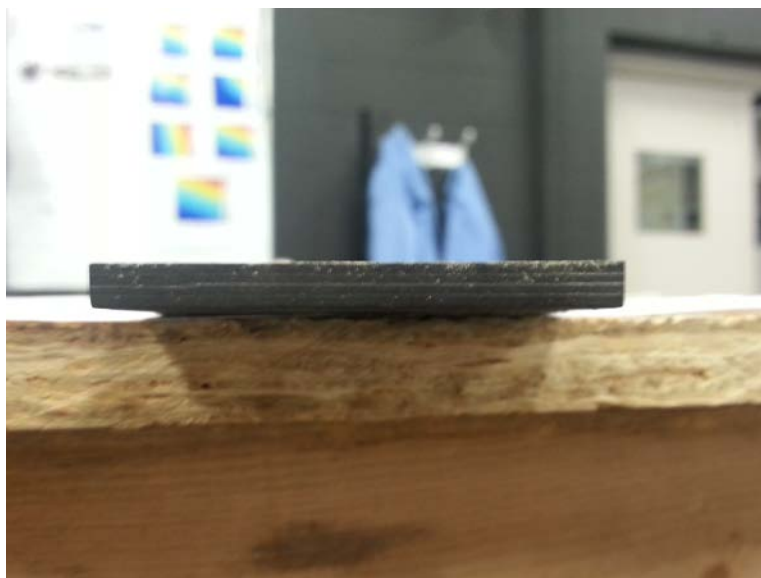
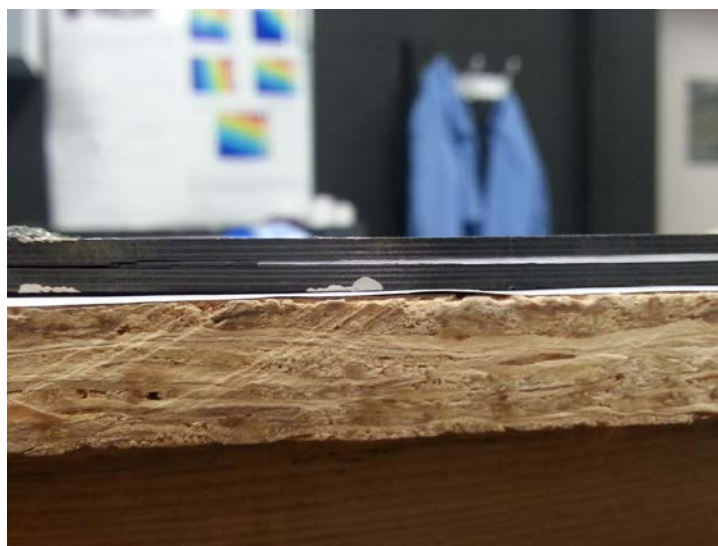
Figure 4.36: Side 1 Delamination of Sample 1-7

Figure 4.37: Delamination Side 2 of Sample 1-7

Figure 4.38: Delamination Side 3 of Sample 1-7

Figure 4.39: Delamination Side 4 of Sample 1-7

out the sample out of the fixture it was determined that there was massive delamination in the center layers of the composite. The damage is seen in Figures 4.36-4.39.
