**Investigation of improved utility cut repair techniques to reduce
settlement in repaired areas**

A thesis submitted to the graduate faculty
in partial fulfillment of the requirements for the degree of
MASTER OF SCIENCE

Major: Civil Engineering (Geotechnical Engineering)

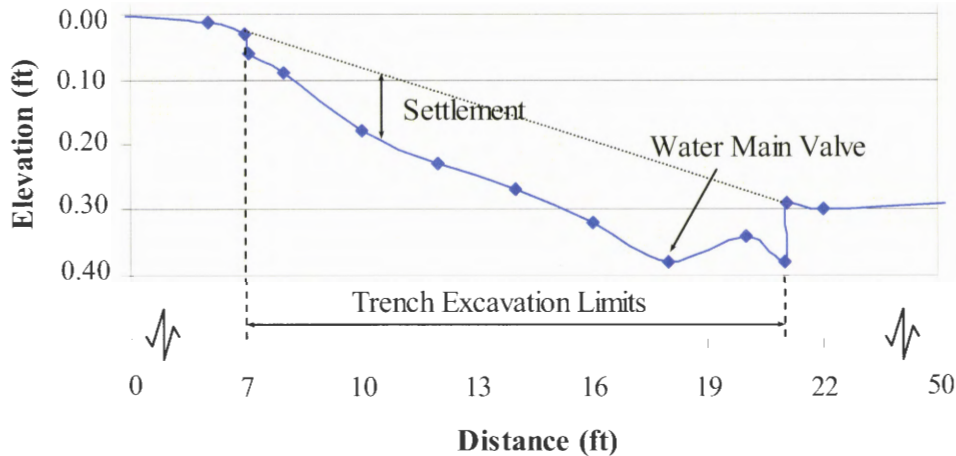
Figure 1. Poorly performing utility cut in asphalt pavement.

The amount of distress and damage resulting from a pavement cut may be subjective, since a majority of the survey results indicate a low percentage of utility cuts performing poorly. However, through city visits made throughout Iowa, the existence of poorly performing restorations is evident in several roadways. In many cases, differential settlement occurs and therefore reduces the life of pavements in and around utility cuts. Two examples

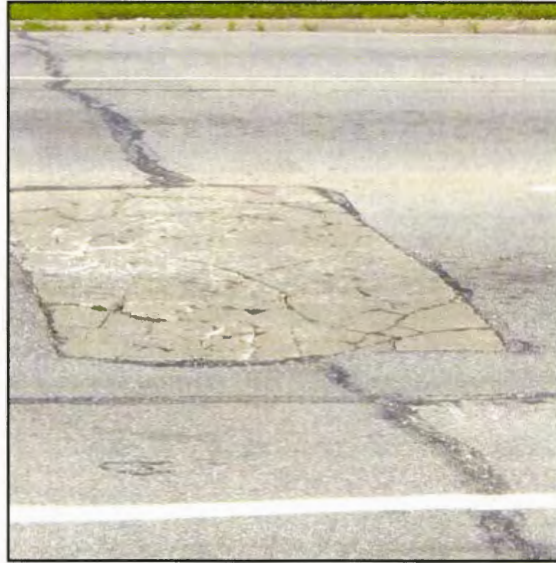
Figure 5. Temporary cold patch in Cedar Rapids.

Utility cuts, specifically water main breaks, are made throughout the year. Breaks that occur in the winter months generally result in a temporary cold patch installed until weather conditions improve for placing of a permanent pavement surface. Figure 5 shows an example of a utility cut constructed by a private contractor in the winter that has yet to receive a permanent asphalt surface. At the time this picture was taken, the patch was said to be three years old. With the deterioration of this temporary patch, visible map cracking can be seen in Figure 5.

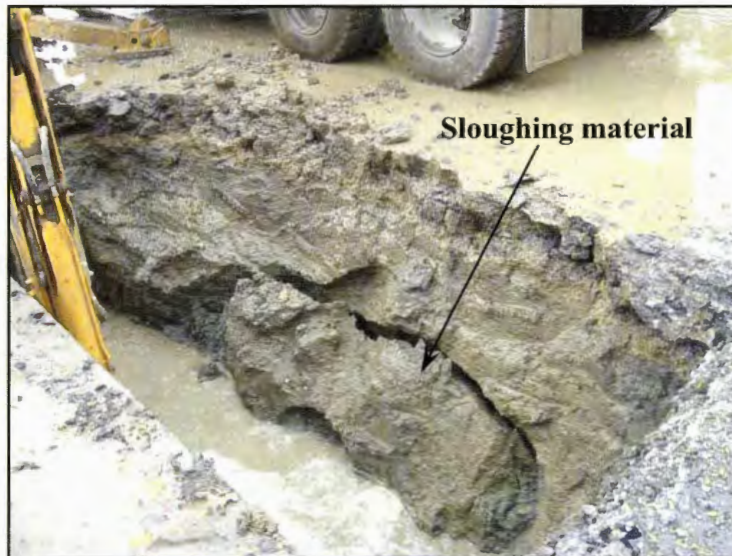
Figure 7. Material sloughing off the edges of the trench.

Natural factors play a role in the performance of a utility cut. For example, during an excavation of a water main break, adverse conditions occur such as that shown in Figure 7. As a result of the break, material becomes saturated and weak and begins to slough off. This

in turn forms large voids underneath the existing material surrounding the cut, making adequate compaction difficult. Other problems that may arise during the reconstruction of the trench include large lift thicknesses, improper compaction, and lack of moisture control.

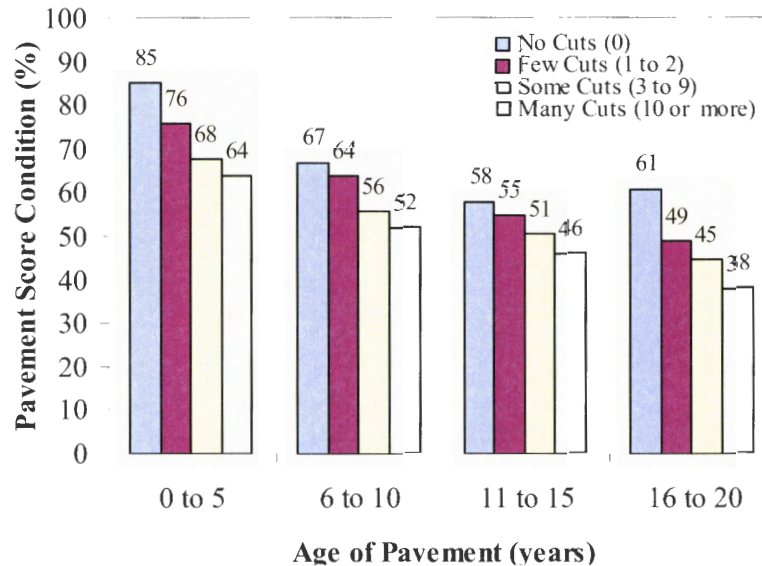
Figure 8. Utility Cut Effects on Pavement Condition (from the Department of Public Works City and County of San Francisco 1998).

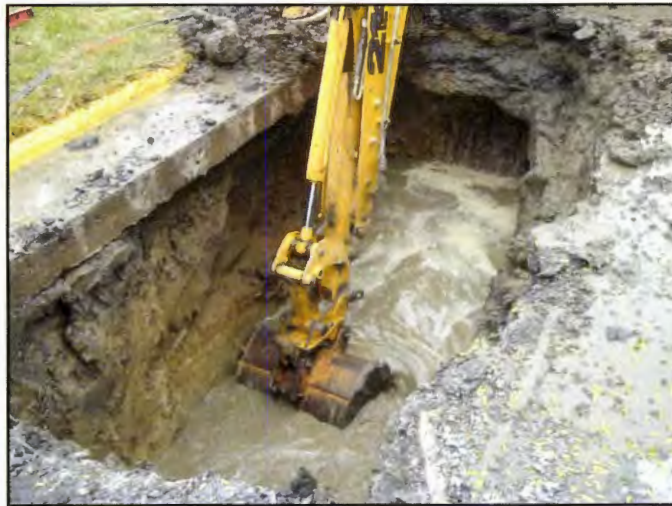
Figure 23. Trench excavation.

by immersing the pump which was placed in the backhoe bucket, into the trench and pumping soiled water through a hose into the street. As the excavation proceeded and additional water was removed during the dewatering process, saturated material along the perimeter of the trench began to slough off (see Figure 24). Cavities continued to develop around the perimeter of the trench until the broken water main was reached.

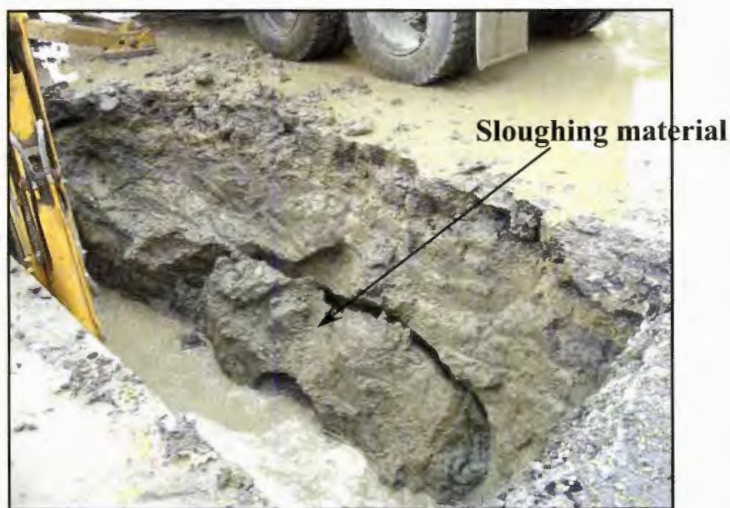
Figure 24. Material sloughing off in Ames site.

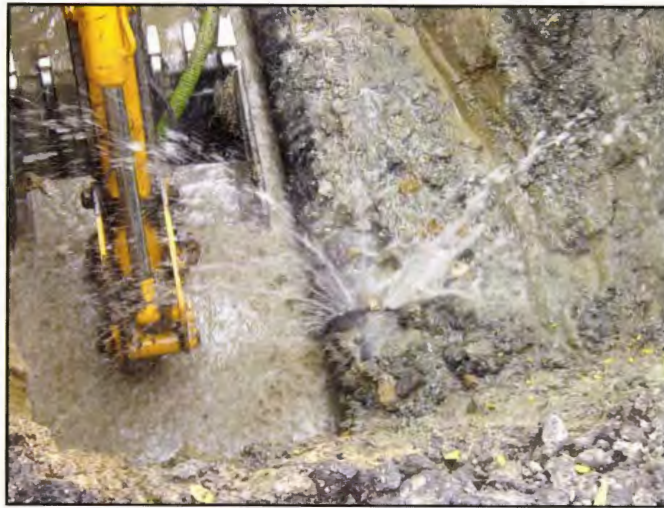
Figure 25. Ames water main break.

The water main break was reached at a depth of about 10 ft (3 m) into the trench. After the trench was dewatered, construction crew members were able to repair the break. Figure 25 shows the break in the pipe as water sprayed out and Figure 26 shows the shoring box being placed into the excavation. This shoring box acts as a support brace from the surrounding soil, which protects workers from material caving in during break repairs. The break was repaired with a pipe sleeve and the shoring box removed.

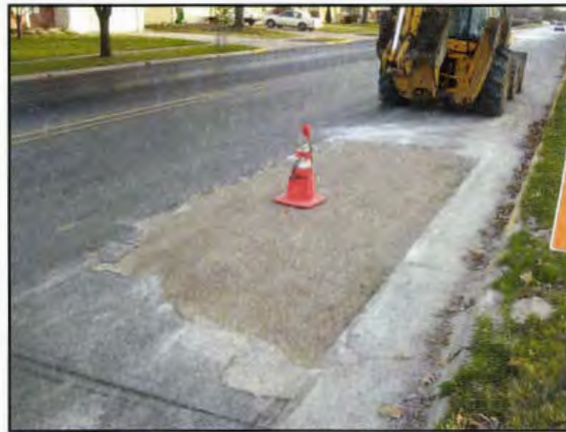
Figure 30. Utility cut left open for two weeks.

leading to a non-uniform edge. Therefore this cut in the pavement was made because of a need for straight edges in surfacing the trench. Once the cut was made, excess pavement was removed and hauled away. As stated before, the purpose of leaving the trench unpaved for two weeks was to reduce future settlement, however during this pavement removal process conducted by the backhoe, backfill material was disturbed and loosened (see Figure 31). After this backfill material disturbance, no additional compaction equipment was brought in to compact this area again. Instead, the backhoe leveled off excess material and then completed several passes with the weight of the backhoe and patting the material with the backhoe bucket as a method of compaction (see Figure 32). Figure 33 shows the completed trench in Ames.

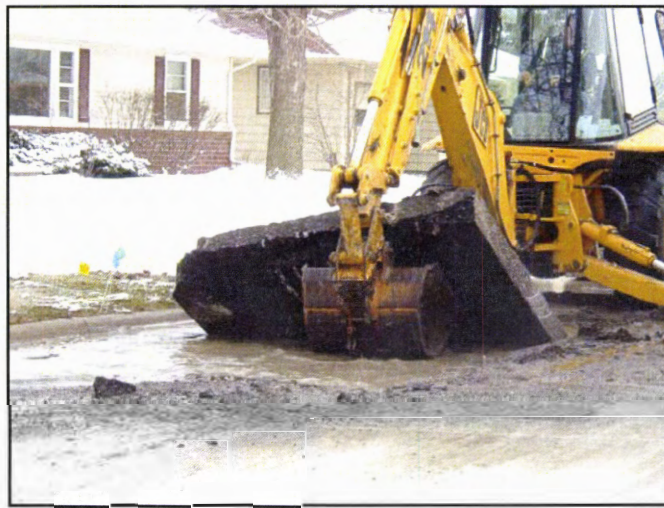
Figure 34. Pavement removal from Ames winter break site.

This winter water main break in Ames occurred near the intersection of Marston Avenue and 16th Street on February 7, 2005, where water was temporarily turned off. The excavation on the site was 7.5 ft (2.3 m) long, and 8.5 ft (2.6 m) wide, with a depth of 6 ft (1.8 m). This utility cut was constructed by the city of Ames, in pavement consisting of 10 in (0.3 m) of asphalt. The removal of pavement from the trench can be seen in Figure 34.

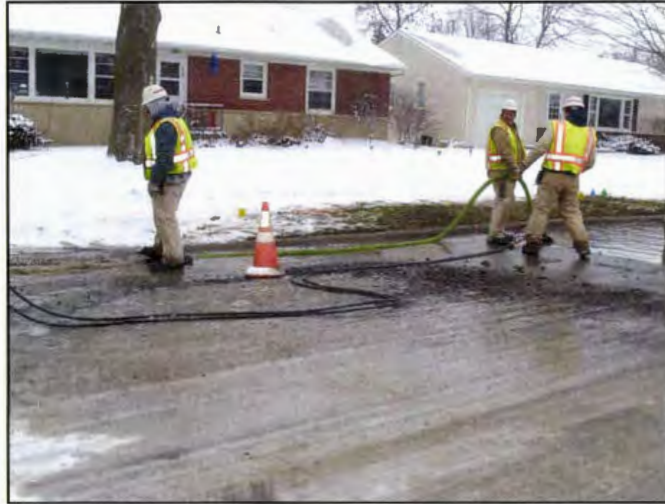
Figure 35. Dewatering the trench.

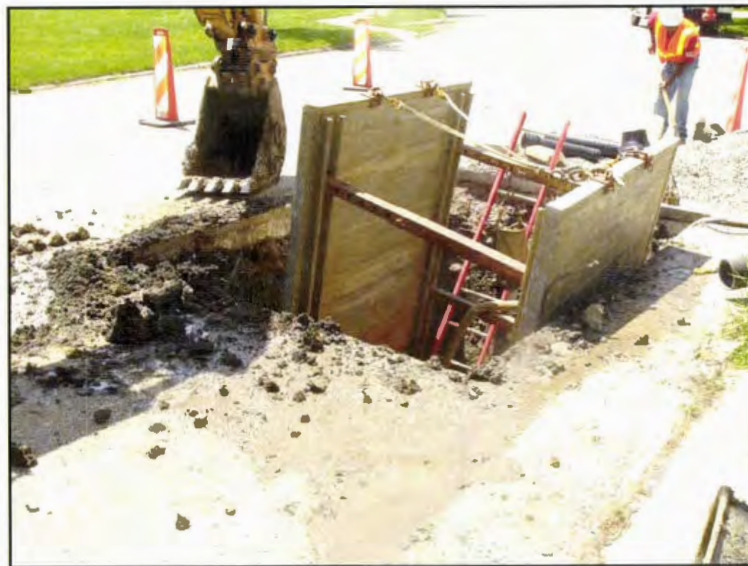
Figure 40. Shoring box in place.

A standard vertical cut was made in the pavement and excavation of the native material began. At the completion of the excavation a shoring box was placed into the trench (see Figure 40). The leaking valve was repaired and a two inch by four inch block of wood and concrete block was placed beneath the pipe for support. The pipe was also wrapped with black plastic wrap for protection against corrosion.

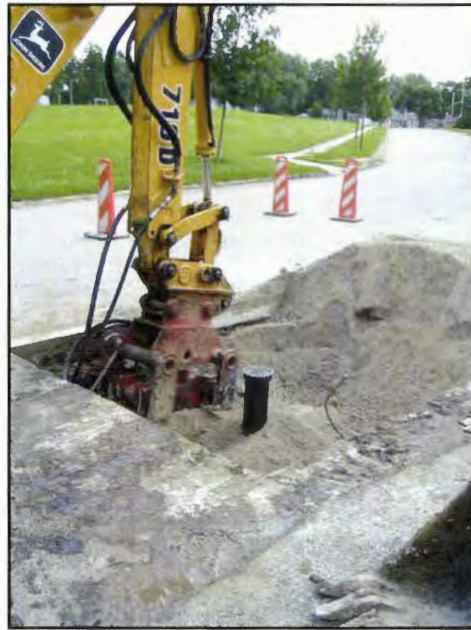
Figure 41. Backfill compacted into trench.

each and was tamped with a vibrating plate for about three to four seconds in no specific compaction pattern. Figure 41 shows a lift of the material being tamped in place. The pavement surface consists of six inches of concrete and two inches of asphalt overlay. As a result of the backhoe rolling over the edge of the trench during the backfill compaction process, the surrounding composite pavement was damaged (see cracked pavement in Figure 42).

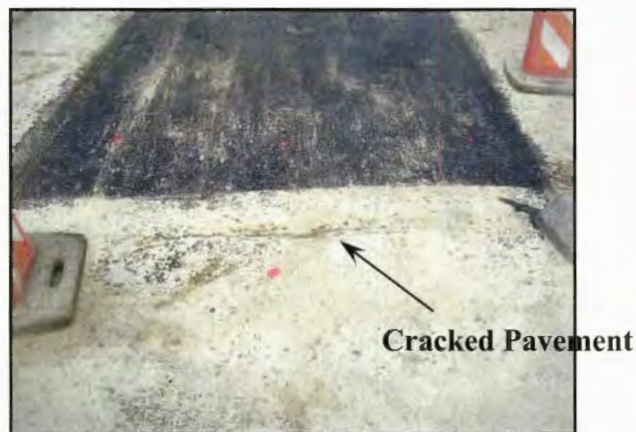
Figure 42. Visible pavement damage on utility edge.

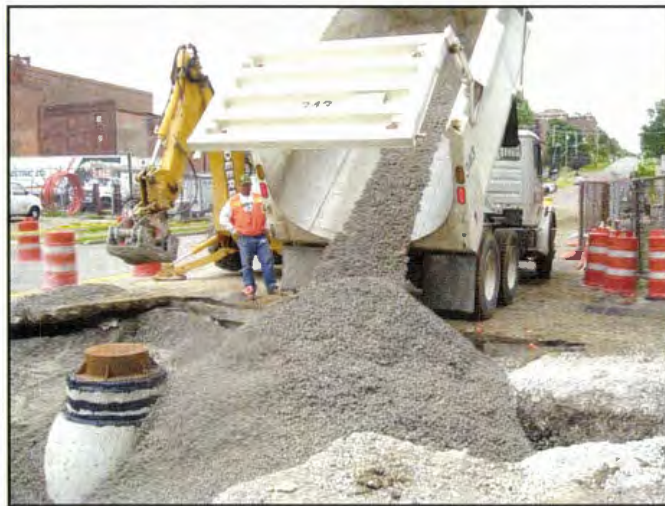
Figure 43. Large backfill lift being placed.

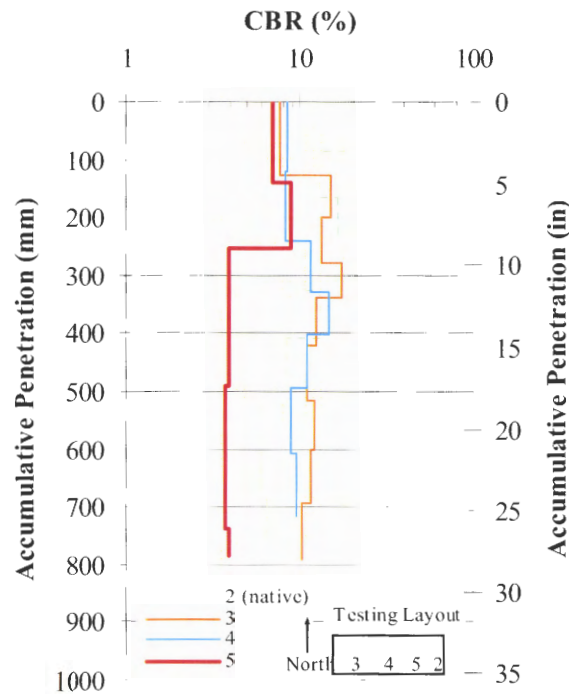
Figure 52. CBR Profile for Ames.

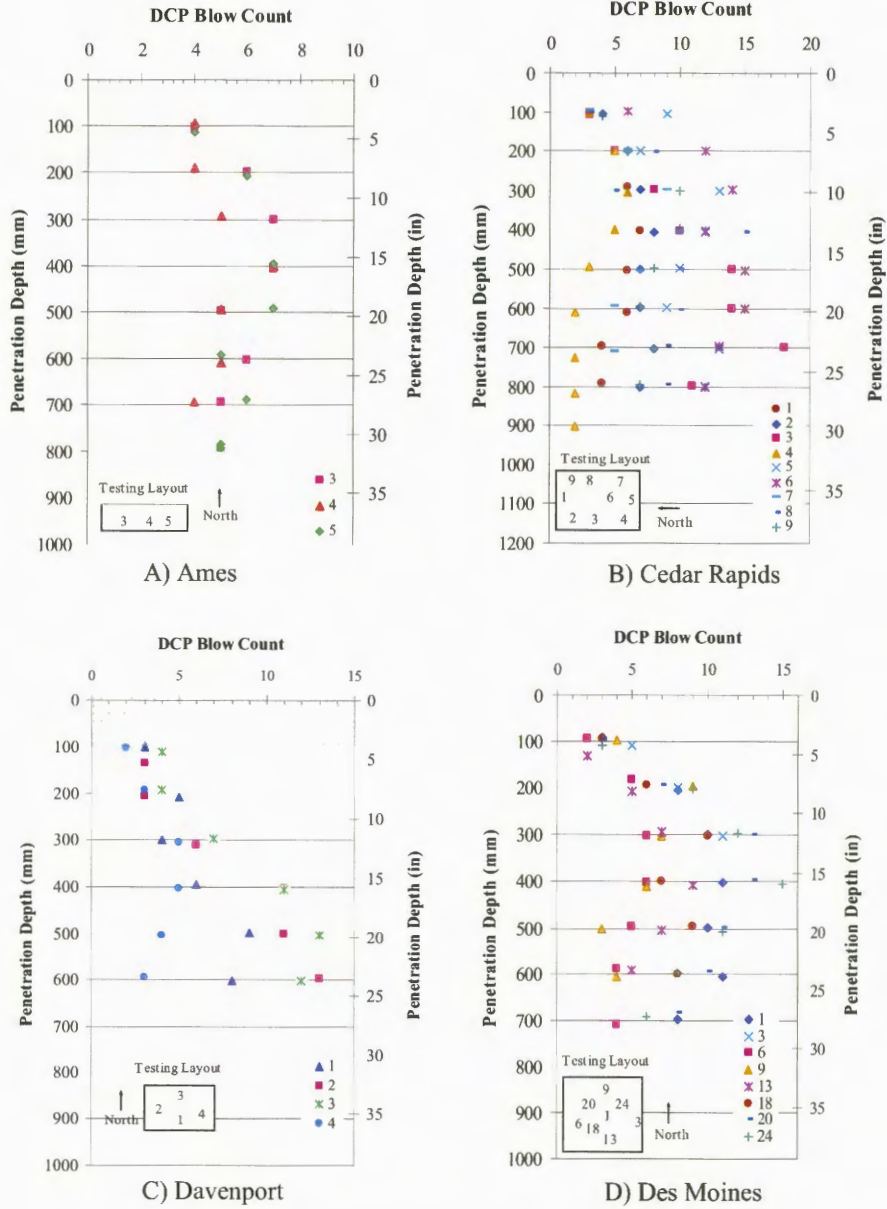
Figure 56. DCP Blow Count Profiles.

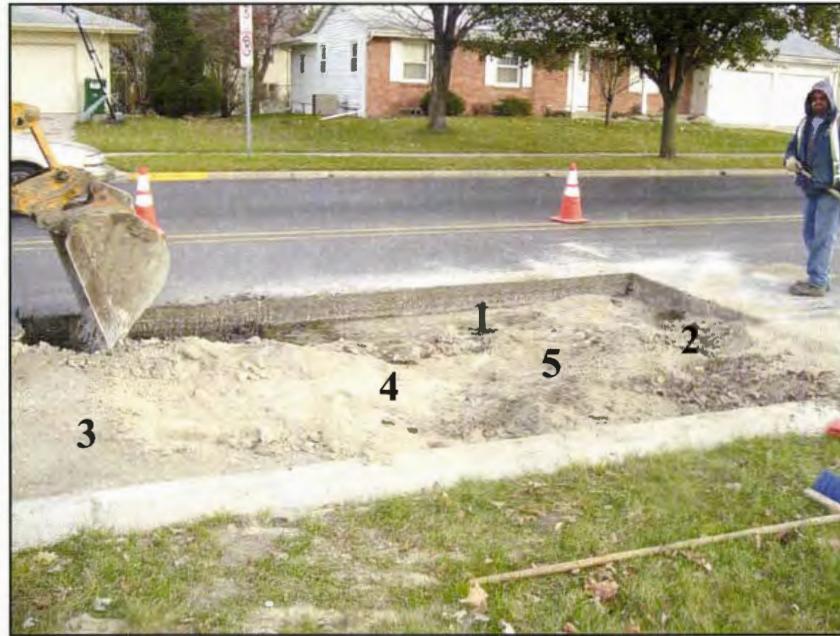
Figure 59. Testing layout of trench.

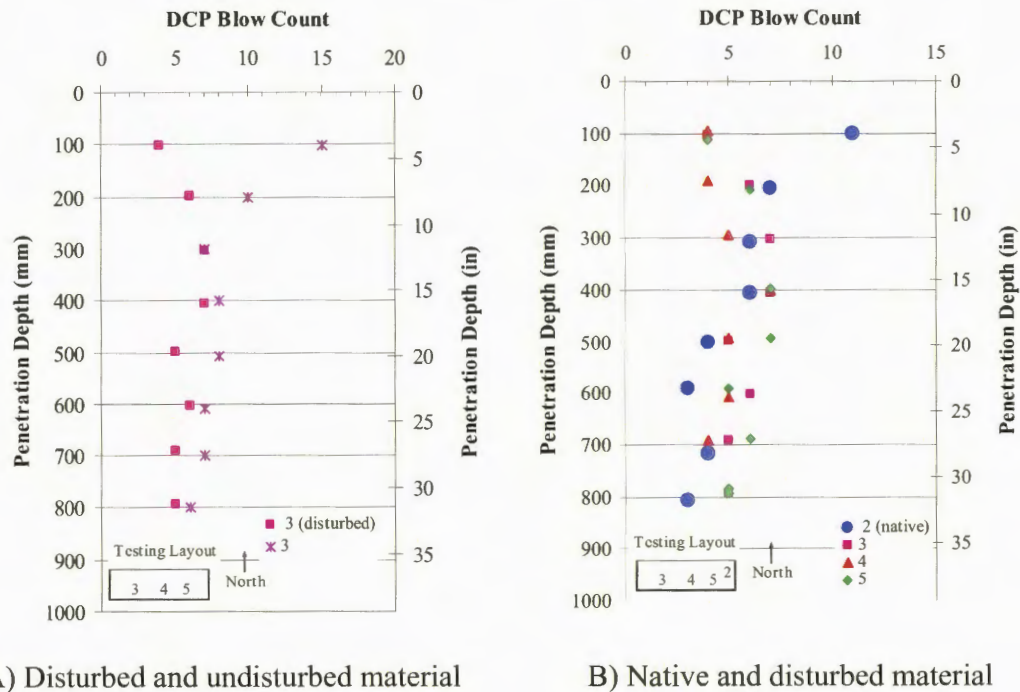
Figure 60. Ames DCP Profile.

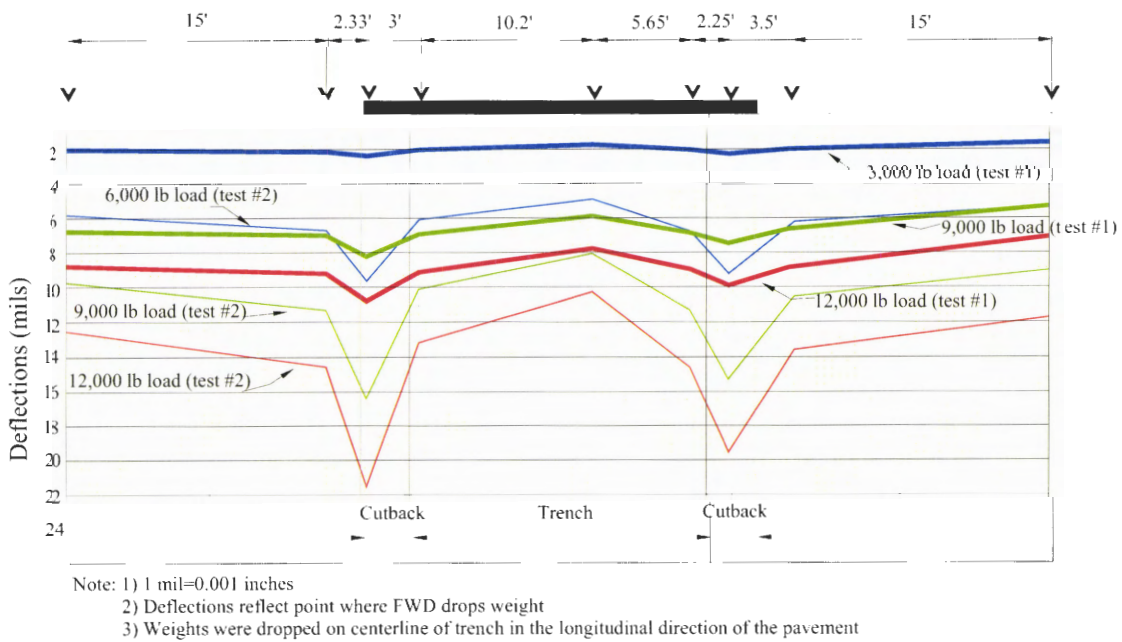
Figure 62. Ames FWD response profile.

In general, each FWD plot indicates a significant lower vertical deflection in the region just outside the excavated area, leading to an indication of decreased pavement life.

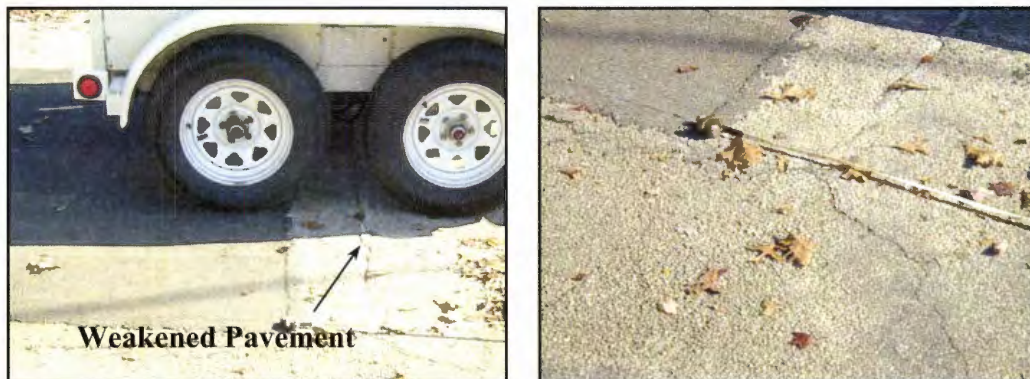
Figure 63. Cedar Rapids pavement distress.

This site was tested October 25, 2004 and then again April 20, 2005 to see the effect of deflections with time. When designing the FWD testing layout, this damaged region was of great importance to determine what effect additional stress has on the edge of the open excavated area. Figure 64 shows the FWD drop locations and Figure 65 shows the influence zone again causing the greatest deflection, specifically near the damaged edge of the trench. The distressed point of the trench, was missed on the second visit. A difference in deflections with time ranged from 0.5 mils to 12 mils at a load of 9,000 lb (4082 kg). Again the seasonal effect of the ground thawing increased the deflections observed in the data.

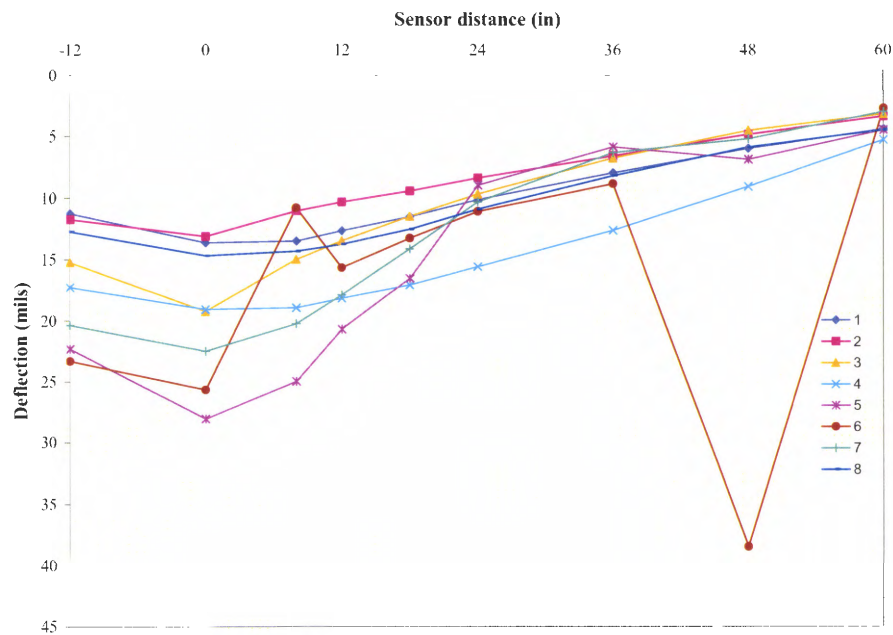
Figure 110. Cedar Rapids test #2: 11000 lb. FWD raw data.

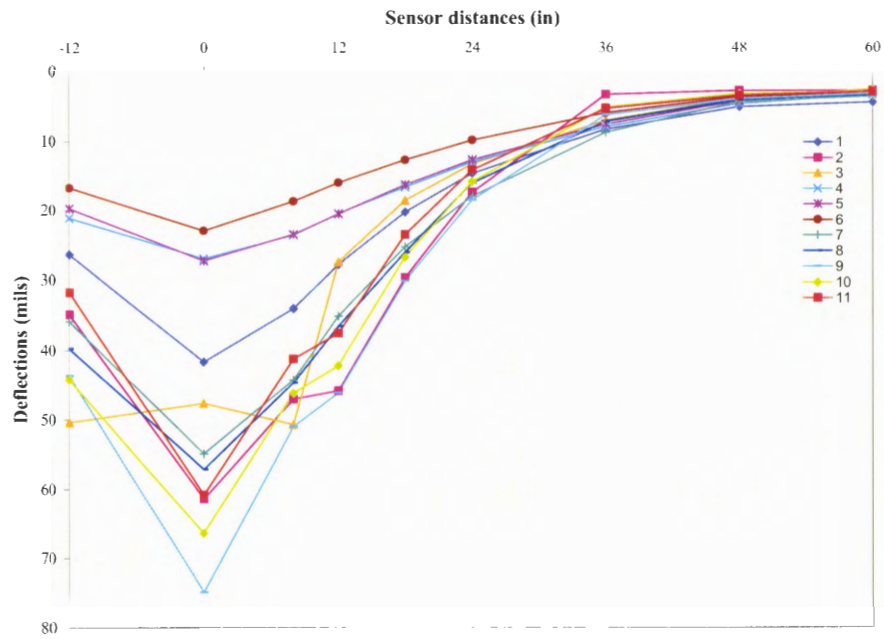
Figure 121. Ames McKinley St.: 12000 lb. FWD raw data.
