# Investigation of negative moment reinforcing steel in pre-cast pre-stressed concrete beam bridge decks

**Investigation of negative moment reinforcing steel in pre-cast pre-stressed concrete  
beam bridge decks**

Major: Civil Engineering (Structural Engineering)

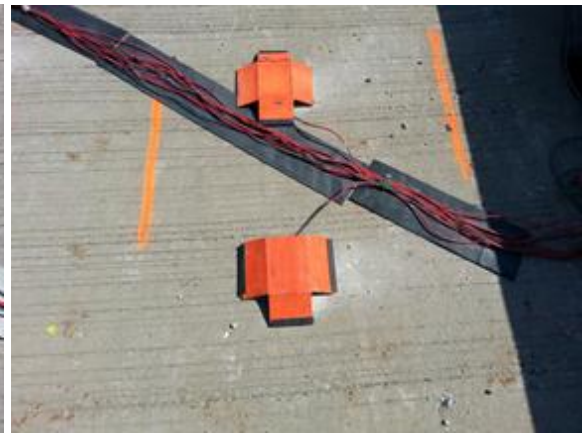
**Figure 4. Cover plate to prevent damage**

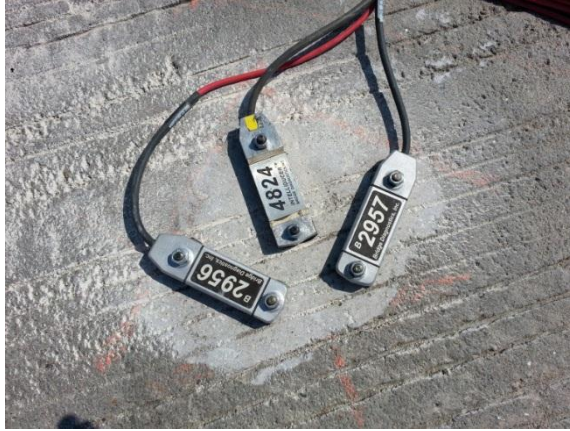
To investigate the behavior of the principal strains, several rosettes were also installed 1ft inside and 1ft outside at the end of the b2 reinforcement.

**Figure 5. Rosette near b2 reinforcement**

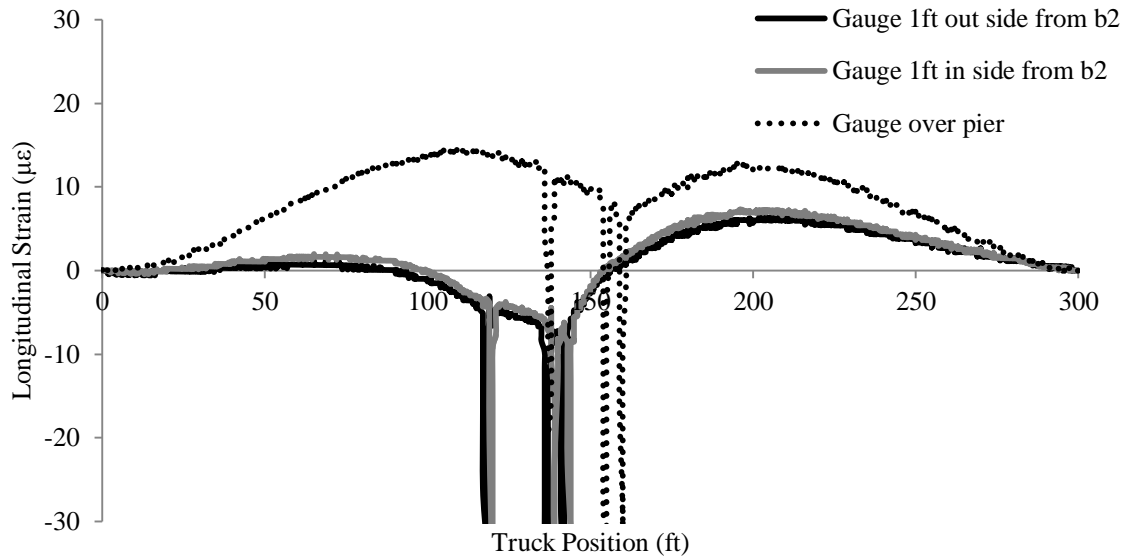
tests involved 5 bridges with different properties, the strain profiles of the deck gauges look similar in terms of pattern and sometimes magnitudes. This suggests that the effect of the negative moment b2 reinforcement may not be affected by the properties of the bridges, such as number of spans, span lengths, widths, skew angles, number of girders and girder types.

**Figure 8. Typical strain variation of deck gauges**

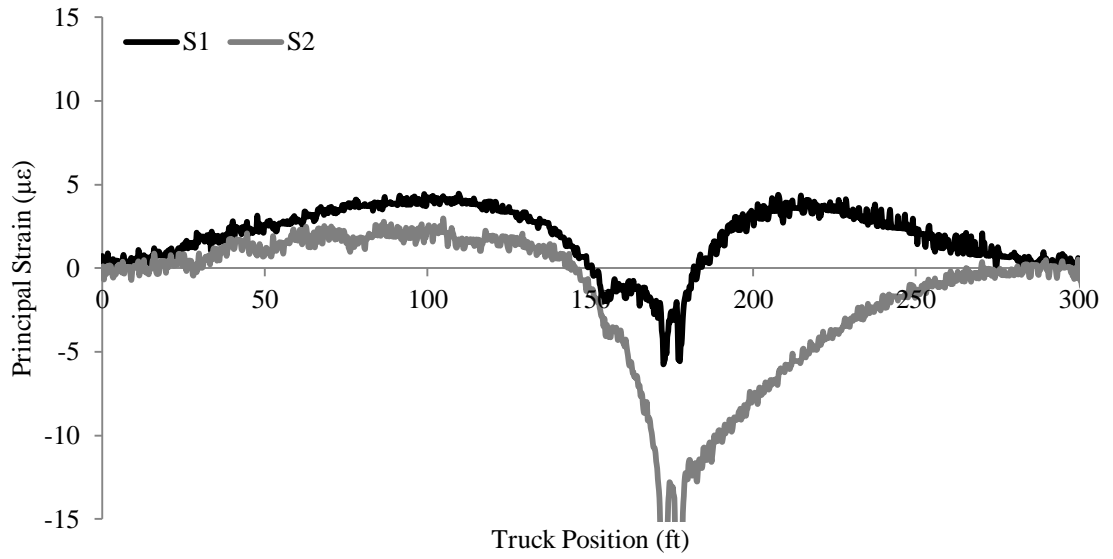
**Figure 11. Typical variation of principal strains for two-span bridges with truck axle closer to rosettes**

Based on the principal strain profiles, no significant difference was observed between the inside and outside rosettes at the end of the b2 reinforcement. However, in two-span bridges, when truck axle was in the vicinity of the rosettes, an expected strain variation was observed (Figure 11). But when the truck axle was away from the rosettes, major and minor principal strains of approximately the same magnitudes with opposite signs were observed (Figure 12). In the three-span bridges, approximately same principal strain magnitudes with opposite with signs was observed (Figure 13 and Figure 14).

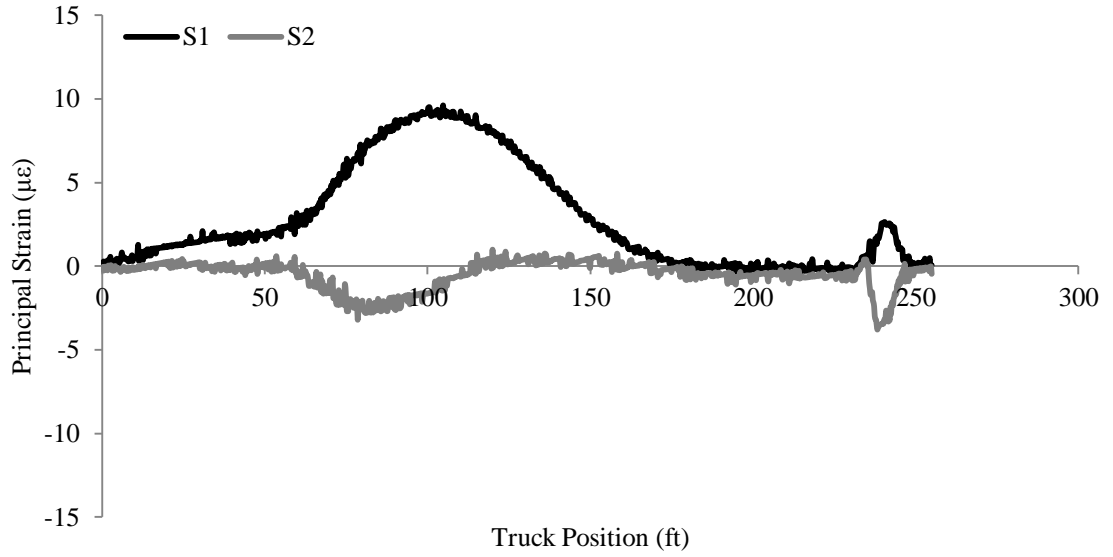
**Figure 13. Typical variation of principal strains for three-span bridges with truck axle away from rosettes**

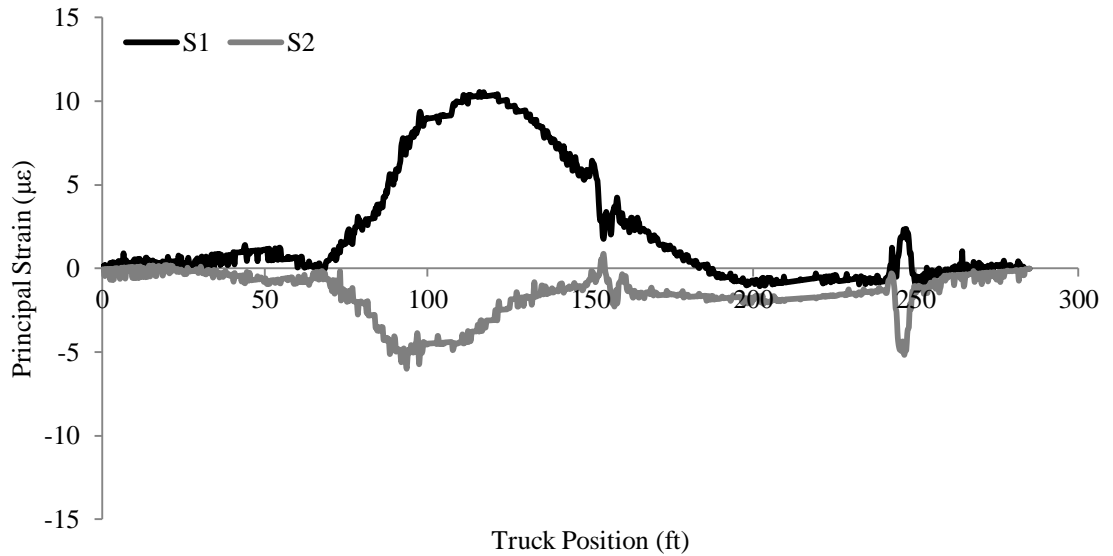
**Figure 14. Typical variation of principal strains for three-span bridges with truck axle closer to rosettes**

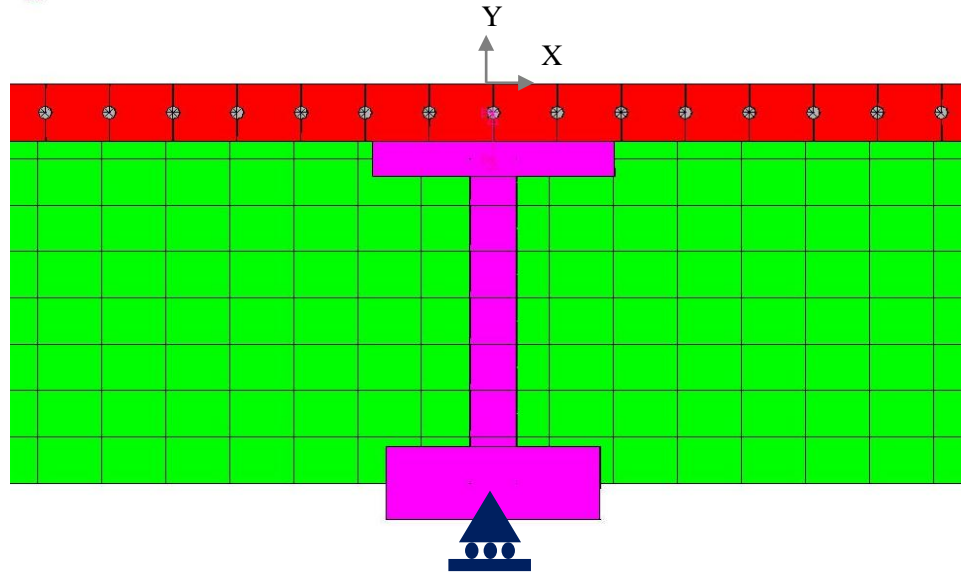
The girders of Bridge A are connected to the pier cap through a pintle, which restrains the three translational degrees of freedom at the end of the girders. The pier cap is supported on five pier columns, which are connected to the pile foundation. The support conditions for the girders at the pier were approximated by a roller support, which restrained the Y direction translation (Figure 20) from movement.

Figure 20. Support condition at the pier diaphragm

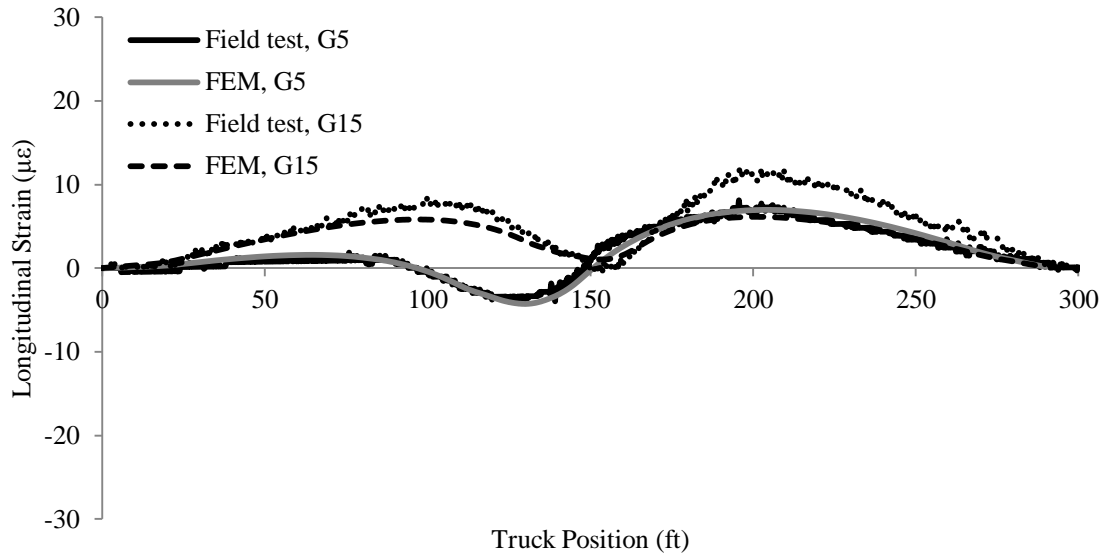
**Figure 24. Strain variation of deck gauges (G5 and G15) away from axles, (LC1)**

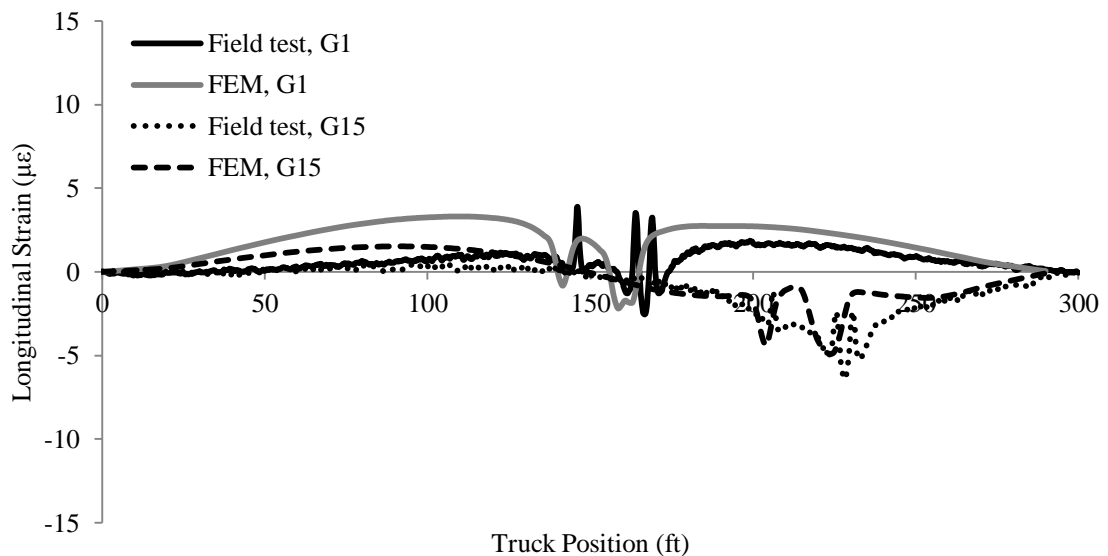
Calibration results for the girder gauges are presented in this section. According to Figure 25, field test results for the gauges at the top flange at the pier and mid span locations agree with the FEM results. However, strain magnitudes of those gauges are very small.

**Figure 25. Strain variation of girder gauges (G1 and G15) close to axles, (LC1)**

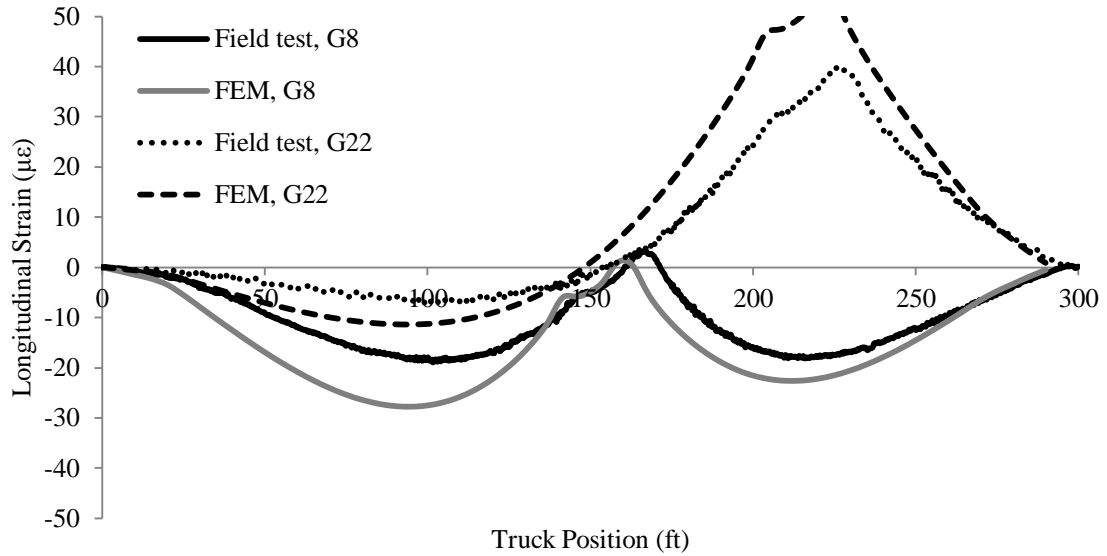
Figure 26 and Figure 27 show the finite element and field test results of girder gauges “close” to the truck axles. The pattern of both the finite element and field test results are similar. But, there is a maximum of 30% average strain difference between FEM results and field test results.

**Figure 26. Strain variation of girder gauges (G8 and G22) close to axles, (LC1)**

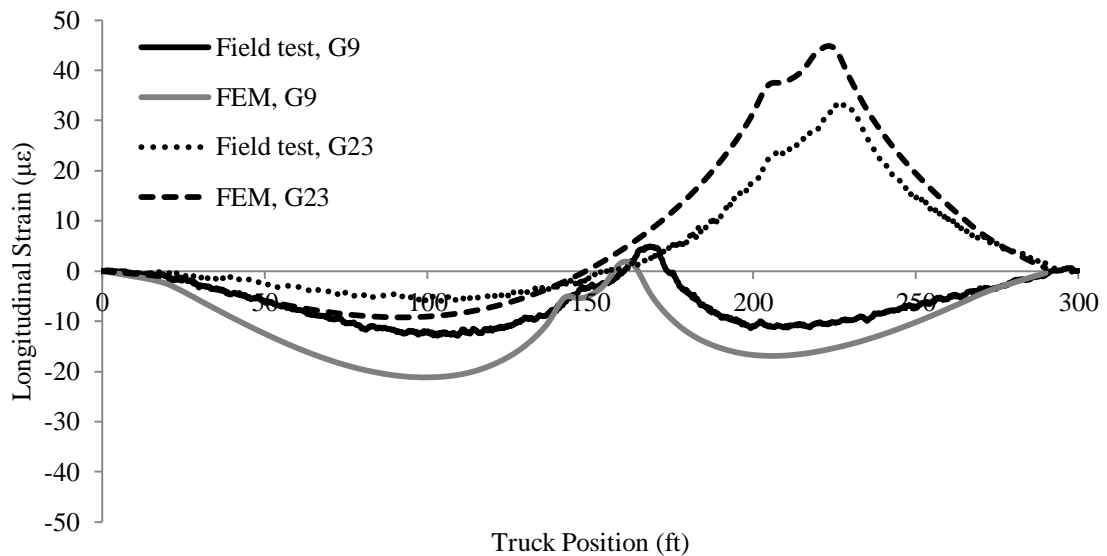
**Figure 27. Strain variation of girder gauges (G9 and G23) close to axles, (LC1)**

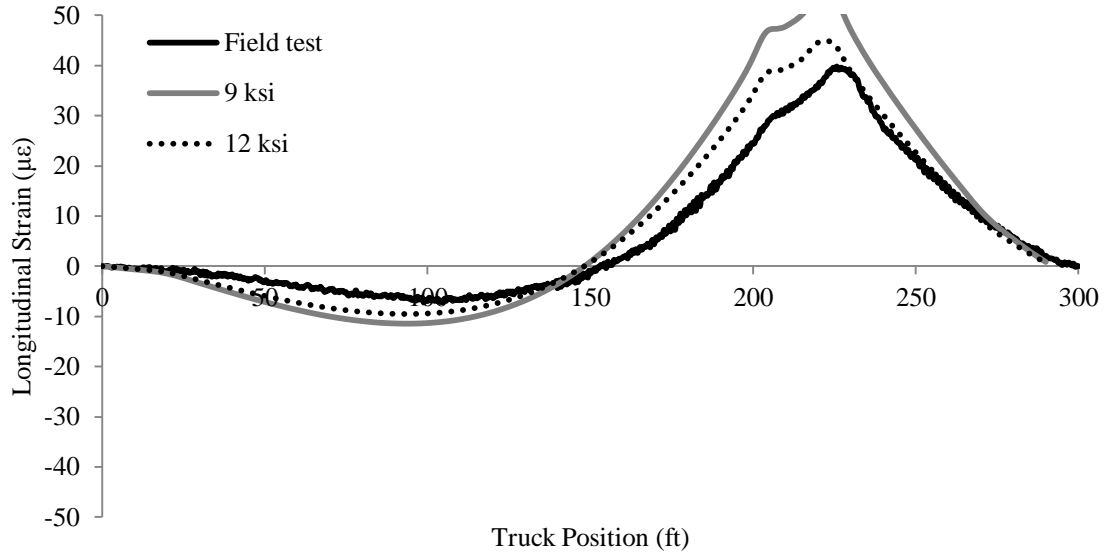
**Figure 29. Strain variation of girder gauge G22 with different girder  $f'_c$**

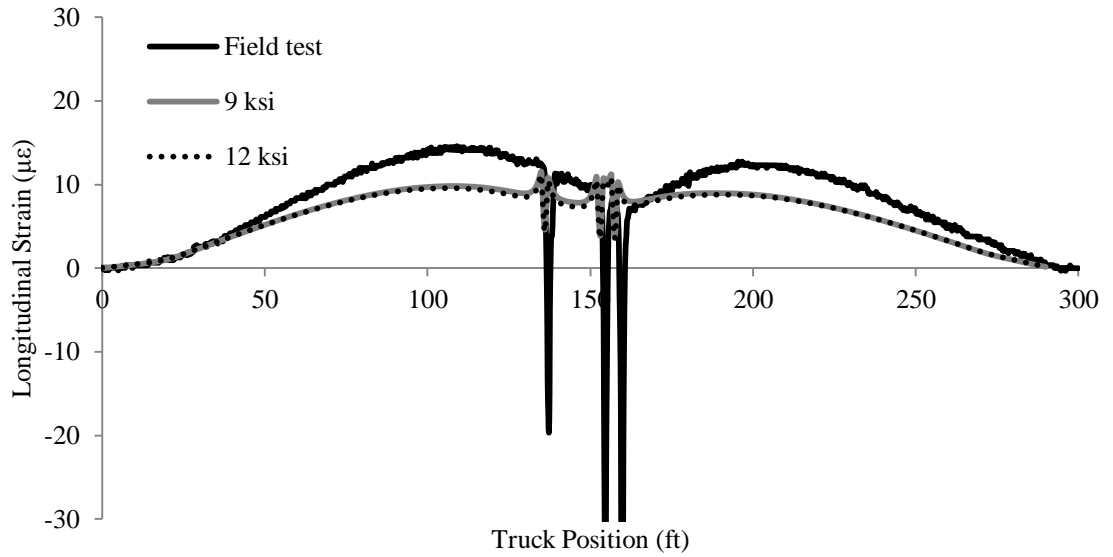
Importantly, Figure 30 and Figure 31 show that the change of the strength and Modulus of Elasticity of the girder does not significantly affect the strain in the deck.

**Figure 31. Strain variation of deck gauge G11 with different girder  $f'_c$**

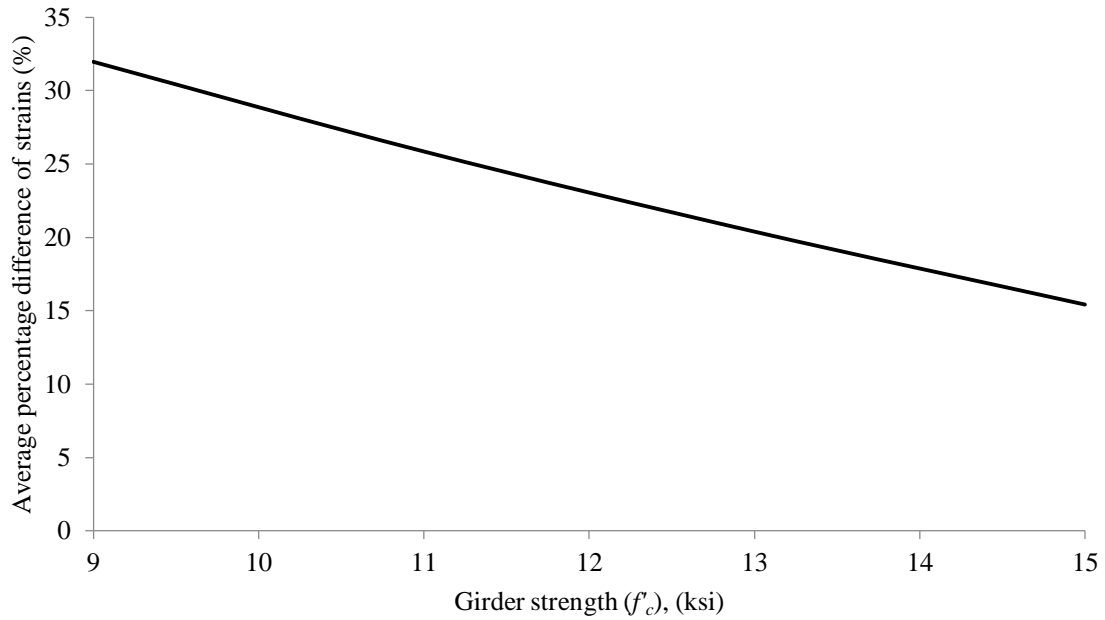
Figure 32 shows the variation of the average percentage difference of peak strain with the girder strength. Beyond a 15 ksi of girder concrete strength, the average percentage strain difference is less than 15%. Since the strength of the girders beyond 15 ksi is not realistic, it was decided to use 12 ksi for the girder strength, which gives about a 23% average difference in the strain peak.

**Figure 32. Variation of average % difference with the girder strength**

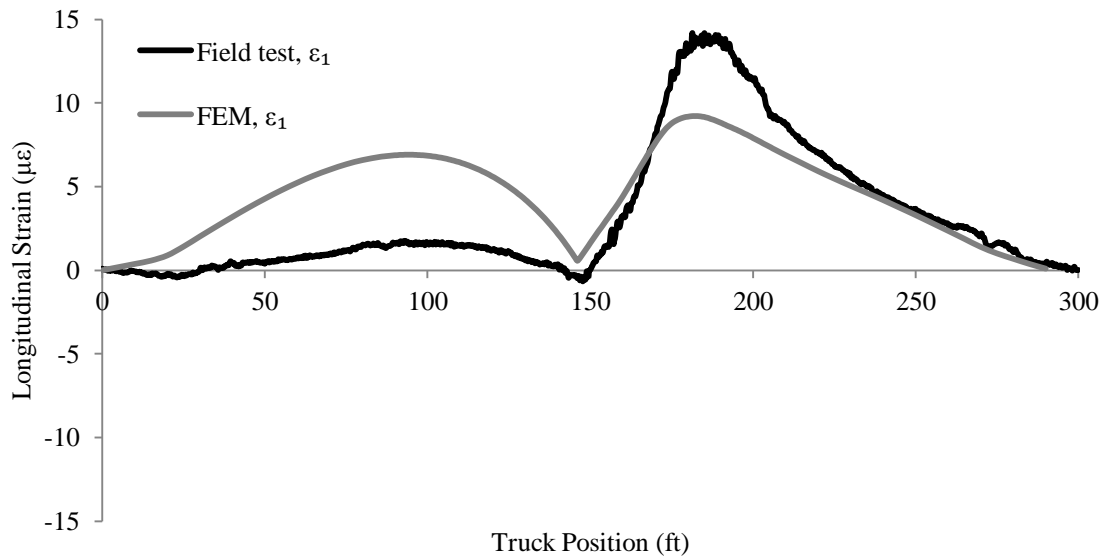
**Figure 38. Variation of principal strains of rosette R6 for LC1**

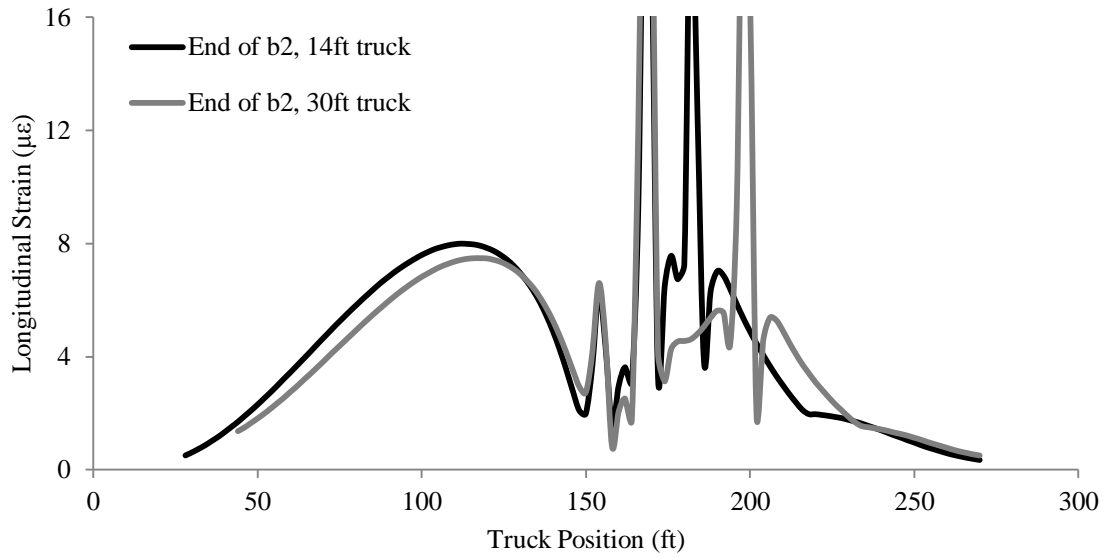
**Figure 41. Typical variation of  $\epsilon_1$  strain for truck over Lane1, end of the b2 reinforcement**

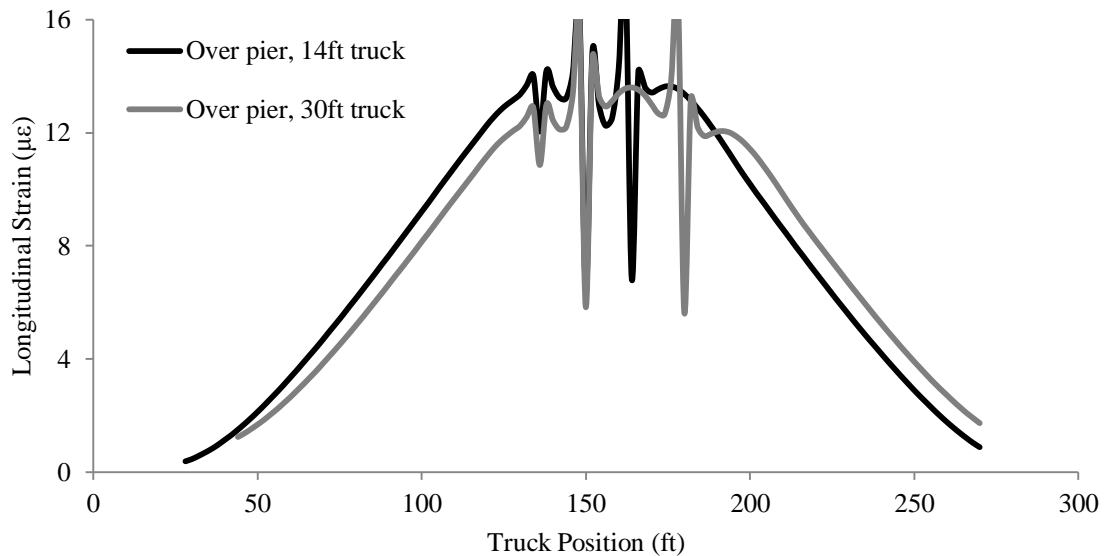
**Figure 42. Typical variation of  $\epsilon_1$  strain for truck over Lane1, at the pier**

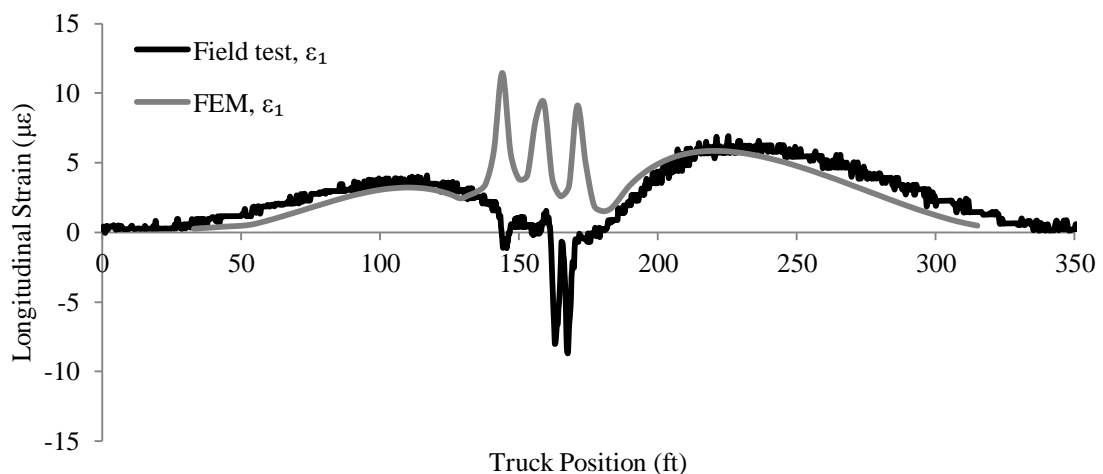
Comparisons were made between the FEM and the major principal strains ( $\epsilon_1$ ) determined from field test results. According to Figure 52, there is a significant difference between the FEM and field test results of the principal strains around the pier. Other than that, the finite element model predicts the field test results of the rosettes.

**Figure 52. Variation of principal strains of rosette R2 for LC1**

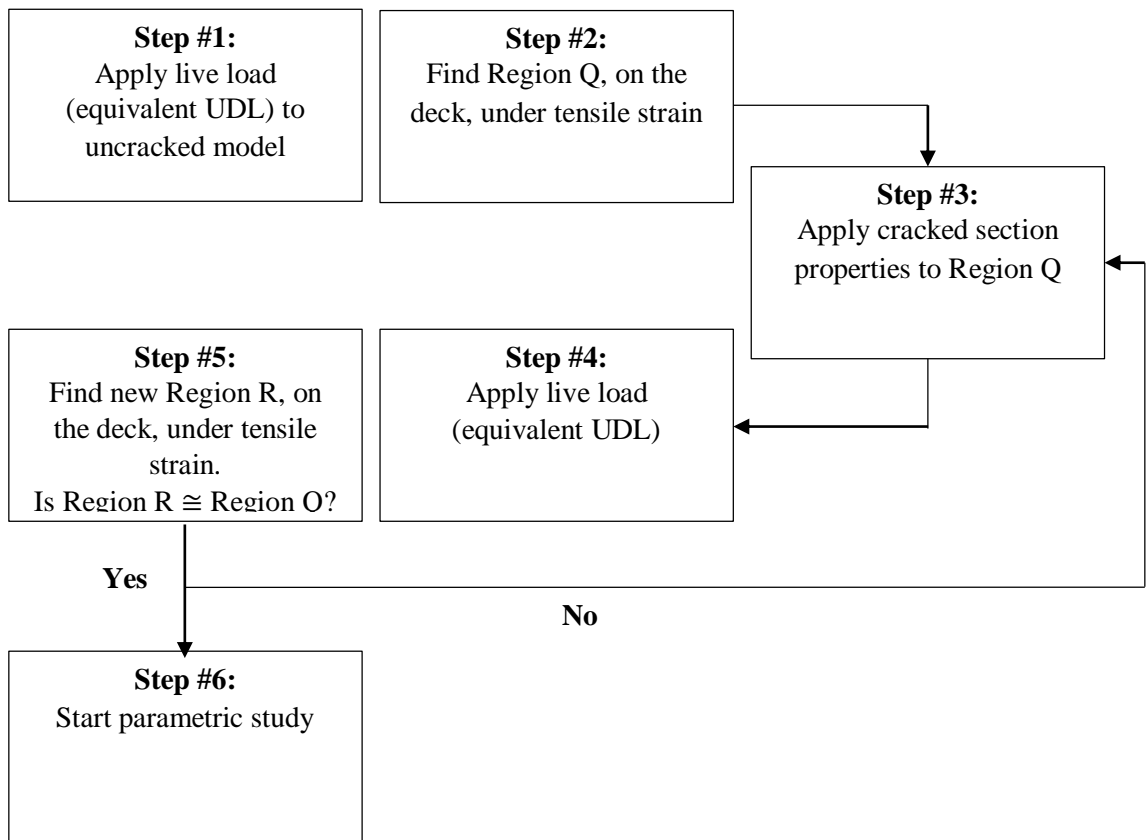
Figure 55. Method to determine cracked section

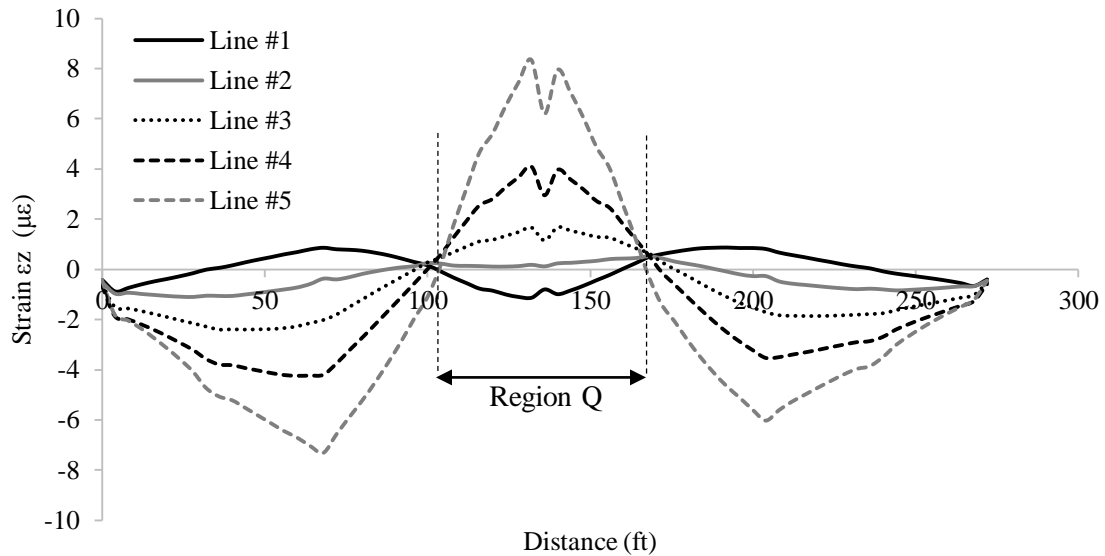
**Figure 56. Negative moment region over pier**

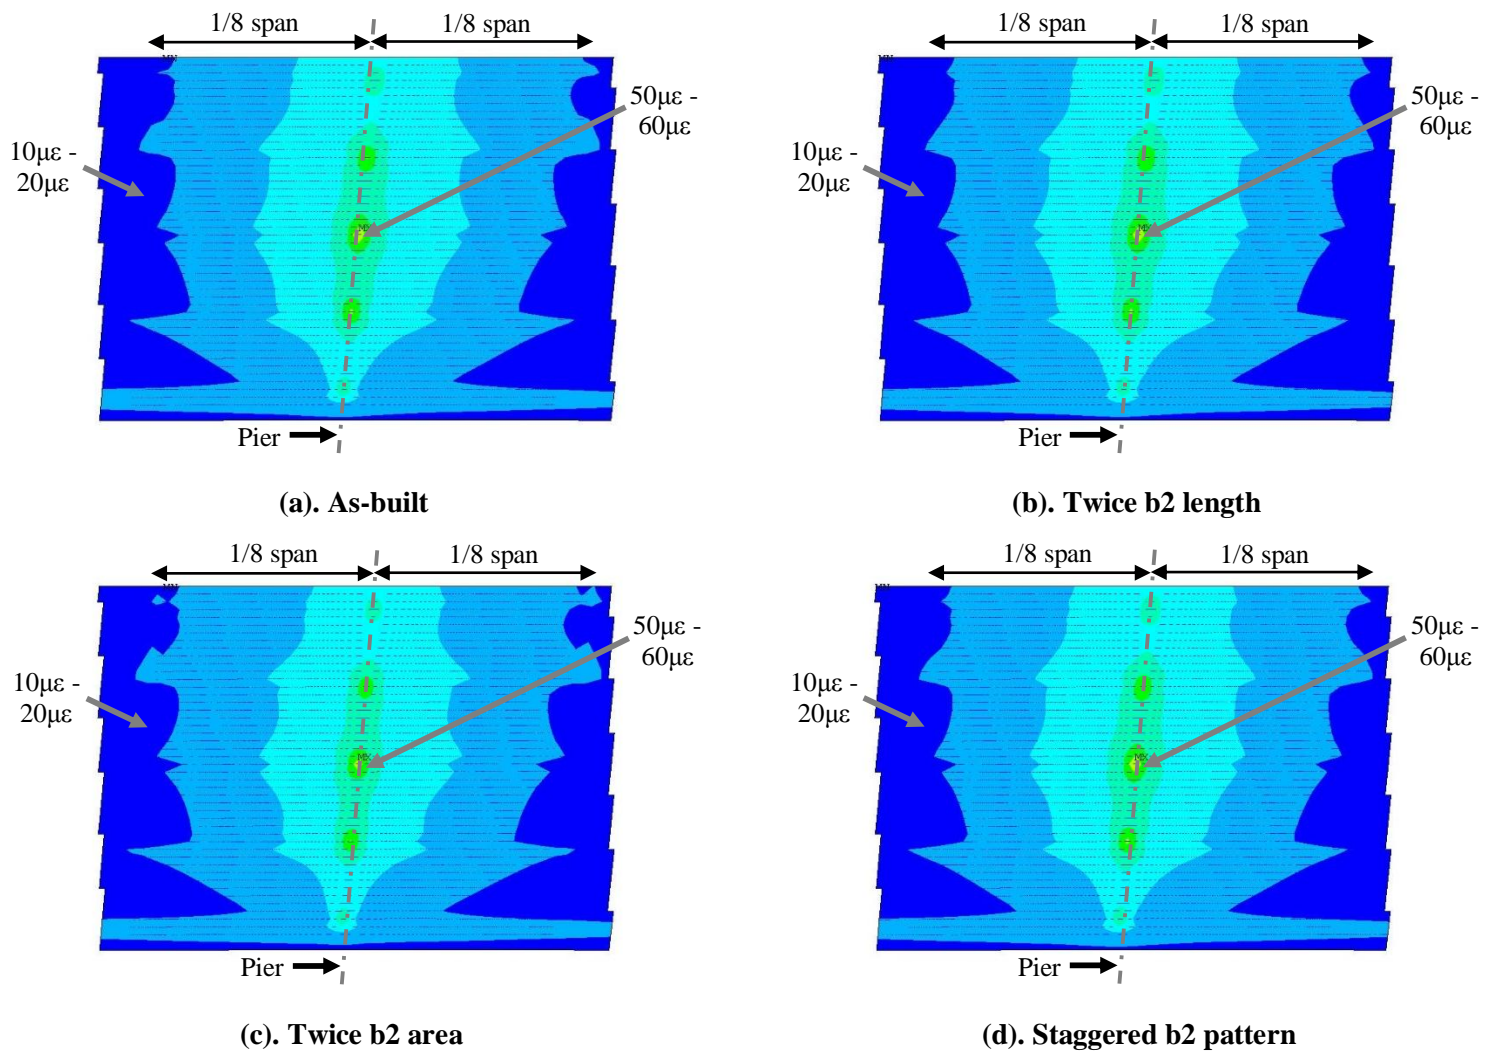
Figure 59. Variation of  $\epsilon_1$  of Bridge A of Model 1, Load = Equivalent UDL

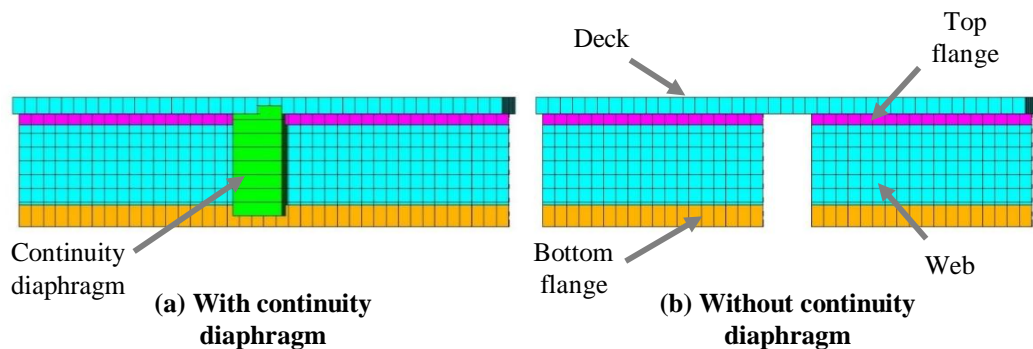
Figure 73. Finite element model at the intermediate support

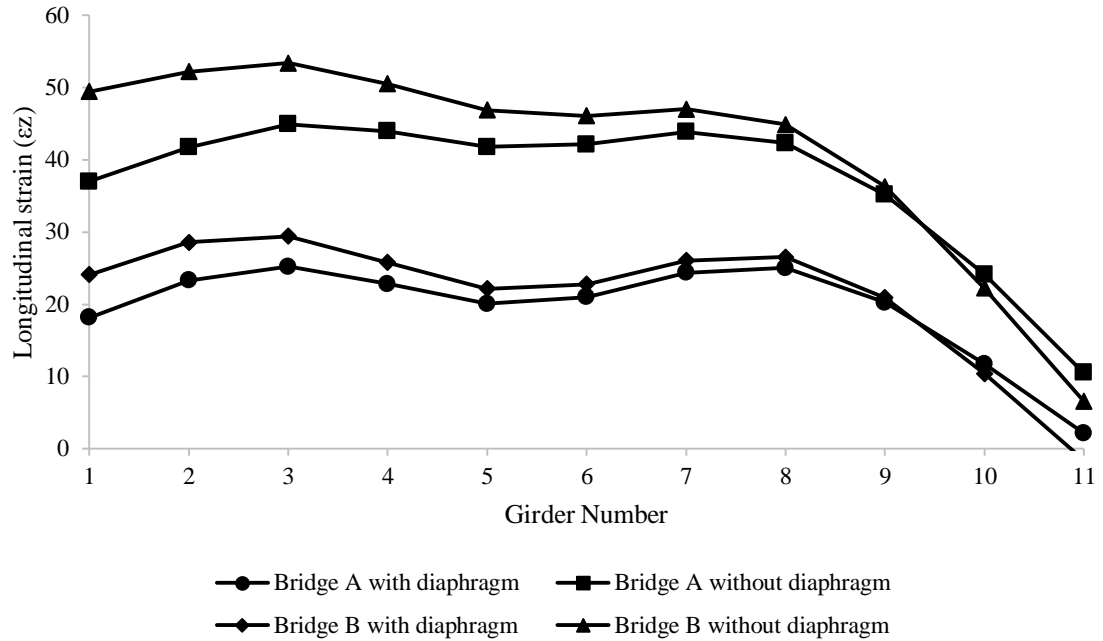
**Figure 76. Strain of the girder mid-span**

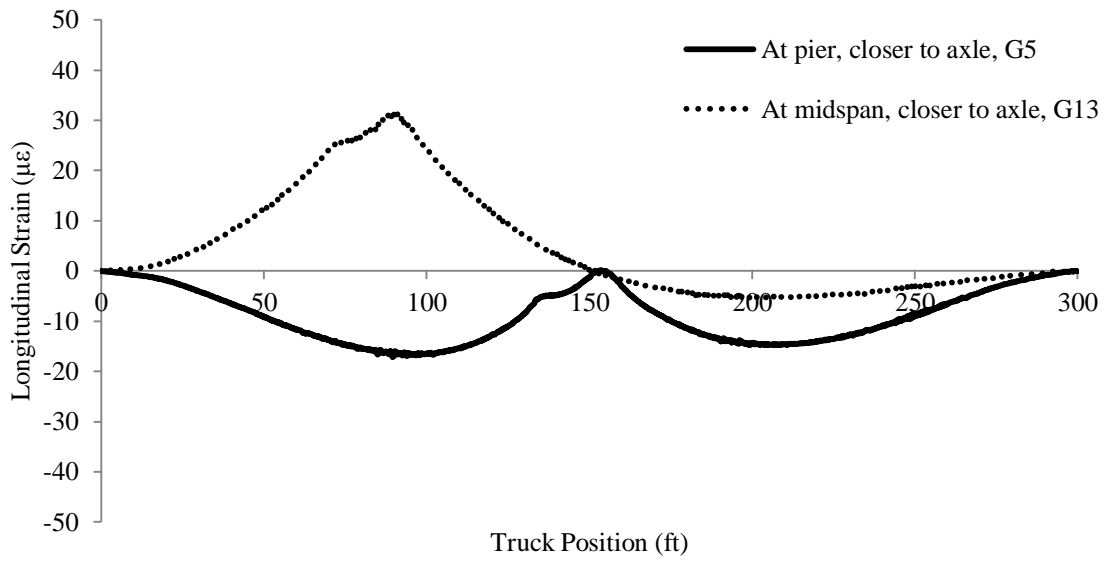
Typical strain variation of girder gauges of Bridge 1 (LC1)

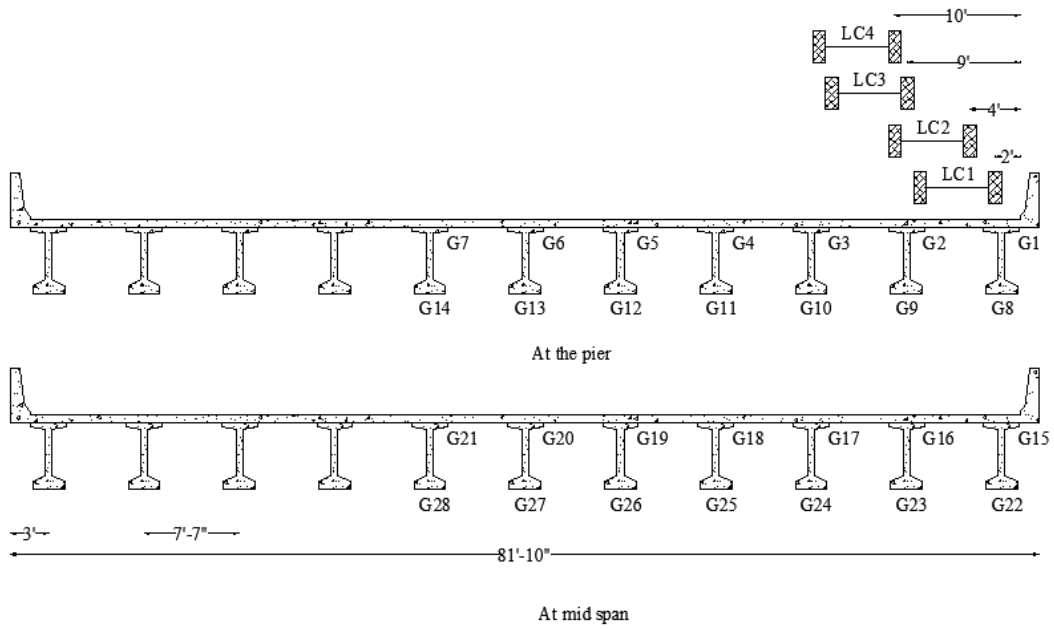
Bridge 3; Instrument plan of girder gauges
