Investigation of steel stringer bridge superstructures

A thesis submitted to the graduate faculty
in partial fulfillment of the requirements for the degree of
MASTER OF SCIENCE

Major: Civil Engineering (Structural Engineering)

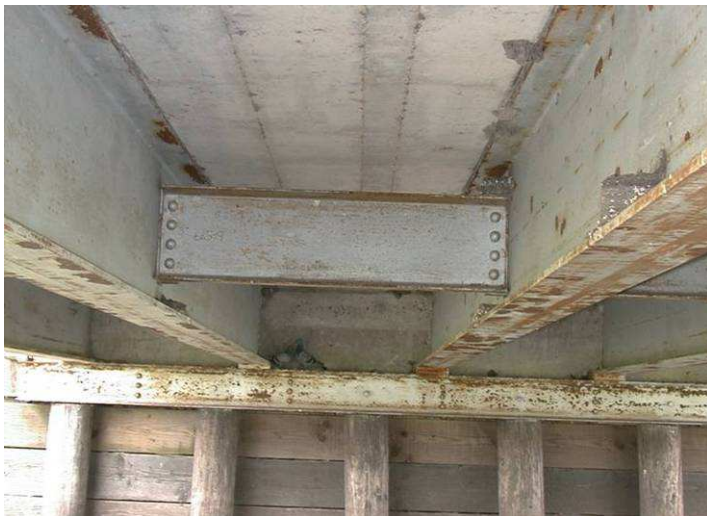
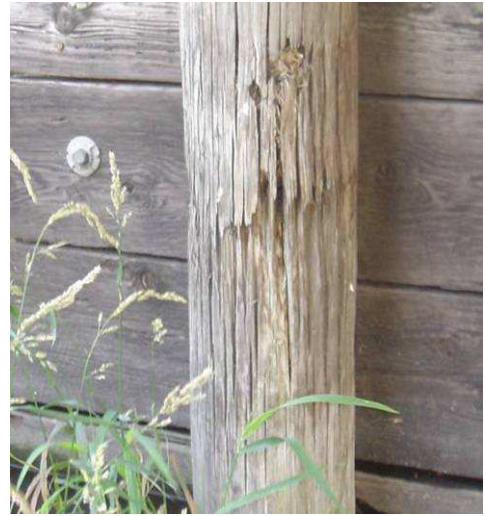
Figure 3.4. BCB Deterioration.

The superstructure appears to be in good condition with some minor rust in areas as shown in Figure 3.4(a). Typical decay that was found in some of the piles is shown in Figure 3.4(b). There were minor repairs made to the bridge in 1993 when the south bridge approach was washed away; the repairs consisted of the installation of a sheet pile wall behind the existing timber back wall and then filling the void with concrete. Shown in Figure 3.5(a) is the sheet pile wall while the concrete behind the top of the timber backwall is shown in Figure 3.5(b).

(a) Minor rust on girders

(b) Rotten pile

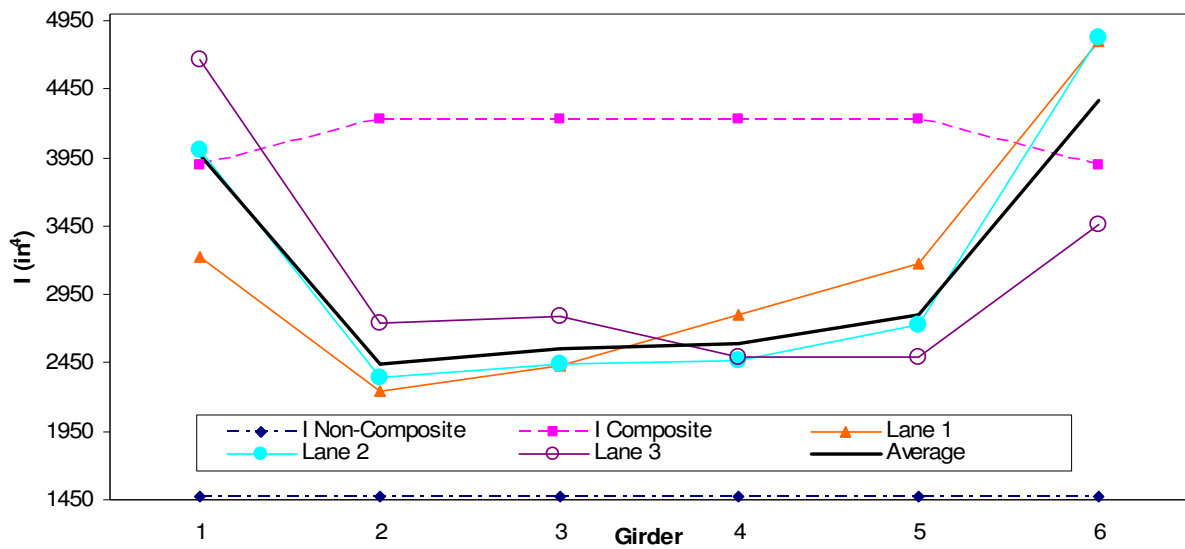
Figure 3.21. BCB Effective Moments of Inertia.

composite section. As was the case with the neutral axis locations in the exterior girders that did not have the load directly above them, the relatively small strains observed in the top flanges of the girders caused the moment of inertia to be larger than those calculated from the larger strain values. The increased stiffness of the curb and railing that were not accounted for in the composite moment of inertia calculations account for the difference. The moments of inertia for each girder and lane loading are shown graphically in Figure 3.21 along with the values for the non-composite and composite neutral moments of inertia. An average moment of inertia for the three lane loadings is also provided in this figure.

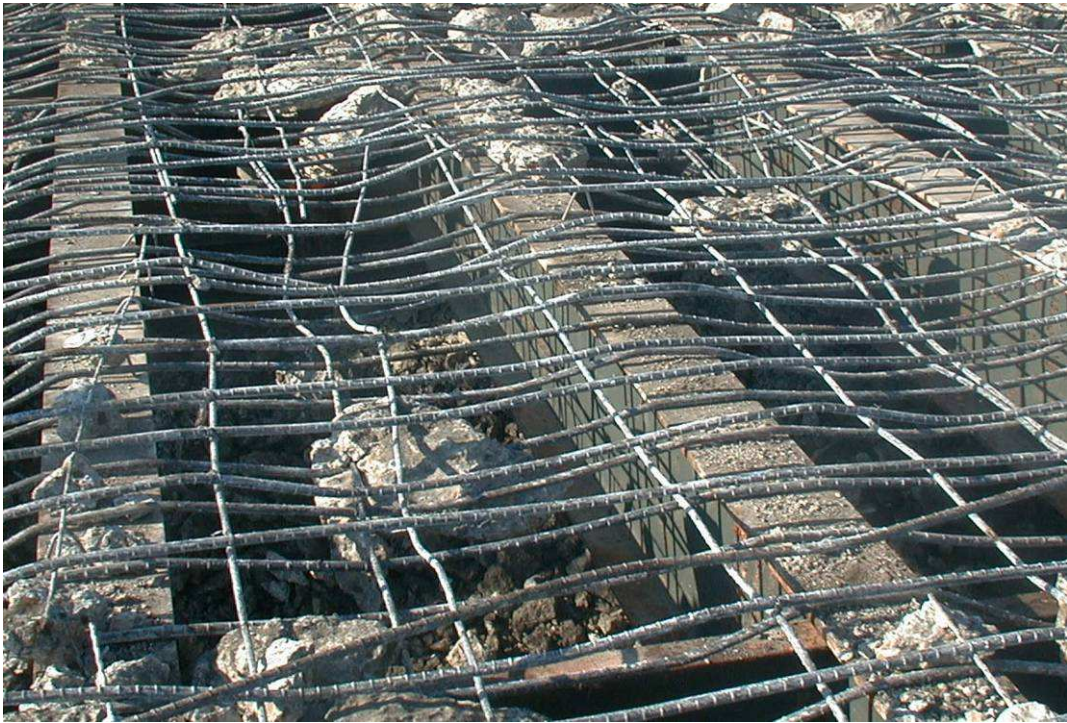
Figure 4.17. Exposed Top Flanges After MCB Deck Demolition.

creating the composite action even though no such a connection appeared on the plans provided. Approximately two weeks after testing this bridge it was removed and replaced with a new bridge. The bridge demolition provided little explanation as to why this composite action occurred as the top flanges were completely free of any kind of mechanical shear connector as shown in Figure 4.17.

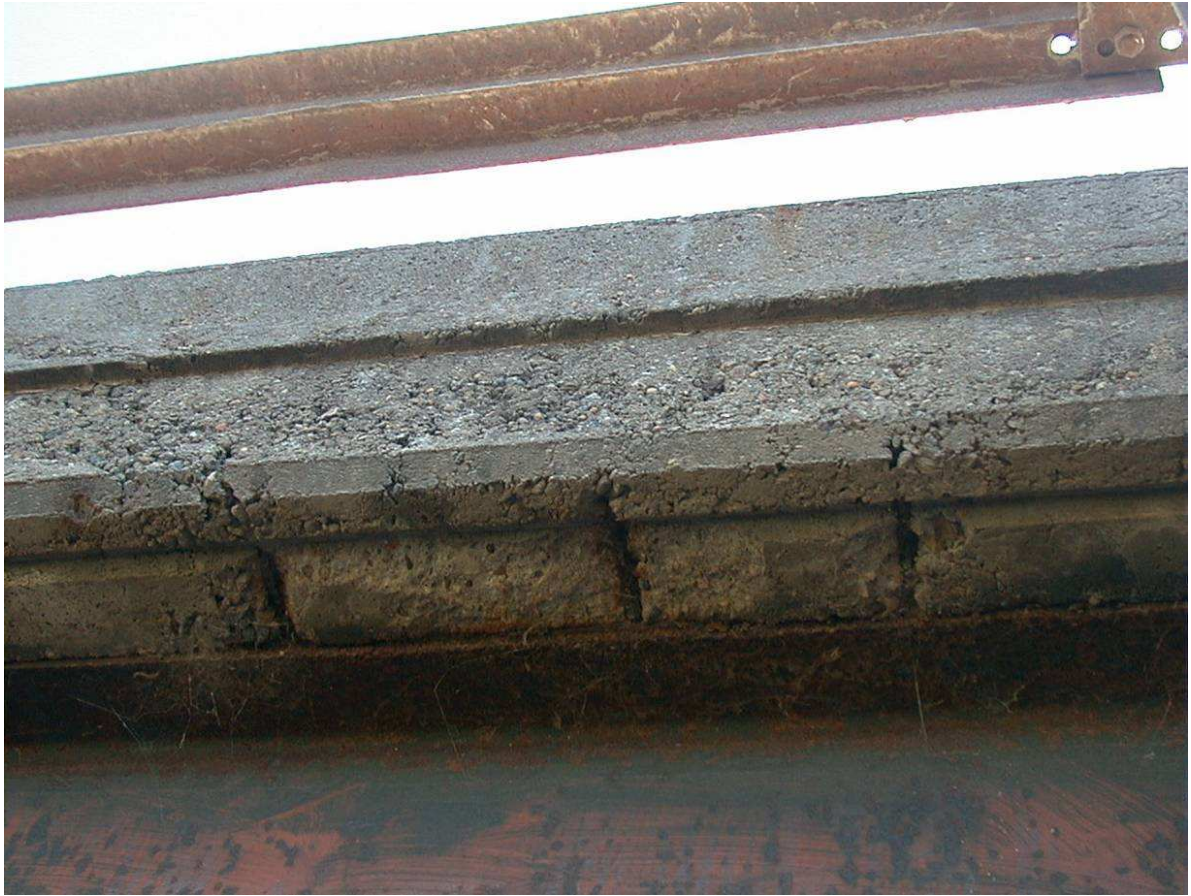
Figure 5.2. KCB1 Poor Concrete Consolidation.

The superstructure was in relatively good condition with only minor rust on the girders. Signs of poor concrete consolidation during the construction of the deck were observed on the underside of the deck where there were large voids near the midspan. The poor consolidation caused some of the reinforcing steel to be exposed as shown in Figure 5.2. There was also a large crack in the concrete deck located at the midspan of the bridge, a photograph of which is provided in Figure 5.3.

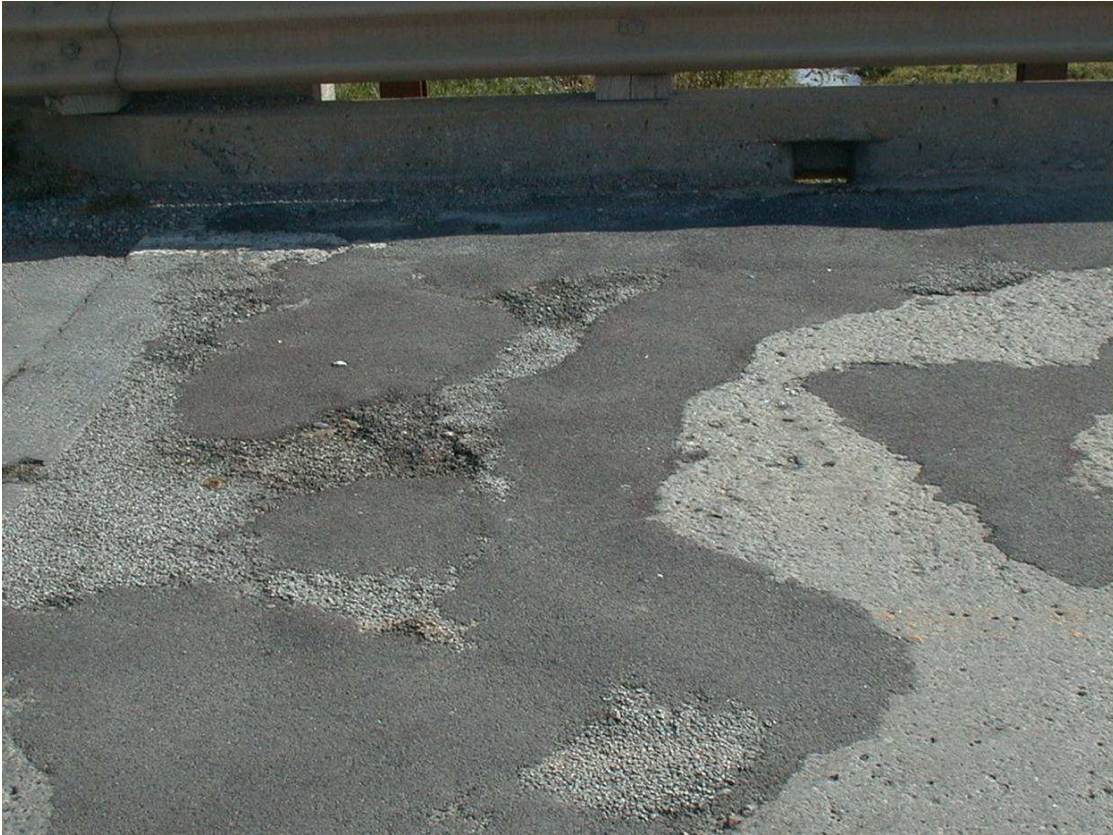
Figure 6.2. Asphalt Patches in CCB Concrete Deck.

The superstructure was in relatively good condition with only minor rust on the girders. The concrete deck however was in poor condition; there were areas of severe spalling on the wearing surface of the deck that had been patched with asphalt to create a smoother ride over the bridge. A photograph of the asphalt patches is shown in Figure 6.2.
