Investigation of the impact of environmental conditions on field welding of precast concrete connections

Investigation of the Impact of Environmental Conditions
on Field Welding of Precast Concrete Connections

A Thesis

Master of Science

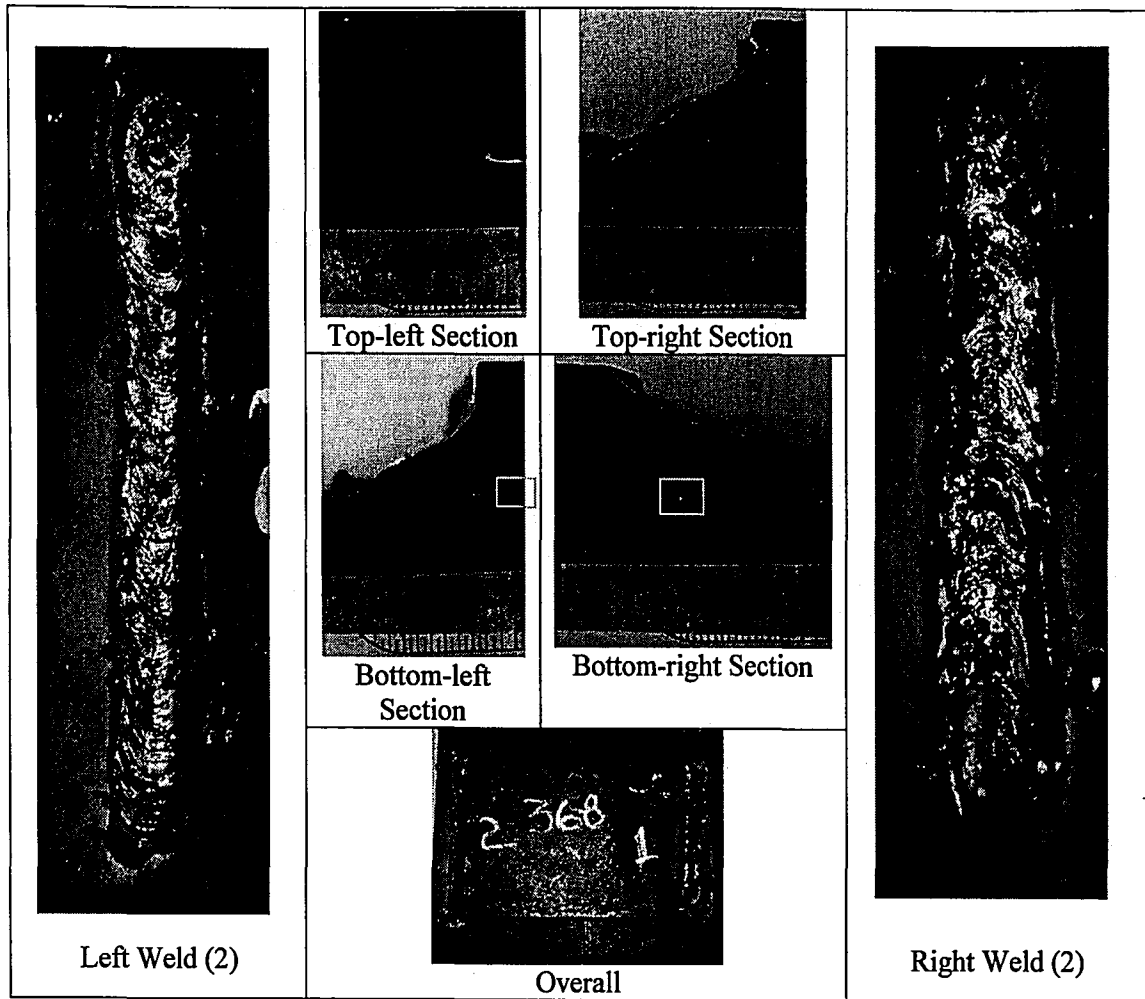
Figure 4.11: Specimen 36-8

The welded specimen is shown in Figure 4.11. Photographs of each of the two welds are presented along with an overview photo of the entire specimen. Sections were taken at four locations from the specimen and polished to examine the quality of the weld. These photos are also included.

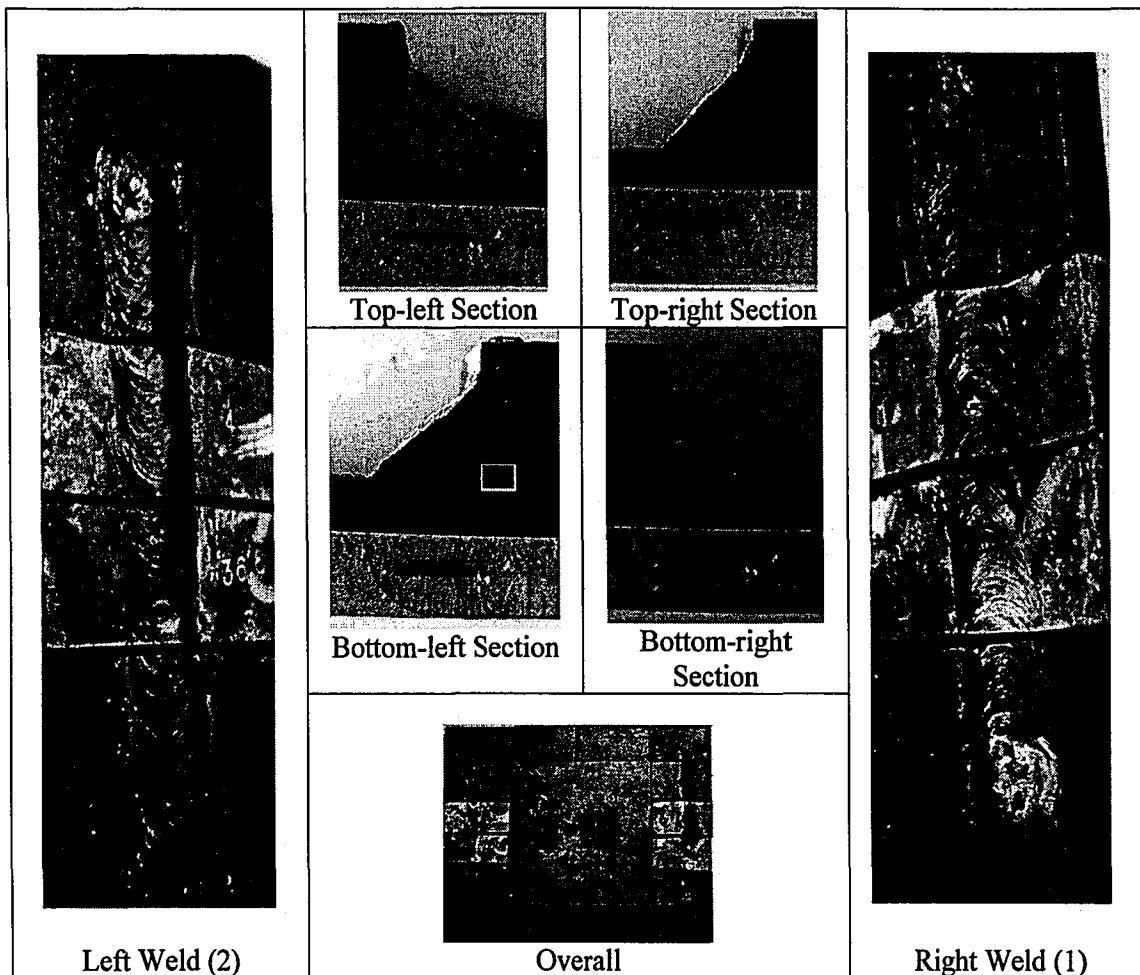
Figure 4.14: Specimen 36-14

The welded specimen is shown in Figure 4.14. Photographs of each of the two welds are presented along with an overview photo of the entire specimen. Sections were taken at four locations from the specimen and polished to examine the quality of the weld. These photos are also included.

The right weld had some edge-melt, and both weld surfaces had a slight amount of choppiness likely caused by wind. There was one small slag inclusion (.02-in.) at the root and two pores (.028-in., .020-in.) near the weld face in the top-left section (comprising 1.5% of the weld area), and a small inclusion (.025-in.) in the bottom-right section. Leg and throat dimensions satisfied the 1/4-in. profile requirements for all sections, although the top-left section had a profile which fell slightly below the proper 1/4-in. profile shape, rendering it unacceptable.

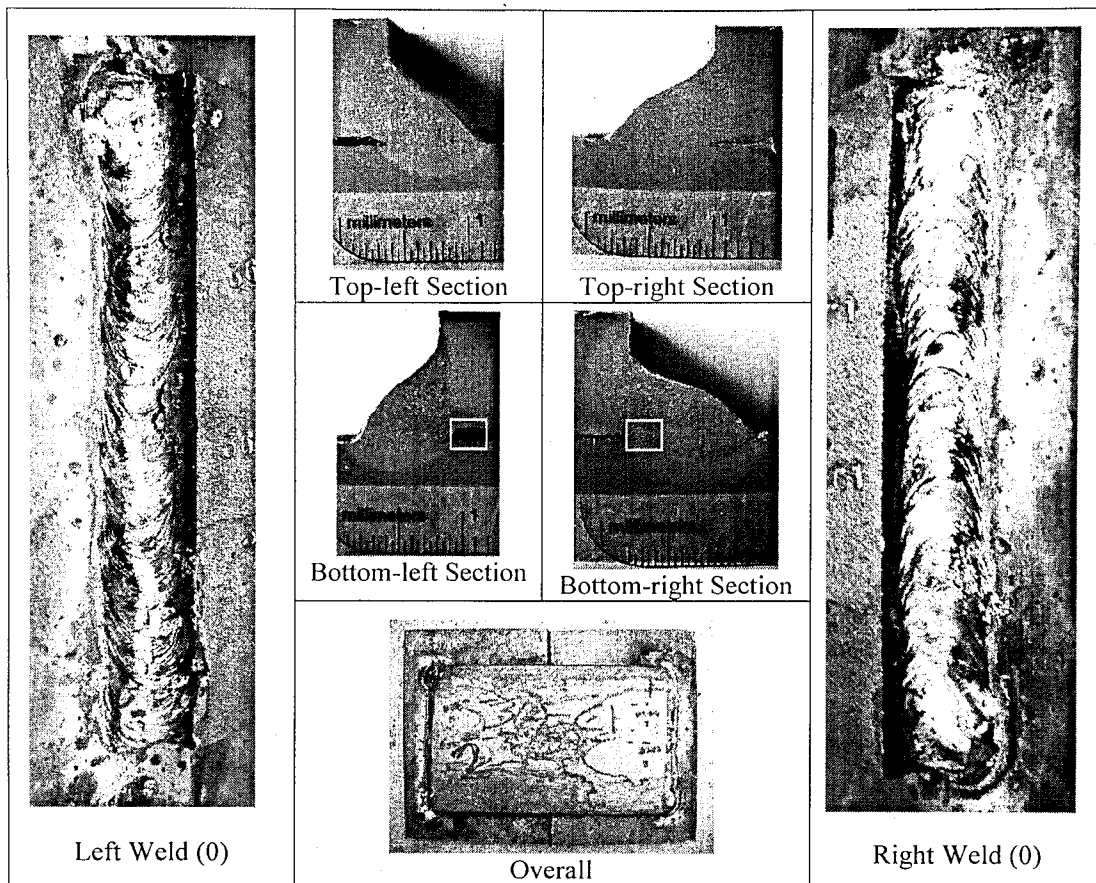
Figure 4.27: Specimen 36-C1

The welded specimen is shown in Figure 4.27. Photographs of each of the two welds are presented along with an overview photo of the entire specimen. Sections were taken at four locations from the specimen and polished to examine the quality of the weld. These photos are also included.

The right weld was oversized but had no pores, undercut, or edge-melt. The profile was fairly regular over the length. The left weld was slightly undersized for roughly 3/8-in., had minimal edge-melt at its beginning, but had no pores or undercut. The only section flaws observed were crack-like in nature and occurred at the roots of the bottom-right and bottom-left sections with associated incomplete fusion. All sections satisfy the 1/4-in. profile requirements except the bottom-right section which, due to curvature, falls just below the full profile at one location along the weld face.

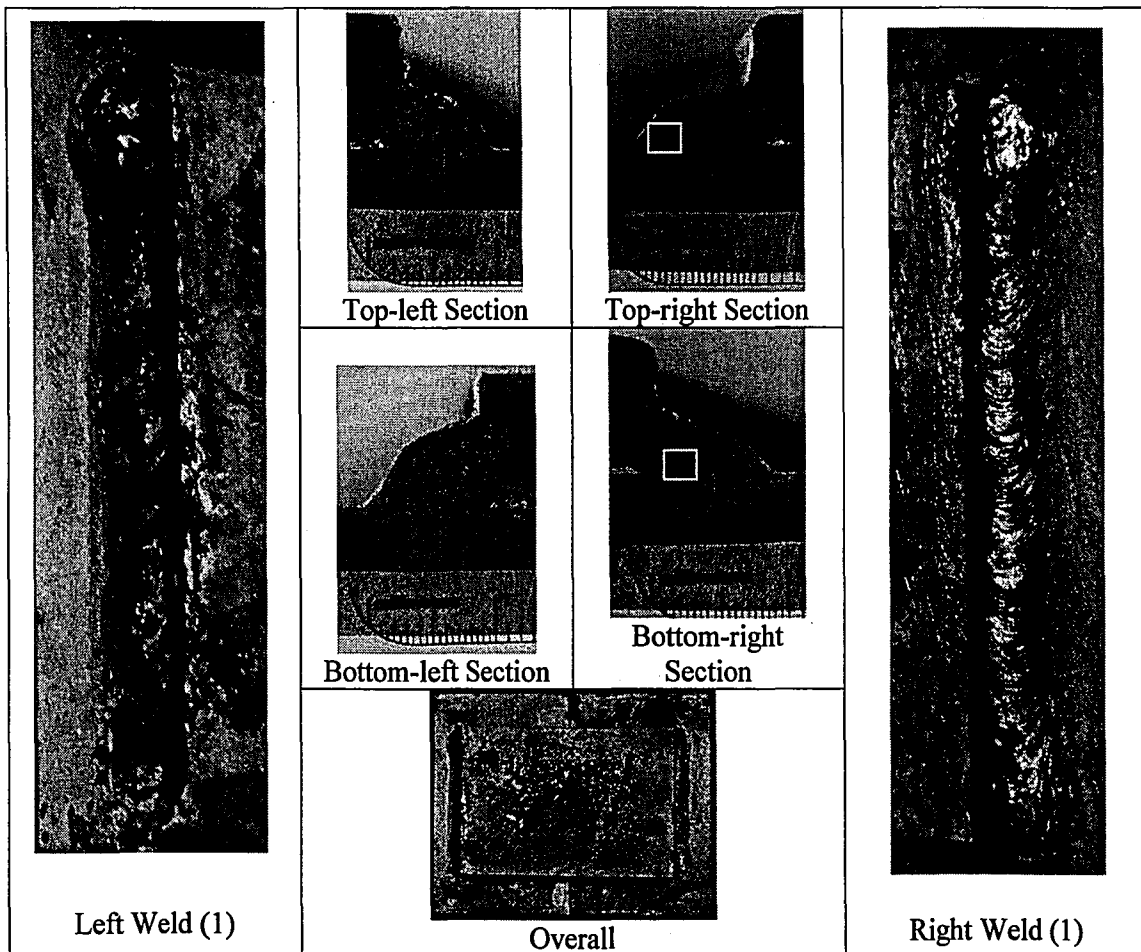
Figure 5.8: Specimen 36G-17HR

The welded specimen is shown in Figure 5.8. Photographs of each of the two welds are presented along with an overview photo of the entire specimen. Sections were taken at four locations from the specimen and polished to examine the quality of the weld. These photos are also included.
