# Investigation of the structural behavior of historical covered timber bridges

A thesis submitted to the graduate faculty  
in partial fulfillment of the requirements for the degree of  
**MASTER OF SCIENCE**

Major: Civil Engineering (Structural Engineering)

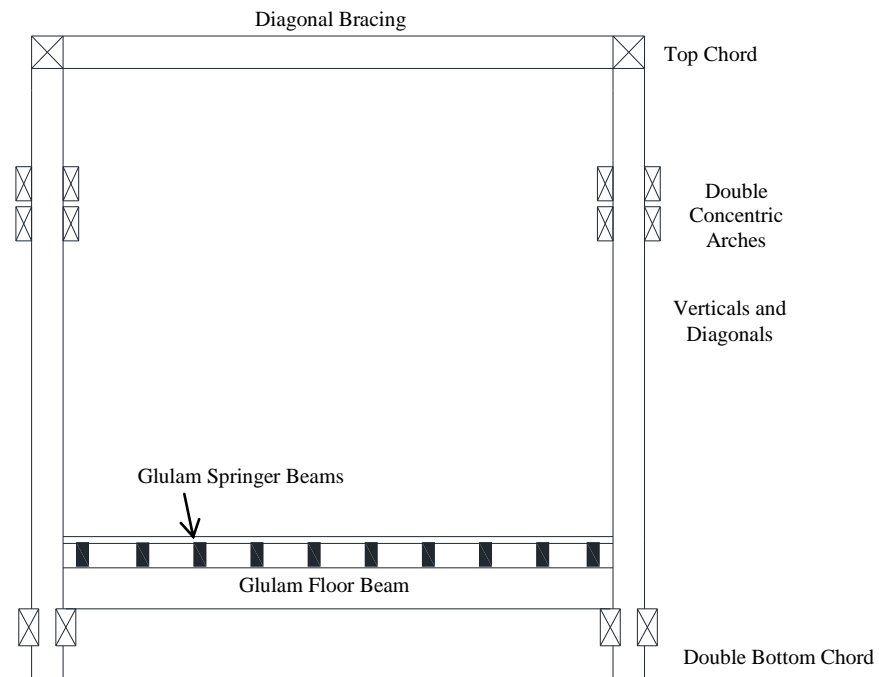
Figure 3.20: Cross sectional views of structural components

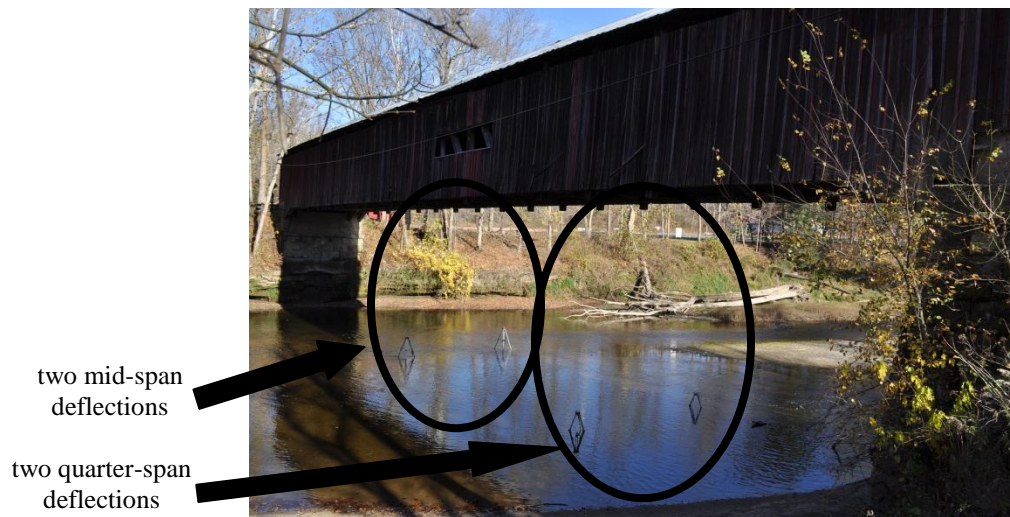
a. Displacement gauges and tripods for mid-span and quarter-span deflection measurements on both trusses

Four global displacement measurements were completed on each bridge. Two transducers were placed at the mid-span point, one on each main supporting element, and the other two were placed at the quarter-span point in a similar fashion (Figure 3.24.a). Also, at each splice joint which was selected to be evaluated in the field, two or three displacement transducers were used to measure the movement both longitudinal and transverse of the joint (Figure 3.25.b).

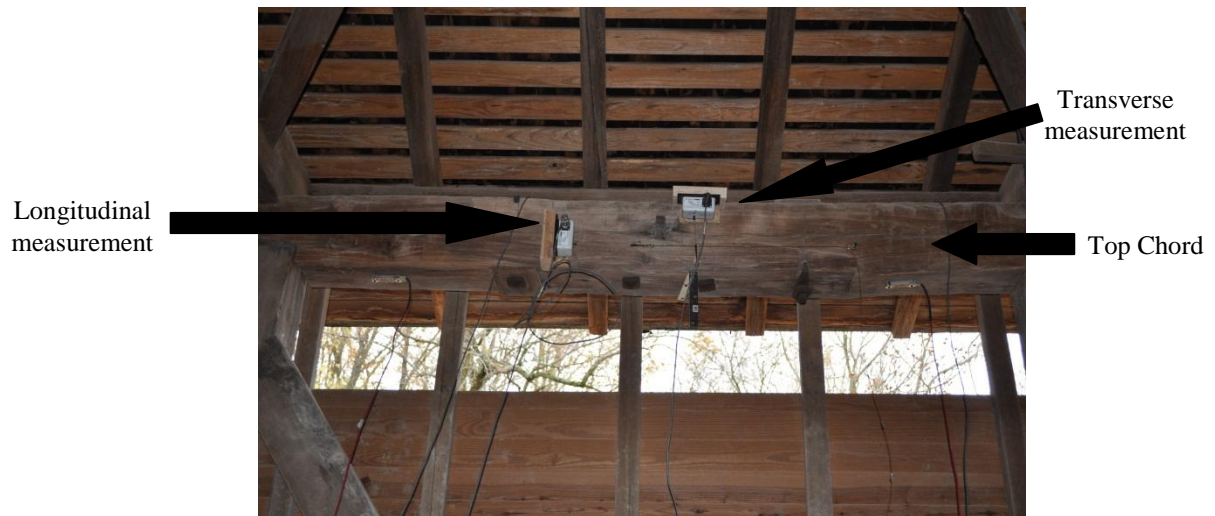
- b. Displacement transducers for splice joint (i.e., top chord) for deflection in the longitudinal and transverse directions with respect to the orientation of the bridge structure

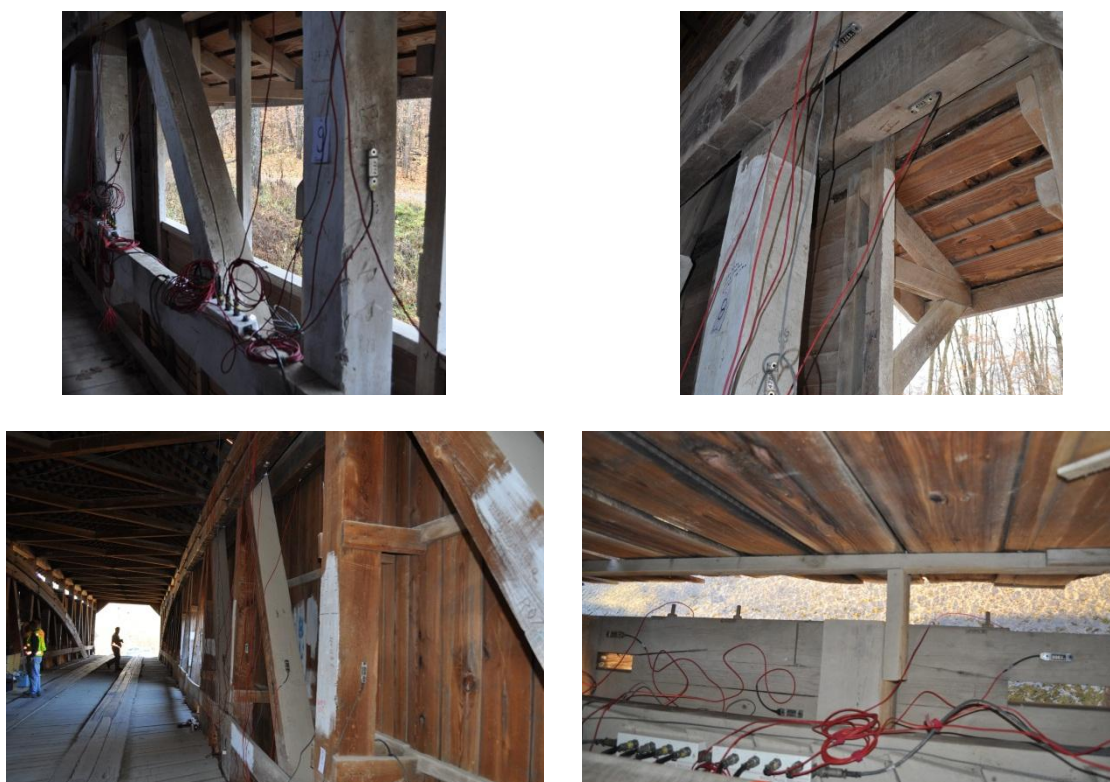
Figure 3.25: Typical strain transducer testing set up (top left is of multiple verticals, top right is underside of double concentric arch and vertical, bottom left is of multiple verticals and diagonals and bottom right of a splice joint in the bottom chord)

Strain measurements were taken at many different locations along the bridge's structure. In general, measurements were taken at the splice joint locations in the bottom and top chords, at mid-span of the mid-span floor beam, in the verticals around mid-span, diagonals near the bridge mid-span and at multiple arch locations (Figure 3.25). Each strain gauge was connected to the timber member with two zinc-plated steel hex washer head sheet metal screws, slotted, No. 12 size and 1.5 in. in length.

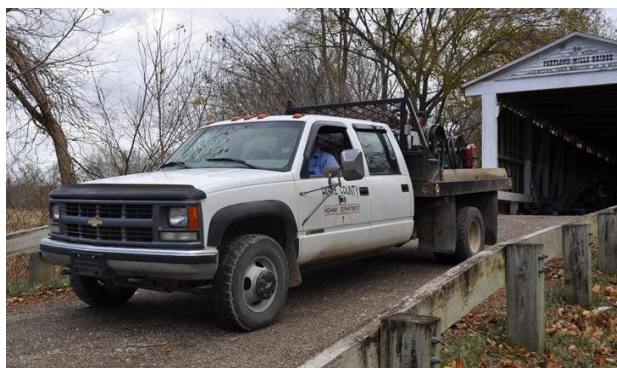
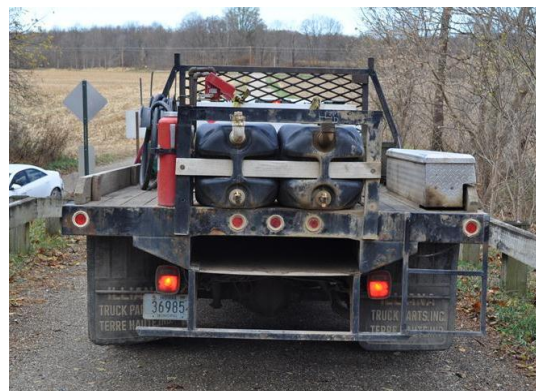
Figure 3.36: Images of different views of the small truck testing vehicle

For testing, two vehicles were provided by the Parke County Public Works Department. The first vehicle was a two axle water truck (Figure 3.36) and the second a two axle dump truck (Figure 3.37). Table 3.4 provides the axle weight and axle center to center measured distance for each vehicle. The trucks were driven across the bridge down the center of the structure at a slow rate, approximately five miles per hour, to simulate static loading conditions.

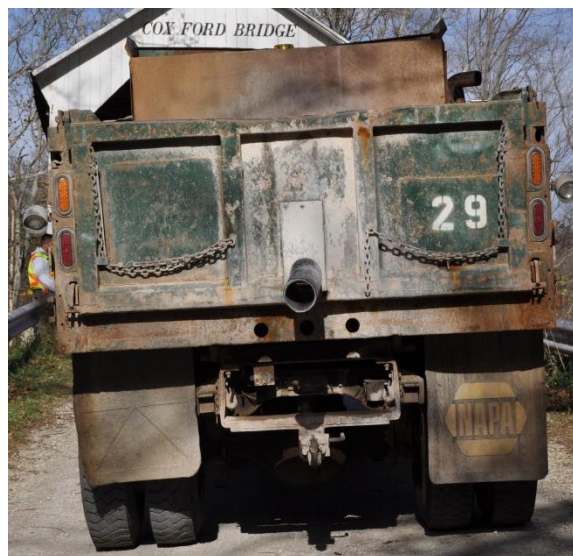
Figure 3.37: Images of different views of the large truck testing vehicle

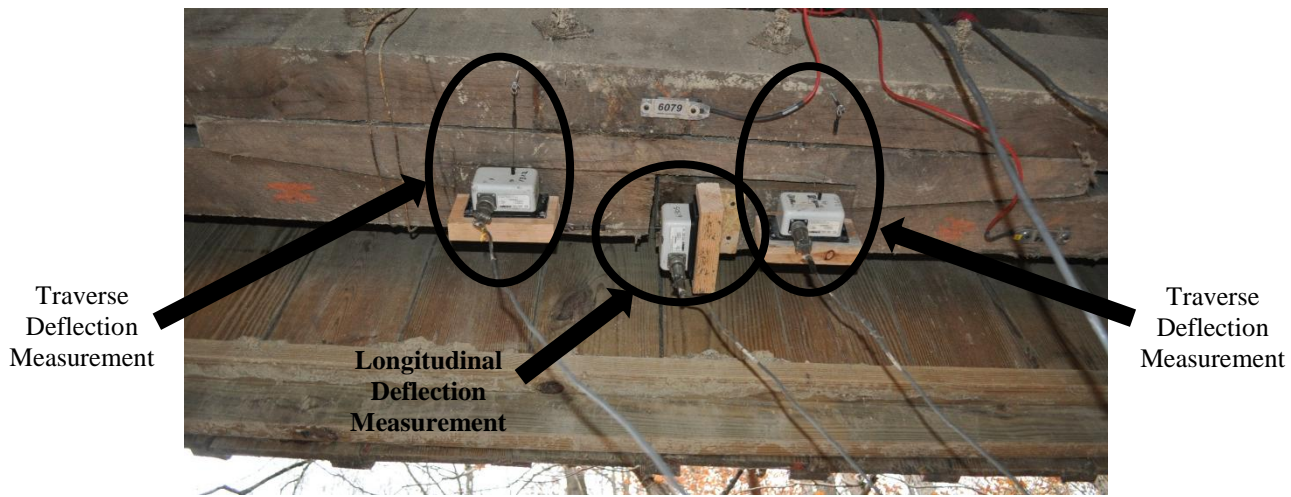
a. Photograph of the bottom face of the bottom chord displacement measurements

Below in Figure 4.1 is a picture of the bottom face of one of the bottom chord south truss's splice joint with the field displacement instrumentation. Table 4.1 lists the field recorded maximum deflection values, positive and negative, seen in both the bottom chord north and south truss joints. The north truss splice joint has similar displacement instrumentation as that shown in the south truss.

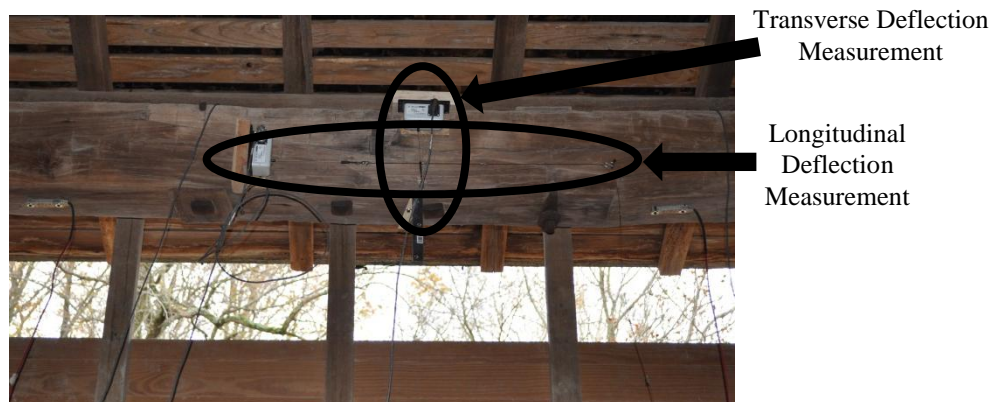
a. Photograph of the elevation view of the top chord displacement measurements

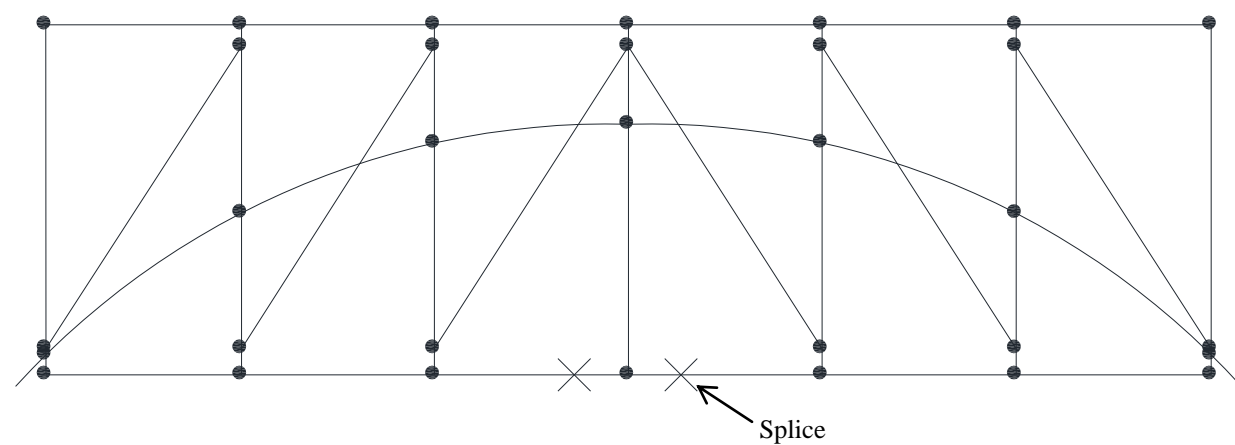
Figure 4.4: Two dimensional stick model idealizations for the Zacke Cox Bridge

As was also noticed in the field, each arch was composed of several simple elements that span between the vertical members. The members composing the arch are connected to the truss vertical members using two steel bolts. Therefore, it was necessary to break the continuity of the arch at these locations in model IV (Figure 4.4.d). This was accomplished by inserting a rotational spring with a small stiffness coefficient at each end of the element which is indicated with an open circle on Figure 4.4.d. Furthermore, the ends of each arch member were constrained to follow the movement of the vertical member at the intersection location. The connections between the diagonal and the vertical posts were modeled utilizing a similar approach. Model V (Figure 4.4.e) is similar to model IV but the moments at the ends of the diagonal members were released. Model VI (Figure 4.4.f) is a replication of model V with the exception of releasing the moments at the end of the vertical member near its intersection with the bottom chord of the truss. Finally, model VII (Figure 4.4.g) is similar to model VI but the modeling was done in accordance with the constructed top chord of the truss members. Examination of the in service Burr arch bridge indicated that the top chord member was constructed as simple members in the first and last panels of the truss, while as continuous members over the two of the interior panels on each side of the truss center vertical. Therefore it was necessary to model the top chord members as shown in Figure 4.4.g, i.e., releasing the moments at the ends of each member where such a discontinuity occurs.

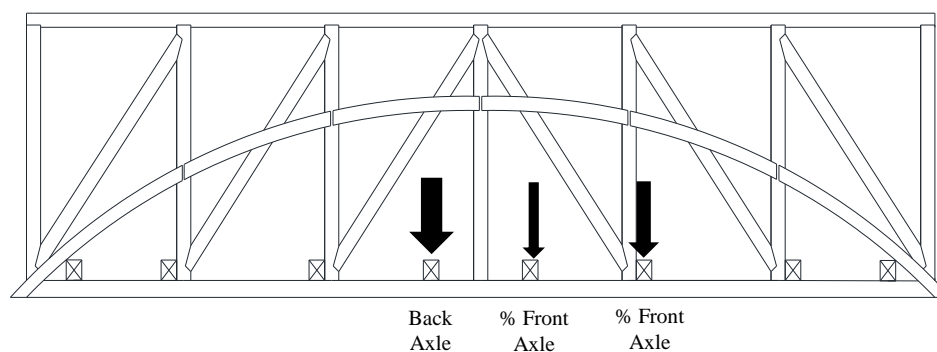
a: Actual field truck loading position

b: Analytical representation of the truck loading distribution

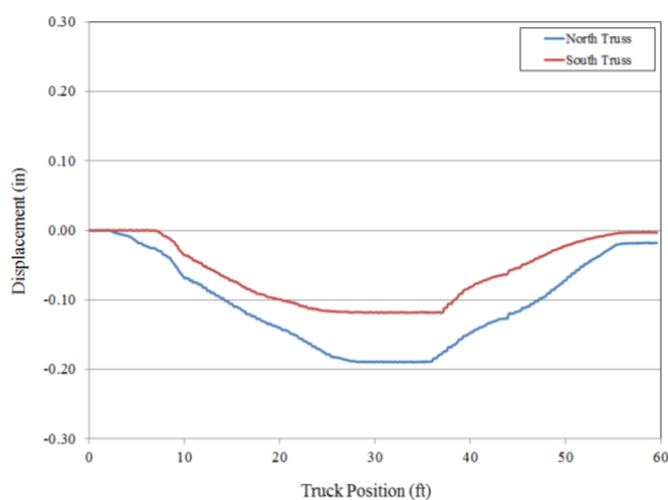
Figure 5.13: Deflection values for both the north and south truss as a function of the load truck position on the bridge (Zacke Cox Bridge) – large truck

When evaluating the percentage difference in the deflection that was caused by the small and large load truck in the Zacke Cox Bridge, one may notice that with the increased load, the percent difference between the measured and the calculated deflection increased from 20.95% to 58.24% for the small and large truck, respectively. Since the only change in the load idealization was the distribution quantity and location of the truck axles, one would have expected the change in the measured or calculated deflections to be proportioned to the applied loads. Furthermore, examining the field test results indicated that both main supporting elements, i.e., the two trusses, experienced different deflection (see Figure 5.13) even though the truck load was symmetrically applied on the bridge deck. These observations suggest that the load distribution is more complex than just dividing the applied loads equally between the two trusses. Through improved strain measurements and placement in the bridge structure could help in understanding how applied loads are distributed in these types of bridges.

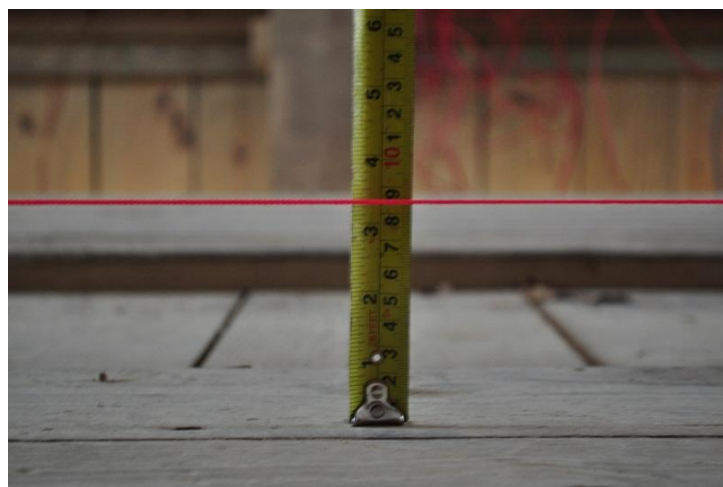
c. Pre-existing sag in the overall bridge with measurement at mid-span

Due to the length of time these bridges have been in service, there are characteristics that are both qualitative and quantitative which have not been introduced into the analytical models. With each bridge being uniquely different due to many events that the bridge has experienced such as construction methods, out of plane alignment of the truss and arch, deterioration due to time and weathering, and properties of the joints, just to name a few. Due to these irregularities, each bridge presents its own difficulties in accurately modeling a simplistic idealization. The following summarizes are some of the observations that were noticed in the field while testing the three bridges presented herein this study.

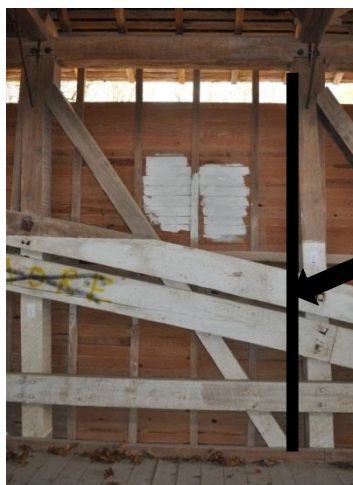
Added vertical line to show the vertical skew of the vertical timber member with respect to the top and bottom chords

Just as in the Zacke Cox Bridge, there were pre-existing gaps between connection interfaces of the timber members. As can be seen in Figure 5.15.a, many vertical members within this bridge had a vertical misalignment with respect to the location of the connection between the top and bottom chord members. Furthermore, Figure 5.15.b shows some irregularities of how the ends of the arches were connected to the abutments. In addition, Figure 5.15.c shows deterioration to timber members such as the vertical member that could lead to a concern about the connection between those members, i.e. the vertical and bottom chord. These irregularities can easily affect the results of the analytical results but were not introduced into the analytical model.

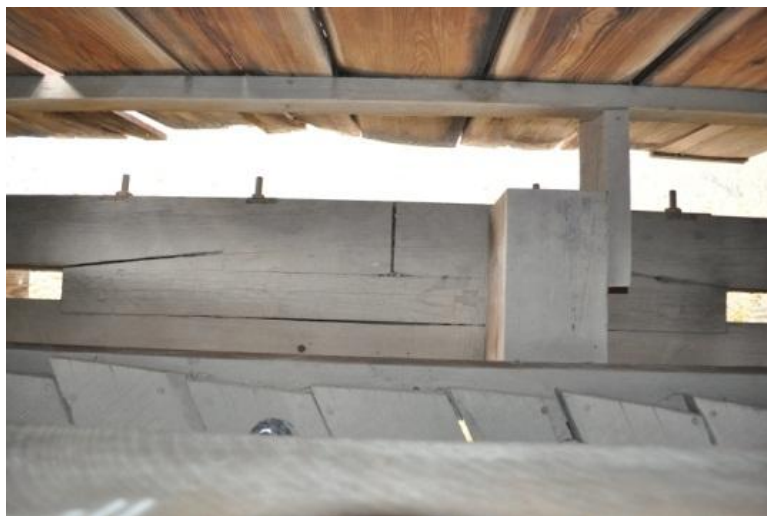
a. Gaps within the interface between the bottom chords and splice joint

Many of the same irregularities such as the gap between the connections of timber members were also present within the Cox Ford Bridge. Just as in the other bridges, gaps between the splice joint and chord member existed. Many of these gaps are filled with gravel and debris which could alter the performance of the splice joint from its original intention. An example of the gaps between a bottom chord members and the splice joint is seen in Figure 5.16.a. Also, related to the concern of the splice joint performance, one bottom chord splice joint within the Cox Ford Bridge showed signs of failure between the connection of the chord member and joint material. Figure 5.16.b shows a portion of the bottom chord at the location of a splice joint that is detached from the rest of the bottom chord member. Within all the bridges, but especially in the Cox Ford Bridge, checking of the timber was present in many members. As can be seen in Figure 5.16.c, the length of the check and also depth into the member are a concern due to the effect on the load carrying capacity and dimensional properties of this member.

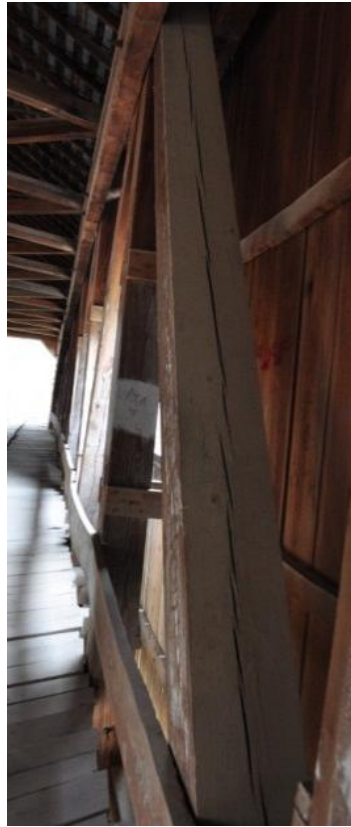
c. Length and depth of checks within timber members

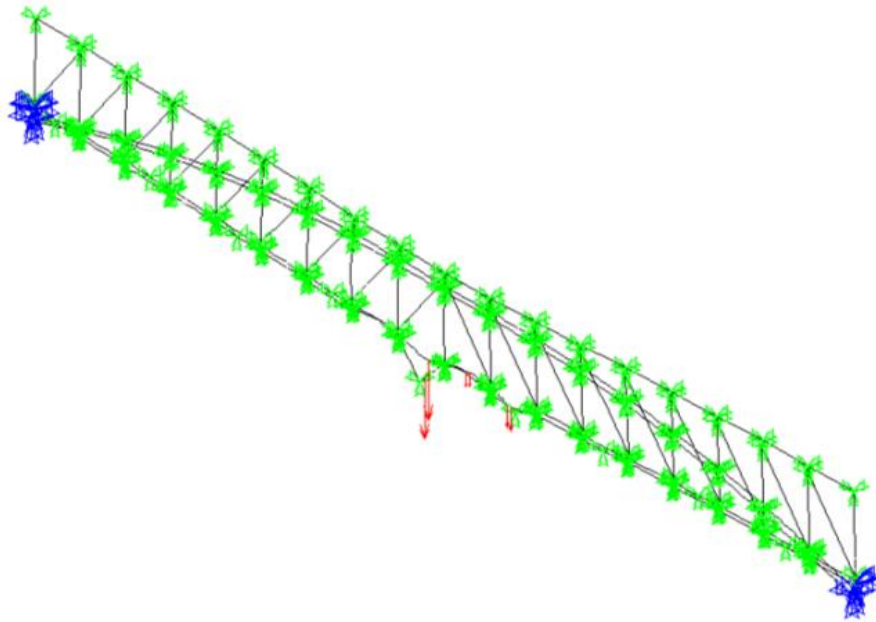
Figure A.3: Analytical deflected shape for the Cox Ford Bridge
