Laboratory testing of Ultra High Performance Concrete deck joints for use in accelerated bridge construction

**Laboratory testing of Ultra High Performance Concrete deck joints for use in
accelerated bridge construction**

Major: Civil Engineering (Structural Engineering)

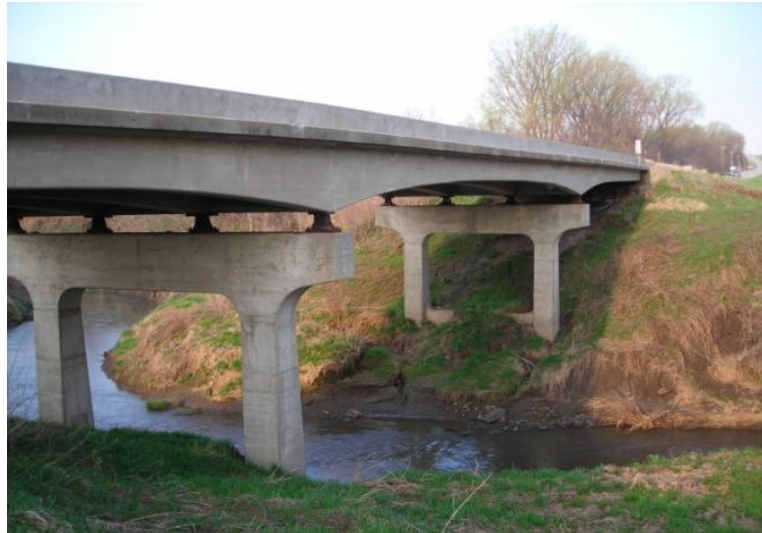
Figure 2.1. Existing US Highway 6 Bridge over Keg Creek

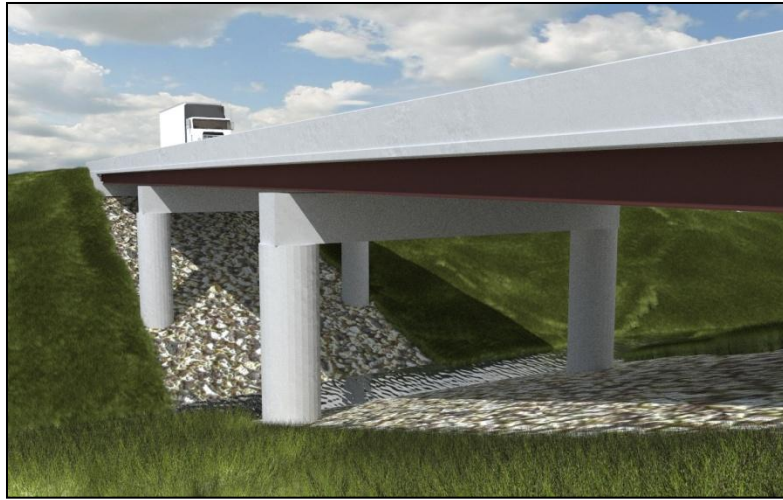
Figure 2.5. Completed SHRP 2 Project R04 Demonstration Bridge

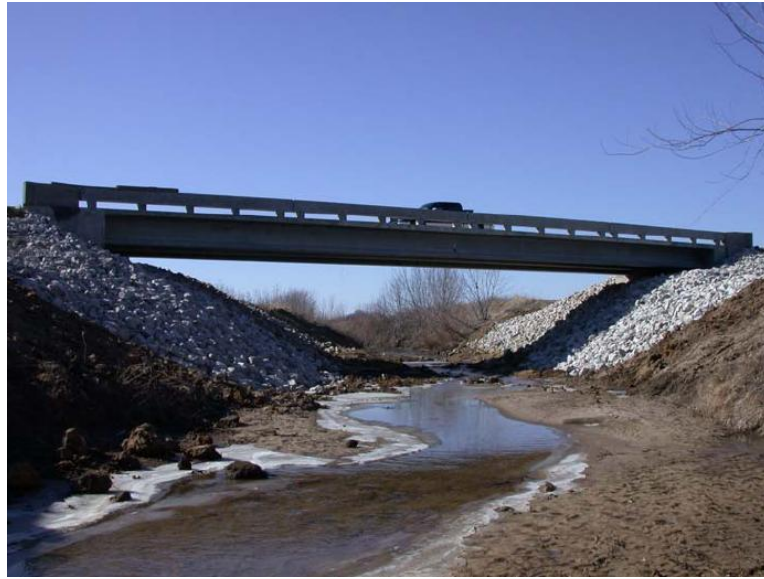
In the United States, two simple-span prestressed concrete girder bridges have been constructed using UHPC I-girder shapes. The Mars Hill Bridge in Wapello County, Iowa, was the first to be constructed in 2005 by the Iowa Department of Transportation (Iowa DOT). The bridge was a 111 ft long single span bridge with a 3 girder cross section at 9 ft 7 in spacing and a 4 ft overhangs. The UHPC I-girders are modified Iowa 45-in bulb-tee sections. To save material in the section, the web width was reduced by two inches, the bottom flange by two inches, and the top flange by one in (Bierwagen and Abu-Hawash 2005).

Figure 2.6. UHPC I-Girder Bridge - Wapello County, Iowa

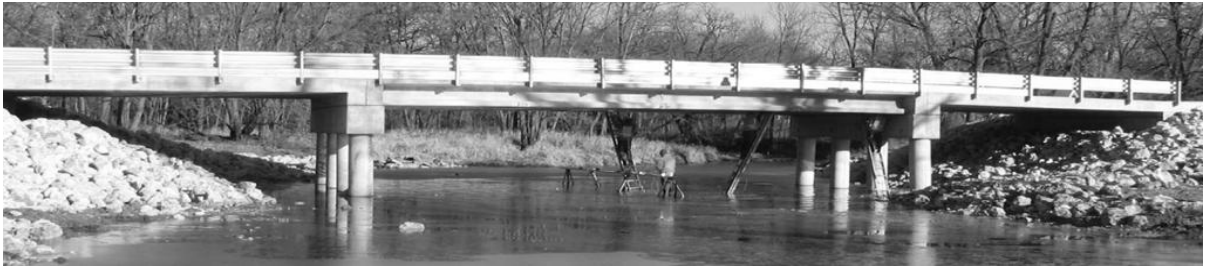
Another deployment of UHPC in bridge construction in the United States involves the design and implementation of a UHPC bulb-double-tee girder or PI section in Buchanan County, Iowa. The 112 ft 4 in long, 24 ft 3 in wide three span bridge utilized 3 PI sections in the 51 ft 2 in center span. IDOT worked in collaboration with the Federal Highway Administration's (FHWA) Turner-Fairbank Laboratory, Iowa State University's Bridge Engineering Center (ISU BEC), and Massachusetts Institute of Technology to develop the UHPC PI section (Keierleber, Bierwagen, et. al 2007).

Figure 2.7. PI Girder Bridge - Buchanan County, Iowa

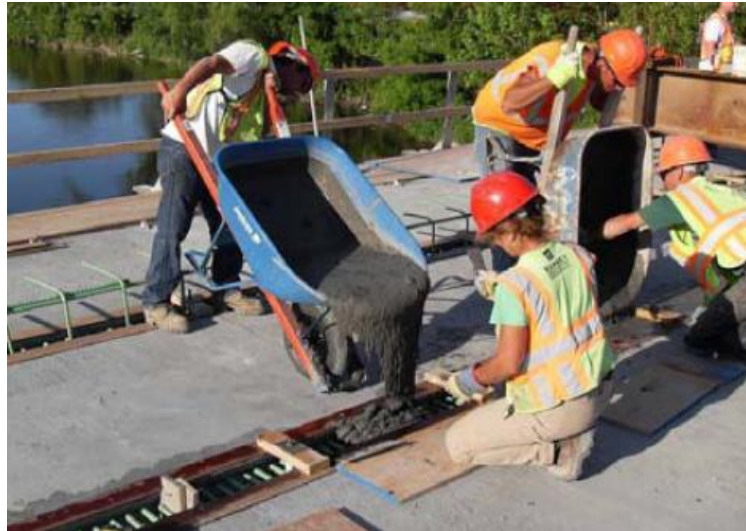
There have been two instances where UHPC was used as a deck joint closure material in the United States. Two bridges in New York implemented UHPC as joint closure material between precast deck panels. The New York State Department of Transportation (NYSDOT) used the UHPC joint fill material in transverse deck joints of Route 23 Bridge in Oneonta, New York and longitudinal deck joints of Route 31 Bridge in Lyons, New York. However, unlike in the current demonstration project, the transverse deck joints in the Oneonta bridge were located in the positive bending moment region, placing the UHPC joint in compression.

Figure 2.8. UHPC Deck Closure Joints

Graybeal (2010) conducted testing on the UHPC bridge deck connections used in the NYSDOT's bridges under static and cyclic structural loading at the Turner-Fairbank Highway Research Center's Structural Testing Laboratory. Wheel patch loads were applied adjacent to the UHPC joints for four transverse joint specimens. The test specimens were arranged and tested so that flexural stresses which would be caused by traffic were oriented parallel to the joint. It is important to note that the test setup focused on local flexural behaviors of the deck only. The test did not account for global flexural behaviors of the deck and girder system. Neglecting overall flexural effects of the deck and girder system, Graybeal found no significant UHPC or interface cracks parallel to the transverse joint.

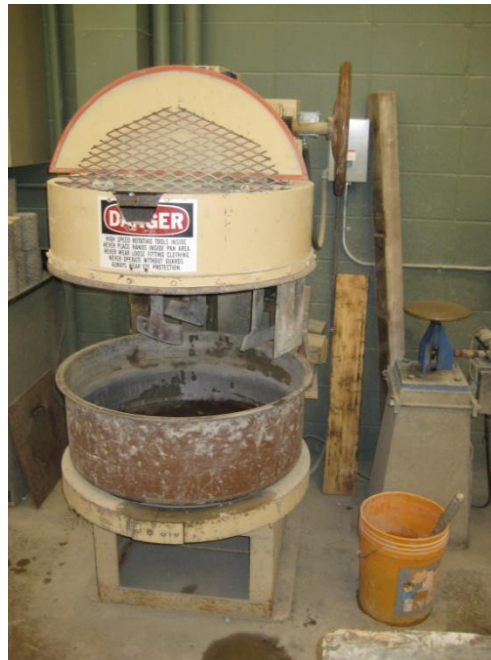
**Figure 3.1. Lancaster Products Mixer**

The batching procedure was adapted from the procedure recommended by Lafarge Canada for the Ductal® JS1000 premix in a Imer Mortarman 750 mixer to batch the UHPC mix design (Lafarge Batching Procedure). A Lancaster Products 1.5 ft³ mixer was used to mix the two 0.58 ft³ batches and one 0.40 ft³ batch of UHPC for the test specimens.

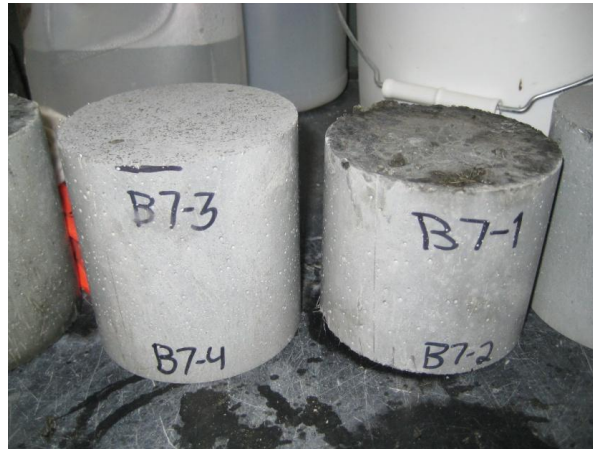
Three surface finishes were tested for grindability during the abrasion testing; a rough top surface, a diamond cut surface, and a smooth formed surface. Upon curing the cylinders at the various temperatures, four specimens were produced by cutting each cylinder in half. For one cylinder at each cure temp and time, one rough top surface, one smooth form surface, and two diamond cut surfaces were tested.

Figure 3.2. Diamond Cut and Rough Top Surface Finishes

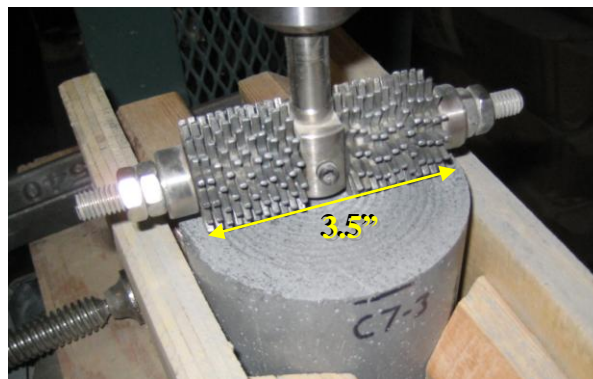
To evaluate the UHPC material for grindability, testing was completed using ASTM C944, the Standard Test Method for Abrasion Resistance of Concrete or Mortar Surfaces by the Rotating-Cutter Method (ASTM C944). For fabricated concrete or mortar based specimens, this test helps indicate the relative wearing resistance. ASTM C944 uses a drill press with an abrading cutter rotating at 200 rotations per minute. The normal force exerted on each specimen surface in this test is 22 ± 0.2 lbf. The rotating cutter head leaves a 3.25 in diameter abraded circular area.

Figure 3.3. Rotating Cutter Head

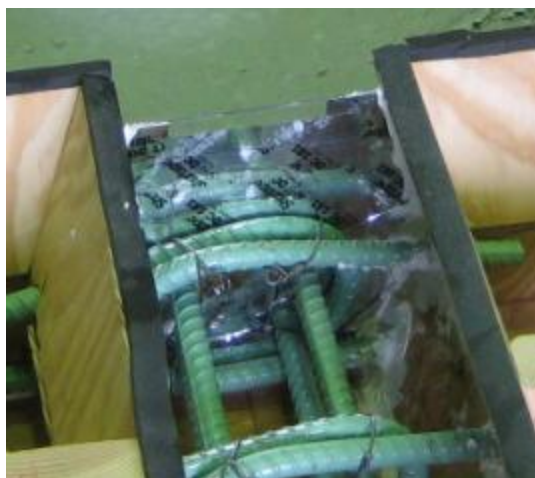
Figure 3.7. Acrylic Glass Vertical Bulkhead

To replicate the proposed demonstration bridge UHPC placement technique, the last element of the formwork for the specimen was the acrylic glass bulkheads which aimed to prevent the formation of cold joints. In the test specimen, the bulkheads were located in the longitudinal joint approximately two in from the transverse joint. The placement of the vertical bulkheads in the longitudinal joints allowed for continuous placement of the transverse closure joint.

A new construction sequence, which limited continuous placement to the transverse joints and allowed vertical cold joints in the longitudinal joints, was suggested for the joint constructability testing and demonstration bridge as a result of these discussions. A prototype of the stay-in-place acrylic vertical bulkheads (Figure 3.7) was fabricated and used during the joint constructability testing so its performance could be evaluated. The acrylic vertical bulkheads successfully acted to limit the placement of UHPC to the transverse joint.

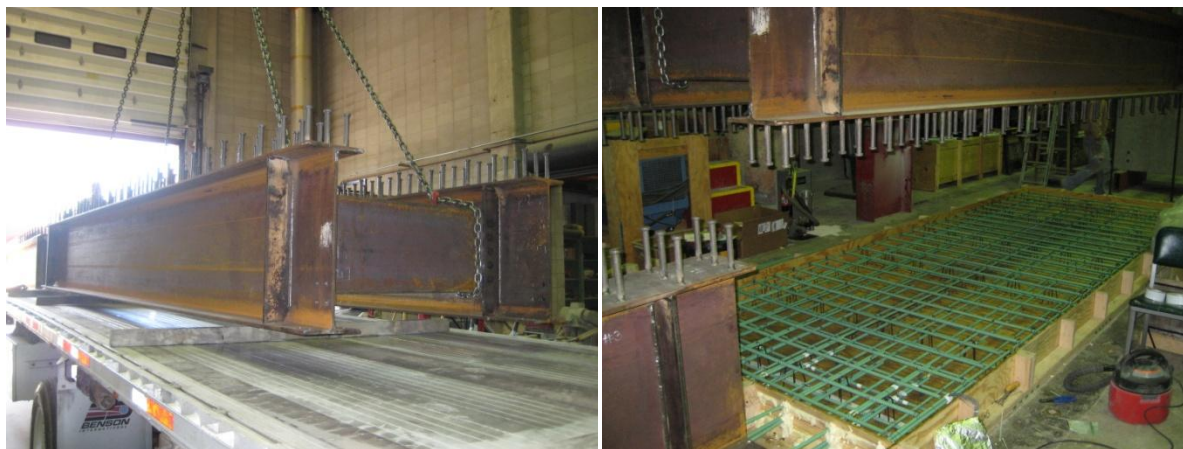
The steel frames for the prefabricated deck modules were fabricated in Muscatine, Iowa and shipped to the laboratory at Iowa State University. In the laboratory, the modules were constructed in an upside-down orientation such that the concrete deck could be cast on the ground. The two steel frames were placed in their respective deck slab forms upon arrival.

All epoxy coated reinforcing steel bars present in the deck slab were placed and tied prior to setting the frames.

Figure 3.11. Prefabricated Deck Module Construction

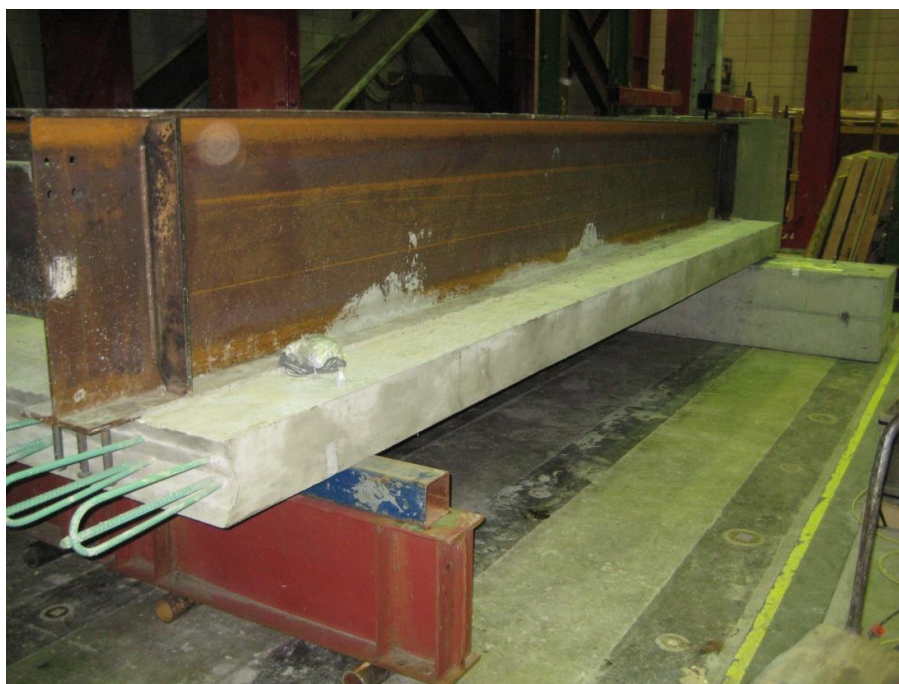
Eight and a half cubic yards of HPC were cast to complete the two deck modules. In addition, 24 – 4x8in cylinders and 6 – 6 in by 6 in by 3 ft beams were cast for compressive and flexural strength tests (ASTM C39 & ASTM C78).

**Figure 3.12. Completed Deck Module**

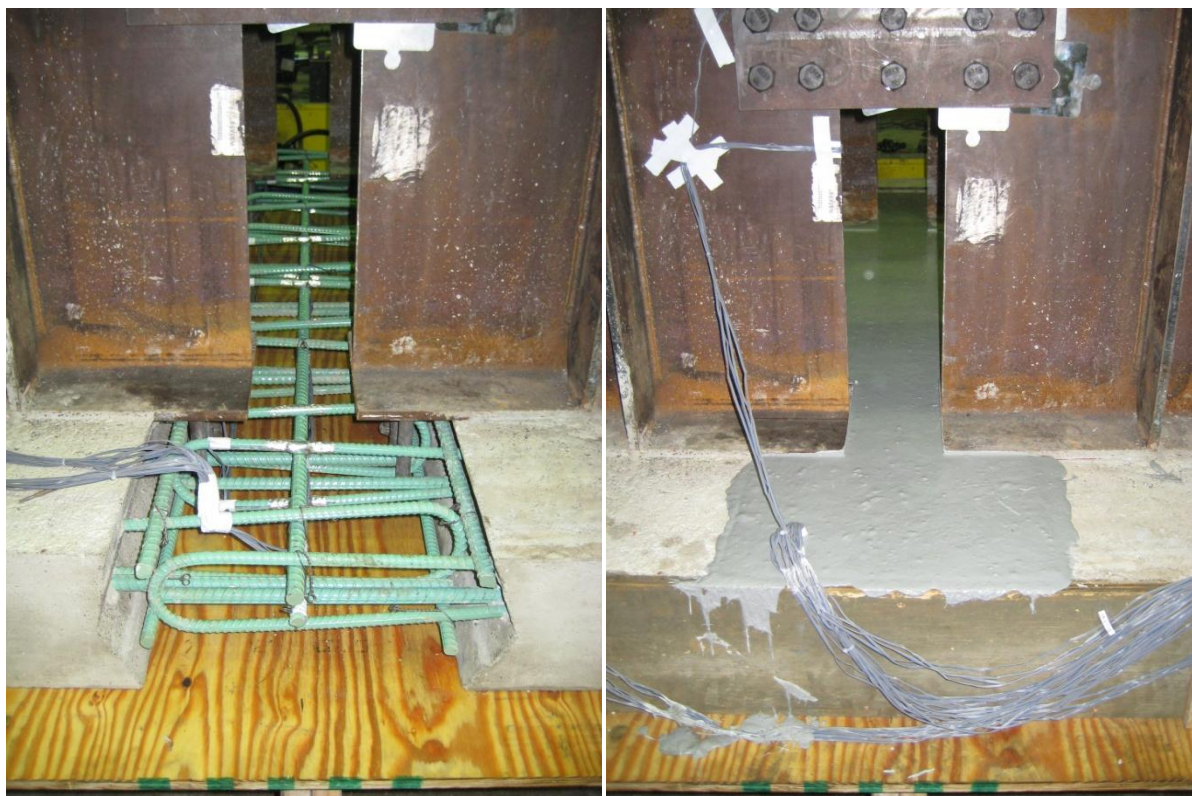
Prior to placing the UHPC joint, the adjoining HPC deck surfaces were prepared as recommended by Lafarge Canada. The HPC surfaces were removed from the forms, brushed with a steel brush grinding head, and pressure washed with water. On the morning of the UHPC pour, the HPC surfaces were wetted in order to attain saturated surface dry conditions during placement.

Figure 3.14. UHPC Joint Preparation and Placement

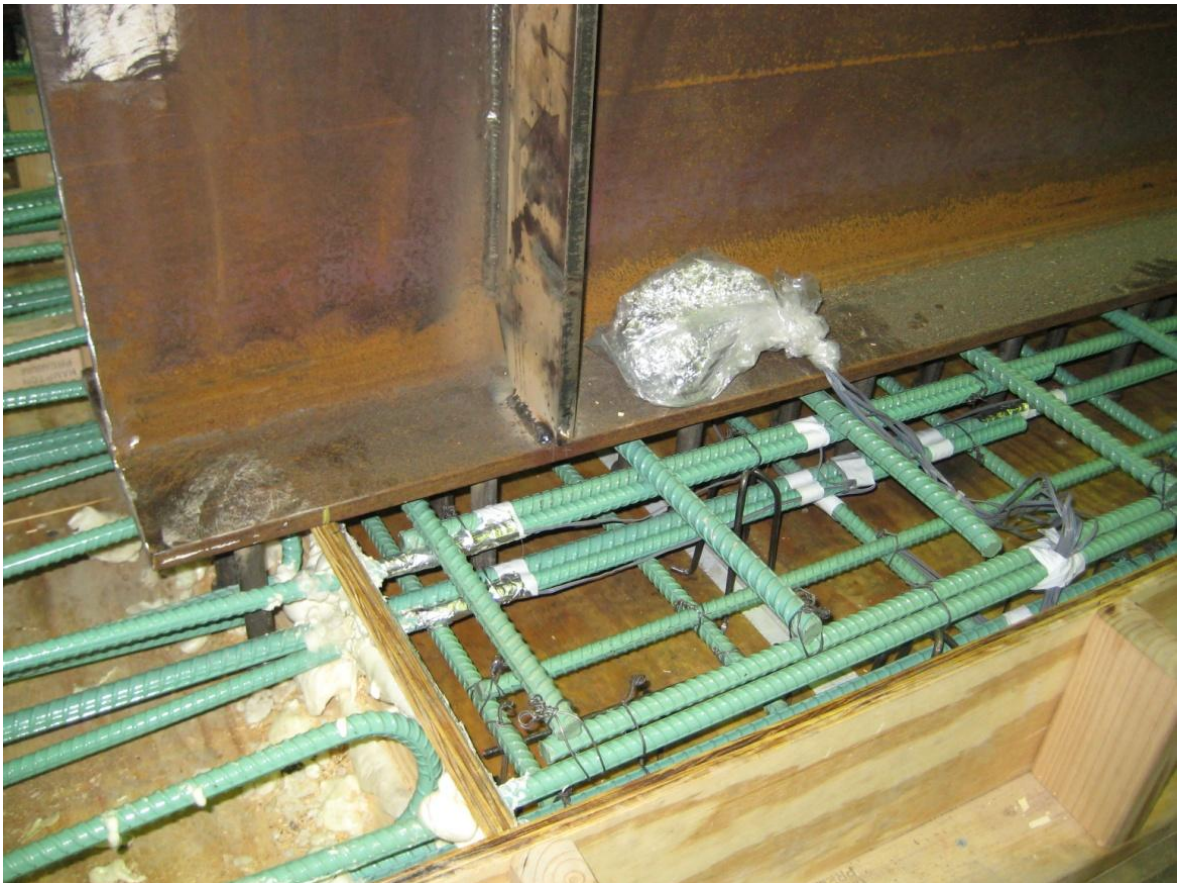
Figure 3.17. Embedded Bonded Strain Gages in HPC Deck

4. In addition, eight embedded bonded strain gages were placed on the straight transverse lacer bars within the UHPC joint.
5. Additional gages included four embedded bonded strain gages mounted to the surfaces of the steel angle connectors between opposing steel beams across the joint.
6. Specimen displacements were measured with seven string potentiometers mounted to the lab floor (three directly under the centerline of the transverse joint, one at each bearing location, and one at the transverse centerline of each module).

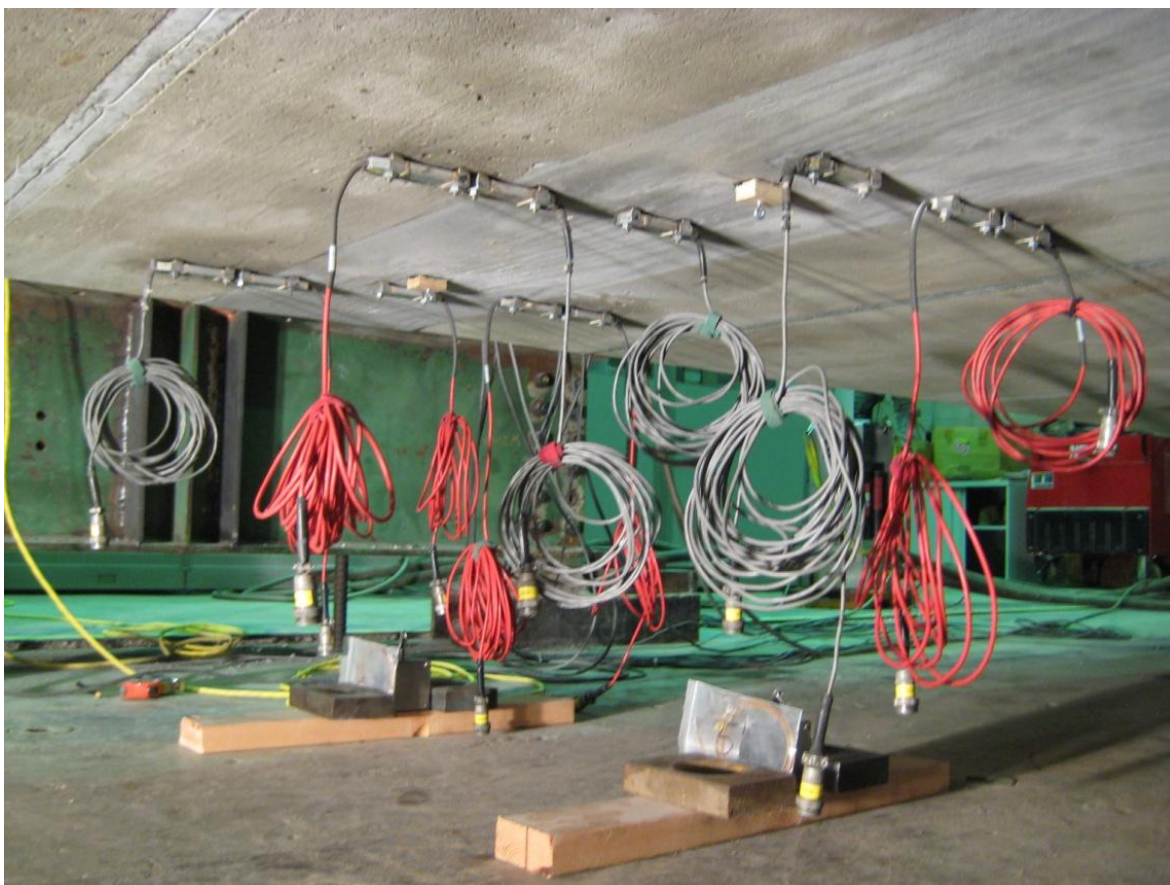
Figure 3.18. Surface Mounted Strain Gages on Top of Deck

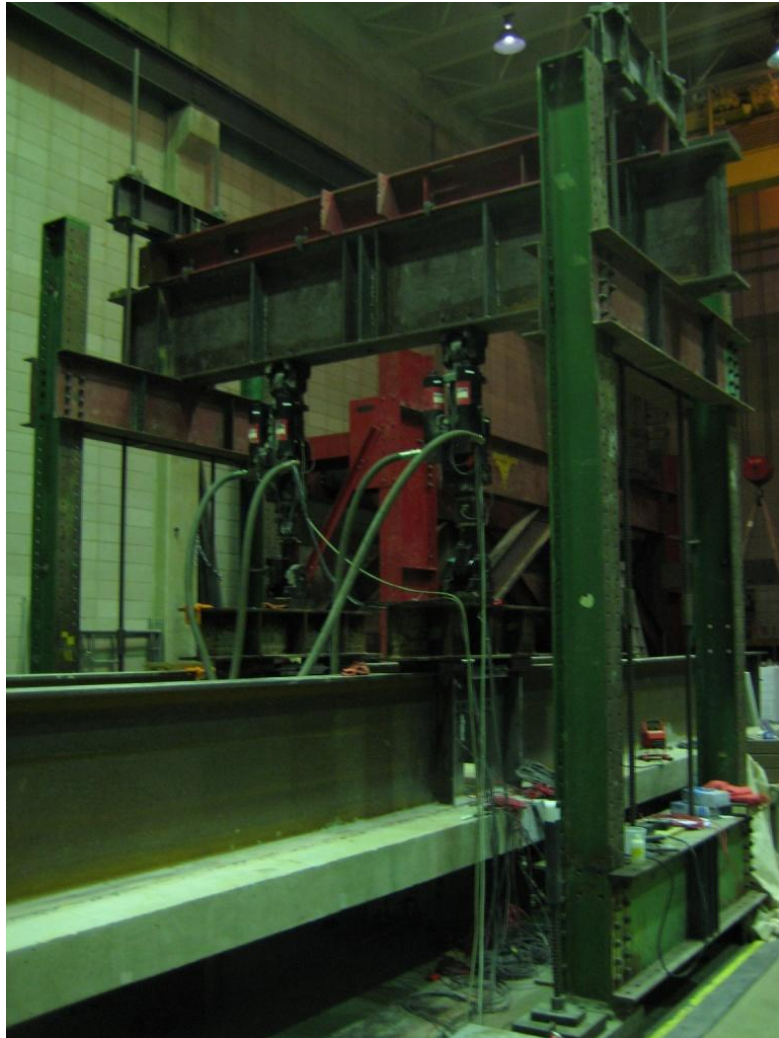
Load testing of the module-to-module transverse connection specimen was performed through Service Level I and up to Service Level II moment. Loads were applied with two hydraulic actuators each fitted with load cells and connected to spreader beams (Figure 3.21 and Figure 3.22). The spreader beams allowed for load application replicating the demonstration bridge's bearing support conditions at the pier. Lubricated steel plates acted as the bearing points for load application. The lubricated plates allowed the specimen and spreader beam to act independently. Four days after the placement of the transverse UHPC joint, upon reaching the specified 14,000psi compressive strength threshold for the cast-in-

Figure 3.21. Load Frame for Service Level Testing

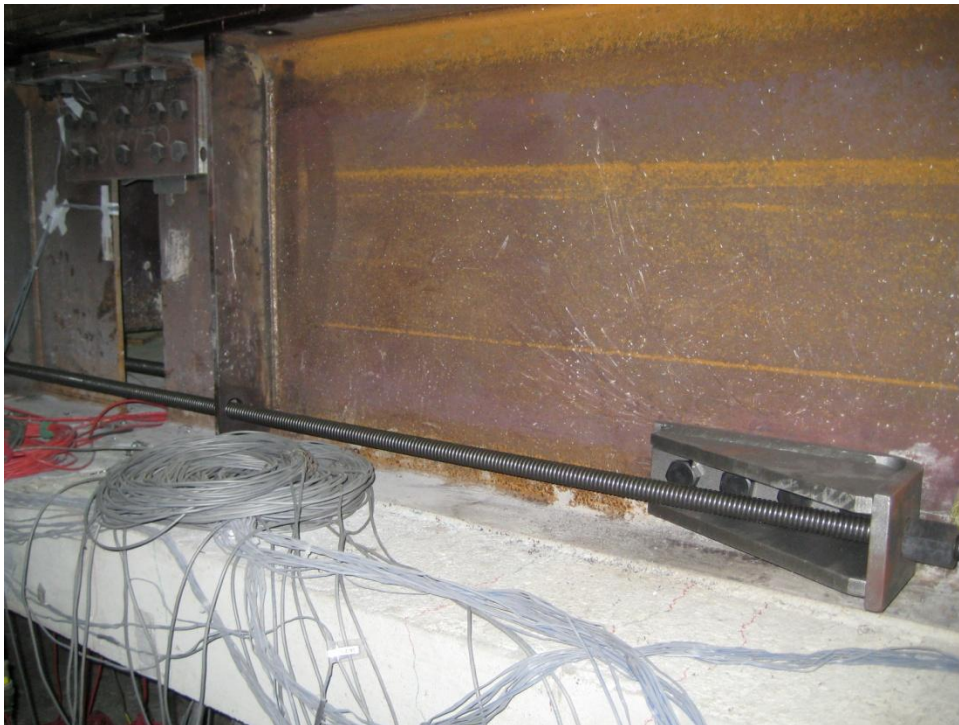
Figure 3.24. Connection Retrofit Installed

Four-one in diameter high strength threaded rods were installed following the attachment of the ASTM A709 Grade 50W steel brackets to the W30X99 beams. The high strength rods were initially post-tensioned to achieve an effective force of 60 kips per rod at each location. Once the retrofit detail was successfully installed, the incremental static service level load testing through Service Level II moment was conducted in the same manner as previously described. Upon completing service level testing of the 60 kip per rod post-tensioned retrofit, the high strength rods were post-tensioned up to 70 kips per rod. The service level testing was repeated at the 70 kip post-tensioning force level as previously described.

After analyzing results from the initial service level load testing and observing the formation of undesirable cracks, HNTB, the design engineer, designed a retrofit for the transverse module-to-module connection (Figure 3.23 & Figure 3.24). The retrofit employed high-strength steel rods mounted just under the deck surface to post-tension the entire connection and lower tensile strain levels present in the HPC deck and UHPC joint to below

Following fatigue testing, the specimen was modified to include high strength steel rods mounted just under the deck surface to post-tension the entire joint region and prevent any possible cracking of the deck or joint in this region (Figure 3.23). The retrofit detail was tested through the full range of service level moments with a 60 kip post-tensioning force per rod and again with a 70 kip post-tensioning force per rod. The static test results for surface mounted strain gages across the joint interface (Figure 4.35 & Figure 4.42) and embedded strain gages in rows 1, 2, and 3 (Figure 4.36 – Figure 4.39 & Figure 4.43 – Figure 4.46) are presented in this section.

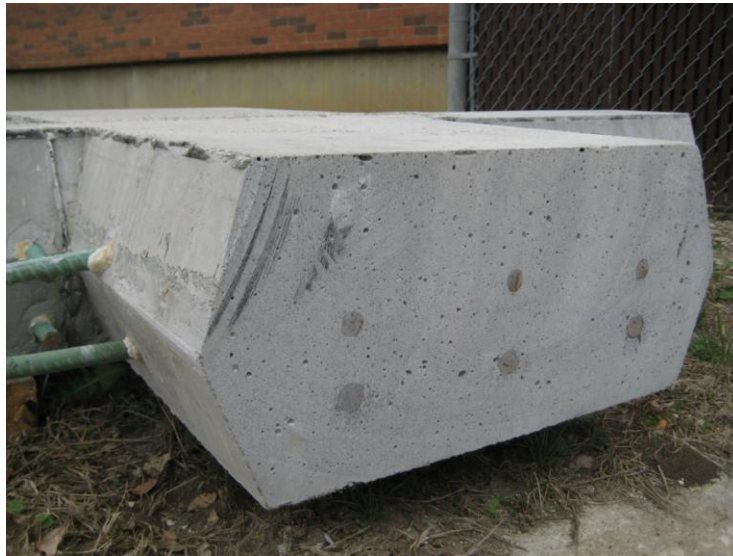
After the specimen was cured and removed from the forms, it was cut into several sections to examine consolidation and potential cold joints. Upon investigation of the cut specimen, no significant voids around steel reinforcing bars were observed (Figure 4.6 & Figure 4.7).

Figure 4.6. Section of Transverse Joint (1)

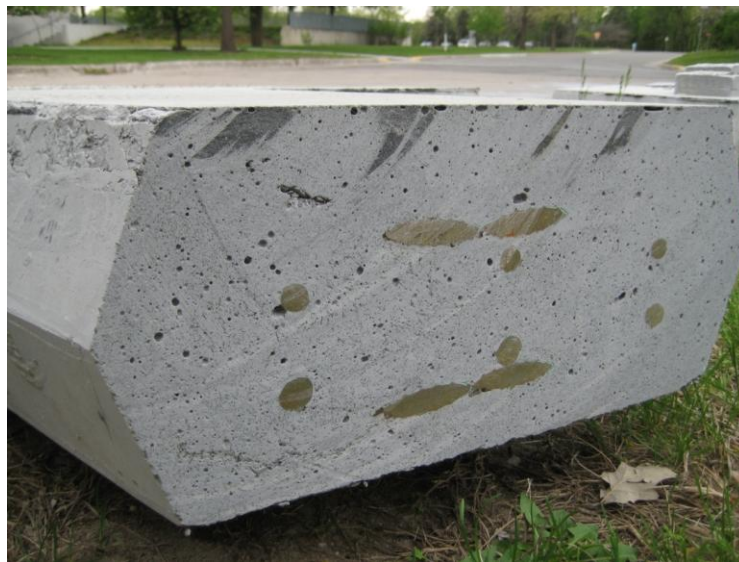
Figure 4.7. Section of Transverse Joint (2)

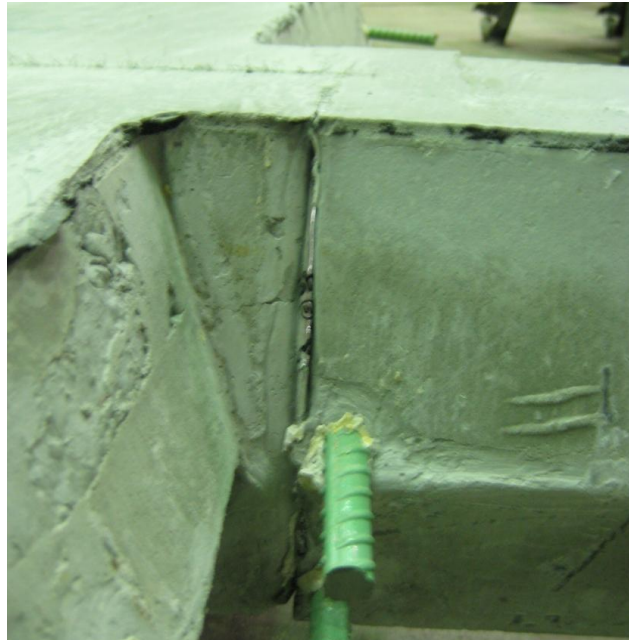
Final inspection of the specimen upon removal from the forms allowed for additional observations and recommendations. The proposed stay-in-place acrylic bulkhead successfully allowed for sequential placement of the UHPC, but also created a possible infiltration plane where water and chemicals could access the embedded steel joint reinforcement (Figure 4.9).

Figure 4.9. Stay-in-Place Acrylic Bulkhead

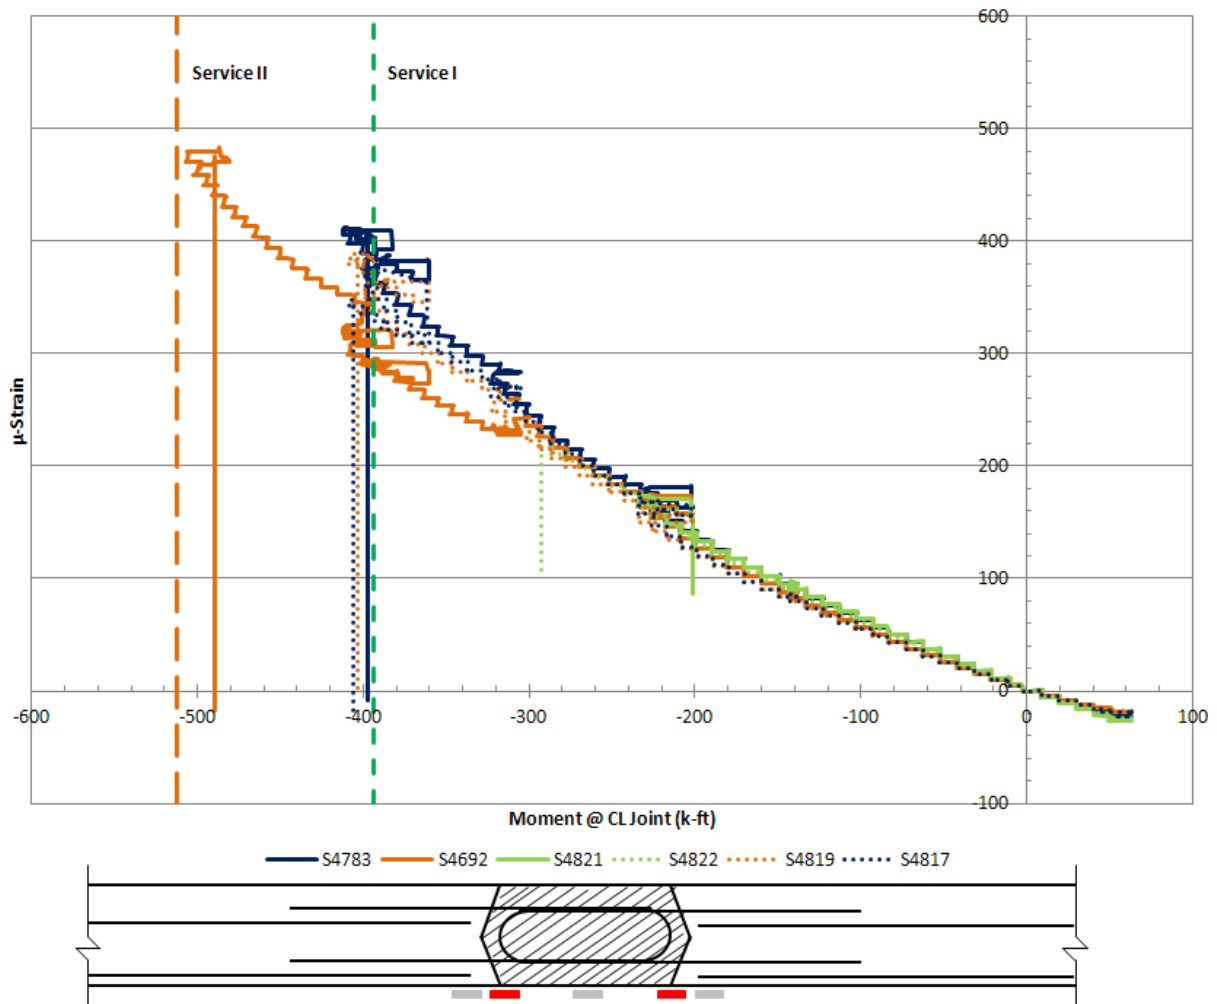
Strain levels were monitored through the embedded and surface mounted strain gages located throughout the specimen (Figure 3.15 & Figure 3.16). Strain levels for surface mounted strain gages at locations which spanned the HPC/UHPC interface exceeded $110\mu\epsilon$, the HPC cracking strain, at approximately halfway to Service Level I moment (Figure 4.15).

Figure 4.15. Top-of-Deck Surface Mounted Strain Gages over the Joint Interface

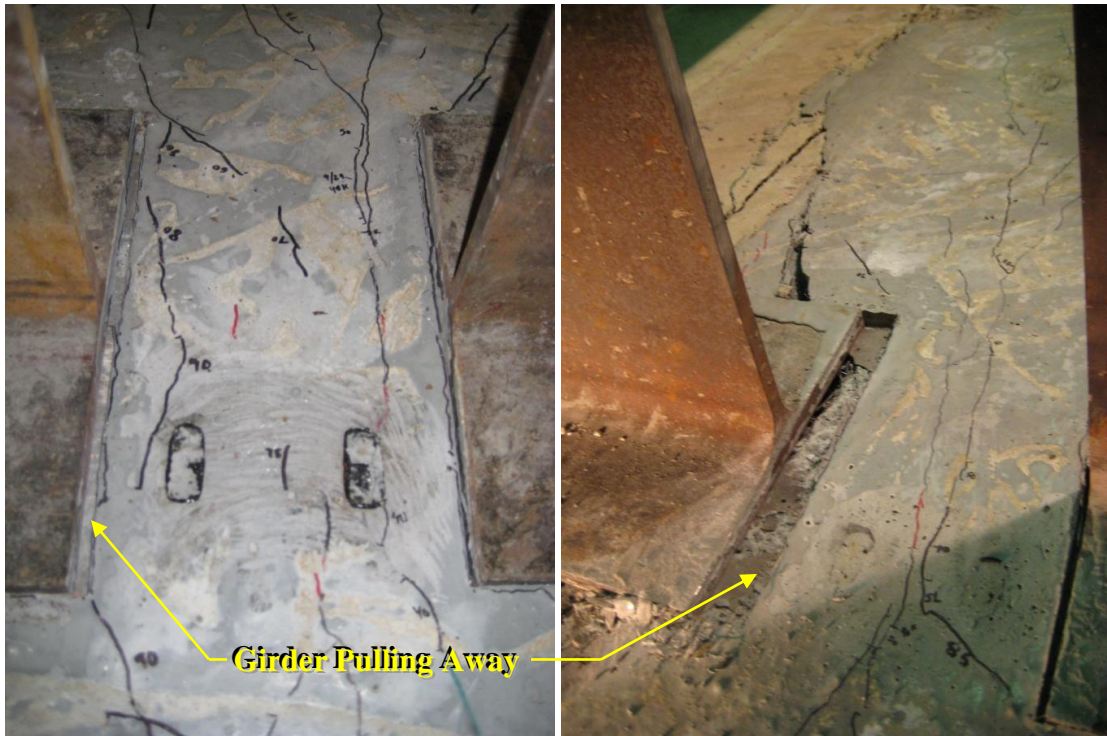
Throughout ultimate moment capacity testing, the W30X99 girders appeared to be slowly pulling away from the joint. All of the cracking in the UHPC joint and HPC deck could be seen accumulated locally where the girder appeared to pull away (Figure 4.57).

Figure 4.57. Girder-Deck Interface

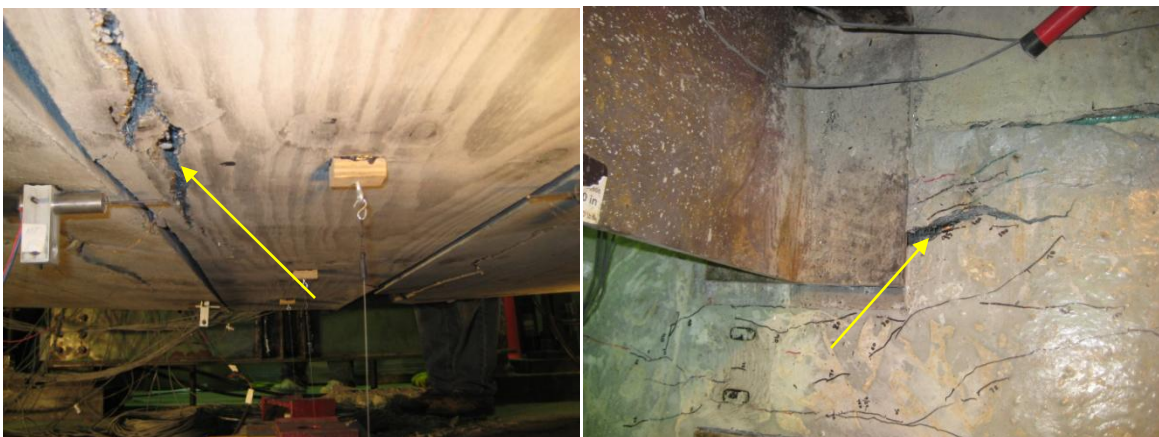
Figure 4.58. UHPC Rupture (Top and Bottom-of-Deck)

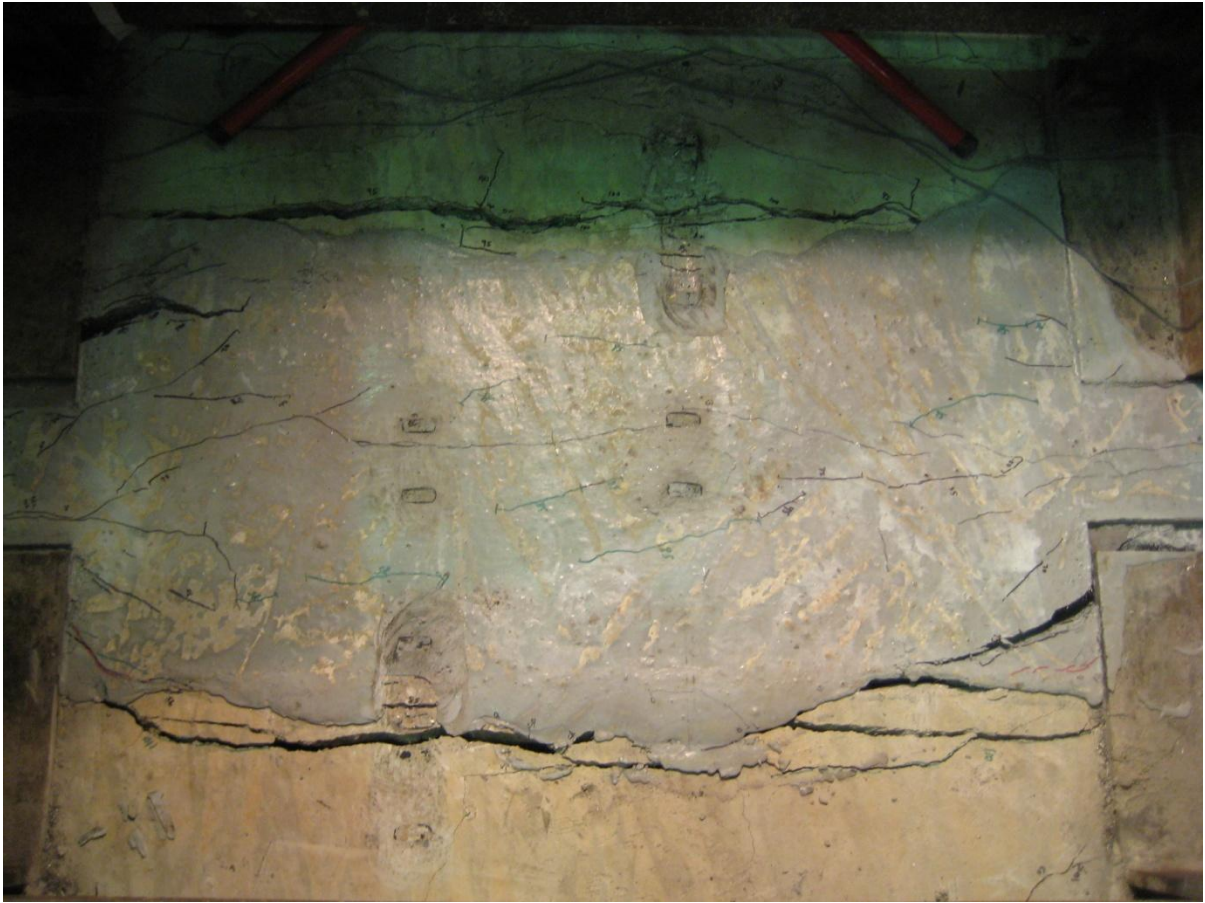
Figure 4.59. Bottom-of-Deck at Failure

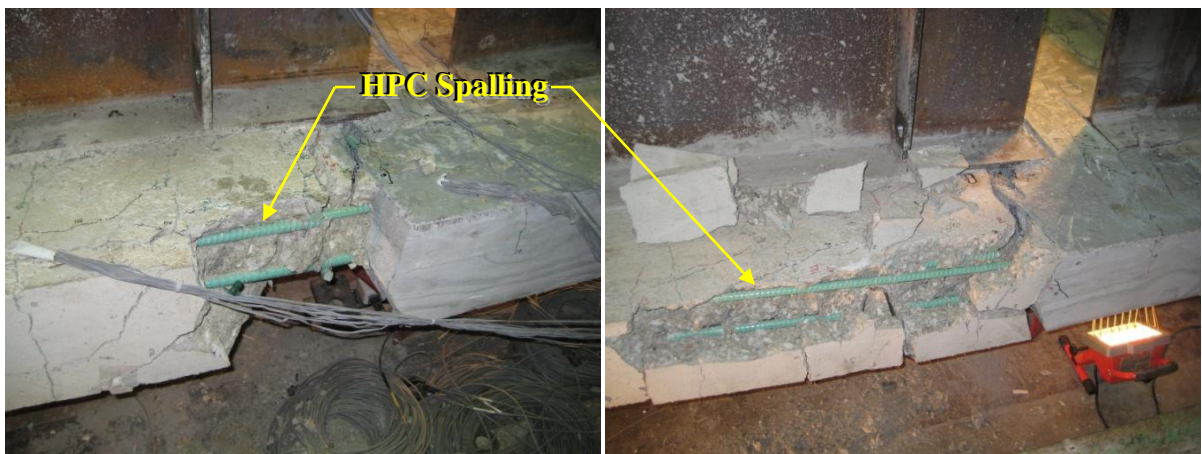
Figure 4.60. Exterior Hairpin Reinforcement (Opposite Sides)

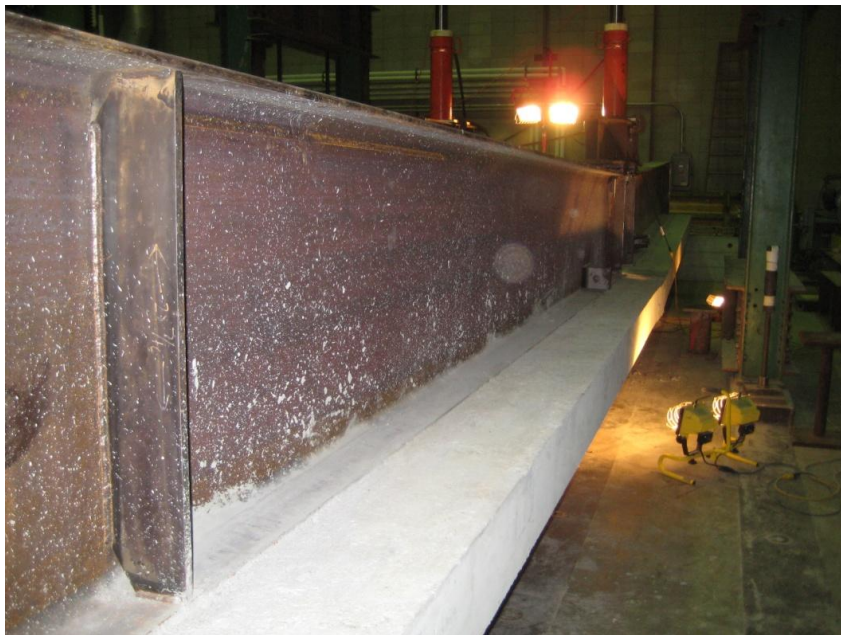
Deformation in the bottom flange of the W30X99 girders was identified as the test progressed and the specimen underwent large deflections (Figure 4.61). In addition, during the ultimate moment capacity testing, the slip critical bolted connections went into bearing and caused local deformation in the flange holes. Upon failure, the total deformation of the specimen at the centerline of the UHPC joint was 9.3 in (Figure 4.62).

Figure 4.62. Overall Specimen Deflection
