# Laboratory testing of full-depth precast, prestressed concrete deck panels used in the Boone County IBRC accelerated bridge replacement project

**Laboratory testing of full-depth precast, prestressed concrete deck panels used in the  
Boone County IBRC accelerated bridge replacement project**

A thesis submitted to the graduate faculty  
in partial fulfillment of the requirements for the degree of  
**MASTER OF SCIENCE**

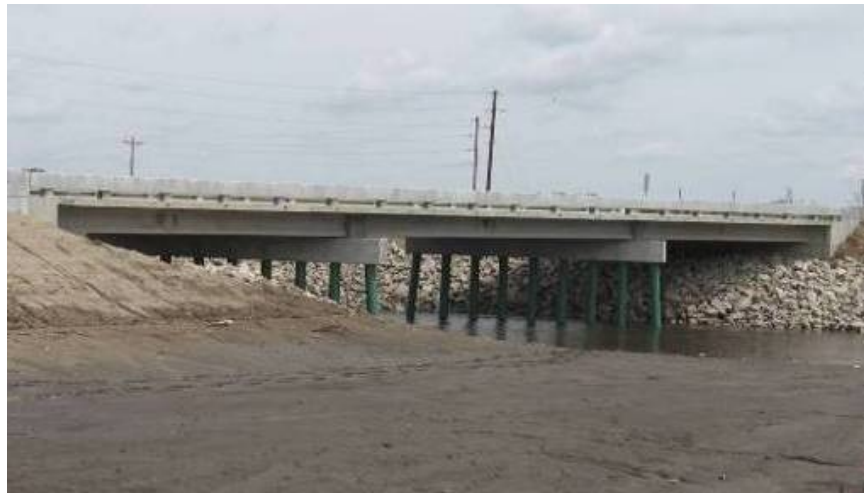
**b) completed replacement bridge**

**Figure 1.2. Original and replacement Boone County bridges.**

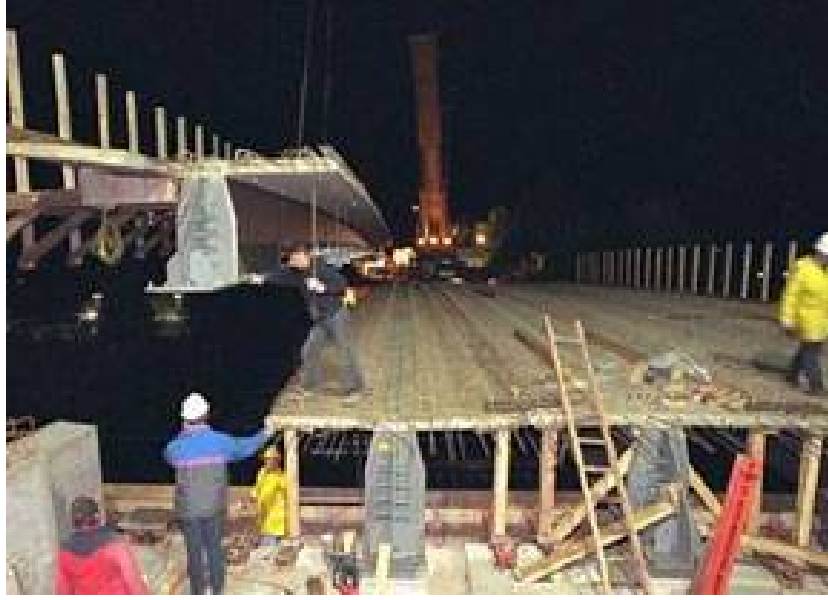
**Figure 1.3. Placement of partial depth panels cast on beams (Russell *et al.*, 2005).**

While on a scanning tour in April 2004, the Federal Highway Administration (FHWA) and the American Association of State Highway and Transportation Officials (AASHTO) observed the use of a partial depth panel system in Germany similar to the PCU system. The German system involved casting a partial depth panel on a beam prior to erecting the beam. Beams are then set into place so the panels almost touch. Because of the closeness of the panels, there is no need for additional formwork prior to placing the CIP concrete (Russell *et al.*, 2005). A project using this system can be seen in Figure 1.3.

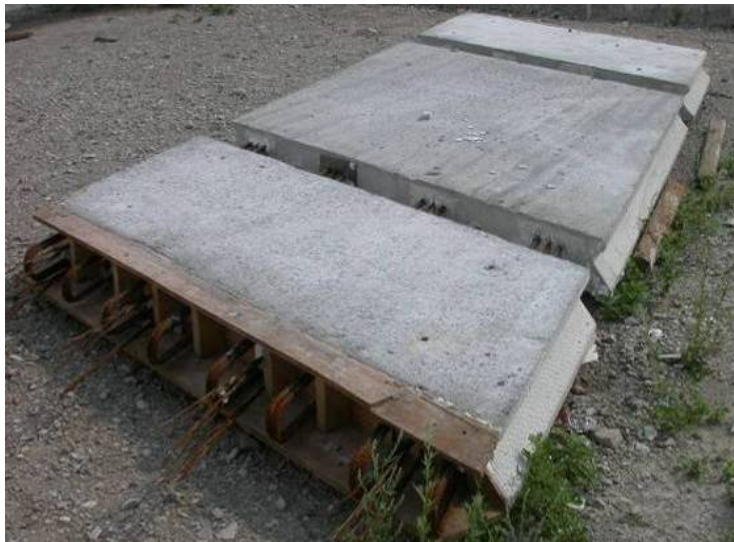
**Figure 2.1. Full-depth precast concrete deck panel (courtesy of Iowa DOT).**

Deck panels were fabricated at Andrews Prestressed Concrete, Inc. of Clear Lake, Iowa and delivered to ISU. ISU received three precast deck panels for testing. The project proposal called for the testing of two deck panels; however, ISU was able to purchase a third deck panel which had been rejected by the Iowa DOT due to the presence of a cold joint. Laboratory testing included concrete coring to determine the concrete compressive strength, determination of the compressive force in the #7 reinforcing bars due to prestressing, determination of strains in the panels while leveled and while lifted with a crane, service load testing, and ultimate load testing. A photograph of one of the precast deck panels used in this project is presented in Figure 2.1.

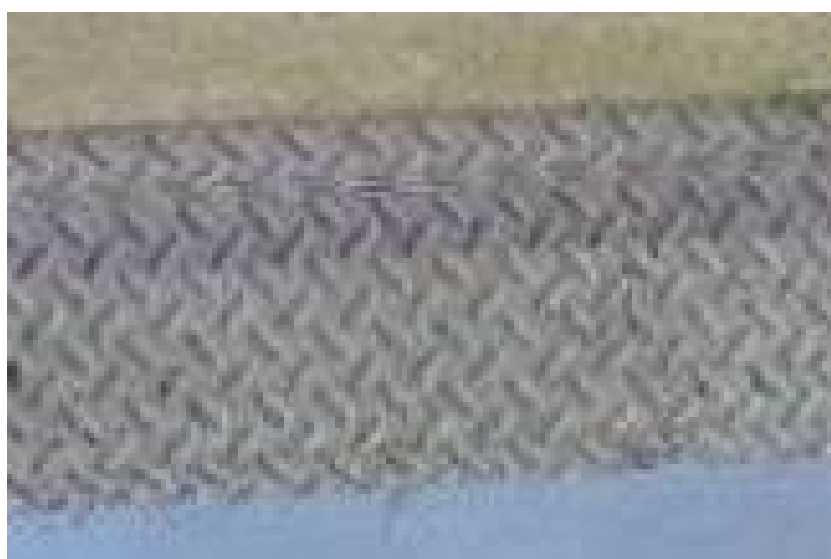
**Figure 2.3. Textured surface of transverse joint.**

Also of note in Figure 2.2 is that the bottom of the panels is 3 in. wider than the panel top. This provides an opening for placing the concrete for the shear key between the individual panels. The shear key runs transversely and provides continuity between the deck panels. As shown in Figure 2.3, the shear key surface had a diamond pattern to provide a better bond between the concrete in the panels and the concrete placed in the shear key.

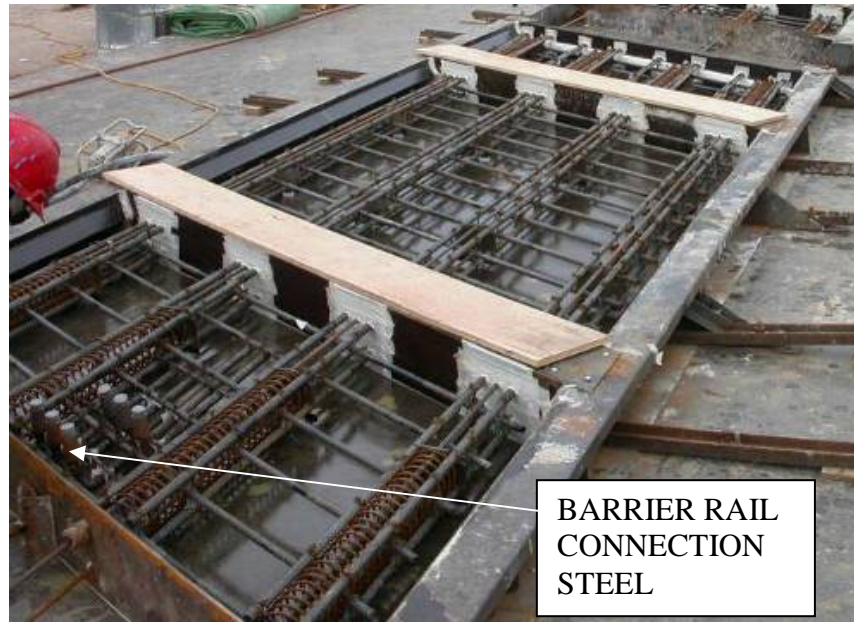
**a) deck panel reinforcing steel**

Shown in Figure 2.5 is the steel reinforcement in the deck panel casting beds. The four groups of prestressing steel and mild steel are visible in both figures, as well as the spirals encasing the ends of the prestressing strands. The additional steel seen in between the spirals in Figure 2.5a is the reinforcement for the barrier rail connections. Prestressing steel exiting the formwork and the double hooks are visible in Figure 2.5b.

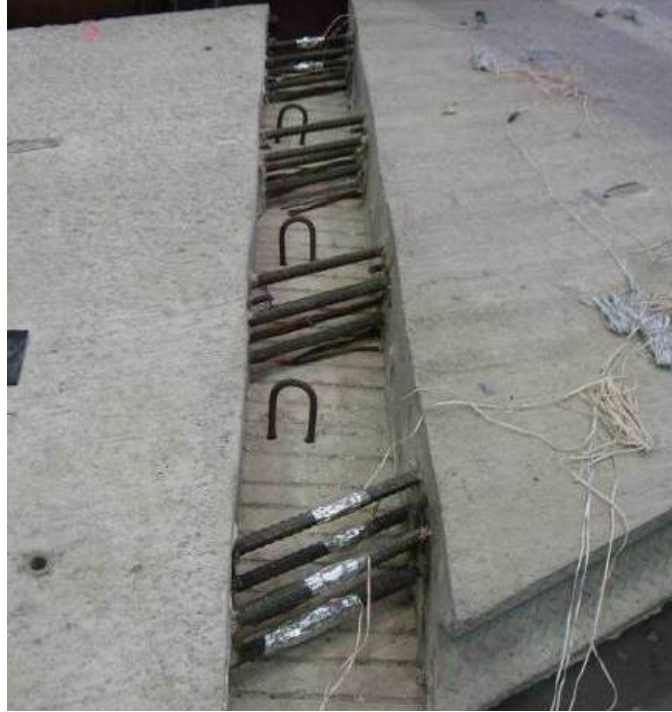
**Figure 2.10. Reinforcing bars instrumented with steel strain gages.**

The eight prestressing strands present in one longitudinal channel of Panel 3 were cut to determine the compressive force in the mild reinforcement due to prestressing. Strains were measured while cutting the strands by installing strain gages on six of the twelve mild reinforcing bars. Bars 1T, 1B, 2T, 2B, 8T, and 8B (shown in Figure 2.7a) were instrumented; a photograph of these strain gages is shown in Figure 2.10.

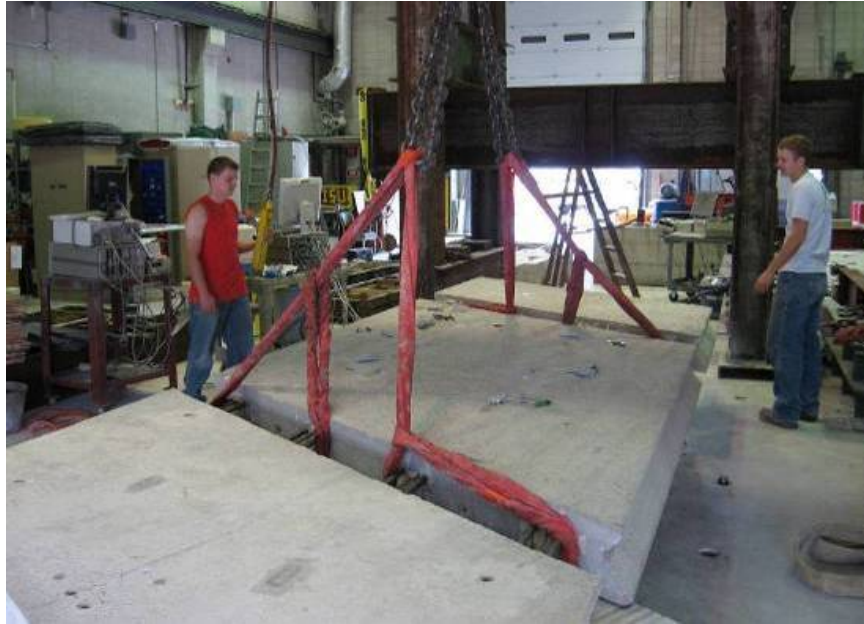
The first lifting configuration used four straps to lift the panel. Each strap was wrapped around two groups of reinforcing steel bars, after which the ends of two straps were paired together; the crane hook was then put through the ends of the straps to lift the panel. A photograph and sketch of the straps wrapped around the bar groups are shown in Figure 2.12. Straps had to be wrapped around the bar groups in different configurations in order to have a balanced pick of the panel. Panel 2 and Panel 3 were tested in this configuration. Eight gages on Bars 1, 2, 7 and 8 shown in Figure 2.7 were used to collect data in both panel tests. Each panel was lifted twice and the results compared.

**a) photograph of lifting the deck panel with four straps**

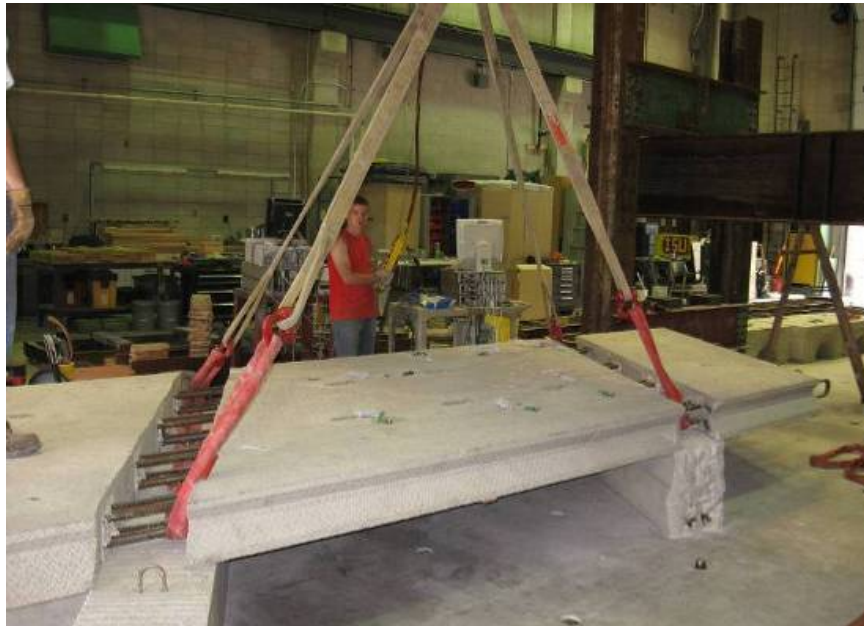
The second lifting configuration used two straps to lift the panel. Each strap was wrapped around the four bar groups in the longitudinal channel, as shown in Figure 2.13. Once both straps were in place, the panel was lifted and strain readings taken. Only Panel 3 was tested with this setup, and data were collected from four lifts. Steel strains using six strain gages on Bars 1, 2, and 8 were recorded during the tests.

**a) photograph of two strap setup prior to lifting**

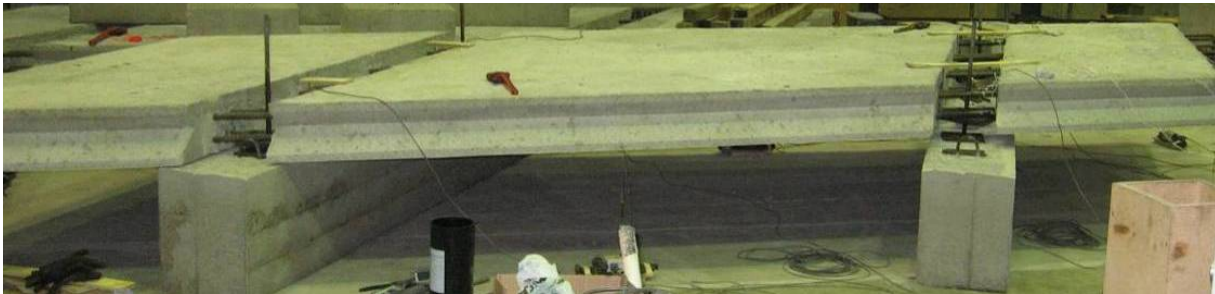
**Figure 2.14. Deck panel setup for leveling test.**

In addition to during moving and transporting, there was concern about the stresses in the mild reinforcing steel during the leveling of the panels. Therefore, Panel 2 was tested in the laboratory to determine the magnitude of the stresses exerted on the mild reinforcing steel during panel leveling. For this test, two supports simulating the precast girders in the field were cast to support the panels; the simulated beams were 18 in. tall, 14 in. wide, and 10 ft long. Panel 2 supported by two simulated girders is shown in Figure 2.14.

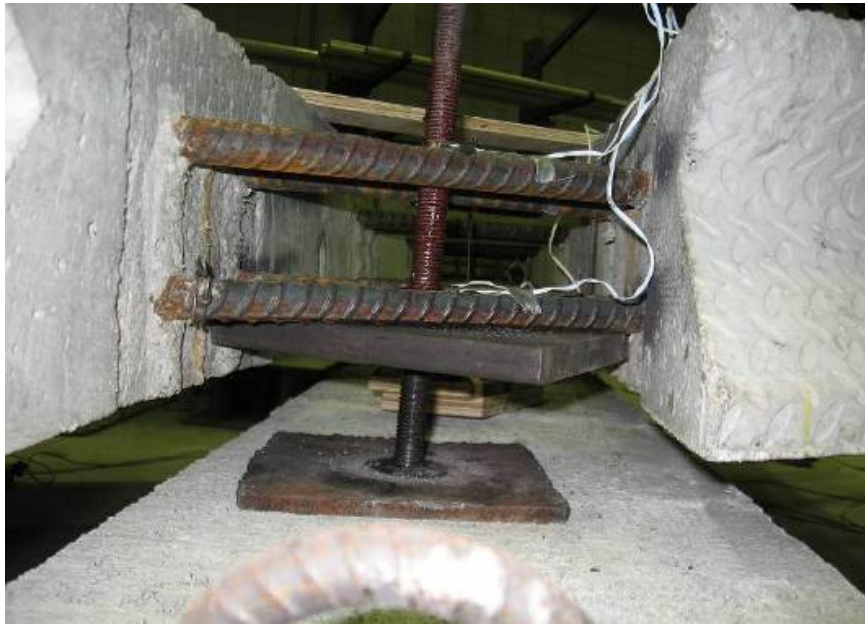
b) photograph of leveling device

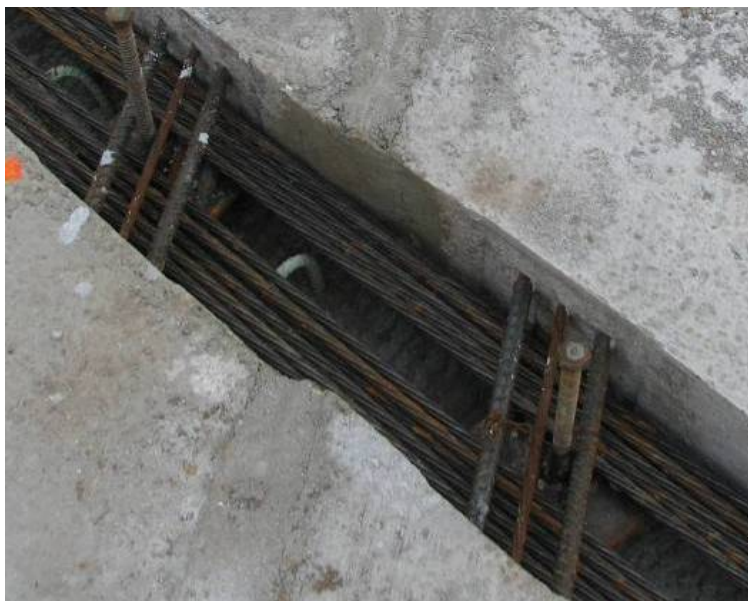
**Figure 2.17. Photograph of longitudinal post-tensioning channel prior to casting concrete in the field.**

One concern about the deck panel system was the placement of concrete in the post-tensioning channel (i.e. could concrete could flow around all of the steel in the post-tensioning channel?). Shown in Figure 2.17 is a photograph of one of the post-tensioning channels in the bridge prior to placement of concrete. In order to check this concern, a model of the channel was constructed in the laboratory and concrete was placed multiple times to determine if any void spaces were left around the steel.

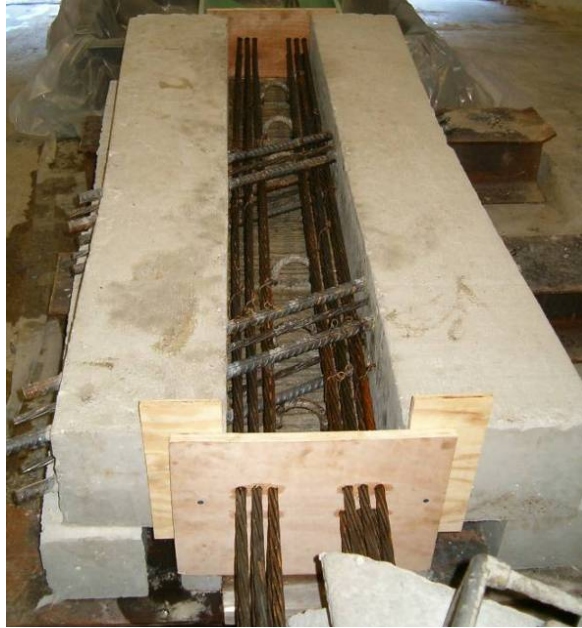
a) constructed channel used in concrete placement tests (courtesy of Iowa DOT)

Elements composing the completed model included a simulated deck panel with mild steel and prestress strands, a simulated girder, and concrete beams to support the simulated deck panel. Plywood was placed at the ends of the channel to close the channel and support the post-tensioning strands. The plywood could be removed between tests to allow for cleaning of the specimen before reuse. Presented in Figure 2.18a is a photograph of the constructed test specimen.

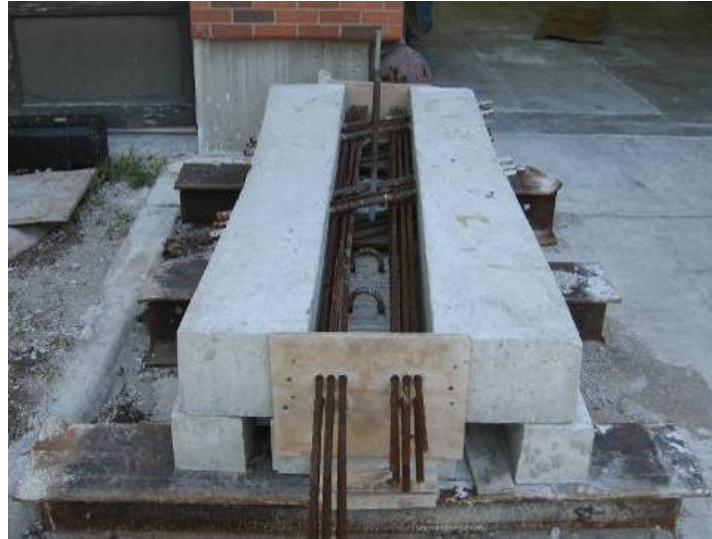
**a) outdoor test setup**

Placement testing was conducted on two days, November 9, 2006 and May 17, 2007. A total of three tests were conducted, two on the first test day and one on the second day. The third test will be the focus of this section. Unlike the first two tests, which took place inside the laboratory due to weather conditions, the third test was conducted outdoors. Photographs of the setup of the channel outside of the laboratory are presented in Figure 2.19.

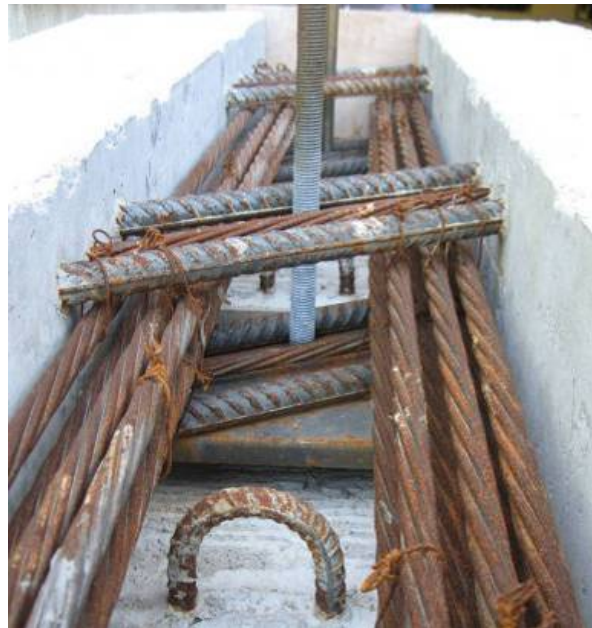
**b) steel in channel**

setup provided a worse-case scenario for the opening between the leveling device plate and the girder because in the field, the plate would be raised higher due to leveling the deck panels. During this test, the space between the plate and the girder was 1 1/4 in. A photograph of a leveling device in the channel prior to testing is shown in Figure 2.19b.

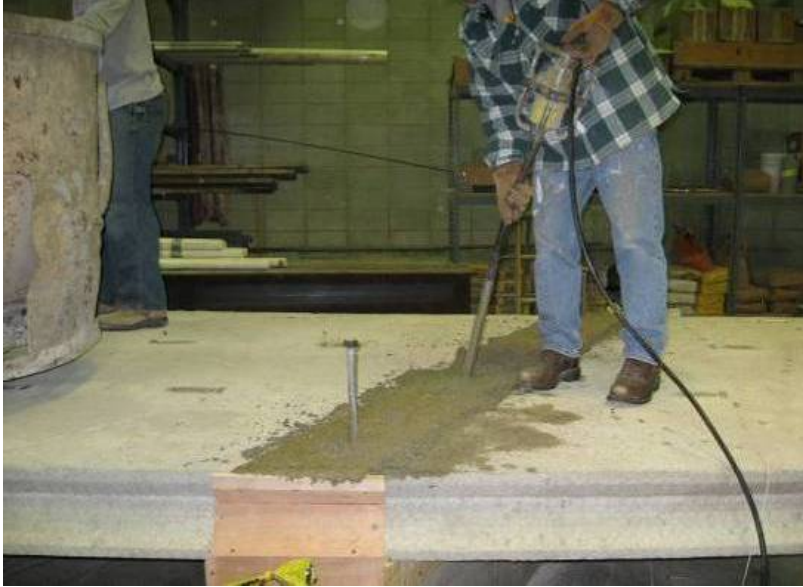
### b) placement of concrete in channel

Concrete placement for the third test began near the mild steel, which is the right end of Figure 2.18. For this test, concrete from the concrete truck was placed into a wheel barrow, and then placed by the shovelful into the channel and vibrated. One location of the channel was filled at a time, and as the channel filled, placement continued until the channel was full.

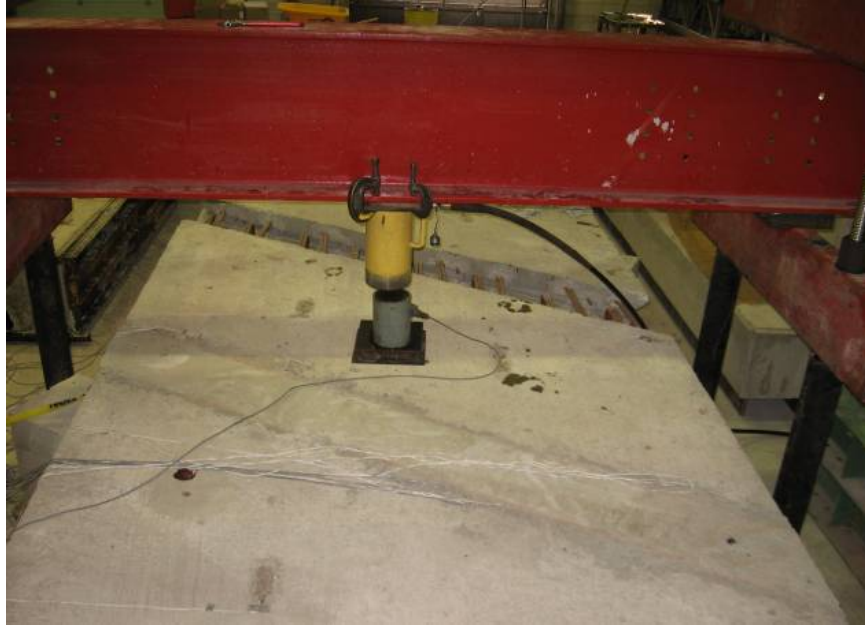
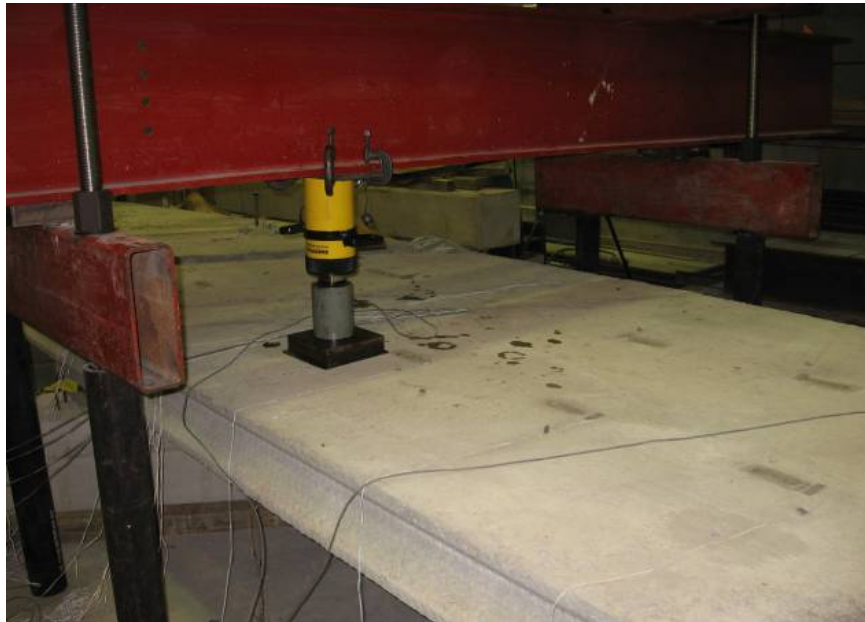
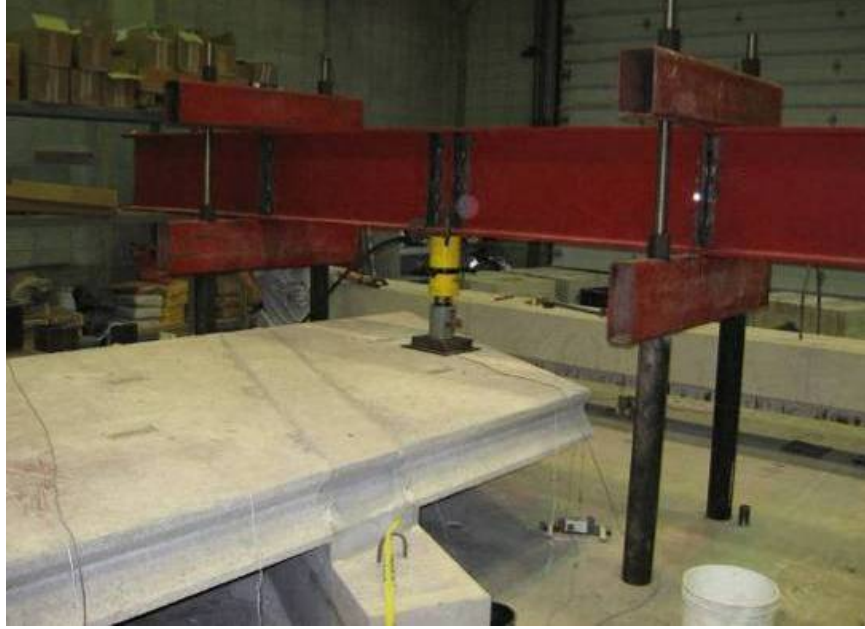
**Figure 2.22. Individual panel service load test setup.**

**a) service load at Position B9**

**b) service load at Position C10**

c) service load at Position B14

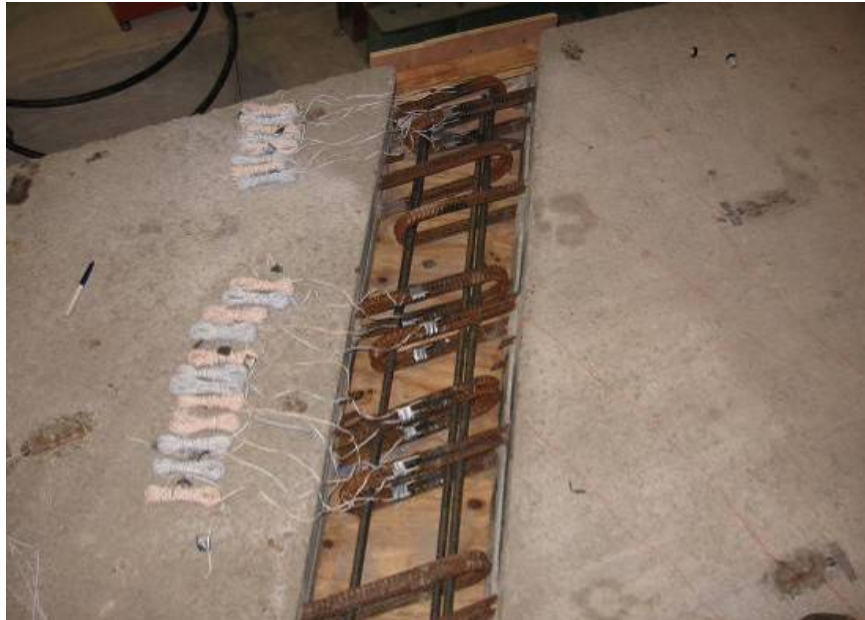
Figure 2.23. Longitudinal closure between panels prior to concrete placement.

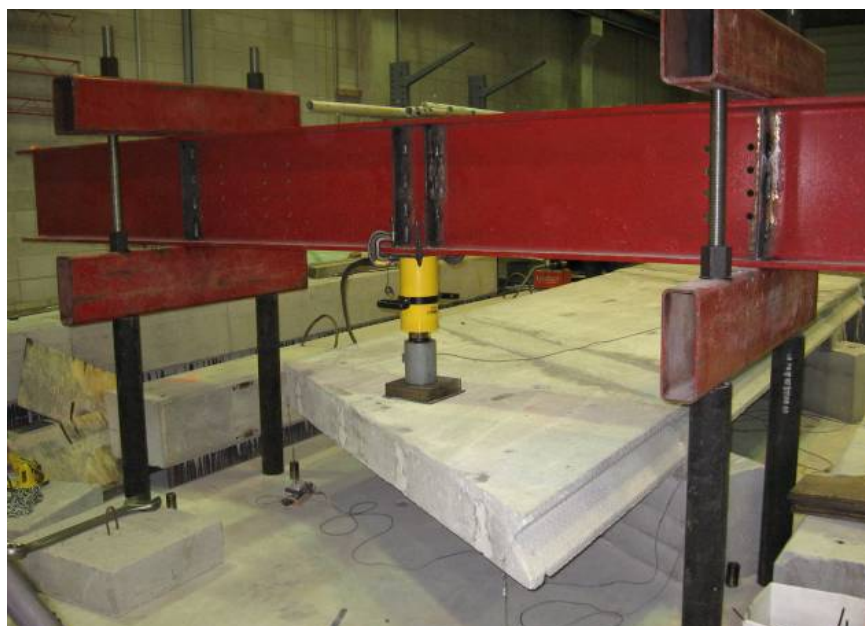
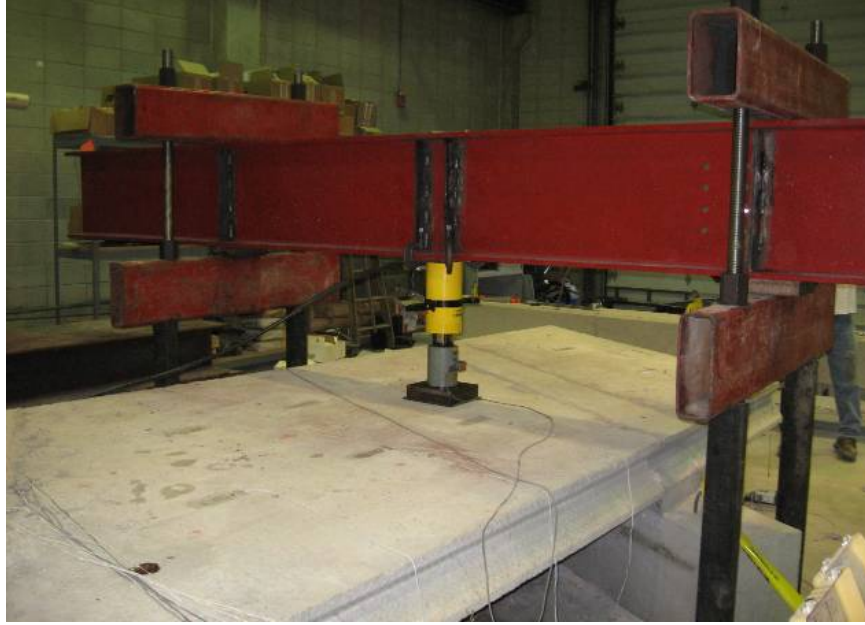
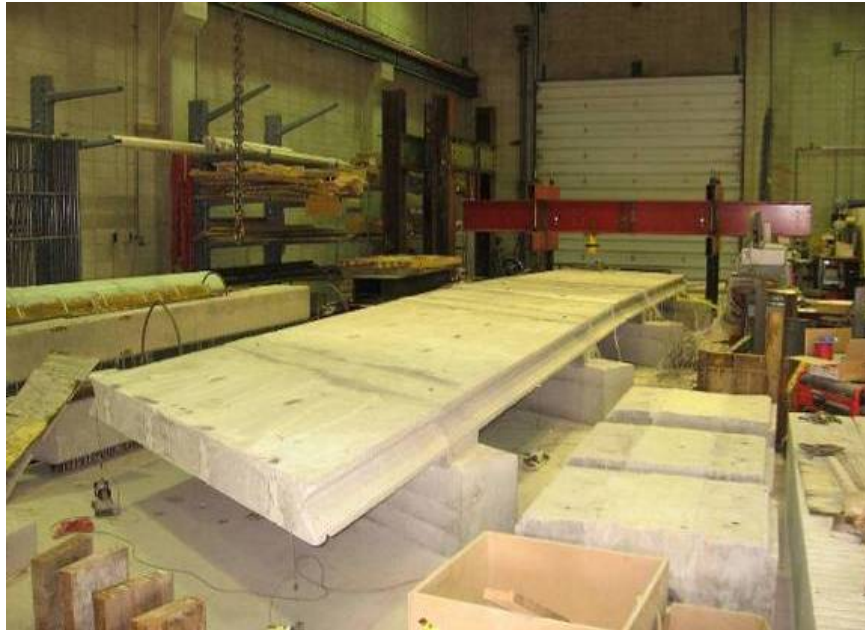
**Figure 2.25. Test setup for connected panel service load tests.**

a) service load at Position B2

**b) service load at Position B12**

**c) service load at Position A14**

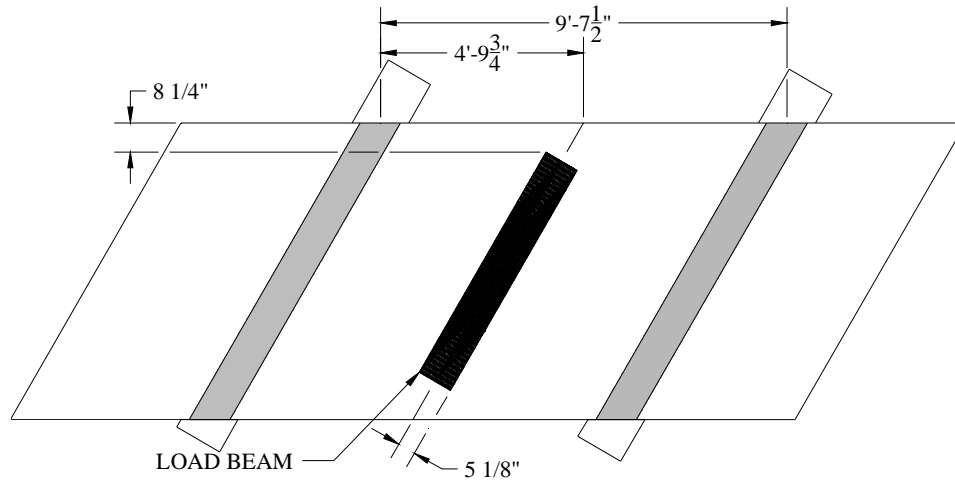
Panel 3 was tested to determine the flexural capacity of a single panel. This was accomplished by applying a line load at the midspan of the panel. As previously noted, Panel 3 also contained a cold joint, so this test would help determine if the cold joint affected the strength of the panel. The position of the line load is shown in Figure 2.26a.

a) location of line load for Panel 3 test

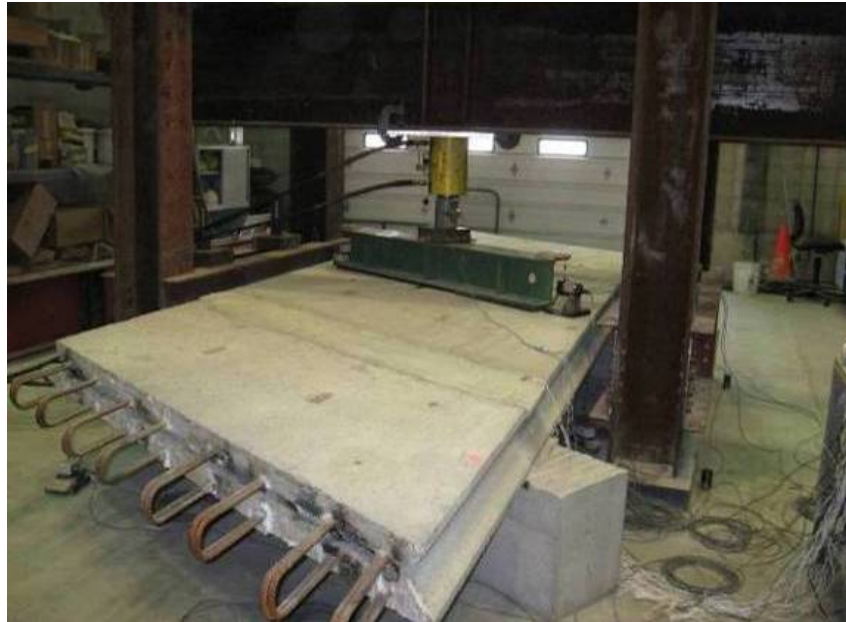
b) Panel 3 setup prior to testing

Figure 2.26. Laboratory setup for Panel 3 ultimate load test.

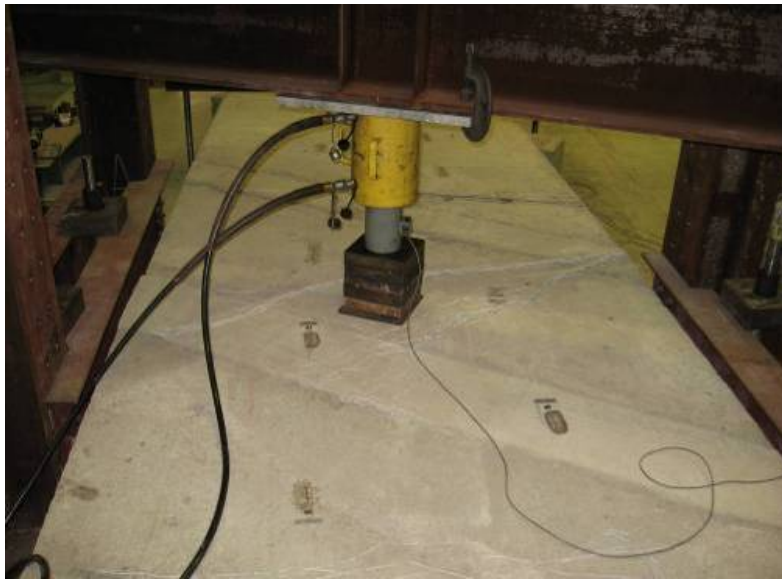
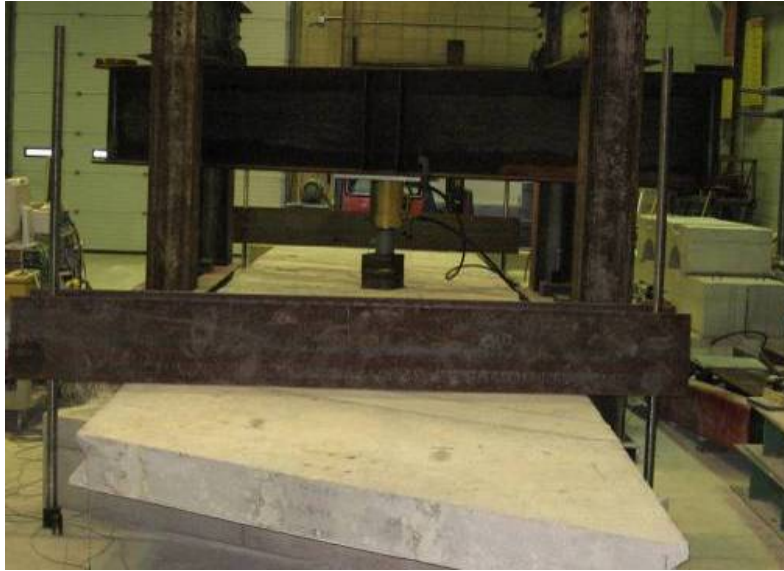
**Figure 2.27. Laboratory setup for closure joint ultimate load test.**

**b) test setup for closure joint ultimate load test**

**c) restraining beams positioned for ultimate load test**

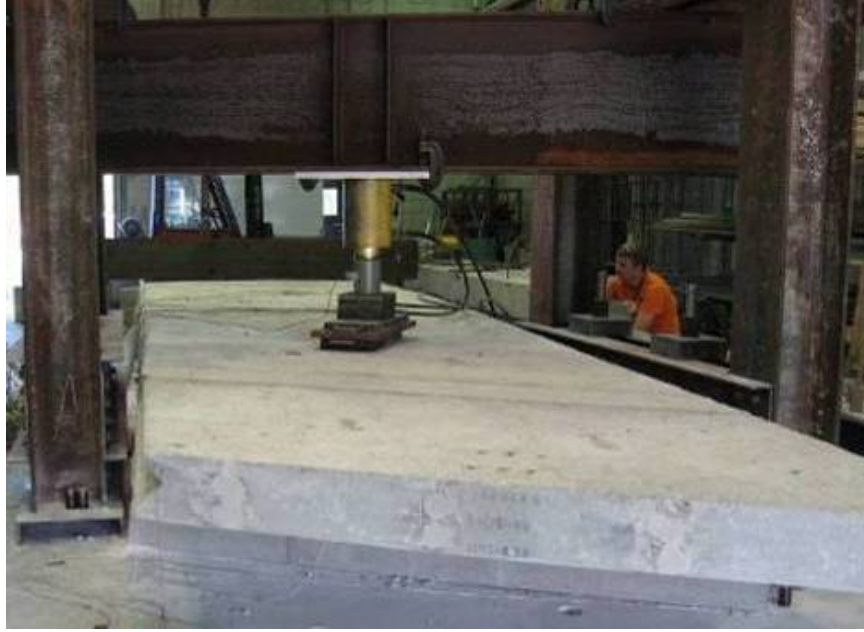
**b) laboratory setup**

A tandem wheel footprint was used for the third ultimate load test. The load was positioned as close to midspan of Panel 2 as possible based on the layout of the tie down floor. Shown in Figure 2.28a is the exact position of the load. A steel beam was positioned over one of the support beams to keep the panel from lifting during loading due to uplift forces. Presented in Figure 2.28b and c are photographs of the test setup.

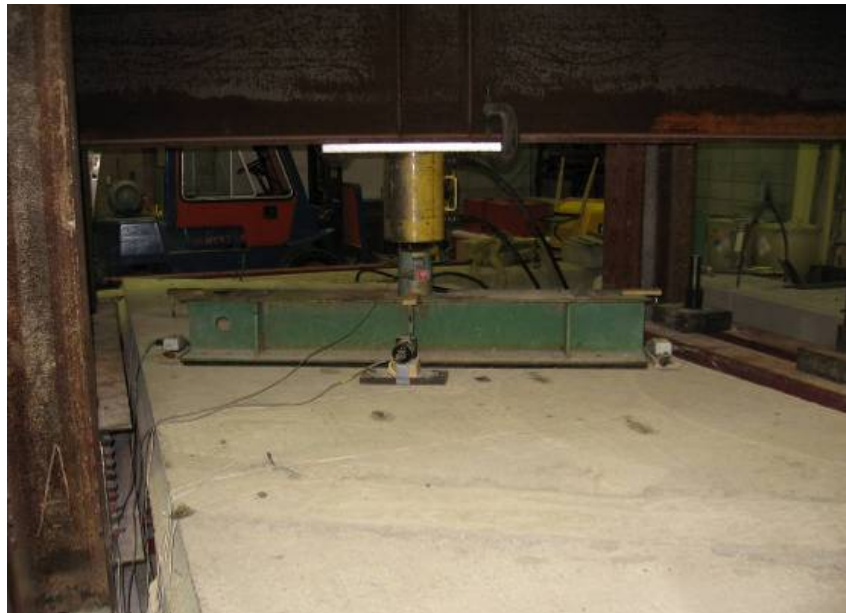
The line load was applied by loading a 6 ft long HP10x42 section. Neoprene pads were placed between the load beam and deck panel to account for the roughness in the deck panel surface and to evenly distribute the load. A 300 kip load cell was placed between the load beam and the actuator. Deflection transducers were installed at the ends and midpoint of the load beam so the load distribution through the beam could be monitored. A photograph of the setup in the laboratory prior to testing is shown in Figure 2.29a.

a) laboratory setup for line load ultimate load test

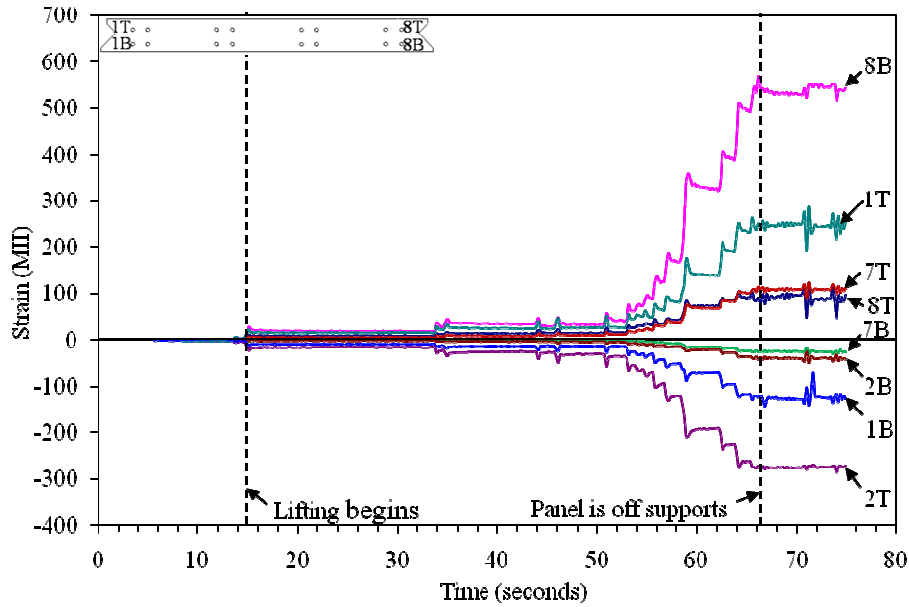
As can be seen in the graph, half the bars experienced tension and half were in compression. However, not all the top bars experienced tension and not all the bottom bars experienced compression, as one would expect. Three of the top bars (1T, 7T, and 8T) and one bottom bar (8B) were in tension. The tension in the bottom bar, 8B, was due to a localized effect caused by bearing of the lifting strap directly on the bar near the strain gage. Bar 1T experienced

**Figure 3.1. Strain results for first lift of Panel 2 with four straps.**

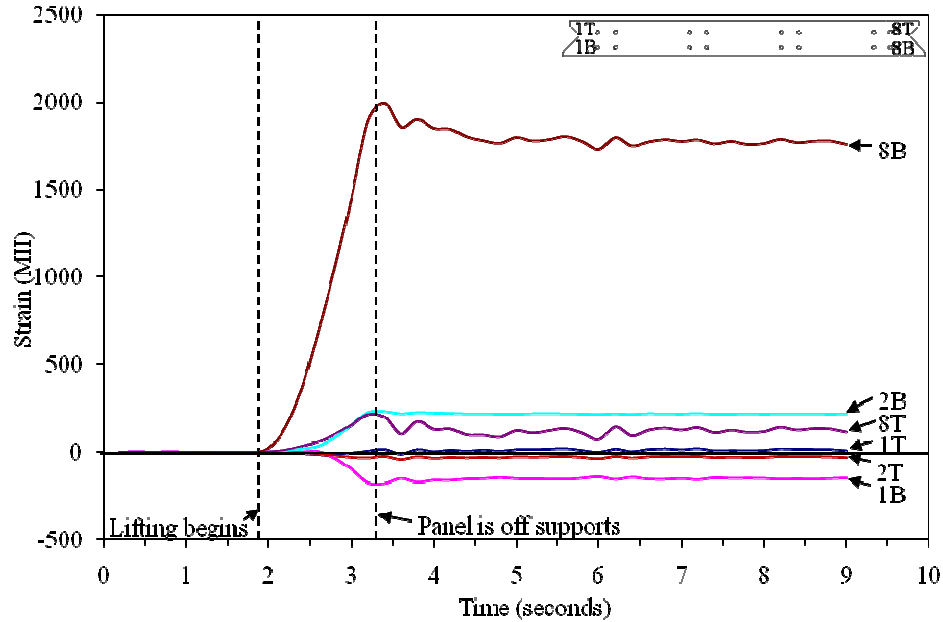
Bar 8B had the largest strain, stabilizing at a strain of 1780 MII. However, this strain was caused by a localized effect from the lifting strap bearing directly on the bar near the strain gage. Neglecting this strain, all the instrumented bars experienced strains less than 250 MII. The

**Figure 3.2. Strain results for fourth lift of Panel 3 with two straps.**

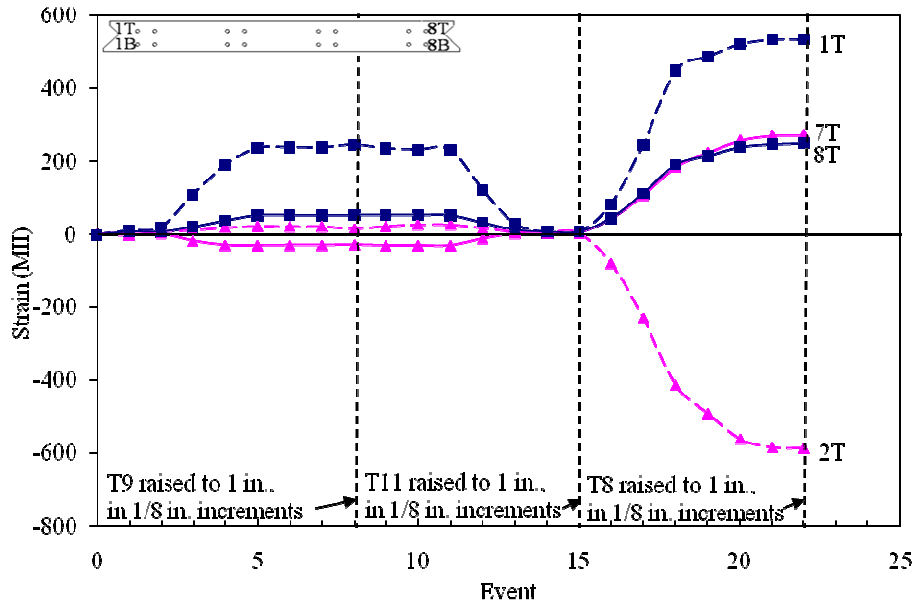
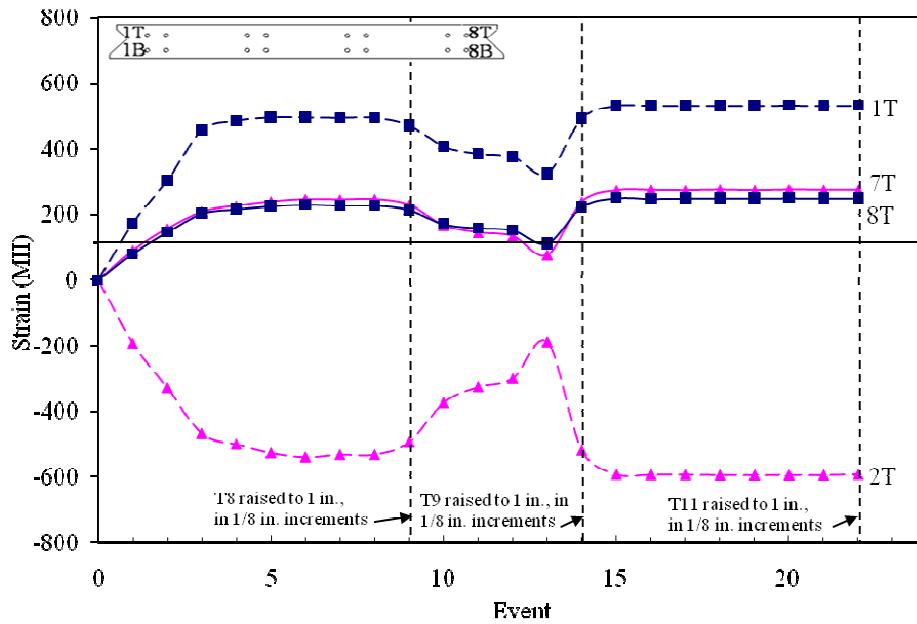
Strains experienced during the various leveling tests conducted are presented in Figure 3.3. Tests conducted and the order leveling devices were raised were presented in Section 2.6; locations of the instrumented mild reinforcing bars were shown in Figure 2.7. Each event plotted on the horizontal axis in Figure 3.3 represents an increase of 1/8 in. in height of the leveling rod being adjusted.

**Figure 3.3. Measured steel strains in Panel 2 mild reinforcing bars during leveling tests.**

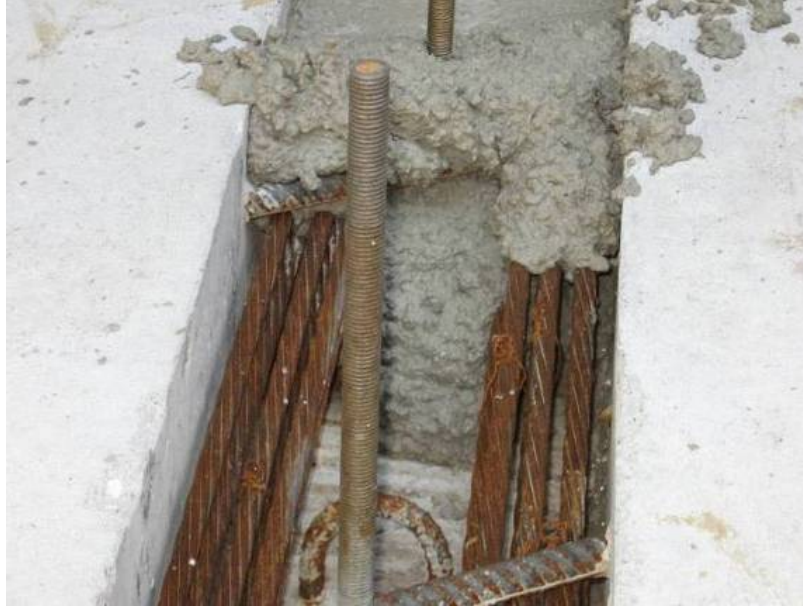
**a) concrete flowing in channel**

The photographs in Figure 3.4 address concerns the Iowa DOT had about the flow of concrete in the post-tensioning channel, specifically the flow around all of the steel present in the channel. In Figure 3.4a, one can see the concrete flowed through the channel in three layers, first under the prestress strand, then between and around the strands, and finally above the strands.

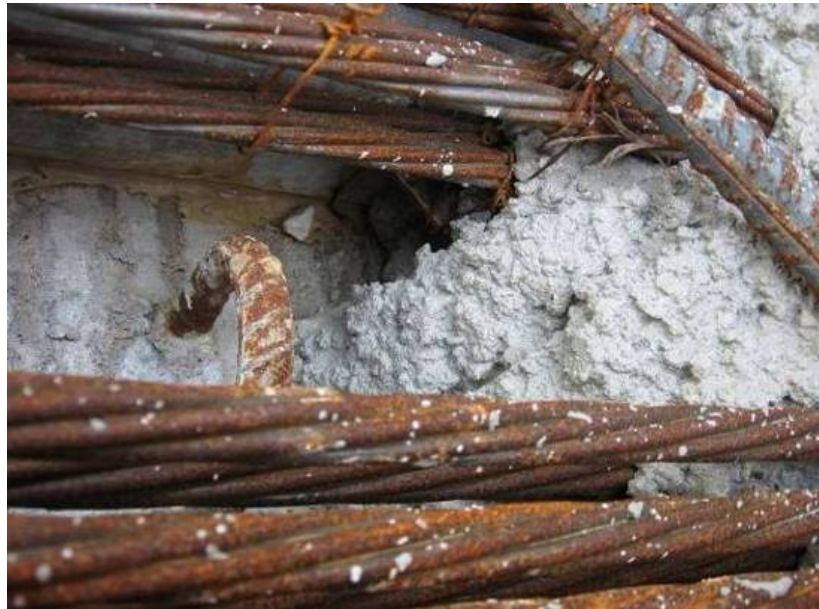
**b) concrete flowing between post-tensioning strands**

This was typical of all three tests conducted. Shown in Figure 3.4b is concrete flowing between the prestressing strands, addressing concerns of the Iowa DOT if concrete would leave void space between the strands.

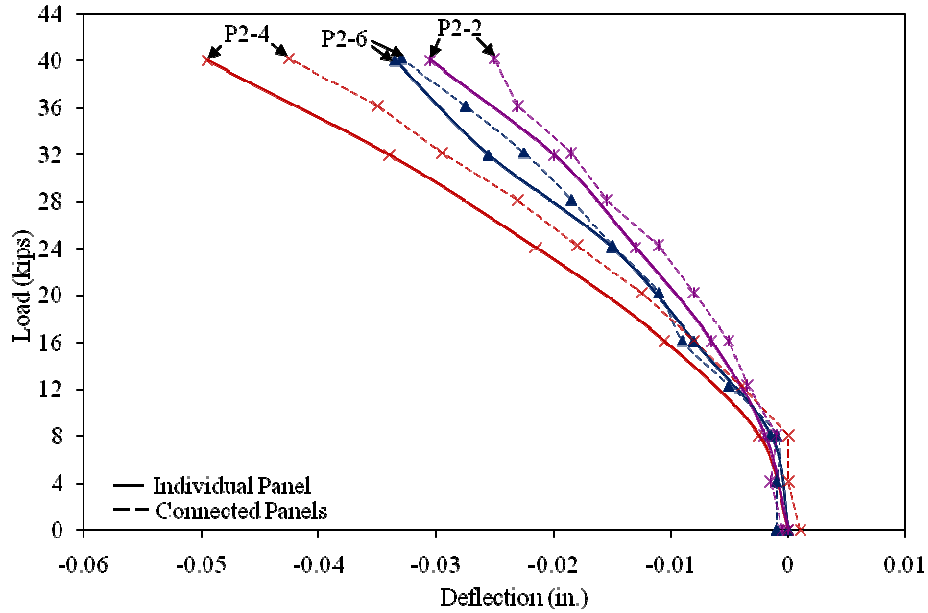
A plot of deflections for a load at point B11 for the individual and connected panels is shown in Figure 3.16. From these plots, one can see the effect the closure pour had on the system. Every deflection decreased after the closure pour was cast, with the greatest changes occurring at the cantilevered sections of the deck panel. Deflections at P2-7, located at a corner of the cantilevered deck panel, decreased by 0.02 in. after the closure pour was cast. In Figure 3.16, deflections CP-1 and P2-5, along with CP-3 and P2-7, are at approximately the same location and can be compared. Casting the closure pour resulted in a decrease of 0.025 in. in deflections at the locations.

Figure 3.16. Deflections for load point B11 before and after casting the closure pour.

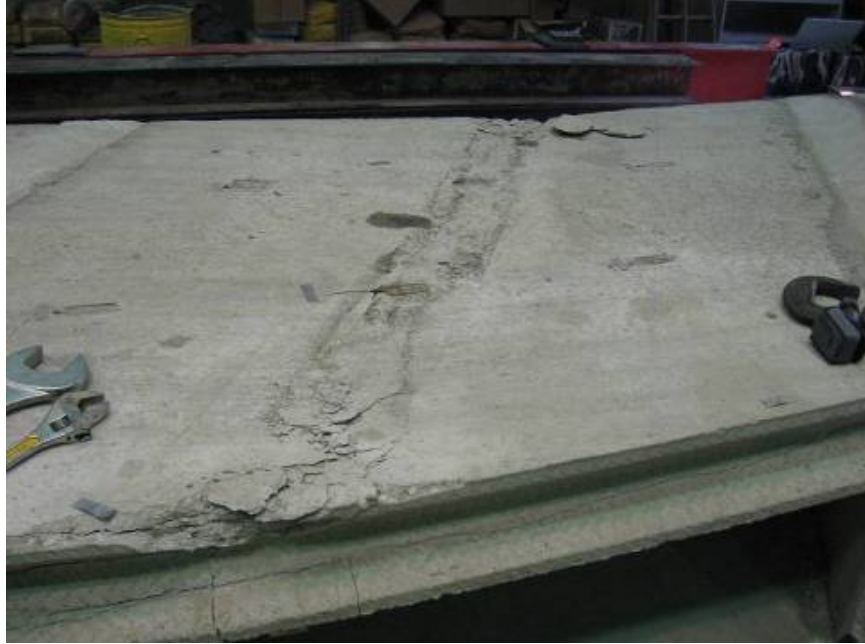
**a) deck panel after loading**

Photographs of a single panel tested to failure are presented in Figure 3.17. A line load was applied to the deck panel, and a flexural failure occurred at a load of 153 kips. Concrete that spalled from the deck panel surface is visible in Figure 3.17a. In Figure 3.17b one can see flexure cracks propagating up the side of the deck panel.
