# Laboratory testing of full-depth precast, prestressed concrete deck panels used in the Boone County IBRC accelerated bridge replacement project

**Laboratory testing of full-depth precast, prestressed concrete deck panels used in the  
Boone County IBRC accelerated bridge replacement project**

A thesis submitted to the graduate faculty  
in partial fulfillment of the requirements for the degree of  
**MASTER OF SCIENCE**

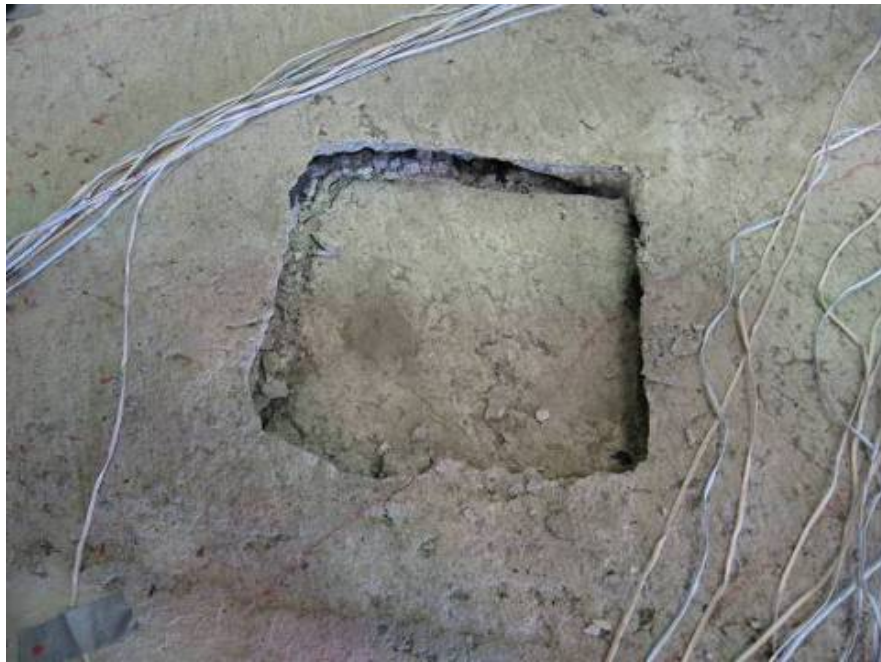
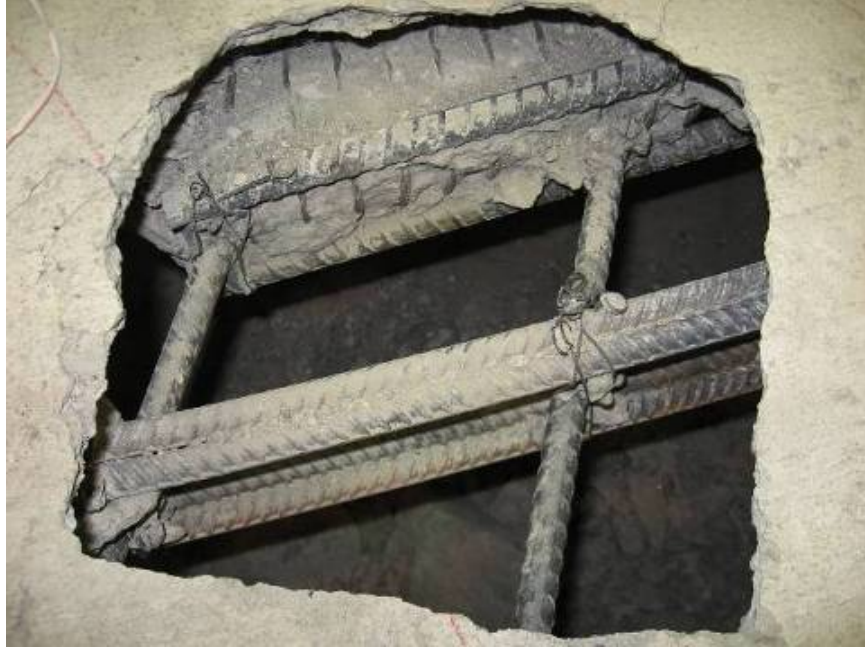
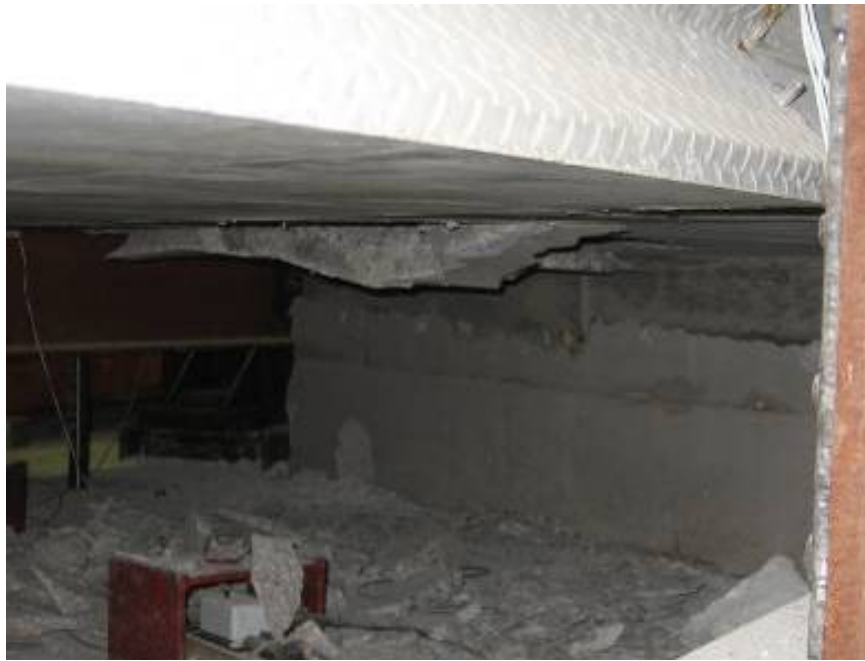
**Figure 3.20. Photographs of the deck panel after a punching shear failure.**

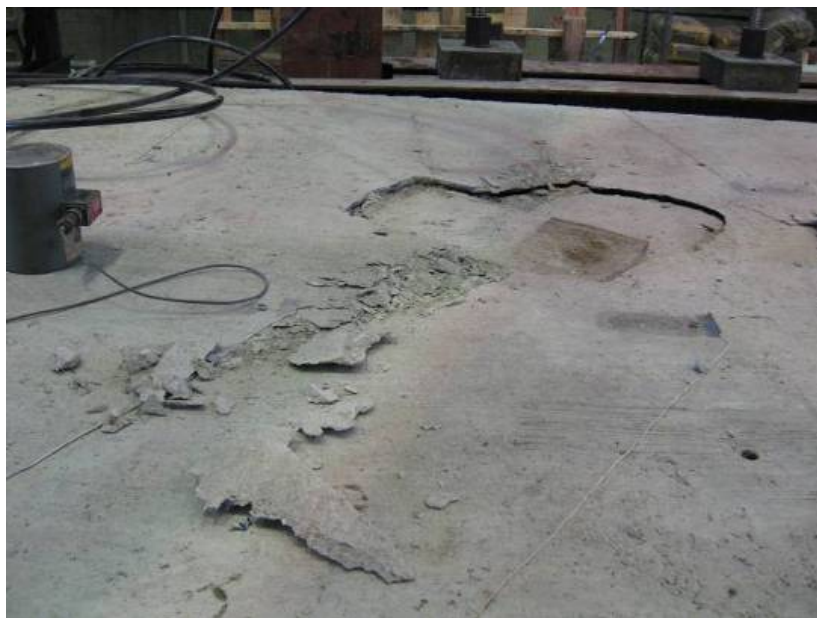
**Figure 3.25. Punching shear and flexure failure due to tandem wheel footprint.**

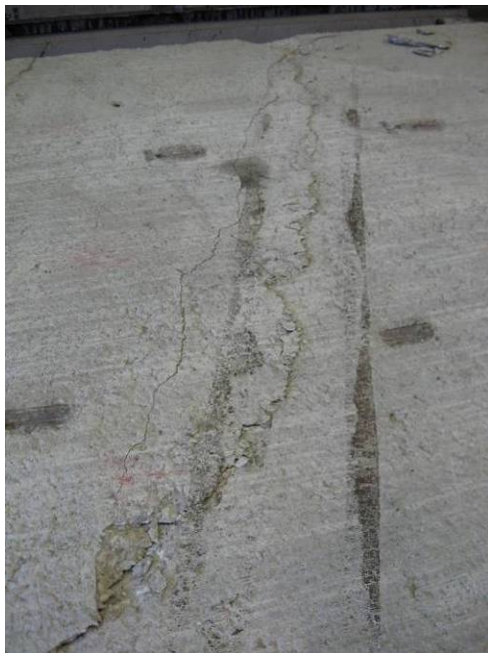
Figure 3.30. Flexural cracking in deck panel due to applied line load.
