Landslide Remediation Methodology For Low-Volume Roads In North-Central Pennsylvania

LANDSLIDE REMEDIATION METHODOLOGY FOR LOW-VOLUME ROADS IN
NORTH-CENTRAL PENNSYLVANIA

A Thesis

Master of Science in Geological Engineering

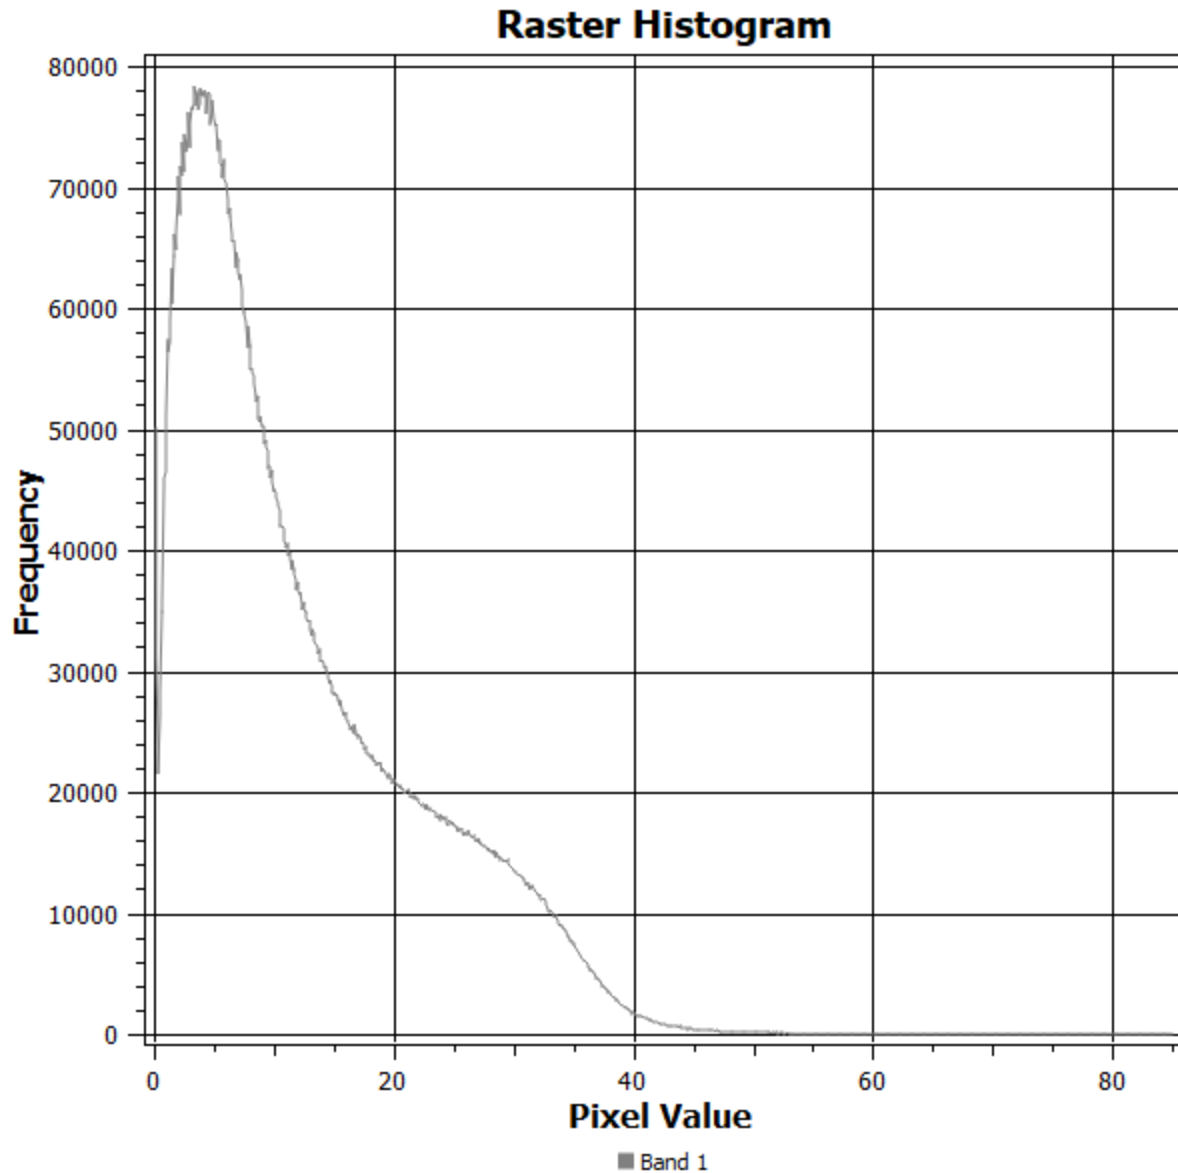
Figure 22: Histogram of slope degree frequency in Lycoming County

GIS raster layers attribute 3.2' by 3.2' pixels values. In the case of a slope map, each pixel has a specified degree. The distribution of pixel degree values for Lycoming and Sullivan County are provided in Figure 21 and Figure 22.

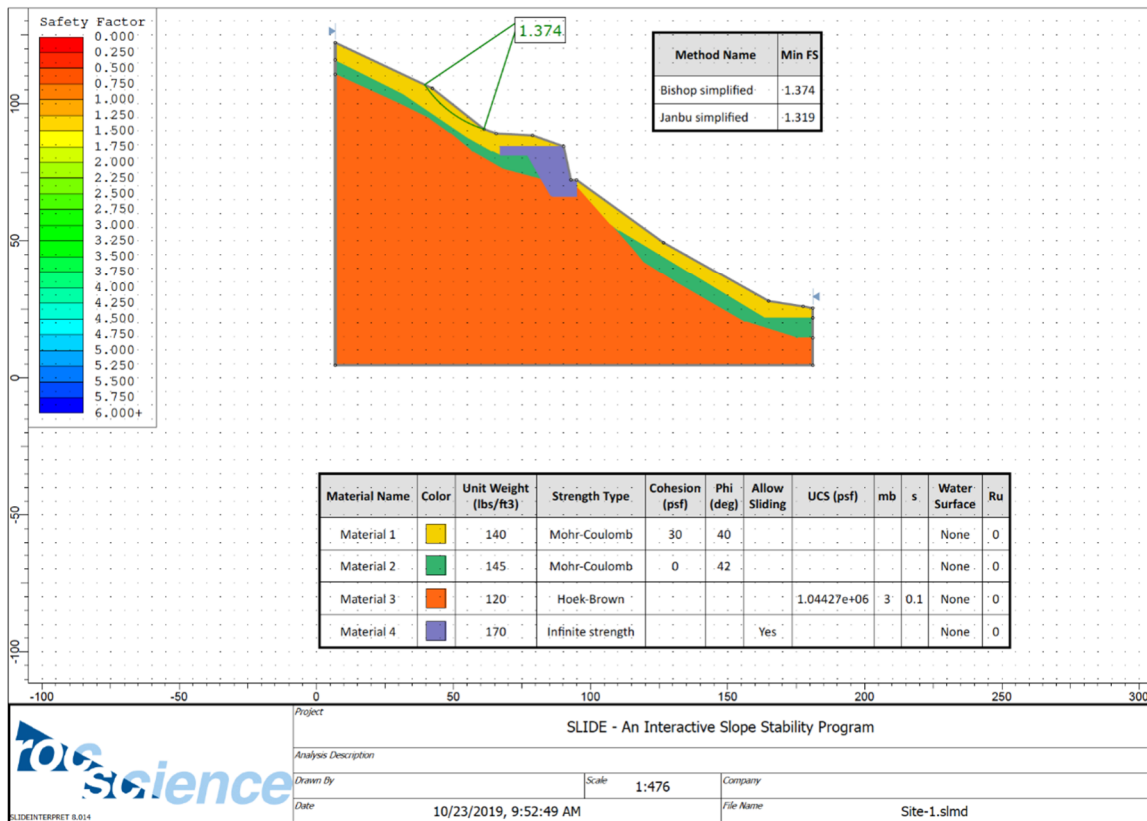
Figure 25: RocScience SLIDE 8.0 Analysis of global stability of rockery wall at Worlds End State Park

Parameter	Factor of Safety
Sliding	3.8
Overturning	2.3
Internal Overturning	5.8
Bearing Capacity	3.0
RS SLIDE Global Stability (Bishop / Janbu)	1.4 / 1.3

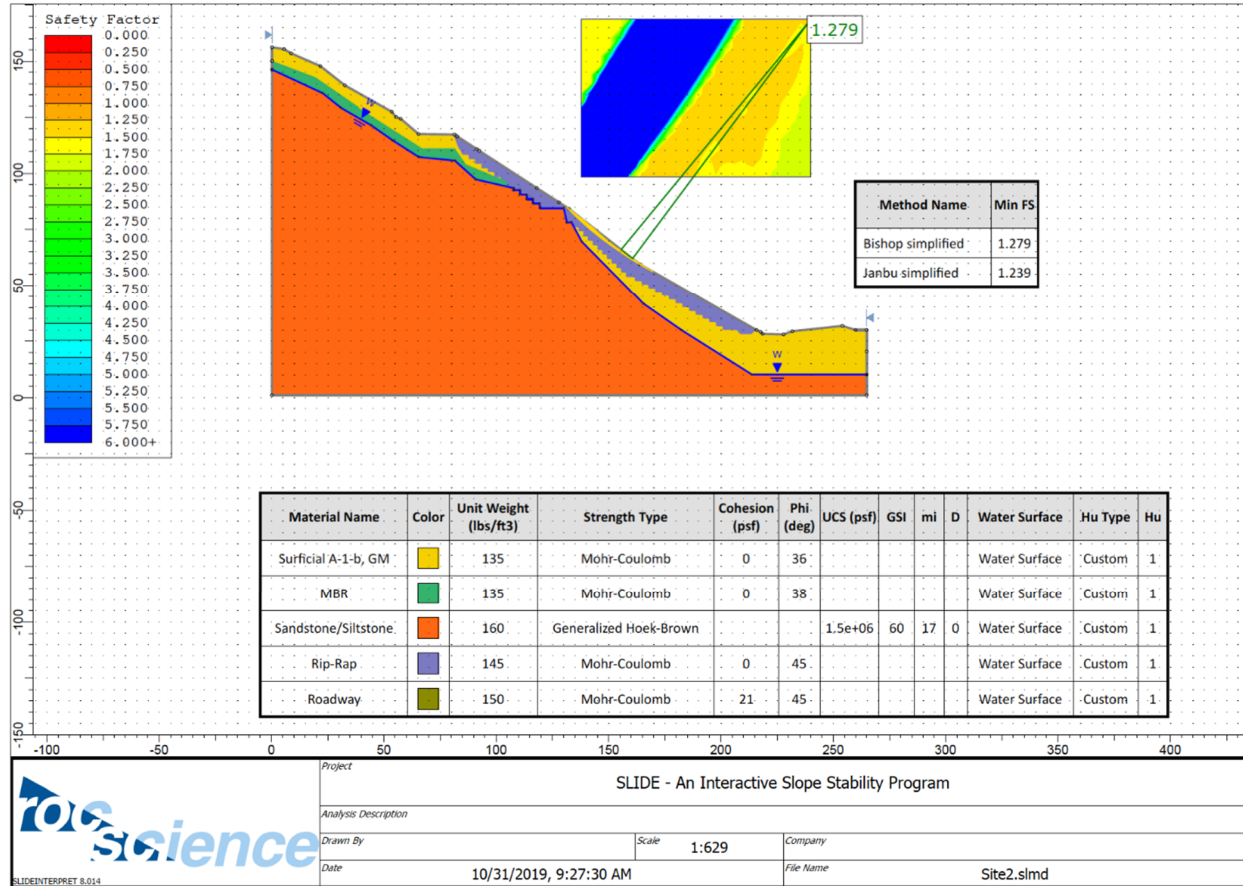
Figure 27: RocScience SLIDE 8.0 global stability analysis of rip-rap benching landslide remediation at Site 2 at Worlds End State park

Due to the significant height and degree of steepness increase at Site 2, it was determined that a rockery wall would not be feasible. Additionally, the slope's height and steepness was such that an alternative retaining wall would be cost-prohibitive. Thusly, it was decided to bench rock at various grades not to exceed 1.5 (H) : 1.0 (V) with 4.0' minimum lift widths and implement a rock key at the base of the slope, as shown in Figure 26. This slope detail was verified with RocScience SLIDE 8.0, as shown in Figure 27.

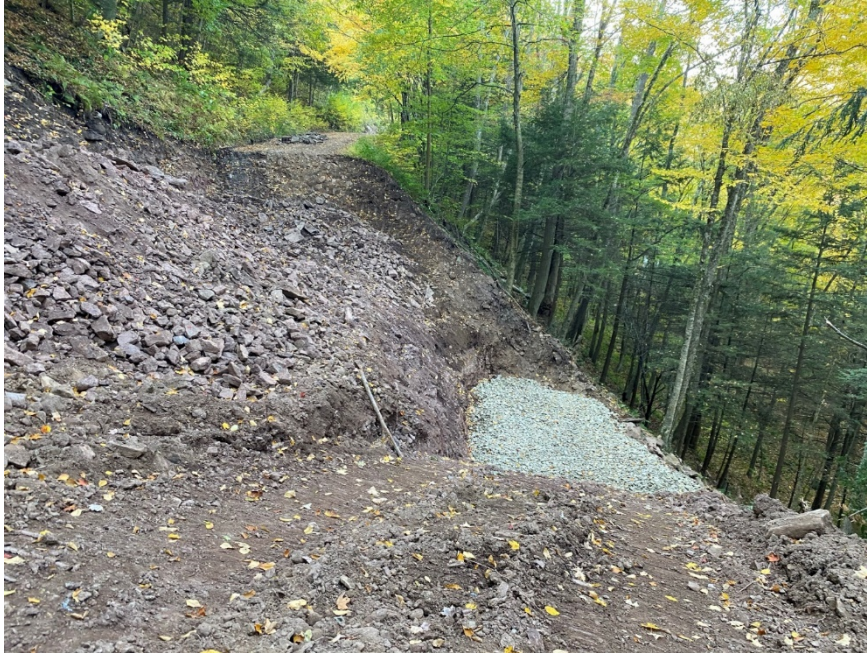
Image 1: Footprint of rockery wall with placed AASHTO No. 8 coarse aggregate at Site 1 at Worlds End State Park

Site 1 was remediated by the use of a rockery wall. The extent of excavation was more significant than at Site 2, as shown in the rockery's excavated footprint below (Image 1).

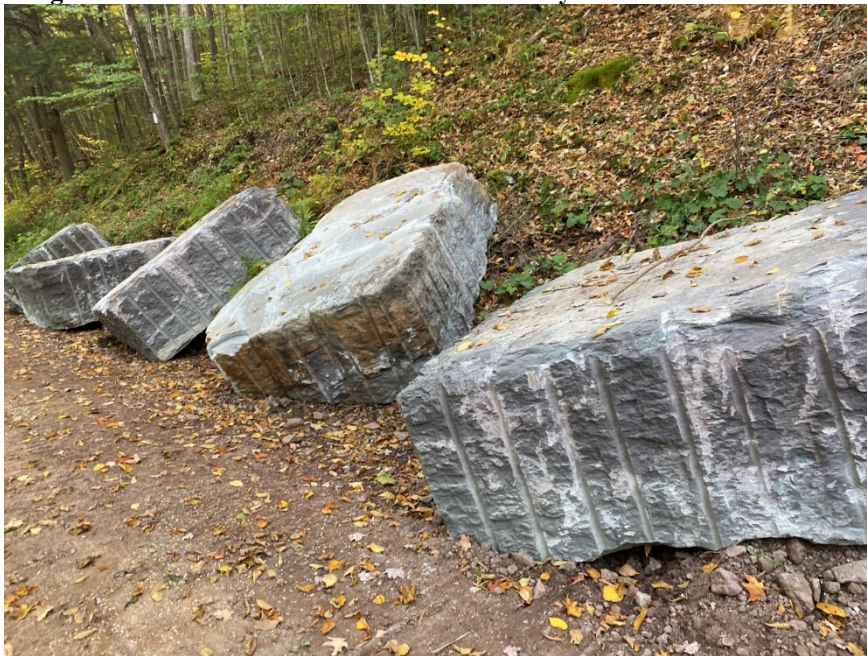
Image 2: Blocks utilized for base stone of rockery wall at Site 1 at Worlds End State Park

Additionally, the blocks' size in the rockery system requires an experienced contractor to maneuver and stack. The base blocks, before placement, are shown in Image 2.

These rocks were approximately 6.0' by 4.0' by 8.0', with the longest section running into the slope. Two layers of these larger stones were placed as base-bearing stones. After the base stones, 2.0' by 3.0' by 8.0' stones were stacked until the required height was reached, tapering the face at a 4.0(V):1.0(H) slope. A drainage pipe was chinked into the wall near the top to manage roadway drainage. The final build is shown from the top of the roadway in Image 3, and from just below the wall in Image 4.

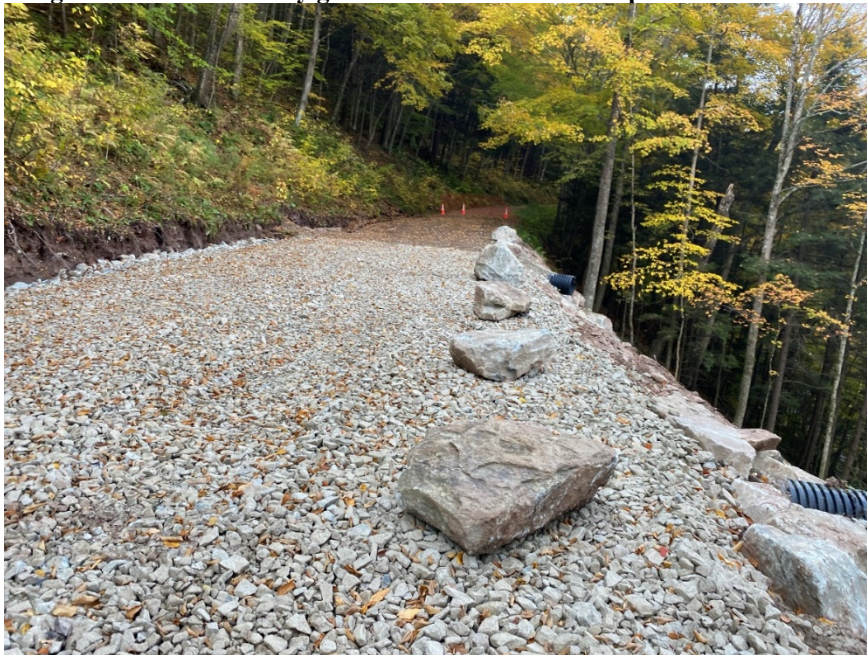
Image 5: View of roadway grade above remediated slope at Site 2 at Worlds End State Park

Site 2 was remediated by utilizing clean aggregate benched into the slope at a 1.5(H):1.0(V) slope. Due to this methodology's nature, the entirety of the slope had to be remediated. As water was likely the main instigator of the original landslides at this location, drainage systems were implemented as well. The drainage tubes can be viewed from the top of the slope, as shown in Images 5 and 6.

The extent of clearing and remediation is also shown in Images 5 and 6 and in Image 7, taken from the bottom of the slope.

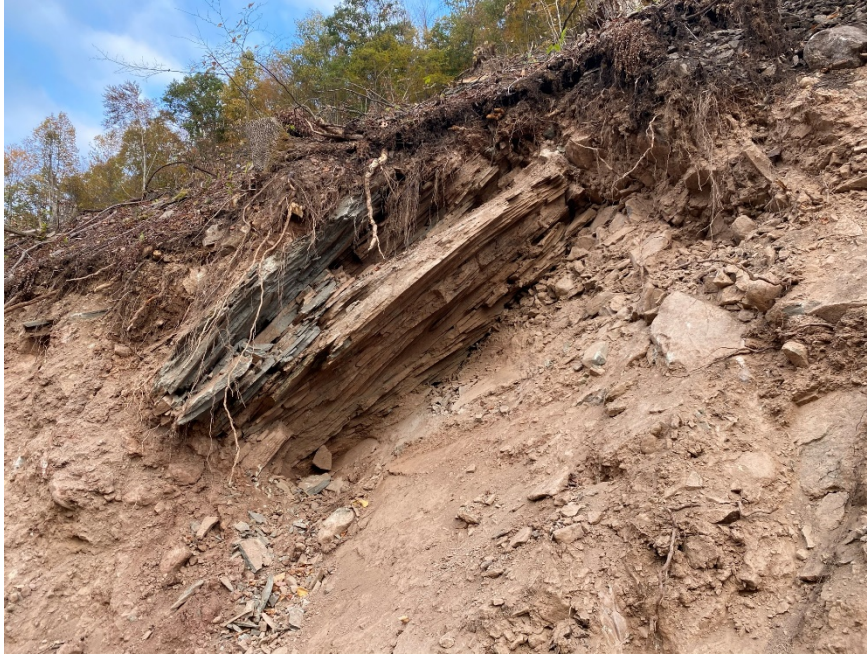
Image 8: View of steeply dipping interbedded sandstone and siltstone at the base of a proposed steep slope at Loyalsock State Forest

at a minimum of every 100' along the steep slope areas to verify rock dip, dip direction, and general quality was sufficient to utilize the steep cut. These exposed areas are shown in Image 8, Image 9, Image 10, and Image 11.

To maintain the stability of the rock cuts, blasting was not permitted. All slopes were excavated with typical construction methods, the most common being ripping with excavator teeth. Bedrock of sufficient quality was encountered in all areas where steep slopes were anticipated, and soil benching with geosynthetics was not required.
