Local calibration of the MEPDG prediction models for pavement rehabilitation and evaluation of top-down cracking for Oregon Roadways

A dissertation submitted to the graduate faculty
in partial fulfillment of the requirements for the degree of
DOCTOR OF PHILOSOPHY

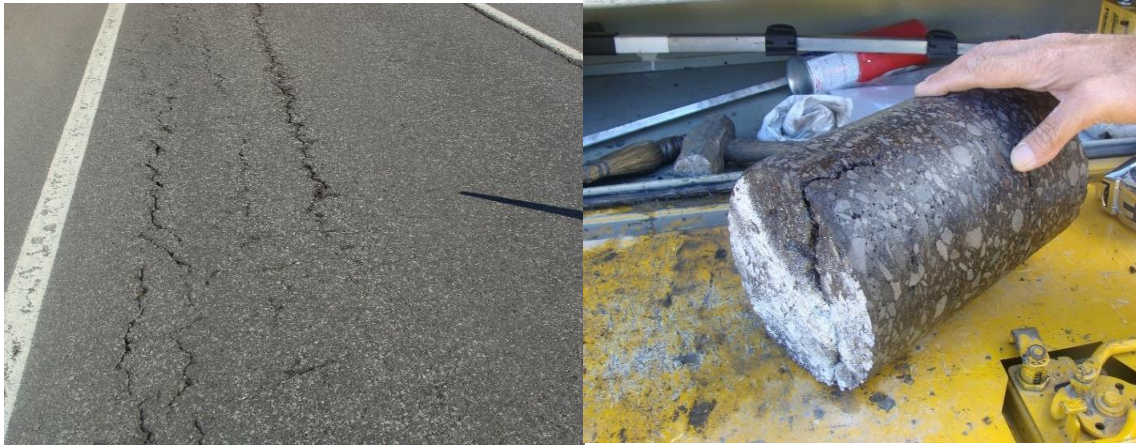
Figure 1-1 Pictures showing the development of top-down cracking

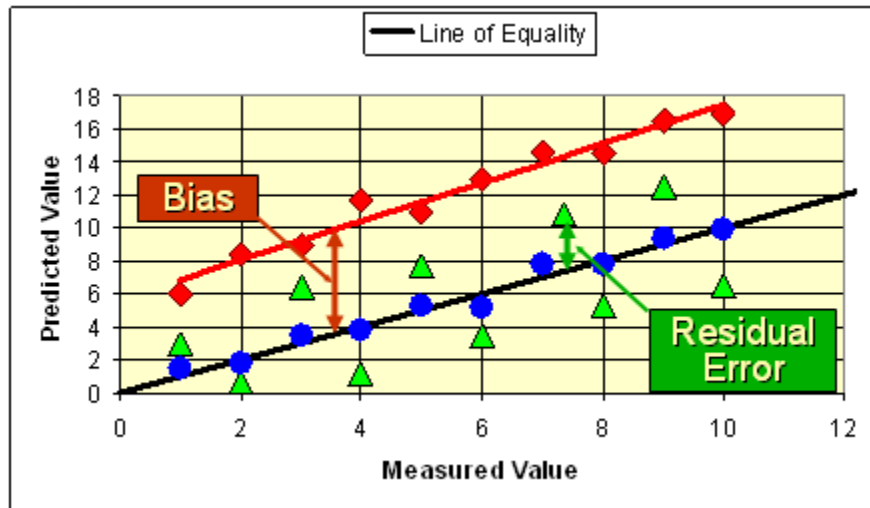
Figure 2-1 The bias and the residual error (Von Quintus 2008a)

using the bias (defined as average over or under prediction) and the residual error (defined as the predicted minus observed distress) as illustrated in Figure 2-1. If there is a significant bias and residual error, it is recommended to calibrate the models to local conditions leading to the second step.

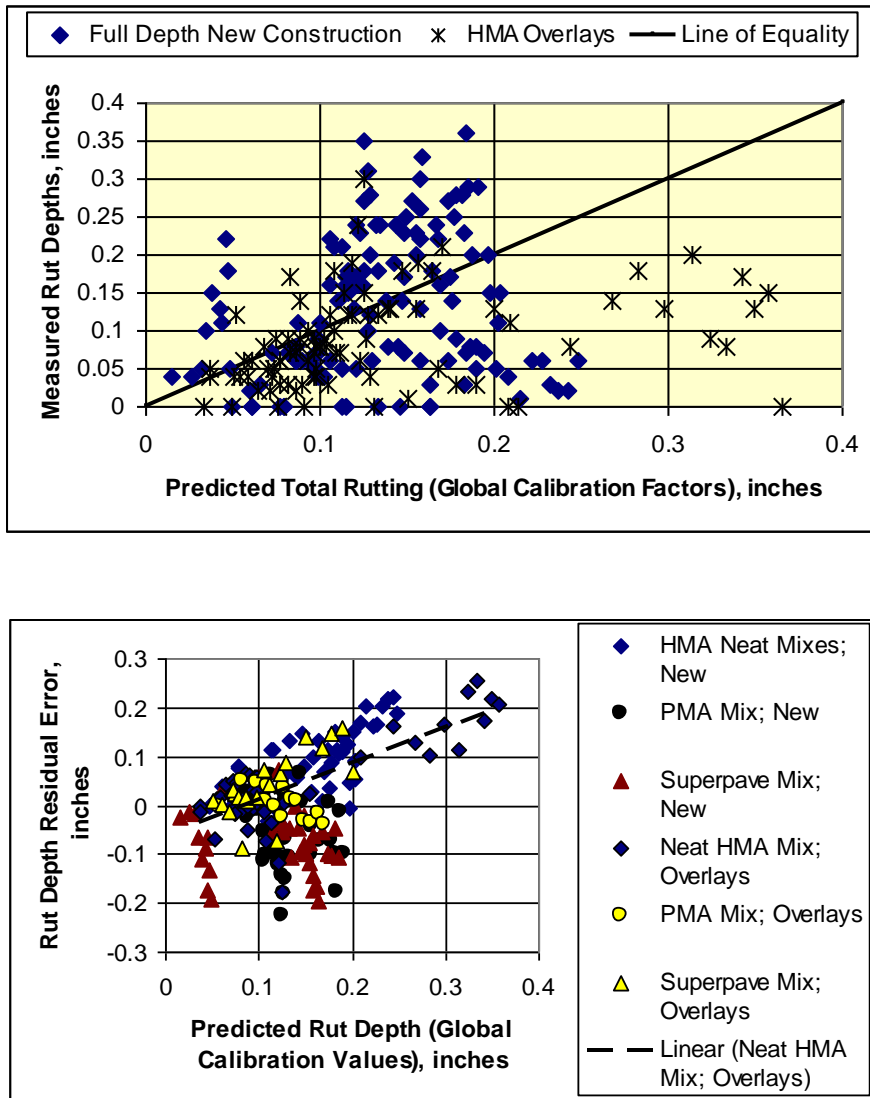
Figure 2-5 Comparison of predicted and measured rut depths using the global calibration in KSDOT study (NCHRP, 2009)

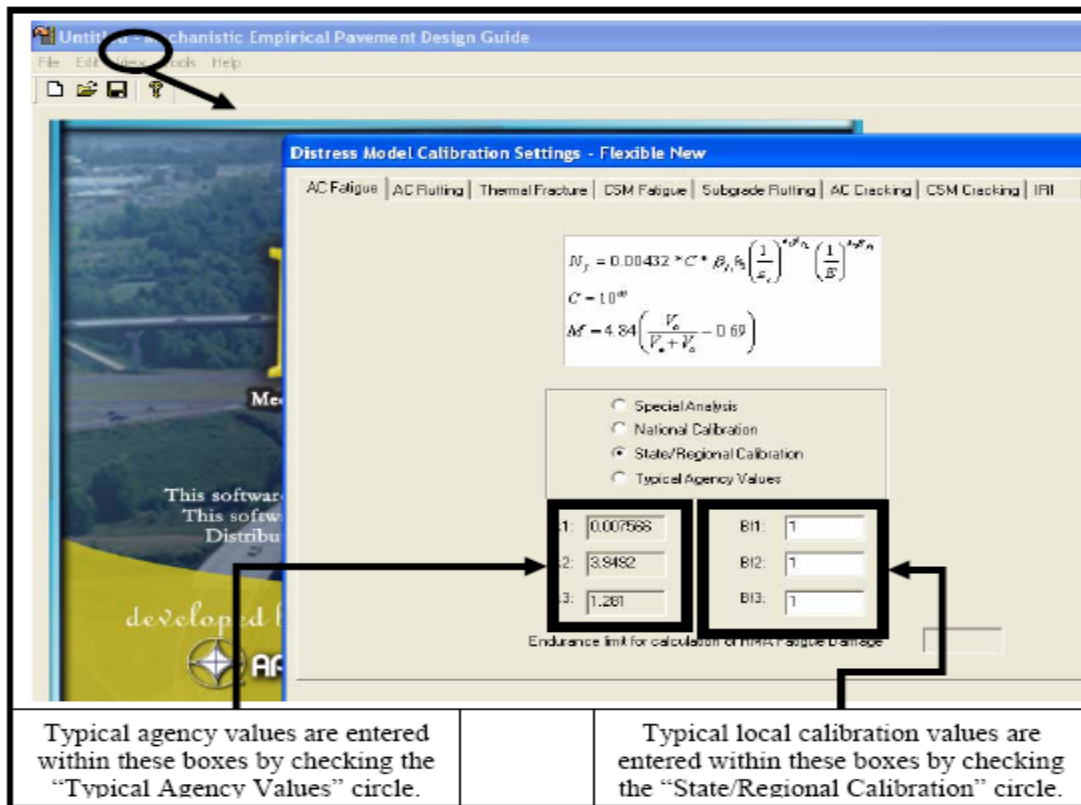
Figure 2-7 Screen shot of the MEPDG software for the local calibration and agency specific values (Von Quintus, 2008b)

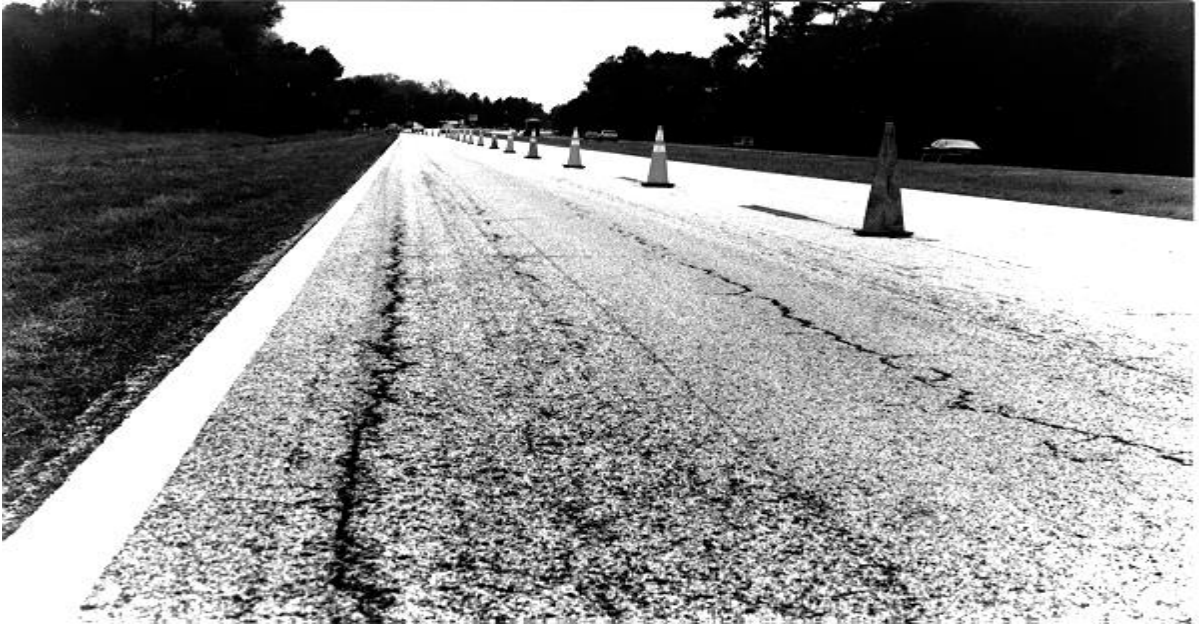
Figure 2-10 Lane exhibiting surface initiated top-down cracking in both wheelpaths (Myers et al., 2000)

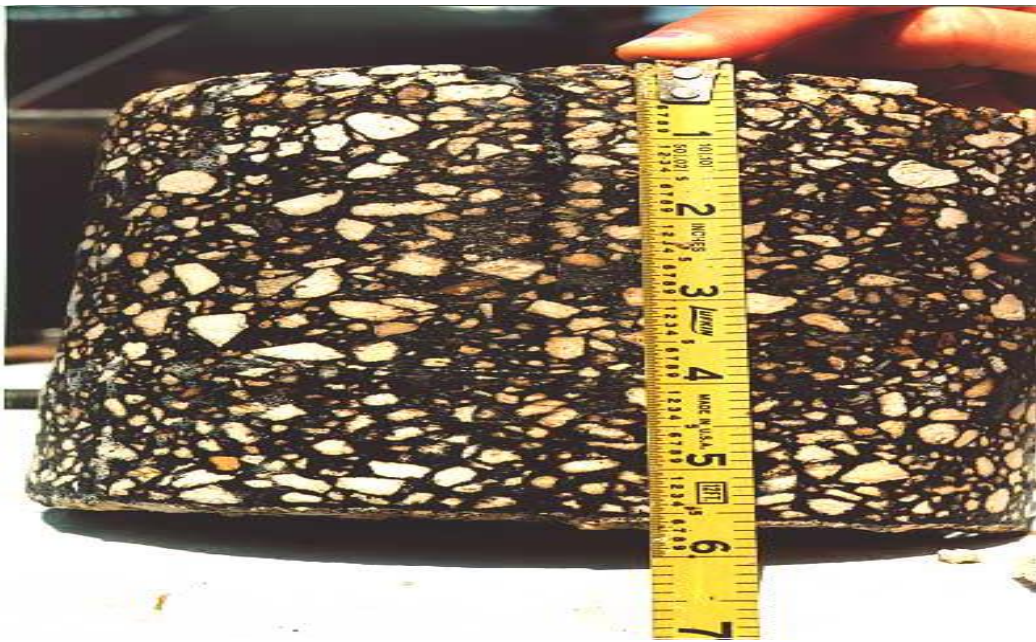
Figure 2-11 Core extracted from wheelpath shows top-down cracking (Myers et al., 2000)

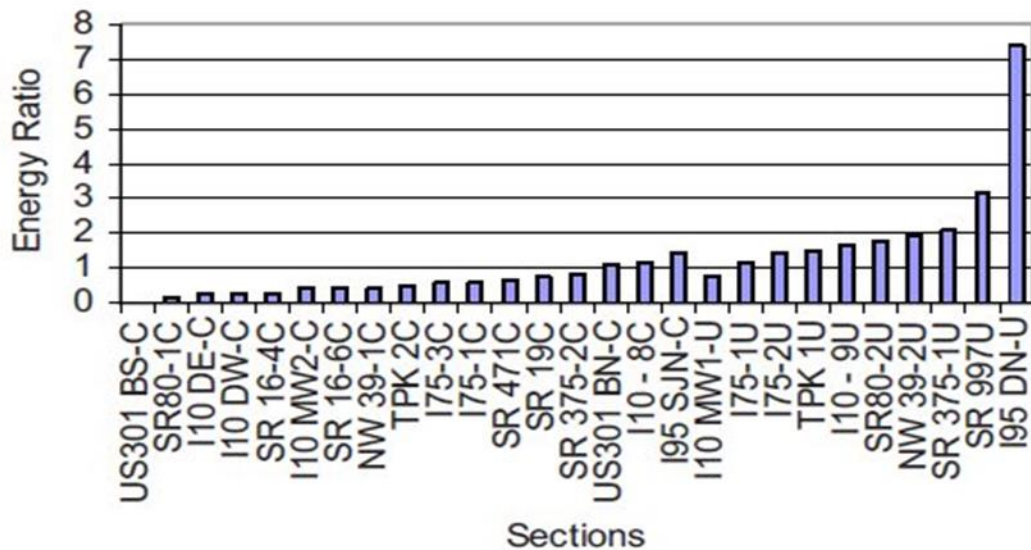
Figure 2-15 Energy ratio for 27 field test sections in Florida (Kim et al., 2009)

Energy ratio is used to evaluate the asphalt mixture's resistance to cracking. Roque et al. (2006) performed an extensive study on 27 pavement sections collected from cracked and uncracked sections throughout the state of Florida to evaluate the top down cracking in flexible pavements, as shown in Figure 2-15.

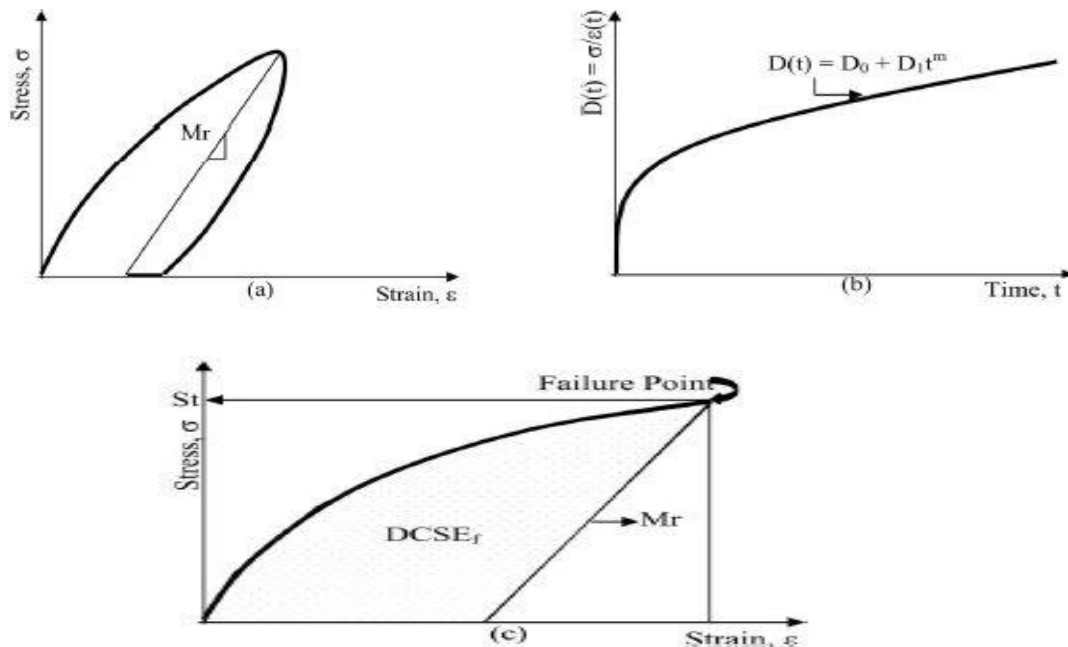
Figure 2-16 Description of parameters obtained from (a) resilient modulus, (b) creep compliance, and (c) strength tests (Kim et al., 2009)

Where $DCSE_f$ is dissipated creep strain energy at failure, σ is the tensile stress obtained at the bottom of the asphalt layer using elastic layer analysis, m and D_1 are power function parameters. The parameters required for the top down cracking model can be obtained from resilient modulus, creep compliance and tensile strength tests. The resilient modulus, M_r is determined from the stress-strain curve obtained in resilient modulus test. The power function parameters are obtained by fitting the creep compliance curve performed using a constant load control load. The tensile strength and dissipated creep strain energy at failure are determined from the stress-strain curve of a given mixture from the strength test. Figure 2-16 shows the description of parameters determined for top down cracking model.

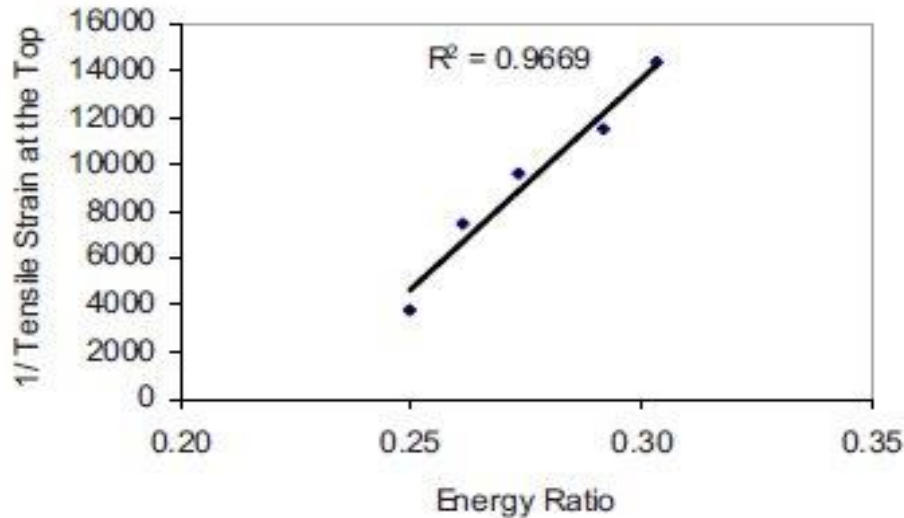
Figure 2-17 Inverse tensile strain at top of the asphalt layer versus energy ratio
(Kim et al., 2009)

Kim et al. (2009) found that tensile strain obtained at the top is inversely related to energy ratio, if the identified tensile strain at top is a primary cause of top down cracking. Figure 2-17 shows the linear relationship between energy ratio and inverse tensile strain at top at the 50-loading cycle. The study indicated that the tensile strain at the top of asphalt layer is a primary factor affecting the top down cracking performance.

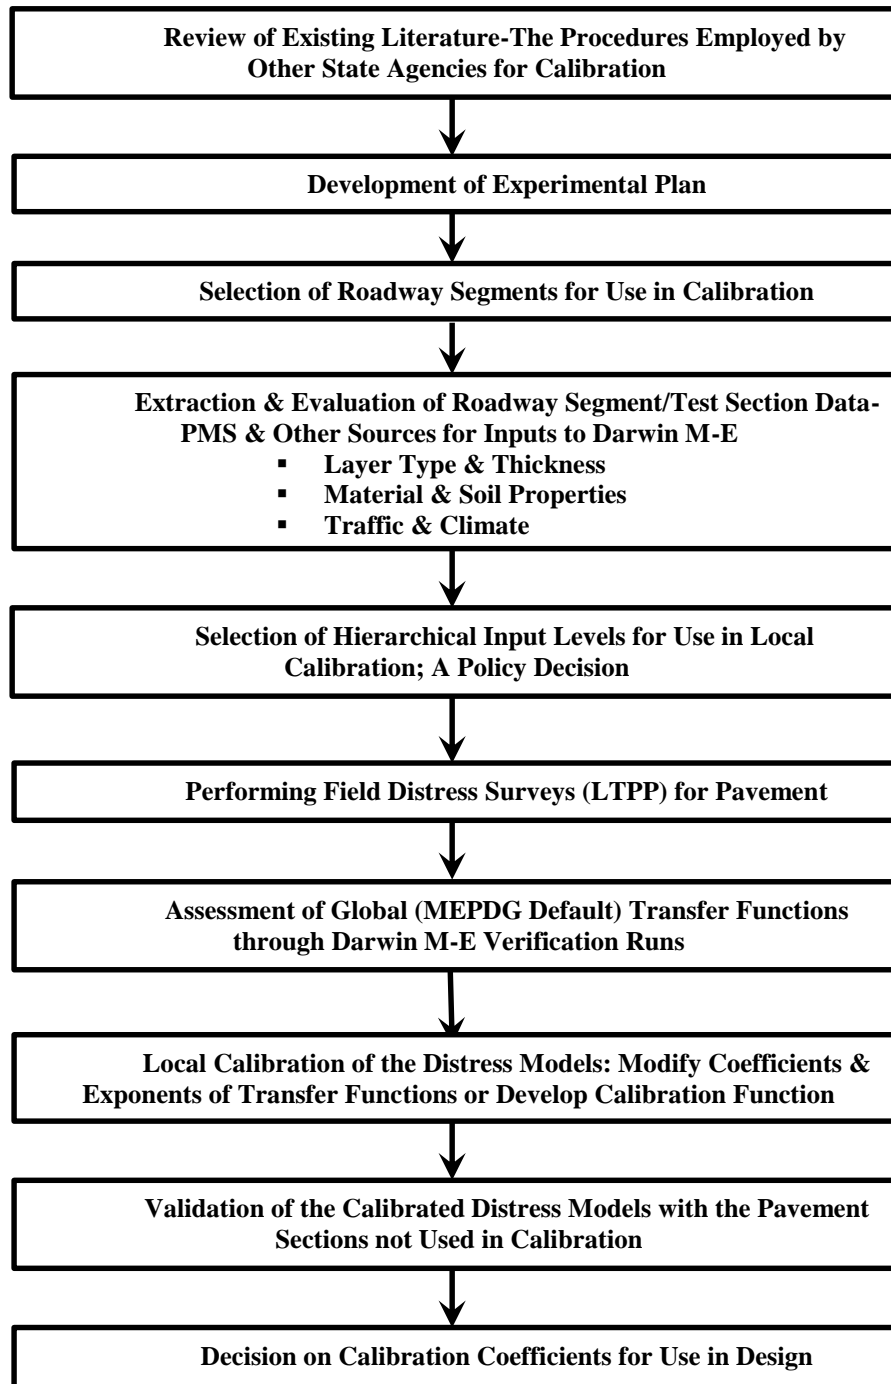
Figure 4-1 Flow chart for the procedure and steps employed for local calibration

The research plan developed for calibrating the MEPDG generally followed the flow chart recommended by Von Quintus et al. (2009). The general procedures and steps employed for calibration of MEPDG as outlined in Figure 4-1 are summarized below.

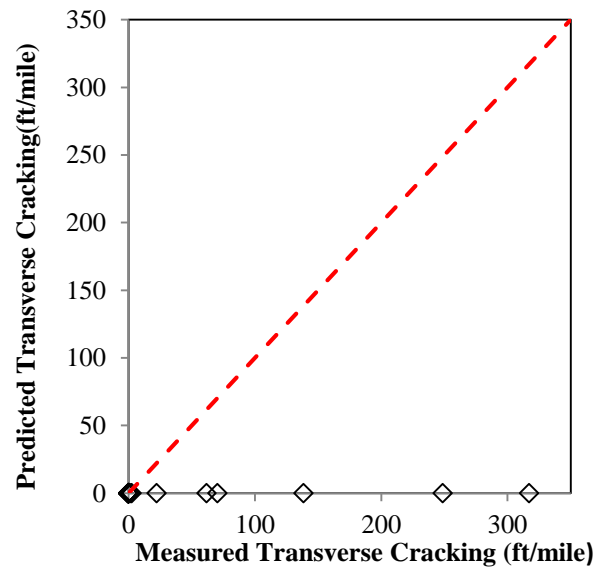
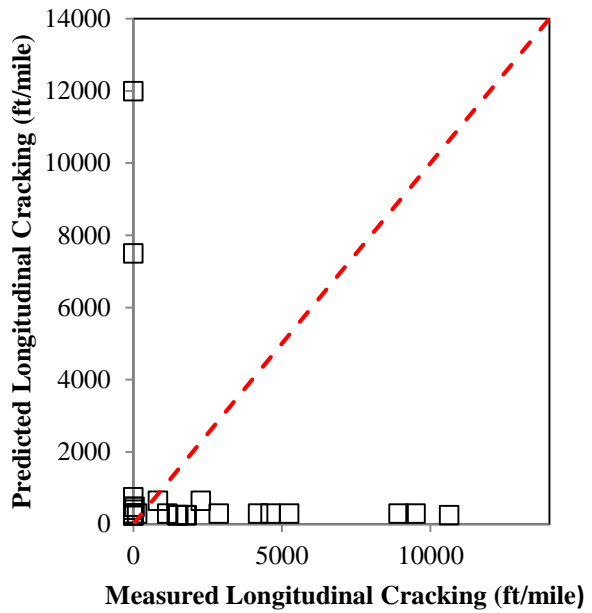
Figure 4-3 Comparison between predicted and measured distresses with Darwin M-E default coefficients: (a) total rutting, (b) transverse cracking, (c) alligator Cracking, and (d) longitudinal cracking.

The Coastal and Valley regions of Oregon do not experience low-temperature thermal cracking (transverse cracking). But, the Eastern region displays a considerable amount of thermal cracking. It is shown in Figure 4-3 (b) that Darwin M-E predicted no thermal cracking even in the Eastern region. While Darwin M-E predicted no alligator cracking (Figure 4-3 (c)) for all the sections considered, a high variability between predicted and measured longitudinal cracking was observed, as shown in Figure 4-3 (d).

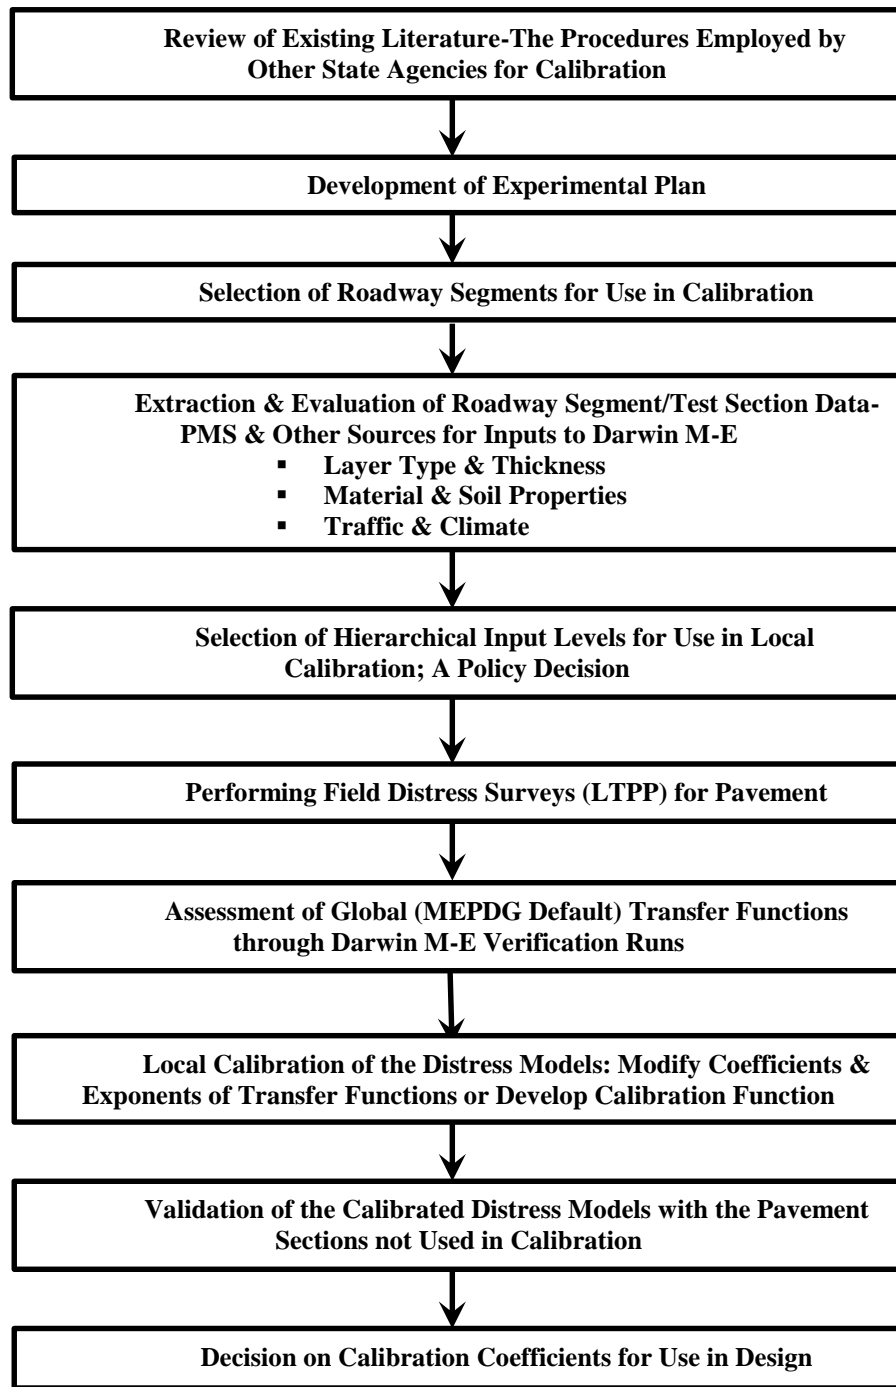
Figure 5-1 Flow chart for the procedure and steps employed for local calibration

The research plan developed for calibrating the MEPDG generally followed the flow chart recommended by Von Quintus et al. (2009). The general procedures and steps employed for calibration of MEPDG as outlined in Figure 5-1 are summarized below.

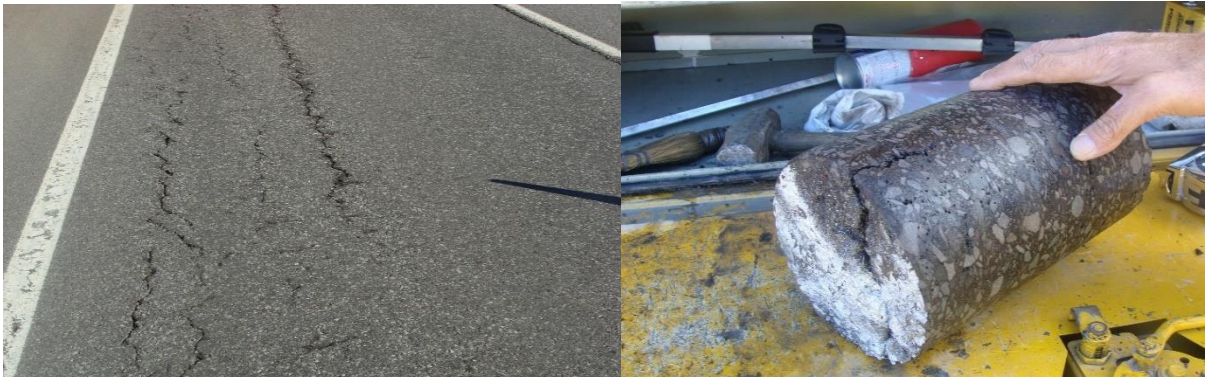
Figure 6-1 Photos showing the development of top-down cracking
