# Mapping the Gap of Water and Erosion Control Measures in the Rapidly Urbanizing Mbezi River Catchment of Dar es Salaam

Mhina Given Justin <sup>1,\*</sup>, Jensen Marina Bergen <sup>2</sup>

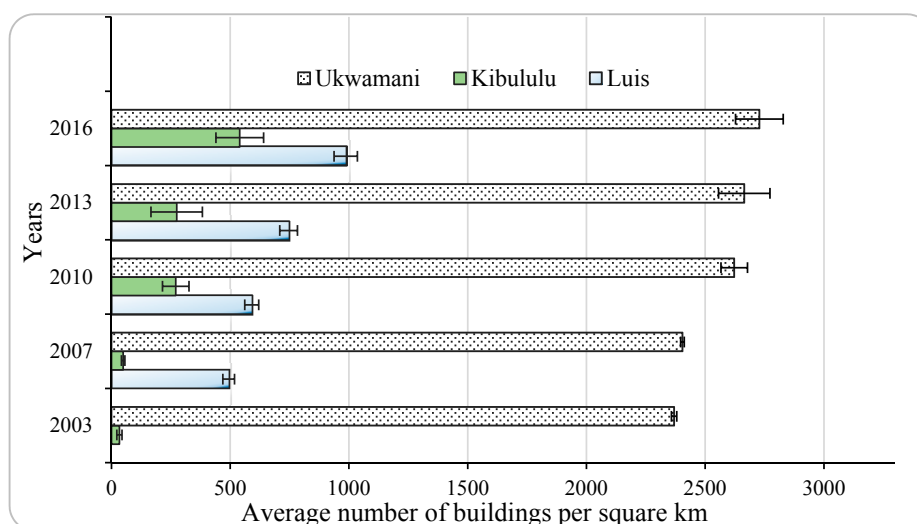
Figure 3 presents the rate of urbanization in the three sub-case areas from 2003 to 2016, based on analysis of Google Earth historical images. In recent years, there has been no significant development in the downstream part of the catchment (Ukwamani), reflecting this area being fully built, while urbanization has occurred at an increasingly rapid rate in the two sub-case areas further upstream in the catchment where space is still available. The Luis area showed the most rapid rate of urbanization, with 124 new building per year in the period 2013 to 2016. Currently, there is a large urbanization difference in terms of building density between the sub-case areas in the upstream and those downstream, ranging from a maximum of 980 to 2780 buildings per km<sup>2</sup>, respectively (Figure 3). To further visualize the rates of urbanization, Figure 4 presents pairs of historical satellite images taken from selected parts of each sub-case area, each covering an area of 0.35 km by 0.6 km. It can be seen that, in the upstream catchments of Luis and Kibululu, the vegetation cover seemed to be gone already in 2003, even though the number of buildings was much lower than in 2016. Regarding the downstream part, represented by Ukwamani, the level of urbanization appears to be about the same in 2003 as in 2016. The average plot sizes appeared to be relatively larger in Luis and Kibululu compared to that of Ukwamani. From the trends presented in Figure 3, the area of the surface sealing (in terms of roof footprints) in the overall catchment rose by 41%, from 8.62 km<sup>2</sup> in 2003 to 12.15 km<sup>2</sup>, in 2016.

**Figure 3.** Bar graph comparing number of buildings per km<sup>2</sup> in sub-case areas for the past 13 years. The whiskers indicate the standard deviation of three individual samples from the mean value. No image was available for Luis 2003.

The results reveal an unfortunate matchup between catchment urbanization (Figures 3 and 4) and the evolution of stormwater related problems (Figure 2), indicating the need for change in management of the Mbezi River catchment area. If new stormwater management schemes are not adopted, it is likely that many of the assets in the already built-up areas will eventually be lost, since erosion gullies will multiply, and flooding events will become both more frequent and more intense. In addition, the freshwater supply is critical, as expressed by the many stormwater harvesting measures (Table 2). With rivers running dry and water being polluted by wastewater discharge and solid waste dumping (Figure 2), the residents are experiencing back-to-back problems with flood and erosion risks in the wet season and water scarcity in the dry season. Referring to studies done in other parts of the world, such problems require informed water resources planning and catchment-based urban stormwater management [43,44]. The goal of this study was to establish an empirical basis for implementing such new practices.

Despite uncertainties in the method, analysis of historical satellite images returned approximate urbanization rates (Figures 3 and 4) that can be used to guide both solution strategies and to prioritize where to invest resources. Both the urbanization rates and urbanization hotspots can be revealed,

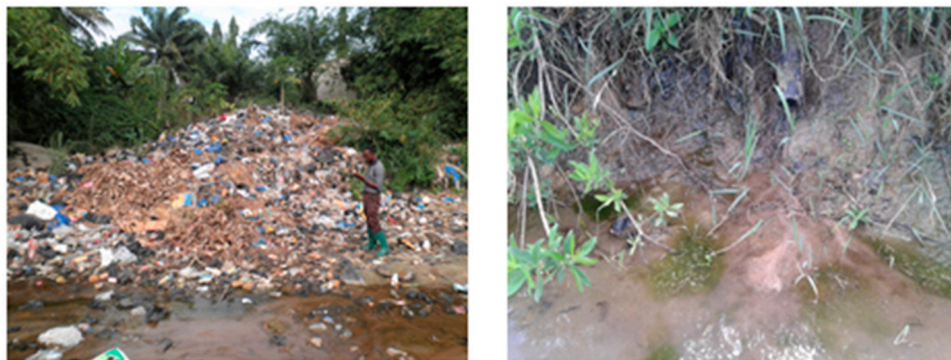
Field observations revealed a number of direct discharges of polluted water as well as piles of solid waste blocking many natural drainage routes, as illustrated in Figure 5. Further, some drainage routes were levelled out for building projects (data not shown). Concerning erosion, this was especially widespread in the middle catchment area. In all cases, erosion was caused by runoff creating deeper and wider gullies as routes merged on their downstream routes. According to the questionnaire survey more than 45% of the respondents settled in riparian areas used the erosion gullies and eroded parts of the river for solid waste dumping, assuming it to be a solution to erosion problems on their land properties.

**Figure 5.** Solid and liquid waste dumping along Mbezi River. The photos were taken with permission on 24 June 2016.
