# Mitigation and Evaluation of Alkali-Silica Reaction (ASR) and Freezing and Thawing in Concrete Transportation Structures

A dissertation submitted in partial fulfillment  
of the requirements for the degree of  
Doctor of Philosophy in Engineering  
with a Concentration in Civil Engineering

August 2017  
University of Arkansas

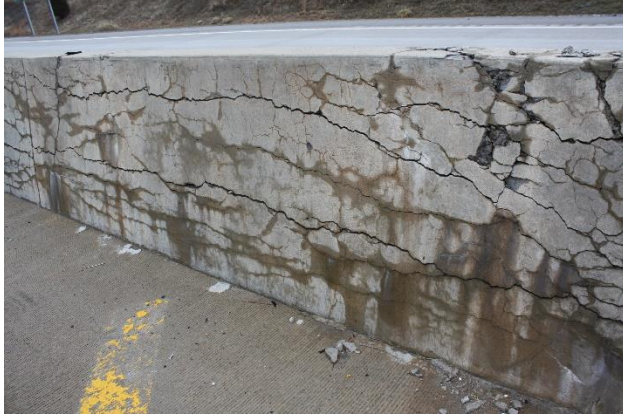
**Fig. 1.1-1**–Typical deterioration in concrete barriers due to F/T and ASR (by Richard Deschenes Jr.).

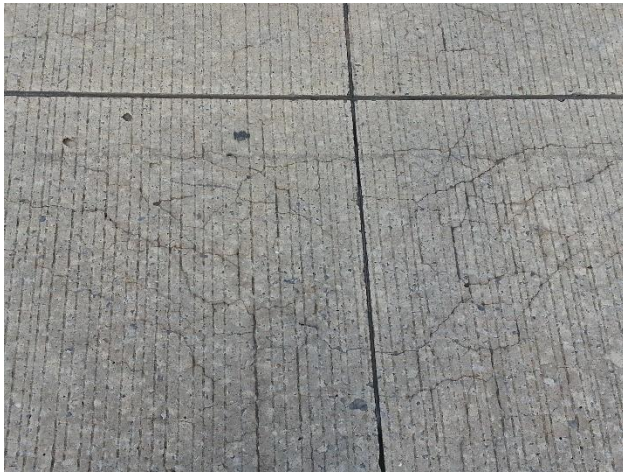
**Fig. 1.1-2**–Typical deterioration in concrete pavements due to F/T and ASR (by Richard Deschenes Jr.).

The cracks often appear at the exposed surfaces of concrete adjacent to joints. In air-entrained concrete pavements, the cracks curve along the joints at corners forming a typical D pattern known as D-cracking. An example of D-cracking is shown in **Fig. 1.1-2**.

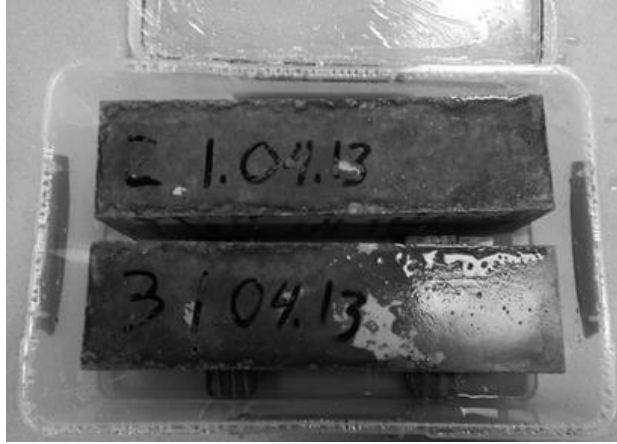
**Fig. 2.2-1**–Typical CPT containers (by Richard Deschenes Jr.).

One of the limitation of the CPT method is alkalis leached from the sample during testing. The standard containers limit the amount of water precipitated onto the surface of the prisms, reducing the transport of alkalis from the concrete. During the cooling period, moisture within the containers condenses and precipitates onto the surface of the prisms. The water then provided an avenue for alkalis to be leached from the concrete and into the water at the bottom of the containers. The smaller containers led to higher alkali leaching than typical for ASTM C1293 recommended CPT container. This caused lower expansion than observed when using the recommended container. A typical container, as shown in **Fig. 2.2-1**, contains two prisms. Six prisms were cast for each aggregate evaluated, and although the prisms were stored in separate containers, the expansion results were consistent between containers.

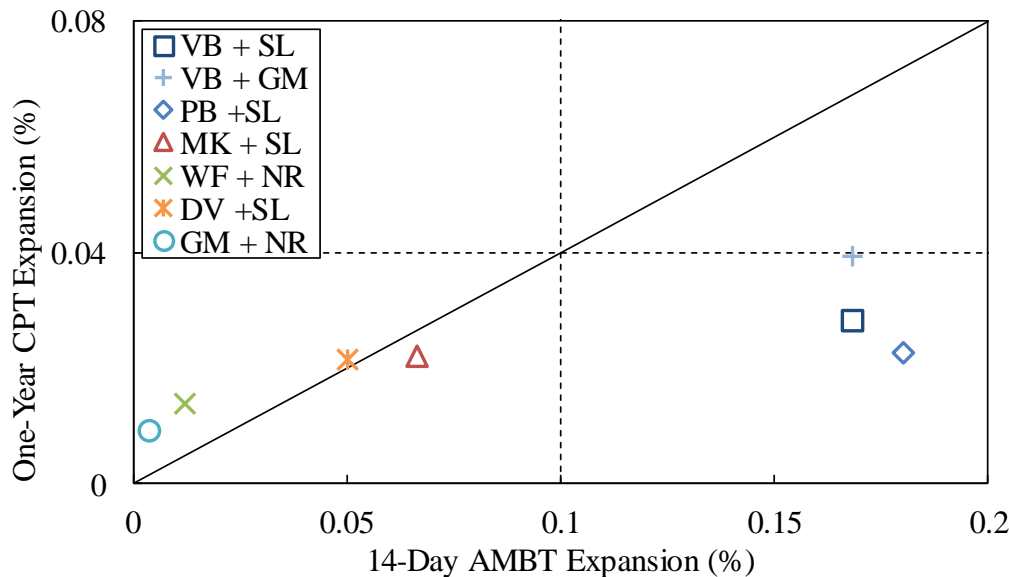
**Fig. 2.3-4**—Comparison of 14-day AMBT and one-year CPT results.

A comparison between the AMBT and CPT results is provided in **Fig. 2.3-4**, similarly to the manner presented in Fournier and Bérubé (2000). The six aggregates evaluated showed a majority of the local aggregates to be inert in both test methods. The VB and PB fine aggregates are potentially deleteriously reactive as indicated by ASTM C1260 results and petrographic analysis results for core samples from the wall containing the aggregate from the Arkansas River VB source. The VB and PB fine aggregates fall into the false negative category for the one-year CPT results, because they do not react deleteriously in CPT tests, while reacting deleteriously in AMBT tests.

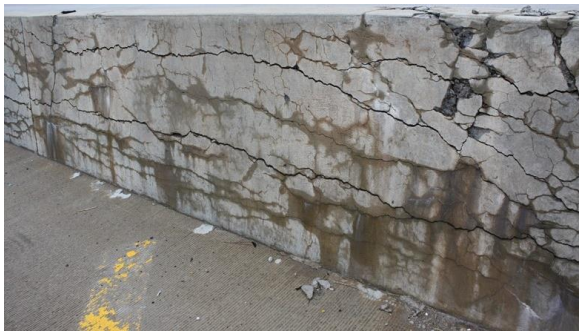
**Fig. 3.3-1**—Typical barrier section with severe damage (by Richard Deschenes Jr.).

Premature deterioration was noted in several sections of interstate median barrier in Northwest Arkansas during a 2012 inspection. A sample of concrete was sent for petrographic analysis and the presence of ASR and freezing and thawing damage was noted. The degree of damage varied considerably throughout the 4.4 mile (7.1 km) length of median barrier. Approximately 2.3 miles (3.7 km) of the median barrier showed minimal visible damage, 1.4 miles (2.3 km) had moderate damage, and 0.7 miles (1.1 km) showed severe damage (**Fig. 3.3-1**). An experimental program was initiated in January 2013 to evaluate methods for mitigating the ASR. Several surface treatments were evaluated to slow the progress of ASR and freezing and thawing, for sections of minimal, moderate, or severe damage.

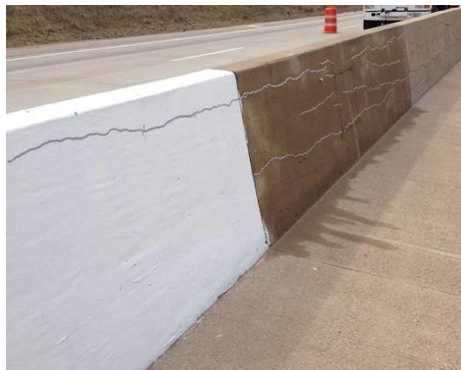
**Fig. 3.3-2**–Barrier sections treated with elastomeric paint (left) and silane (right) (by Richard Deschenes Jr.).

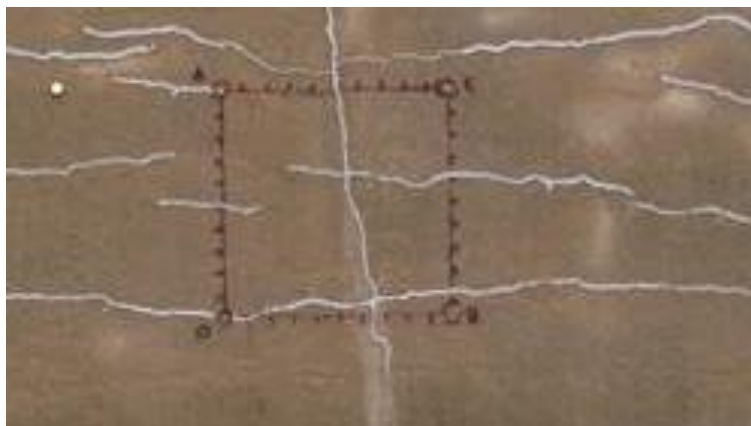
**Fig. 3.3-3**—Typical strain measurement grid on barrier section after treatment with silane (by Richard Deschenes Jr.).

A port was drilled alongside the strain measurement grid (**Fig. 3.3-3**) for inserting a portable humidity probe. The port was drilled to a depth of 6 in. (150 mm) with an inside diameter of 33/64 in. (13.1 mm). A 2 in. (50 mm) long, 1/2 in. (12.7 mm) nominal-diameter polyvinyl chloride (PVC) pipe was epoxied into this hole to allow the humidity probe to fit securely. The port was closed off between measurements using an airtight cap. Portable humidity probes were used for internal-RH and temperature measurements.

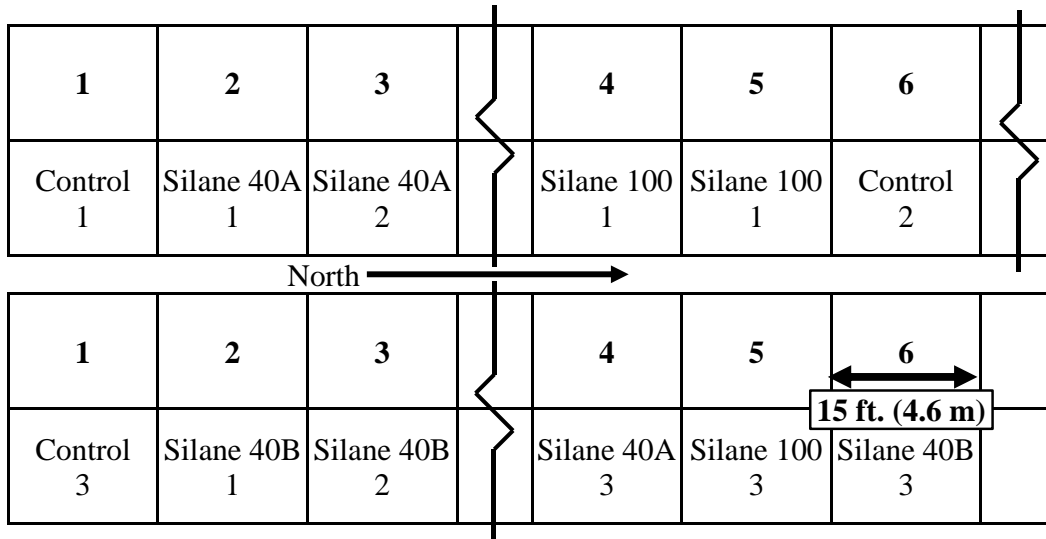
**Fig. 4.3-1** –Diagram of Interstate 49 test sections. Three commercially available silanes were applied to the indicated test panels, and three sections remained untreated as control samples.

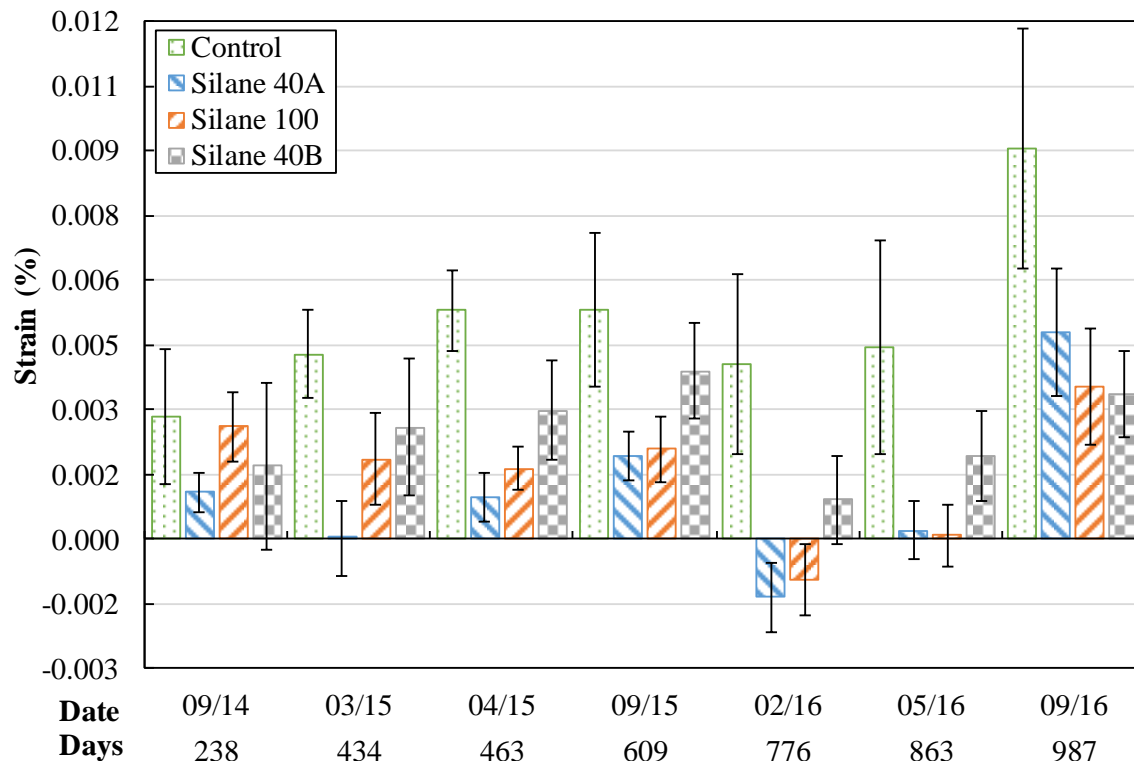
**Fig. 4.5-1**—Temperature-corrected strain (%) measured in the travel direction for control and silane-treated pavement panels. Error bars represent the 90% confidence of the mean.

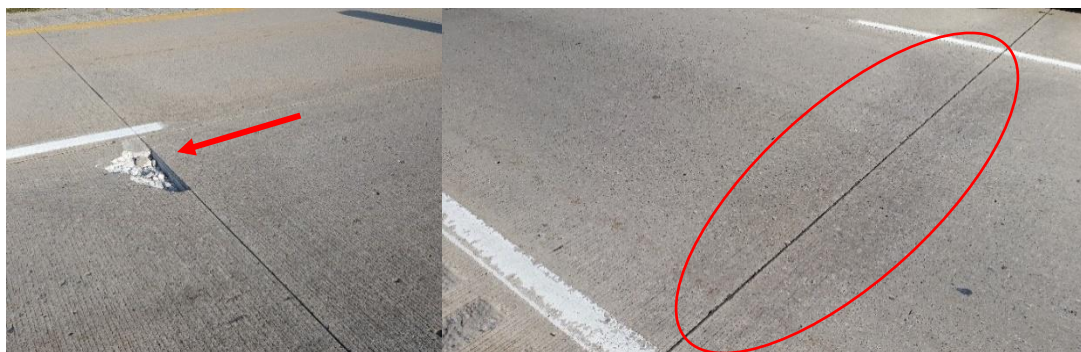
**Fig. 4.5-3**–Joint spalling (left) and discoloration (right) (by Richard A. Deschenes).

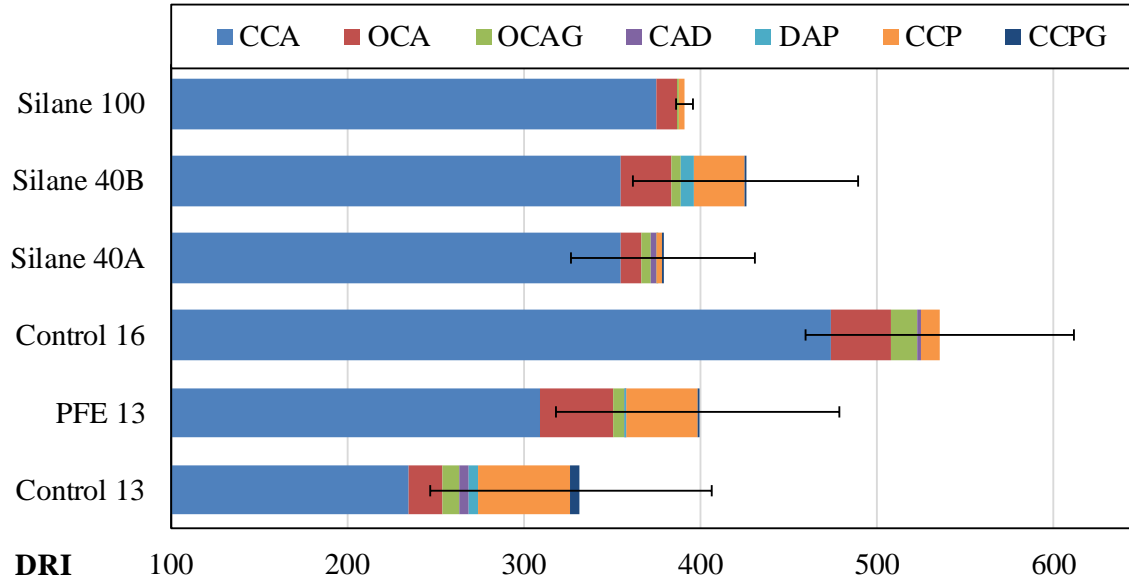
**Fig. 4.5-6**–DRI for core samples taken from pavement panels, error bars represent standard deviation, Interstate 49.

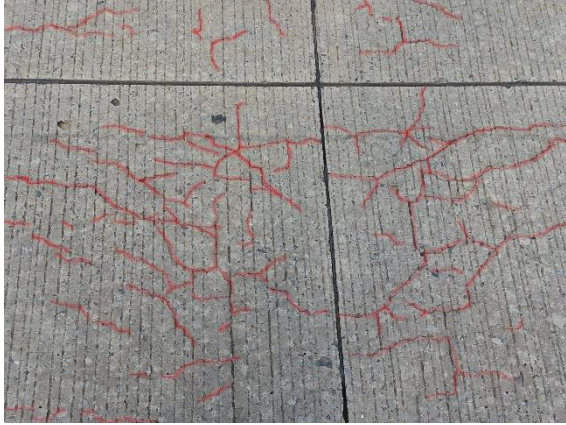
**Fig. 5.1-1-D-Cracking in concrete pavement, Interstate 49 (by Richard Deschenes Jr.).**
