Mitigation of Alkali-Silica Reaction (ASR) in an Interstate Median Barrier

A thesis submitted in partial fulfillment
of the requirements for the degree of
Master of Science in Civil Engineering

Richard Deschenes
University of Arkansas
Bachelor of Science in Civil Engineering, 2008

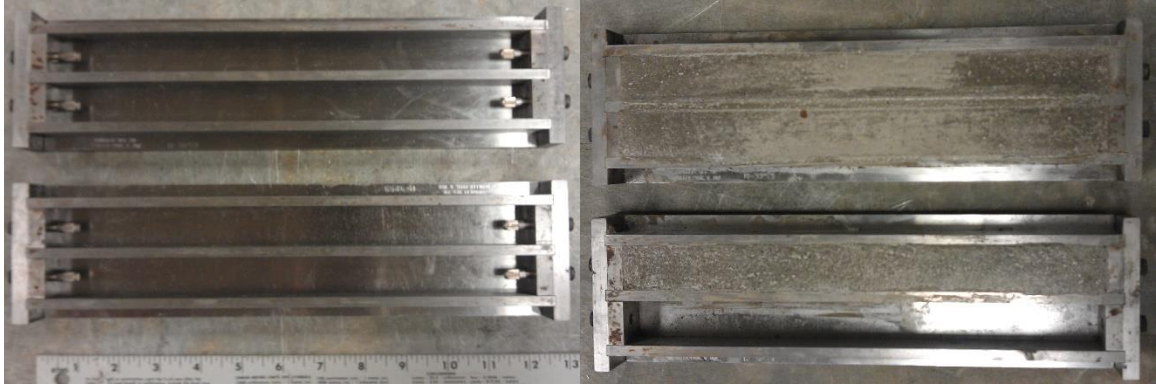
Figure 2.4. Mortar-Bar mold with gage studs (left) and mortar-bar mold with three mortar-bars (right). Picture used with permission from Richard Deschenes.

The standard batch produced enough mortar for three mortar-bars with standard dimensions of 25 x 25 x 285 mm (1 x 1 x 11.25 in). The mortar bars were cured for 24 hours in an environmental chamber with ambient temperature of 23 ± 2 degree Celsius and 95 percent relative humidity. The mortar-bar molds are displayed in Figure 2.4 (left), and typical cured mortar-bars are displayed in Figure 2.4 (right).

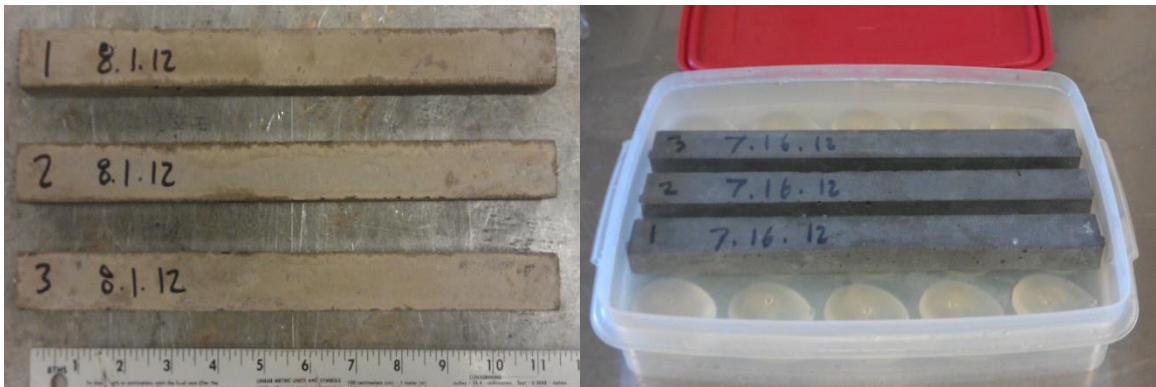
Figure 2.5. Mortar-bars (left) and mortar-bar in storage container (right). Picture used with permission from Richard Deschenes.

The mortar bars were removed from the molds after 24 hours of curing. The mortar-bars were then placed in 80 degrees Celsius water for 24 hours. A typical set of cured mortar bars are displayed in Figure 2.5 (left), and a typical set of mortar-bars in the storage containers are displayed in Figure 2.5 (right).

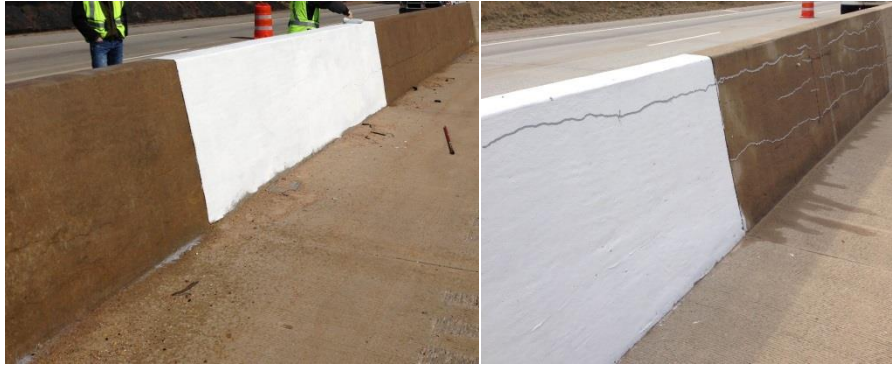
Figure 2.10. Application of surface treatment (left) and crack sealant (right). Pictures used with permission from Richard Deschenes.

single application of silane and then an additional application of silane six months later. A typical application of surface treatments is shown in Figure 2.10 (left). To ensure the correct application rate, the required amount of each respective treatment for a single section was measured and then applied to the section. The sections were allowed to dry for 24 hours, and then initial length-change and internal relative humidity were measured. Several of the moderately and severely damaged sections exhibited wide cracks (> 2 mm) which were sealed with silicon sealant to prevent excess moisture from entering the concrete. The silicon crack sealant is shown as applied in Figure 2.10 (right).

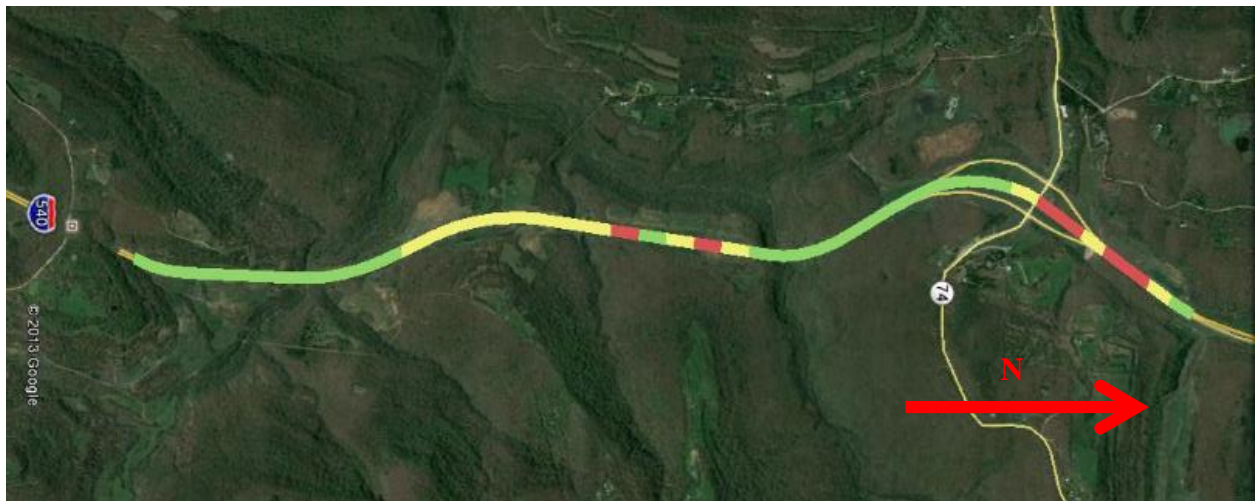
Figure 3.1. Median barrier damage level along Interstate 49. Figure produced in Google Earth.

Damaged Sections (Miles)			
Minimal	Moderate	Severe	Total
2.3	1.40	0.7	4.40

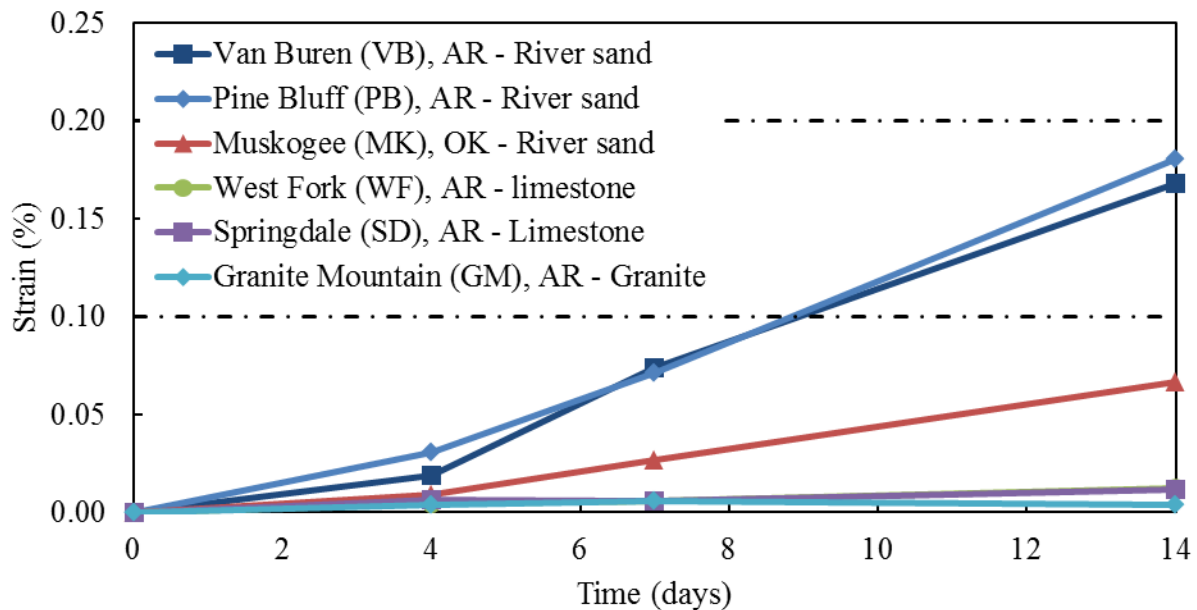
Figure 3.3. Strain (%) with respect to time (days) results for ASTM C1260 tests.

The AMBT was conducted in accordance with ASTM C1260. The aggregates evaluated were first crushed and then sieved to meet the specification. Three mortar bars were produced following the specified mortar mixture. The mortar bars were cured and stored in accordance with ASTM C1260. The mortar bars were periodically measured throughout the 16 day test duration and the strain recorded. For each aggregate evaluated, the strain was determined from the average strain of six mortar bars. The AMBT results are summarized in Figure 3.3 and discussed below. The strain is shown in percent and the time in days. Each aggregate tested is labeled with the city of origin and type of aggregate. The individual batch information is summarized in Appendix A1.1.

Van Buren (VB) –As apparent in Figure 3.3, mortar bars which contained river sand from Van Buren, Arkansas exhibited a large strain rate at the end of the 16 day test duration. As recommended in ASTM C1260 Appendix X1.1.3, an additional test with an extended duration of 28 days was performed on a sample of river sand from Van Buren (ASTM 2008a). As shown in Figure 3.5, the 28 day expansion for mortar bars which contained river sand from Van Buren was 0.25 percent. Therefore, the aggregate is classified as ‘deleteriously reactive’ in accordance with ASTM C1260 Appendix X1.1.2 (ASTM 2008a).

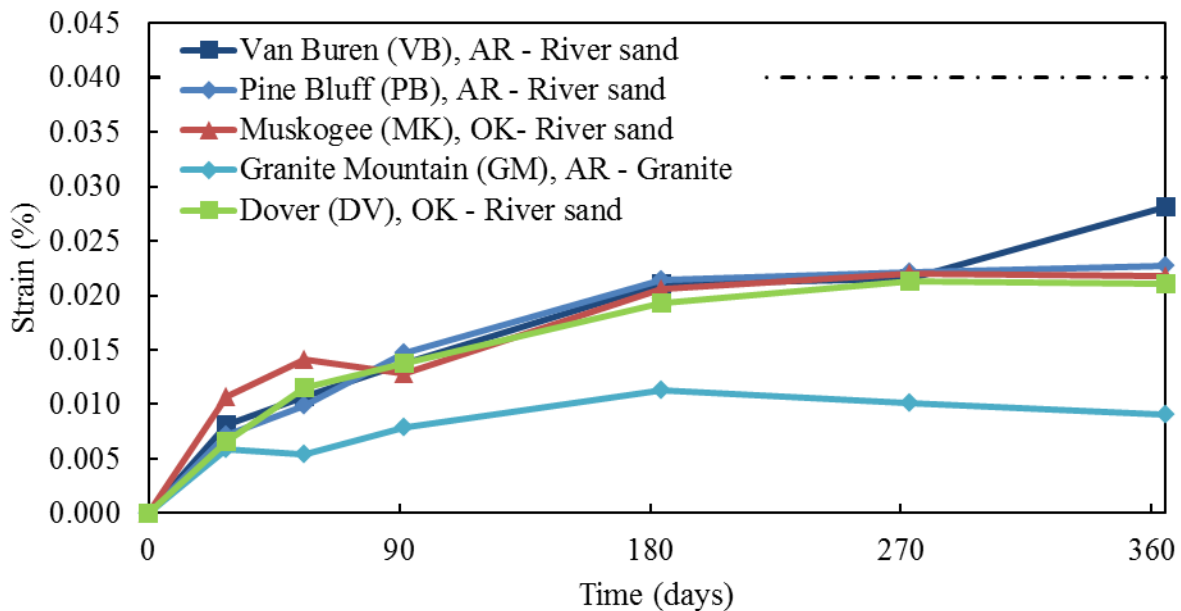
Figure 3.4. Strain (%) with respect to time (days) results for ASTM C1293 tests.

Van Buren (VB) - The one year strain for prisms which contain river sand from Van Buren, Arkansas was 0.028 percent. As specified in ASTM C1293, a one year strain greater than 0.04 percent indicates ‘deleteriously expansive aggregates.’ The aggregate was therefore classified as ‘inert’, which contradicts the results of ASTM C1260 test. However, petrographic examination of concrete from the median barrier determined that river sand from Van Buren, Arkansas was the source of ASR. As stated earlier, the CPT is an accurate test method, which rarely provides invalid results. The strain results of the tests conducted on Van Buren river sand was lower than expected due to alkali leaching during storage of the prisms. Due to limited space, the prisms were not stored in the method recommended by ASTM C1293. Therefore, alkalis were leached from the prisms and expansion was reduced.

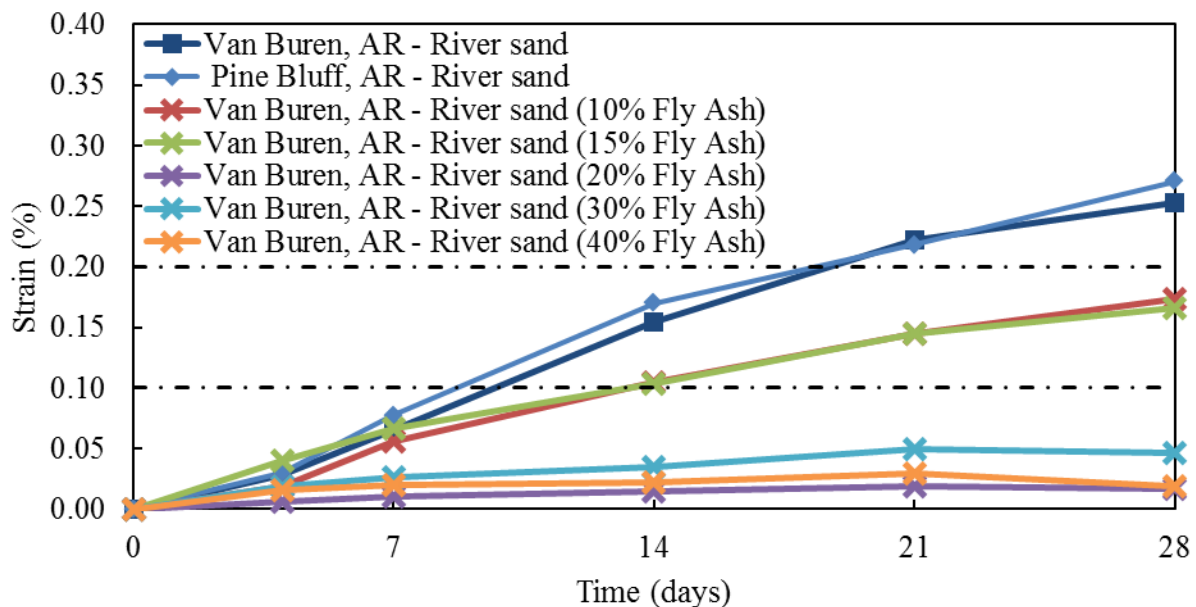
Figure 3.5. Strain (%) with respect to time (days) results for ASTM C1567 tests.

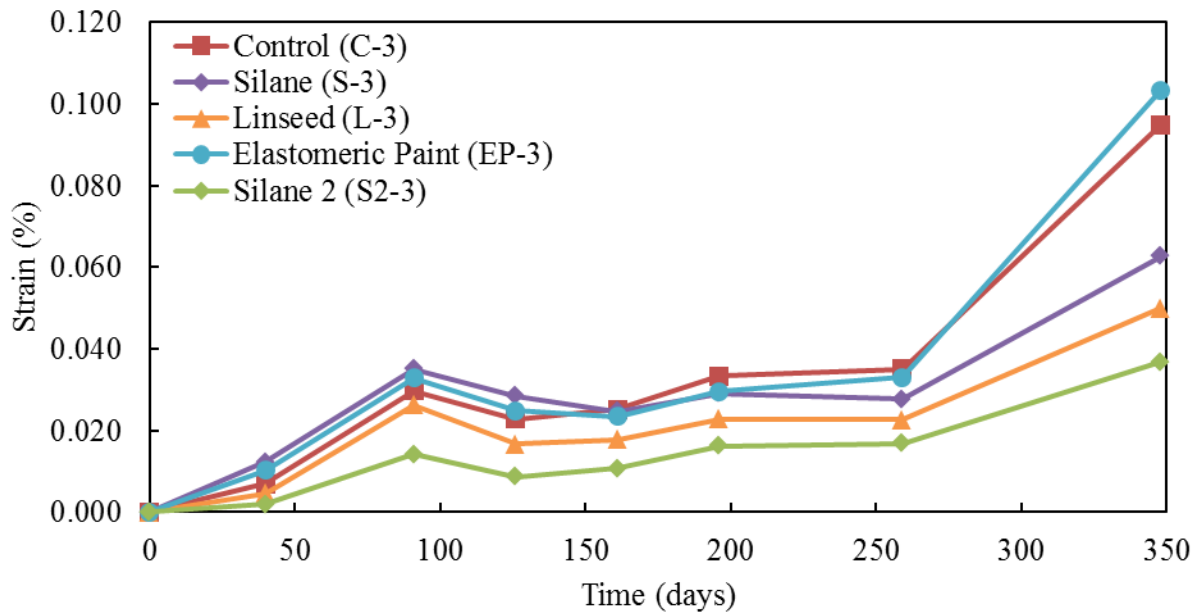
Figure 3.10. Temperature normalized vertical strain (%) with respect to time (days) results for median barrier sections which exhibit severe damage.

section S2-3 continued to exhibit less strain than the other treated sections. The final strain in section S2-2 was 0.037 percent. Section S-3 exhibited greater strain than that of section C-3 between 0 and 161 days and then the strain decreased below that of section C-3 until one-year. The strain in section EP-3 closely followed that of section C-3 throughout one-year. Section EP-3 had greater strain than section C-3, and had the largest increase in strain between 259 days and one-year. The cracks in the sections of severe damage were too wide for elastomeric paint to bridge, and the silicon crack sealer used to fill the large cracks did not provide adequate moisture protection.

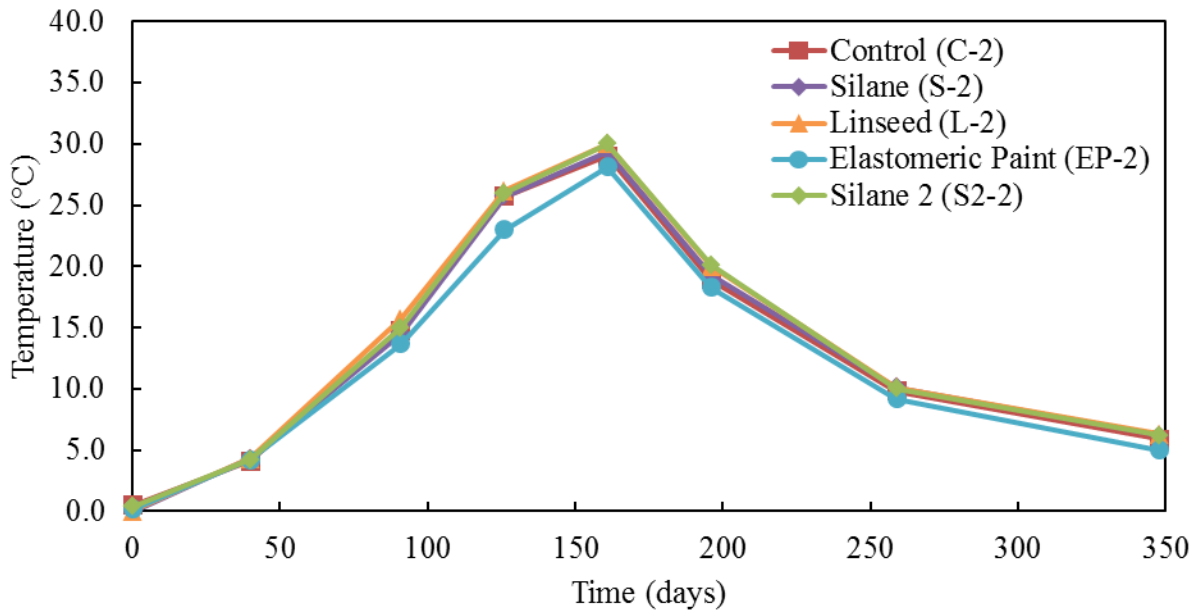
Figure 3.15. Internal temperature (°C) with respect to time (days) results for median barrier sections which exhibit moderate damage.
