Nondestructive evaluation of a carbon fiber wing spar using air-coupled ultrasound

A thesis submitted to the graduate faculty
in partial fulfillment of the requirements for the degree of
MASTER OF SCIENCE

Major: Aerospace Engineering

Iowa State University

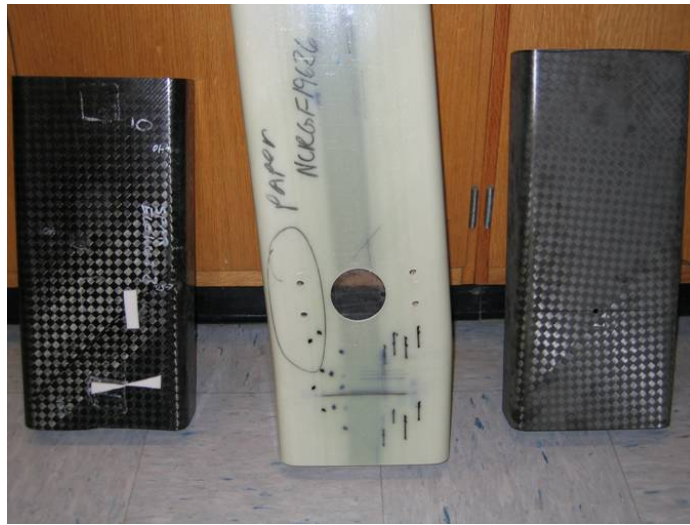
Figure 2.1 The three spar samples used for examination. They are from left to right the CS1, GS1, and CS2.

The three main spar samples used for testing were supplied by Cirrus Design Corp. and can be seen in Fig. 2.1. These test articles were prepared by Cirrus to represent the nominal geometry of the actual spar only. The glass fiber spar (GS1) was supplied to CNDE during the exploratory study in May, 2005. The first carbon spar (CS1) was provided at the kick-off meeting on December 20, 2005. The second carbon spar (CS2) was provided undamaged to CNDE at the end of July, 2006.

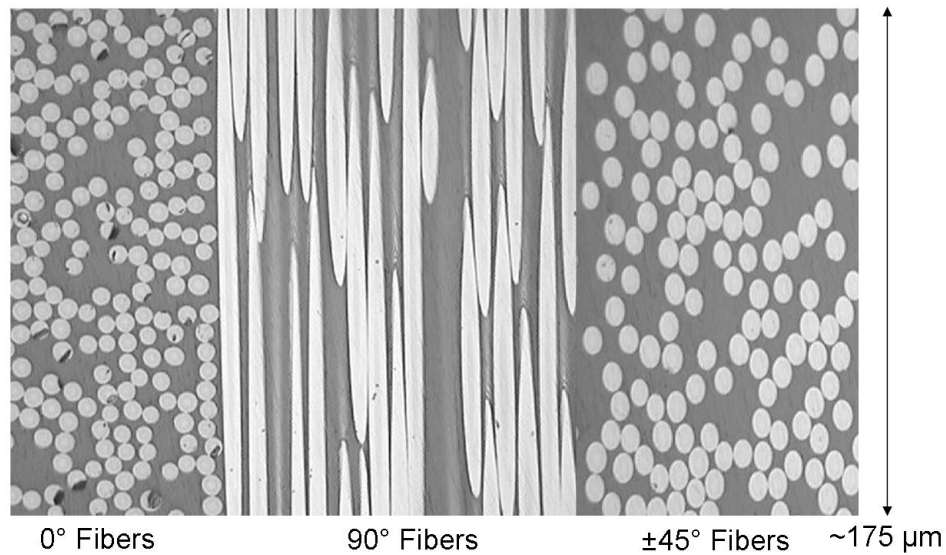
Figure 2.3 Fiber direction identification from micrograph image. The average fiber diameter is $7 \mu\text{m}$.

The polished pucks were examined using a Nikon Epiphot 200 inverted stage microscope. Sequential micrographs were taken across the lay-up to "stitch" together composite photos of the cross sectional view of the different regions. The purpose of the micrographs was to get a general idea of fiber orientation. The fiber orientation is revealed by looking at the microscopic image where the 0° fibers appear circular while the 45° fibers show up as ovals. The 90° fibers appear as long strands or cylinders. With this method it is impossible to tell if the 45° fibers are in the plus or minus direction. The appearance of each type of fiber is shown in Fig. 2.3. A sample of an assembled composite image can be seen in Fig. 2.4.

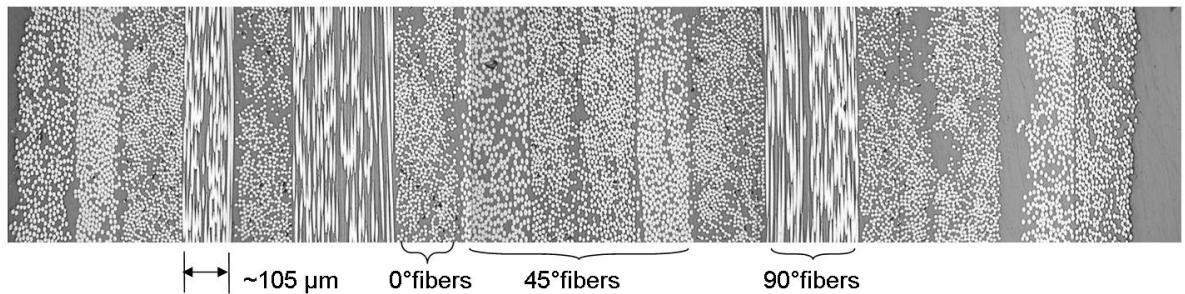
Figure 2.4 A micrograph showing different layers of fiber orientation.

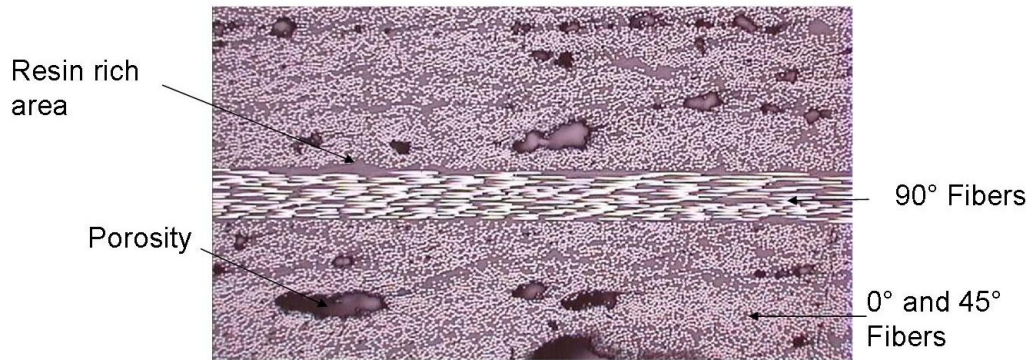
Figure 3.1 Sample micrograph showing key features of the typical micrograph image for processing. This image is of an area approximately 2.56 mm wide by 1.92 mm tall.

The purpose of image processing is to eliminate the fiber and resin rich areas (shown in Fig. 3.1) from the image while leaving the porosity. This elimination is done by thresholding and filtering. Thresholding creates a binary image by turning every pixel with a value above the threshold white, and below, black. The filter's smoothing action creates a grayscale image from the binary image. Erosion occurs in both the porosity and the small dark areas remaining in the fiber and resin rich area. By repeating the thresholding and filtering process, the non-porosity dark areas in the fiber and resin rich areas are removed. The number of iterations to

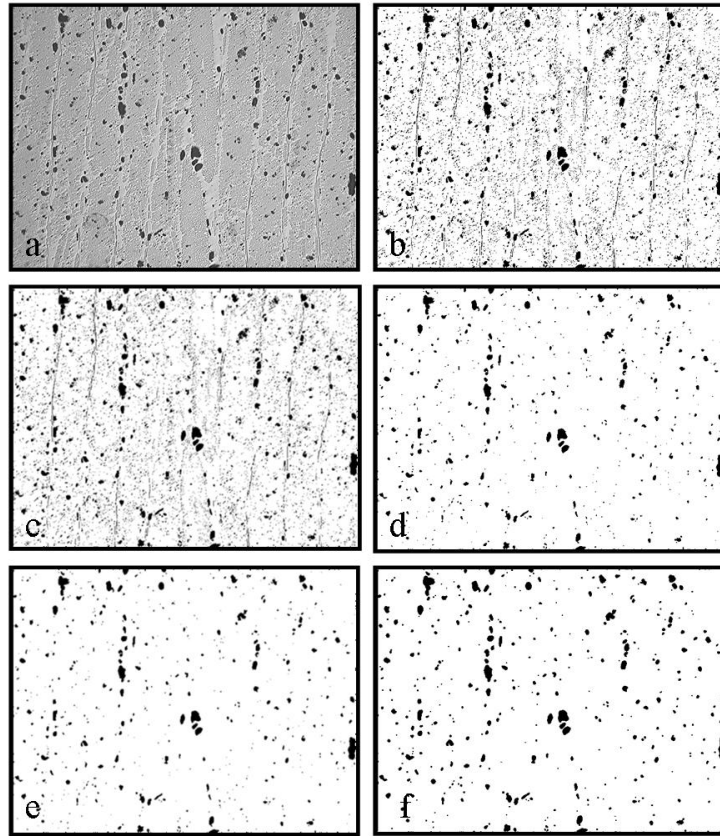
Figure 3.2 The original image (a) through the final processed image (f) as captured from the automated process of ImageTool of a glass/epoxy sample. Images (b, d, f) are after thresholding while images (c and e) are after filtering steps.

the operator is satisfied that the final binary image (Fig. 3.2f) represents only the porosity that was present in the original image. Once the average values are found from the manual thresholding process, they can be inserted into the internal script for automation of the image processing. The automatic scripts used for this experiment will process approximately 125 images per minute. Since the manual thresholding is somewhat subjective and dependent on the operator, the human factors were evaluated by comparing the image processing results obtained using the manual threshold values chosen by four individuals. Individuals were given the same set of five images and instructions on the use of the ImageTool software. They were asked to manually threshold the five images and to record their threshold values for each of the required iterations. The recorded values were then averaged and used to automate the process as would be done when following the reported procedure. The average percent porosity obtained by the four individuals was 8.4 percent and the average deviation was 0.83 percent porosity. This is approximately a 10 percent deviation from the mean value.

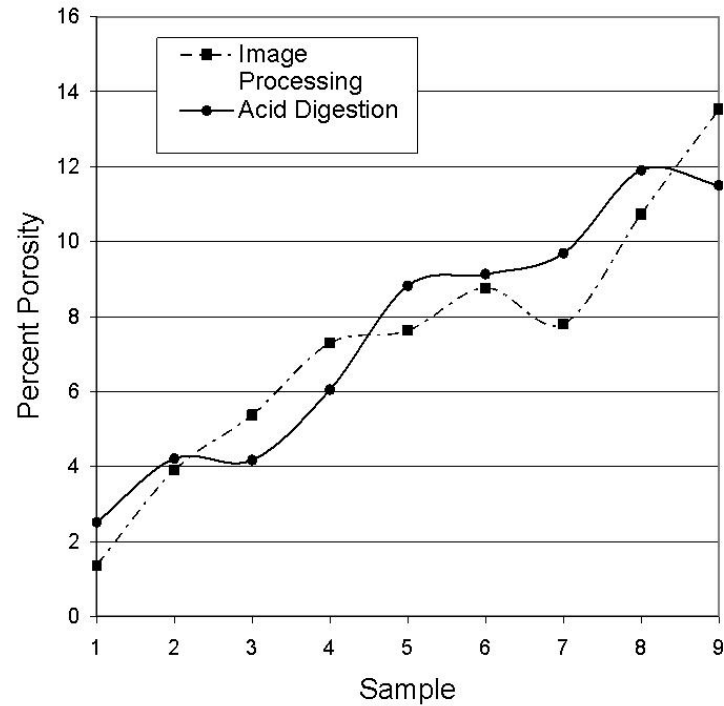
Figure 3.3 The comparison between the porosity levels obtained from the acid digestion and image processing methods on samples of group G.

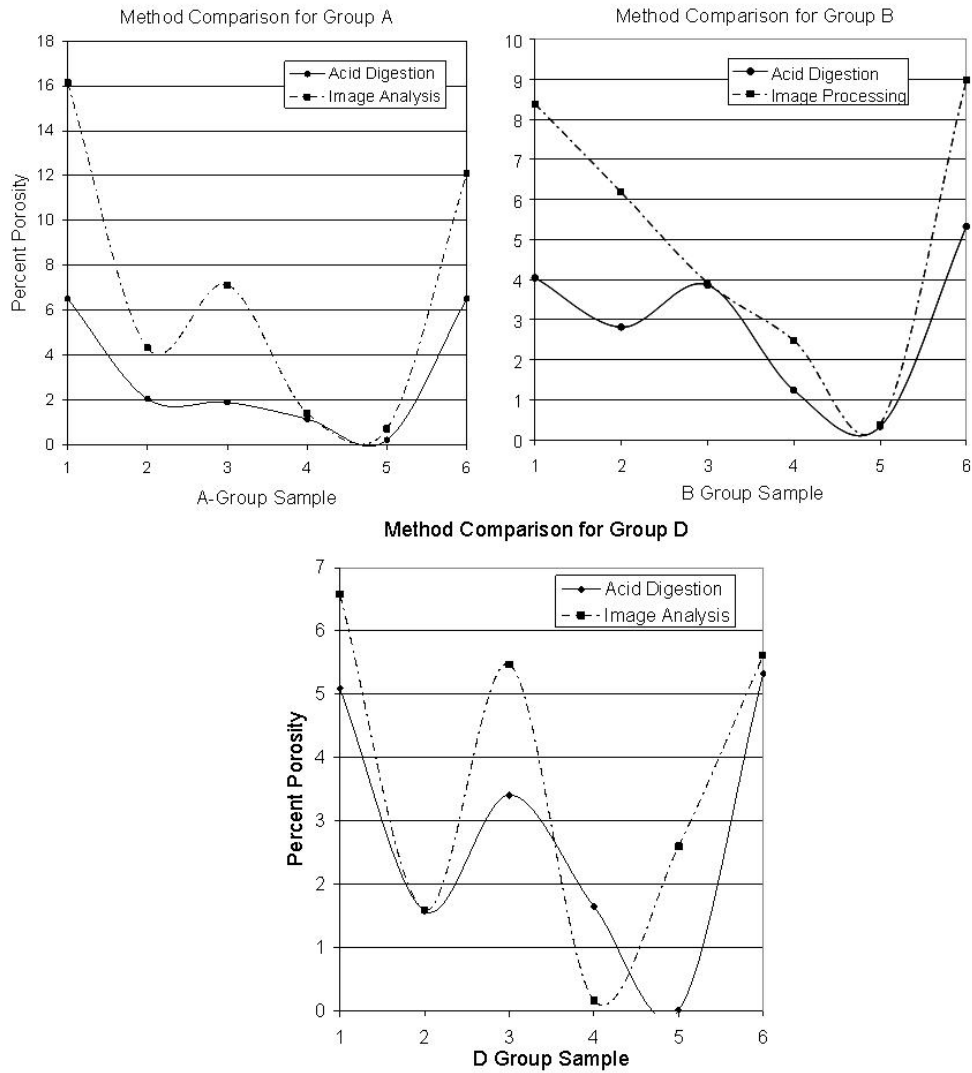
Figure 3.4 The comparison between the porosity levels obtained from acid digestion and image processing methods on sample groups A, B, and D.

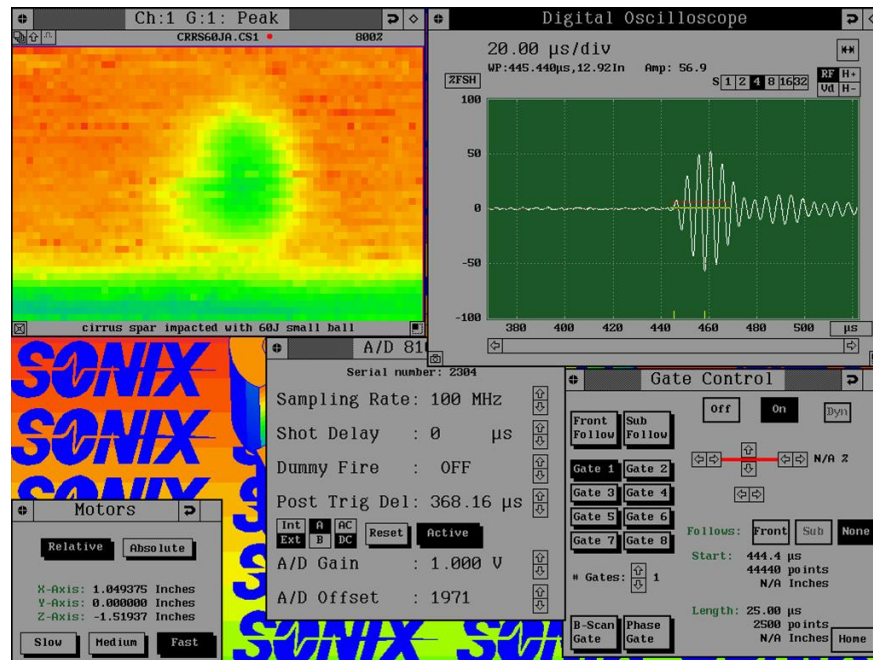
Figure 4.1 Sample display typical to SONIX scanning software.

The SONIX scanning system is a three-axis, computer controlled, positioning system that can be easily programmed to rapidly inspect an area with ultrasonic transducers. The system consists of a scanning frame, a computer controlled positioning motor for each of the three scan axis, an Analog to Digital(A/D) data collection circuit board, and a scanning software program. The software contains a digital oscilloscope along with all the necessary programming and data collection utilities to collect time-of-flight and amplitude data. The SONIX scanner is capable of an xyz scan up to 48 x 24 x 18 inches. Figure 4.1 shows a screen shot of the software with a completed scan image.

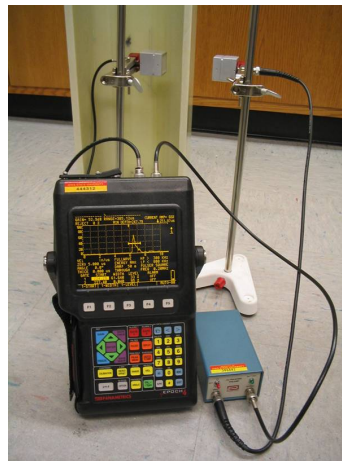
Figure 4.3 The Panametrics Epoch 4 shown with the Ultrasonics GMP transducers performing an A-Scan through GS1.

The Epoch 4, shown in Fig. 4.3, is a hand-held, easily portable, ultrasonic flaw detector that is used by CNDE in the lab and in the field on a regular basis(14). This flaw detector is capable of producing a spike or a tunable square wave pulse. The square wave pulse is used for the inspection of the spar specimens. To provide adequate power to the GMP transducers for through transmission of the spar sections, the Epoch 4 is set to the maximum energy setting with a damping level of 50 ohms. The filters are set to best accommodate the 200 kHz transducers.

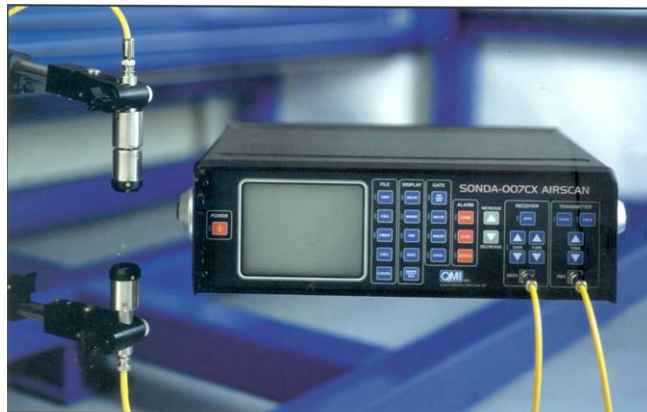
Figure 4.5 The QMI air-coupled ultrasonic system.

The QMI SONDA-007CX Airscan system (5) is shown in Fig. 4.5. This is a stand alone system that houses the pulser-receiver, oscilloscope, and keypad controls in one small unit. The QMI system utilizes all ceramic transducers with a preamplifier built into the receiving transducer and offers the ability to individually tune each transducer to optimize the signal.

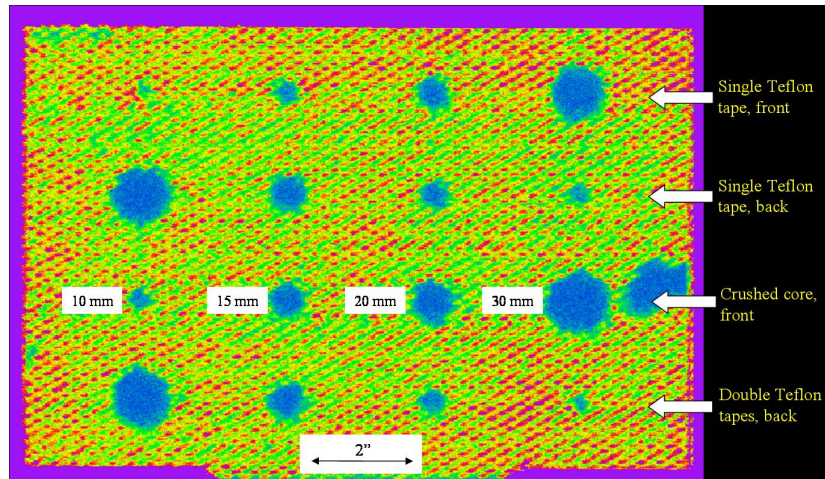
Figure 4.6 Image produced from QMI 400 kHz focused transducers through a Kevlar/Nomex honeycomb sandwich composite.

C-scan images previously produced utilizing the QMI system are shown below in Fig. 4.6 and Fig. 4.7. These images are shown to demonstrate that the capabilities of air coupled ultrasound have already been examined in materials similar to those used in light composite aircraft(15; 16).

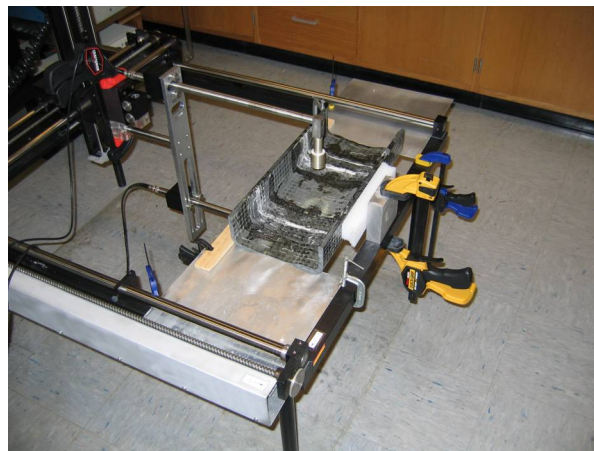
Figure 5.14 The scanning setup used for the CS1 wing spar section.

The SONIX scanning system was utilized with the QMI system to make the first air UT images of the web area as shown in Fig. 5.14. The image produced showed the three impact damages and some of the damage caused by the joint pull-off testing. Interestingly, these defects again appeared as an area of higher transmission, note Fig. 5.15. This is similar to the results on the Grafoil inserts described previously in section 5.2.
