Performance Assessment of Deteriorated and Retrofitted Steel HP Piles

PERFORMANCE ASSESSMENT OF DETERIORATED
AND RETROFITTED STEEL HP PILES

A THESIS

Presented to the Faculty of
The Graduate College at the University of Nebraska
In Partial Fulfillment of Requirements
For the Degree of Master of Science

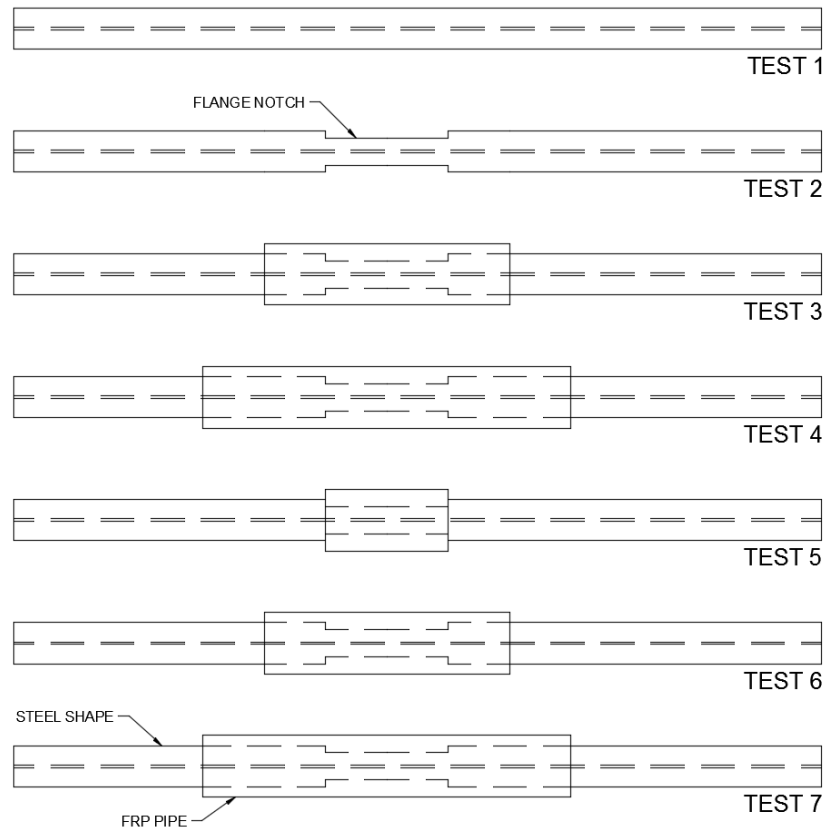
Figure 2.2 Test specimen setups (Liu, 2003)

Liu (2003) researched the benefit of FRP (Fiber Reinforced Polymer) wraps on piles with simulated corrosion. Axial testing was performed at the University of Missouri Rolla to determine capacity of the piles with varying wrap lengths and concrete fills. Test results are shown in Table 2.1 and sketches of the specimens are shown in Figure 2.2. Through axial

Strength increases correlate with longer wrapped lengths because the wrapped provides improved buckling resistance for the cross section. The greater effective moment of inertia affording greater stability. The expansive concrete provides improved effectiveness of transformed section properties with improved composite action between the FRP, concrete, and steel. The findings of this research substantiate the practice of extending the retrofit repairs from above the waterline to below the mud line to provide improved stability near the deteriorated section.

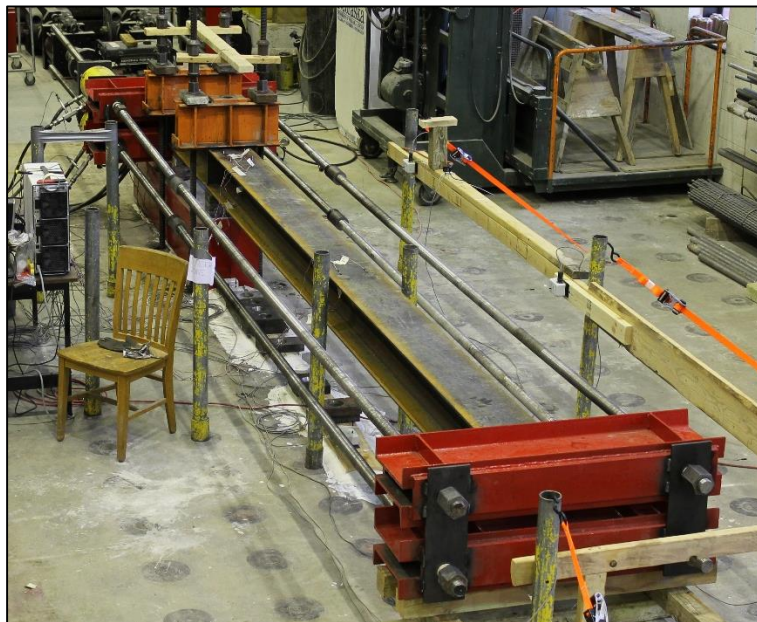
Figure 5.26 Non-deteriorated pile bent test

Of the four test without concrete, the non-deteriorated pile bent case pile (pictured in Figure 5.26) experienced the greatest combination of failures. There were two localized failures, as well as a global failure. The first localized failure was of the top flange behind the tie down location, and the second was a local failure of the top flange at the base section. The final failure the pile experienced was an out of plane failure. The localized failure behind the tie down was not expected but did not impact the test outcome. The other failures were predicted and matched the analytical limit states.

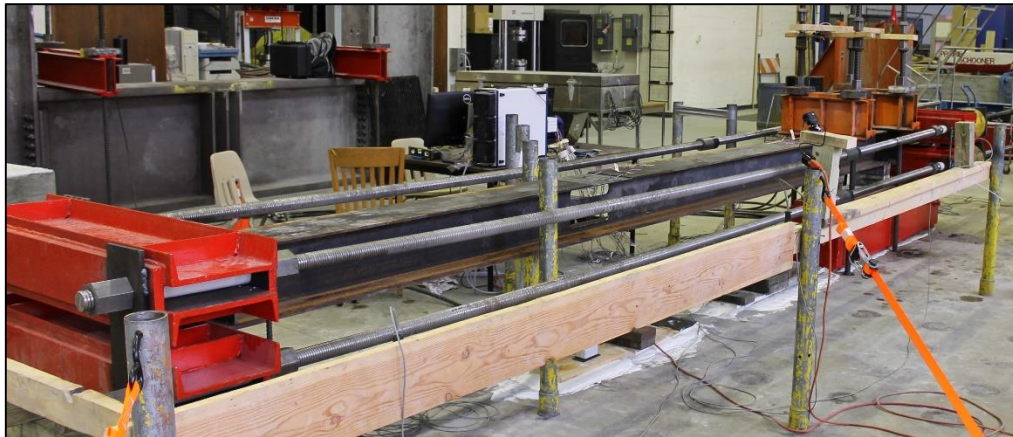
Figure 5.33 Deteriorated pile bent test

The deteriorated pile bent case (pictured in Figure 5.33) underwent the most sudden failure that was observed during the pile testing. Local buckling in the web of the deteriorated section preceded a global buckling (pictured in Figure 5.34) of the cross section at the deteriorated location. The pile buckled in plane in the upper flange and out of plane in the web. The deteriorated section shortened by half an inch in the top flange, and the web buckled out approximately 7/8 of an inch. Overall, the pile displaced vertically 5.5 inches, 4.4 inches of which were gained during the sudden failure, as shown in Figure 5.35. The pile still carried some load after the buckling as shown in Figure 5.36, but any additional load would have resulted in continued deformation.
