Performance evaluation and finite element verification of an ultra-high performance concrete pi-girder bridge

A thesis submitted to the graduate faculty
in partial fulfillment of the requirements for the degree of
MASTER OF SCIENCE

Major: Civil Engineering (Structural Engineering)

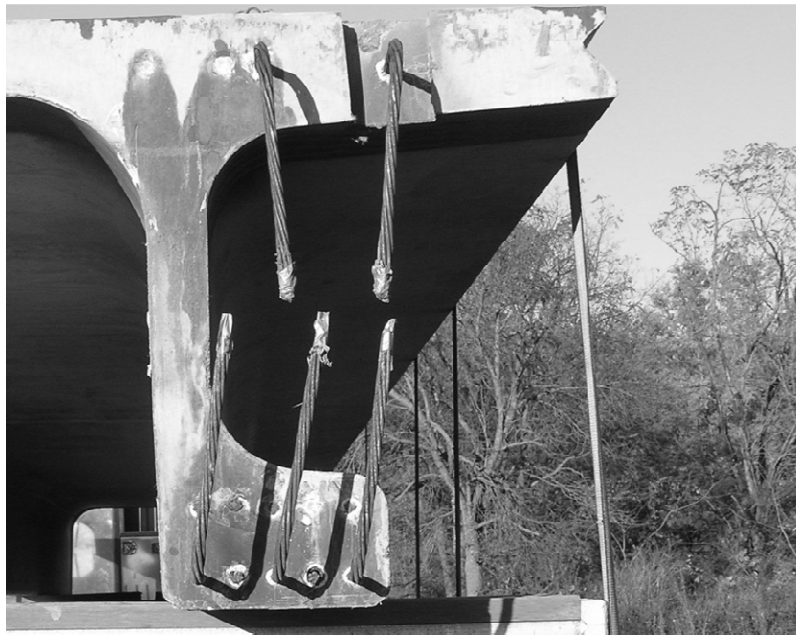
Figure 2.12-Pi-Girder Longitudinal Prestressing

Longitudinal reinforcement details for the pi-girders are shown in Figure 1.4. Twenty-two 0.6 in diameter, low-relaxation prestressing strands provided the flexural reinforcement. Eighteen strands were placed in the bottom of the bulbs, nine in each bulb, and tensioned to a total force of 766 kips (3407 kN). The four strands located in the deck were prestressed to a total initial force of 170 kips (756 kN). Along with Figure 1.4, Figure 2.12 and Figure 2.13 display the layout of the longitudinal prestressing strands.

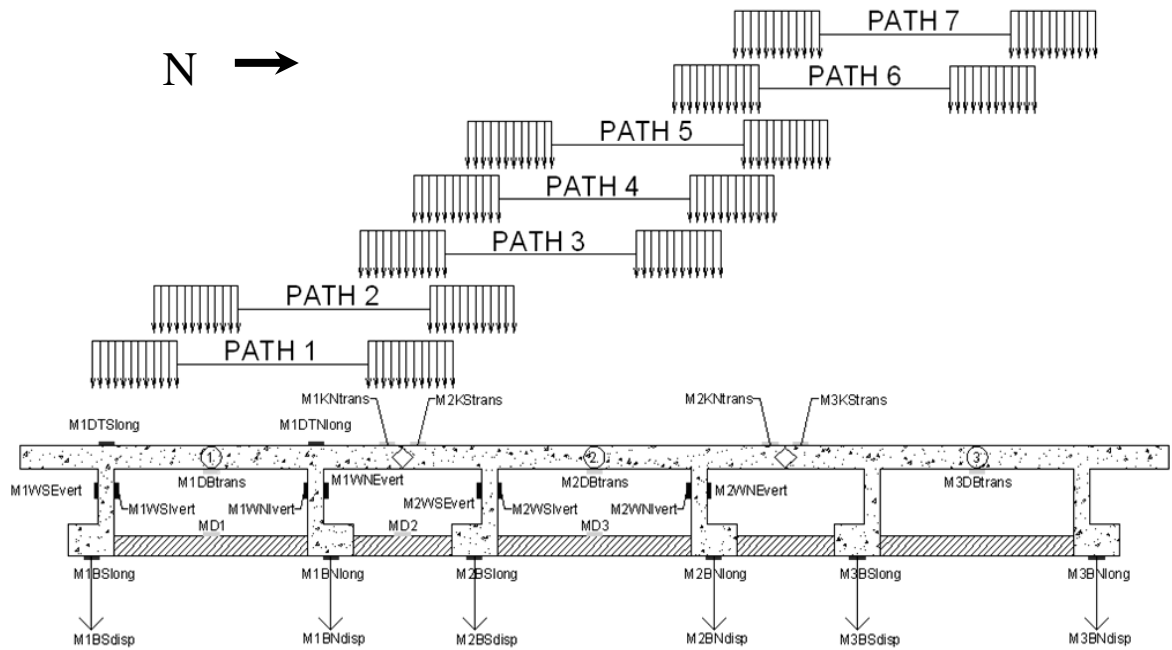
Figure 5.1-Schematic Layout of 2008 Transducers and Loading Paths at Midspan

For the first test in 2008, thirty-two surface mounted strain transducers and six displacement transducers were attached to the bridge to quantify its response under a known static live load. The strain transducers were located at the pi-girder midspan, quarterspan, and near the eastern end. Twenty-six of the thirty-two strain transducers were located at midspan. The six displacement transducers were installed at midspan to monitor maximum vertical deflections. The layout of the 2008 strain transducers and displacement transducers at midspan as well as the naming key can be seen in Figure 5.1 and Table 5.1 respectively. The quarterspan instrumentation consisted of three strain transducers located on bottom of the three southernmost bulbs oriented longitudinally. The instrumentation near the eastern pier consisted of three longitudinal strain transducers, two of which were located on the bottom of the southernmost bulbs oriented longitudinally with the remaining transducer located on the top of the deck over the northern bulb on girder 1 also oriented longitudinally.

The seven transverse load paths shown in Figure 5.1 were used for the static load test conducted 2008. In total, 28 passes were made during the test, 14 with the midspan diaphragm bolts tight and 14 with the midspan diaphragm bolts loose. The initial 14 passes were to quantify the bridge behavior under normal service conditions. These initial passes could then be compared to the passes made with the diaphragm bolts loose to examine the effect of the HSS diaphragm members on the bridge.

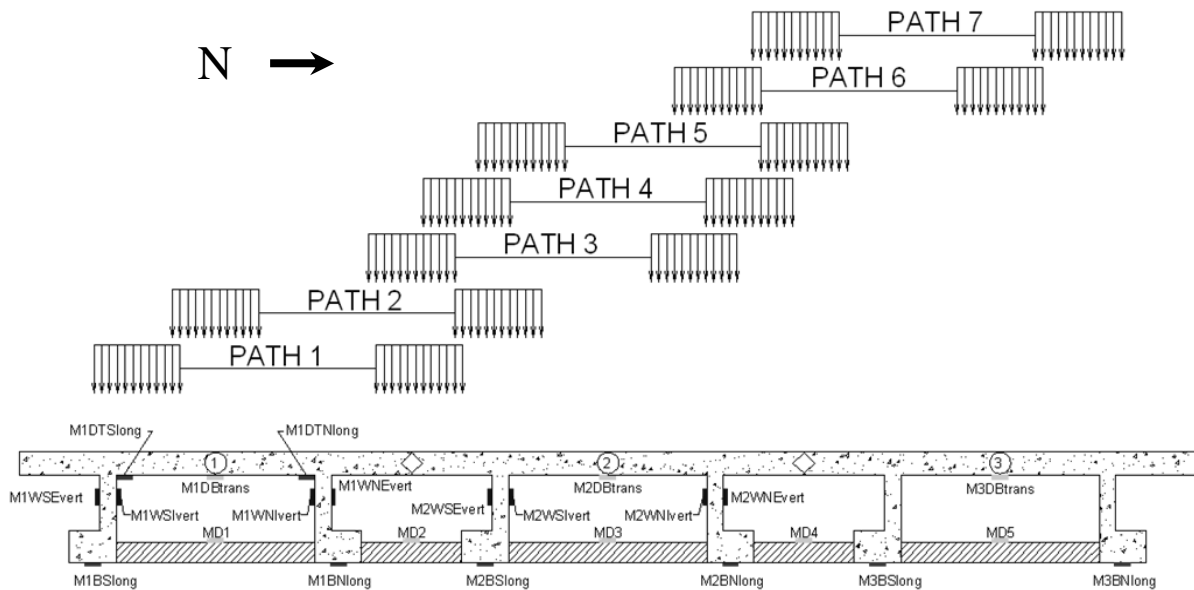
Figure 5.2-Schematic Layout of 2009 Transducers and Loading Paths at Midspan

transducers were not used, as it was verified from the first test that the strain transducers could provide similar information in terms of distribution factors. Strain transducers located on the top of the deck for the 2008 test were relocated underneath due to placement of an asphalt wearing surface on the deck. Three additional transducers were placed on the quarterspan diaphragm to monitor forces in these members. The layout of the 2009 strain transducers at midspan can be seen in Figure 5.2.

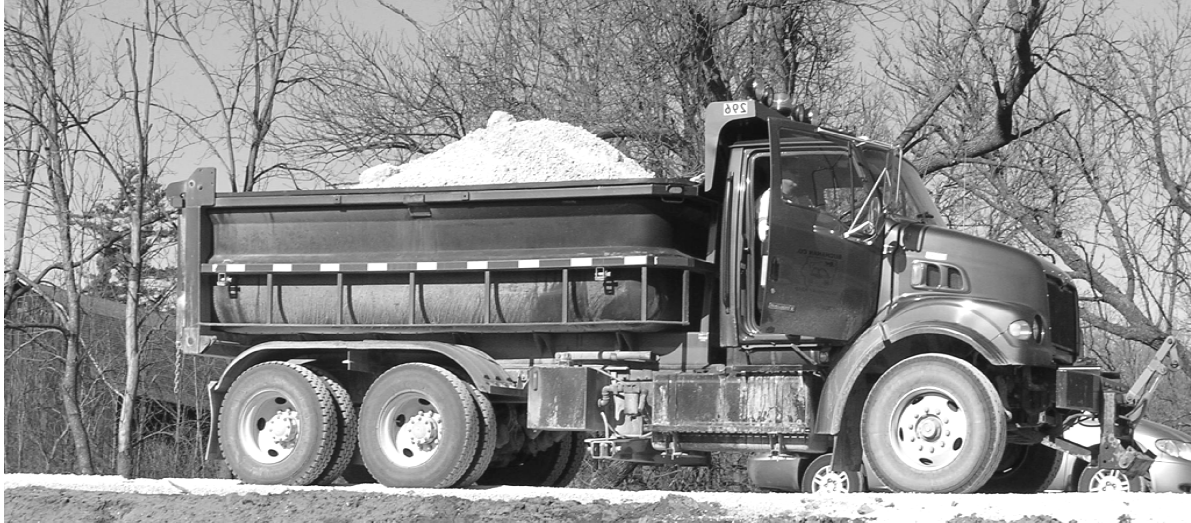
a. 2008 & 2009 Test Truck

configuration of the test truck along with the axle weights for both the 2008 and 2009 test can be seen in Figure 5.3.

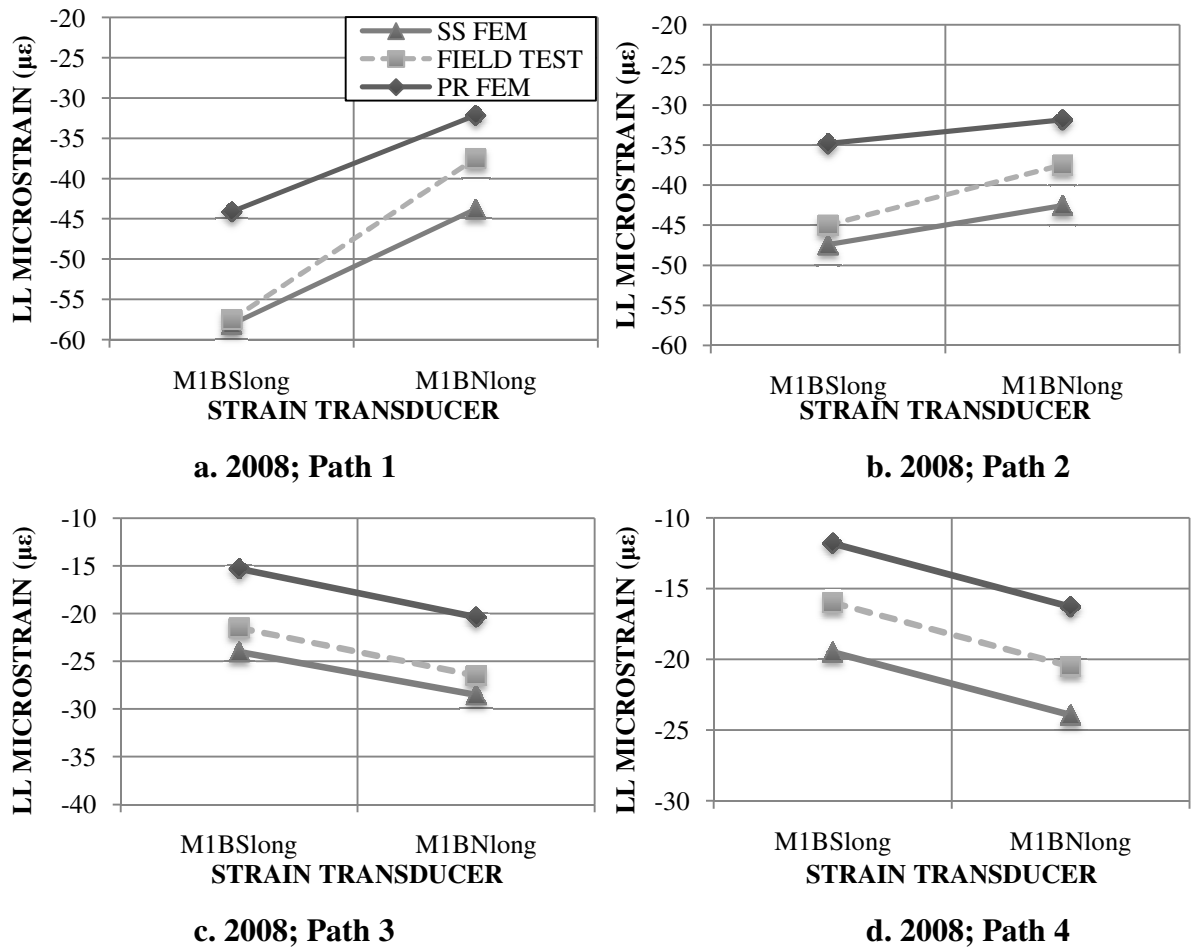
Figure 5.8-FEM LL Longitudinal Deck Strain at Midspan Paths 1-4

The longitudinal deck strains at midspan were also predicted with the FEM. Since only two transducers were orientated longitudinally on the top of the deck, only two data points were available for comparison. The strains were predicted using both a simply supported and partially restrained end condition. The predictions for load paths 1 through 4 are shown in Figure 5.8a-d. Paths 5-7 are not shown due to their similarity to paths 1-3.

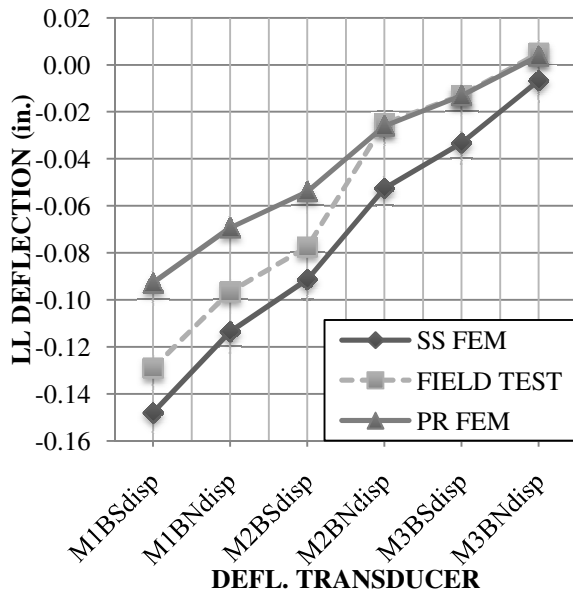
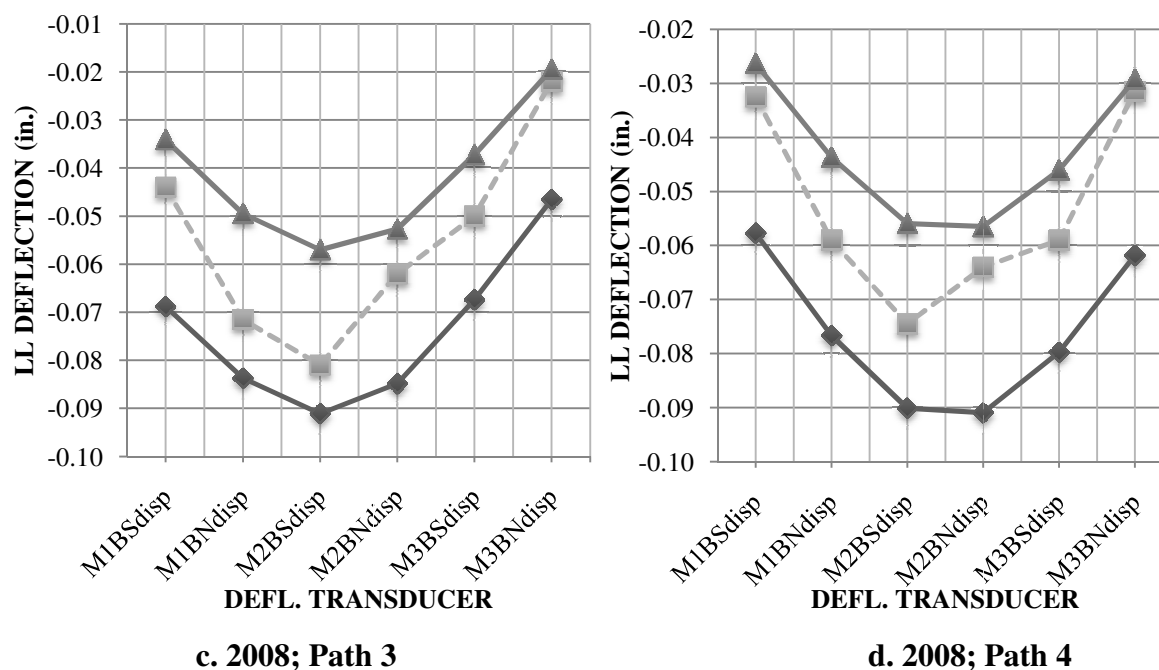
Figure 5.11-FEM LL Deflection at Midspan Paths 1-4

As with the longitudinal strains measured at midspan, the deflections measured at midspan almost always fell between those predicted with the simply supported and partially restrained boundary conditions of the FEM model for all paths. Similarly, the measured deflections indicate that the bridge distributes the loads somewhat less effectively than predicted by the FEM. This is evident on paths 1, 2, 6, and 7 where sharp decreases in measured strain occur on bulbs on the opposite side of the bridge. Figure 5.11a-d shows the results from paths 1 through 4 at midspan. The results for paths 5-7 are not shown, as they are very similar to the results from paths 1-3.
