Performance evaluation of continuity connections for use in modular construction

A thesis submitted to the graduate faculty
in partial fulfillment of the requirements for the degree of
MASTER OF SCIENCE

Major: Civil Engineering (Structural Engineering)

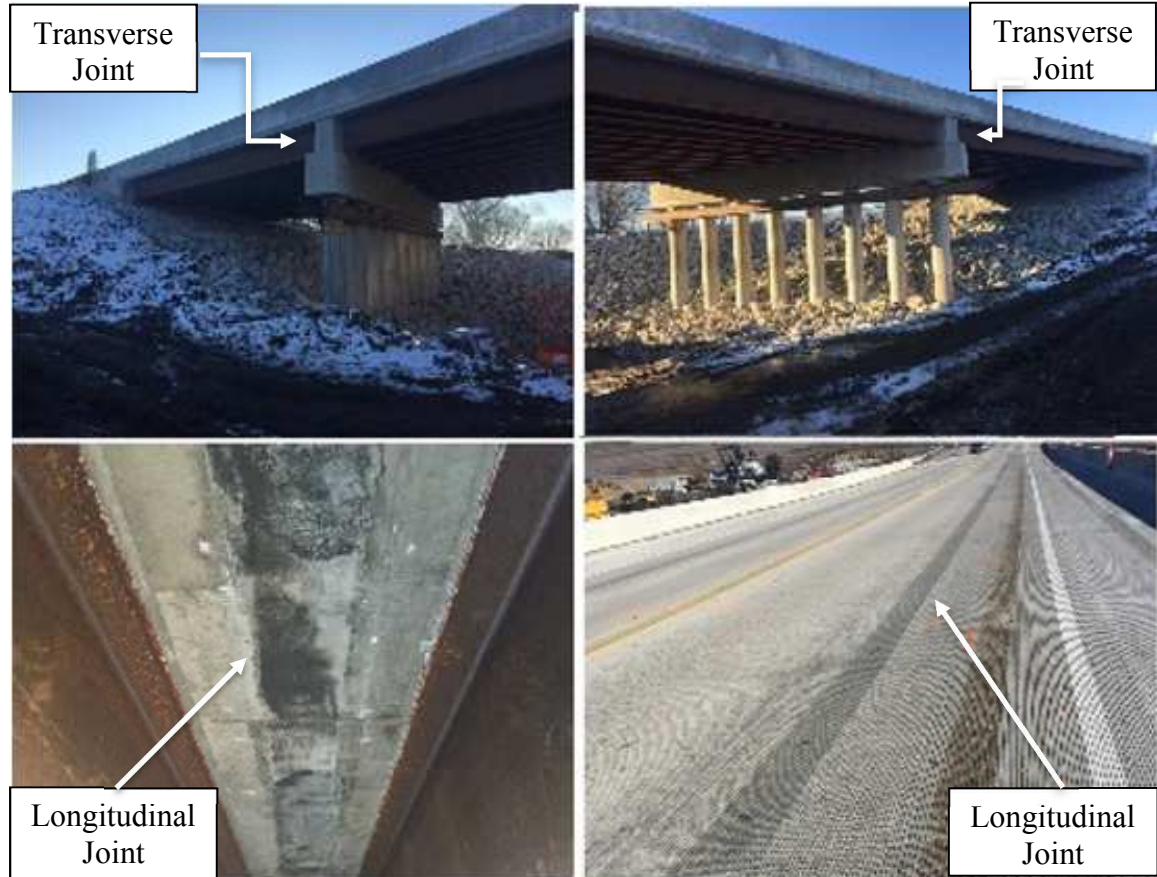
Figure 3-3. Constructed Little Silver Creek Bridge

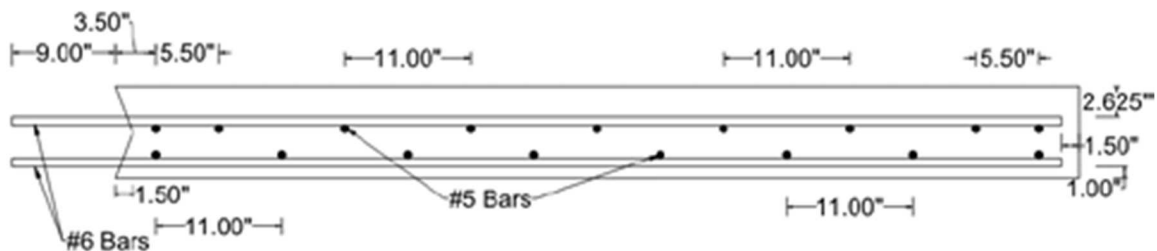
Figure 3-6. Cross Section of Right Deck Panel

Three specimens were constructed using Ductal UHPC to complete the closure pour and three specimens were constructed using Korean-UHPC (K-UHPC) to complete the closure pour. Each specimen was designed as two separate precast modules (deck panels), shown in Figure 3-5 and Figure 3-6. The modular deck panels were specified to use standard Iowa DOT High Performance Concrete (HPC) with a compressive strength of 5 ksi. The dimensions for the two separate modules were the same, 7 ft wide, 3 ft long, and 8 in. deep as shown in Figure 3-5 through Figure 3-8. The modules were placed 10 in. apart to allow for the longitudinal joint connection as shown in Figure 3-4.

and #7 bars. As shown in Figure 3-5 through Figure 3-8, the #6 bars ran along the width of the specimens (transverse direction), while the #5 bars ran along the length (longitudinal direction). A spacing of 11 in. was used for the longitudinal #5 bars and 1 ft for the transverse #6 bars. The longitudinal top and bottom bars were staggered every 5.5 in. There was no stagger between the top and bottom transverse reinforcement. All six #6 bars protruded 9 in. into the joint where they were staggered at 6 in. intervals from each module as shown in Figure 3-4 through Figure 3-8. This allowed for an 8 in. overlap length of each #6 bar in the 10 in. wide joint, which can be seen in Figure 3-4. Two #7 bars were used to longitudinally reinforce the joint and placed directly in the center. Concrete cover was as typically utilized in Iowa DOT bridges and can be seen in Figure 3-5 and Figure 3-6. Specifically, a clear cover of 1 in. was used for the bottom bars while 2 5/8 in. was used for the top bars.

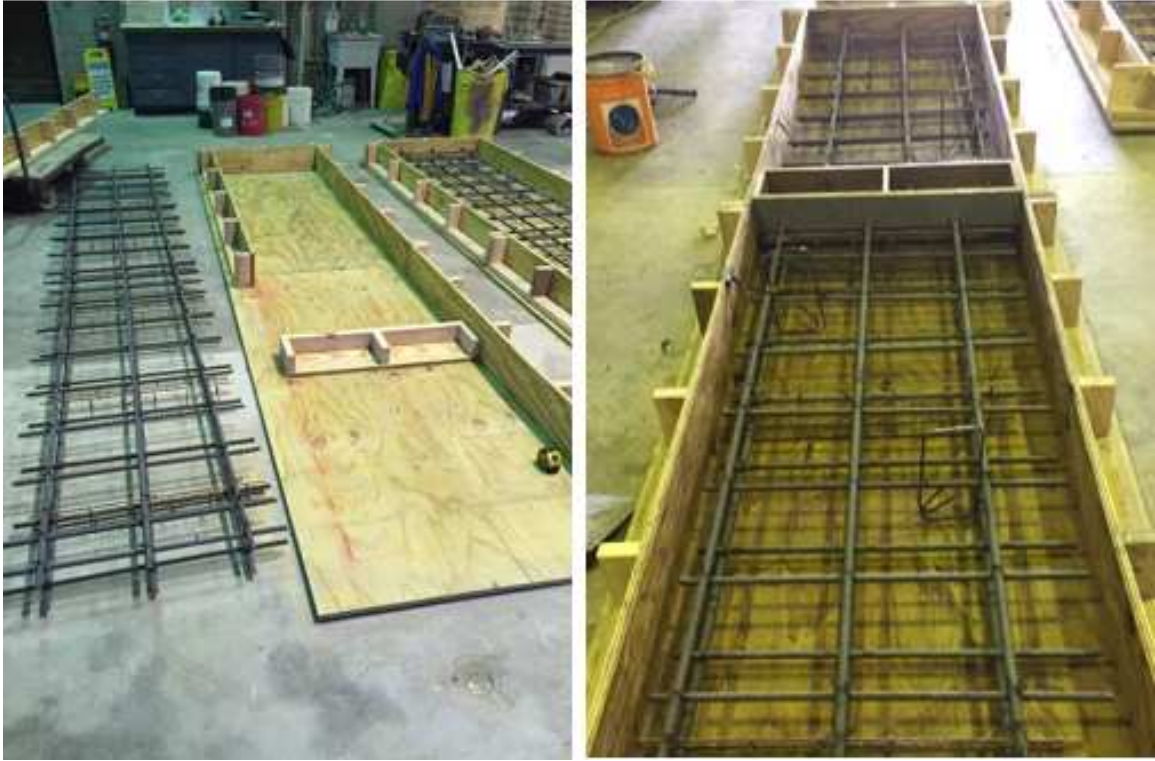
Figure 3-11. Steel Reinforcement and Formwork Fabrication

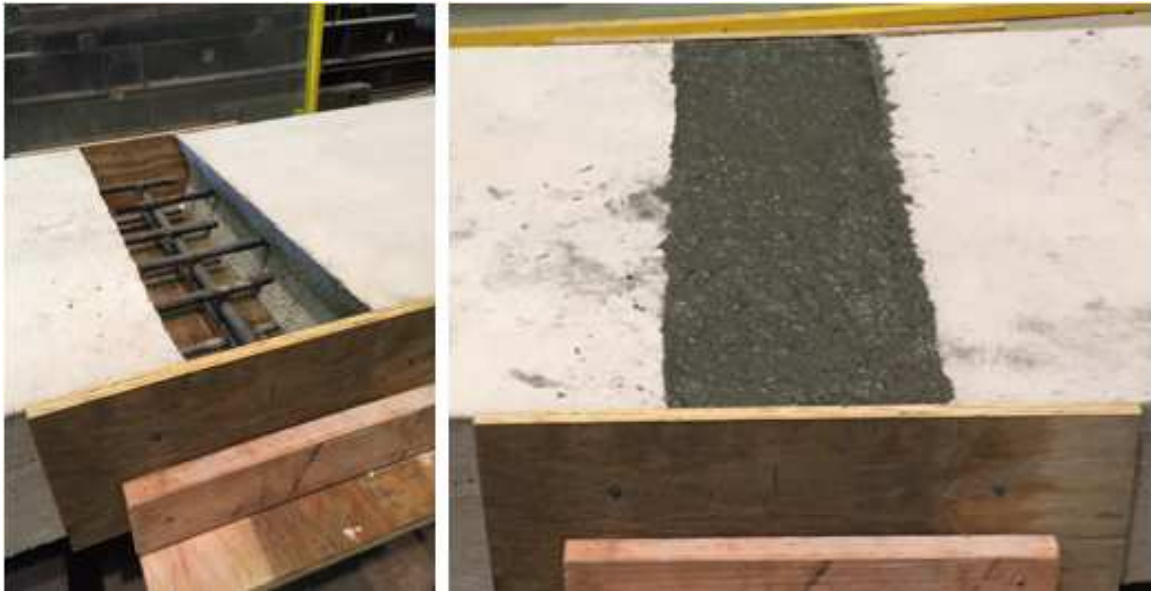
Figure 3-14. Formwork Construction and Placement of Joint Material

The deck panels for the Ductal-UHPC specimens were cast at the same time as the continuous slabs. After the continuous slabs were tested, the deck panels for the Ductal specimens were set in the test apparatus. New formwork was constructed at the joint location for the placement of the Ductal-UHPC, as shown in Figure 3-14. The UHPC was placed in the formwork and allowed to cure. Testing for these specimens was able to start as soon as the compressive strength of the UHPC reached 15 ksi, but no sooner than four days as four days is the minimum cure time specified by the IADOT. The Ductal-UHPC specimens were tested after 6 days with an average compressive strength of the UHPC around 15.5 ksi. All three specimens were tested on day 6 with all testing completed within 8 hours.

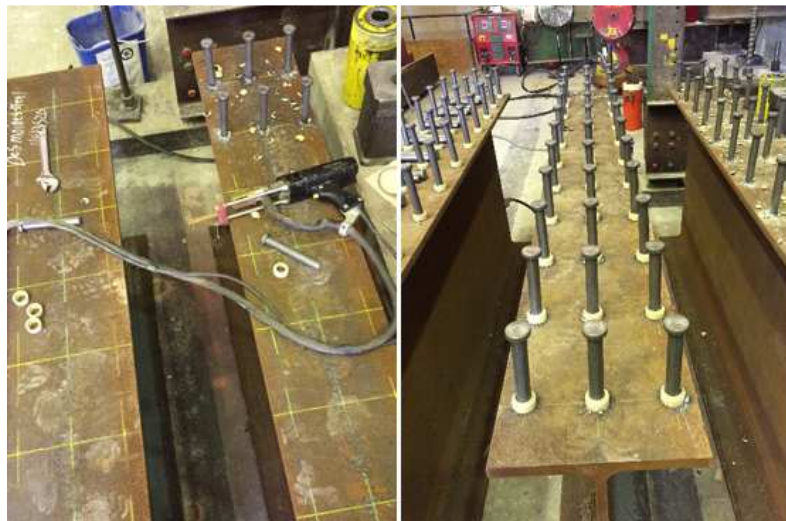
Figure 3-28. Placement of Shear Studs

All of the reinforcing steel mats were assembled first and then set aside until the formwork was completed. Locations of the shear studs were marked out on all of the girders. They were then attached using a stud welder and the process is shown in Figure 3-28. To make sure the proper heat was being used, a 45-degree bending test was performed prior to welding them on the girders.

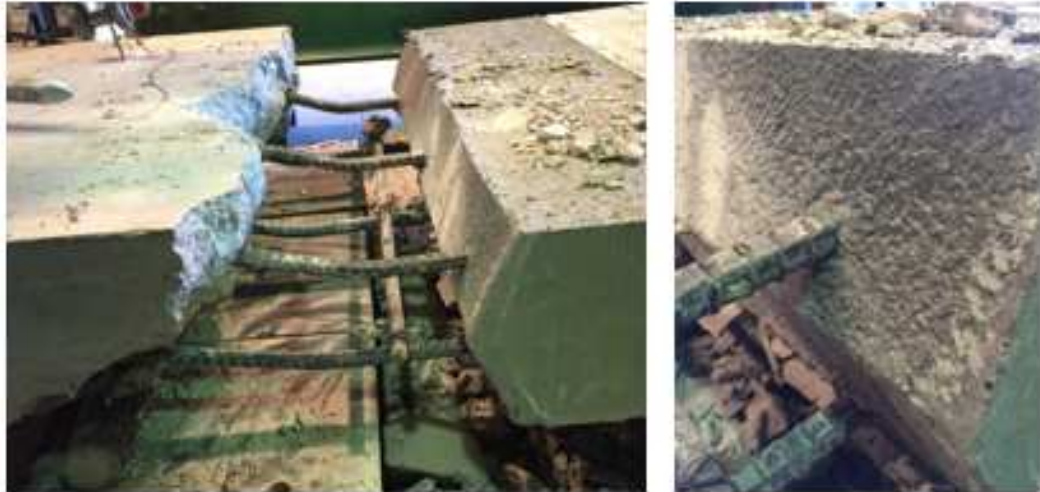
Figure 4-5. Joint Investigation

Both types of joint materials maintained a solid connection to the modules. After testing was finalized, the specimens were taken apart to examine the bond between the bars and the joint as shown in Figure 4-5. There was no observed slip between the reinforcing steel and the joint and no fracture was observed in the bar.

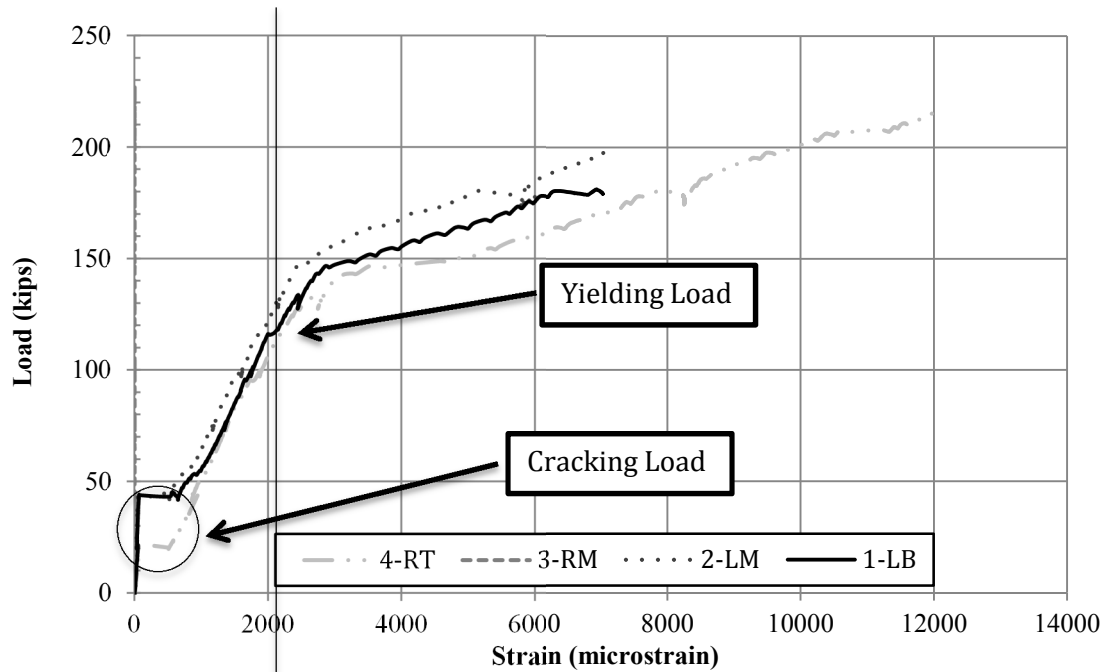
Load-strain relationships were developed for each of the specimens and are shown in Figure 4-7 through Figure 4-16. Locations of the embedded gauges used for the figures were illustrated in Figure 3-16 and Figure 3-17. Through the developed relationships it was possible to determine several characteristics of the specimens including the cracking load, steel yielding load, and failure load. Note that only the strain from the four embedded bar gauges in each specimen were utilized for further analysis. The data produced from the concrete gauges was inconclusive and therefore left out of the overall comparison results. A solid bond did not form when attaching all of the gauges, which caused the results to be inconsistent between all of the tests.

The cracking load was estimated based on the load-strain relationships of the embedded strain gauges. The first point the strain value reached a plateau (an abrupt increase in strain) was recorded as the cracking load. For locations where the initial plateau was not as evident, the cracking load was determined once the first steel reinforcement in the deck reached a strain value equal to that of tensile cracking of concrete, which corresponds to about 135 micro-strains based on a linear stress-strain curve. Since the embedded strain gauges were very close to the surface of the deck, the results produced from strain gauge readings are assumed to closely represent the strain values seen on the deck surface. As for the yielding load, Grade 60 reinforcing steel was used for this project, which has a theoretical yield strain of 2,069 microstrain. The load at which the average strain in the cross section exceeded this limit was recorded as the yielding load of steel reinforcement. The maximum load that was reached prior to failure was recorded as the failure load.

Values for the cracking load, yielding load, and failure load are illustrated for each specimen in Figure 4-7 through Figure 4-16. All four embedded gauges for each specimen are included in each figure. The locations of the gauges are distinguished by linetype and the pattern for these are consistent throughout each figure. There is also a vertical line and circle on each figure that are used to display the yielding load and cracking load, respectively.

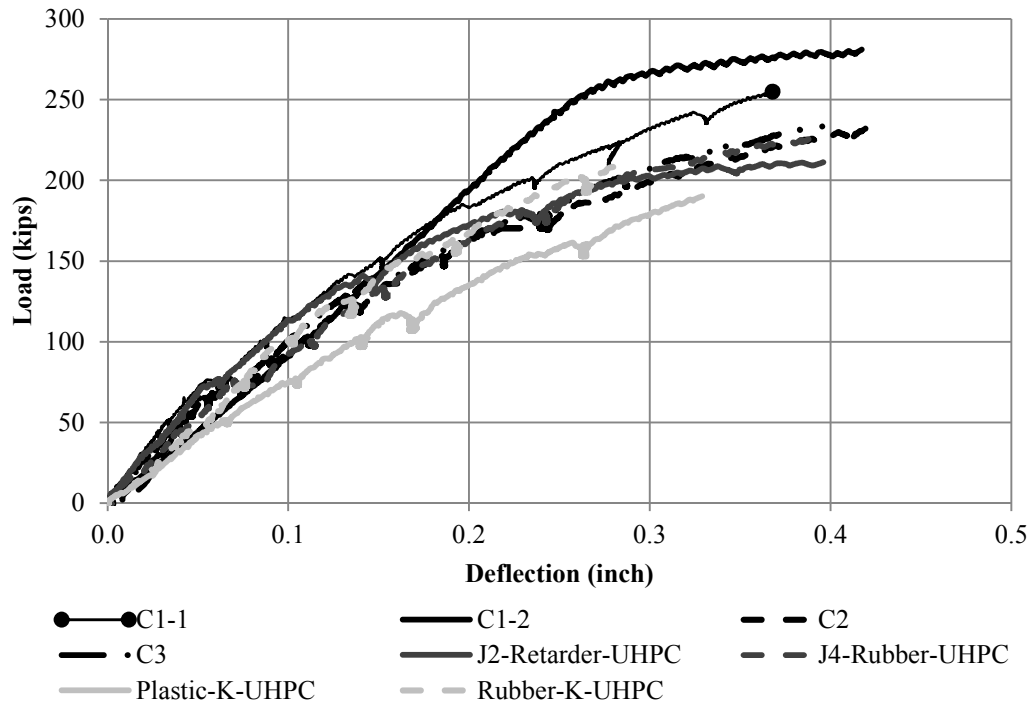
Figure 4-17. Load vs. Deflection for all Test A Specimens

Load deflection relationships were also produced from the deflection transducer that was attached to the bottom surface in the center of each specimen are shown in Figure 4-17. Note the location of the transducer can be seen in Figure 3-16 through Figure 3-15. There was error in the instrumentation for two of the specimens. As a result, the data produced from Specimen J1 (Plastic Formliner-UHPC) and K1 (Form-Retarder-K-UHPC) are not included. It can be seen that all results were very comparable. The deflections at failure for each specimen are shown in Table 4-1. Some of the specimens experienced additional load after failure, but the graph only shows deflection up until failure to keep it consistent. Deflection of almost all specimens appeared to be just over 1/3 inch at the time of failure. This was the case for the continuous specimens as well as all jointed specimens. As shown in Table 4-3 the K-UHPC specimens produced smaller deflection results than the Ductal-UHPC ones. However, they were very close and less than 1/10-inch difference. It appeared the surface preparation technique had little effect on deflection, which is shown in Table 4-2.

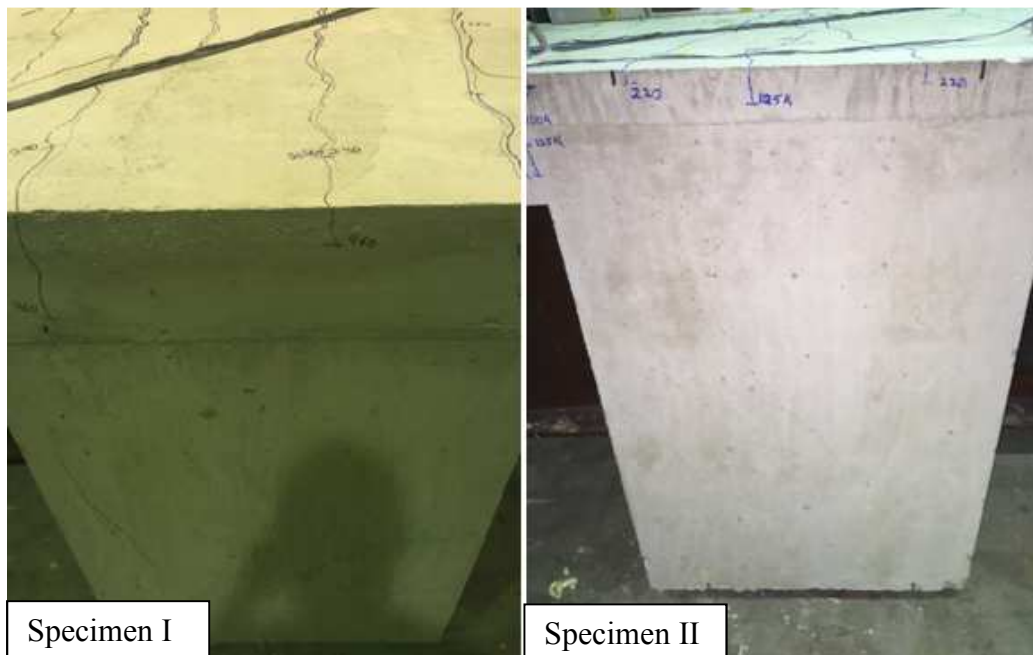
Figure 4-20. Diaphragm Cracks on Long Side for Each Specimen

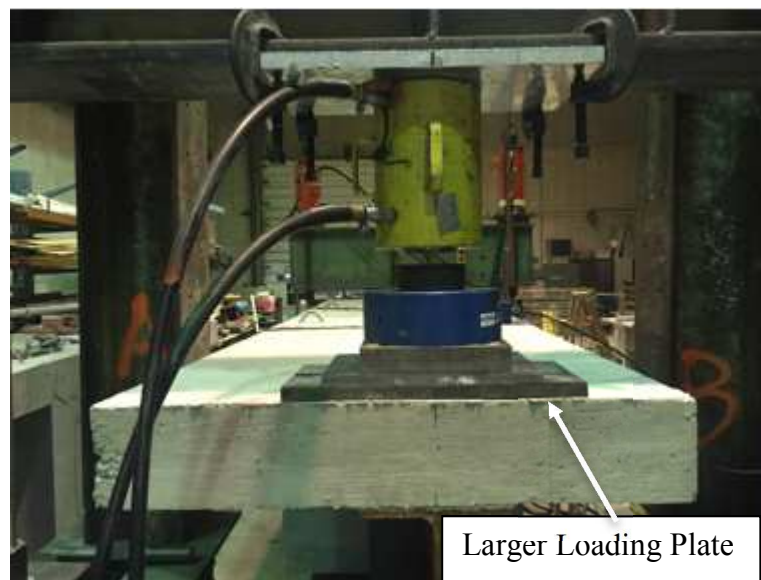
Figure 4-24. Revised Loading Configuration of Specimen I

Cracking and failure patterns for Specimen I were very similar to those of Specimen II. Again, the first cracks were noticed around a load of 50 kips (300 ft-kip) applied to each side and spanned along the width of the specimen in line with the lifting hooks as shown in Figure 4-18. Cracking then followed the same pattern; showing up 1 ft outside the diaphragm, in the center of the diaphragm, and along the vertical face of the deck. Cracking of Specimen I appeared to be more spread out from the loading locations than Specimen II. The cracks on the face of the diaphragm were also very similar. Minimal cracking was observed on the long overhang side, but cracks extended all the way down the face to the supports on the short side, which is shown in Figure 4-19 and Figure 4-20. Small cracks formed on the bottom of the diaphragm and spread to the neoprene bearing pads as shown in Figure 4-23. A larger plate was used at the loading locations to prevent concrete crushing as shown in Figure 4-24. Ultimate failure was

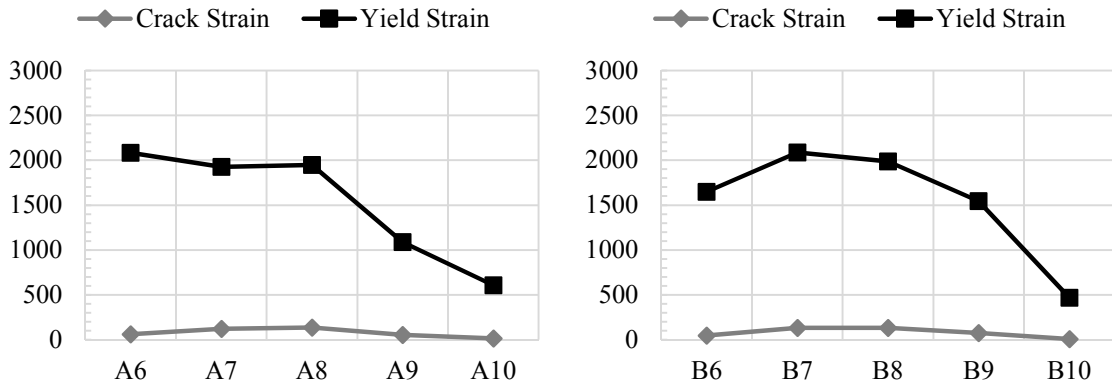
The transverse strain relationships were developed individually for each cross-section. For example, once the first bar reached the theoretical yield limit of 2069 microstrain all other strain values at that point of time were used for each section. The same goes for cracking strain.

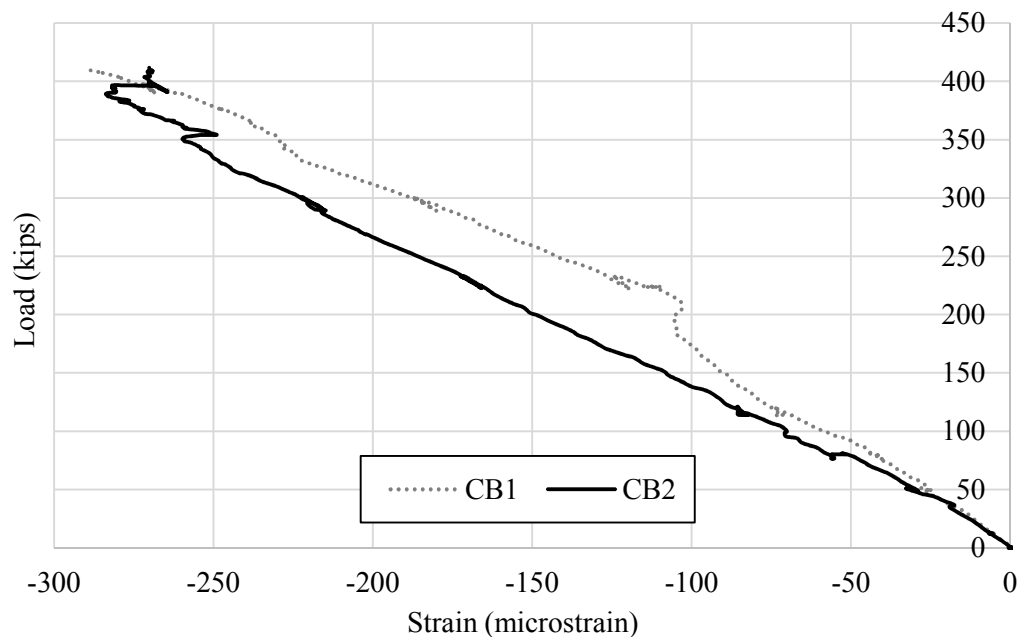
Figure 4-36. Load vs. Strain on Compression Block

Load-strain relationships for the compression block were very similar to those of the bottom flange of the girder. As shown in Figure 4-36 only compressive forces were transferred through the compression block. Based on visual observation after testing was concluded, it is evident that the concrete diaphragm never failed under compression and was still able to transfer some of the compressive forces.
