# Performance of epoxy-coated reinforcement in Iowa bridge decks

A thesis submitted to the graduate faculty  
in partial fulfillment of the requirements for the degree of  
**MASTER OF SCIENCE**

Major: Civil Engineering (Structural Engineering)

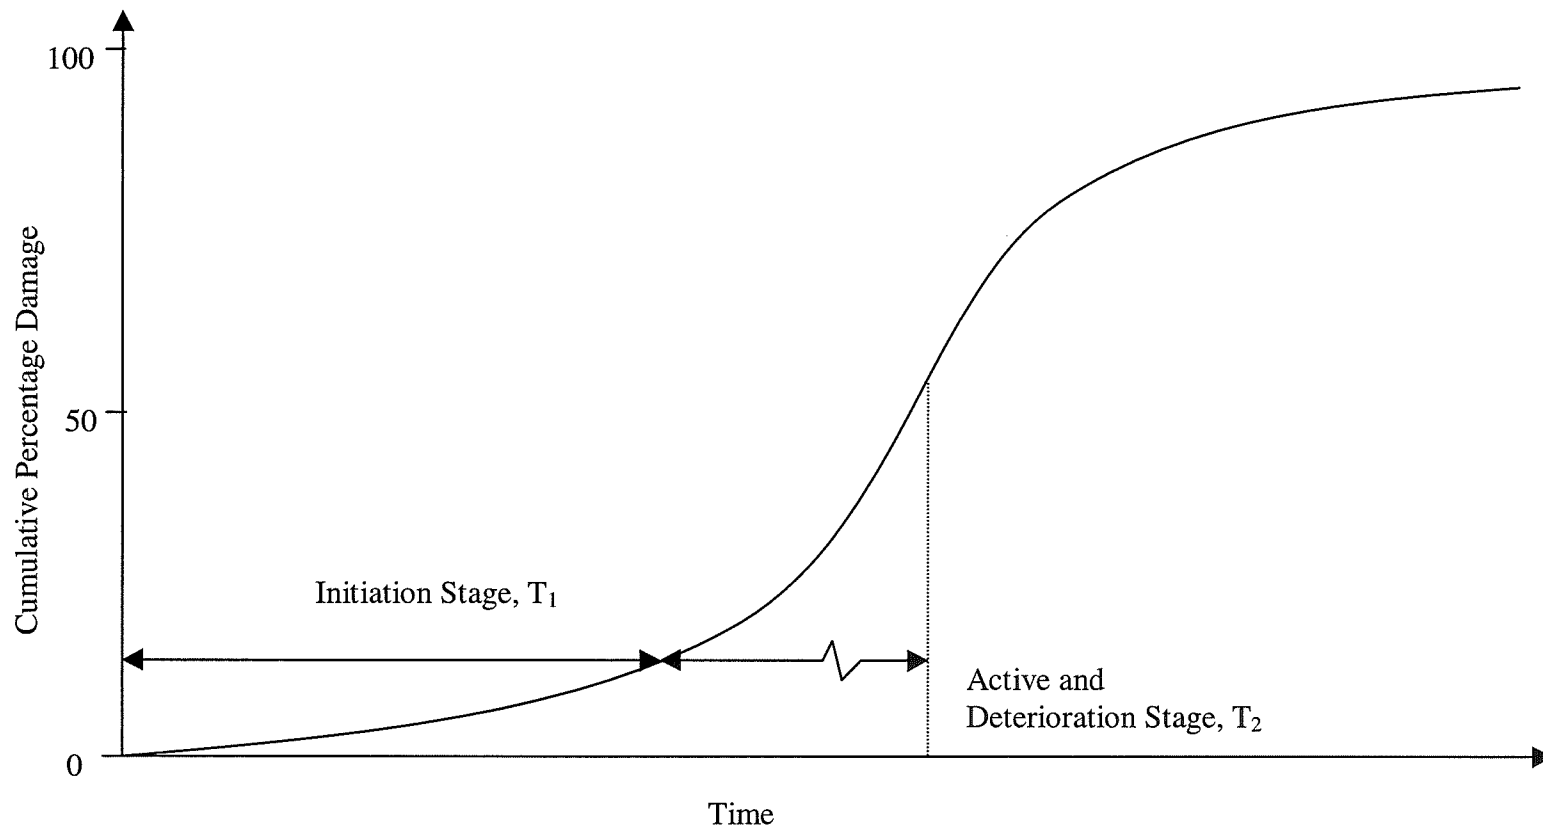
Figure 2.3 General Deterioration Curve vs. Time

As discussed previously chloride ions penetrate through concrete capillaries. As a result of chloride ion ingress, the chloride concentration may reach a corrosive threshold

at the reinforcing bar level. This will initiate corrosion resulting in concrete distressed due to the change of reinforcing rebar volume. Ultimately, spalls and delaminations accelerate the deterioration of bridge deck and reduce its durability. The corrosion threshold at the steel bar level was determined to be 0.2% by weight of the cement content of concrete [15, 16]. Cady and Weyers [17] estimated the corrosion threshold for unprotected reinforcement to be 1.2 lb/yd<sup>3</sup> (0.73 kg/m<sup>3</sup>) of concrete based on 6½ sacks of cement per cubic yard of concrete. However, it is believed that the use of ECR will delay the time required to initiate corrosion. As a result, the corrosive threshold should be higher than that for the bare steel bar. Sagues, ed. Al, suggested the corrosive threshold is about 1.2 lb/yd<sup>3</sup> to 3.6 lb/yd<sup>3</sup> [18]. These limits will be investigated in this research utilizing chloride concentration-rebar rating relationships of ECR collected from bridges across the state of Iowa.

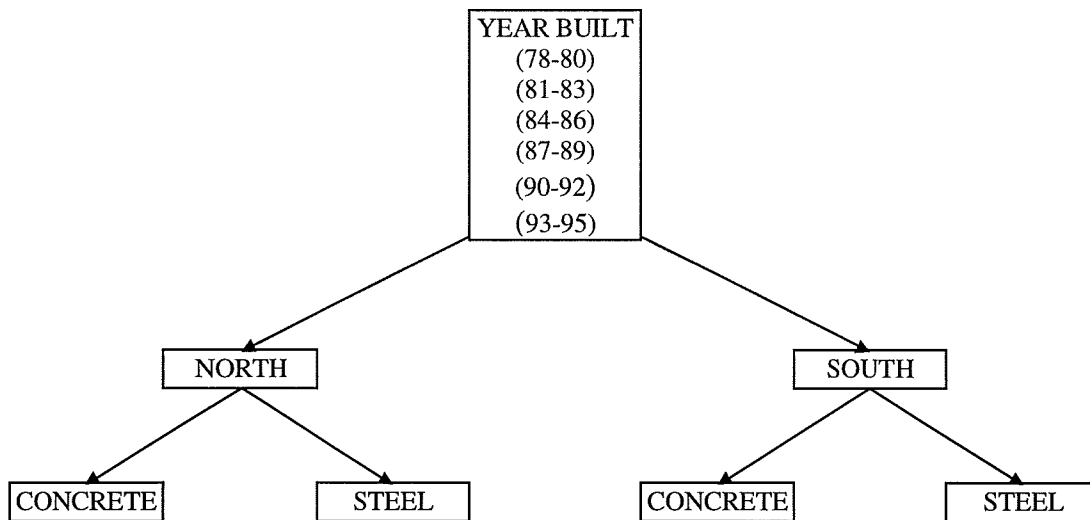
**Figure 3.1 Bridge Grouping [36]**

The effects of many of these characteristics on the deck condition rating of each bridge were analyzed using a spreadsheet/database program [36]. Although the deck condition ratings given by IaDOT inspectors were rated according to surface characteristics of the decks, they were the best sources of information available describing deck conditions. In the study of Phase I, the selection of bridges was grouped on the basis of age in two-year interval (from 1978 to 1995), geographical location and types of structure as shown in Figure 3.1 [36].

As stated in Ref. [36] “Because the long term durability of bridge decks with epoxy-coated rebars was the most important part of this project, more older bridges were selected than newer bridges. About 50 percent of the bridges sampled were built from

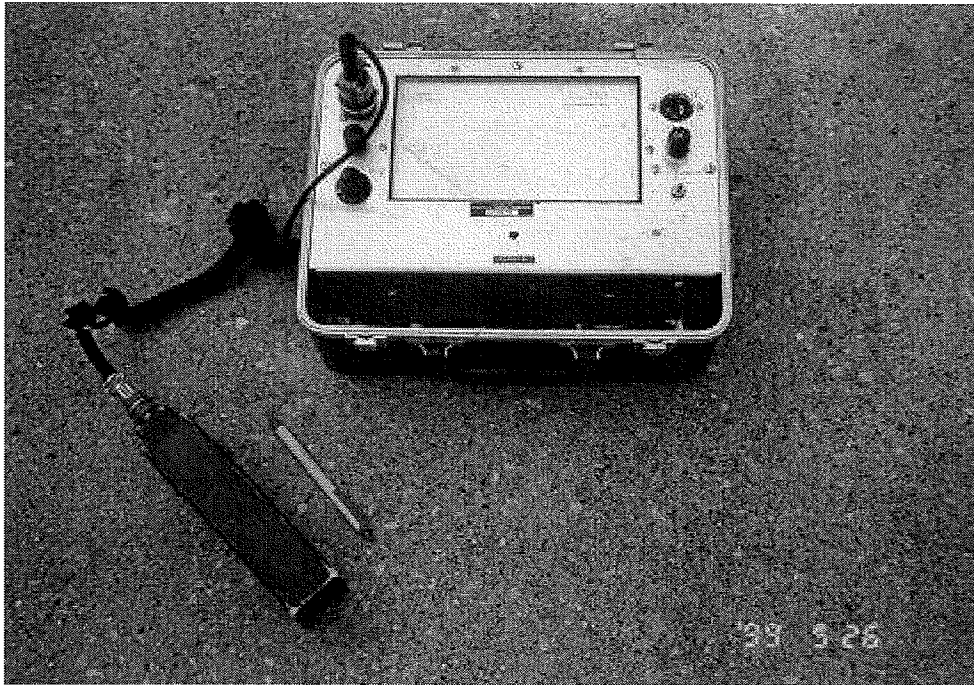
**Figure 4.1 Pachometer Used to Locate Reinforcing Steel in a Bridge Deck**

Prior to coring, a pachometer, as shown in Figure 4.1, was utilized first to locate reinforcing bars in the concrete. The coring drill bit was then centered at the intersection of transverse and longitudinal reinforcing bars (see Figure 4.2). The diameter of the extracted core was four inches and the length was varied depending on the breaking depth of a core. Usually the length of a core was about 3 to 6 inches.

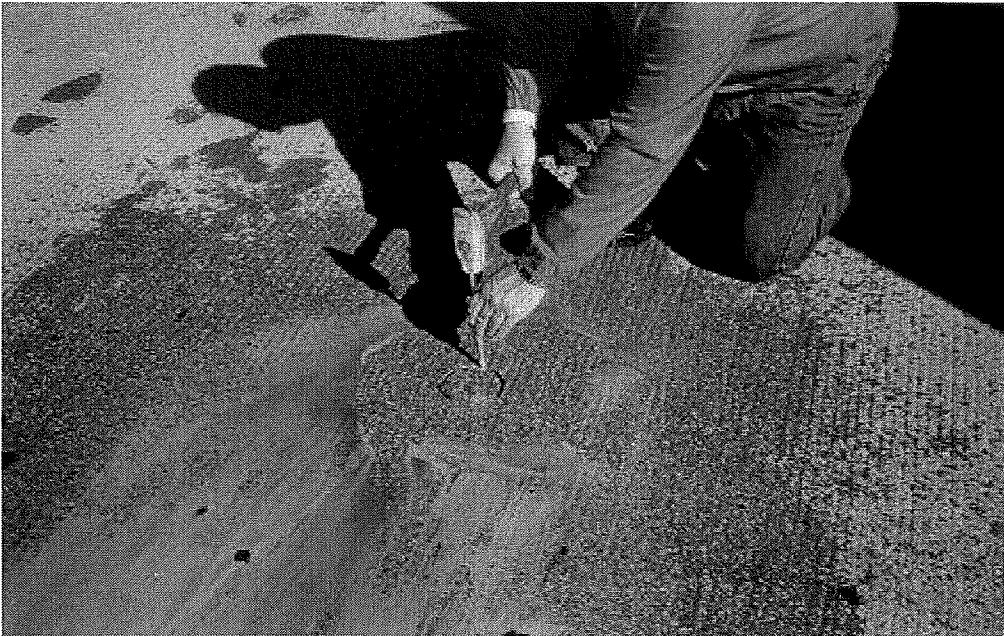
**Figure 4.3 Breaking the Core**

7. In cracked location, draw the cracked pattern on the deck before coring
8. Extracted the core after drilling to the desired depth (see Figure 4.3 and Figure 4.4)

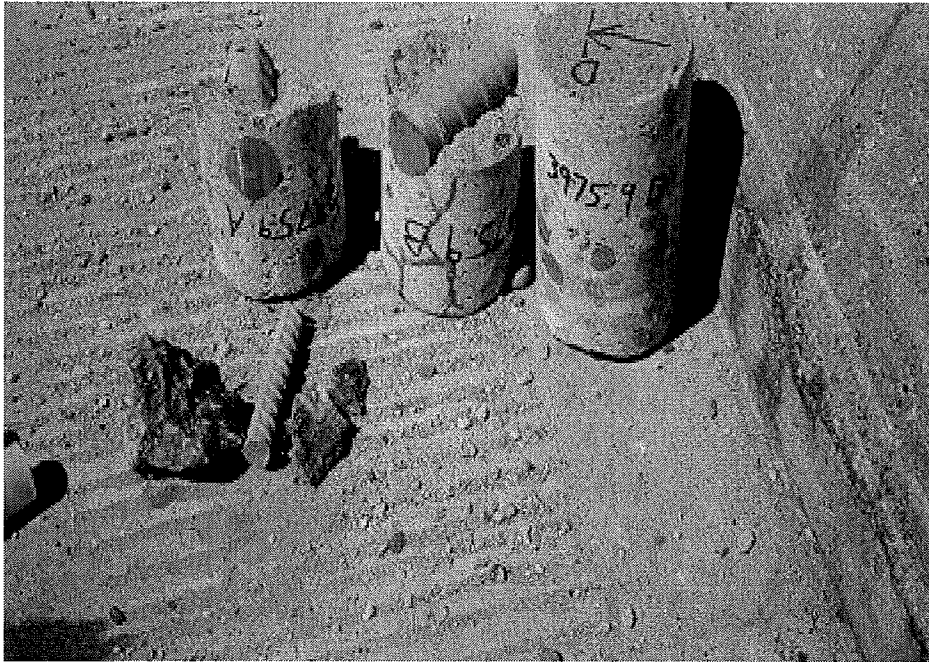
**Figure 4.5 Extracted Cores**

10. Record core's information on data sheet
11. Photograph extracted cores (see Figure 4.5) and record the film serial number on photograph log
12. Allow cores to be air dry and then place cores in a Ziplock bag that is marked with bridge ID.

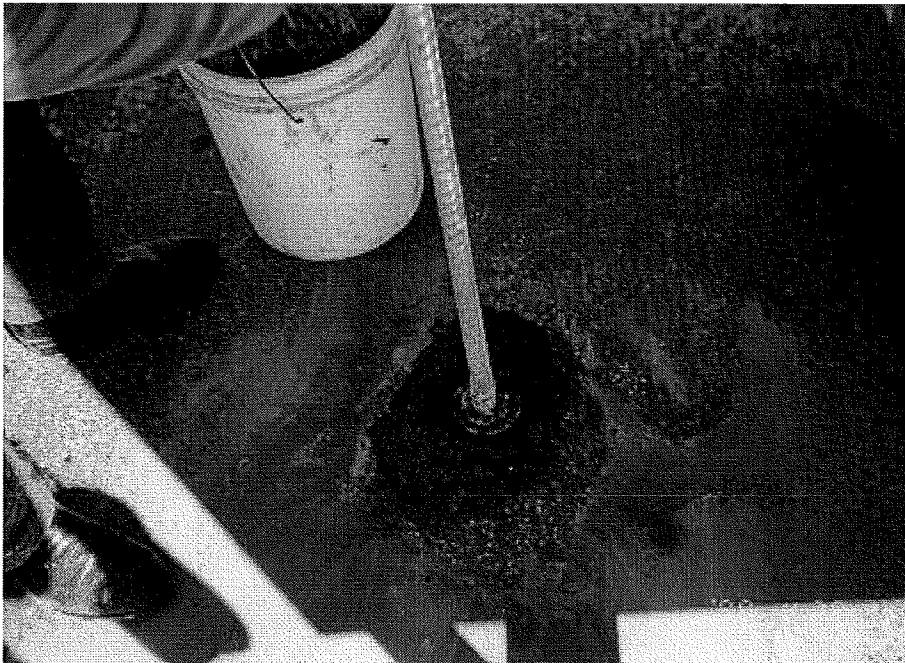
**Figure 4.6 Patching the Hole After a Core being Extracted**

13. Patch holes after coring and clean the worked area as necessary as shown in Figure 4.6

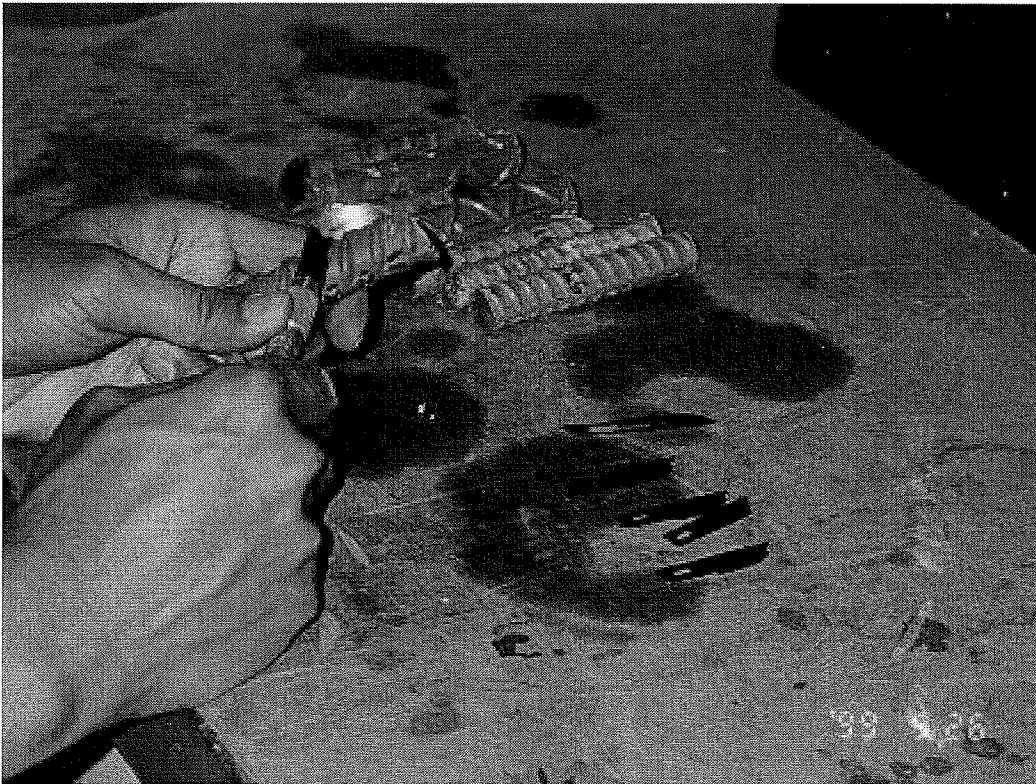
**Figure 4.9 Epoxy Coating Bond Test**

determine adhesion performance. An average of three attempts shall be used to rate the sample.

The epoxy coating was rated following the recommendation given in the Pennsylvania Department of Transportation study [35]. Table 4.1 summarizes the description of each bond rating value recommended by Ref. [35].

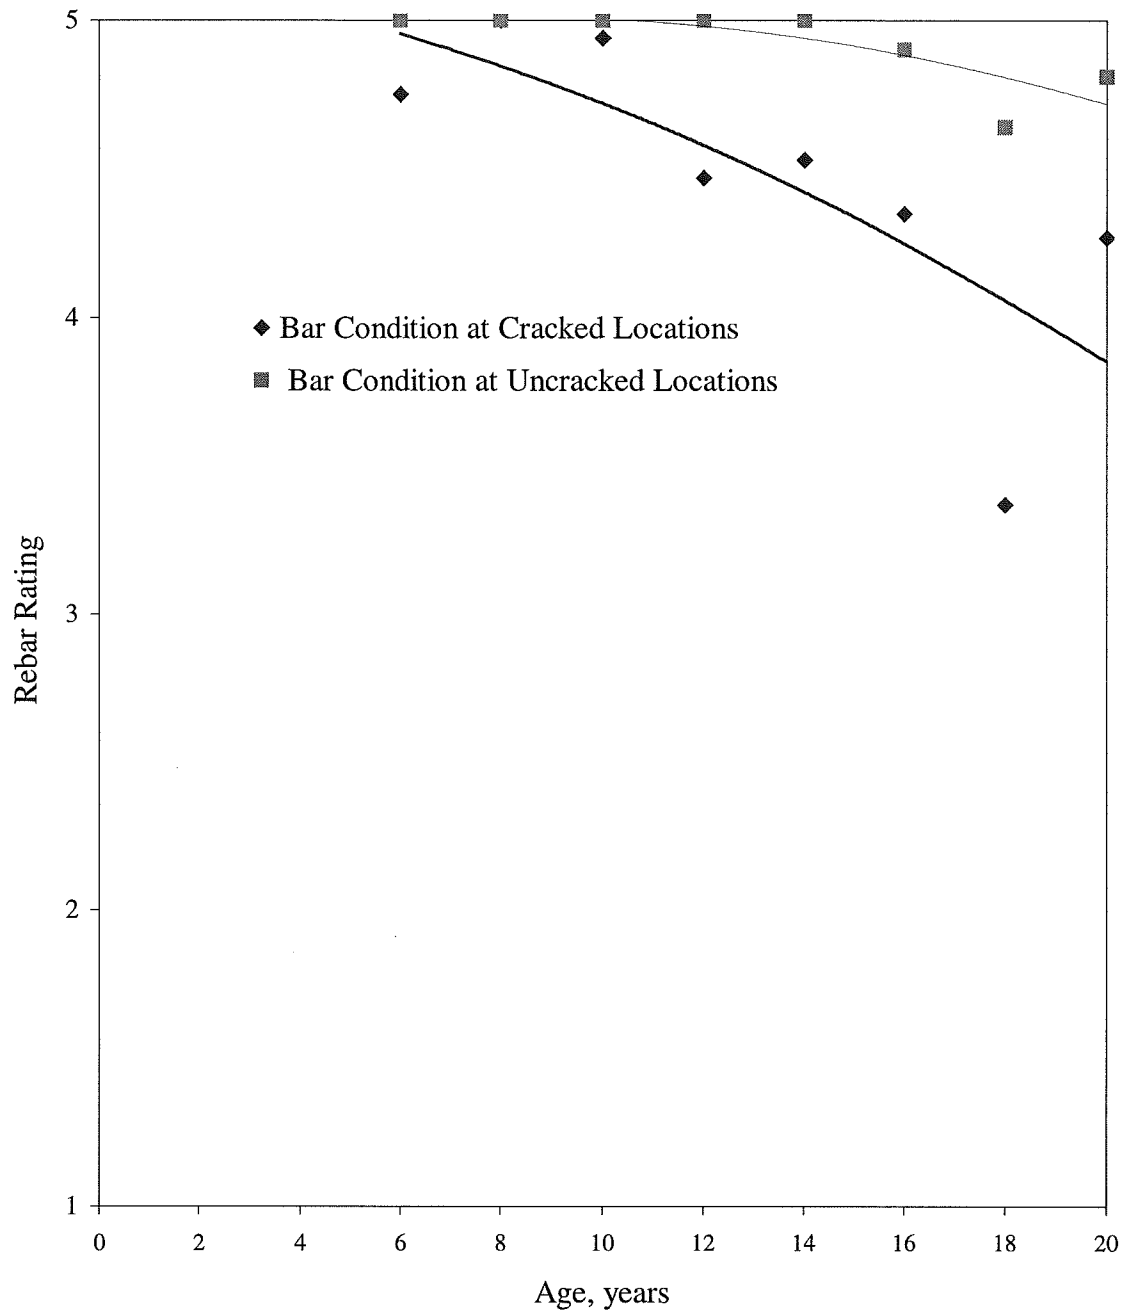
**Figure 6.4 Rebar Rating vs. Age (Equations 6-6 and 6-7)**

The relationships in Equations 6-4 through 6-7 can be employed to estimate the effect of deck cracking on ECR conditions in bridge decks in the state of Iowa. For example, let condition 2 represent the rating condition at which corroded ECR will result in delamination and spalling of the concrete. Utilizing this assumption in conjunction with these relationships, one can estimate the time it takes an ECR located at cracked and uncracked locations to reach such a condition. In this example, Equations 6-4 and 6-5 yield approximately 32 and 53 years for an ECR to reach condition 2 at cracked and uncracked locations respectively. Whereas Equations 6-6 and 6-7 yield 34 and 46 years respectively.

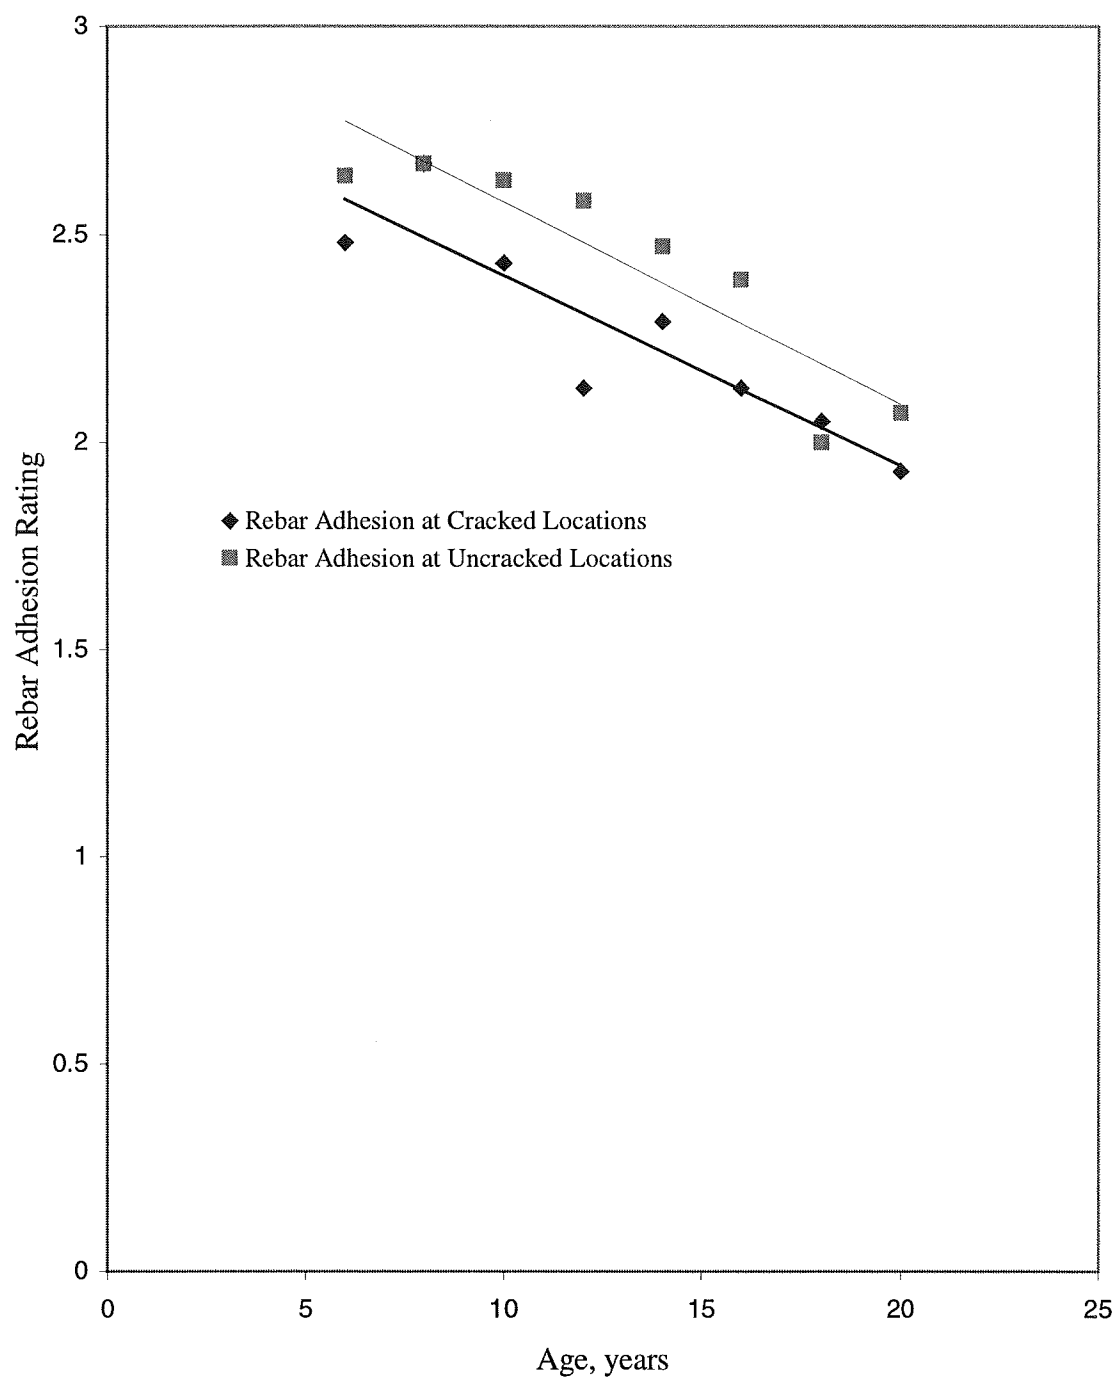
**Figure 6.5 Rebar Adhesion Rating vs. Age**

The approach described in Section 6.1 was utilized to determine the deterioration of the adhesion of the coating of the ECR in the state of Iowa. Figure 6.5 illustrates how the adhesion was decreased as time increased.

As can be seen, rebars collected from cracked locations were less bonded than that of uncracked locations. This revealed that the moisture and the high chloride concentration at cracked locations could be the factors attributed to the disbondment of coating.
