# Precast concrete bridge barriers for accelerated bridge construction

Ashley A. Ecklund  
*Iowa State University*

Ecklund, Ashley A., "Precast concrete bridge barriers for accelerated bridge construction" (2019). *Graduate Theses and Dissertations*. 17008.  
<https://lib.dr.iastate.edu/etd/17008>

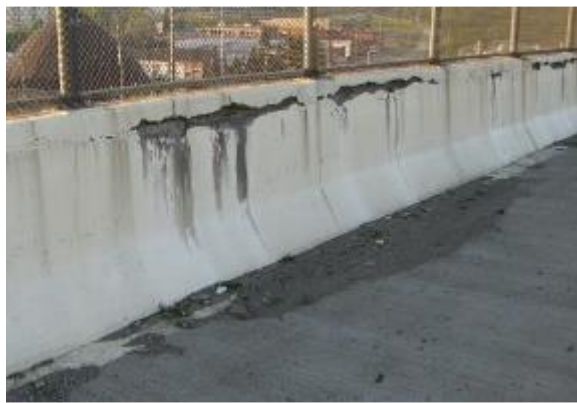
**Figure 1.1** Cast-in-place barrier requiring maintenance (*Courtesy of T. Capuano*)

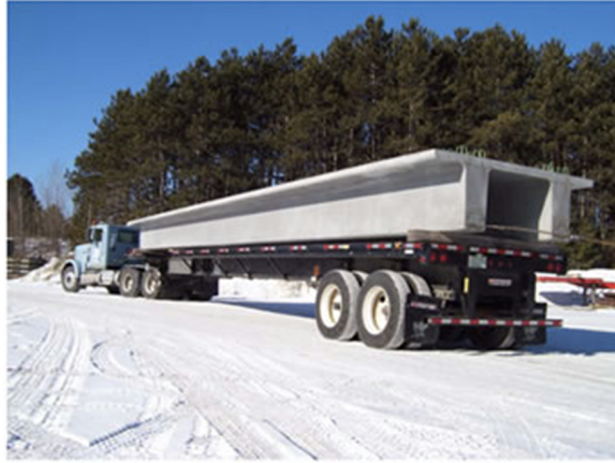
**Figure 1.2** Prefabricated bridge element (*Courtesy of FHWA*)

With ABC, the bridge components are built outside of the traffic area and then transported to the bridge site where they can be installed quickly (see Figure 1.2, Courtesy of Federal Highway Administration [FHWA]). This will help reduce the onsite construction time, weather-related delays, and impacts to traffic, while improving worker safety. Prefabricated elements and systems include decks, girders, piers, columns, and abutments. Prefabricated concrete bridge barriers are an emerging prefabricated element that will assist in reducing onsite construction time and traffic impacts. With more research and development, prefabricated bridge barriers may also improve bridge safety with appropriate anchorage details and construction quality while providing a viable alternative for easy repair of a damaged barrier.

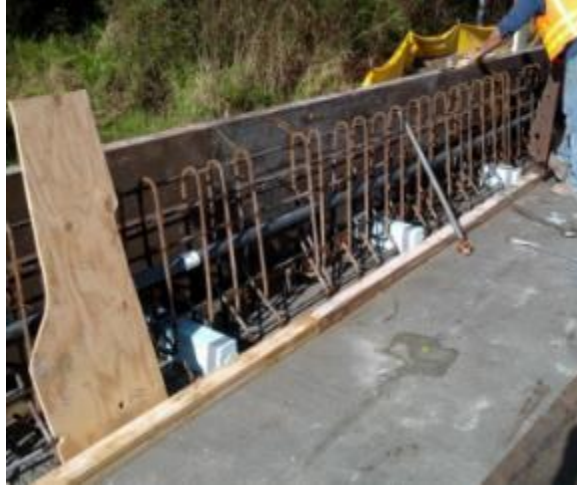
**Figure 1.5** Rock Ridge Road barrier after adding additional reinforcing (*FDOT 2014 Design Training Expo*)

in-place. A portion of the rebar was built into the deck slab unit, Figure 1.4, and bent to be integrated with the concrete barrier reinforcing as shown in Figure 1.5.

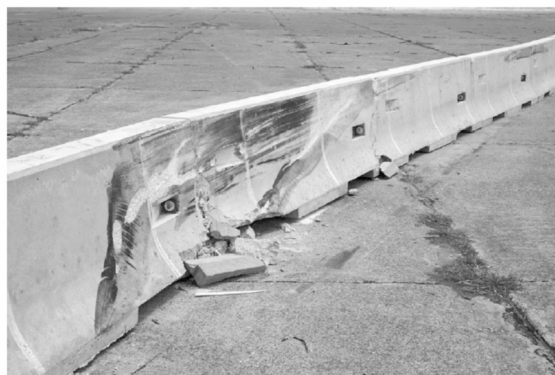
**Figure 2.12** Damage to 10-ft long prefabricated barrier with X-Bolt connections (*TTI, 2005*)

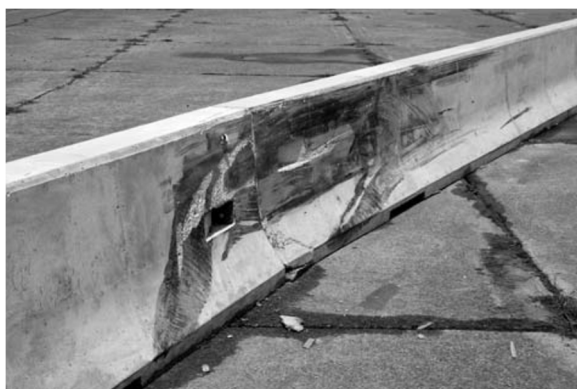
**Figure 2.13** Damage to 30-ft long precast barrier with X-Bolt connections (*TTI, 2005*)

The second test had the same barrier and connection details, but the test installment included seven 30-foot barrier segments for a total length of about 210 feet. The pickup truck used for this experiment was 4531 lbs. The damage resulting from the vehicle impact is shown in Figure 2.13. After the test, the connection bolts could easily be removed and possibly reused. The maximum deflection experienced by the system was 19.0 inches.

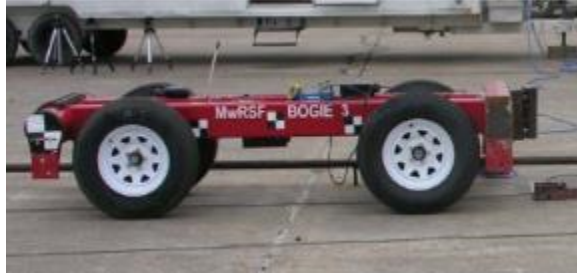
**Figure 2.14** Impact bogie vehicle (*MWRSF, 2012*)

The Midwest Roadside Safety Facility (MWRSF) and the University of Nebraska, Omaha conducted a study with an objective of developing an aesthetic precast concrete bridge rail. This study examined six different dry joint design details and three different grouted joint design methods. Two of the most promising details were selected to be tested using a dynamic impact bogie vehicle shown in Figure 2.12

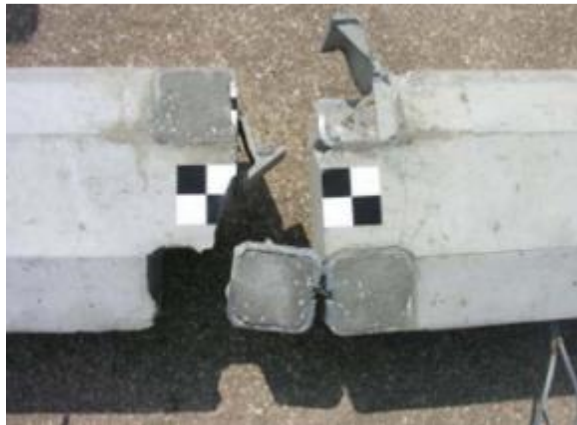
**Figure 2.17** Failed MWRSF I-Shaped rail connection (*MWRSF, 2012*)

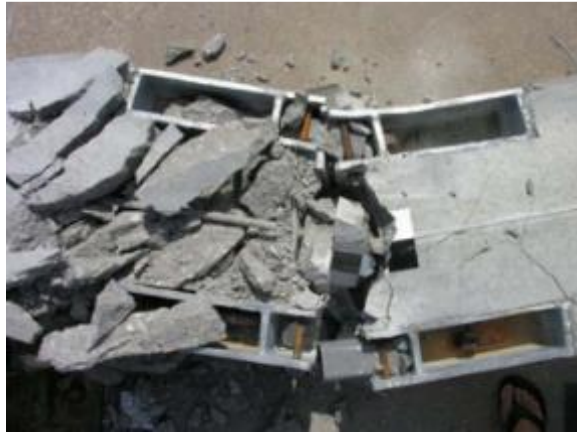
**Figure 2.19** Side bolt and shear tube connection failure (*MWRSF, 2012*)

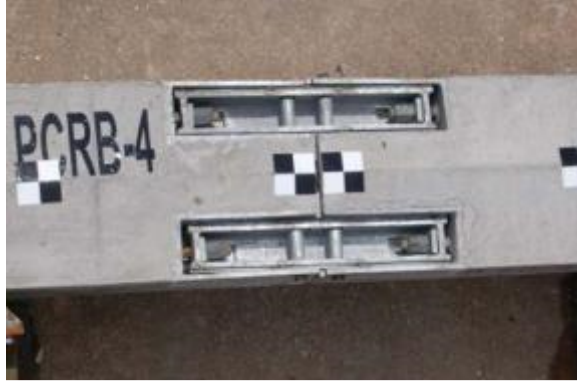
**Figure 2.24** Side bolts and shear tube connection improvements (MWRSF, 2012)

The side bolt and shear tube connection were modified in a similar fashion. The longitudinal steel size was increased to a threaded no. 8 bar, the steel tubes were cut to form U-shaped pieces, the size of the joint pockets increased, and shear bolts were added. See Figure 2.24 below. The testing results of this joint proved that the connecting threaded rods were too weak and failed at a load just over 60 kips. Resulting damage is shown in Figure 2.25.

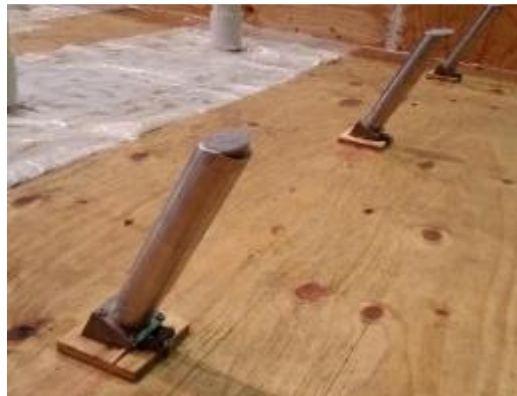
**Figure 4.7** Connected inclined receiving end piece to the deck formwork

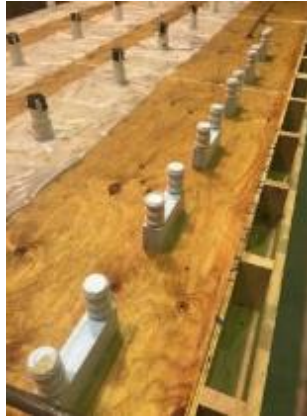
**Figure 4.8** Deck block outs to facilitate U-bar installation

As noted, the u-bars for the PBU connection are inserted from the underside of the overhang into pockets in the bride deck. Cutouts were made, and proper blockage was established before pouring the deck concrete. The block outs of these access pockets are shown in Figure 4.8.

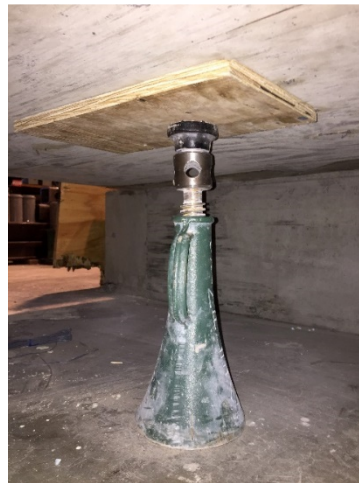
**Figure 4.20** Sealed U-bar pocket for grouting

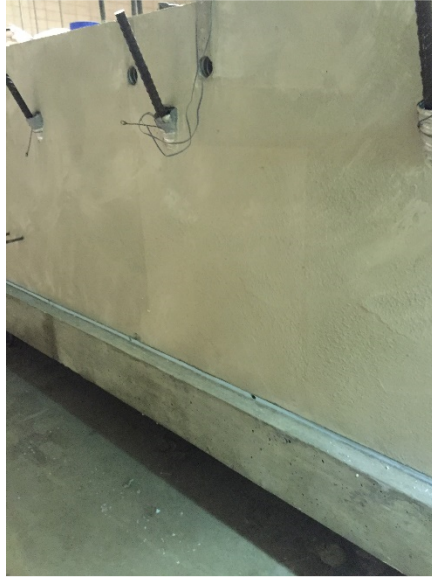
**Figure 4.21** Foam added to grout pad to minimize damage cover concrete

After the bars were in place, the grout pad between the overhang and the barrier was poured. In this case, the grout pad had a depth of three-quarter inch. Also, a foam was placed under the barrier three quarter inches from the back side to limit the damage to the barrier during the push test, shown in Figure 4.21.

shown in Figure 4.21, was grouted as well. To improve aesthetics, the exposed bars can be cut flush with the back side of the barrier.

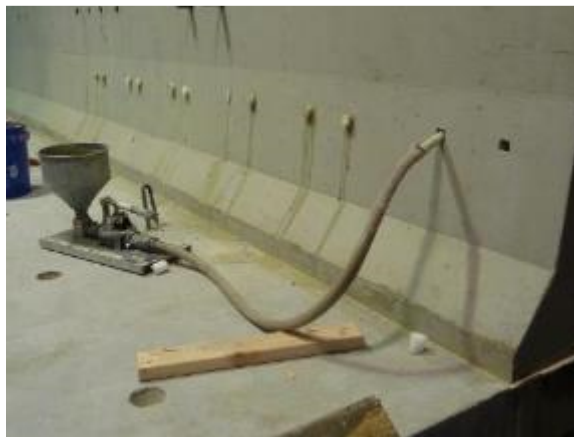
**Figure 4.22** Grouting of U-bar pockets

The corrugated tubes in PBU were grouted through the inlet until it filled the u-bar pocket and began to outflow through the outlet hole on the front face of the barrier, see Figure 4.22. The finished underside of the u-bar pocket is shown in Figure 4.23.

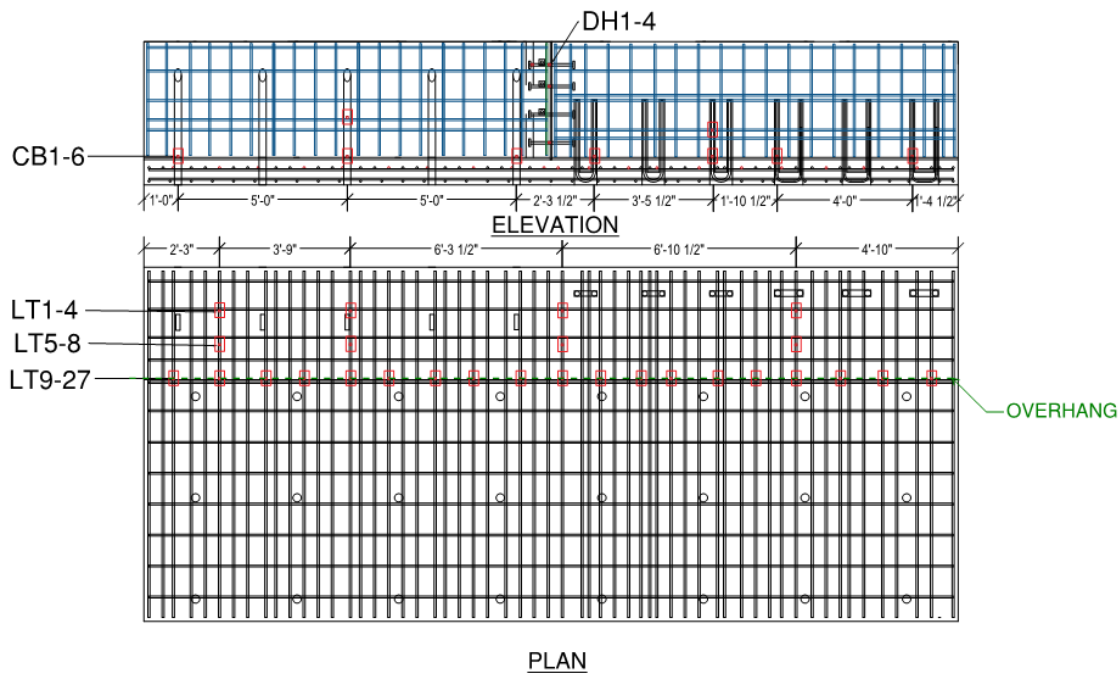
**Figure 4.26** Location of strain gauges in barrier connection reinforcement and top deck reinforcement

deck reinforcing bars (LT1-27). The strain gauges were applied to the barrier to deck connections near where the load applications would occur. The dimensions to each gauge can be seen in Figure 4.26. There were four strain gauges placed on the double headed transverse bars. DH1 was applied to the PBI side of the bar. DH2-DH4 were placed on the center of the bar at the barrier to barrier interface. There were three rows of gauges on the top deck reinforcing bars. Dimensions to LT1-8 are shown in Figure 4.26. LT9-LT27 were located at the beginning of the bridge deck overhang, roughly 42 inches from the edge of the deck slab. Gauges were attached every three to four reinforcing bars.

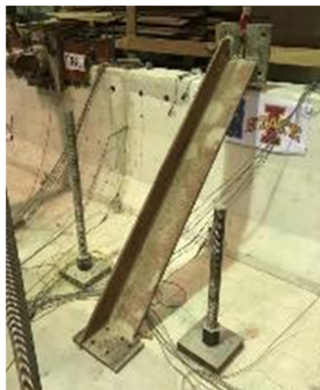
**Figure 5.2** Brace Beam

PBI was subjected to the desired target force of 54 kips during Test 1. During Test 2, PBU experienced premature failure and thus the test was terminated after applying 36 kips. Test 3 conducted at the center barrier-to-barrier connection was tested to the desired target force of 54 kips, followed by an additional load step of six kips to further evaluate the connection performance. In order to protect any more damage occurring to PBU during Test 4, which was conducted on the PBI side of the barrier-to-barrier connection, a brace beam was added to the test unit to limit the deflection of PBU, see Figure 5.2. This explains the increased stiffness seen in Test 4 in Figure 5.1.

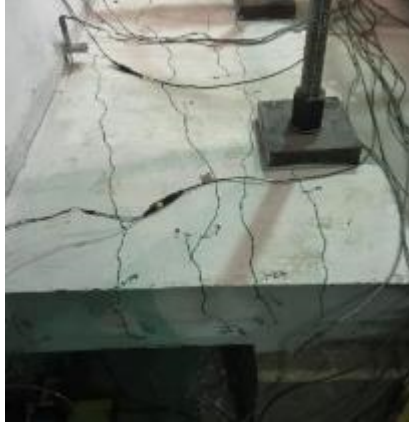
**Figure 5.4** Test 1 - Formation of flexural cracks on the deck overhang

The loading block and actuator were set up to apply the load at the center of PBI at the top of the barrier over 3.5 ft length. The first two load increments produced no visible cracks on the test unit. The deck began to crack as the applied load approached 18 kips. The initial flexural cracks were noticed on the bridge deck overhang, as seen in Figure 5.4; three

somewhat uniformly spaced flexural cracks were formed on the deck overhang and they were visible along the entire length of PBI. The lateral deflection at the top of the barrier was 0.105 inches after applying 18 kips.

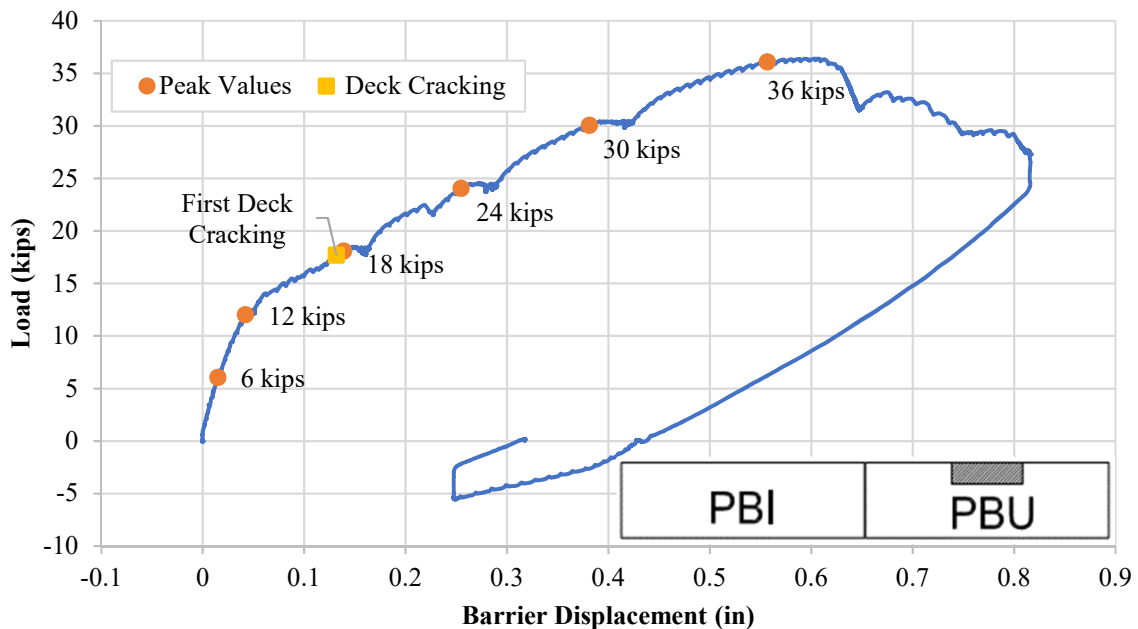
**Figure 5.13** Lateral vs. force displacement obtained for Test 2 – PBU

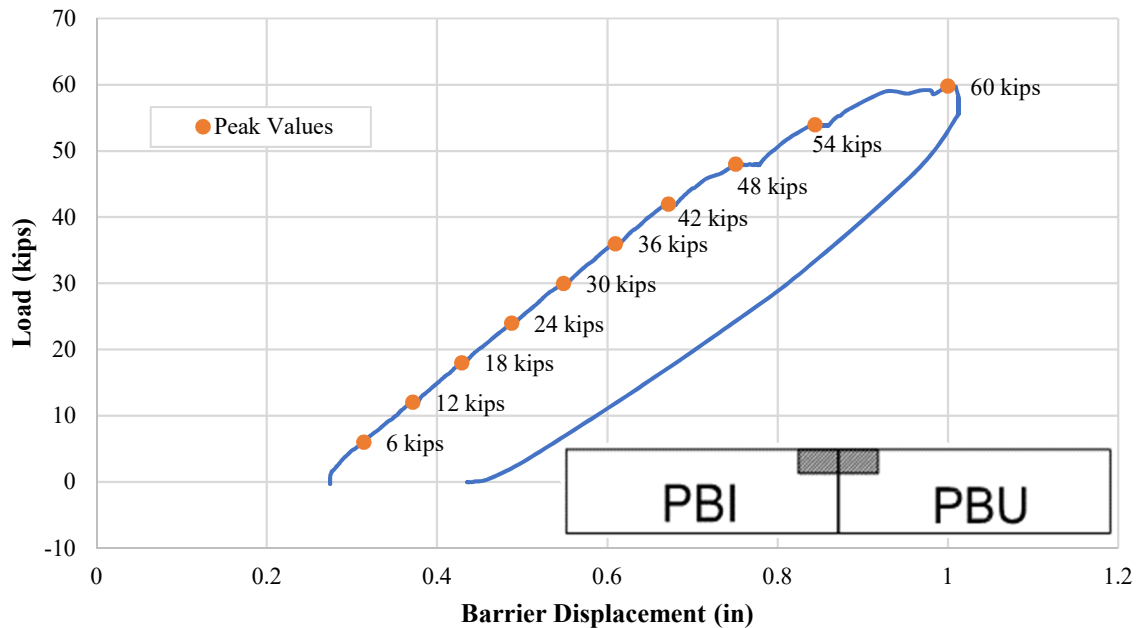
**Figure 5.19** Force-Displacement response obtained for Test 3

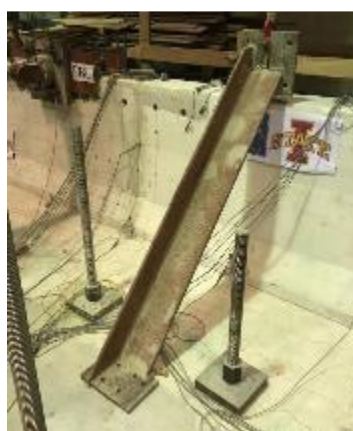
**Figure 5.24** Beam used to brace PBU with respect to the deck during Test 4

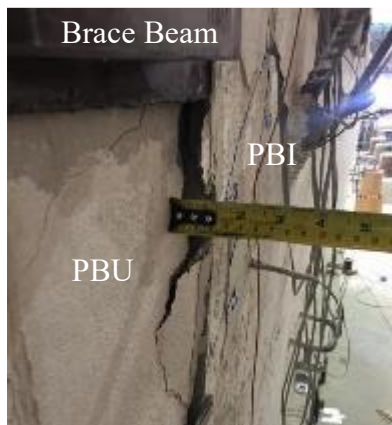
**Figure 5.29** Difference in barrier movement at barrier to barrier connection at the maximum load during Test 4

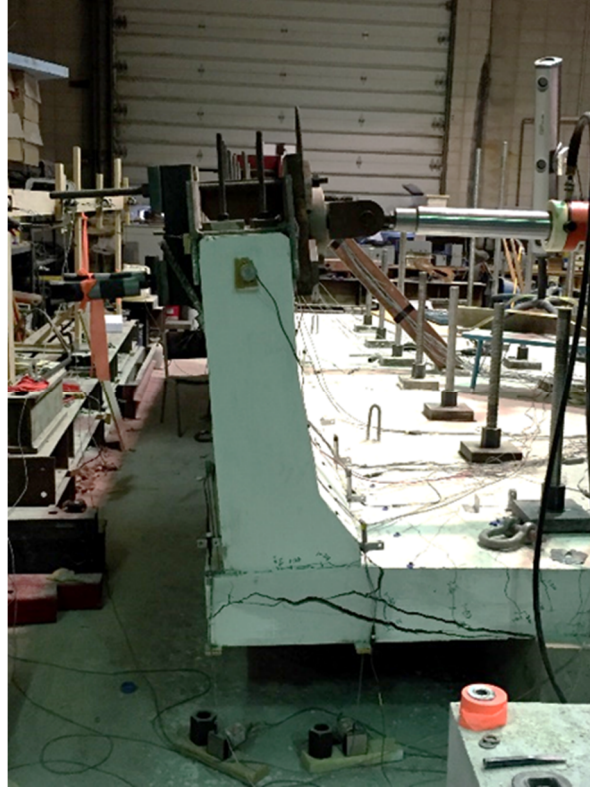
**Figure 5.33** Final barrier deflection and cracking in bridge deck during push direction loading in Test 5

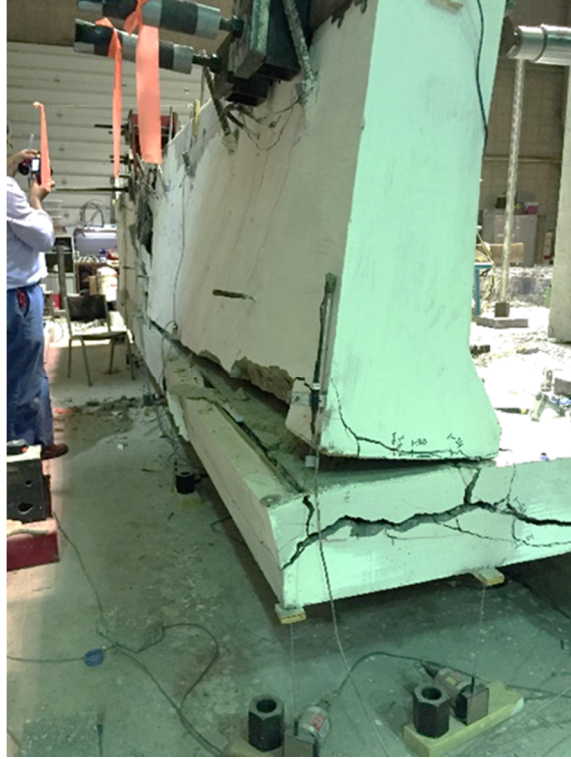
**Figure 5.34** Damage to barrier and deck after Test 5 pull test

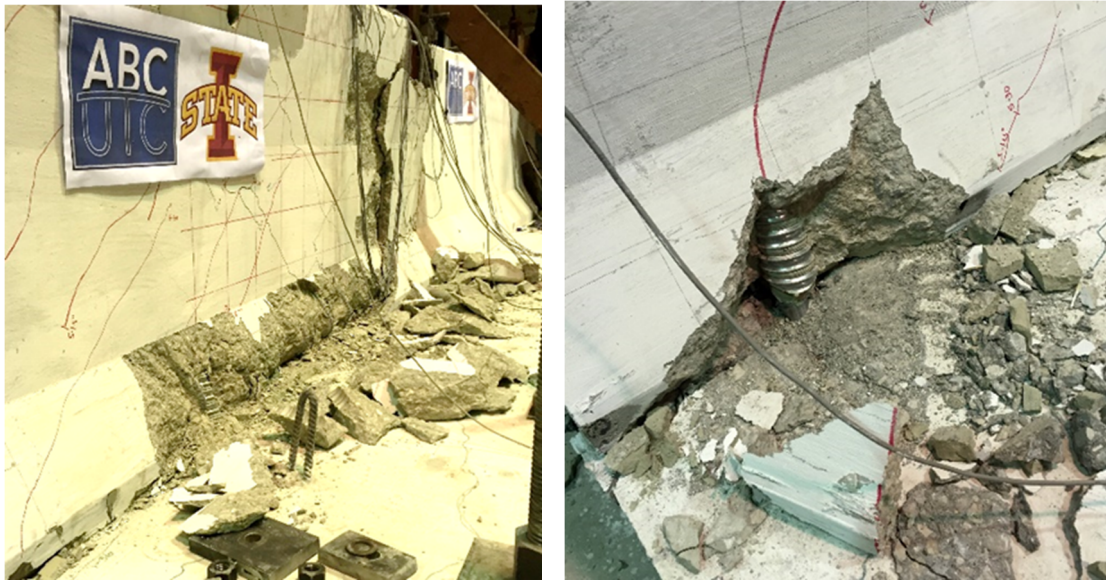
**Figure 5.36** Concrete spalling on front of PBI at deck interface and barrier to deck connection

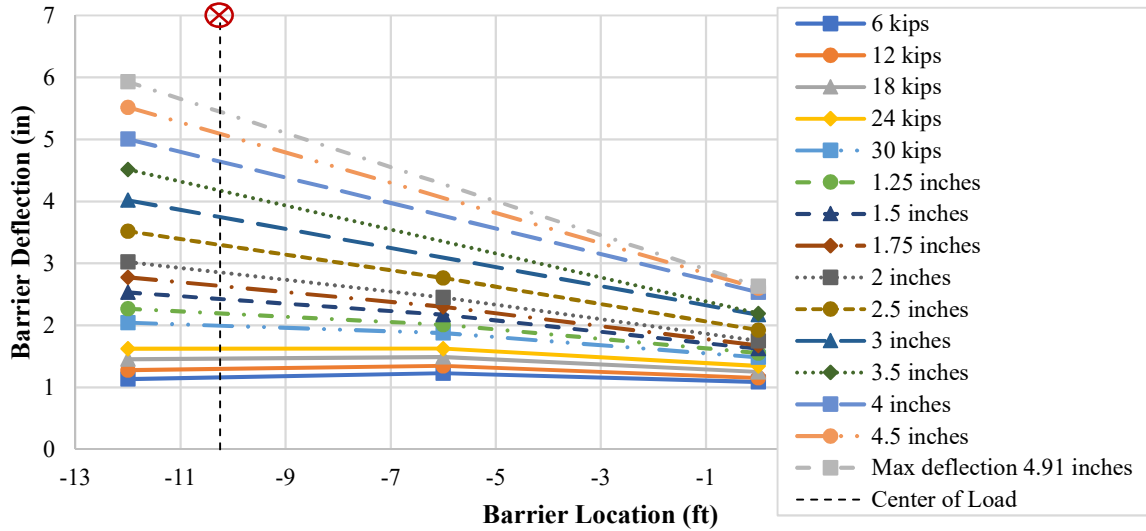
**Figure 5.38** Deflection at the top of the barrier during Test 5

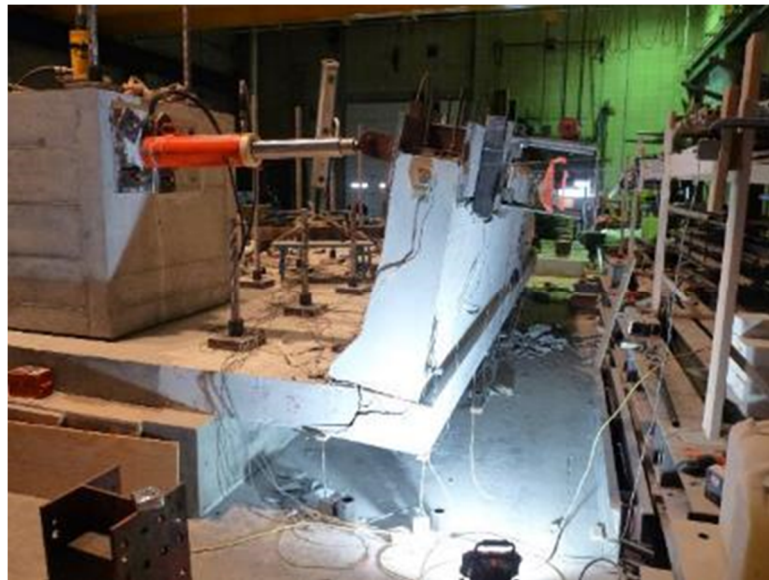
**Figure 5.40** Final barrier deflection and the corresponding damage to the bridge deck during Test 5

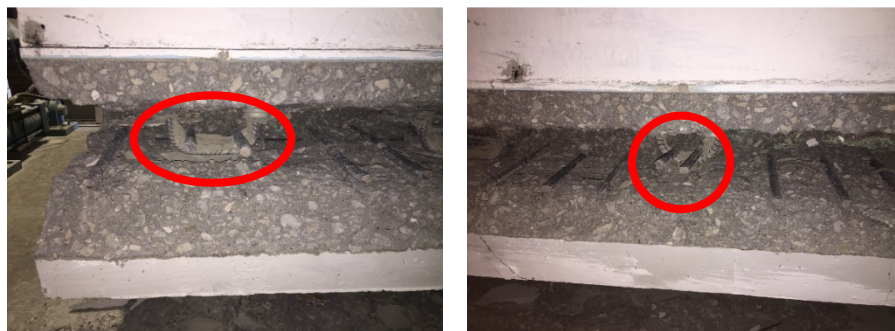
**Figure 5.41** Top matt of the bridge deck reinforcement after the Test 6 pull test
