RESTORATION AND PRESERVATION OF ENGRAVED LIMESTONE BLOCKS DISCOVERED IN ABU MOUSA EXCAVATION, SUEZ- EGYPT

Abstract:

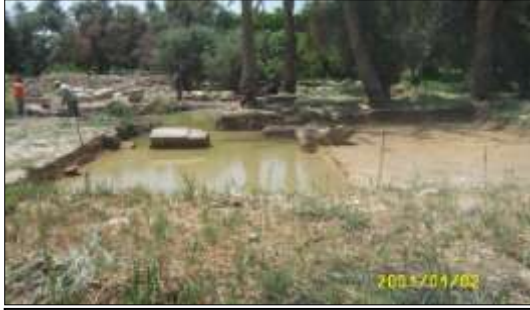
Figure 1 shows the Abu Musa Excavation during 2001 season.

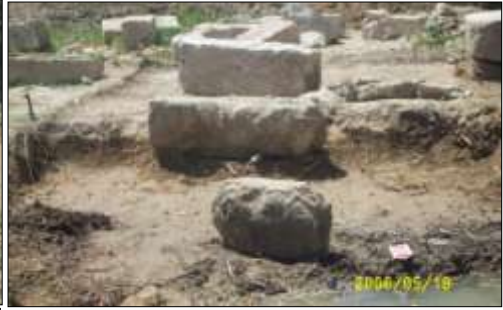
Figure 2 shows the Abu Musa Excavation during 2006 season.

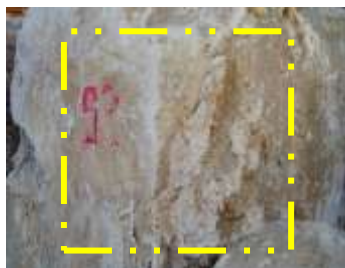
Fig. (5) Crystals of soluble salts pushing off a surface layer of stone.

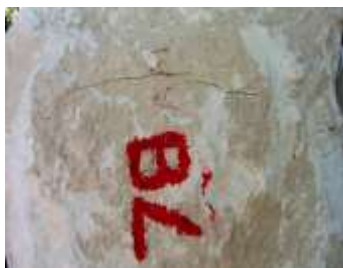
Fig.(6) shows the cracks and microcracks.

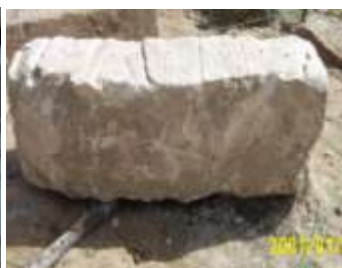
Fig. (7) powdering/crumbling of the engraving stone due to salts efflorescence.

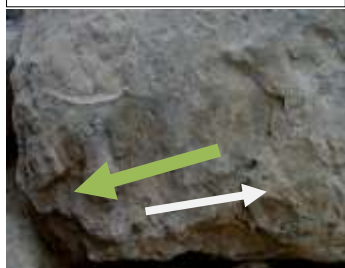
Fig. (8) Exfoliation of the engraving limestone in Abu Musa Excavation.

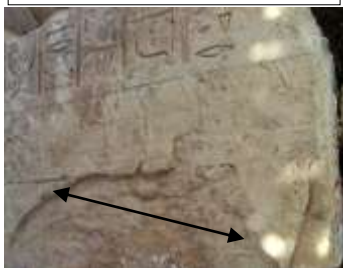
Fig. 9 shows the disintegration of the engraving limestone.

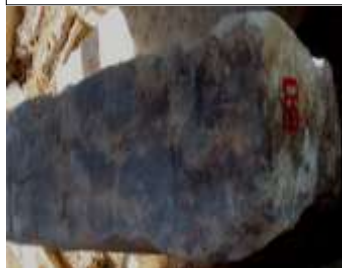
Fig. (10a,b) discoloration of the engraving limestone in Abu Musa Excavation.

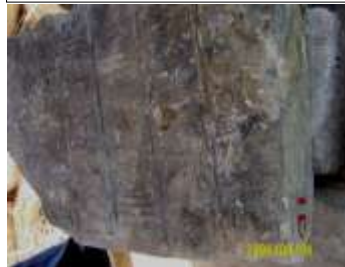
the accumulation of black to dark-colored crust tracing the surface and brown, green and white stains of microorganisms caused the discoloration of stone surface (fig.11). Black rust was found in the surface of some limestone blocks (fig.12). All stone blocks surfaces were covered with thick clay layer with soil particles and vascular plants. Roots are growing which disfigured them and hid their reliefs (fig.13). The deterioration caused by plants is both mechanical and chemical. In this case the chemical action is influenced. The chemical action is due to the acidity of the root tips and the acidity and chelating properties of the exudates. Certain plants, for instance ivy, can also cause a change in stone color as a result of the release of organic compounds ⁽⁵⁾. Also the main weathering forms characterizing deposits on the stone blocks were the growth algae. These are in fact extremely simple plants which live in very damp places or in water. They appear as greenish or brownish slimes or suspensions in water; a sudden increase in their numbers gives a dense bright coloration known as a bloom (fig.16).

Fig. (11) Microbiological colonization to dark-colored crust tracing the surface of reliefs.

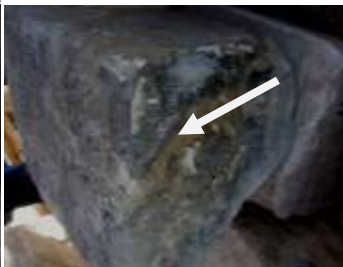
Fig. (12) Black rust found in the surface of some limestone blocks.

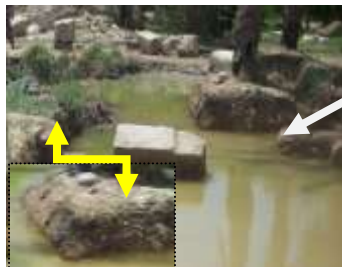
Fig. (13) Stone blocks were covered with thick clay & soil particles and vascular plants.

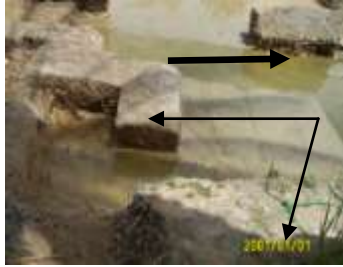
Fig. (14) Growth of algae as greenish, brownish slimes at stone blocks.

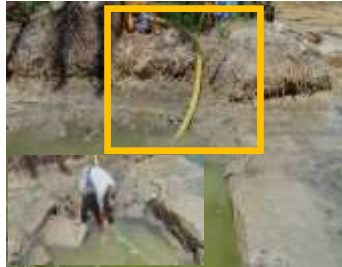
Fig. (15) The process of water suction suddenly from the area of Abu Musa

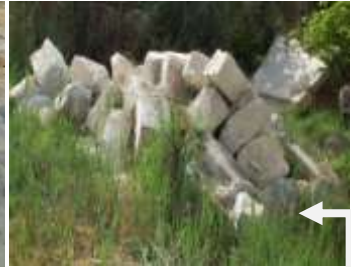
Fig. (16) Wrong storage between grass and areas of high humidity

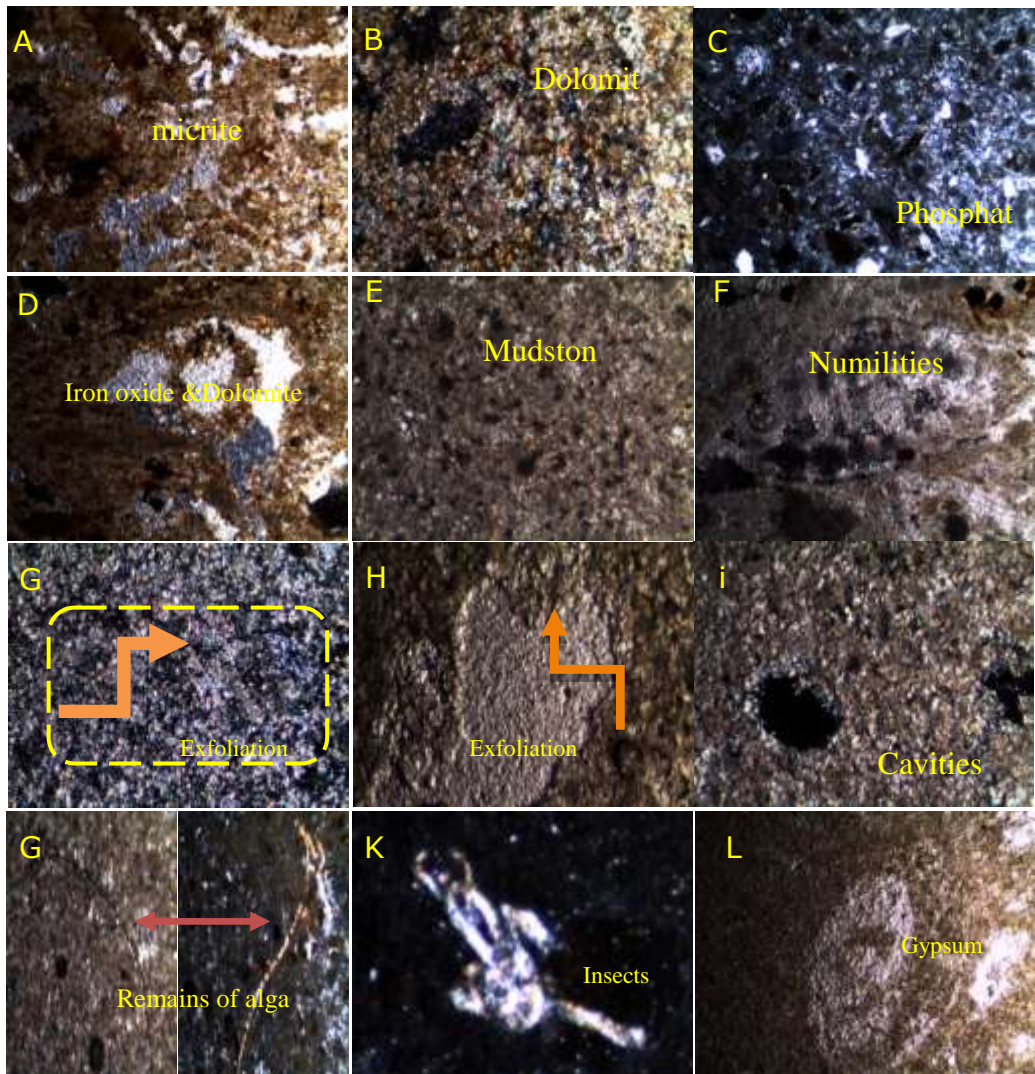
The examination of thin sections of the limestone samples under plan polarized light microscope (PLM) revealed that, the limestone consists of fine grained calcite (micrite), iron oxides, dolomite, fossil fragments, phosphate, clay minerals and some fine grained quartz. Also micrographs revealed deterioration aspects such as, micro-exfoliation of calcite grains, cavities and cracking in calcite grains, remains of alga, insects, and Gypsum crystals. The micro cracks, halite and gypsum crystals related to weathering processes, all of these features are shown in figure (17 a-l).

Figure(17) The examination of the limestone samples under polarized microscope shows **a** fine grained calcite (micrite), **b** Dolomite and iron oxides, **c** phosphate, **d** iron oxide and dolomite **e** mudstone **f** Numilities, **g,h** micro-exfoliation of calcite grains, **i** cavities and variety of cracking in calcite grains **g** remains of alga, **k** remains of insects, **l** Gypsum crystals.

Plan polarized light microscope (PLM) displayed that; the micrite is the main component of limestone cemented by sparry calcite. Amount fossil fragment, Numulities and insects embedded in a micrite matrix. Remains of remainder of micritized red alga are also observed. Opaque minerals and shapeless aggregates that coated by ferruginous martial are also observed. Impregnating ferrous substances are probably responsible for the reddish color of some limestone blocks. Dolomite crystals are also noticed in the sample (M3). Numerous grains of Quartz are found, occurring as sub-rounded to angular grains. Slide showed the intrusions of Gypsum. Phosphate crystals are noticed in the sample (M5). The photographs showed an increase in porosity, more micro-cracks and micro-exfoliation within the thin section, this increase the rate of stone decay, (fig15,16).

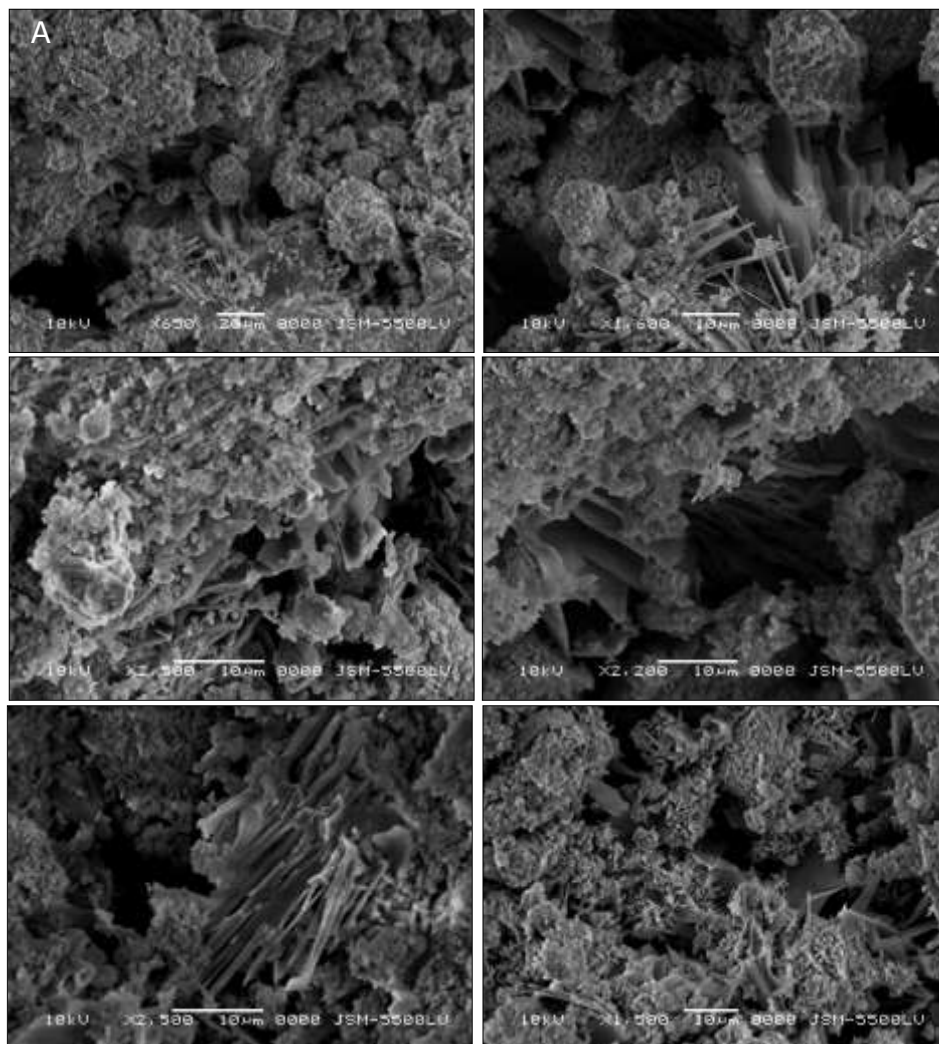
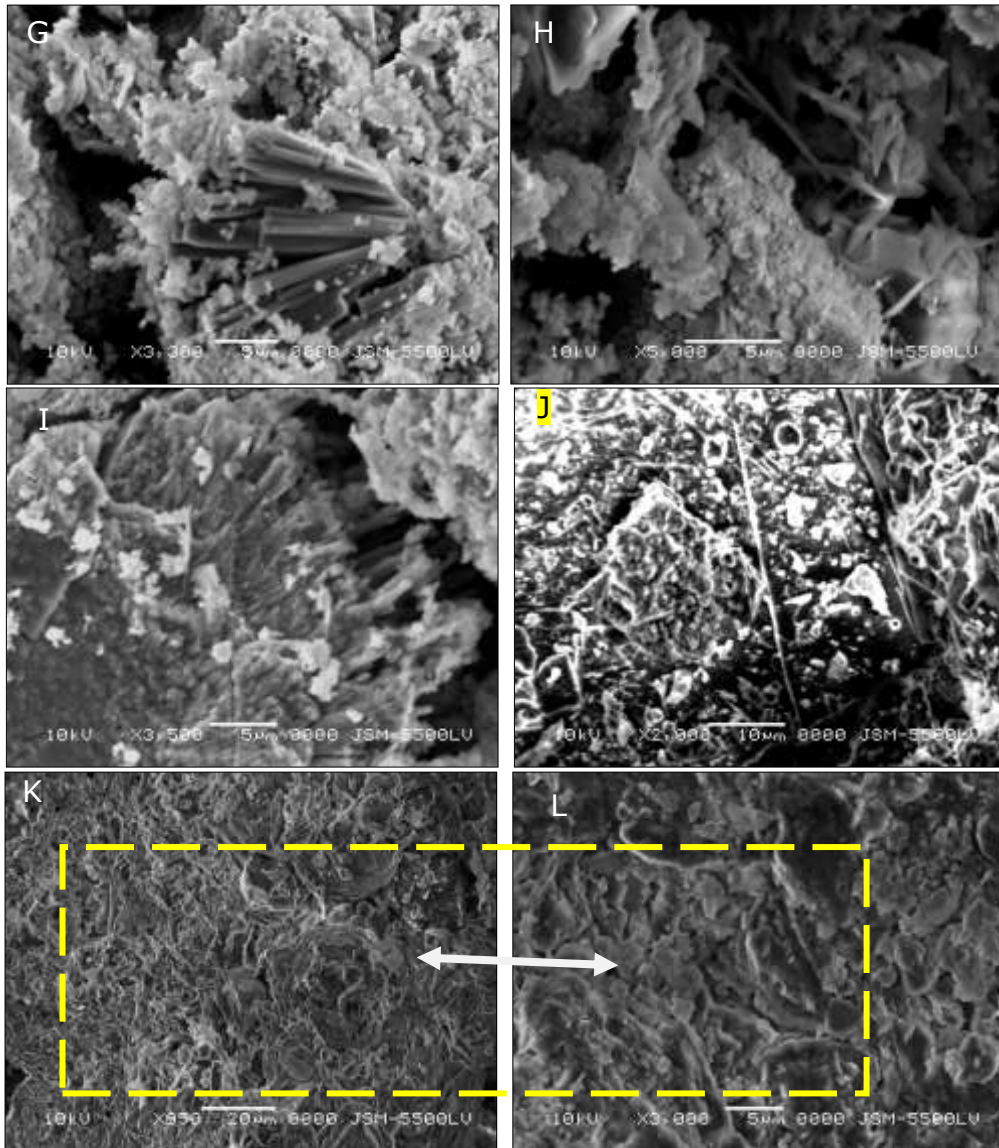
The scanning electron microscope results confirm that a major deterioration is the abundance of soluble salts in the rock. SEM photomicrographs show that there is wide range of deterioration features as shown in (Fig.18a-l) such as disintegration

between calcite crystals. Dissolution of some parts of calcite crystals and loss in the binding materials between grains by the effect of salts crystallization, dusting, small fissures and cracks, localized cavities, the clay minerals is also exiting among the calcite grains; also, it showed the content of gypsum in the samples is due to the transformation of calcite into gypsum. Scanning study also indicated growth of hyphae of fungi and remains of alga.

Figure (18) SEM micrographs of deteriorated stone reliefs in Abu Musa excavation, **a** Cracks, pitting and losses of cohesion between grains **b** Different salt crystals such as halite and Gypsum; **c** Destroyed and dissolution of calcite crystals **d** gypsum crystals **e** Halite crystals occur as blocky shaped and rectangular crystals **f** A variety of cracking patterns in calcite grains. **g** Gypsum and halite salts grow on calcite cleavage plane and dissected it into several flakes **h,I** Many cracks and separation of scales from the rock as a result of gypsum and sodium sulphate salts. **J** growth of hyphae of fungi, **k,l** collapsed of grains and micro exfoliation of the calcite grains.

SEM photomicrographs showed disintegration between calcite crystals. Lose in the binding materials between grains by the effect of salts crystallization. Decayed samples show etching features in some calcite grains indicating micro-dissolution processes (chemical weathering). Carbonate cement dissolution and subsequent calcite recrystallization are also observed. Halite crystals are found in glassy shape. Observation by SEM also showed destroys of calcite grains, droplets of halite mixed with clay minerals crystals. Gypsum in white crusts accumulates below the surface of the crust was detected. This suggests that reprecipitation takes place on moisture exposed surfaces where white crusts are forming after gypsum dissolution. SEM observation indicated the hyphae of micro-organisms.

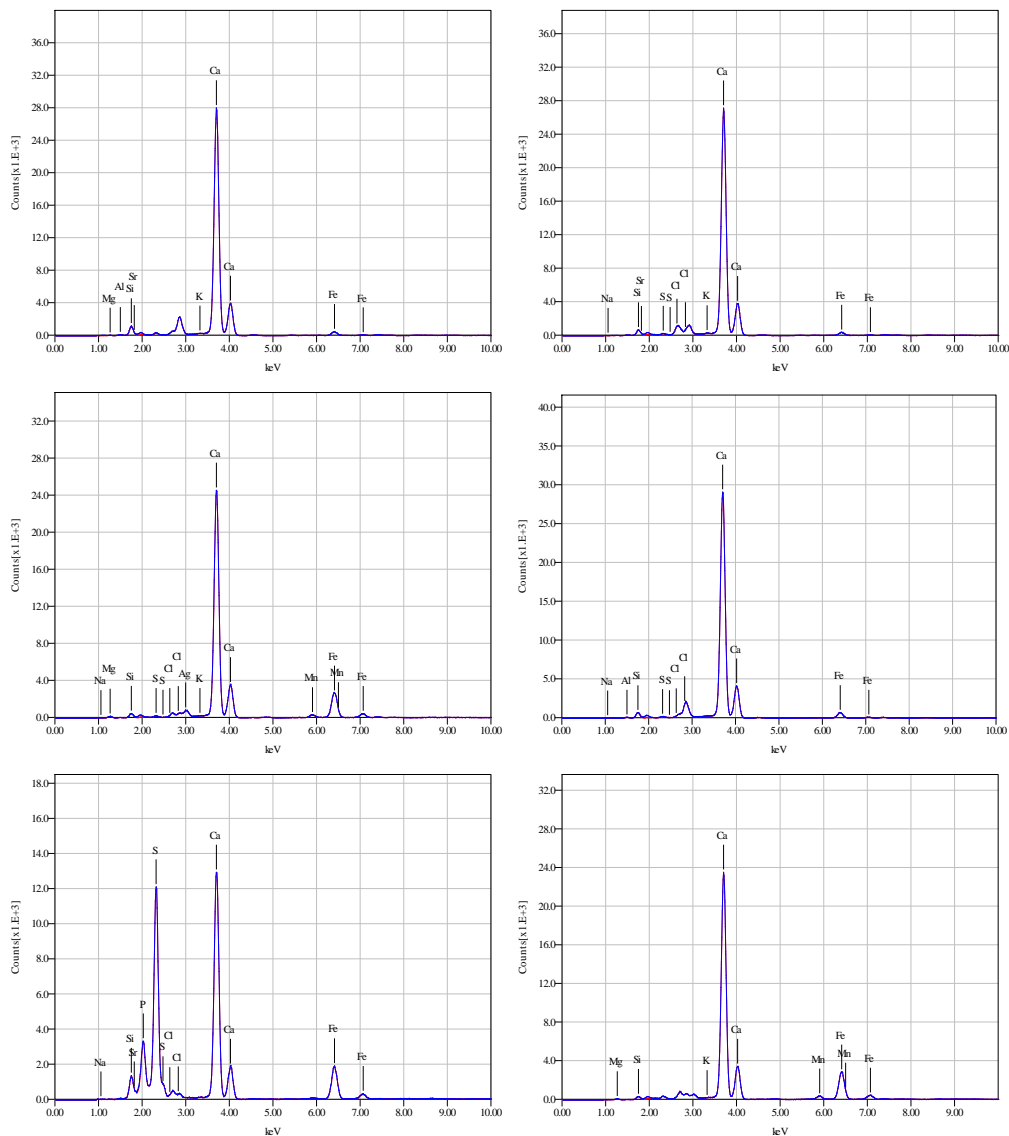
EDX microanalysis of various samples listed in (figure 19 and table1) showed that, the samples essentially consist of calcium (Ca), silicon (Si), sulfur (S), chlorine (Cl), sodium (Na), magnesium (Mg), aluminum (Al), potassium (K), iron (Fe), strontium (Sr), phosphates (P), manganese (Mn) and silver (Ag) potassium (K) and phosphorus (P). Ca as a main source of limestone samples is decreasing in all weathered samples compared (92.60, 90.90, 83.77, and 53.78). These variations may have been due to the ions exchange between the main components of stone samples and different salty ions present in groundwater. High concentration of phosphate (P_2O_5 5.84%), it attributed to phosphates salts, which was produced from fertilizers (ammonium phosphates) used in agriculture land of Abu Musa.

Figure 19 shows EDX patterns of the engraved limestone samples from Abu Musa excavation.

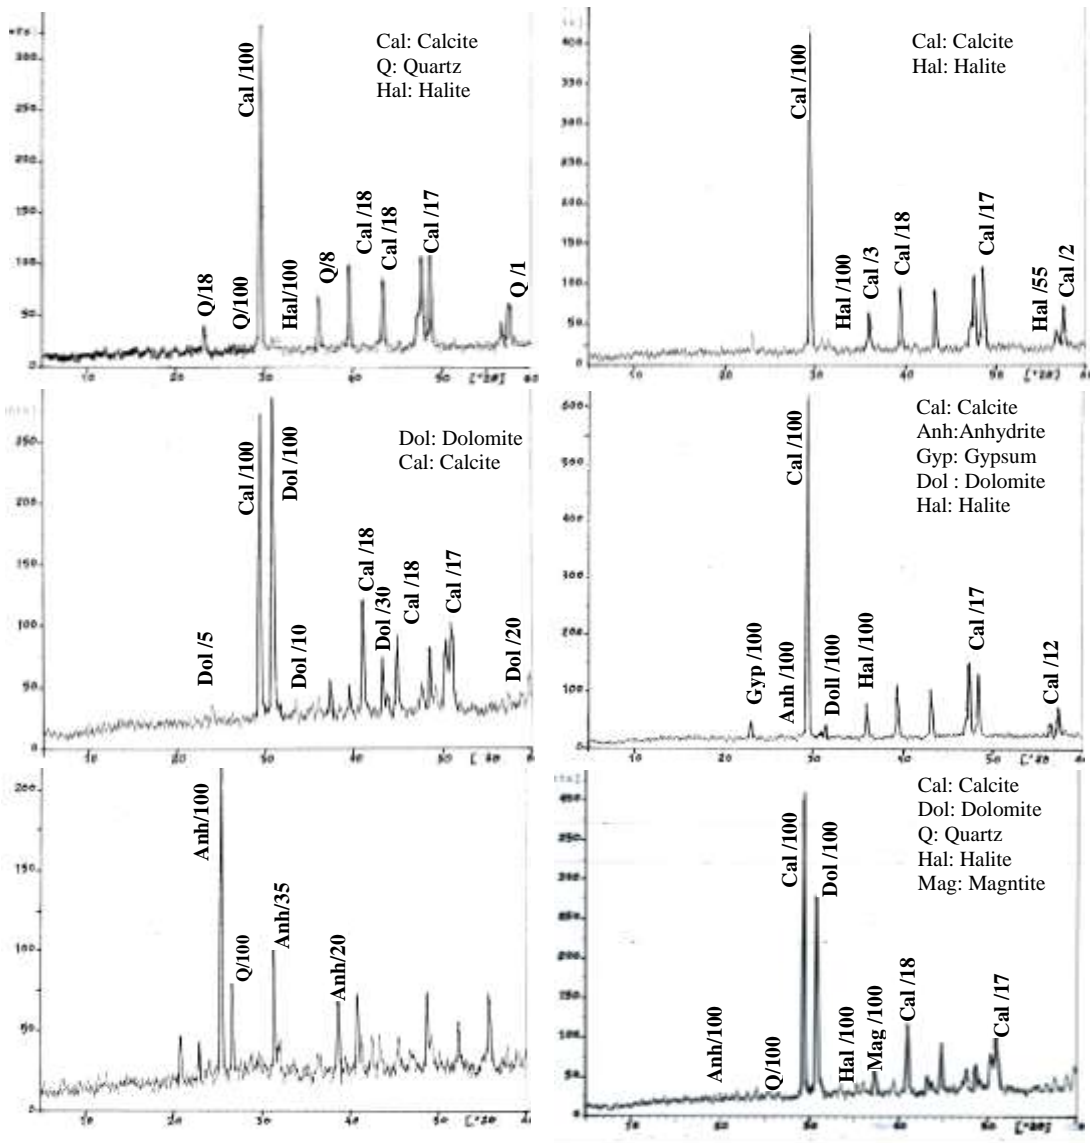
The XRD analysis of studied samples (the results are summarized in table 2 and figure 19) have shown that the, the sample consisted essentially of calcite CaCO_3 , Dolomite $(\text{Ca,Mg})\text{CO}_3$ and small amount of halite NaCl , Quartz SiO_2 , Gypsum $\text{CaSO}_4 \cdot 2\text{H}_2\text{O}$, Anhydrite CaSO_4 and traces of iron oxide and Orthoclase KAlSi_3O_8 .

Fig. (20a- g) show the XRD patterns of investigated limestone samples.

The mineralogical analysis using XRD of the limestone samples have shown that, the salt layers consists mainly of halite and phases of sulphates (gypsum and anhydrate). The halite salts related to groundwater salinity from Sues Canal and cultivated land. Gypsum was produced by the reaction between the SO_4^{2-} ions present in the acid deposition and the calcium carbonate ($CaCO_3$) present in limestone or perhaps it is a natural mineral in the stone, it is generally found in Abu Musa limestone in the form of dehydrated sulphate($CaSO_4.2H_2O$) Gypsum and Anhydrate ($CaSO_4$). The most important source of sulphate is atmospheric pollution, Agriculture land as Abu Musa region, sea sprat from Suez Canal and micro-organisms. Transformation of Gypsum to anhydrate by heating in summer causes a great change in the volume of the crystal of gypsum which decreases when transformed to anhydrite resulting in many cracks and microcracks in blocks, gypsum loses water after reaching $42^\circ C$ transforming into Anhydrite. So, the most common damaging salts consist of sulfate and chloride anions. The problem is more complicated by the existence of aluminum and Quartz may be attributed to the clay minerals. The SEM photograph documented these results. Also iron oxide is found in the samples as traces minerals; it could be argued that the fracturing form affected the samples exposed to salty bath contains due to the presence of the Fe ion, which leads to the creation of sever deterioration forms. These forms are due to the effect of alternative cycles between hydration and crystallization pressures created by the effects of contact with the oxygen and moisture in the open environment. This cycle leads Fe ions to change into hydrous iron oxide (the density is 7.8) which occupies a much larger volume than the parent Iron (the density is 3). This difference leads to the pressure generated in the confined spaces by this volumetric increase is large enough to fracture the stone⁽¹¹⁾.

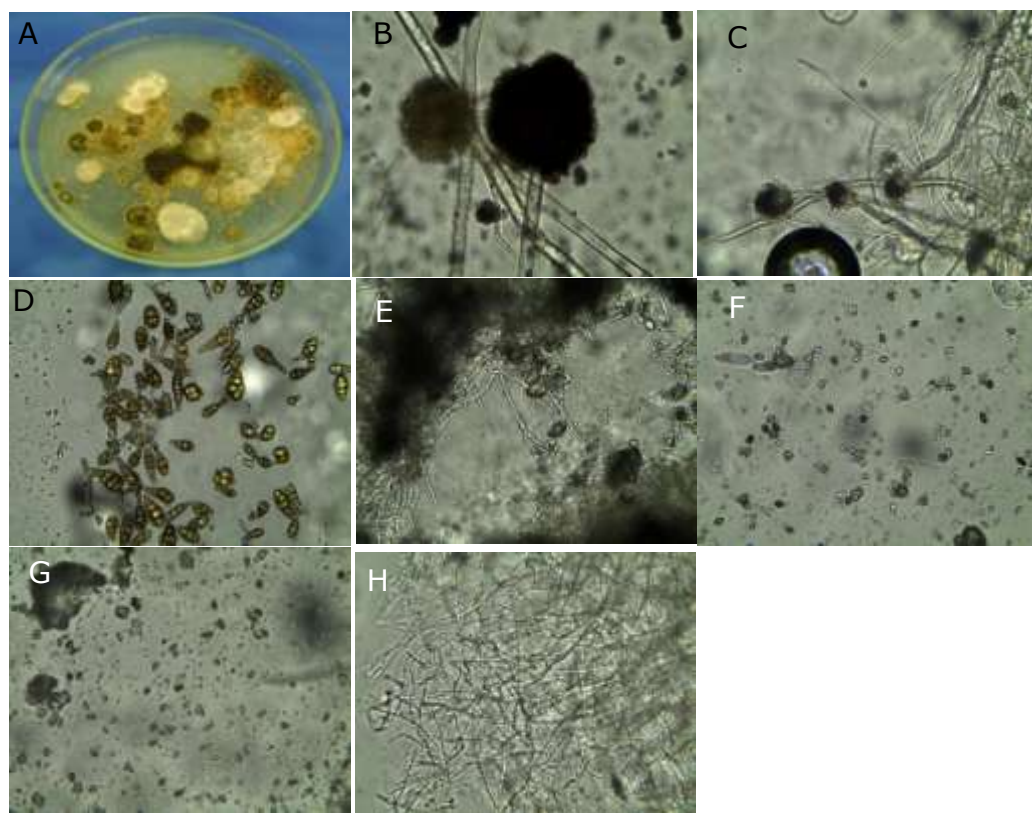
Depending on the conditions at the excavation, various kinds of fungi were identified as shown in (table3 and figure21). and the study revealed growth of Bacillus Bacteria (negative gram), fig.22.

Fig. (21) Light microscope photos of isolated fungi from engraved stone **a** different colonies of isolated fungi. **b** *Aspergillus niger* **c** *candidus*, **d** *Alternaria alternate*, **e** *Penicillium* **f** *Stach state*, **g** *Stachbotrys state*, **h** *Sterile mycelia*.

Biodeterioration study revealed seven fungi isolated from weathered samples (*A.niger*, *candidus*, *Alternaria alternate*, *Penicillium*, *Stach state*, *Stachbotrys*). These micro-organisms play an important and substantial role in all alteration processes that occur in the stone. It was estimated that, biological weathering is 100-1000 times greater than inorganic weathering ⁽¹²⁾. Biodeterioration of stone blocks in the Abu Musa excavation classified broadly into three categories: biophysical, biochemical, and aesthetic deterioration ^{(13),(14)}. The aesthetic or visual effects of biodeterioration resulting in the engraved stone from the growth of

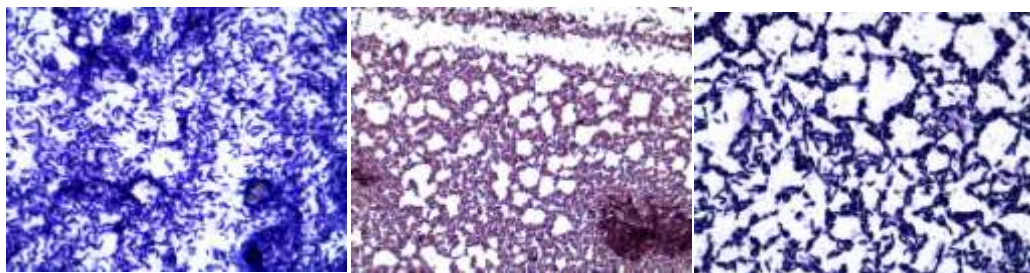
Fig. (22) Light microscope photos of isolated Bacteria from stone infection Bacillus Sp.

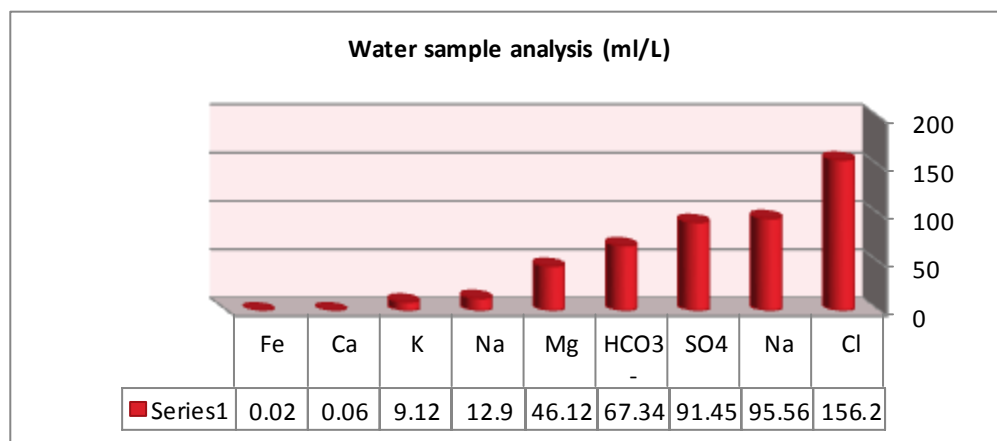
The chemical analysis of the water samples (the results are summarized in figure 23) showed that it is rich in sodium (Na⁺), chloride (Cl⁻), potassium (K⁺), magnesium (Mg²⁺), nitrate NO₃⁻ and calcium (Ca²⁺) ions. The water also has a high content of bicarbonates (HCO₃⁻) and (Cl⁻), sulphates (SO₄⁻). PH was 8.2 and the temperature was 26°C, (fig.23).

Fig. (23) The chemical analysis and ASS results of groundwater analysis from Abu Musa.

Chemical analysis showed that the water sample is very rich in Sodium (Na^+), chloride (Cl^-), potassium (K), magnesium (Mg^{2+}) and calcium (Ca^{2+}) ions. The water also has a high content of bicarbonates (HCO_3^-) and sulphates (SO_4^{2-}). Sample from groundwater was analyzed for comparison with the samples from the stone blocks to see how much the water had affected them, The analysis of several stone blocks and salt samples showed similar results and the presence of the same salts in addition to percentage of sodium and chloride, which are contained in halite, sulphate, potassium, magnesium and calcium related to the presence of gypsum and anhydrate. The results in the present study proved that the engraved stone is affected by the water of the nearby canals (Ismailia and the Suez Canal represent the main source of water in the Abu Musa area).
