Islamic University of Gaza
High Studies Deanery
Faculty of Engineering
Civil Engineering Department
Rehabilitation and Design of Structures

Rehabilitation Needs for Existing Buildings In Gaza Strip

**A Thesis Submitted in Partial Fulfillment of the Requirements for the
Degree of Master of Science in Civil Engineering –Rehabilitation and
Design of Structures**

November, 2008

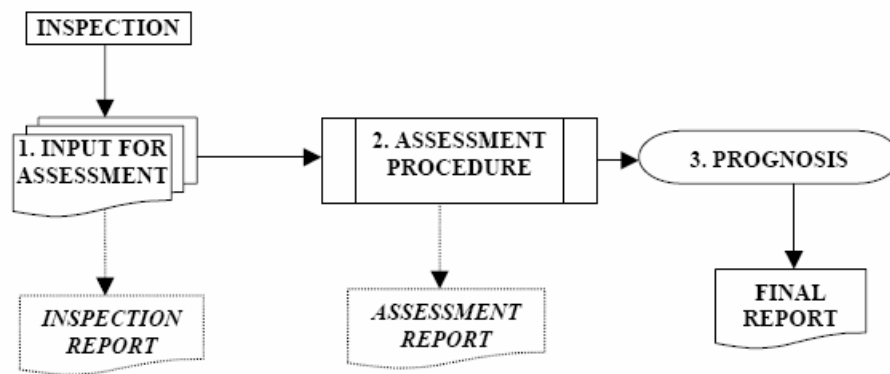
Fig. 2.1: General Overview of CONTECVET Simplified Assessment Method ^[13].

The main tasks to be carried out during the simplified method are divided into three steps that are sequenced in time. The first one is a complete inspection of the structure that allows knowing the data needed for the input in the second task, which is the assessment phase. Finally, the prognosis about the structural performance is made through the data available from the assessment. Figure 2.1 shows the main steps and their results in the simplified methodology.

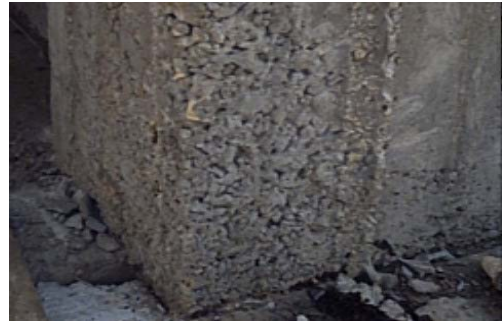
Honeycombing (Al-Nasser Hospital-Gaza)

Bugholes (www.usace.army.mil)

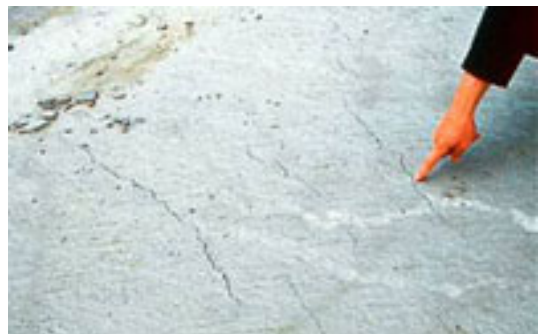
Fig. 3.2: Plastic Shrinkage Cracks.
(www.cement.org/tech/faq_cracking.asp)

Plastic shrinkage cracking as shown in Fig. 3.2 occurs when concrete is subjected to a very rapid loss of moisture caused by a combination of factors including air and concrete temperatures, relative humidity, and wind velocity at the surface of the concrete. When moisture evaporates from the surface of freshly placed concrete faster than it is replaced by bleed water, the

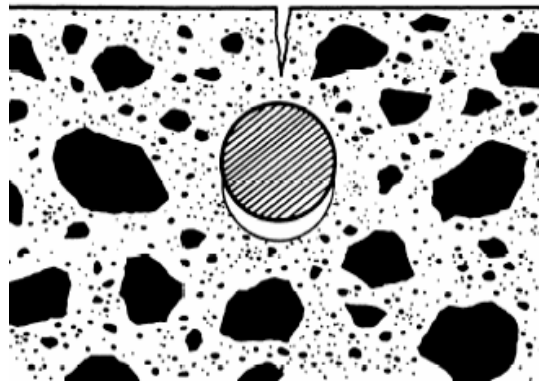
Fig. 3.3: Settlement Cracks.
(ACI 224.1- R93)

After initial placement, vibration, and finishing, concrete has a tendency to continue to consolidate. During this period, the plastic concrete may be locally restrained by reinforcing steel, a prior concrete placement, or formwork. This local restraint may result in voids and/or cracks adjacent to the restraining element such as shown in Fig. 3.3. Settlement cracking increases with increasing bar size, increasing slump, and decreasing cover. The degree of settlement cracking may be intensified by insufficient vibration or by the use of leaking or highly flexible forms^[30].

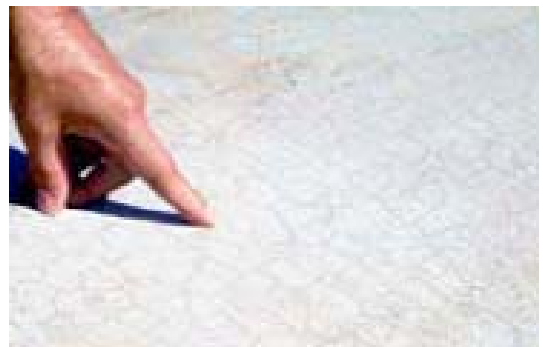
Fig. 3.4: Craze Cracks.
(www.prairie.com)

Drying shrinking is caused by the loss of moisture from the cement paste. Concrete tends to expand on wetting, and to shrink on drying. If the shrinkage of concrete could take place without restraint, the concrete would not crack. It is the combination of shrinkage and restraint that causes tensile stresses to develop.

Surface crazing (alligator pattern) on walls and slabs is an example of drying shrinkage on a small scale as shown in Fig. 3.4, while improper joint spacing may result in cracks like that shown in Fig. 3.5

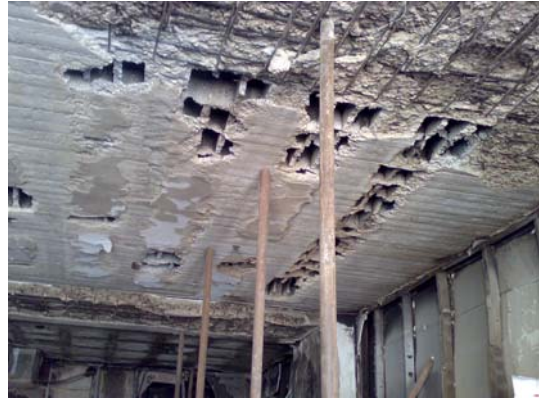
Fig. 3.7: Typical Fire Damages.
(IUG Library Building-March, 2008)

extent of damage depends on the temperature reached, loading conditions under fire, and characteristics of the concrete, which includes the quality of concrete and type of aggregates used ^[31]. Typical fire damage is shown in Fig.3.7.

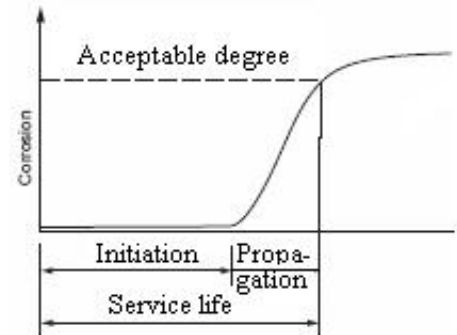
Fig. 3.8: Schematic Diagram of Corrosion Process of Steel in Concrete^[31].

formed in the alkaline environment produced by cement hydration. Hydration products, give the pore solution of concrete a pH value around 13. However, aggressive agents such as carbon dioxide or chloride ions can destroy this passivating film. Once destroyed, corrosion proceeds with the formation of electrochemical cells on the steel surface. Finally, the corrosion product causes cracking and spalling of the concrete cover. Thus, the corrosion process of steel in concrete can be divided into two stages: initiation and propagation as shown in Fig. 3.8. The initiation stage is determined by the ingress of carbon dioxide or chloride ions into the concrete cover while the propagation stage, or corrosion rate, is dependent on the availability of water and oxygen in the vicinity of the steel reinforcement. The time before repair, often referred to as the service life of the reinforced concrete element, is determined by the total time of these two stages^[31].

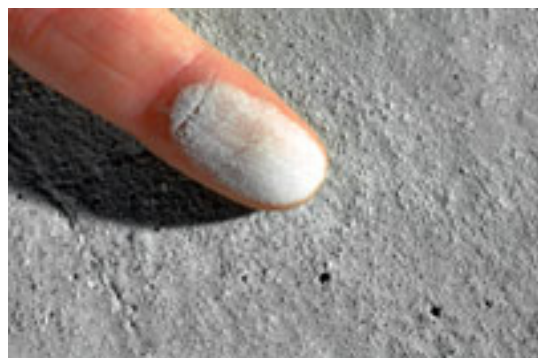
Fig. 3.11: Dusting of Concrete Surface.
(<http://www.prairie.com>)

Dusting as shown in Fig. 3.11 is the development of a fine, powdery material that easily rubs off the surface of hardened concrete. It can occur either indoors or outdoors, but is more likely to be a problem when it occurs indoors.

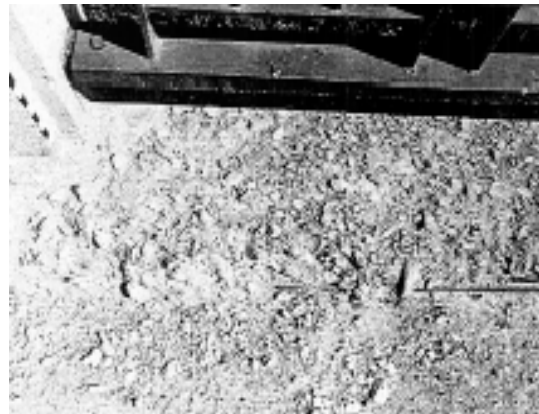
Very Severe Scaling

Scaling is a local flaking or peeling away of the near-surface portion of hardened concrete or mortar. It may be light scaling (loss of surface mortar without exposure of coarse aggregate), medium scaling (loss of surface mortar 5 to 10 mm in depth and exposure of coarse aggregate), severe scaling (loss of surface mortar 5 to 10 mm in depth with some loss of mortar surrounding aggregate particles 10 to 20 mm in depth), and very severe scaling (loss of coarse aggregate particles as well as mortar, generally to a depth greater than 20 mm). Fig. 3.13 illustrates these types of scaling^[21].

Fig. 3.13: Types of Scaling. (ACI 201.1R-92)

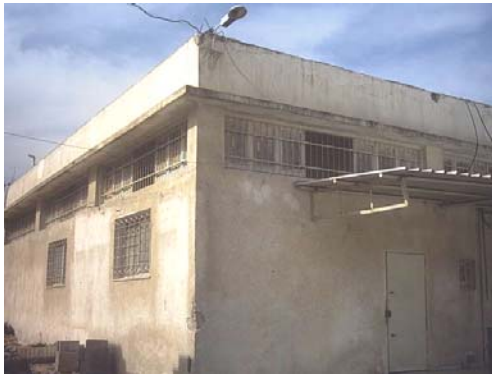
(a) An old building in Gaza. (Shifa Hospital)

Fig. 4.3: Components and Materials in the RC with Concrete Block Bearing Walls System.

According to the case studies survey, reinforced concrete buildings in Gaza Strip had appeared in about 1950's or earlier. Buildings in this period comprised thin two-way

solid slabs with drop beams or steel I-beams supported on concrete blocks bearing walls or on drop beams resting on concrete block walls. The concrete was made of coarse and fine aggregates. The sand was mainly the sea shore sand where some shells were found in samples taken from such concrete. Reinforcing steel bars used were of the round mild steel. Fig. 4.3 gives an idea about such constructions and the used materials. Buildings from this type comprised about 28% of the surveyed cases.

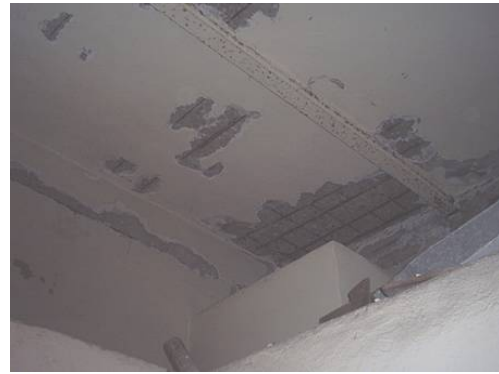
(b) Two-way slab with steel I-beams. (Abu Asi Building- Gaza)

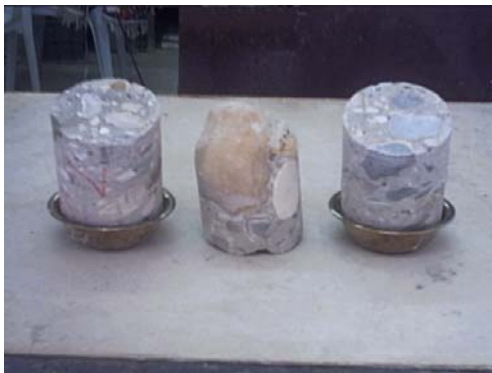
(c) Core Samples from Concrete showing type of aggregates used. (Shifa Hospital)

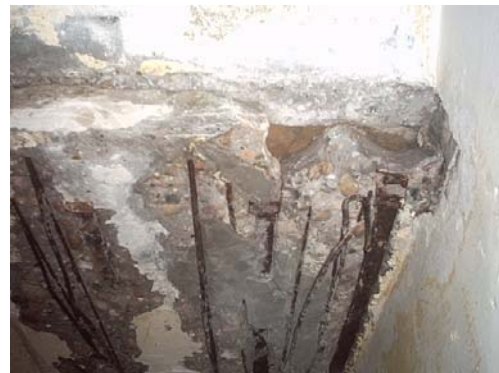
(d) Round mild steel bars in concrete. (Abu Asi Building- Gaza)

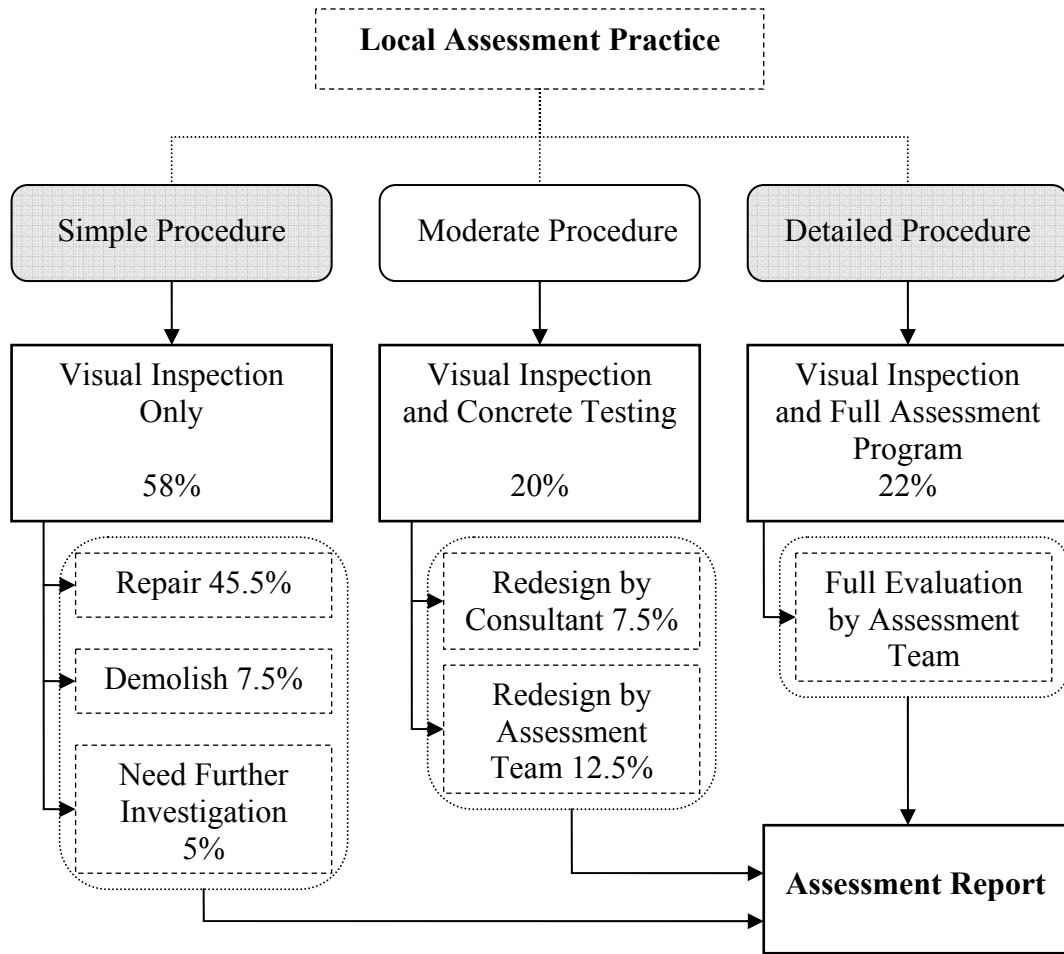
Fig. 4.5: Steps of Local Assessment Practice.

Assessment of defects and errors in existing structures within the case studies was normally performed by experienced engineers who started their investigations by visual inspection. The assessment steps involved in the case studies comprised one form of the following regimes shown in Fig. 4.5:

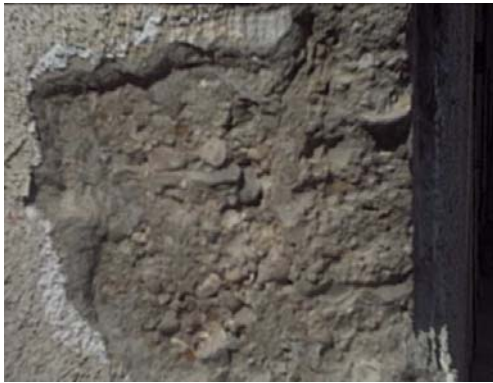
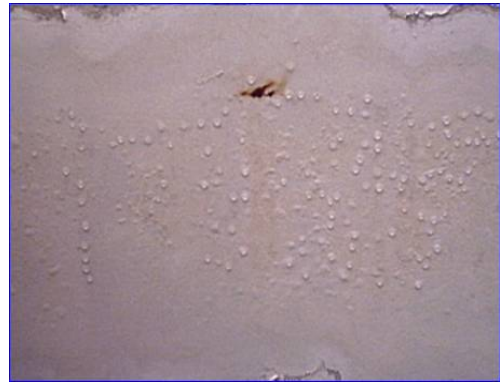
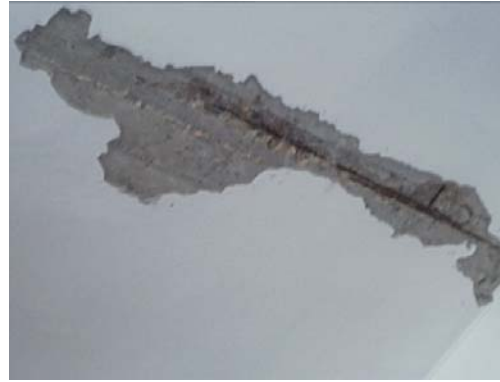
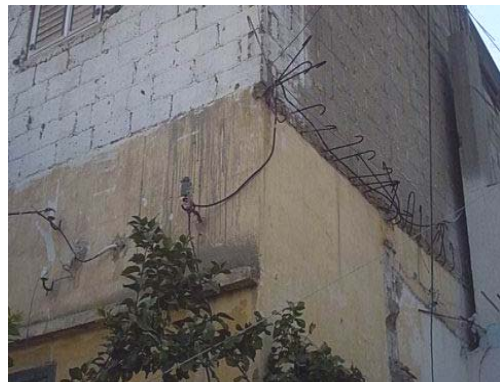
- i. Disintegration of concrete close to ground or to a water source, due to probable chemical reaction indicated by weakness of mortar, roughness of concrete surface, and appearance of coarse aggregates at the surface. Fig. 4.6 illustrates such damage. This type was rare in the case studies and no efforts were made to determine its real cause by laboratory testing.
- ii. Signs of steel corrosion indicated by the appearance of rust on the concrete surface as shown in Fig. 4.7 were caused by the penetration of water into concrete.
- iii. Cracking along steel bars due to steel corrosion as in Fig. 4.8.
- iv. Spalling of concrete cover in some locations such that shown in Fig. 4.9.
- v. Complete spalling of concrete cover and appearance of corroded steel as in Fig. 4.10. Some cut off bars may be encountered.
- vi. Corrosion of steel bars due exposure to environment as in Fig. 4.11.

Fig. 4.6: Deterioration of Concrete.

Fig. 4.7: Appearance of Rust on Surface.

Fig. 4.8: Cracks along Steel Bars.

Fig. 4.9: Local Spalling of Concrete Cover.

Fig. 4.10: Complete Spalling of Concrete Cover.

Fig. 4.11: Corrosion of Exposed Steel Bars.

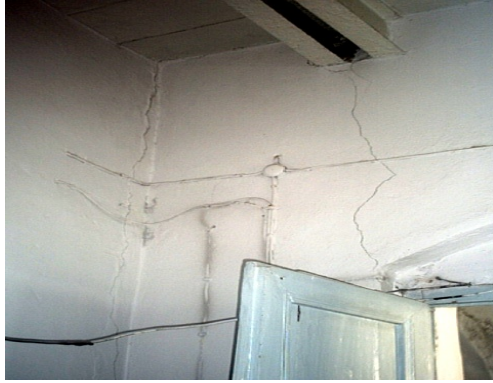
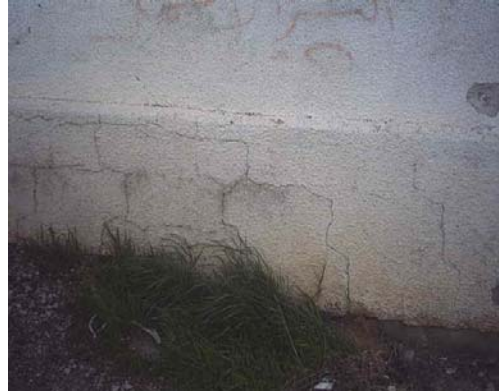
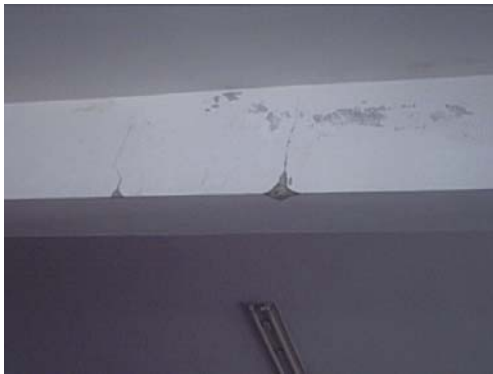
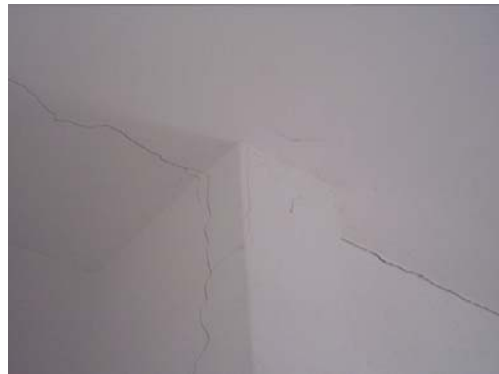
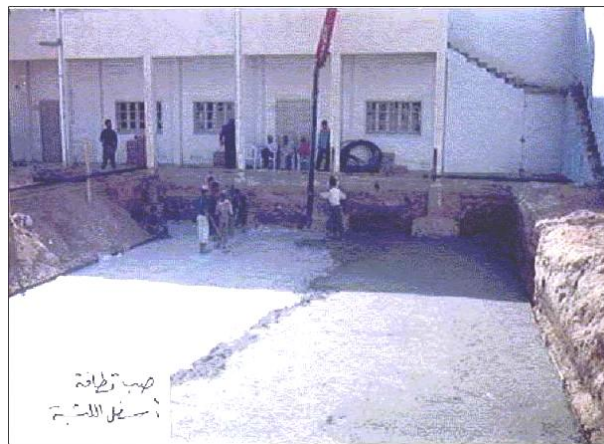
- v. Horizontal cracks in columns, vertical cracks in slabs, and inclined cracks in walls due to foundation settlement as a result of the effect of over loads due to excavation very close to an existing building or imposing additional loads on foundations due to an adjacent new constructions (Fig. 4.16).

Fig. 4.12: Vertical and Inclined Cracks in Bearing Walls.

Fig. 4.13: Vertical and Inclined Cracks in Bearing Walls under Ground Beams.

Fig. 4.14: Vertical Cracks in Drop Beams.

Fig. 4.15: Differential Settlement Cracks at Expansion Joints.

Fig. 4.16: Excavation to Foundation Level of an Existing Building.

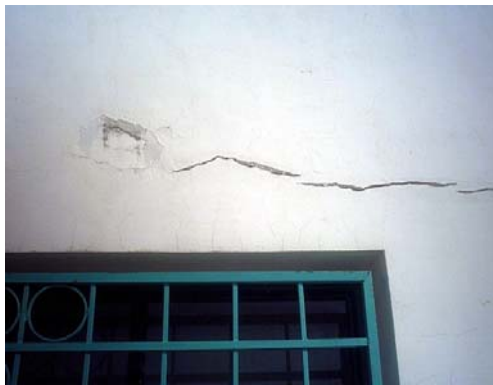
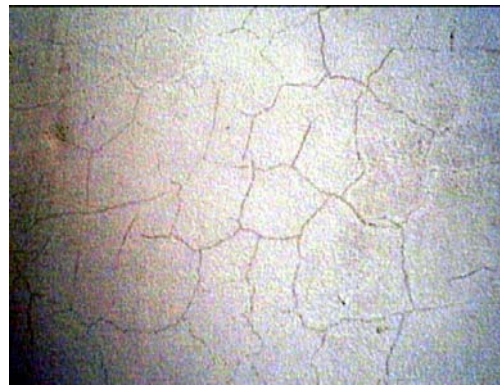
Minor defects in non structural elements that didn't affect the structural capacity were encountered in most of the cases such as cracks between concrete elements and concrete block works shown in Fig. 4.17, which normally appeared as a result of variation of thermal expansion characteristics between concrete and block, in addition to a weak bond between the two materials or improper building practice. Others are associated with deflection of the wall sub-base or foundation settlements in case of sandy soils. Also craze cracking are sometimes found in external walls plastering due to improper curing or weak plaster mortar as shown in Fig. 4.18.

Fig. 4.17: Horizontal Cracks Between Windows Concrete Lintel and Block Works.

Fig. 4.18: Craze Cracks in External Plaster.

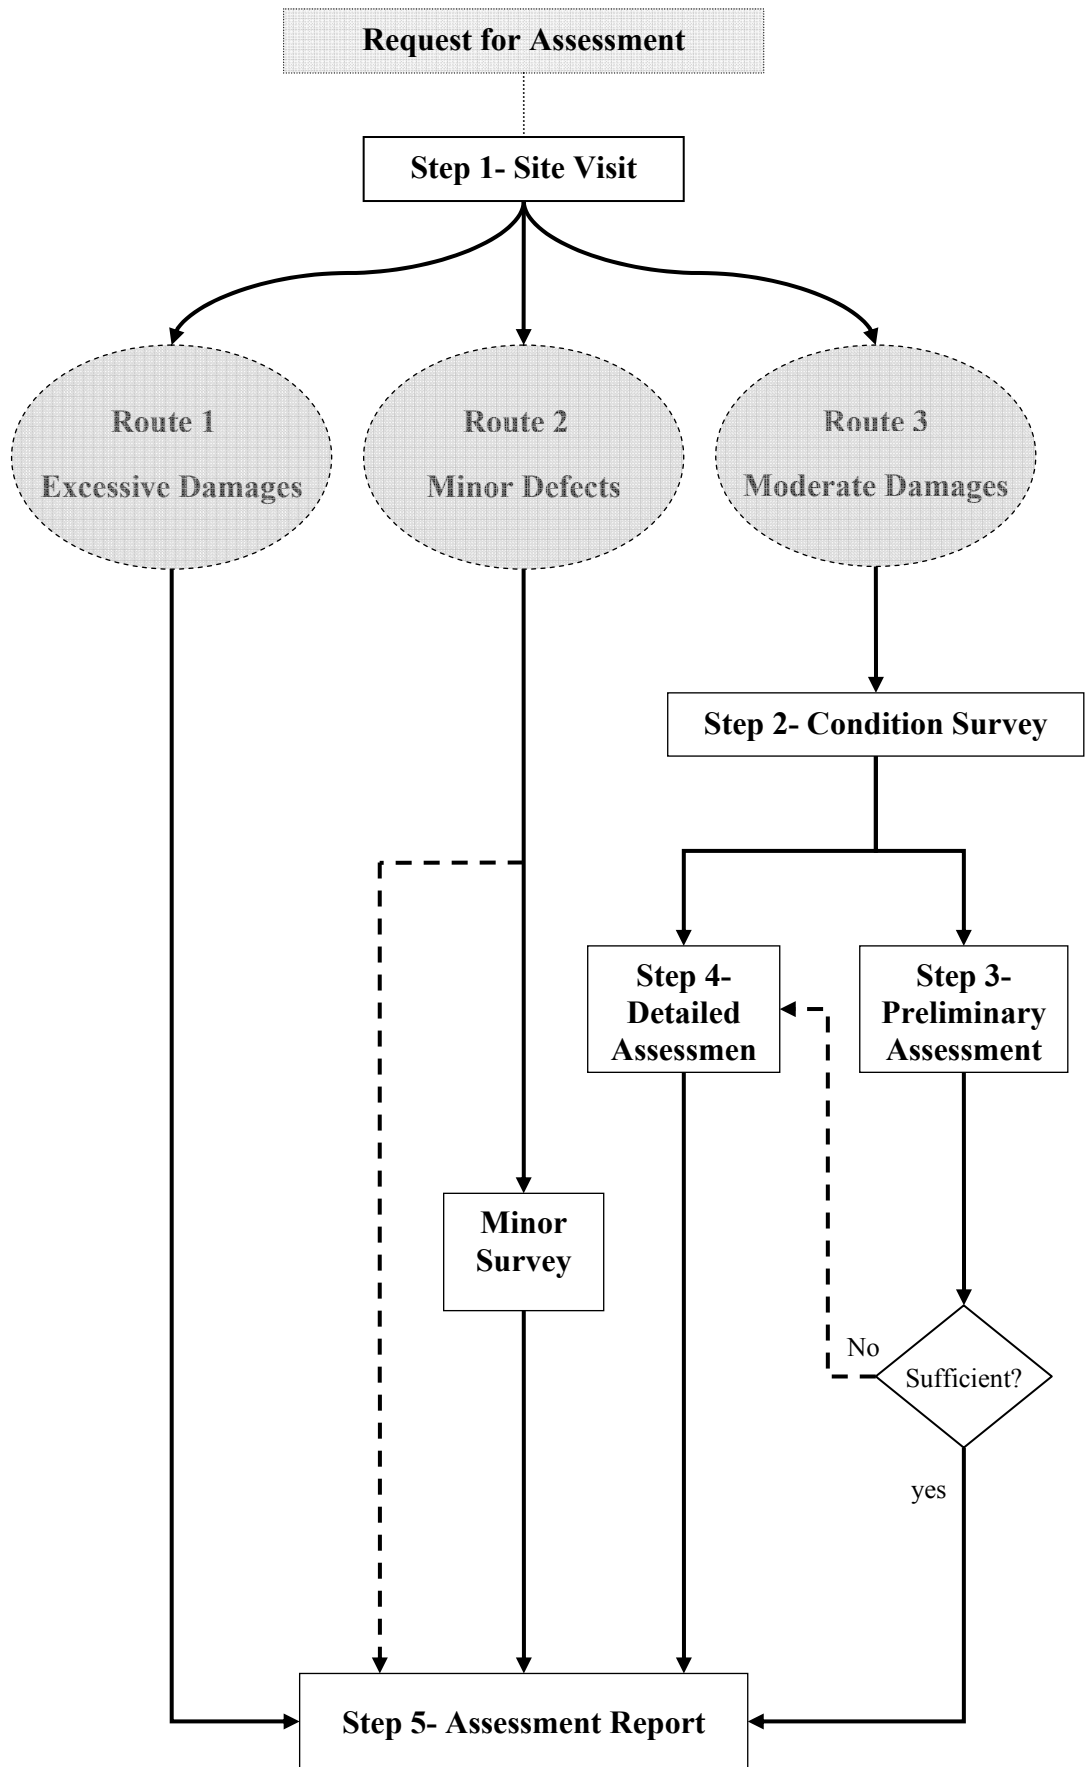
Fig. 5.1: Schematic Diagram of the Proposed Assessment Approach.

The proposed assessment approach consists of three routes according to the needed assessment efforts, with five main steps as shown in Fig. 5.1. Since the steps are designed to be sequential in time, each one depends to a large extent on the previous steps.

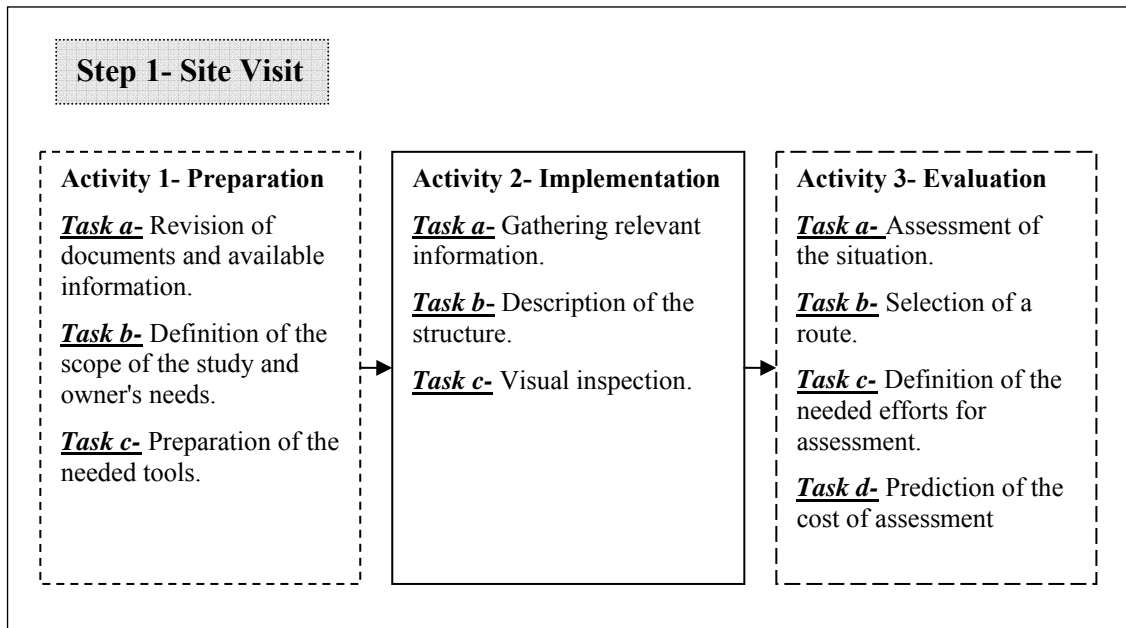
Fig. 5.3: Activities of the Site Visit.

A site visit is essential for any assessment. It is the key which opens or closes the process. It aims to let expert's eyes identify the case and take an initial impression regarding the condition of the structure. As shown in Figs.5.2 and 5.3 it consists of three activities: Preparation, Implementation and Evaluation.

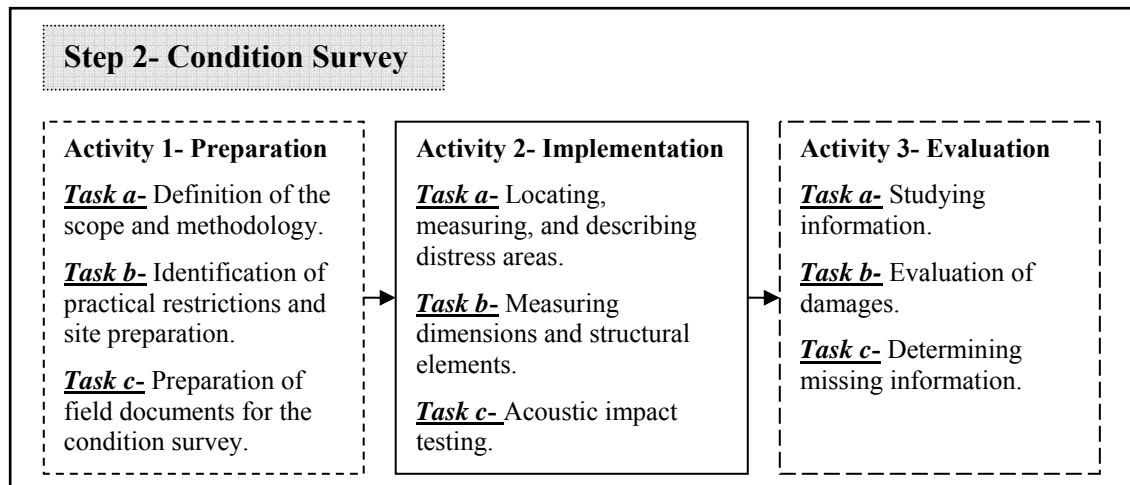
Fig. 5.4: Activities of the Condition Survey.

The Condition Survey is an examination of the structure for the purpose of locating and identifying areas of distress. It includes a mapping of the various types of defects that may be found, such as cracking, surface problems (disintegration, spalling, etc.), and deteriorations. The activities within the condition survey are illustrated in Fig.5.4:

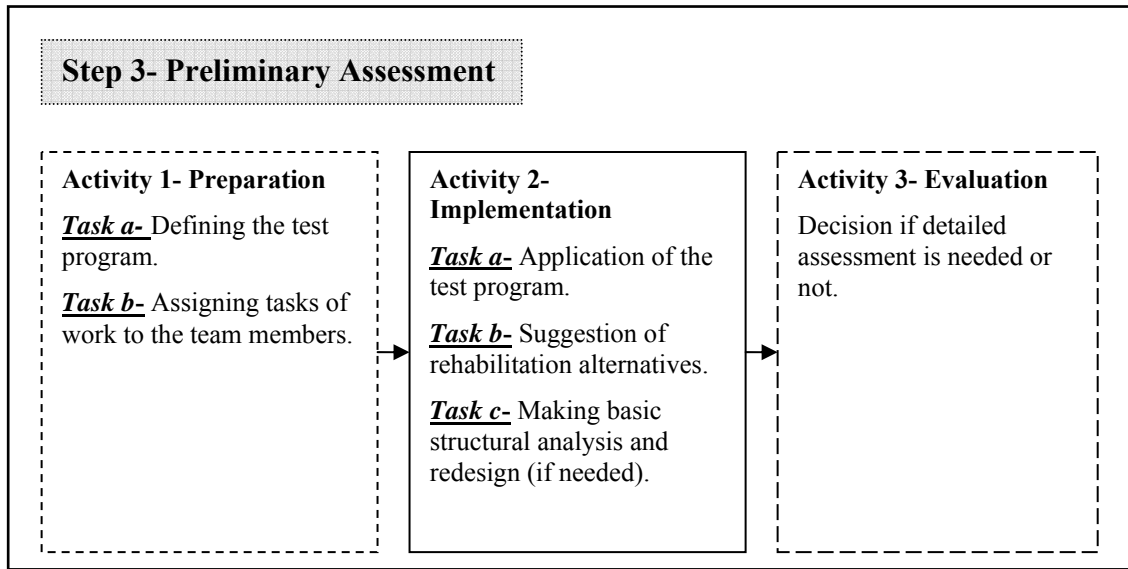
Fig. 5.5: Activities of the Preliminary Assessment.

These objectives are achieved from the preliminary assessment as described in Fig. 5.5.

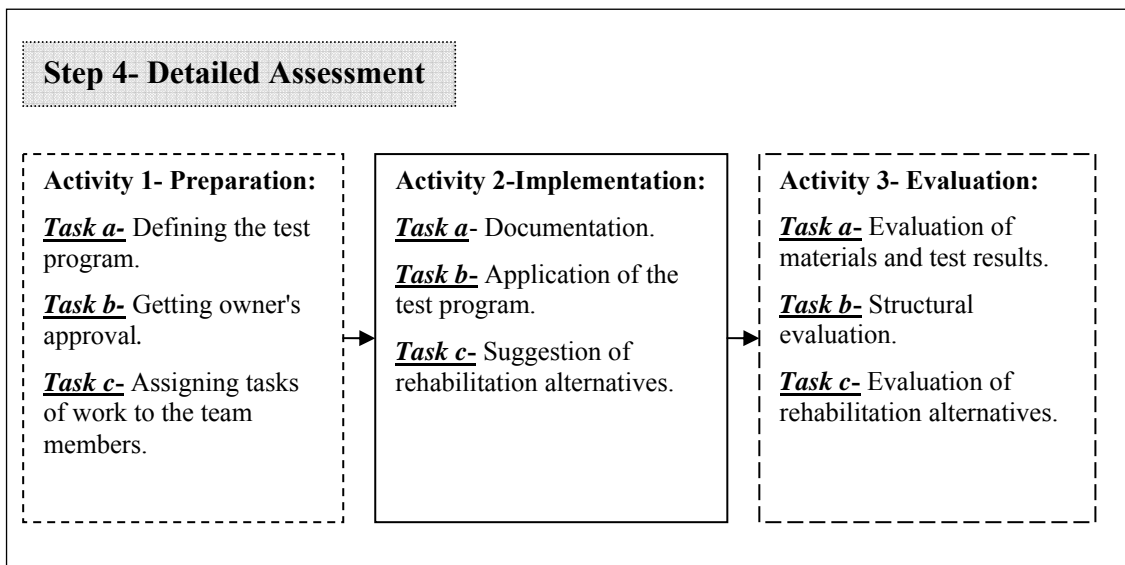
Fig. 5.6: Activities of the Detailed Assessment.

The detailed assessment is a process in which intensive efforts are made to get more precise information about the condition of the structure and the intervention action. Cases that require a detailed assessment are typically the cases that lack sufficient information to assess the building condition with confidence such as the cases of structural upgrading without the presence of sufficient structural details and material properties. This process is illustrated in Fig. 5.6.

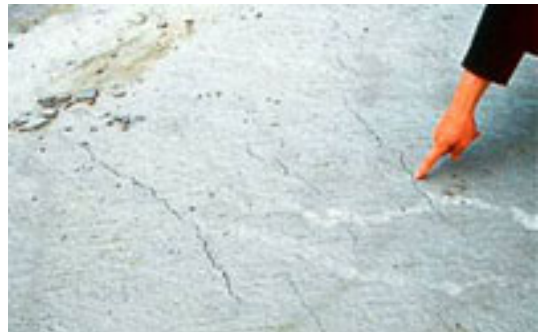
Fig. 3.2: Plastic Shrinkage Cracks.
(www.cement.org/tech/faq_cracking.asp)

Plastic shrinkage cracking as shown in Fig. 3.2 occurs when concrete is subjected to a very rapid loss of moisture caused by a combination of factors including air and concrete temperatures, relative humidity, and wind velocity at the surface of the concrete. When moisture evaporates from the surface of freshly placed concrete faster than it is replaced by bleed water, the

surface concrete shrinks. Due to the restraint provided by the concrete below the drying surface layer, tensile stresses develop in the weak, stiffening plastic concrete, resulting in shallow cracks of varying depth which may form a random, polygonal pattern, or may appear parallel to one another. These cracks are often wide at the surface. They range from a few centimeters to meters in length and are spaced from a few centimeters to as much as 3m apart. Plastic shrinkage cracks begin as shallow cracks but can become full-depth cracks^[15].

surface concrete shrinks. Due to the restraint provided by the concrete below the drying surface layer, tensile stresses develop in the weak, stiffening plastic concrete, resulting in shallow cracks of varying depth which may form a random, polygonal pattern, or may appear parallel to one another. These cracks are often wide at the surface. They range from a few centimeters to meters in length and are spaced from a few centimeters to as much as 3m apart. Plastic shrinkage cracks begin as shallow cracks but can become full-depth cracks^[30].

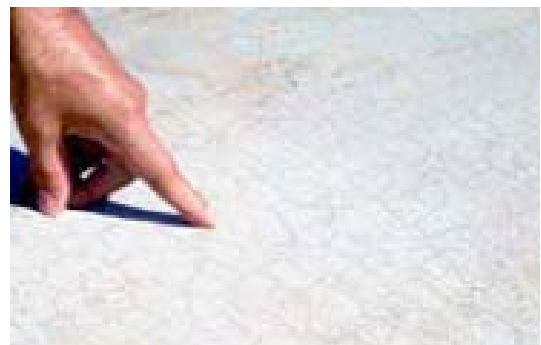
Fig. 3.4: Craze Cracks.
(www.prairie.com)

Drying shrinking is caused by the loss of moisture from the cement paste. Concrete tends to expand on wetting, and to shrink on drying. If the shrinkage of concrete could take place without restraint, the concrete would not crack. It is the combination of shrinkage and restraint that causes tensile stresses to develop.

Surface crazing (alligator pattern) on walls and slabs is an example of drying shrinkage on a small scale as shown in Fig. 3.4, while improper joint spacing may result in cracks like that shown in Fig. 3.5

Crazing usually occurs when the surface layer of the concrete has higher water content than the interior concrete. The result is a series of shallow, closely spaced, fine cracks.

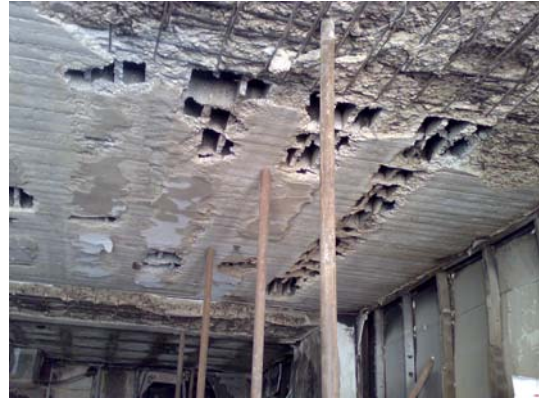
Fig. 3.7: Typical Fire Damages.
(IUG Library Building-March, 2008)

As a special case, fire creates high temperature gradients and because of this, the hot surface layer tends to craze, followed by spalling from the cooler interior of the concrete member. The reinforcement may become exposed and the action of fire accelerates. The

extent of damage depends on the temperature reached, loading conditions under fire, and characteristics of the concrete, which includes the quality of concrete and type of aggregates used [16]. Typical fire damage is shown in Fig.3.7.

As a special case, fire creates high temperature gradients and because of this, the hot surface layer tends to craze, followed by spalling from the cooler interior of the concrete member. The reinforcement may become exposed and the action of fire accelerates. The

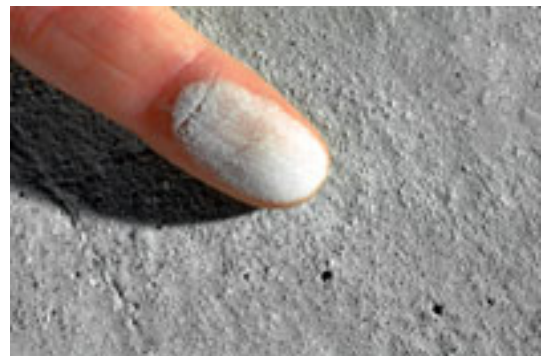
Fig. 3.11: Dusting of Concrete Surface.
(<http://www.prairie.com>)

Dusting as shown in Fig. 3.11 is the development of a fine, powdery material that easily rubs off the surface of hardened concrete. Dusting is the result of a thin, weak layer, called laitance, composed of water, cement, and fine particles usually

appears as a result of construction faults or concrete weakness. Floating and trowelling concrete with bleed water on it mixes the excess water back into the surface, further weakening the concrete strength and wear resistance and giving rise to dusting. Dusting may also be caused by water applied during finishing, exposure to rainfall during finishing, spreading dry cement over the surface to accelerate finishing, a low cement content, too wet a mix, and lack of proper curing (especially allowing rapid drying of the surface^[17]).

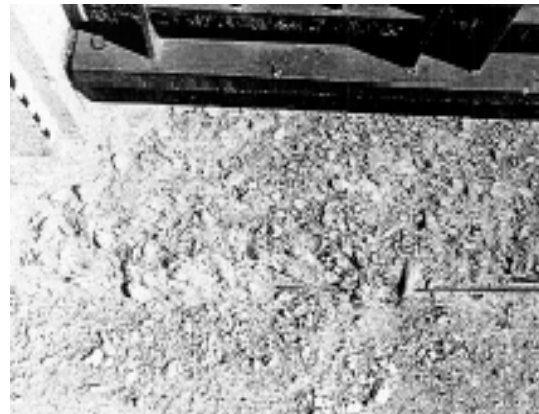
Very Severe Scaling

Scaling is a local flaking or peeling away of the near-surface portion of hardened concrete or mortar. It may be light scaling (loss of surface mortar without exposure of coarse aggregate), medium scaling (loss of surface mortar 5 to 10 mm in depth and exposure of coarse aggregate), severe scaling (loss of surface mortar 5 to 10 mm in depth with some loss of mortar surrounding aggregate particles 10 to 20 mm in depth), and very severe scaling (loss of coarse aggregate particles as well as mortar, generally to a depth greater than 20 mm). Fig. 3.13 illustrates these types of scaling^[19].

Fig. 3.13: Types of Scaling. (ACI 201.1R-92)

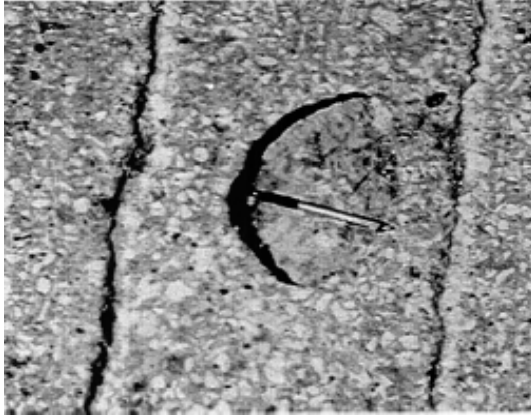
(a) Small Spall

Spalling is a deeper surface defect than scaling, often appearing as circular or oval depressions on surfaces or as elongated cavities along joints. Spalls may be 25mm or more in depth and 150 mm or more in diameter, although smaller spalls also occur. Spalls are described as small or large. Small spalls as shown in Fig. 3.14 (a) are roughly circular depressions not greater than 20mm in depth nor 50mm in any dimension while large spalls shown in Fig. 3.14 (b) may be roughly circular or oval or in some cases elongated, more than 20 mm in depth and 150 mm in greatest dimension^[18,19].

Spalls are caused by pressure or expansion within the concrete, bond failure in two-course construction, impact loads, fire, or weathering. Improperly constructed joints and corroded reinforcing steel are two common causes of spalls^[17].

Fig. 3.14: Types of Spalling (ACI 201.1R-92).

Spalling is a deeper surface defect than scaling, often appearing as circular or oval depressions on surfaces or as elongated cavities along joints. Spalls may be 25mm or more in depth and 150 mm or more in diameter, although smaller spalls also occur. Spalls are described as small or large. Small spalls as shown in Fig. 3.14 (a) are roughly circular depressions not greater than 20mm in depth nor 50mm in any dimension while large spalls shown in Fig. 3.14 (b) may be roughly circular or oval or in some cases elongated, more than 20 mm in depth and 150 mm in greatest dimension^[21,33].

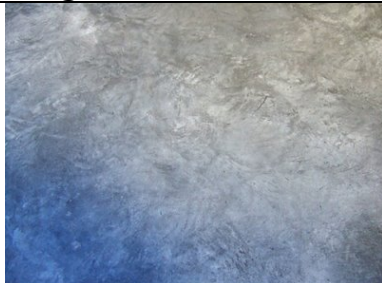
Type of Defect	Image	Cause	Prevention	Repair
COLOR VARIATION Difference in color across the surface of concrete. May appear as patches of light and dark.

1- Uneven or variable curing conditions. 2- Applying a different brand or type of cement to the surface as a 'drier'	1- Use an even concrete mix when placing, compacting and finishing and keep concrete evenly moist. 2- Do not use driers	Not necessary, if the surface will not be covered, repeated gentle treatments with a weak acid may solve the problem, or apply a surface coating.
CRAZING A network of fine cracks across the surface of concrete.

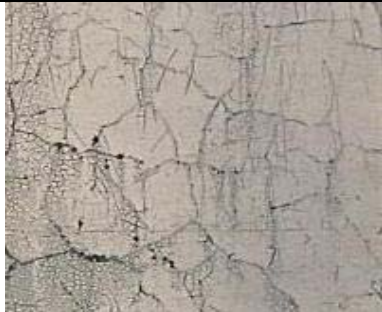
<ul style="list-style-type: none"> Minor surface shrinkage in rapid drying conditions. (Low humidity and hot temperatures, or alternate wetting and drying.) 	<ul style="list-style-type: none"> Finish and cure concrete correctly. 	Usually not necessary, If the crazing looks too bad then a surface coating of a paint or other overlay sealer can be applied to cover and/or minimize the effect of the cracks.

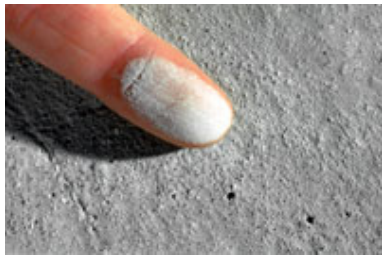
DUSTING A fine powder on the concrete surface which comes off on your fingers.

1- Finishing before the bleed water has dried. Or finishing during the rain. 2- Not cured properly, or the surface is drying too quickly. 3- Concrete subject to severe abrasion or of a low grade	1- Let any bleed water dry up before trowelling. 2- Cure correctly, Protect concrete from drying out too quickly in hot or windy conditions. 3- For harsh conditions use a stronger concrete	Where dusting is minimal the application of a surface hardener can be beneficial. If the surface is showing significant wear distress it is essential to remove all loose material by grinding or scrapping the surface to a sound base and then applying a suitable topping.

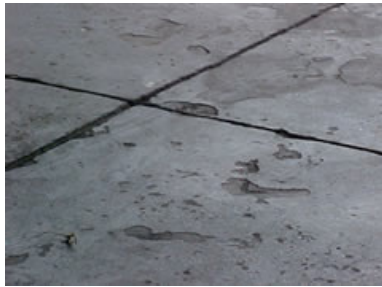
Type of Defect	Image	Cause	Prevention	Repair
<p>SPALLING When the slab edges and joints chip or break leaving an elongated cavity.</p>

<ol style="list-style-type: none"> 1- Edges of joints break because of heavy loads or impact with hard objects. As concrete expands and contracts the weak edges may crack and break. 2- Entry of hard objects, such as stones, into joints may cause spalling when the concrete expands. 3- Poor compaction of concrete at joints. 	<ol style="list-style-type: none"> 1- Design the joints carefully. Keep joints free from rubbish. 2- Keep heavy loads away from the joints and edges until they have properly hardened. 3- Ensure proper compaction. 	<p>For small spalled areas: scrape, chip or grind away the weak areas until reaching sound concrete, making sure you brush the old concrete clean of any loose material. Then refill the area with new concrete or repair mortar. Compact, finish and cure the new patch carefully. Care should be taken that all joints be maintained and not filled. For large spalled areas: use proper technique.</p>

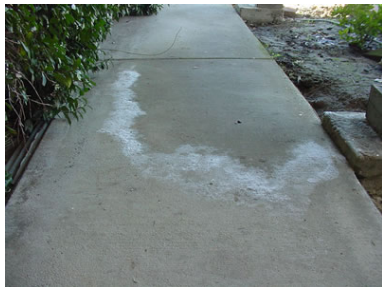
<p>EFFLORESCENCE A white crystalline deposit sometimes found on the surface of concrete soon after it is finished.</p>

<ol style="list-style-type: none"> 1- Sometimes mineral salts are dissolved in water. If water with dissolved mineral salts collect on the concrete surface as water evaporates salt deposits are left on the surface. 2- Excess bleeding can also result in efflorescence. 	<ol style="list-style-type: none"> 1- Use clean, salt-free water and washed sands. 2- Avoid excessive bleeding. 	<p>Remove efflorescence by dry brushing and washing with clean water. Do not use a wire brush. Wash with a dilute solution of hydrochloric acid.</p>

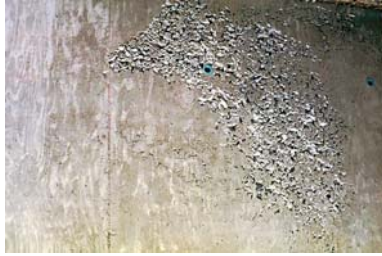
Type of Defect	Image	Cause	Prevention	Repair
<p>HONEYCOMBING Too much coarse aggregate appears on the surface.</p>

<ol style="list-style-type: none"> 1- Poor compaction, segregation during placing or paste leakage from forms. 2- A poor concrete mix with not enough fine aggregate causing a rocky mix. 	<ol style="list-style-type: none"> 1- Take care during placing concrete to avoid segregation. Compact concrete properly. Good watertight formwork. 2- Use a better mix design. 	<p>If honeycombing happens only on the surface it can be rendered. Rendering means to cover the surface with a layer of mortar. If honeycombing happens throughout the concrete it may need to be removed and replaced.</p>
<p>BLISTERING Blisters are hollow, low profile bumps on the concrete surface filled with either air or bleed water.</p>

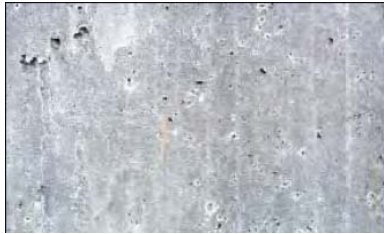
Type of Defect	Image	Cause	Prevention	Repair
<p>BLOWHOLES (BUGHOLES) Individual rounded or irregular cavities formed against the formwork. Small blowholes (less than, say, 10 mm) tend to be approximately hemispherical while larger ones are irregular and often expose coarse aggregate particles.</p>

<p>Permeable forms and poor compaction. Blowholes tend to be more prevalent towards the top of a concrete placement than at the bottom, due to the increased compaction and static head at the bottom layer of the pour.</p>	<p>The use of permeable forms may significantly reduce, if not eliminate, the incidence of blowholes.</p>	<p>Generally, they are regarded as an appearance problem though a concentration of large blowholes may lead to loss of durability.</p>
<p>FLAKING Discrete pieces of the surface become detached leaving a rough indentation behind. The pieces are usually flat.</p>

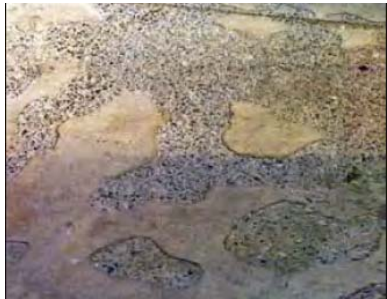
<p>Flaking is caused by inappropriate finishing techniques that seal the surface and trap the water which would otherwise have risen to the surface as bleed water. This water accumulates below the surface forming a plane of weakness and resulting in delamination of the surface layer.</p>	<ul style="list-style-type: none"> • Avoid the use of finishing techniques that tend to seal the surface. • In summer, use an evaporative retarder to prevent rapid surface drying and give time for the bleed water to rise to the surface. 	<ul style="list-style-type: none"> • Grind the delaminated areas back to sound concrete and apply a proprietary sealing compound. • Remove the delaminated concrete and apply a bonded topping or epoxy coating to the floor.

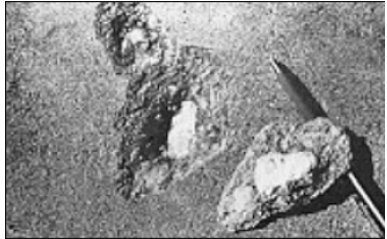
Type of Defect	Image	Cause	Prevention	Repair
<p>POPOUTS Popouts are roughly conical depressions in the concrete surface created by localized pressure within the concrete, usually occurring after the concrete has been in place for some time. They can be categorized as small, medium or large depending on whether the diameter of the cavity is 10 mm or less, 10 to 50 mm, or greater than 50 mm respectively.</p>

<p>They are usually caused by the expansion of a deleterious aggregate particle located near the surface or the expansion (due to freezing) of water absorbed by an aggregate particle. In either case, the particle breaks away from the mass of the concrete carrying with it the surface layer of mortar. Experience has shown that generally it is coarser sizes of deleterious aggregate, e.g. 9.5 to 19 mm, that give rise to the problem. Deleterious aggregates include shale, but contaminants such as pieces of wood, clay and coal can also cause popouts.</p>	<ul style="list-style-type: none"> • Use aggregates free from deleterious particles that are known to cause popouts. • Use higher strength concrete that will better resist the tensile stresses leading to popouts. • Ensure that good concrete practices are employed on the project as poor compaction and inadequate curing will increase the likelihood of popouts. 	<ul style="list-style-type: none"> • Filling the popout crater with a mortar of similar color to the base concrete.
