River View (Fairfax), c. 1845-1856, White Pine, Tennessee: An Historical Analysis

Shannon Tew
University of Tennessee - Knoxville

Tew, Shannon, "River View (Fairfax), c. 1845-1856, White Pine, Tennessee: An Historical Analysis. " Master's Thesis, University of Tennessee, 1989.
https://trace.tennessee.edu/utk_gradthes/3438

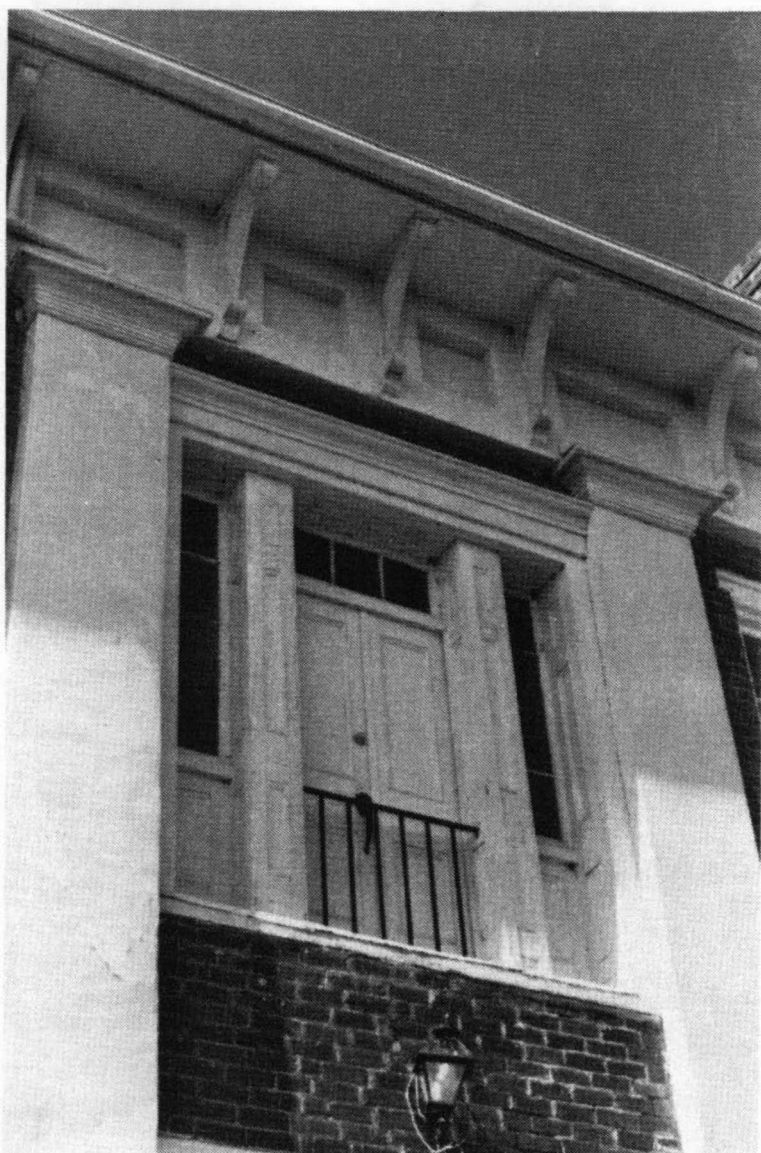
Figure II-1. Pilaster and frieze features on Fairfax' south facade.

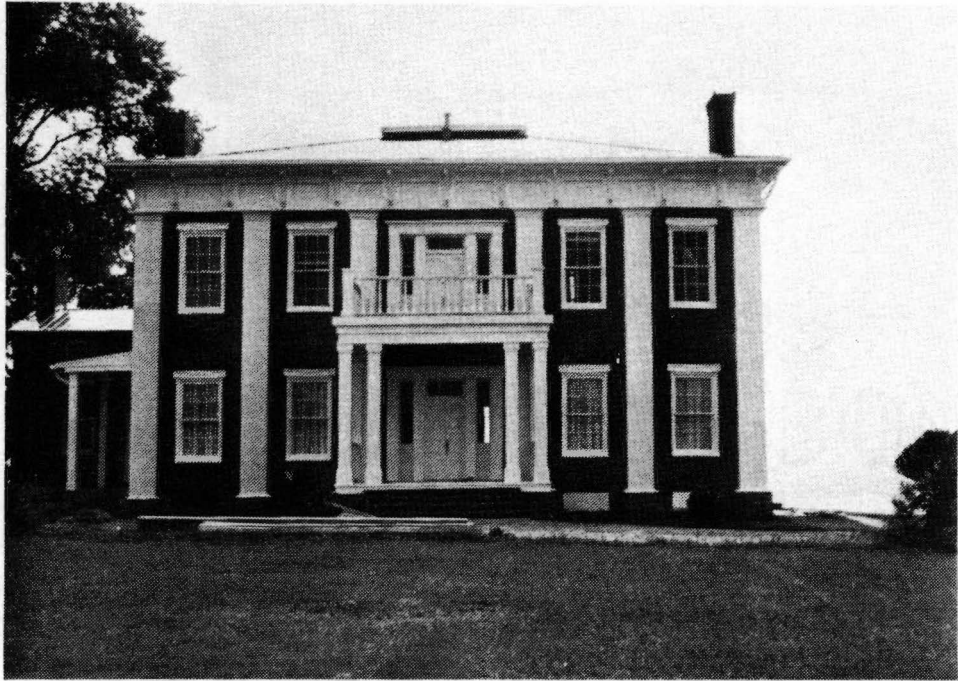
Figure III-1. West elevation of Fairfax.

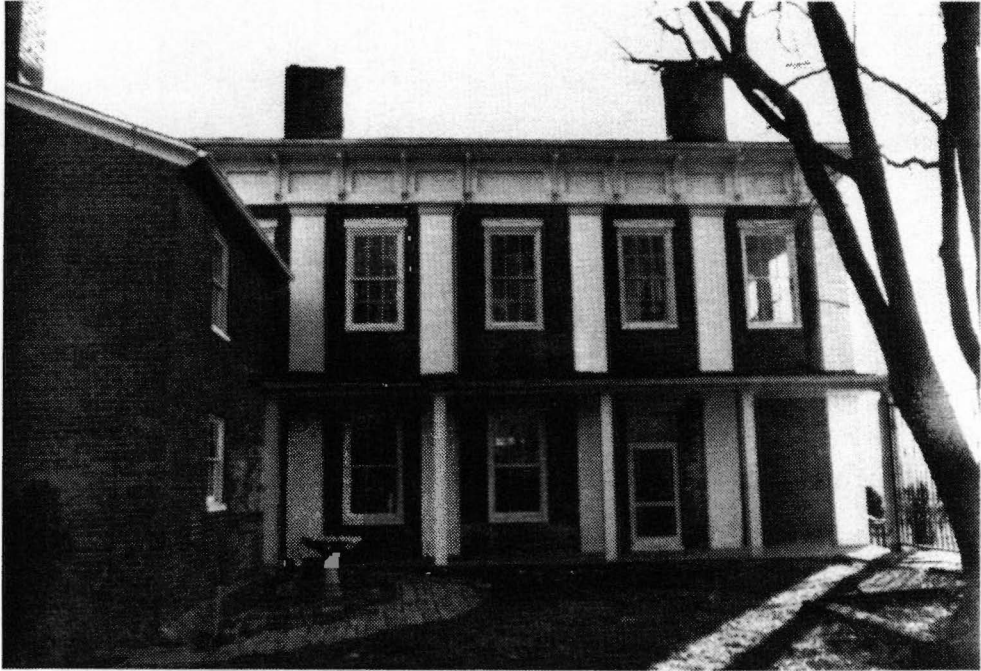
Figure III-3. East elevation of Fairfax.

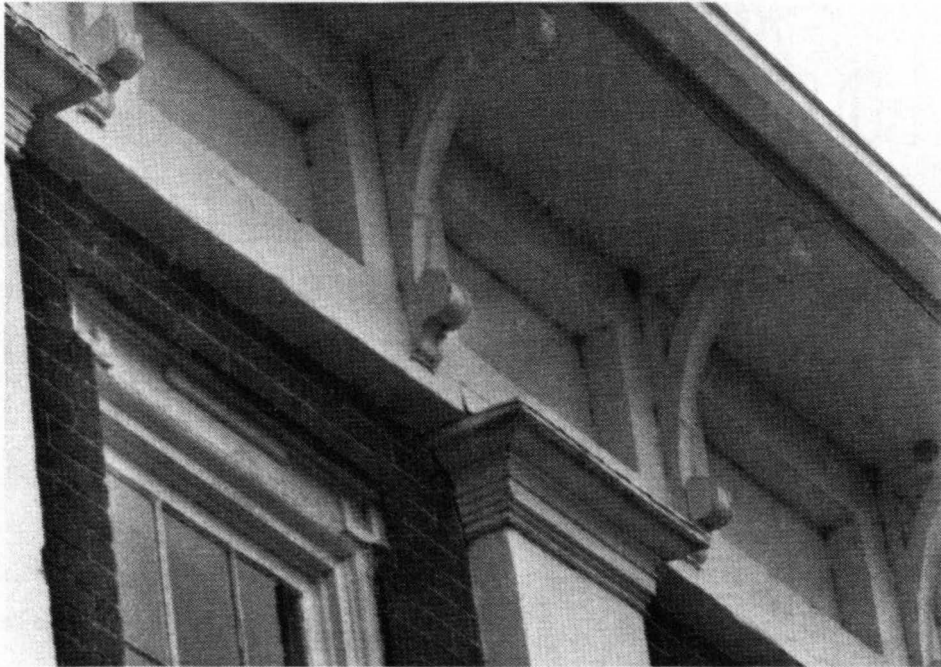
Figure III-14. Frieze, brackets and overhanging eaves at Fairfax.

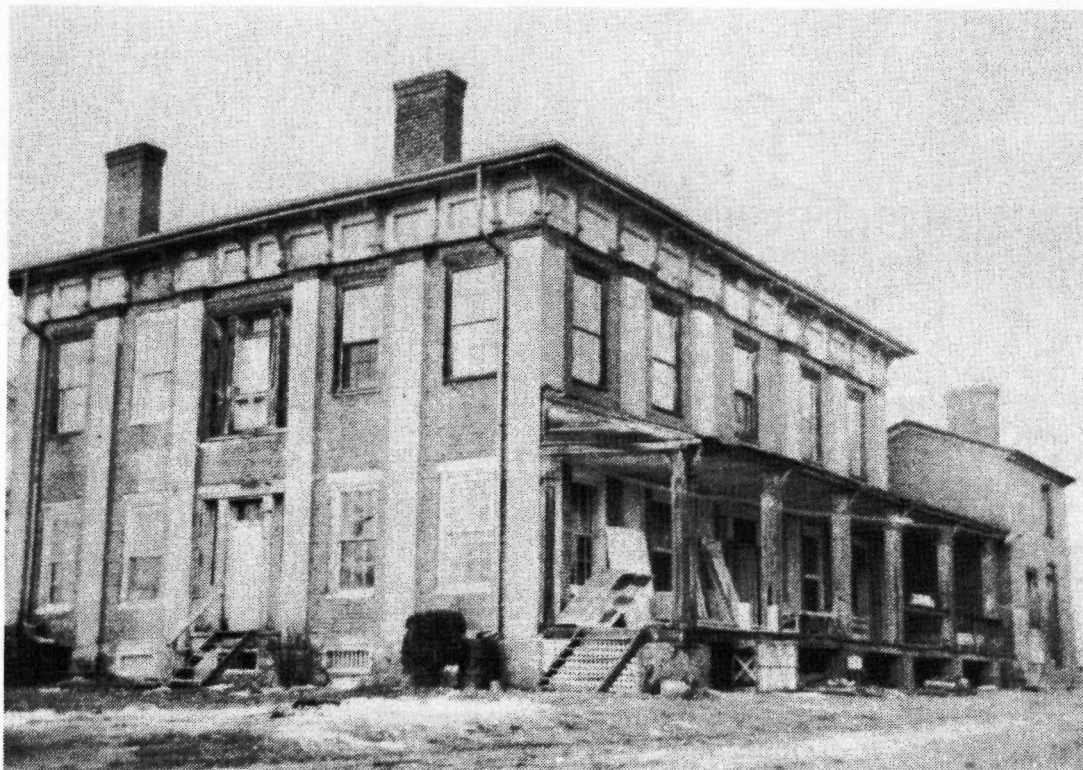
Figure III-25. Rear veranda prior to Fairfax' 1954 renovation.

Photographs taken before reconstruction work began exhibit a back veranda (Figure III-25), believed to have been constructed shortly after the

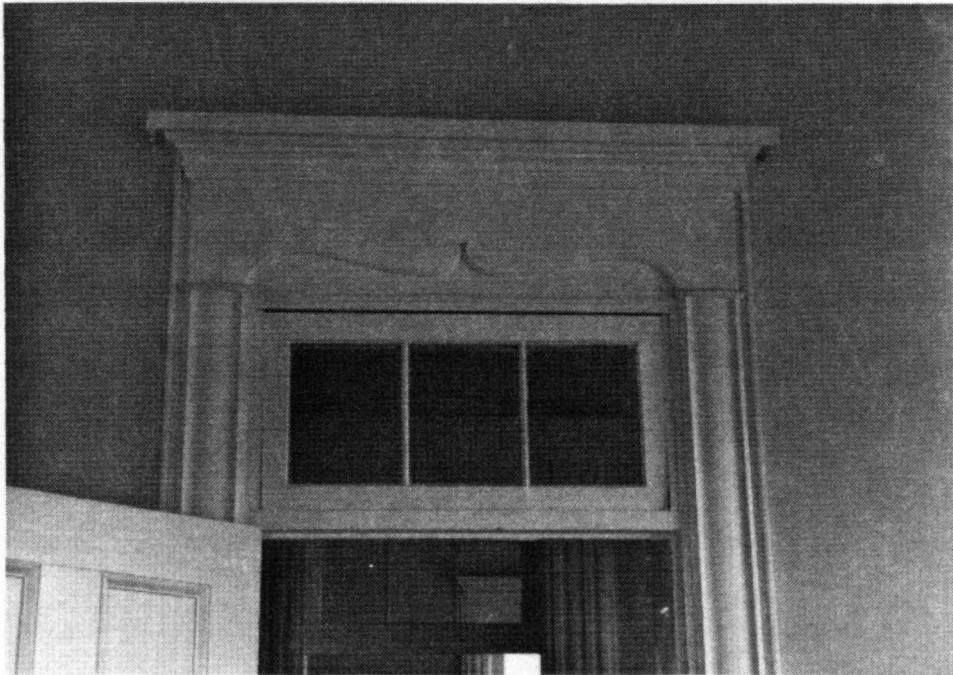
Figure III-34. Curvilinear door details of Fairfax' first floor rooms.

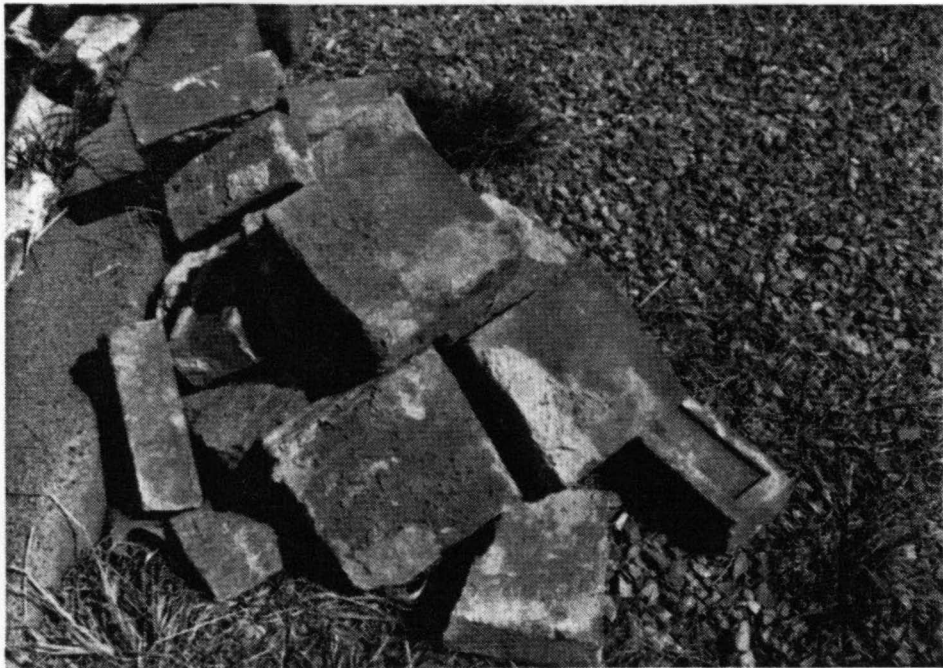
Figure III-68. Eight inch by eight inch bricks.

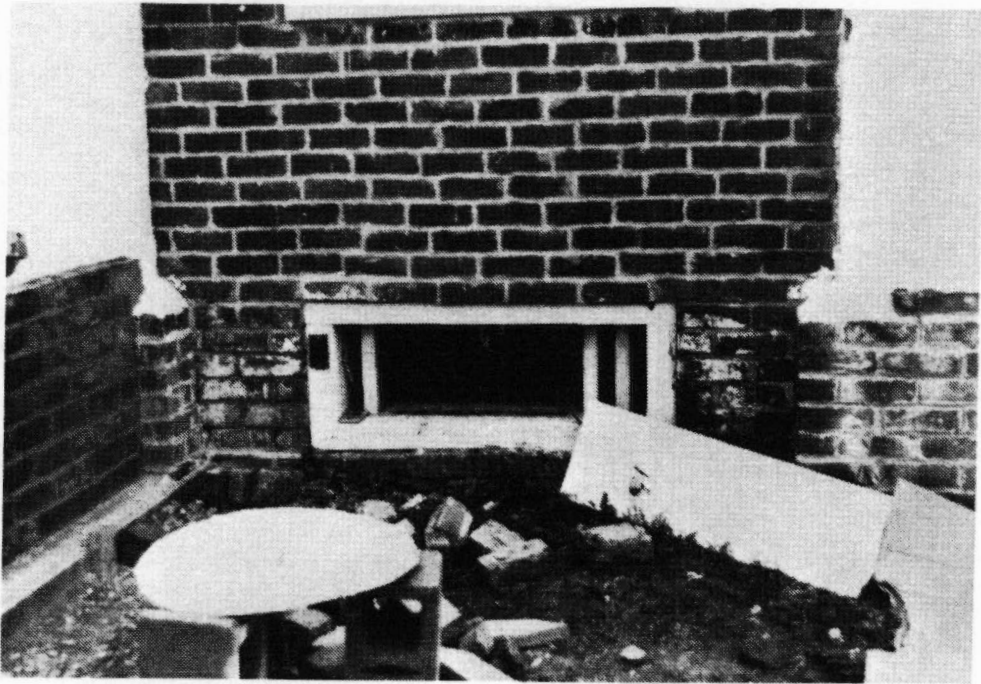
Figure III-69. Ventilation of Fairfax crawl space.

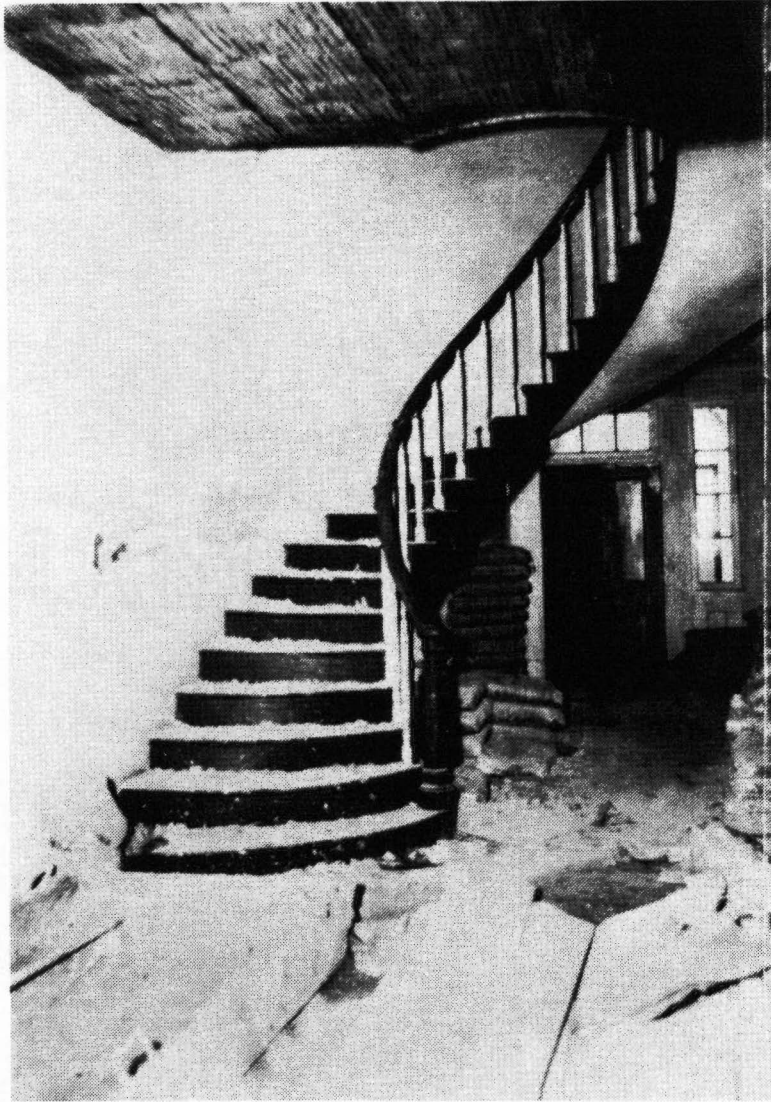
Figure III-73. Wood slat ceiling construction.
