**Rock-slope Activity Index (RAI): a lidar-derived process-based
rock-slope assessment system**

A thesis submitted in partial fulfillment of the requirements for the degree of

Master of Science in Civil Engineering

University of Washington

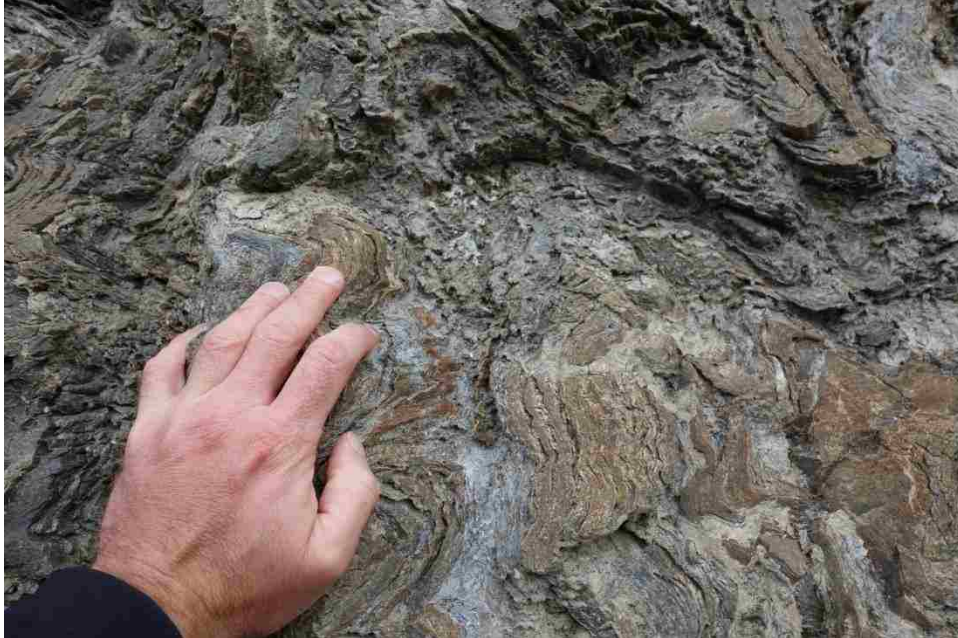
Figure 2.4 Close up of Healy Schist a metamorphic rock containing quartz, schist and mica.

The main type of rock found within the Parks Highway study area is a rock is known as Birch Creek Schist or Healy Schist (Figure 2.4) that Connor (1988) describes as “metamorphic rocks, muscovite-quartz schist, micaceous quartz and lesser amounts of graphitic schist.” Wahrhaftig (1958) notes that Birch Creek schist is inherently weak because of its "ease of separation along planes of foliation, produced by tiny, oriented mica flakes." This rock also includes cross joints, which run near vertical and may locally abut basalt dikes. Figure 2.6 is a geologic map of the area that shows volcanic

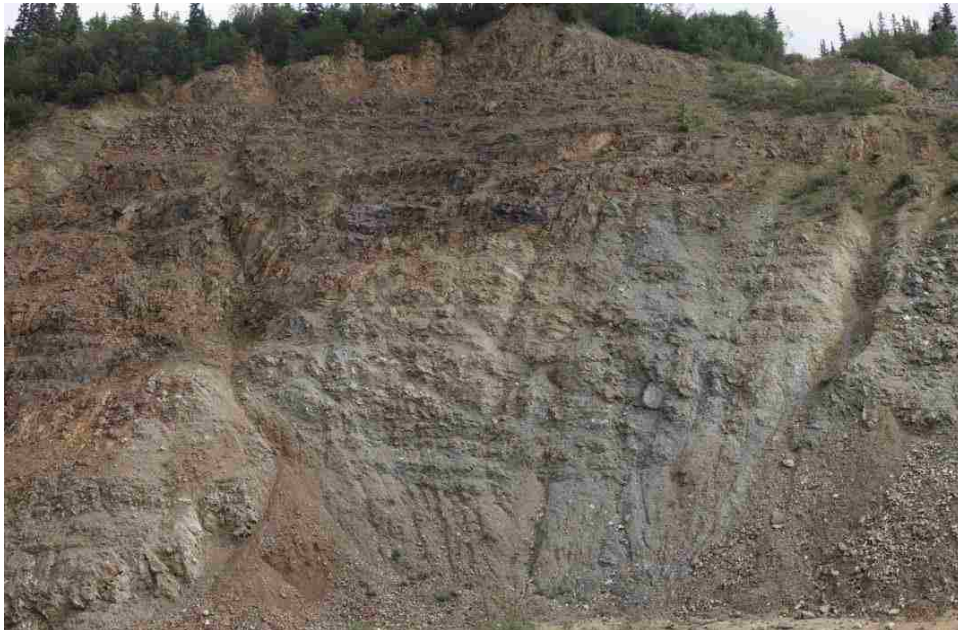
Figure 2.5 Slope at parks highway showing the darker volcanic rock, on top of the lighter Healy schist.

dikes (Tvim, Tvif) within the Healy schist (PzpCp). The volcanic rock can be clearly seen as the darker rock in Figure 2.5, with a lighter Healy schist layer below.

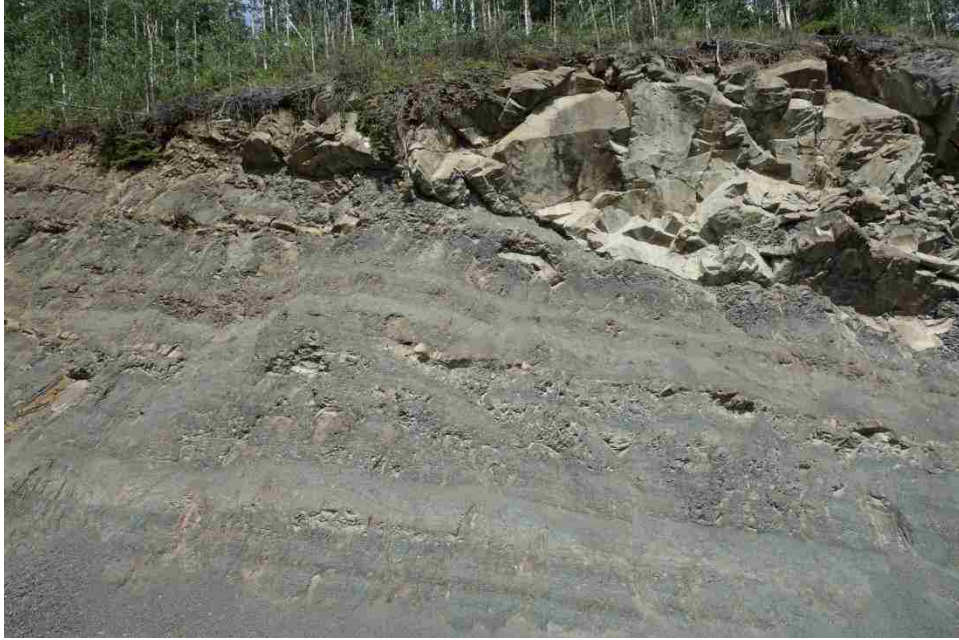
Figure 2.8: Carbonous rock in the Chickaloon Formation below with mafic sill intrusions on top as seen near Milepost 85

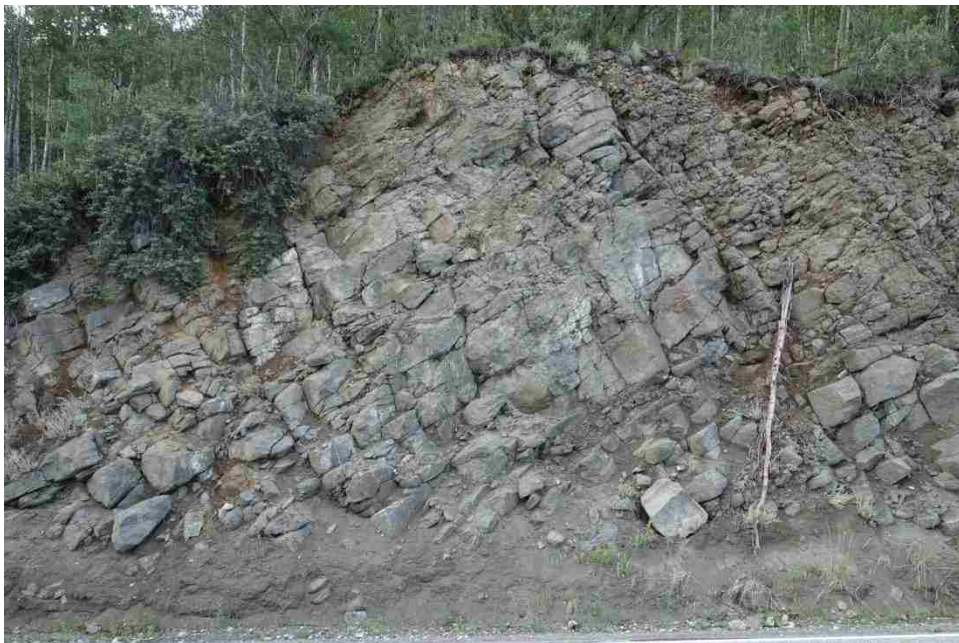
Figure 2.9: Chickaloon formation sandstone in block failure near Milepost 85.5.

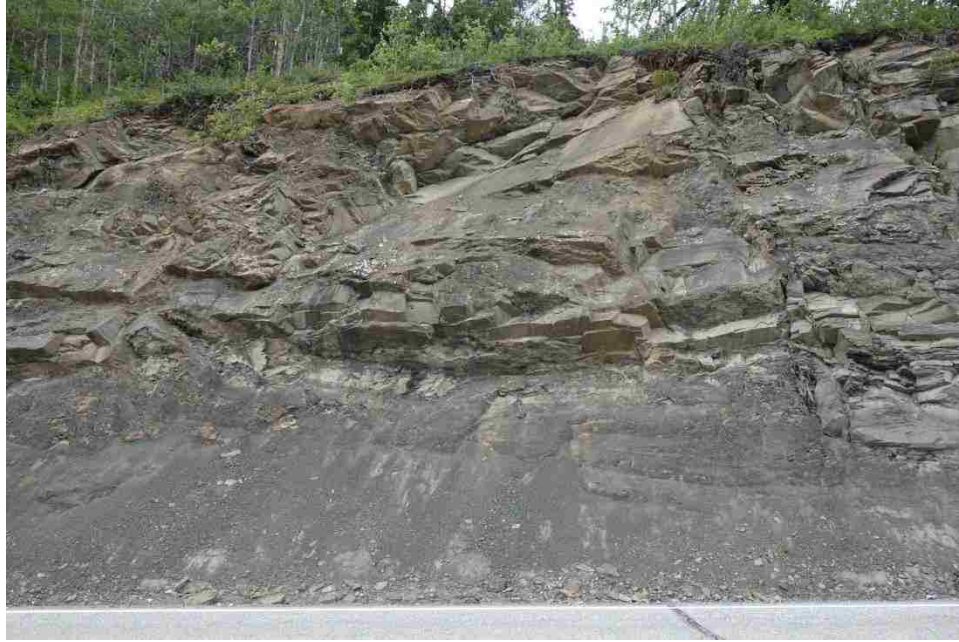
Figure 2.10: Carbonous siltstones overridden by a sill. The siltstones are a weaker material and therefore erode faster than the sill causing overhangs within the sill. To the right a fault can be seen offsetting these strata. These faults can be seen throughout the Chickaloon formation.

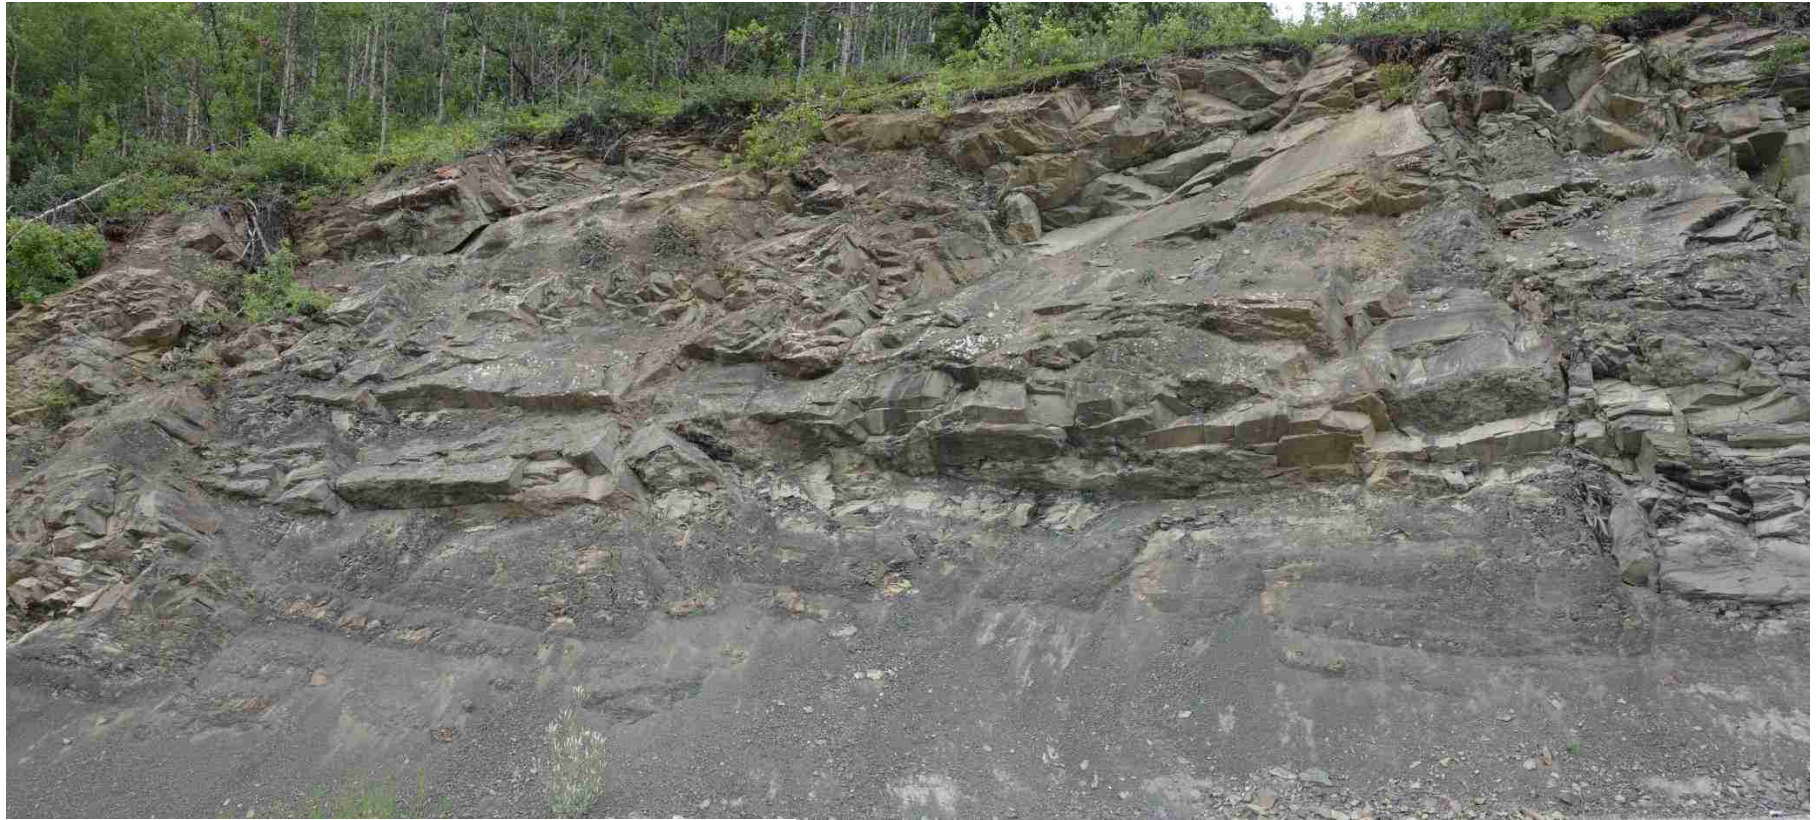
Figure 2.13 (above): Chickaloon formation at Milepost 87 along Glenn Highway. This site has soft sedimentary rock overridden by hard mafic sills causing differential erosion resulting in overhangs within the slope.

Milepost 87 seen in Figure 2.13 is part of the Chickaloon formation and consists of soft sedimentary rock overridden by hard mafic sills. The contrast between strengths of these units has caused differential erosion forming overhangs within the site. The mafic sills have two major joint sets, one dipping at approximately 50 degrees with a dip direction of 195 degrees and the other dipping at approximately 40 degrees with a dip direction of 5 degrees. The overall slope and direction of the site is approximately 58 degrees slope with a direction of east to west. The stereonet for this site can be seen in Figure 2.14.

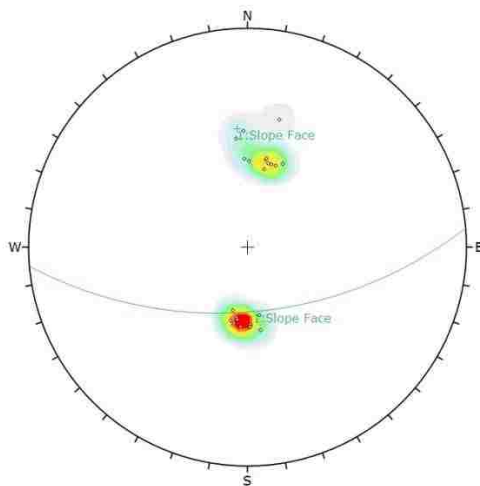
Figure 2.14 (left): Stereonet representing the two joint sets found at milepost 87. The slope face itself runs nearly east west with a slope of 58 degrees. The two joint sets are approximately 50 degrees dip with dip direction of 195 degrees and 40 dip with a dip direction of 5 degrees.

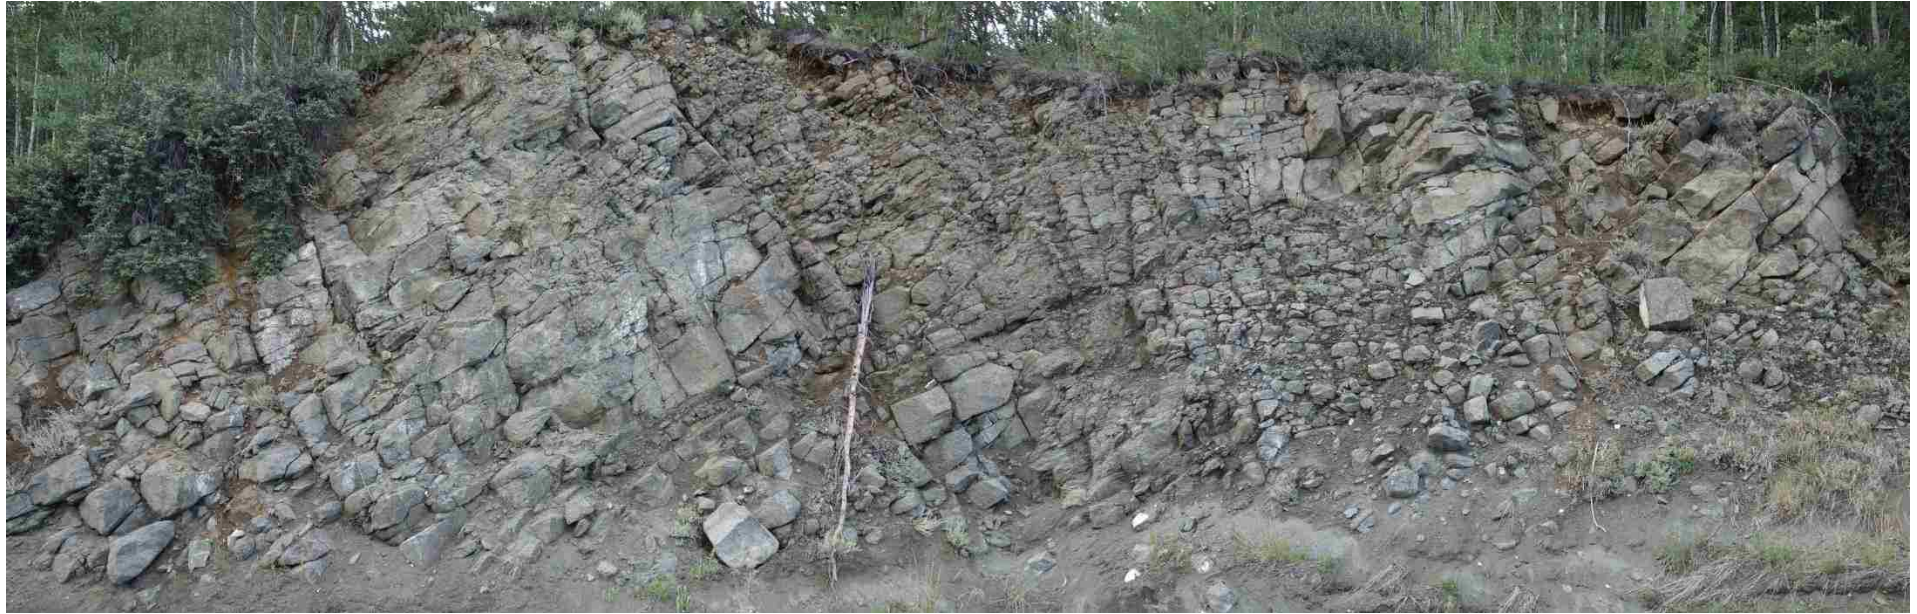
Figure 2.15 (above): Sandstones from Chickaloon formation at Milepost 85.5 along Glenn Highway.

Milepost 85.5 is an outcrop of fine-medium grained grey and tan sandstone of the Chickaloon formation, Figure 2.15. This area has been moderately weathered and three joint sets are visible Figure 2.15. The dip and direction of these sets are approximately: 60 degrees dip, 90 degrees dip direction; 85 degrees dip, 0 degrees dip direction and 30 degrees dip, 200 degrees dip direction. The overall slope and direction of this site is 60 degrees slope with a northeast to southwest direction.

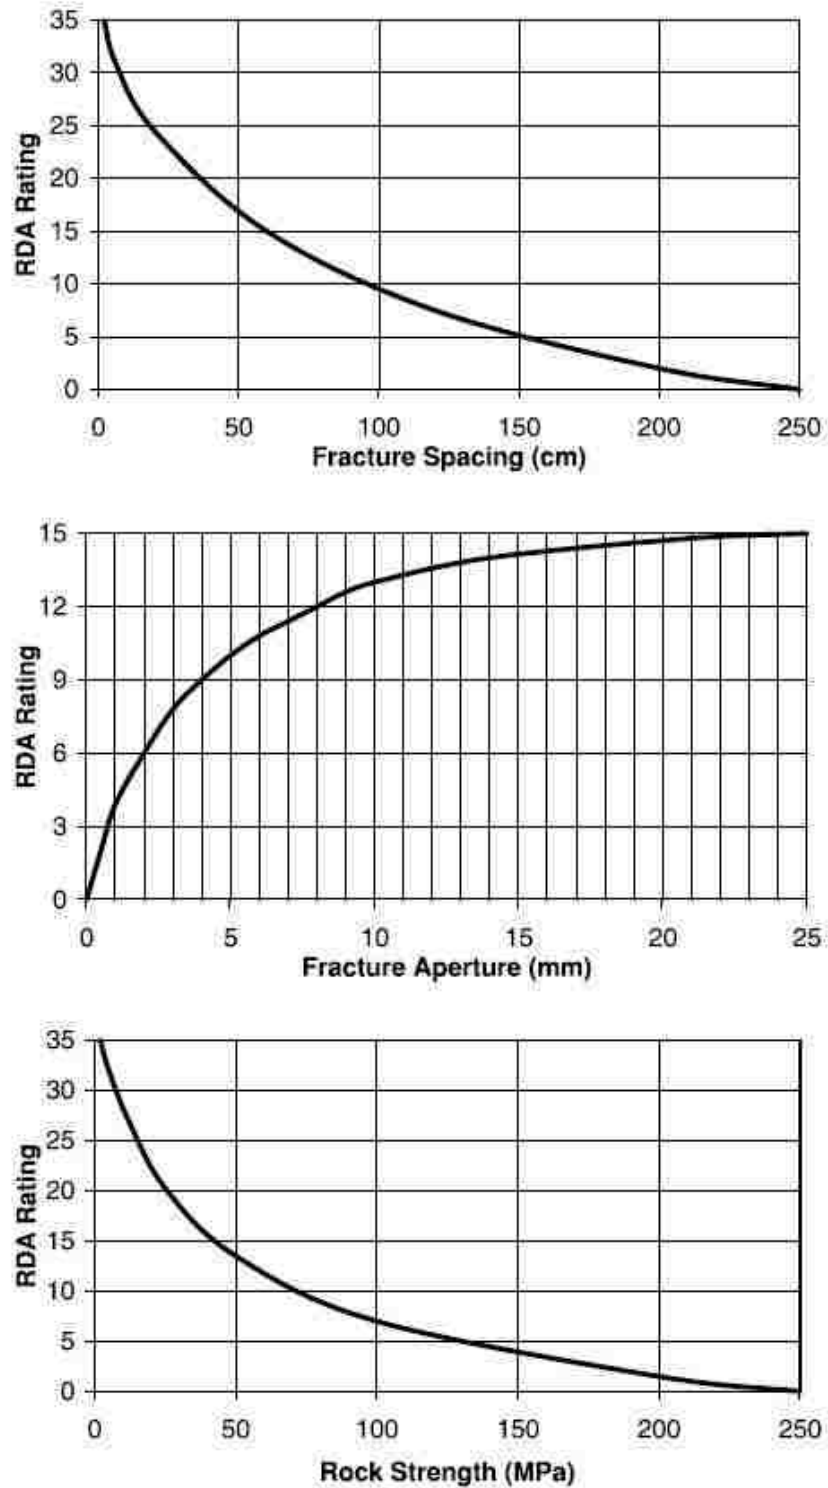
Figure 3.1 RDA Main Factors charts to determine the score of fracture spacing, fracture aperture and rock strength (Nicolson 2004).

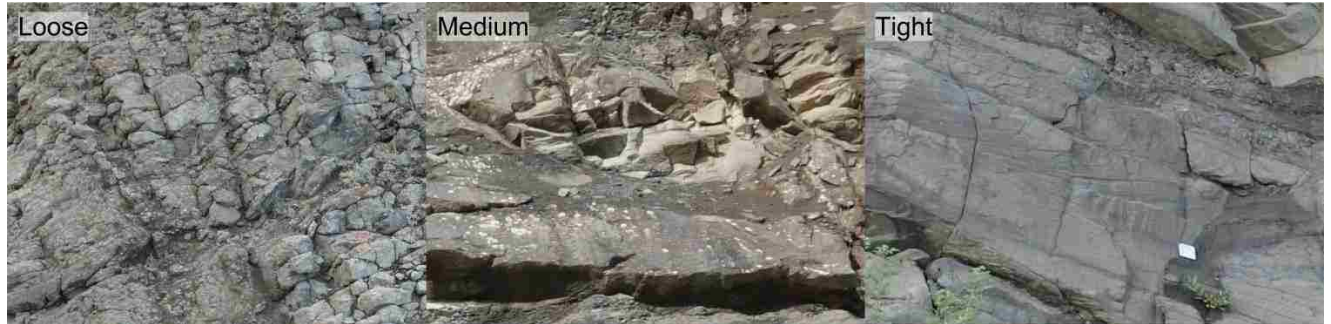
Figure 4.7: Examples of the generalized levels of Fracture Aperture using examples from Glenn Highway and Parks Highway study areas.

These were determined visually as seen in Figure 4.7.

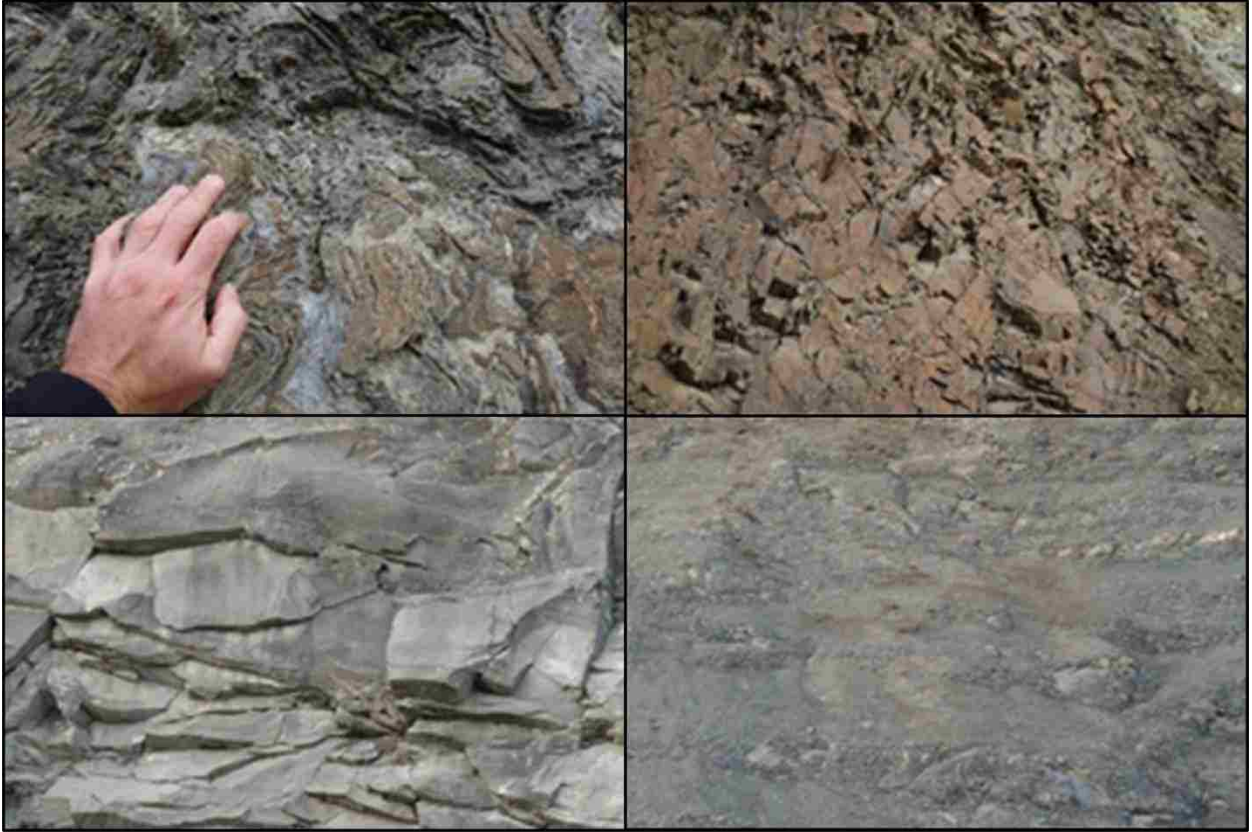
Figure 4.8: Top left, Healy Schist, top right: mafic intrusion along Parks highway, bottom left: sill intrusion along Glenn Highway and bottom right: carbonous rock from the Chickaloon formation.

Rock strength was calculated with the use of Schmidt hammer measurements as described in Appendix B. The sites were then separated according to lithological units as shown in Figure 4.8.

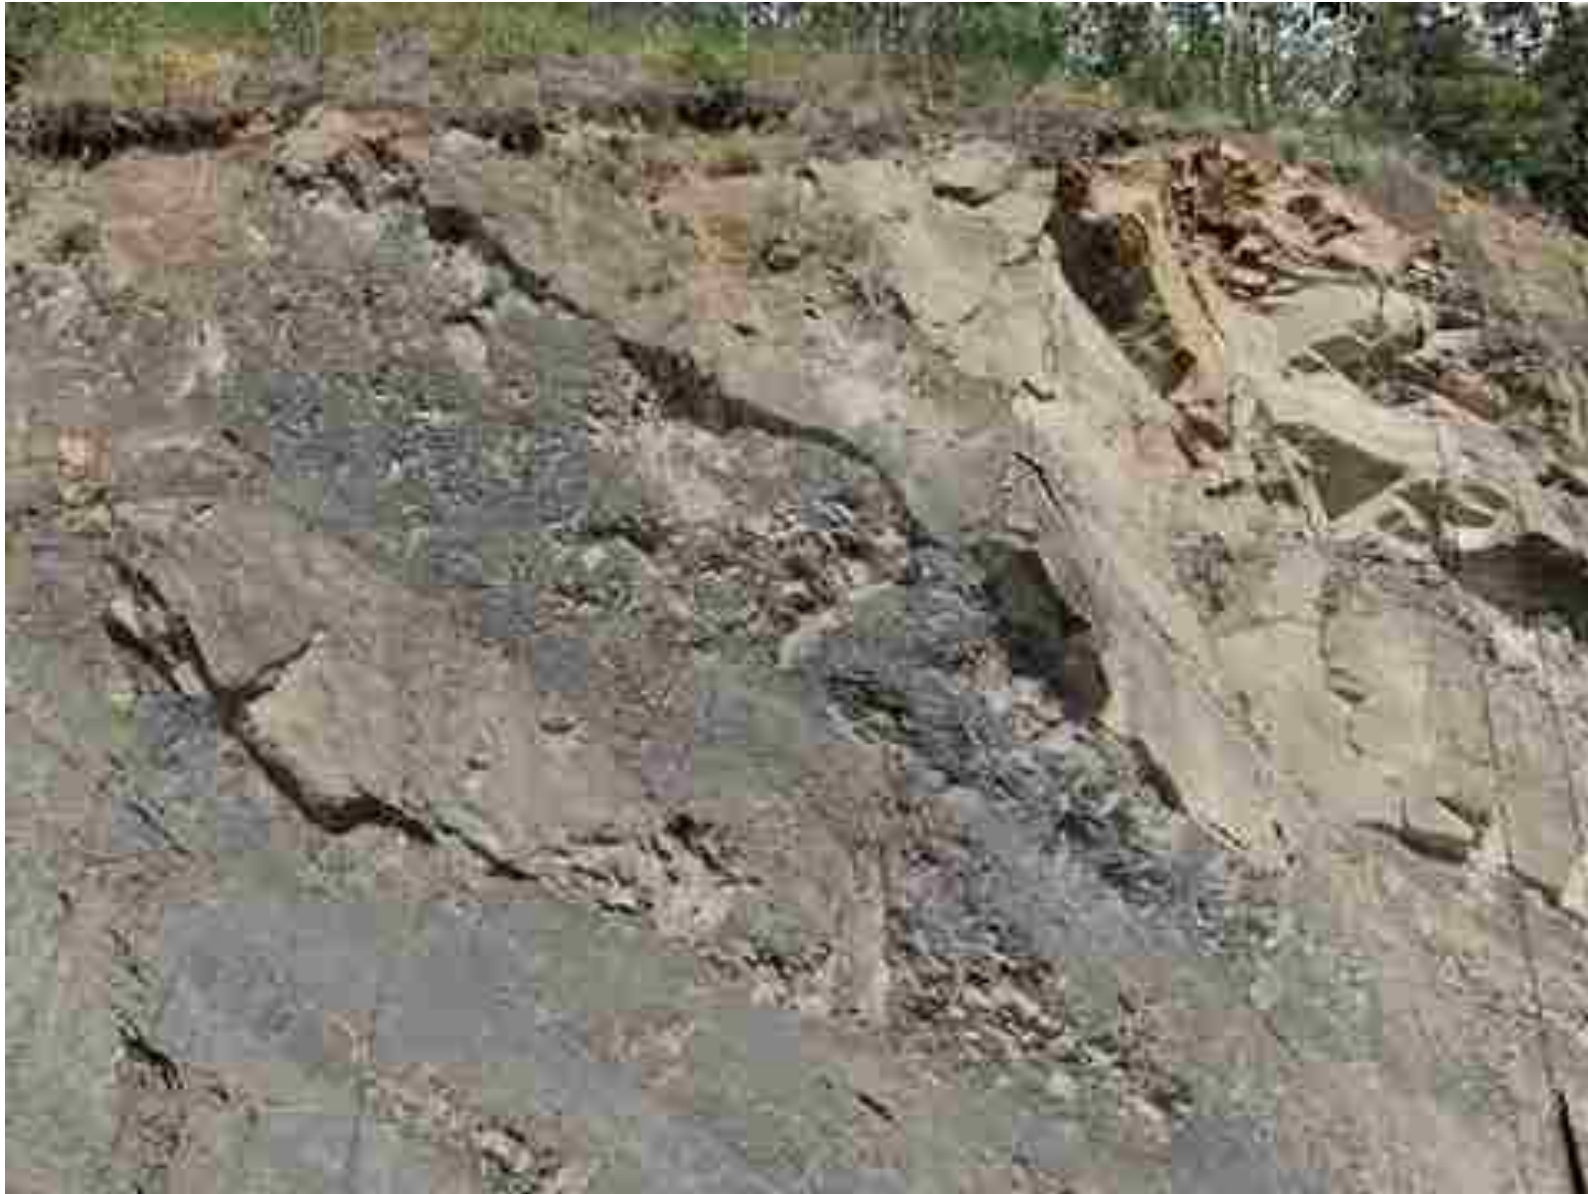
Figure 5.4: Example of 2013 lidar scan from an area along Parks Highway in an area that has highly unstable rocks.

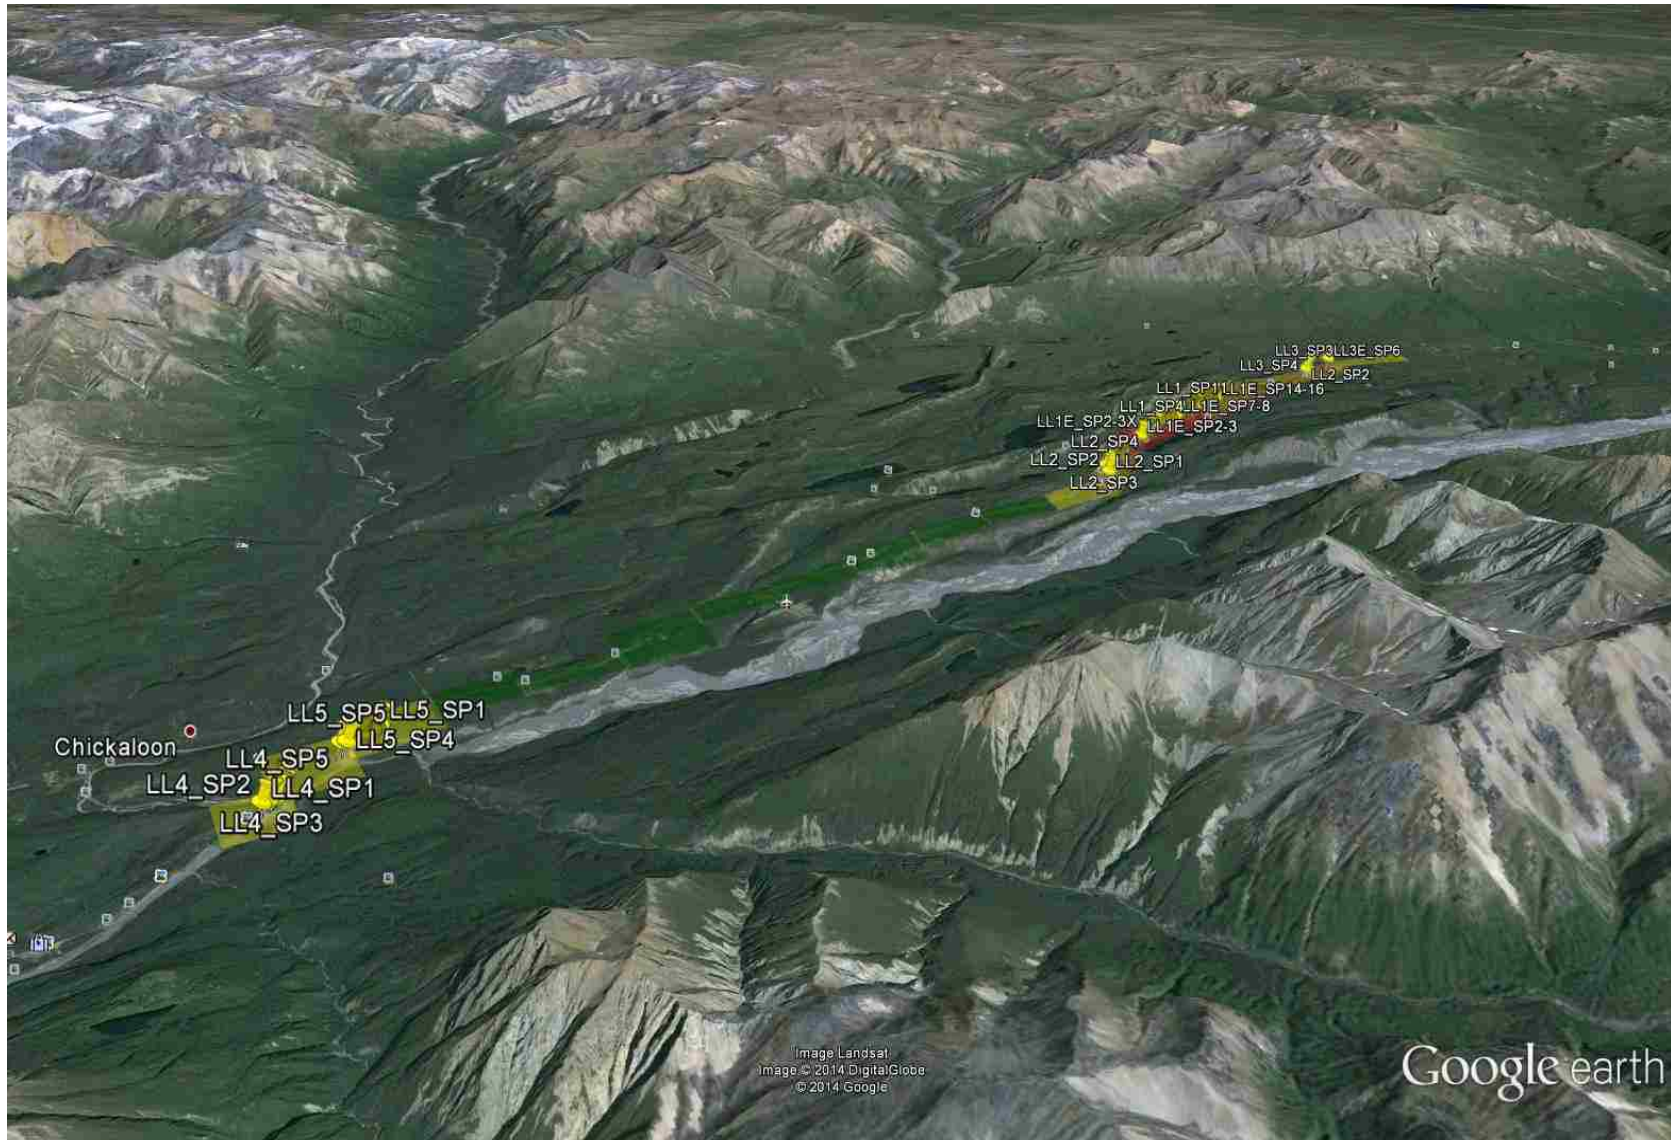
Figure 5.6: Glenn Highway survey site. The different shaded colors were for the priority of the sites, the yellow pins were scan positions. The priority colors were: Red->Green = Highest -> Lowest Priority

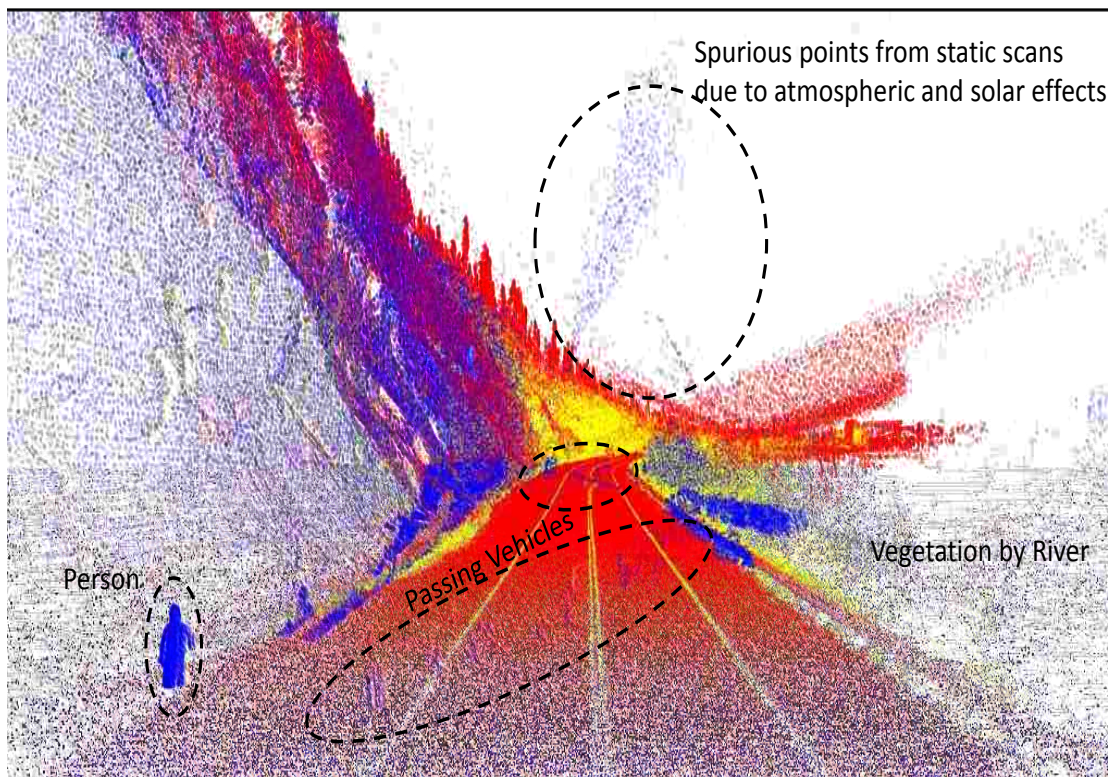
Figure 5.7: Examples of noise that is removed from lidar scans. If this noise is not removed, it can interfere with the analysis of the data.

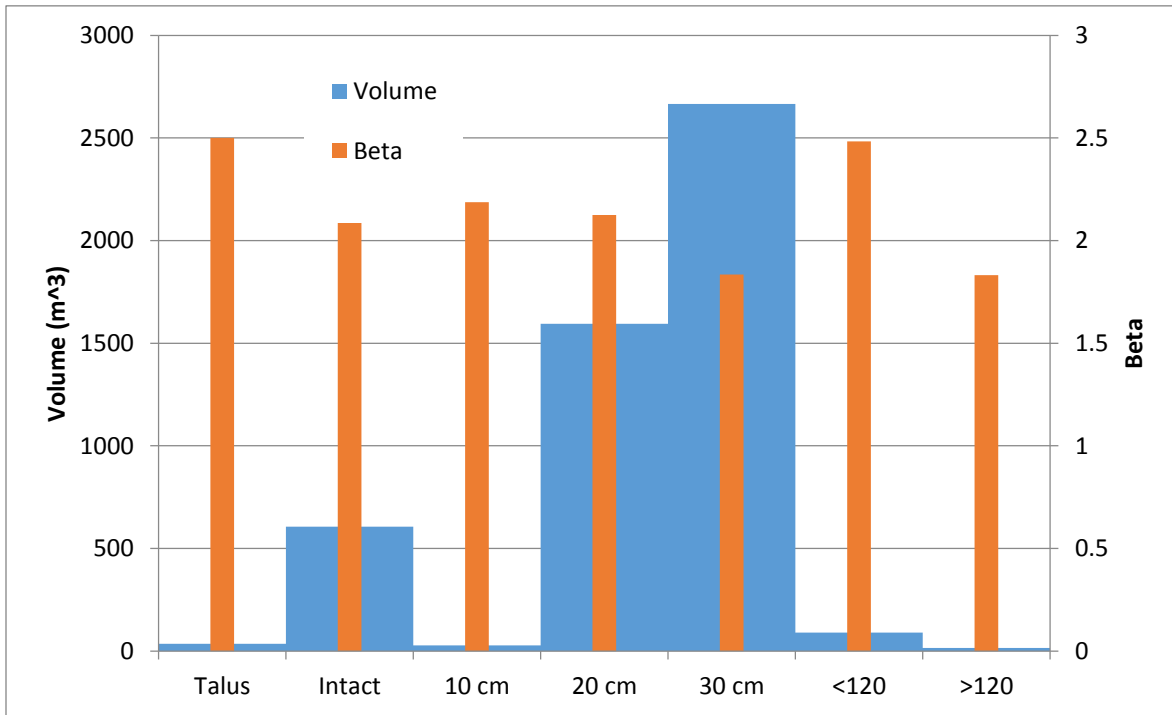
Figure 8.9: Maximum volume and beta value per class. As the beta value goes down, the ratio of large to small events increases which explains the large increase in maximum volume for the smallest beta values.

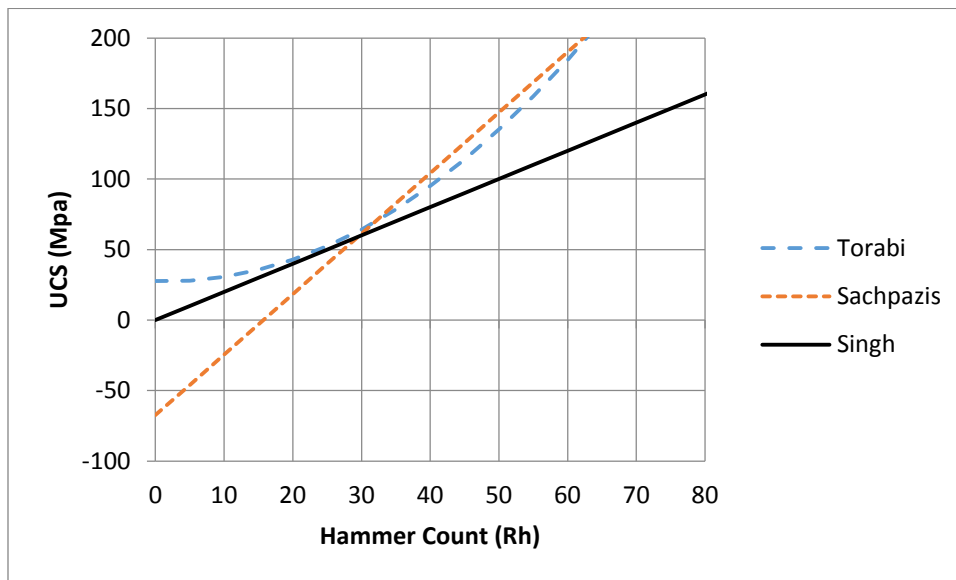
Figure B3: Graphed equations for Torabi et.al. (2011), Sachpazis (1990) and Singh (1983) empirical relations
