Seismic performance of accelerated bridge construction (ABC) precast bulb-tee girder-to-bent cap connection

A thesis submitted to the graduate faculty
in partial fulfillment of the requirements for the degree of
MASTER OF SCIENCE

Major: Civil Engineering (Structural Engineering)

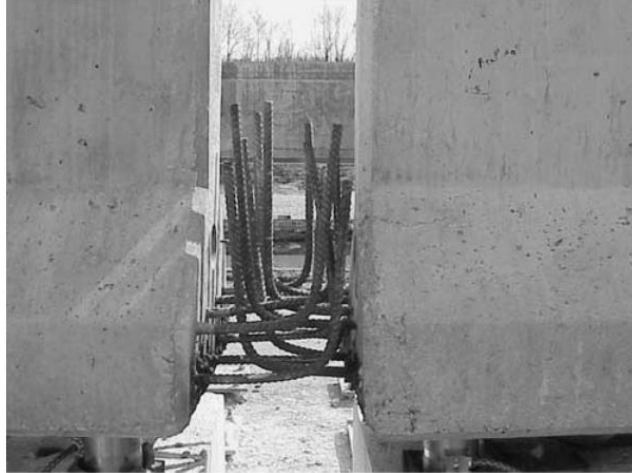
Figure 2-15 Congestion within Connection Region due to the Use of Bent Bars (Miller et al., 2004)

Additional reinforcement that is required in order to develop the continuity resulting in congestion within the connection region as shown in *Figure 2-15*. The congestion of reinforcement induces the consolidating concerns for connection resulting from the use of small spacing between reinforcement. The honeycombs surrounding reinforcement may cause a weak bonding and result in the reduction of effective strength of reinforcement. The bent bars are difficult to use in construction, labor intensive, and are often asymmetrical, which can lead to uneven stresses and failure in the interface between the precast girders and bent cap (Miller et al., 2004). Also, the extended bars are likely damaged or fractured during fabrication and transportation. In the event of damaged bars, holes must be drilled into the girder ends through which the new bars are embedded and anchored with epoxy.

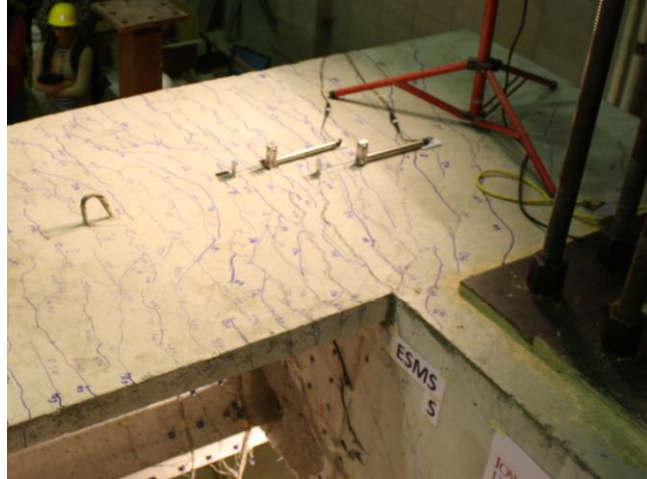
Figure 5-2 Flexural Cracks on Deck of the ESMS Connection

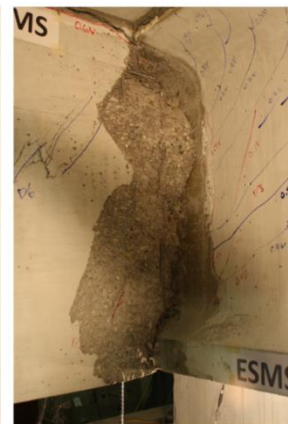
Figure 5-4 (a) Separation between Girder End and Bent Cap; (b) Penetration Cracks on Diaphragm; (c) Diaphragm Region where the Spalling of Concrete Was Observed
