# Selected Topics in Foundation Design, Quality Assurance, and Remediation

Danny Winters

A dissertation submitted in partial fulfillment  
of the requirements for the degree of  
Doctor of Philosophy  
Department of Civil and Environmental Engineering  
College of Engineering  
University of South Florida

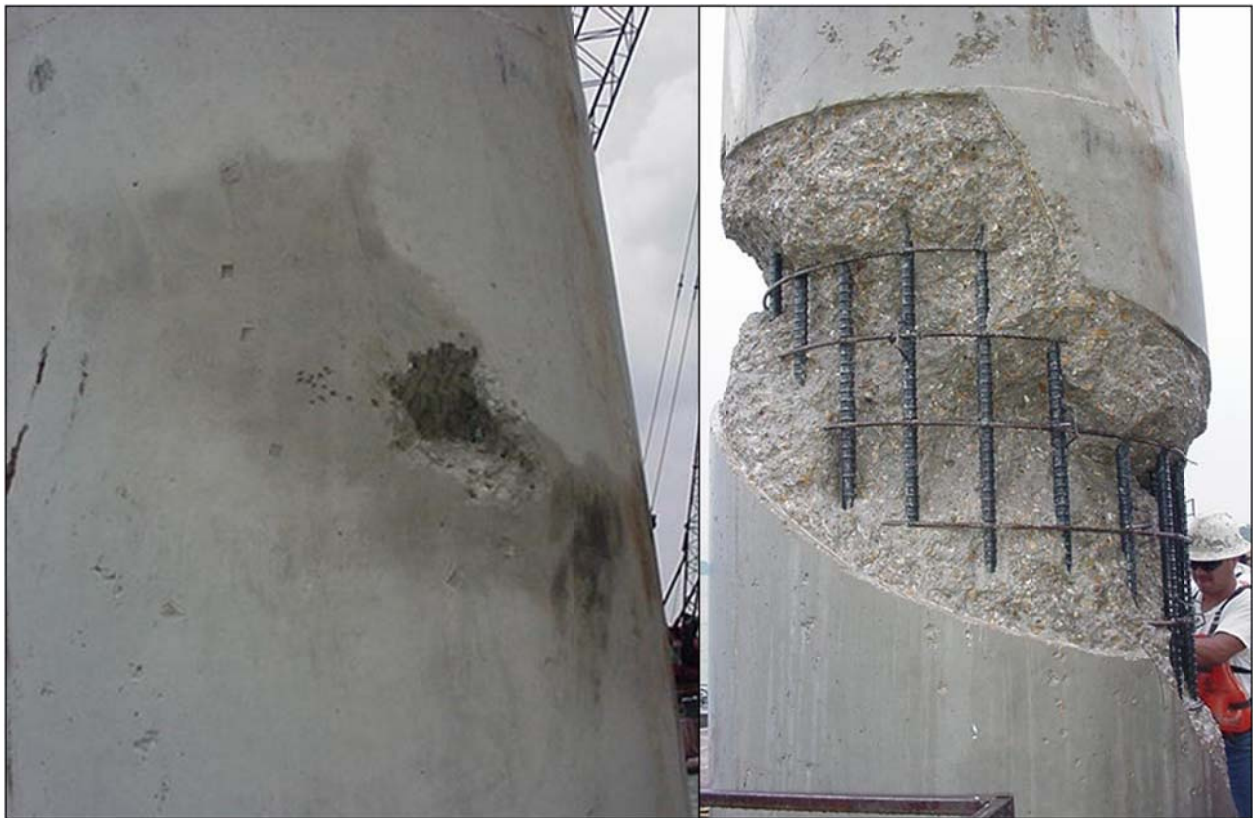
Figure 3.1 Soft concrete visually identified (left); full anomalous extent removed (right).
