Selected Topics in Foundation Design, Quality Assurance, and Remediation

A dissertation submitted in partial fulfillment
of the requirements for the degree of
Doctor of Philosophy
Department of Civil and Environmental Engineering
College of Engineering
University of South Florida

Keywords: Drilled Shaft, Driven Piles, Thermal Integrity
Post Grout, Fiber-Reinforced Polymers

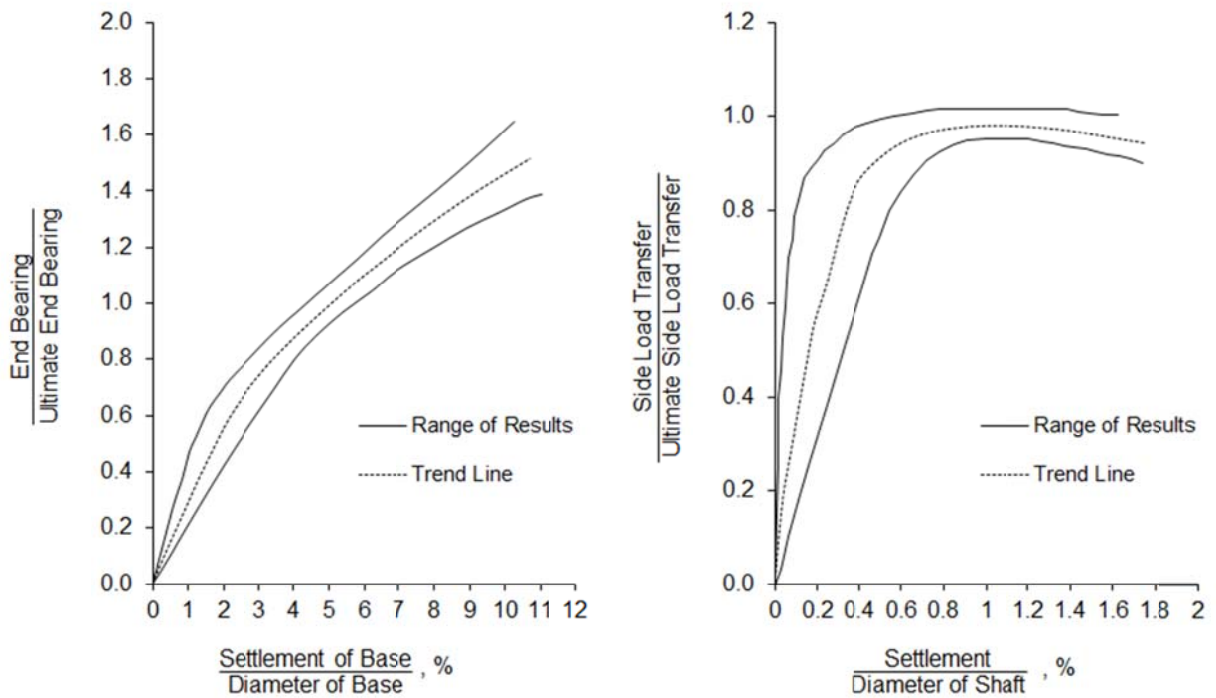
Figure 1.2 Normalized load transfer in side shear (left) and end bearing (right) versus settlement in cohesionless soils for drilled shafts (after Reese and O'Neill, 1988).

Chapter 2 presents design procedures and investigates how to improve the load carrying capacity of drilled shaft foundations. Drilled shafts are cast-in-place concrete elements that develop load carrying capacity via side shear and end bearing. The displacement at which side shear and end bearing develop is drastically different causing engineers to adjust the amount of load carrying ability accordingly. Figure 1.2 shows the degree of side shear and end bearing that can be developed in cohesionless soils (sands) as a function of shaft diameter (Reese and O'Neill, 1988). Combining the two plots further accentuates this incompatibility (Figure 1.3). Side shear develops fully (~100%) within a settlement of 0.5%D (where D is shaft diameter)

while at that same displacement end bearing develops only 25%. To develop full end bearing, the shaft is required to displace $4.25\%D$ or more. As a result of the strain incompatibility, design of drilled shafts typical does not include (or significantly reduces) end bearing within the load carrying capacity. By pressure grouting the bottom of the shaft, full development of the end bearing occurs within the same range of settlement associated with side shear, and the potential of higher end bearing values within loose soils can be provided. A design method for the application of pressure grouting is presented.

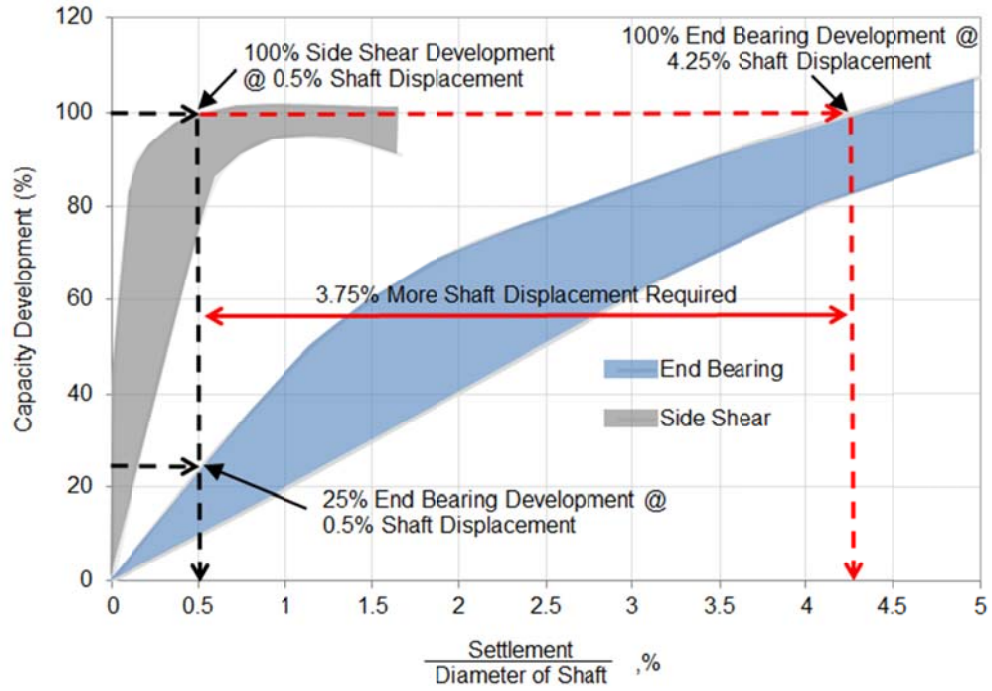
Figure 1.3 Combined load transfer plots for side shear and end bearing.

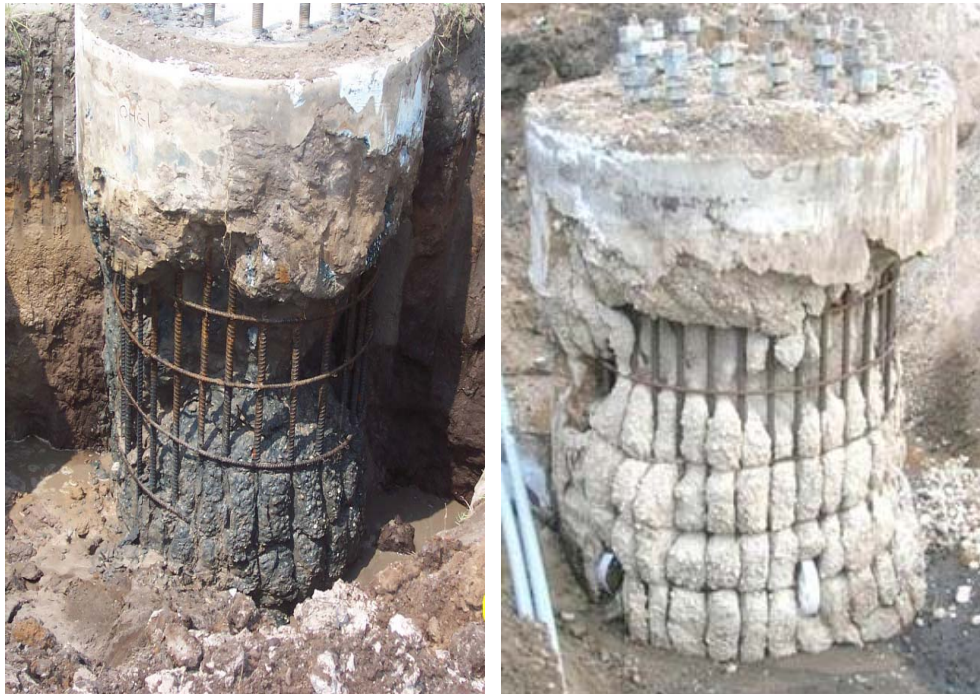
Figure 1.4 Underground flaws in drilled shafts that required excavation to identify.

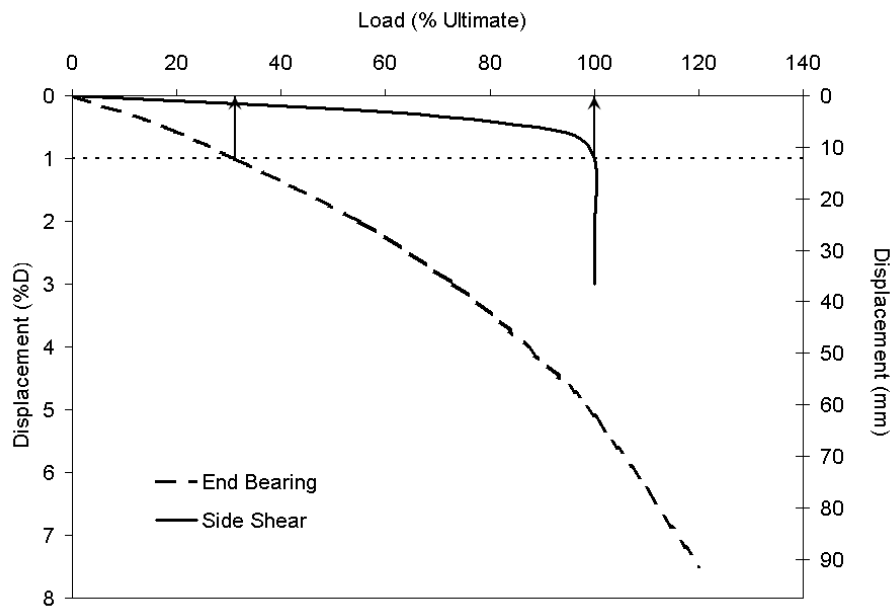
Figure 2.4 Typical displacement mismatch between end bearing and side shear.

TCM values greater than 1.0 corroborate Bruce's (1986) statement that shafts tipped in sand could continue to develop capacity up to 15%D. Unfortunately, large displacements such as these are rarely permissible due to service limits. For example, a 1.2 m (4 ft) diameter shaft would have to displace 61 mm (2.4 in) in order to achieve ultimate capacity; whereas the side shear would develop in 6 - 12 mm (0.24 - 0.48 in), shown in Figure 2.4. At full side shear

development, only about a third of the design end bearing has been developed. As an alternate, post grouting beneath the shaft tip provides a method to avail higher usable end bearing at more reasonable displacements.

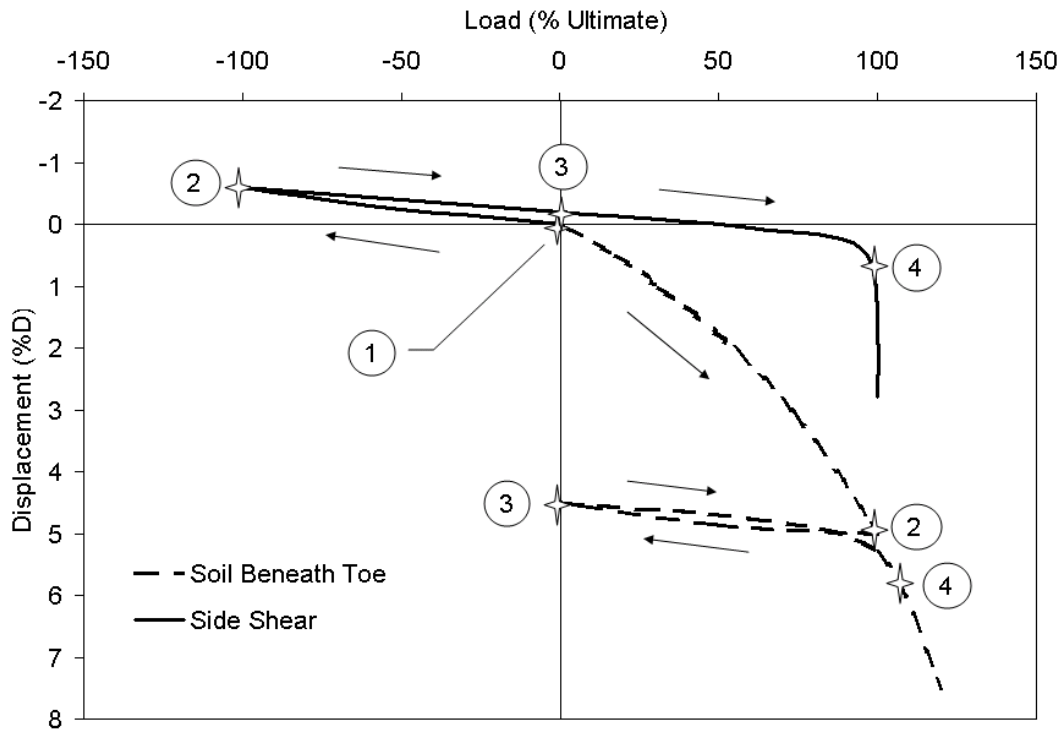
Figure 2.6 Conceptual load / displacement history for unlocked grout pressure.

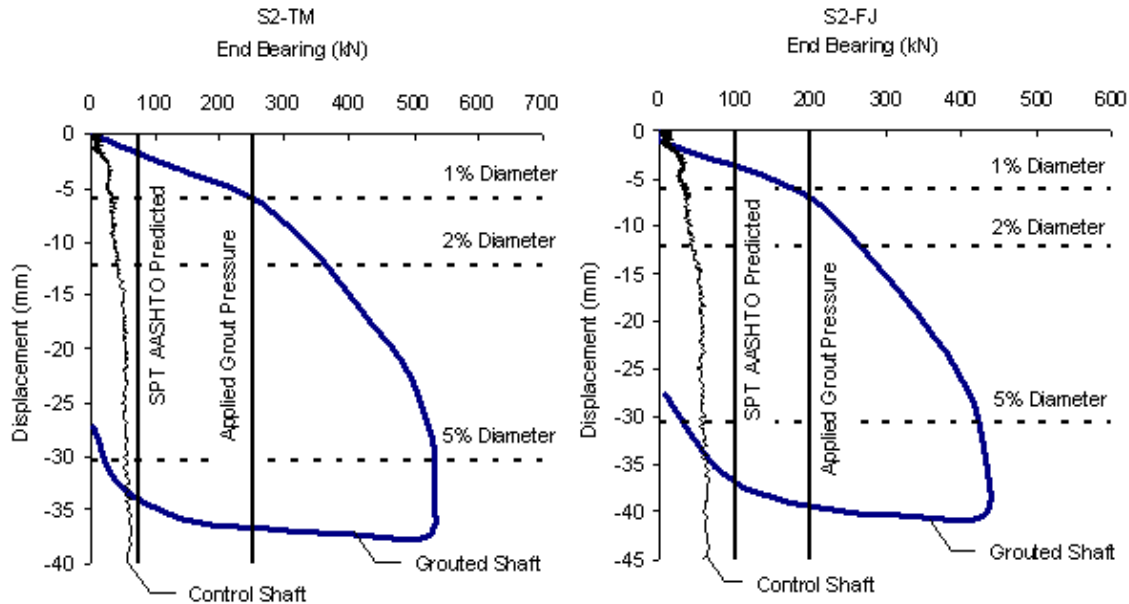
Figure 2.10 Load test results for Site II.

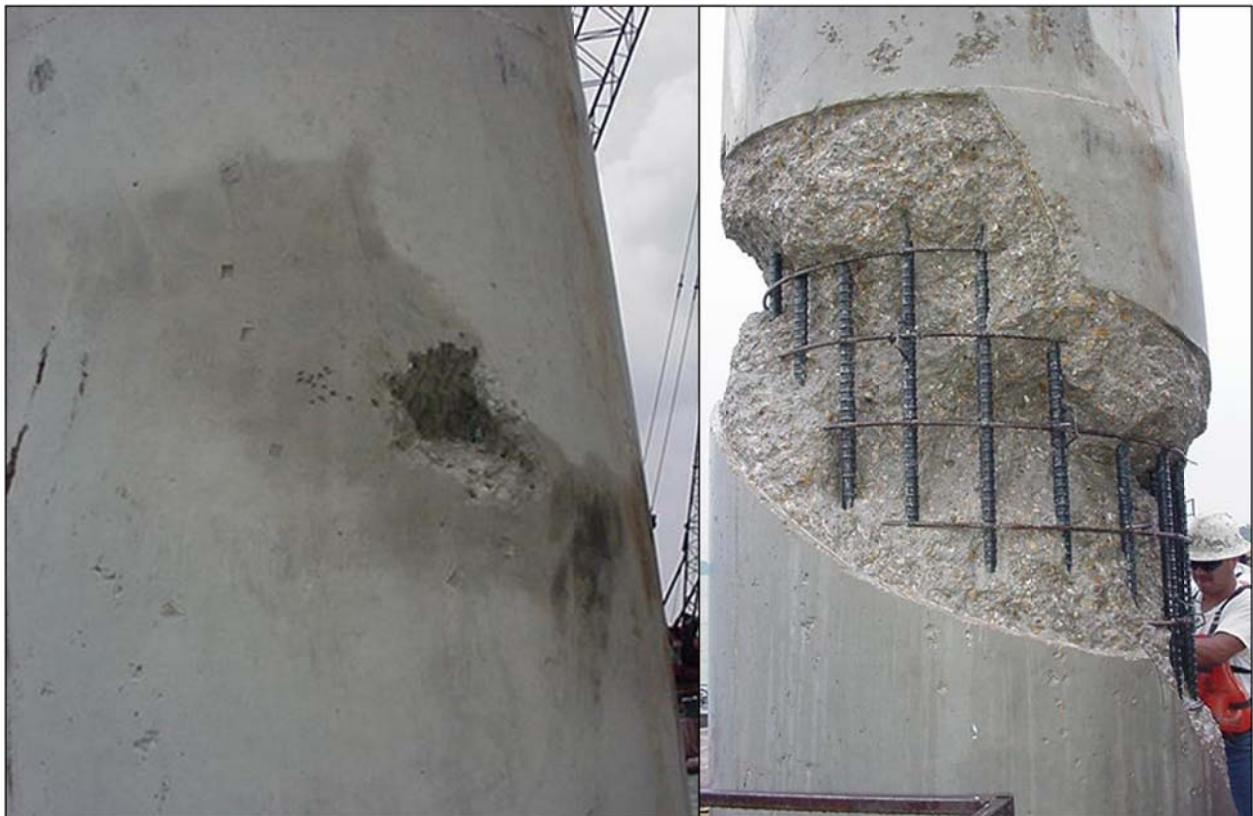
Figure 3.1 Soft concrete visually identified (left); full anomalous extent removed (right).

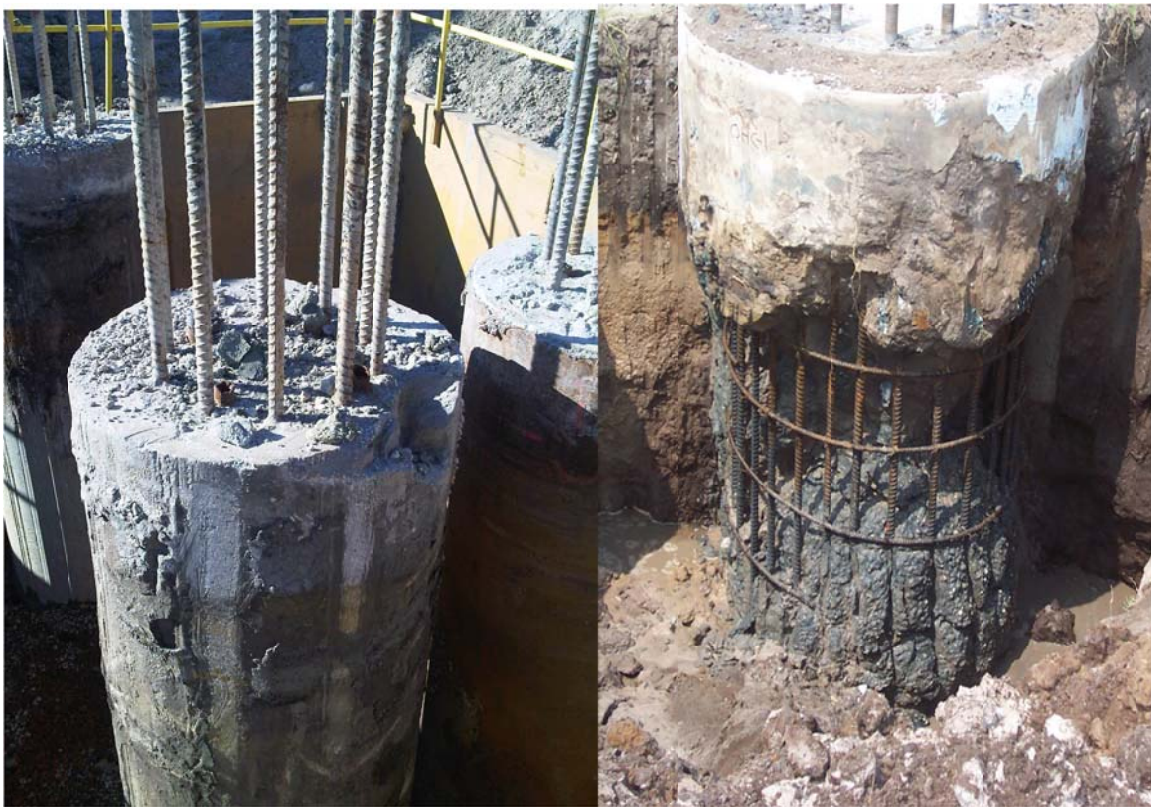
Figure 3.2 Visually intact shaft (left); visually deficient shaft (right).

In cases where concreting logs indicate an incorrect placement volume (less than theoretical), simple surface excavation might reveal the problem, lead to full exhumation, or installation of a nearby supplemental shaft. Visual inspection alone does not verify concrete quality, it just helps identify problems. Figure 3.2 shows shafts exposed to find visually intact and visually deficient cases. Unfortunately, the visually intact shaft required a supplement shaft due to poor concrete quality (discussed later).

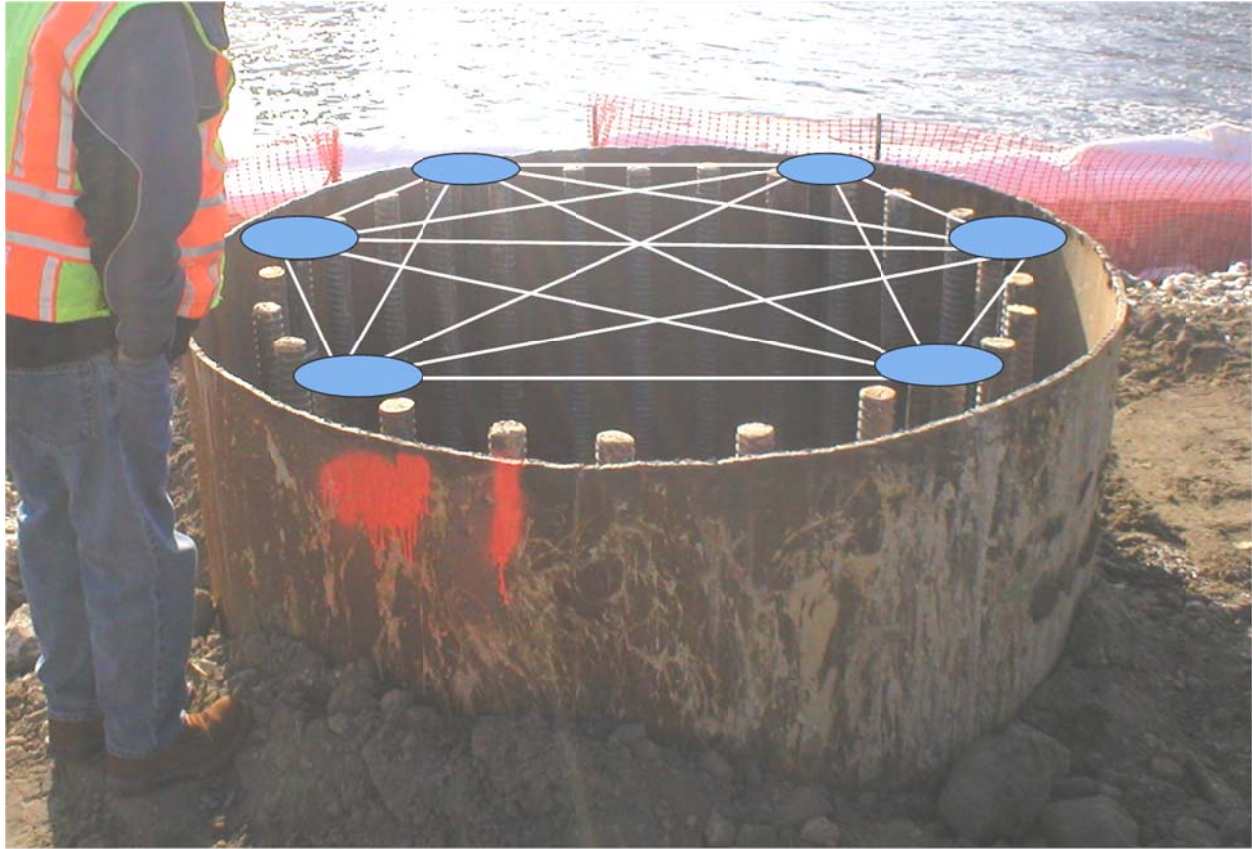
Figure 3.3 Testing coverage from acoustic (lines) and gamma radiation (circles) methods.

The most common non-destructive test methods of assessing shaft integrity use: acoustic waves sent between access tubes to check the concrete between tubes (Figure 3.3 white lines); or gamma radiation reduction to check the density of the material immediately surrounding the access tubes (zone shown as blue circles). Alternate single-tube acoustic methods have similar coverage to the gamma radiation method.

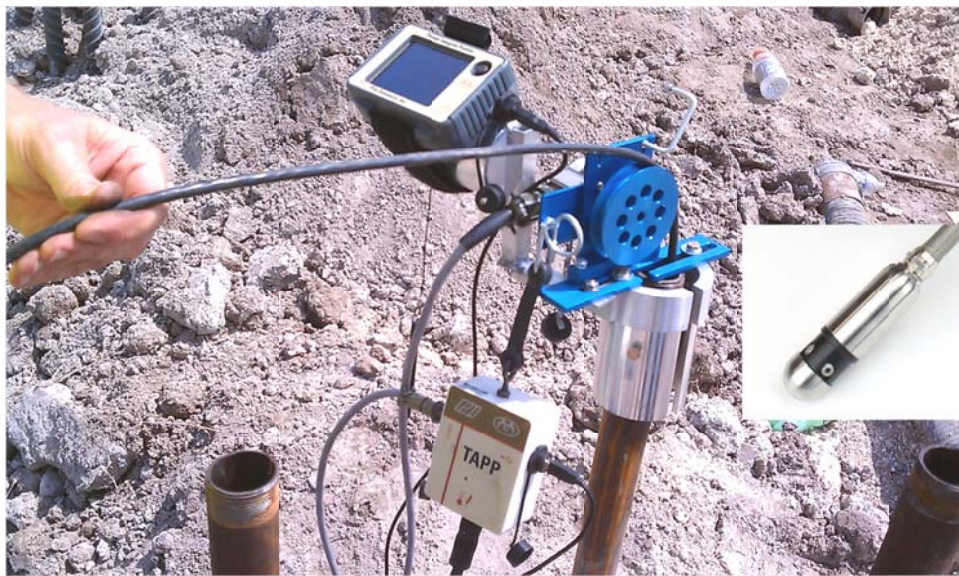
Figure 3.8 Thermal profiling using the thermal probe method (probe shown separately).

Thermal integrity profiling can be performed using a reusable thermal probe lowered into standard access tubes or by installing thermal wires into the reinforcing cage (in conjunction with or in lieu of access tubes). Figures 3.8 and 3.9 show the basic equipment types used for the two field testing methods. When using the thermal probe, a single set of profiles are taken from each tube at a time near or after the peak temperature. The beginning of the testing window is determined by the concrete mix design and the cement and flyash constituent compositions. The time of testing is usually 1 to 2 days after casting but extends to at least the number of days expressed in feet of shaft diameter (e.g. 4 ft shaft can be tested from 1 to 4 days after concreting). Tubes need not be filled with water for thermal testing, but often are to accommodate all other methods of testing that require it.

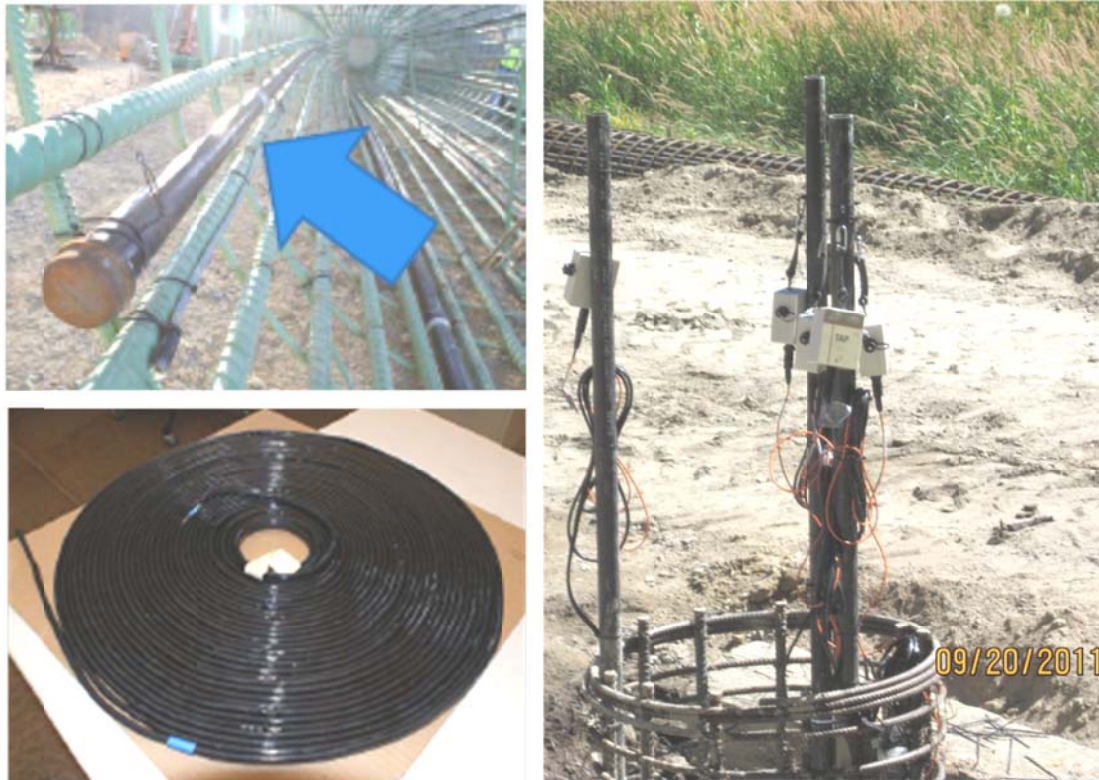
Figure 3.9 Thermal profiling components using the thermal wire method.

When using the thermal wire method, individual data collectors are attached to the top of each thermal wire shortly after concreting. The data collectors continue to take data at user prescribed intervals (e.g. 15 min.) until retrieved. The peak temperature and hence the optimal time of testing is automatically obtained despite scheduling obstacles. Both methods can provide results of shaft acceptability one to two days after casting.

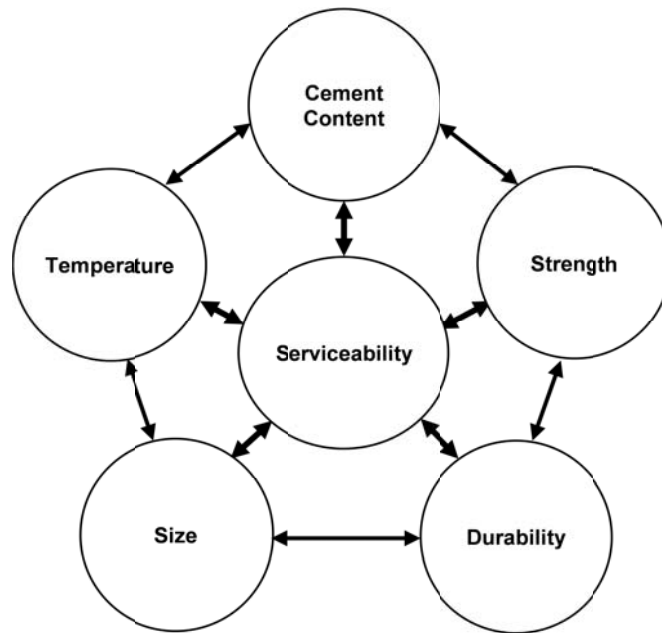
Figure 4.1 Components of drilled shafts to define the serviceability.

durability and strength both structurally and geotechnically (Figure 4.1). The inherent flaw of drilled shafts is the blind construction of these elements, as well as different construction techniques. Testing methods to assess the integrity of drilled shafts and similarly constructed concrete foundations have been developed to combat the blind nature of the construction process. The more popular methods include cross-hole sonic logging (CSL), gamma-gamma logging (GGL), and more recently thermal integrity profiling (TIP) and sonic caliper.

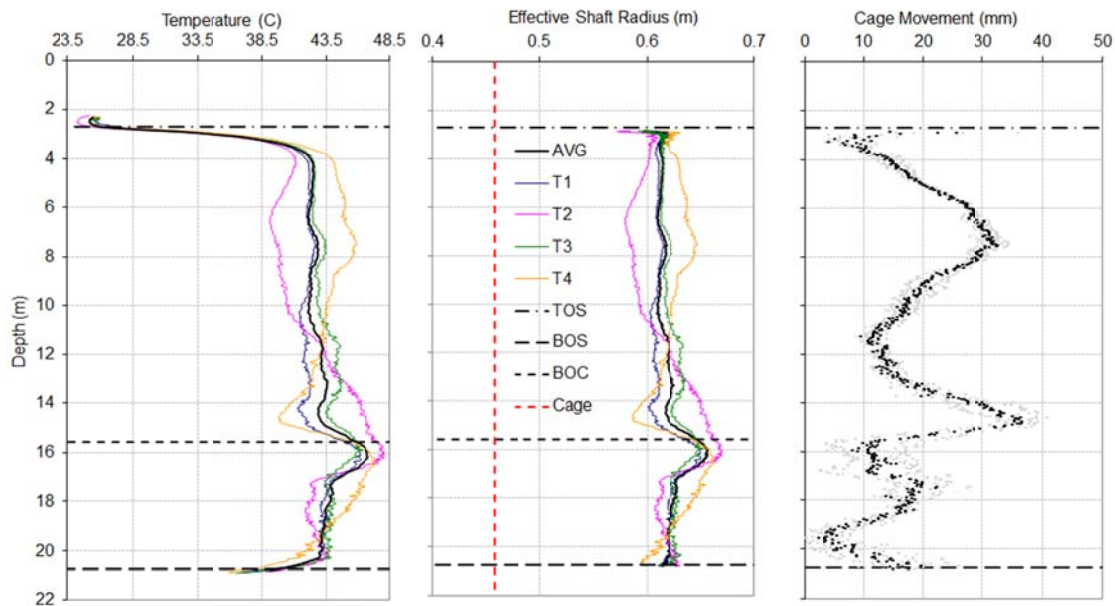
Figure 4.2 TIP results showing measured temp. (left), effective shaft size (center), and cage alignment (right).

The cage alignment can be assessed based on tube temperatures higher and lower than average temperatures and the associated effective radii. As a result tubes on opposite sides of the cage will respond with roughly equal and opposite temperature variations when misaligned. Higher temperatures correspond to tubes closer to the center of concrete while lower temperatures corresponds to tubes closer to wall excavation. Figure 4.2 shows raw temperature measurements, the computed effective shaft radius / effective concrete cover, and cage movement.

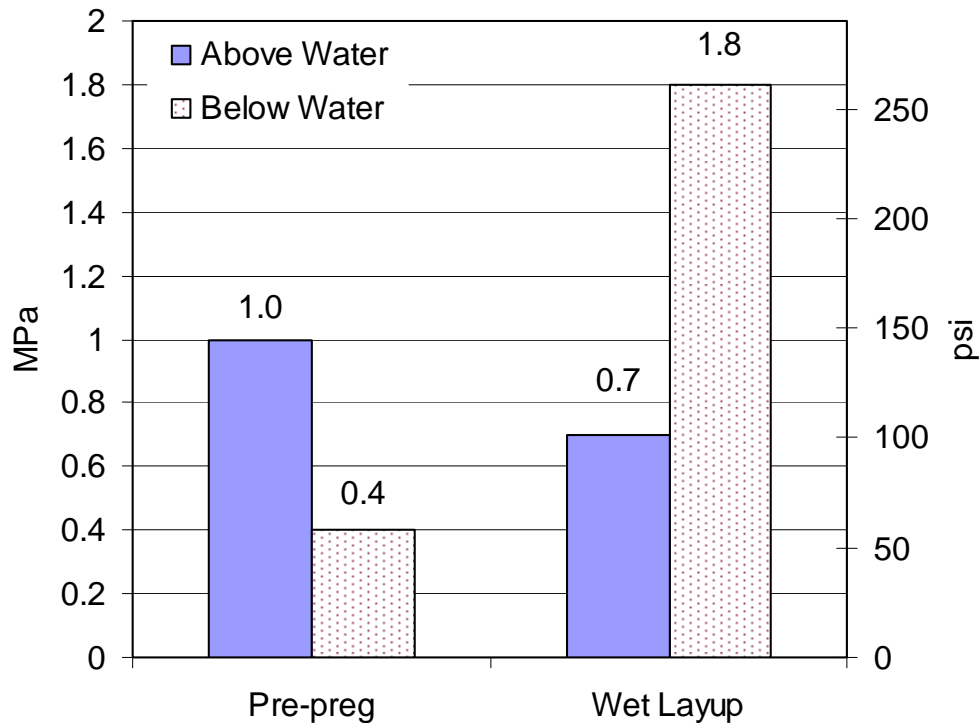
Figure 5.1 Residual bond stress from field study.

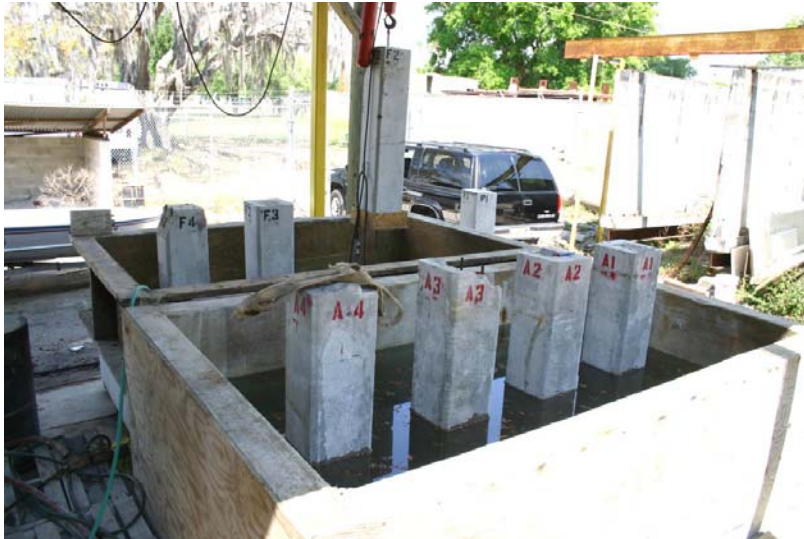
Figure 5.5 View of partially submerged full-size test piles.

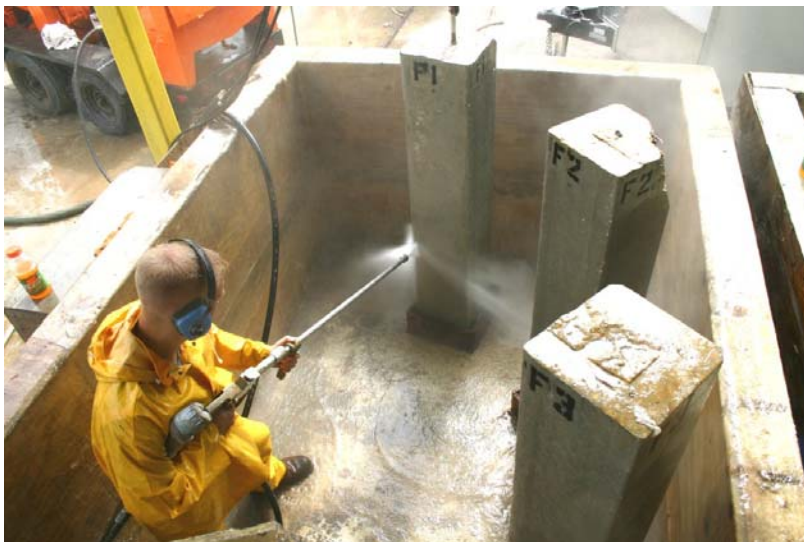
Figure 5.6 Pressure washing test piles with 68.9 MPa water pressure.

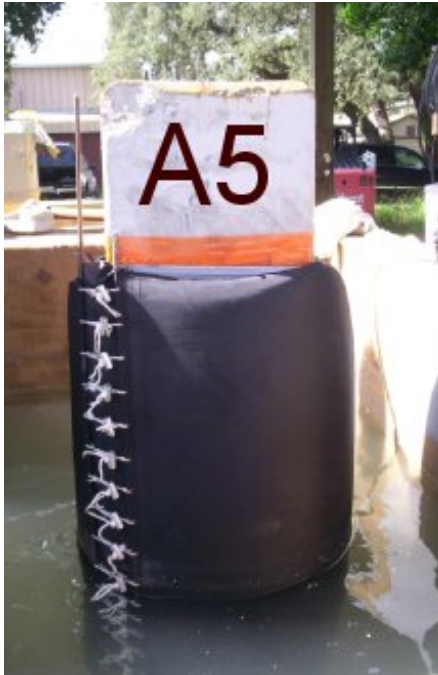
5.9 shows the inflated pressure bag around the test pile. No major difficulties were encountered. However, gas bubbles generated during the curing phase of the urethane resin were seen escaping from between the pile and bag below the waterline.

Figure 5.9 Pressure bag applied to pre-preg system.

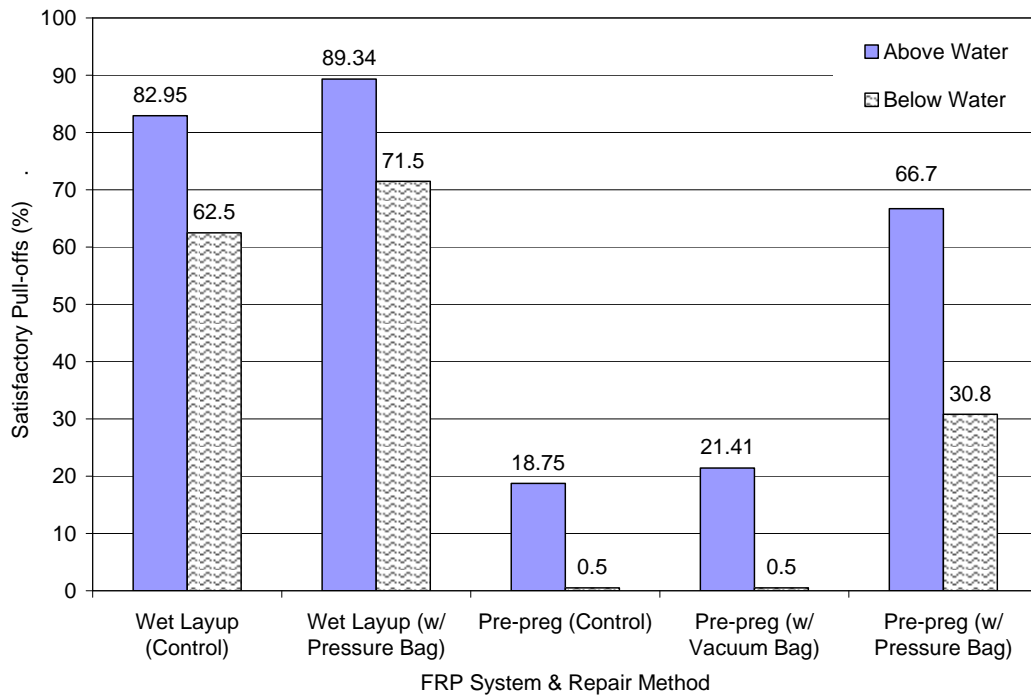
Figure 5.11 plots the percentage of pullout results that exceeded the ACI 1.38 MPa threshold from all the tests. Inspection of this figure shows that pressure bagging benefited both the wet layup and the pre-preg systems. In case of wet layup, the increase in satisfactory bond ranged from around 83% to 89% above water and from around 63% to over 72% below water. For the pre-preg system, the corresponding increase was from 19% to about 67% (above water) and from 0.5% to over 30% below water. The percentage improvement was more noticeable for the pre-preg system due to low initial baseline values (see Figure 5.1).

Figure 5.11 Percentage of satisfactory pullout results using 1.38 MPa cut-off.

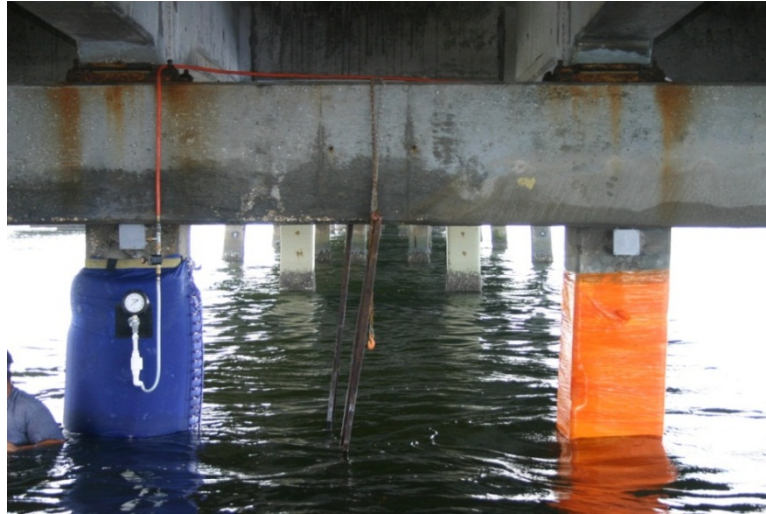
Figure 5.14 Pressure bag applied to the wet layup pile at 14.5 kPa.

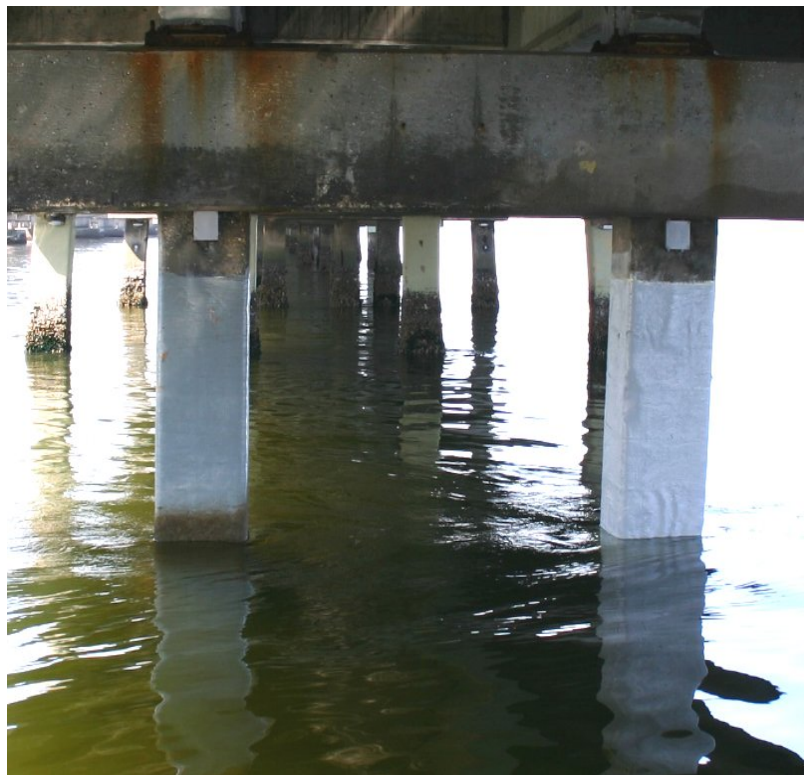
Figure 5.15 Piles after FRP repair with UV coating.
