Short-term Geomorphic Effects of Hofmann Dam Removal on the Des Plaines River

by Tyler Burk, Bachelor of Civil Engineering

A Thesis Submitted in Partial  
Fulfillment of the Requirements  
for the Degree of  
Master of Science  
in the field of Environmental Science

Graduate School  
Southern Illinois University Edwardsville  
June, 2018

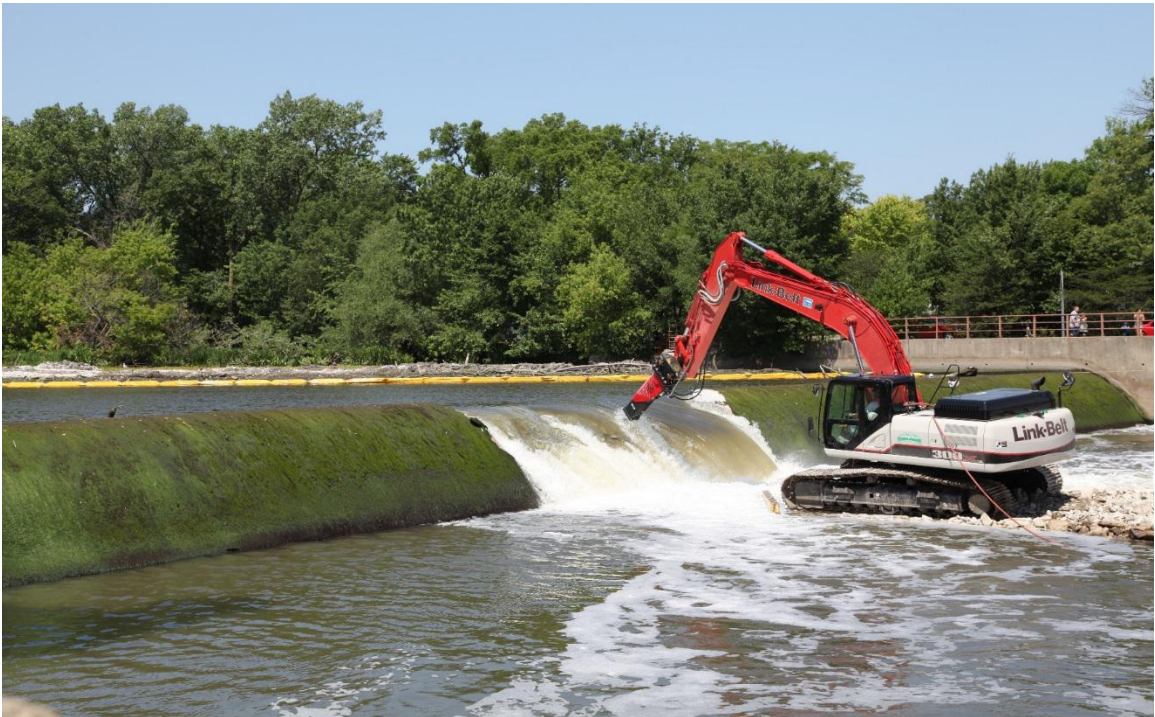
Figure 7: Notching of the Hofmann Dam, June 2012 (IDNR)

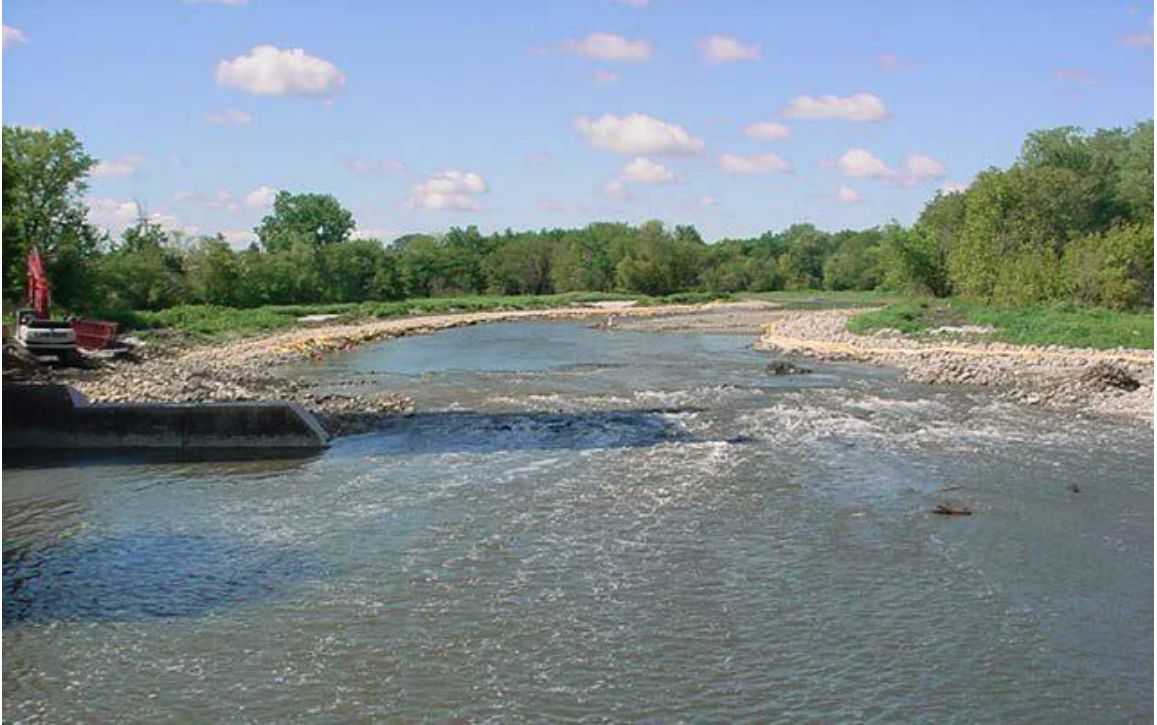
Figure 8: Removal of the Hofmann Dam with 30 foot long section remaining on right bank, looking upstream (IDNR)

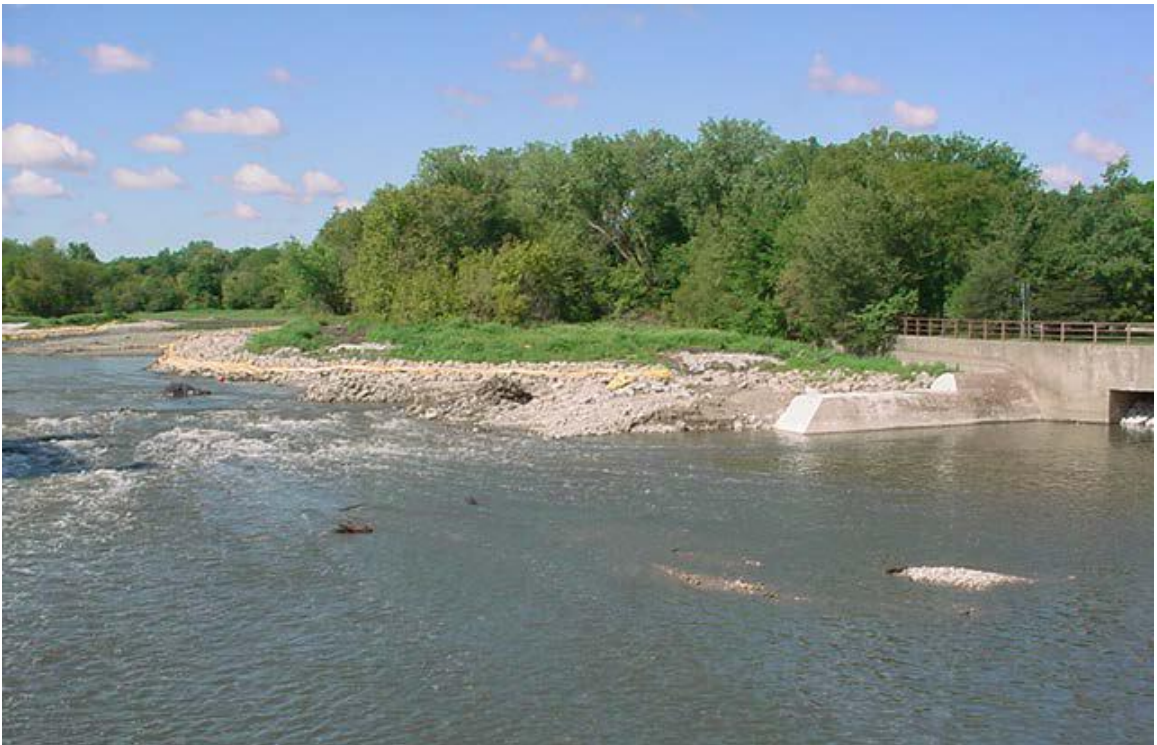
Figure 9: Removal of the Hofmann Dam with 30 foot long section remaining on left bank, looking upstream (IDNR)

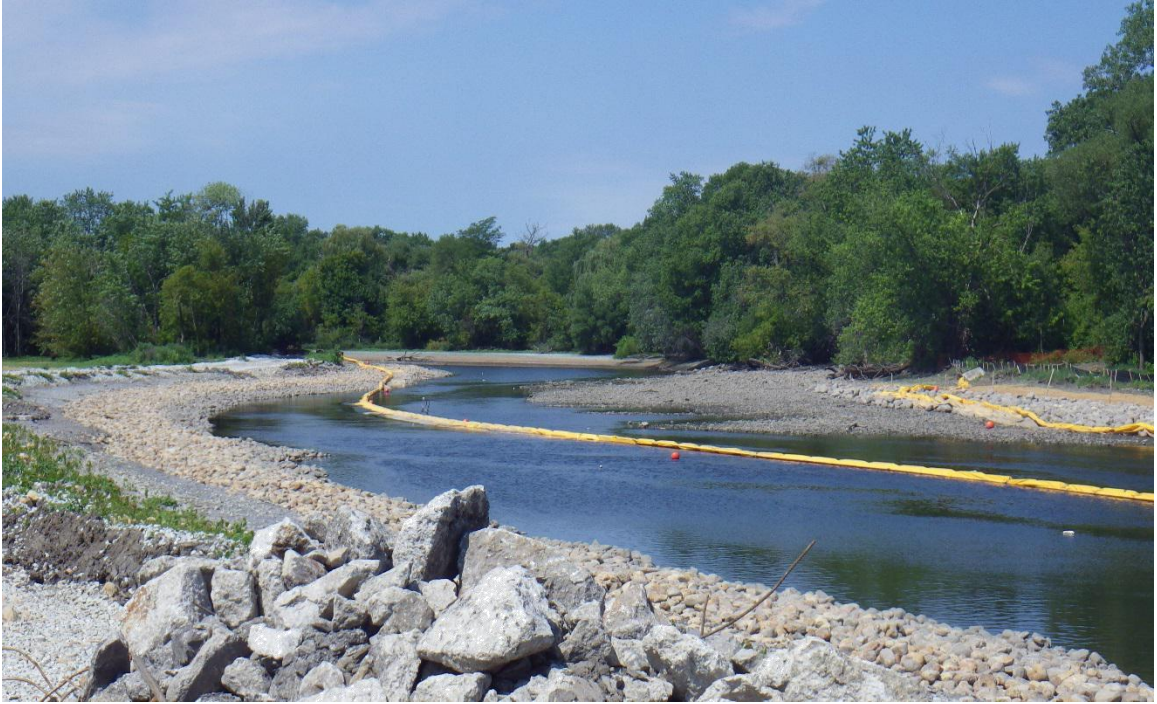
Figure 10: Riprap and silt turbidity curtain installed in the former Hofmann Dam impoundment (IDNR)

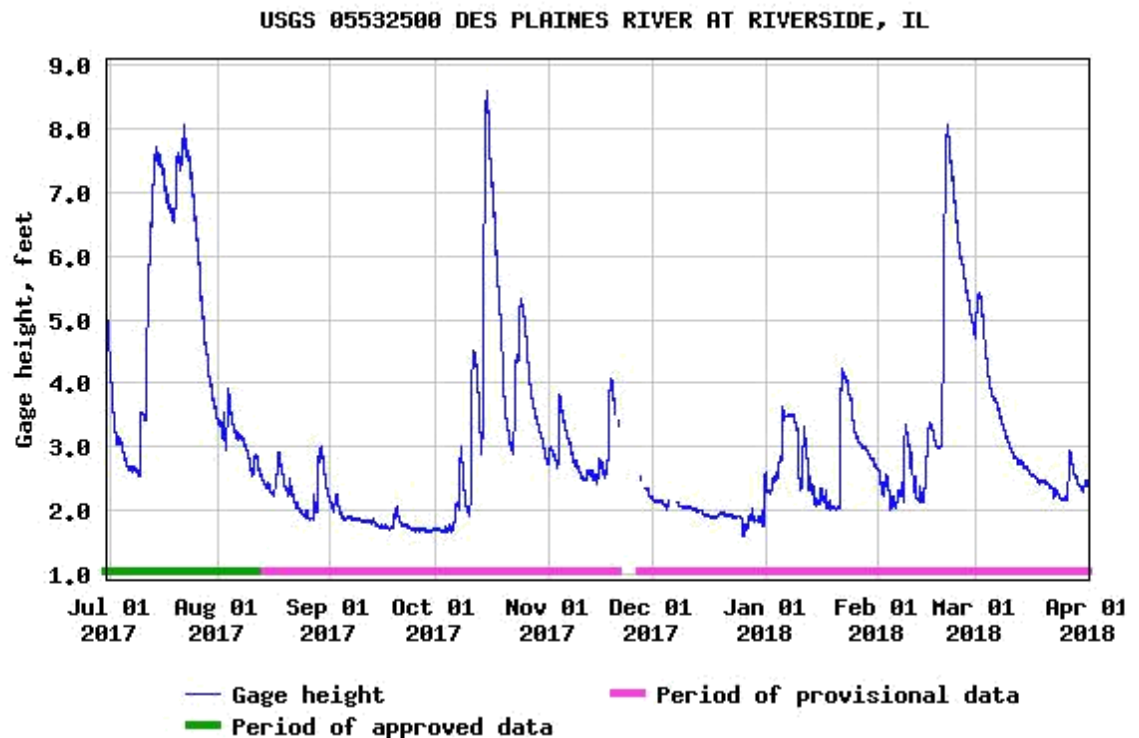
Figure 14: USGS stream gage #05532500 gage height from July 2017 through March 2018 (USGS, 2018)

To determine water depths, I used the United States Geological Survey (USGS) stream gage #05532500 which is located approximately 200ft downstream of the dam at the Joliet Rd. bridge. On an initial site visit in July 2017, I determined that to safely cross the river at each cross section the gage height needed to be near 2.0ft. This gage height correlates with 25<sup>th</sup> percentile of discharge for the Des Plaines, resulting in a small window to collect data. A flow condition with a gage height between 2.0 and 3.0 feet was observed in three distinct separate windows of time, September to October, December to January and mid-March to April, from July 2017 through March 2018 (Fig. 14). These three windows correspond to the dates of the field-collected data.

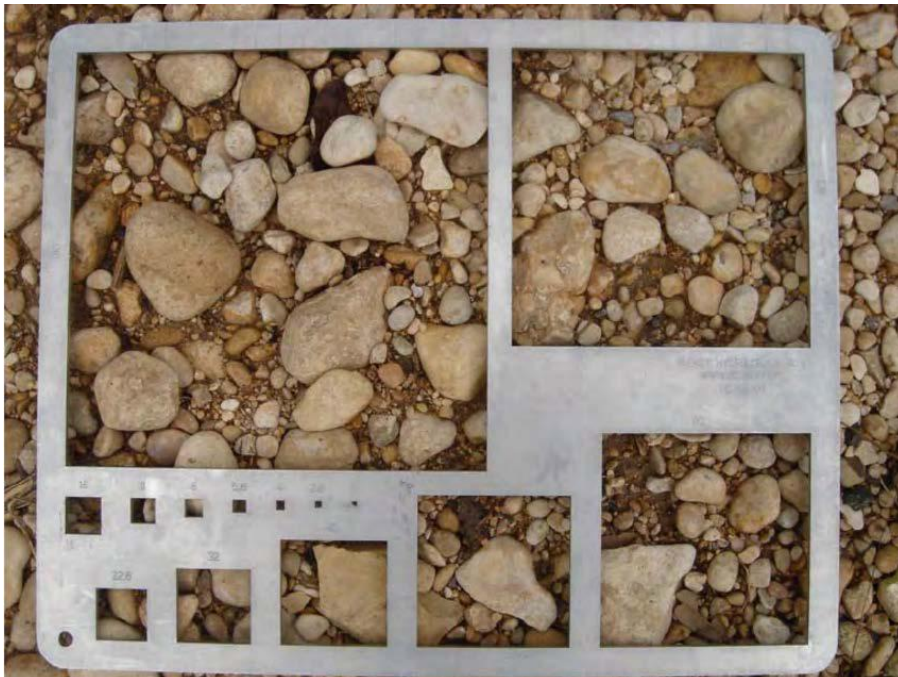
Figure 15: Gravelometer template (Keen-Zebert, 2007)

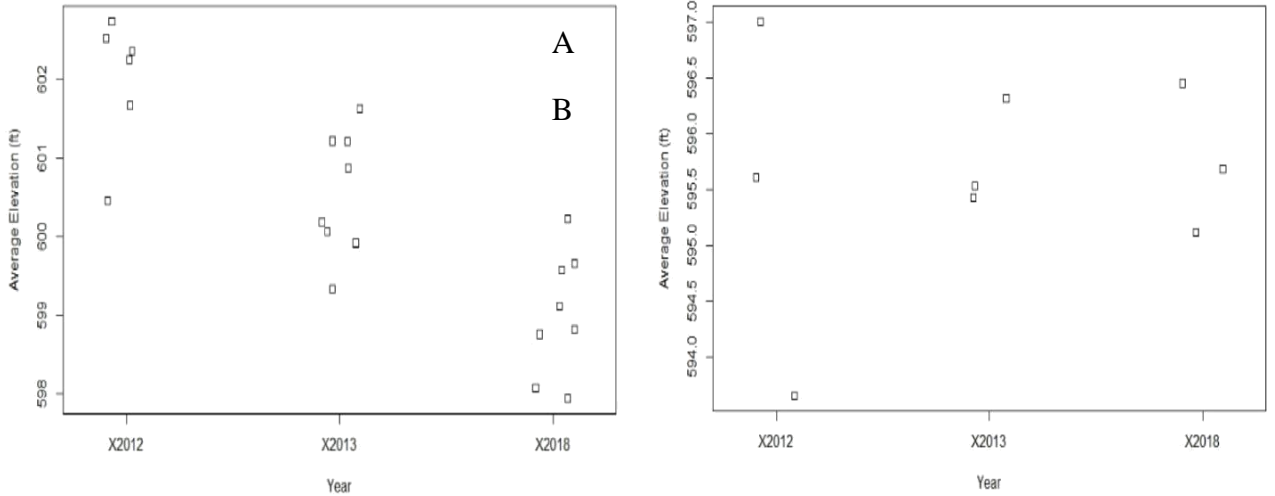
Figure 28: Strip chart of the average elevation of the cross-sections for a given year. A = Upstream of Hofmann Dam, B = Downstream of Hofmann Dam

Although the null hypotheses for both the upstream and downstream cross-sections failed to be rejected, the strip chart and plot of means for the upstream cross-sections showed a trend of decreasing average elevations for each cross-section from 2012 to 2013 to 2018 (Fig. 28A & Fig. 29A). The downstream cross-sections average elevations did not have a distinguishable trend from year to year with a slight increase in average elevation from 2012 to 2013 and slight decrease from 2013 to 2018 (Fig. 28B & 29B).

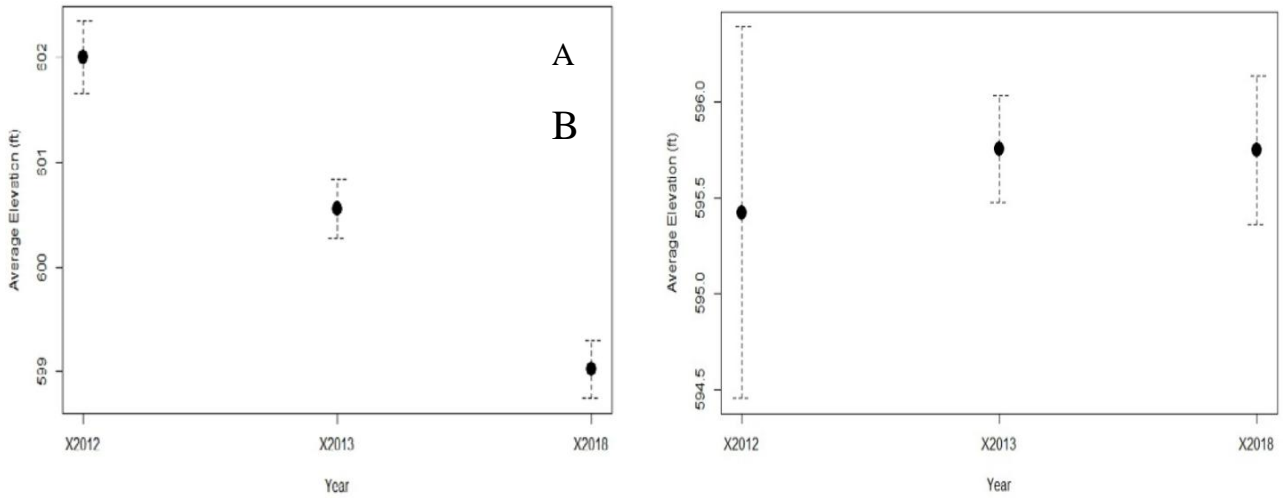
Figure 29: Plot of means for a given year of the average depth of the cross-sections. A = Upstream of Hofmann Dam, B = Downstream of Hofmann Dam

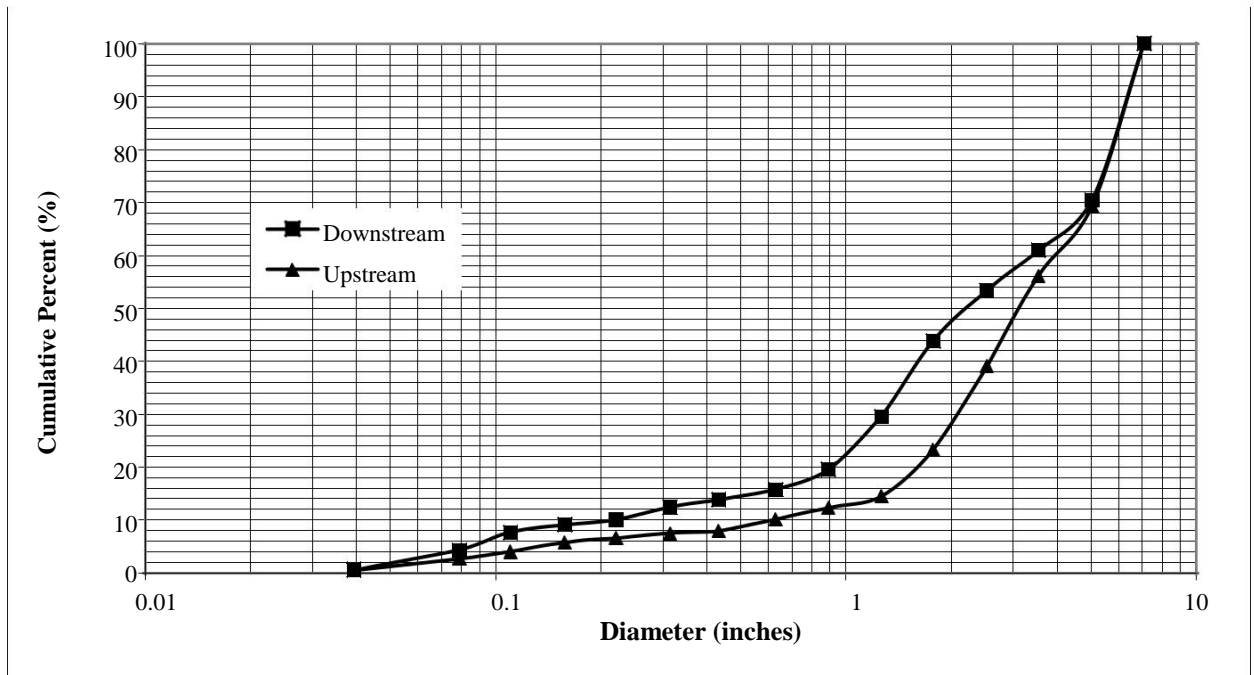
Figure 30: Cumulative particle size distribution curves for upstream and downstream of the Hofmann Dam collection areas.

The particle size distributions of bed sediment upstream and downstream of the Hofmann Dam were plotted on cumulative particle size distribution curves to determine the median particle size (50<sup>th</sup> percentile, d<sub>50</sub>), and coarse particle size (84<sup>th</sup> percentile, d<sub>84</sub>), as well as d<sub>5</sub>, d<sub>16</sub>, and d<sub>90</sub> (Fig. 30). These values are shown in Table 6. The upstream d<sub>5</sub>, d<sub>16</sub> and

d<sub>50</sub> particle sizes are larger than the equivalent percentiles for downstream. The d<sub>16</sub> dimensions for the upstream survey is 1.38 inches, which represents very coarse gravel. The downstream survey d<sub>16</sub> dimensions of 0.63 inches equates to a coarse gravel. The median particle size for the upstream survey is described as a small cobble with a size of 3.15 inches. Downstream of the dam, very coarse gravel defines the 2.20 inches median particle size. The two largest percentiles measured, d<sub>84</sub> and d<sub>90</sub>, were identical for both the upstream and downstream surveys with values of 6.30 and 6.69 inches, respectively. These particles sizes correlate to a large cobble.

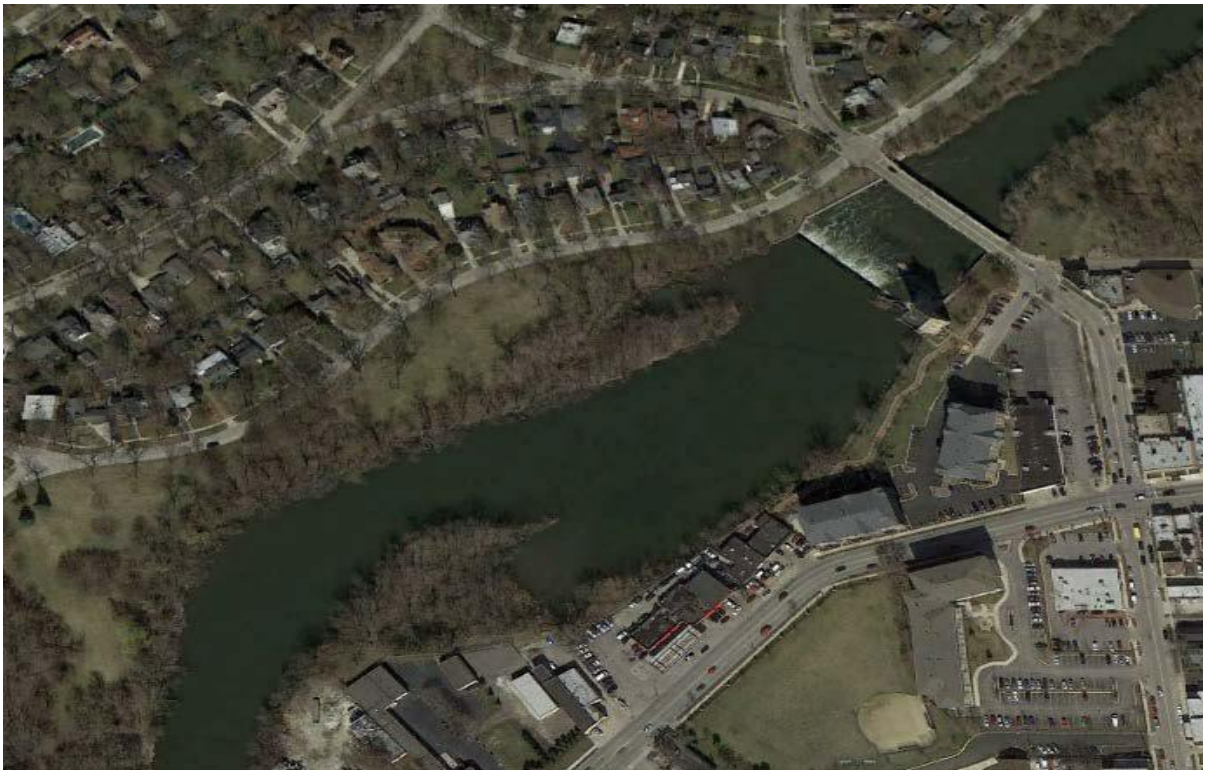
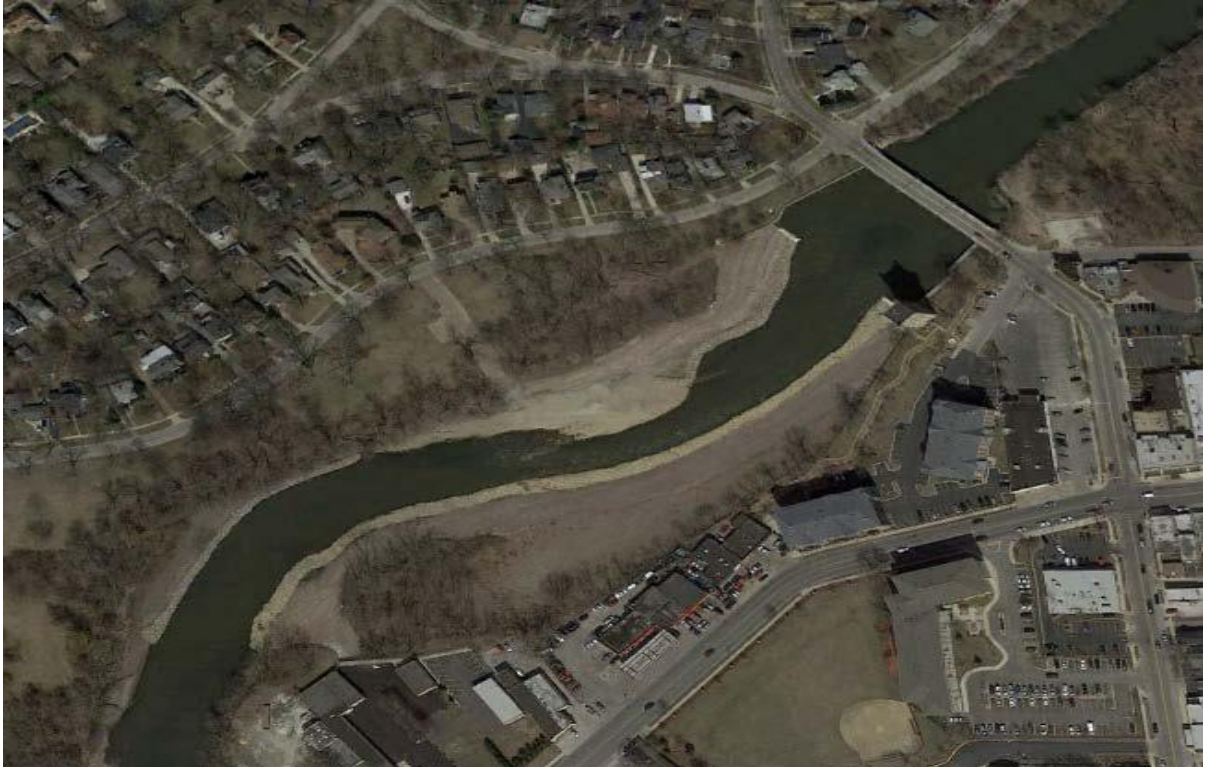
Figure 31: Satellite image of Hofmann Dam study site, 2012 (Google Earth, 2018)

Figure 32: Satellite image of Hofmann Dam study site, 2013 (Google Earth, 2018)

section XS6 confining the channel to a width of 52 feet, the narrowest width throughout the study area (Fig 31 and Fig 32). Narrowing the channel resulted in increased flow velocities, as evidenced within the HEC-RAS model that caused the thalweg to quickly increase in depth by 3.9 feet between 2012 and 2013 to adjust to flow conditions. This change in elevation was the second largest change in riverbed elevation behind only that that occurred at cross-section XS8. Erosion continued in the thalweg between 2013 and 2018 increasing the depth another 0.7 feet but nearly 85% of the change in channel depth and approximately 99% of the change in cross-section area occurred within the first year after removal.

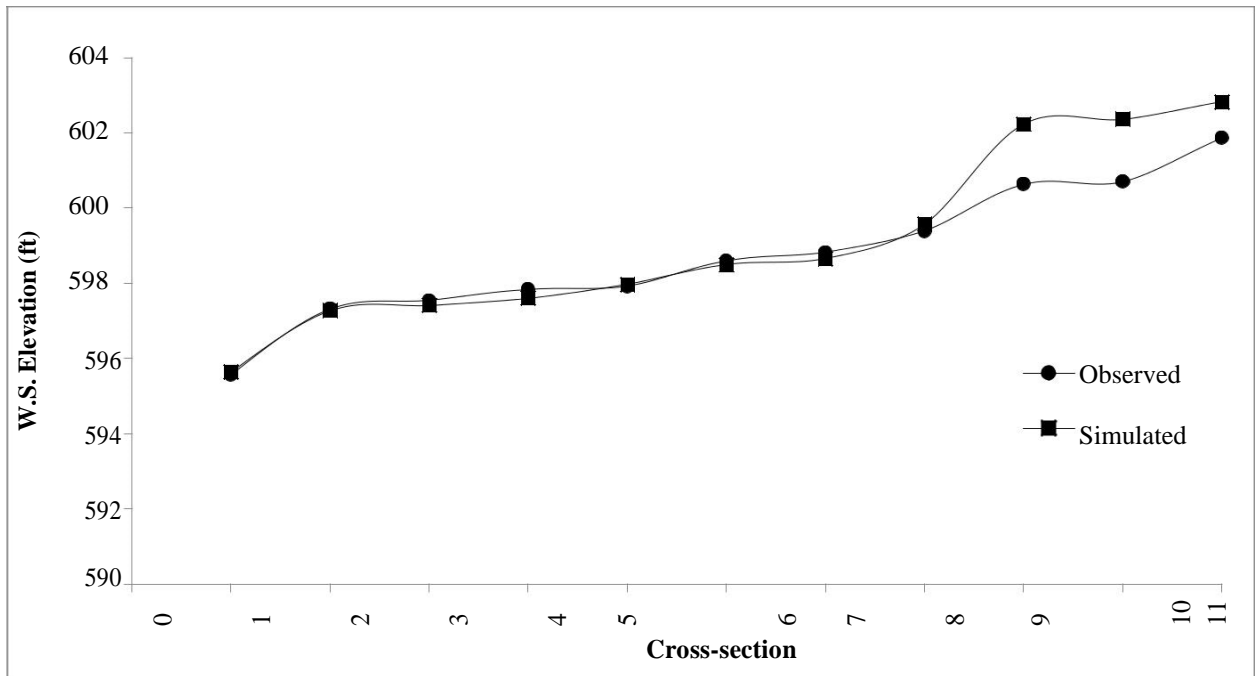
Figure A1: Comparison of observed and simulated water surface elevations for HEC-RAS model.
