Slope Stability Monitoring Using Remote Sensing Techniques

A thesis submitted in partial fulfillment
of the requirements for the degree of
Master of Science in Civil Engineering

Omar A. Conte Robles
Missouri University of Science & Technology
Bachelor of Science in Civil Engineering, 2010

May 2012
University of Arkansas

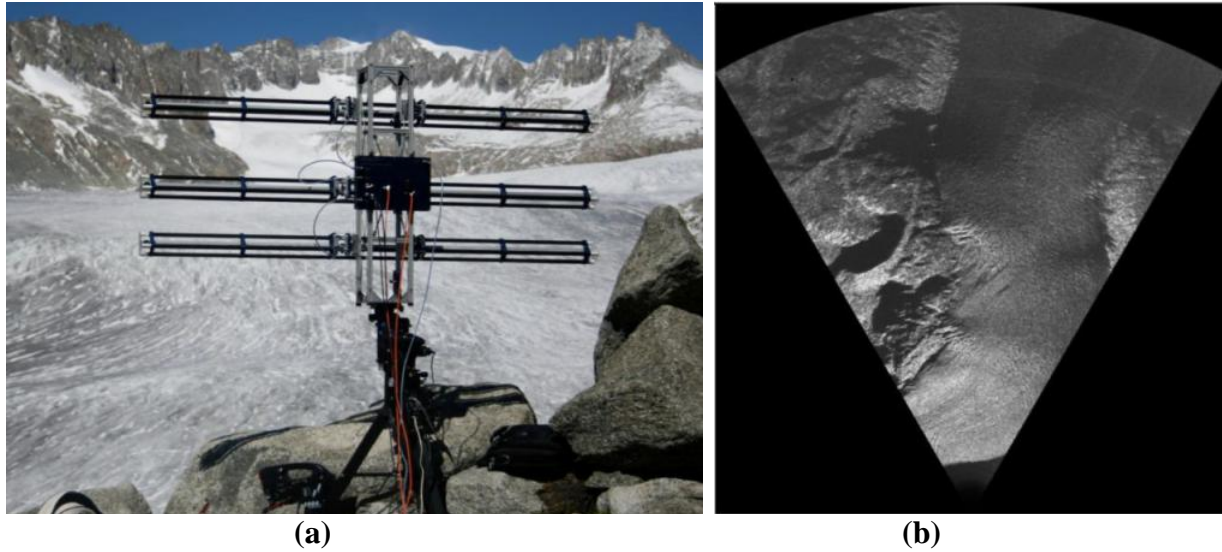
Figure 2.10. a) GPRI-I acquiring images at the Rhône glacier, and b) RADAR image developed after data acquisition at Rhône glacier in October 2007 (from Werner et al., 2008).

The previously mentioned GPRI-I was used for the study described in this section. In October, 2007, the GPRI-I RADAR was deployed to monitor the Rhône glacier located in the Valais region of Switzerland. Multiple images with sub-sampled 2m pixel spacing covering 2.15km in range direction and an angular field-of-view of 70 degrees were obtained (Werner et al., 2008). The average velocity of the glacier in the line-of-sight (LOS) direction, as observed with the GPRI-I, was approximately 4mm/hour (35m/year). Post processing of the acquired data permitted the operator to stack multiple images to develop temporal deformation maps. A photograph of GPRI-I at the Rhône glacier and a backscatter intensity image are presented in Figure 2.10. The amount of deformation that occurred during the 80 minute observation period

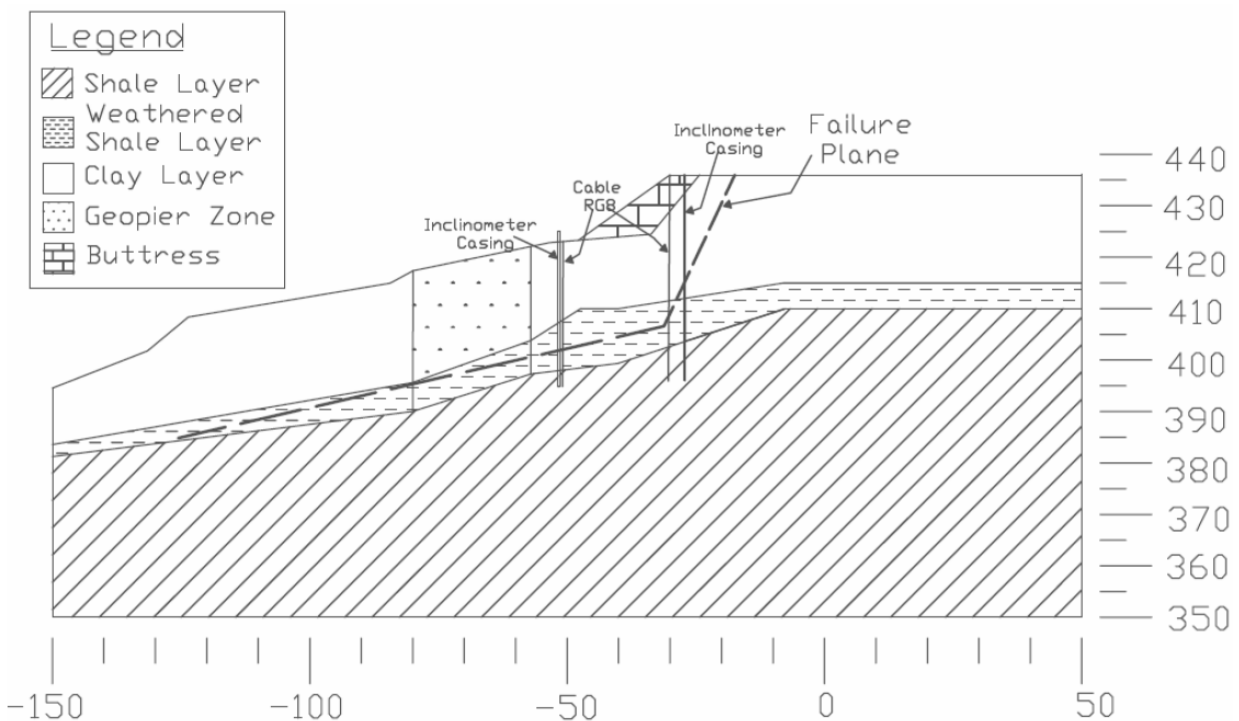
Figure 2.29. Cross-section of the test area along Highway 167 with instrumentation used (from Dennis et al., 2006).

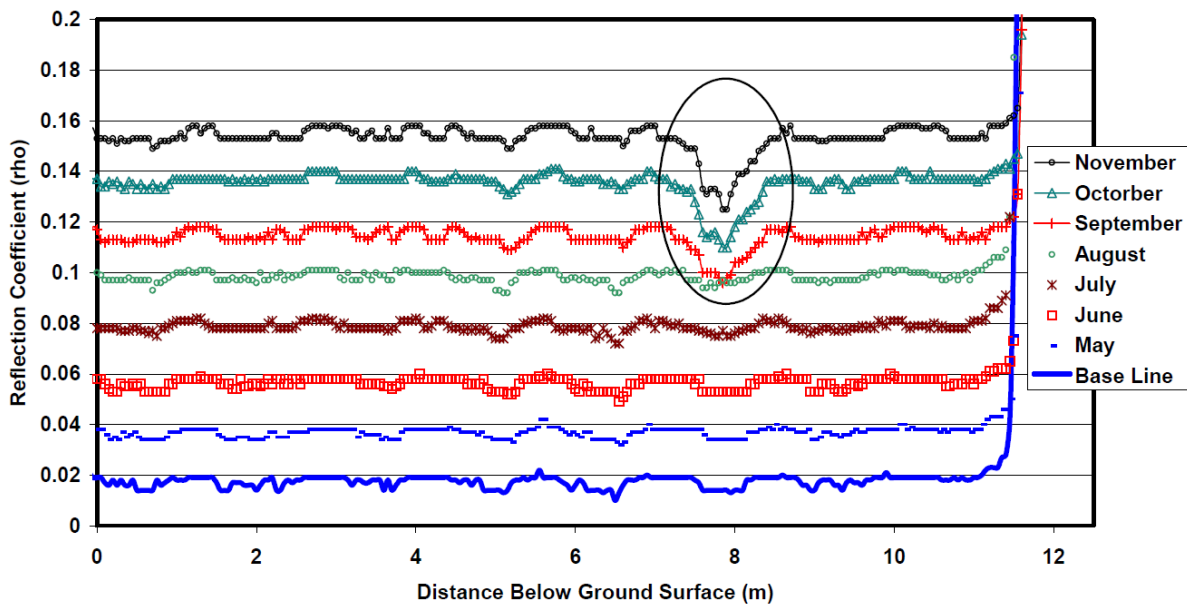
Figure 2.31. Monitoring results obtained by TDR on the Highway 167 project site (from Dennis et al., 2006).

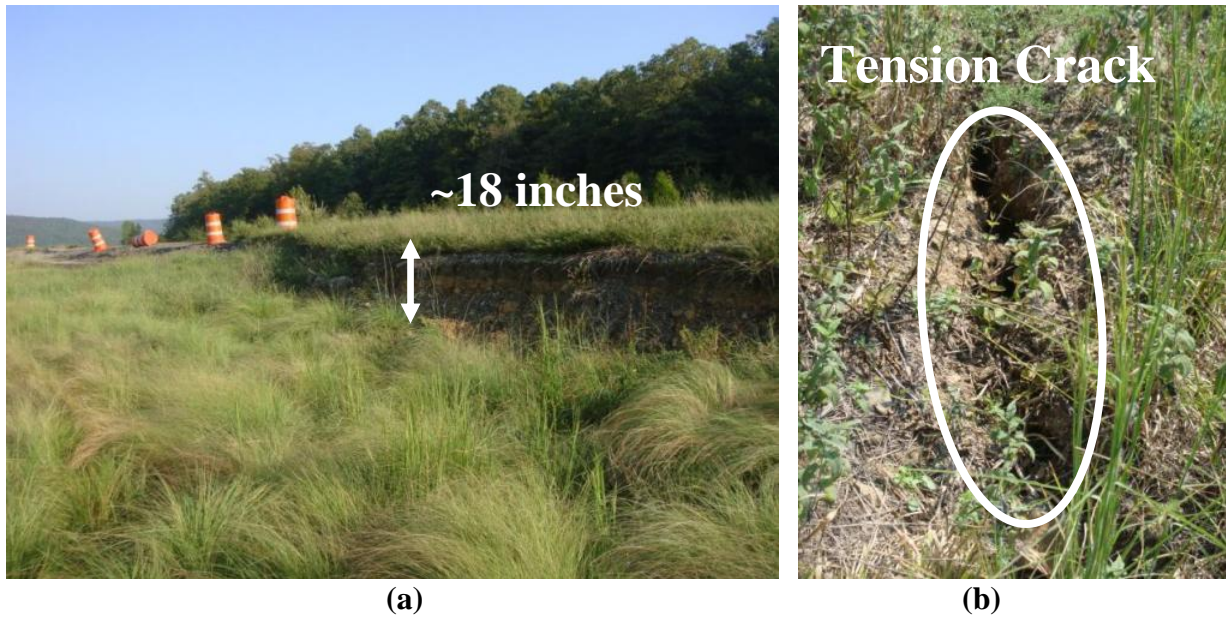
Figure 3.5. a) Looking north, the main scarp at the calibration site located in Chester, Arkansas, and b) tension crack observed in the median of I-540.

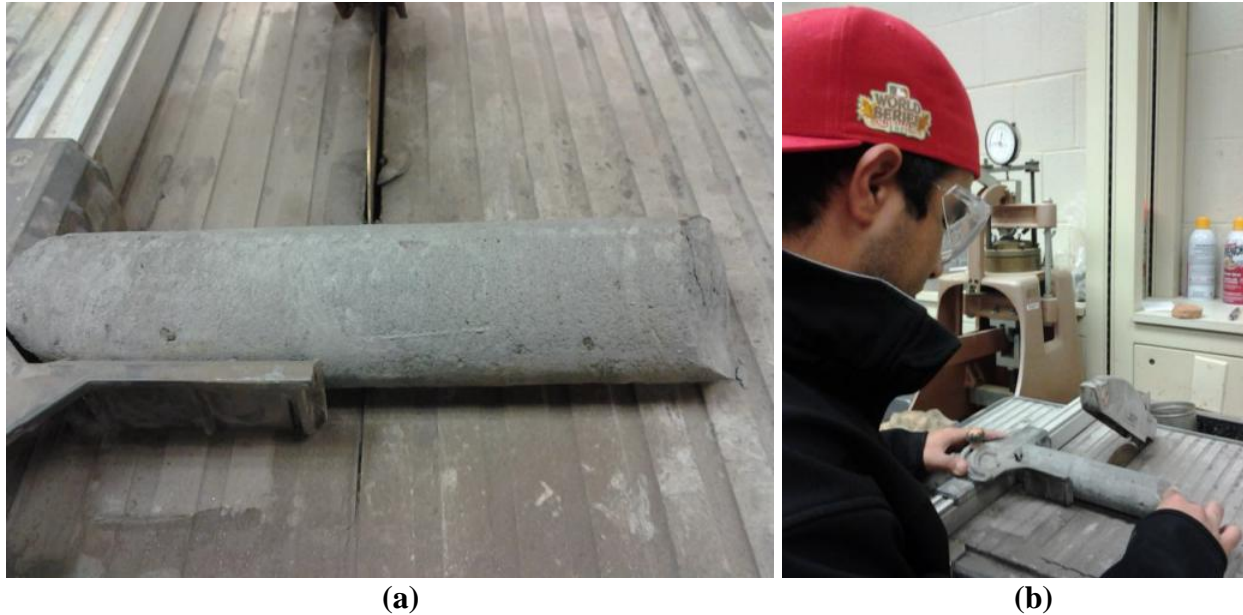
Figure 4.49. a) Rock sample obtained from coring operations at validation site, and b) wet saw used to cut rock samples.

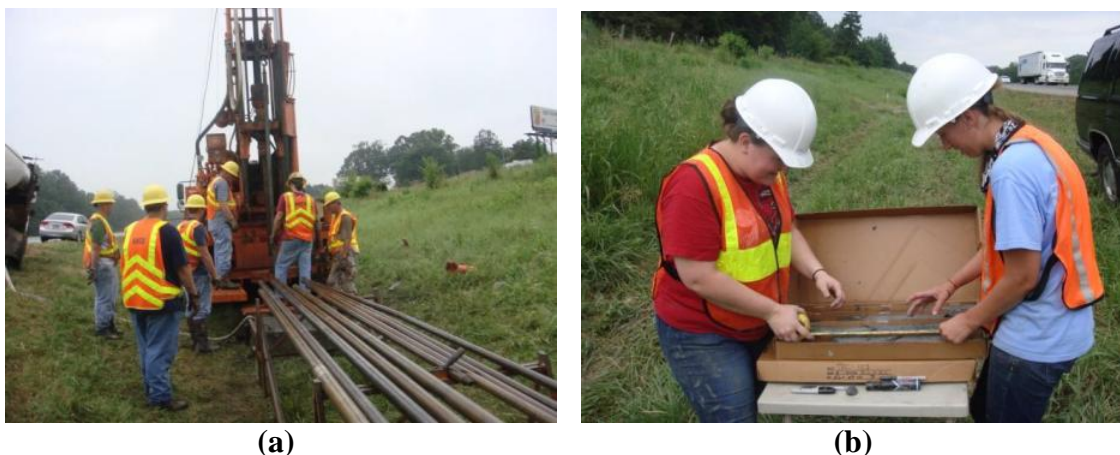
Figure 6.4. a) Drilling operations at B-3, and b) measuring RQD of rock sample obtained from B-3.

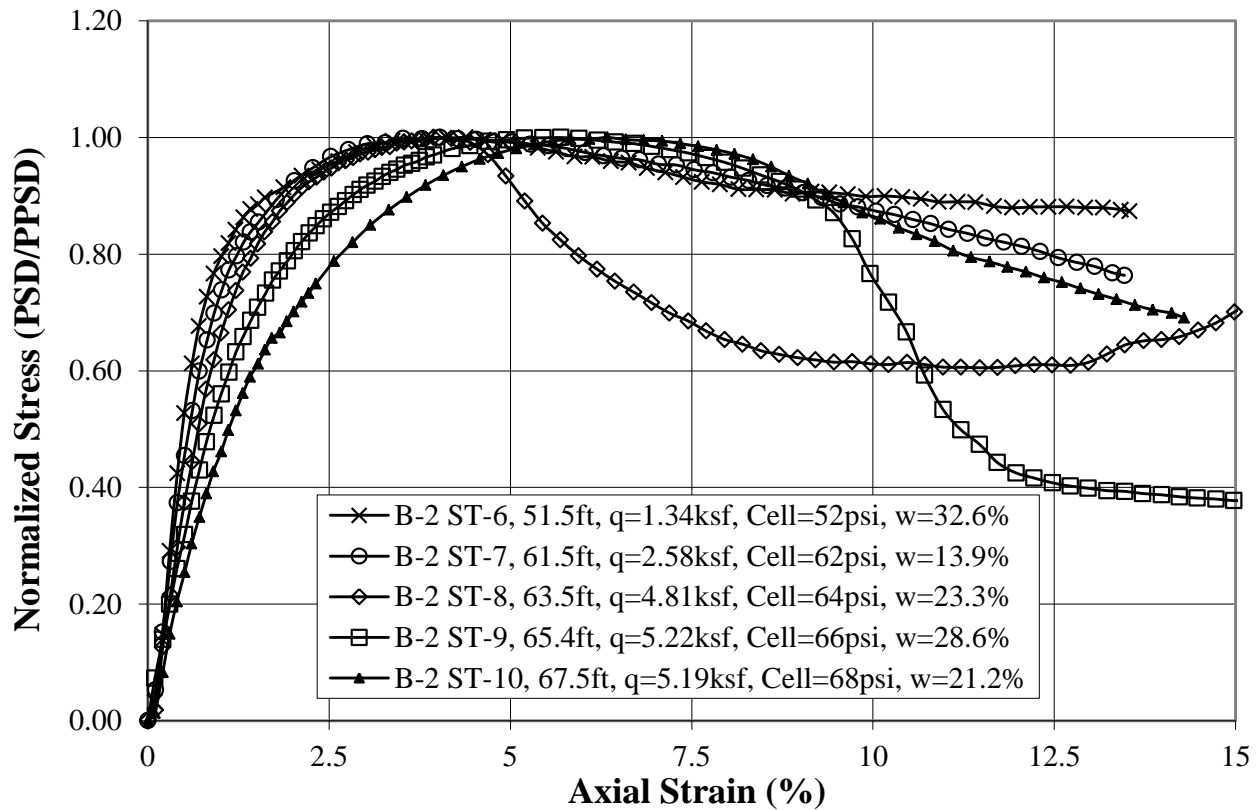
Figure 6.9. Normalized stress-strain graph of UU test for B-2 specimens at validation site.

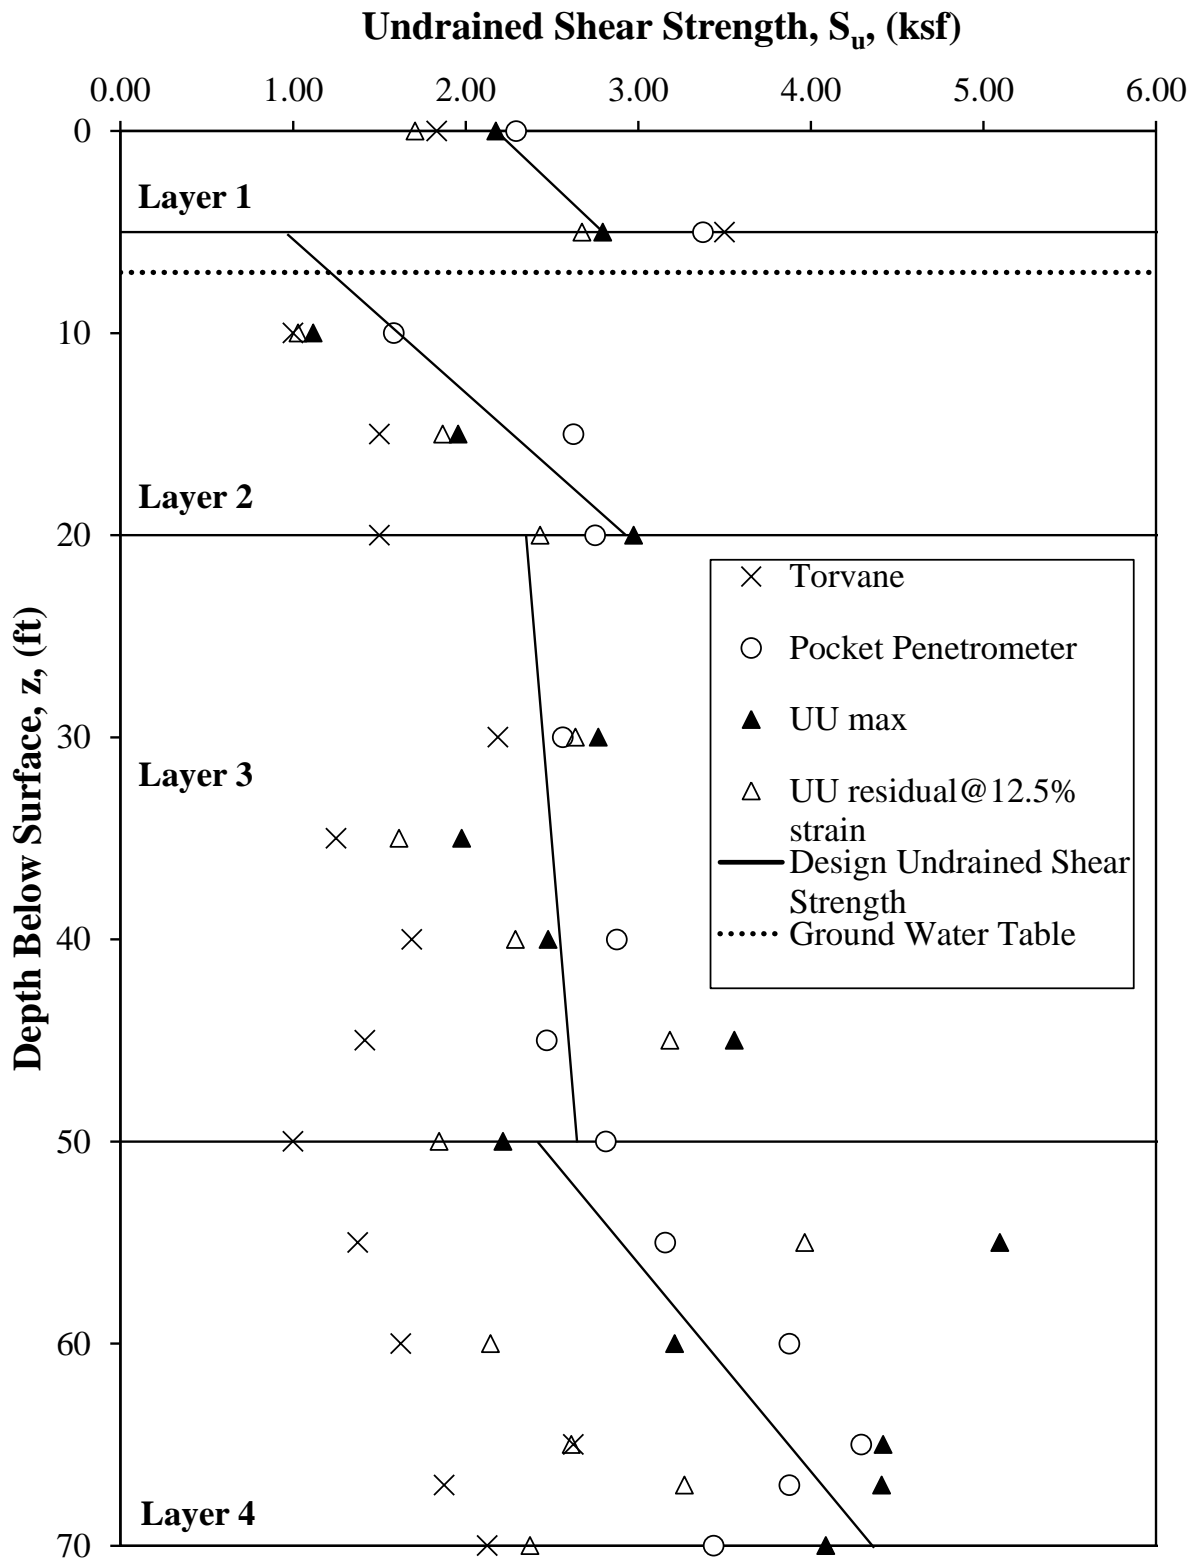
Figure 6.10. Design strength profile for validation site near Malvern, Arkansas.

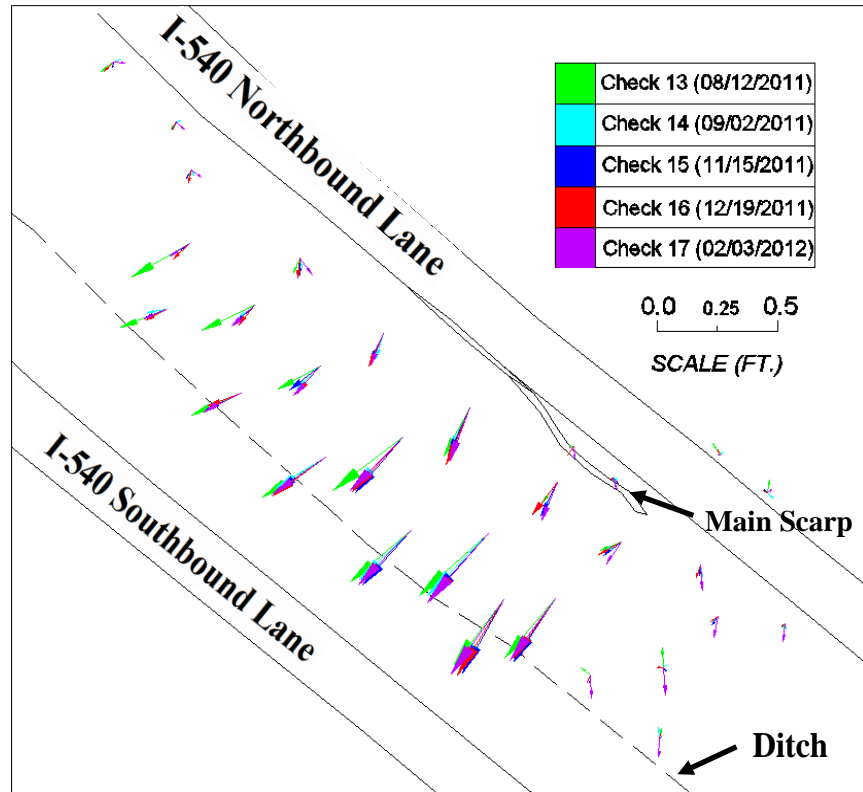
Figure 6.17. Displacements of the last five Checks conducted at calibration site [in color].

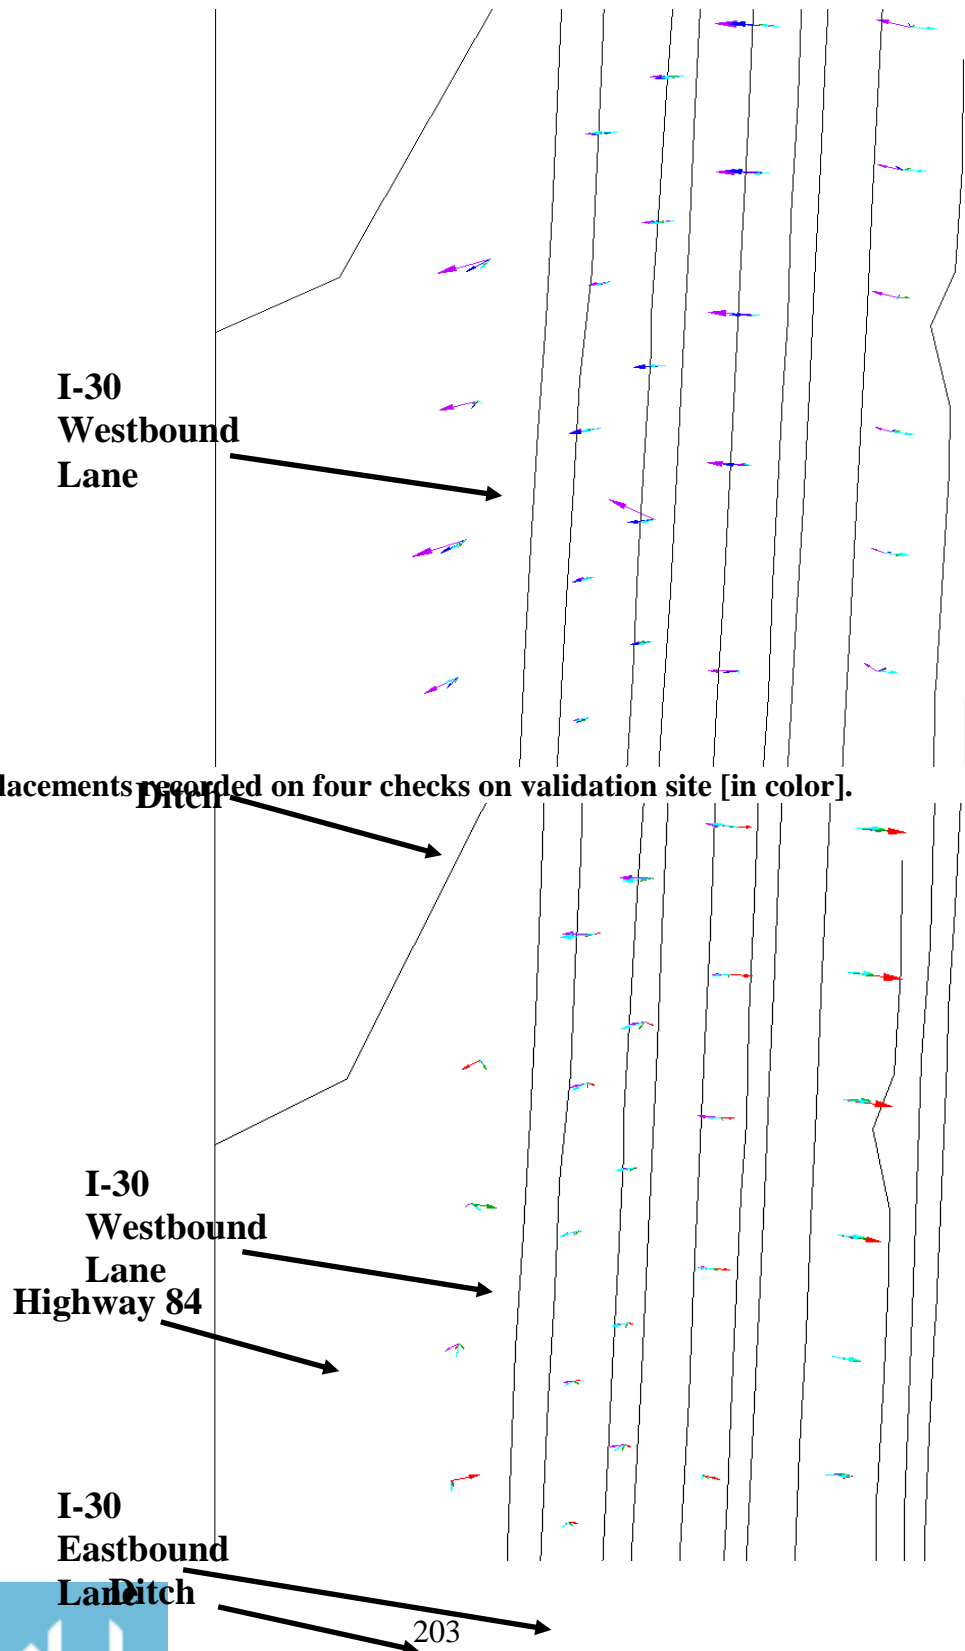
Figure 6.32. Displacements recorded on four checks on validation site [in color].
