Structural Health Monitoring of Concrete Systems

STRUCTURAL HEALTH MONITORING OF CONCRETE SYSTEMS

The first study is aimed at investigating the performance of precast concrete slabs placed on the approaches of a replacement bridge in Union County, S.C. The use of full depth precast panels in bridge construction has been limited by problems associated with the durability of connection joints between adjacent panels. The precast slabs being monitored are designed and constructed using an improved longitudinal joint detail consisting of interlocking looped reinforcement bars. The purpose of this research program is to assess the practicality of further implementation of approach slab system as an alternative to current construction methods. To evaluate the effects of service loads the approach slabs were instrumented with strain and displacement gages and measurements were collected periodically for a period of 18 months. A series of load tests were also

In the second study an accelerated alkali-silica reaction (ASR) test was designed to examine the ability of acoustic emission (AE) to detect this damage mechanism. ASR is a chemical reaction occurring between alkaline hydroxides wi

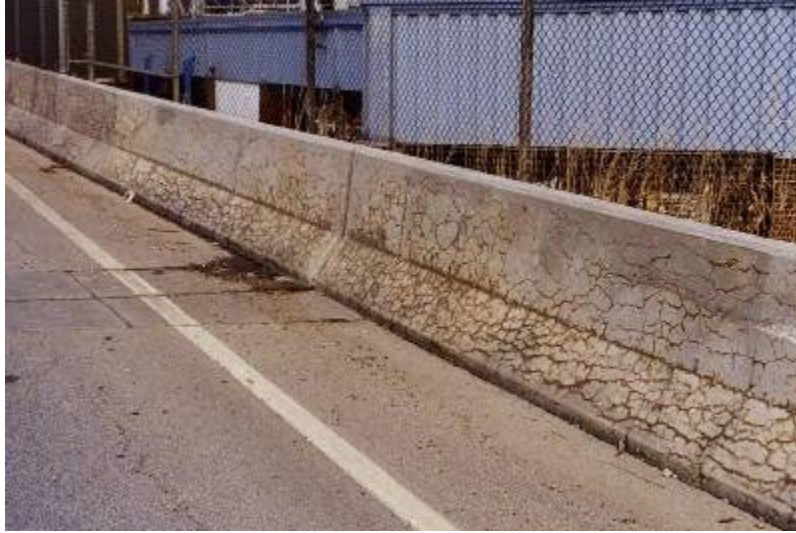
Figure 2.3: Map cracking of ASR affected barrier parapet

Alkali-silica reaction (ASR) is one of the primary chemical reactions causing degradation and loss of service of hardened concrete structures worldwide. ASR is a reaction that occurs over time in concrete between aqueous alkaline hydroxides within the pore solution of the cement paste (Na_2O and K_2O) and amorphous silica within surrounding aggregates (Swamy 1998). This reaction causes the formation of a viscous alkali silicate gel which expands in the presence of water. The accumulation of expansive pressure created by the hydrated alkali silicate is widely believed to induce the deleterious micro-cracking of aggregates and subsequently of surrounding cement paste matrix. The presence of cracks encourages additional ingress of alkaline pore fluid and thus further exacerbates the ASR reaction and resulting damage. If left uninhibited ASR can lead to severe damage of concrete structures. ASR is typically characterized by map cracking (Figure 2.3), spalling of joints, large movements of affected areas, and

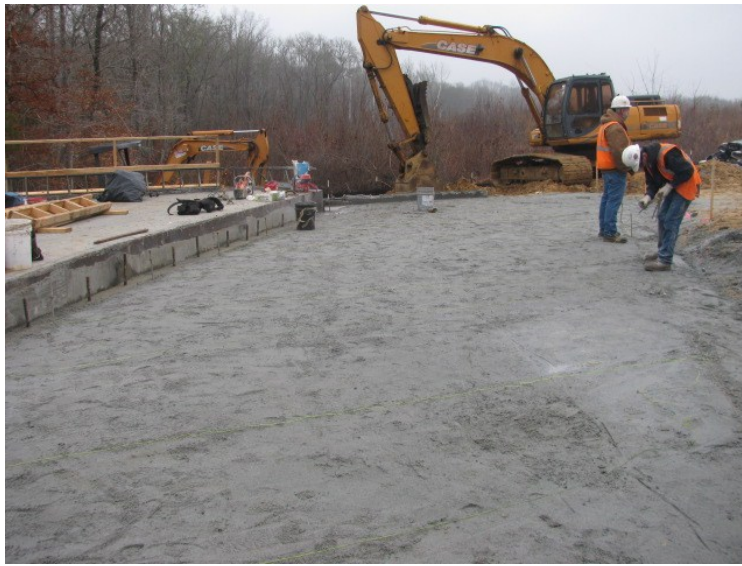
Figure 3.2: Compacted crushed stone sub-base material on the Bent One approach

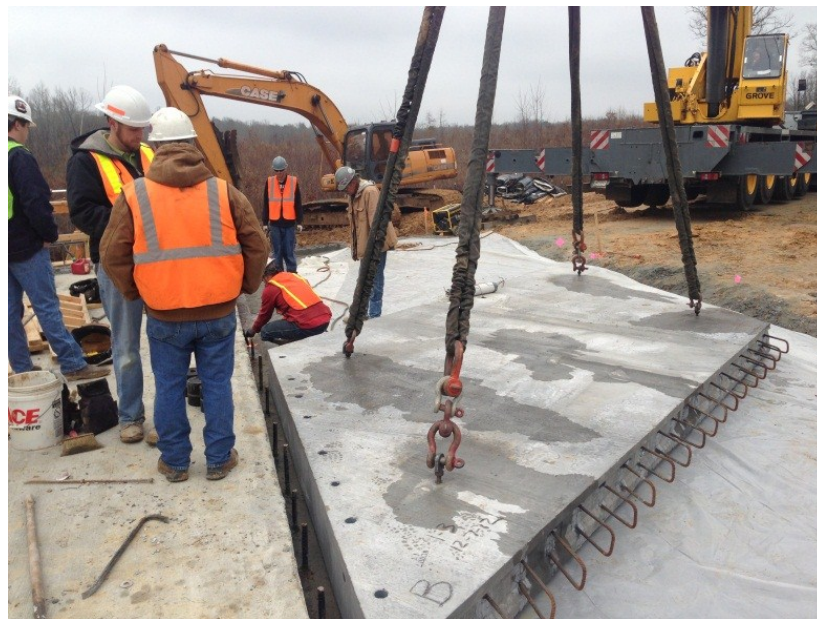
Figure 3.5: Interior approach slab being set with vertical dowel alignment

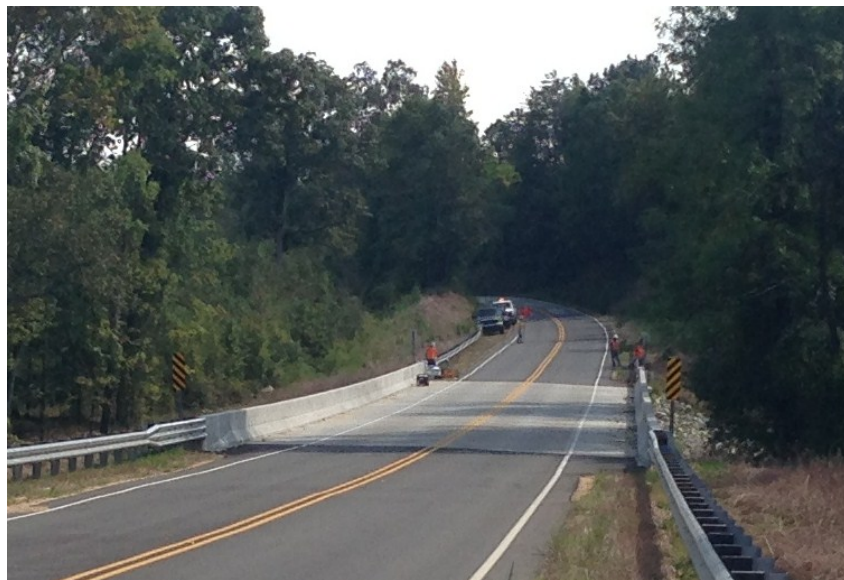
Figure 3.9: The completed replacement bridge over Big Brown Creek

After the approach slabs were set, shear keys filled, and bridge parapets placed each approach was covered with an asphalt pavement. The asphalt surfacing is 2.5 inches thick and extends up to the cast-in-place bridge deck (Figure 3.4). Figure 3.9 shows the bridge after construction was completed.

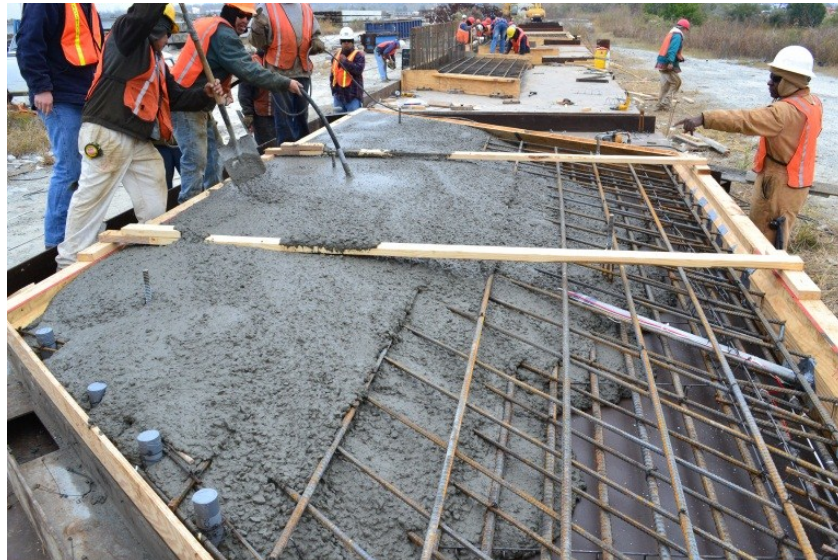
Figure 3.22: Concrete placement - interior slab 'B'

Both Bent One interior approach slabs were cast on this date. Concrete placement was monitored closely by U.S.C personnel to ensure that strain gages were not damaged or excessively disturbed during casting. Concrete test cylinders were collected and slump tests were performed. For 'Batch 1' concrete used for casting interior slab 'B' a slump of 9.0 inches was measured. For 'Batch 2' concrete used for casting interior slab 'C' a slump of 8.5 inches was measured. Placing of concrete is shown in Figure 3.22. Vertical dowel sleeves can be seen in the lower left corner of the approach slab form.

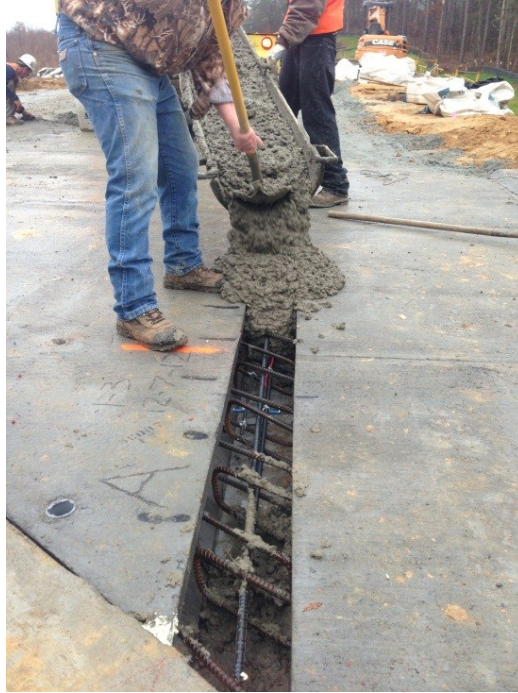
Figure 3.28: Placement of concrete in an instrumented shear key closure

Concrete was placed in all three shear key closures adjoining the approach slabs on this date. A mechanical vibrator was used to ensure concrete was fully consolidated around reinforcement in the closures. Concrete placement and vibration was again monitored closely by personnel from U.S.C. Sufficient space was provided between vibrators and strain gages to prevent damage or disturbance of VWSGs. Concrete test cylinders were collected and slump tests performed. A slump of 5.25 inches was measured for 'Batch 4'. Figures 3.28 and 3.29 show concrete being placed in the shear key closures. Figure 3.30 shows the surface of the closure pour being finished with a trowel.

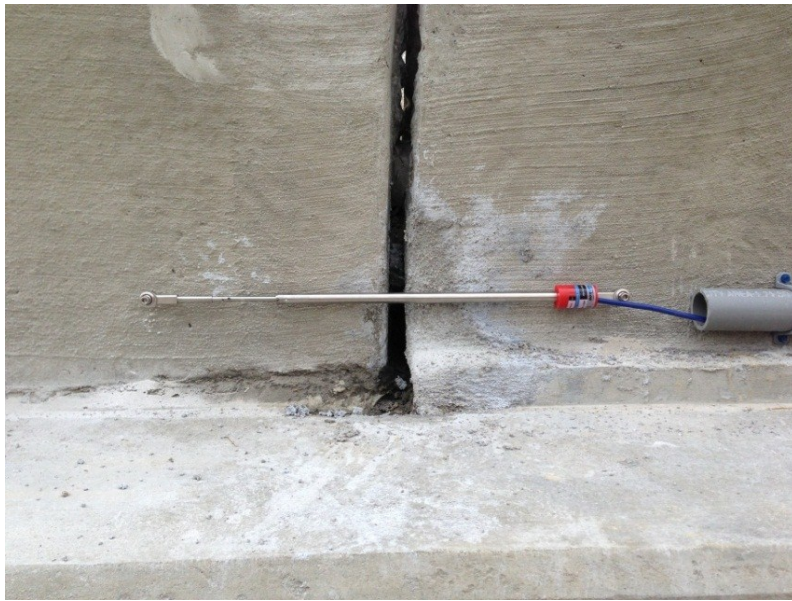
Figure 3.32: VWDG 3

All four VWDGs were installed on the outside of parapets on either side of the bridge on the Bent One and Bent Four approaches on this date and initial readings for the VWDGs were recorded. Cables for all gages were routed through conduits to enclosure boxes provided and installed by SCDOT. Cover plates provided by Geokon were also installed to protect the displacement gages from mechanical damage and disturbance. Cover plates are specially designed to be attached to the concrete substrate and to shield the gages without directly contacting the VWDGs or influencing the measurements. Images of the installed VWDGs and cover plates are shown in Figures 3.32 through 3.34.

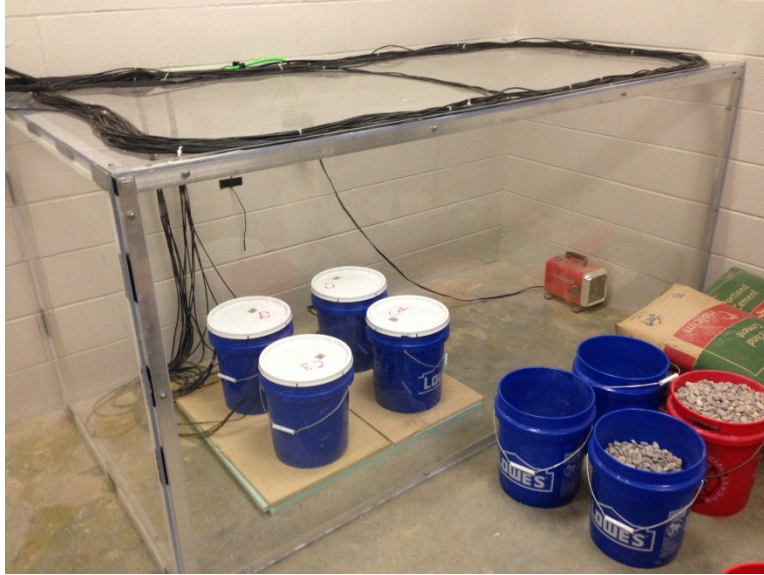
Figure 4.1: Temperature controlled testing chamber

The specimens were placed in a controlled environment with a 100% relative humidity and temperature of $100\pm 2^{\circ}\text{F}$ (Figure 4.2). A sealed insulating chamber was constructed to control the temperature. The chamber has approximate dimensions of 4x4x8 ft and consists of an aluminum frame covered with Lexan panels. In order to create a temperature stable environment a silicon adhesive sealant was applied to corners and seams and expanding polyurethane foam was used in areas where cables were routed into the chamber. A small electric heater with an internal fan (Figure 4.3) was placed inside the chamber and temperature was controlled by a digital thermostat mounted on the wall outside the chamber. Figures 4.2 and 4.4 show the chamber setup and the thermostat is shown in Figure 4.5.

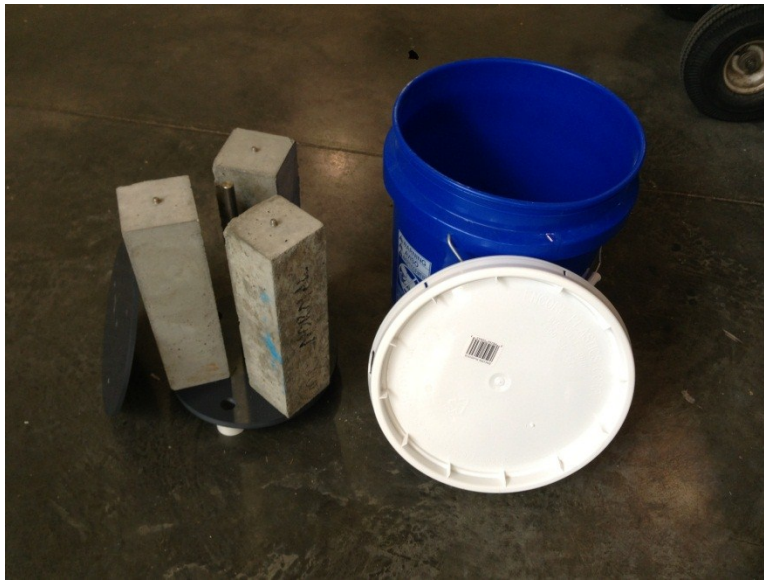
Figure 4.5: Storage container and specimen holder assembly

The purpose of the specimen holder assembly is to provide a means for the secure upright storage of each specimen. The specimen holder assembly was specially made at the University of South Carolina's (U.S.C) machine shop and consists of materials that are chemically inert in high moisture environments. The bottom rack and top plate is made of PVC plastic and the central rod is machined from a high-grade stainless steel. This is an important consideration because the capability of AE to detect corrosion in materials has been shown (Idrissi and Liman 2003; Assouli et al. 2005). If any of the materials inside of the storage buckets are subject to corrosion there is a potential for data being captured that is unrelated to ASR damage. A photograph of the storage container and holder assembly is shown in Figure 4.6.

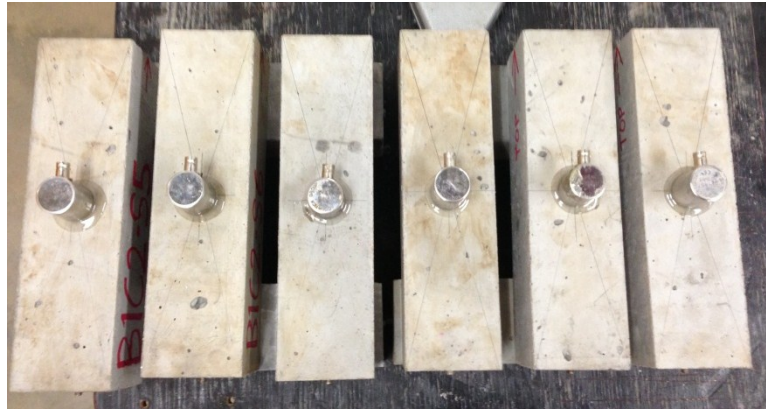
Figure 4.14: Location of sensors

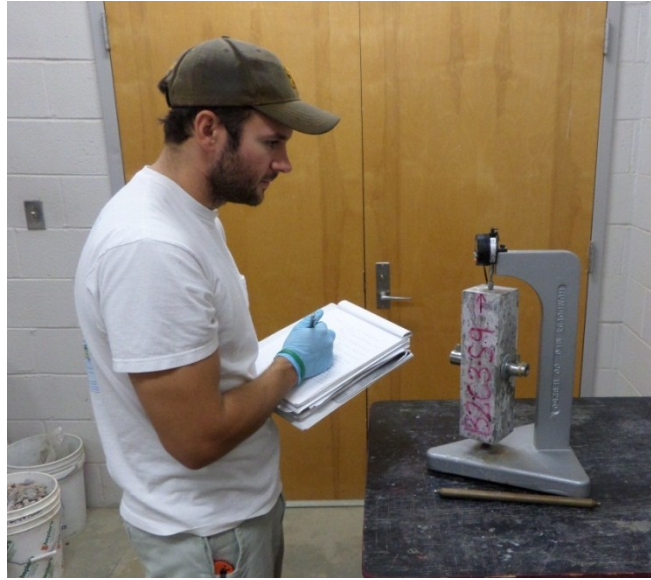
Figure 4.19: Length change measurements being recorded

and weight were machined from stainless steel and affixed to the specimens. The counter weights were located opposite the position of the AE sensors, in order to balance the center of mass of the concrete prism. Erratic ‘wobbling’ of specimens during spinning and length change readings may result in noisy length change results.

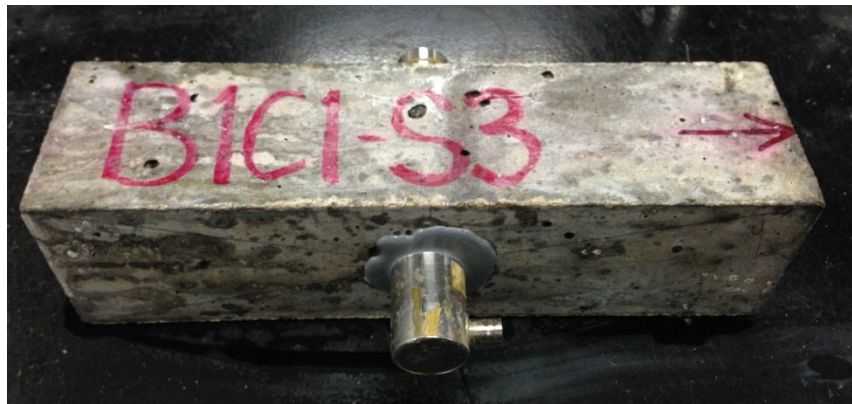
Figure 4.23: Specimen S3 after 56 days of testing

ASR specimen S3 is shown after 56 days of testing in Figure 4.23. No visible signs of cracking were observed on the surface of the specimen significant staining of the specimen was present. Figure 4.24 shows AE data in terms of amplitude and length change with respect to time for test specimen S3. The first length change reading at 1 day shows a decrease in the length of the specimen which is attributed to shrinkage. Following this measurement the length change steadily increases to a maximum value of 0.013% at 56 days (approximately 33% of the threshold specified by the ASTM C1293 for potentially deleterious aggregates after one year). A marked increase in AE activity can be seen after 14 days. This is due to the deterioration of the original epoxy during the first 14 days of testing which resulted in weakening of couple between the AE sensor and the specimen. The poor coupling attributed to the diminished sensitive of the AE sensors during the first 14 days.

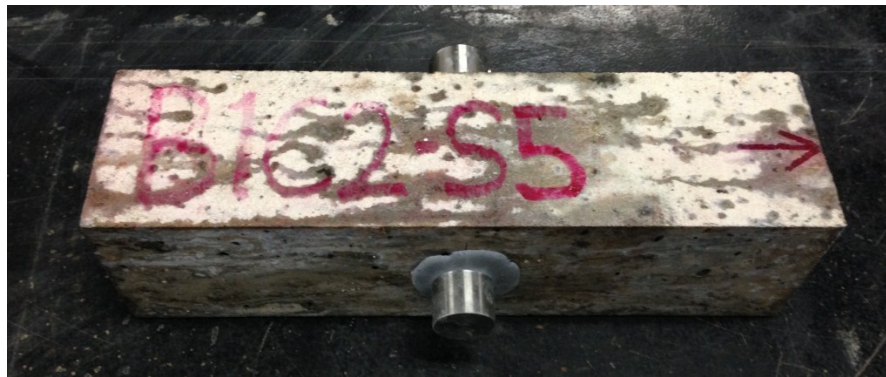
Figure 4.26: Specimen S5 after 56 days of testing

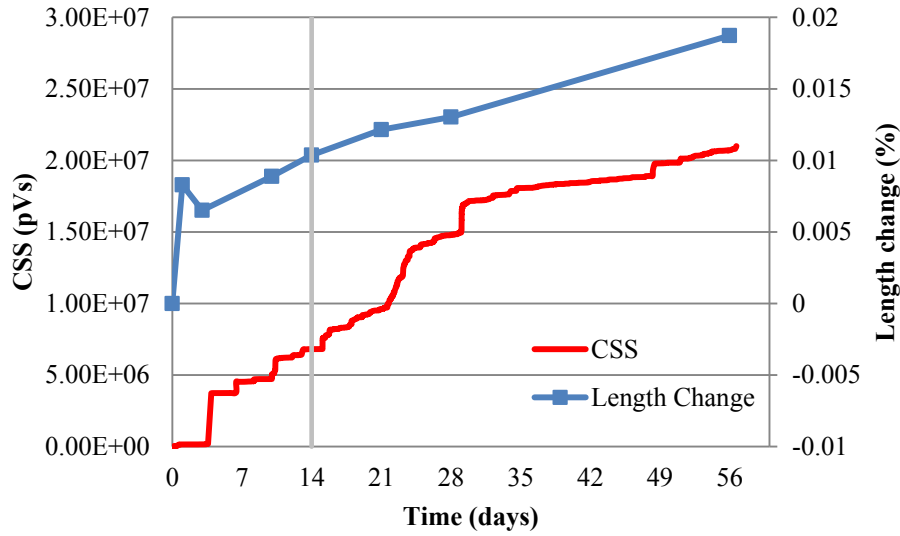
Figure 4.28: Specimen S5 – CSS and length change versus time
