**STUDY OF THE
DETERIORATION FEATURES
OF THE UMM UBAYDA TEMPLE
IN SIWA OASIS - EGYPT**

**Nabil A. Abd El-Tawab
Conservation Department ,
Faculty of Archaeology
South Valley University , Kena**

Journal of Faculty of Archaeology (Qena)

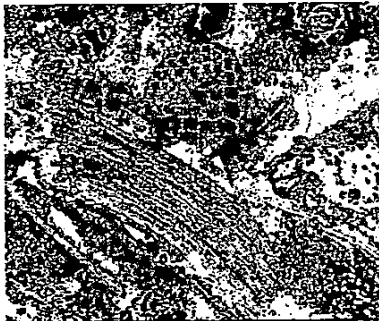
Fig. 5 : Thin section micrograph shows microcracks and Iron oxide

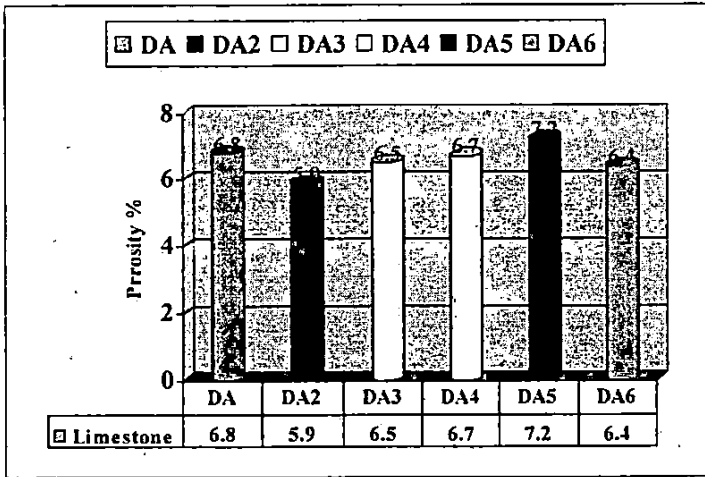
Fig.19 Shows porosity measuring for limestone samples from Umm Ubayda temple. .

Bulk density , water absorption , porosity and compressive strength were determined according to ASTM . The sample sizes used in the study were $5 \times 5 \times 5$ cm cubes . The samples were dried at oven , where temperature average was 105°C . The results showed (fig .17-18) all samples which were collected from Aghormi hill and Umm Ubayda temple have quite similar physical properties . The bulk density is between 1.7 and 1.9 g/cm^3 . The water absorption is between 2.45-3.20 % , and the porosity is between 5.9-7.20 % .

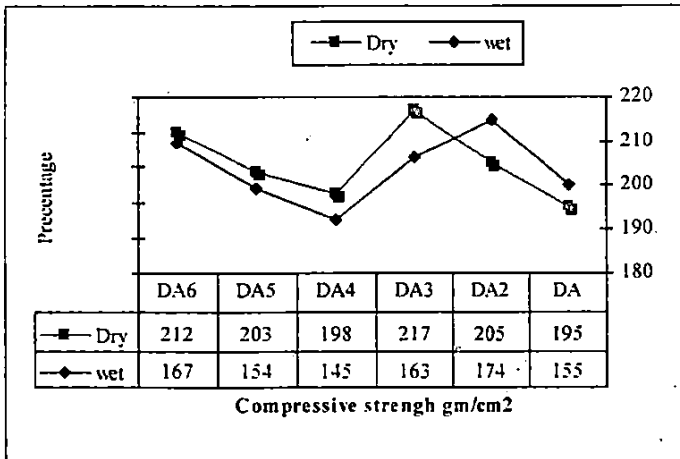
Fig.20 Shows compressive strength (wet and dry) for limestone samples from Umm Ubayda temple. .

The results obtained from mechanical test (compressive strength) summarized in (fig. 20) : There is significant change of compressive strength for the wet samples , that gave a decrease in the compressive value
