TREE ROOT ENCROACHMENT ON LEVEE DRAINAGE SYSTEM

THESIS

Master of Science in Civil Engineering

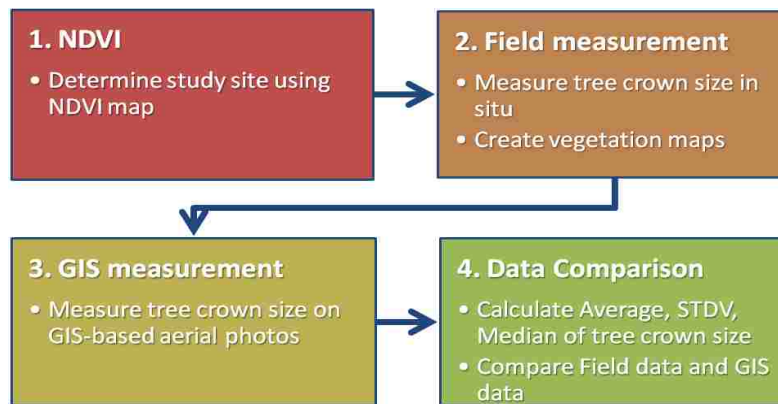
Figure 2.1 shows procedure for crown size estimation. Details of each step are shown in the following sections.

Figure 2.1 Procedure for crown size estimation

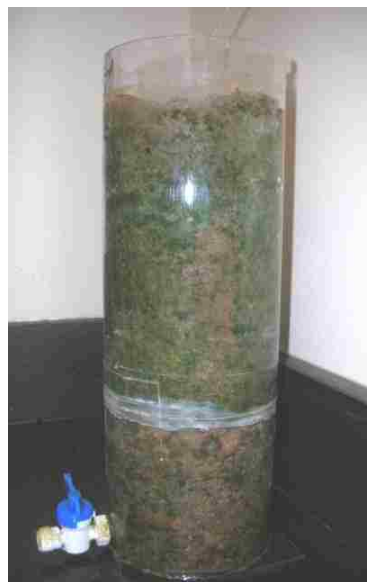
Figure3.2 Photograph of experimental column

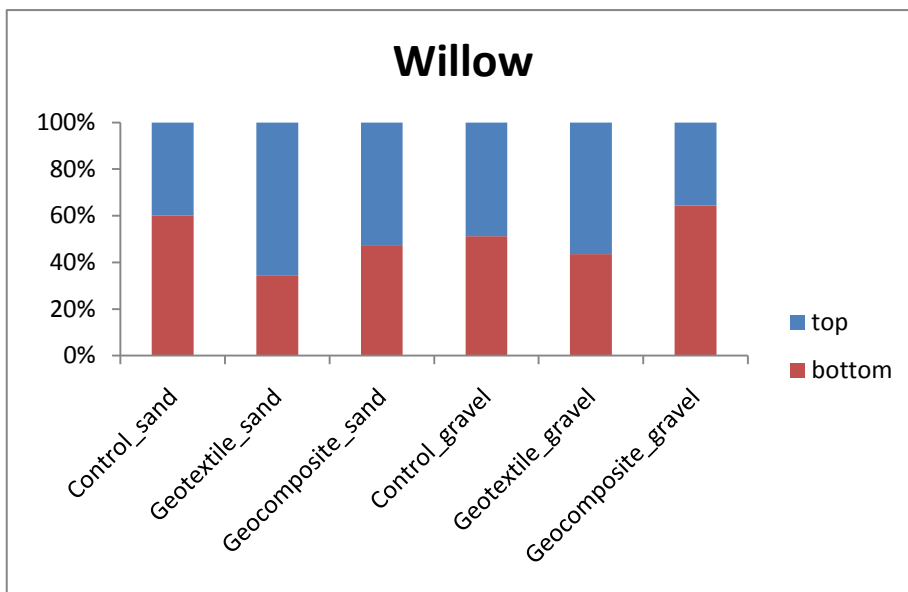
Figure 3.8 Percentage of root length in the upper/lower columns (willow)

As shown in Figures 3.7 and 3.8, root systems are found in all lower columns and the drainage materials and root barriers does not appear to affect the total root length of willows. The numbers of surviving columns made it more difficult to draw conclusions. There were two principal reasons for the low survival rate.

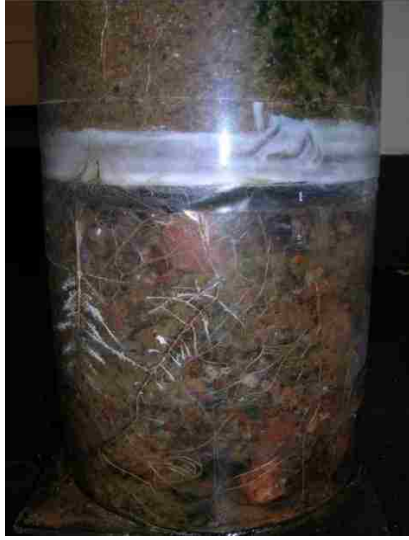
The second reason for low survivability is that some roots did not grow into lower columns. In many columns, some roots grew between the root barrier and the column wall (Figure 3.9). As willow roots are much finer than cottonwood, some root found a small gap along the column wall and the root barrier. When the columns were built, 30 cm of acrylic columns were first cut into two pieces to insert the root barriers, and they

Figure 3.9 Picture of root system grow found outside of the column

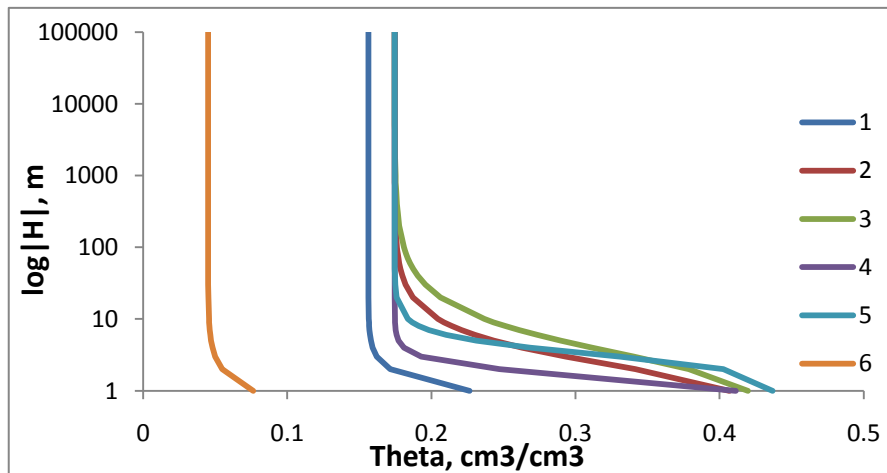
Figure 4.2 Soil water retention curves

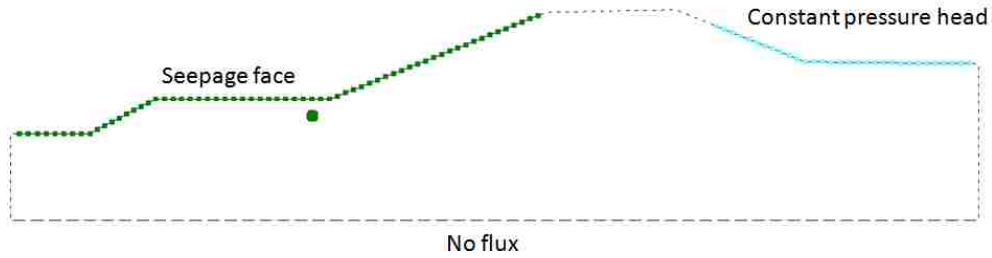
For flood condition, flood water was introduced as constant pressure head boundary (Figure 4.9). Flood depth, associated with the 100-yr flood, was applied on the river side to measure the discharge rate into toe drain with each flood depth. For both the ambient and flood conditions, the bottom boundary was specified as no flux so that water movement into toe drain and ditch could be observed. The pipe was modeled as a seepage face as was the geocomposite edge drain.

Figure 4.9 Boundary condition for flood conditions

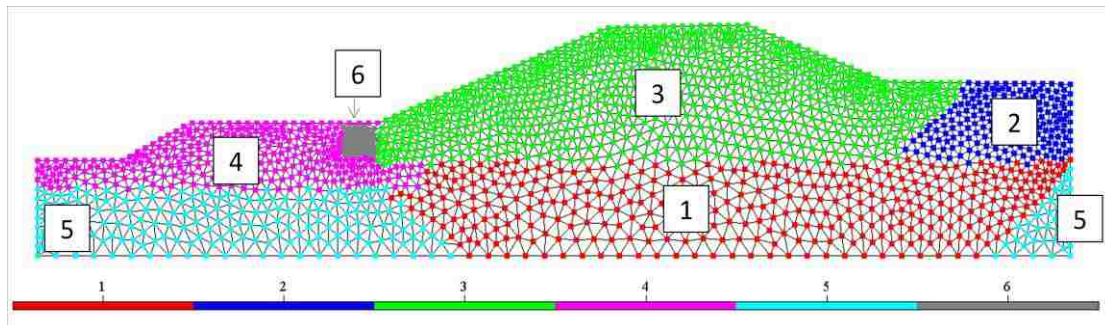
Material distribution is shown in Figure 4.10. As mentioned, properties and distribution of materials were obtained from AMEC report, and hydraulic properties are shown in Table 4.2. Materials can be assigned in each node. The most permeable material, material number 1, is located beneath the levee structure.

Figure 4.10 Material distribution

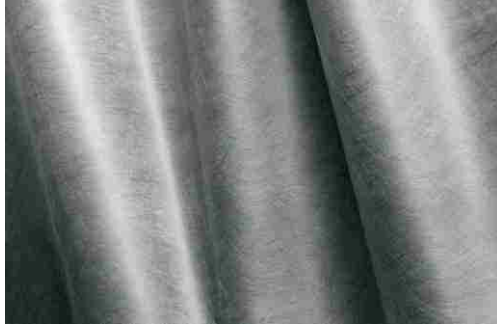
Material: nonwoven polypropylene geotextile fabric, water permeable

Figure A-1 Geotextile

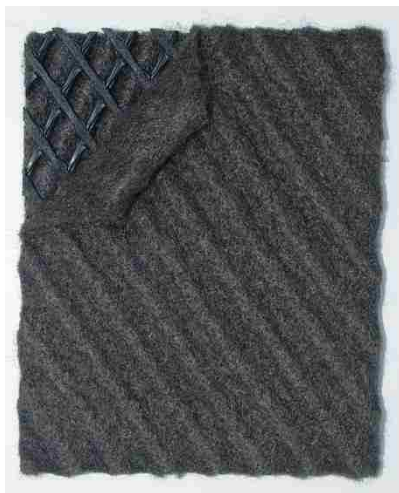
Material: The geotextile is bonded to the geonet with a hot knife application allowing for high bond strength without the reduction of transmissivity values of other processes

Figure A-2 Geocomposite

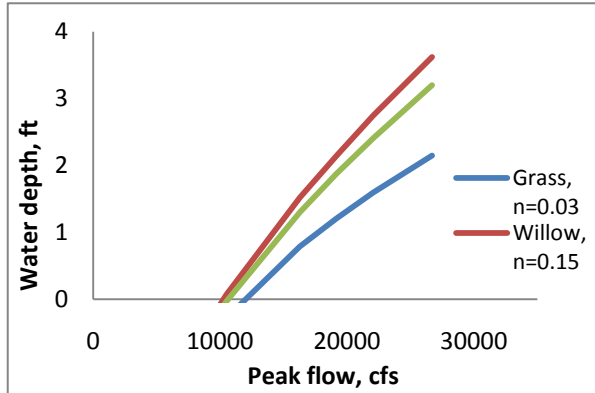
Figure D-6 Flood depth at the Alameda cross
