The Effects of Implements of Husbandry Farm Equipment on Rigid Pavement Performance

Shiyun Wang
Iowa State University

A thesis submitted to the graduate faculty
in partial fulfillment of the requirement for the degree of
Master of Science

Major: Civil Engineering (Geotechnical Engineering)

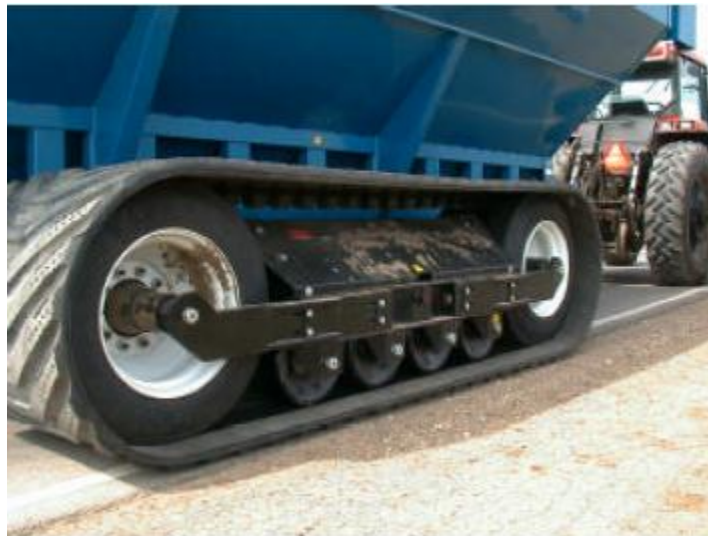
Figure 2-2. KINZE 1040 Tracked Wagon (Fanous, 1999)

The pavement was tested as least twice at crawl speed for both KINZE 1040 and standard-truck loads on the E-29 PCC pavement. A photo of the KINZE 1040 is shown in Figure 2-2. The contact area of the KINZE 1040 is 36 inches by 116 inches and the wagon loading was 70, 140 lbs with a gross weight of 96,000 lbs.

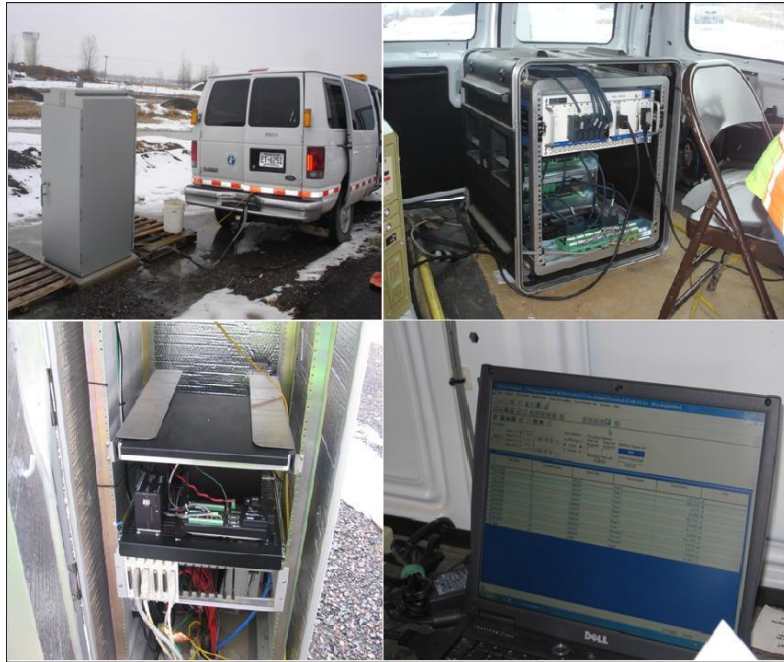
Figure 3-7. MnROAD Pavement Response Data Collection System

Data acquisition for this research study was accomplished with various types of electronic data collection systems at MnROAD as shown in Figure 3-7. Pavement responses data were collected electronically. All the sensors embedded into each test section were wired into the cabinet as shown in the upper left picture in Figure 3-7.

MnROAD data acquisition system starts to record response measurements when a test vehicle approaches a testing Cell and passes a trigger. These systems collected response measurements at a rate of 1,200 data points per second (1,200 Hz) and each vehicle pass typically has a collection time of fifteen to eighteen seconds (Lim, 2011). Approximately 18,000 to 22,000 data points per sensor were recorded under one vehicle run.

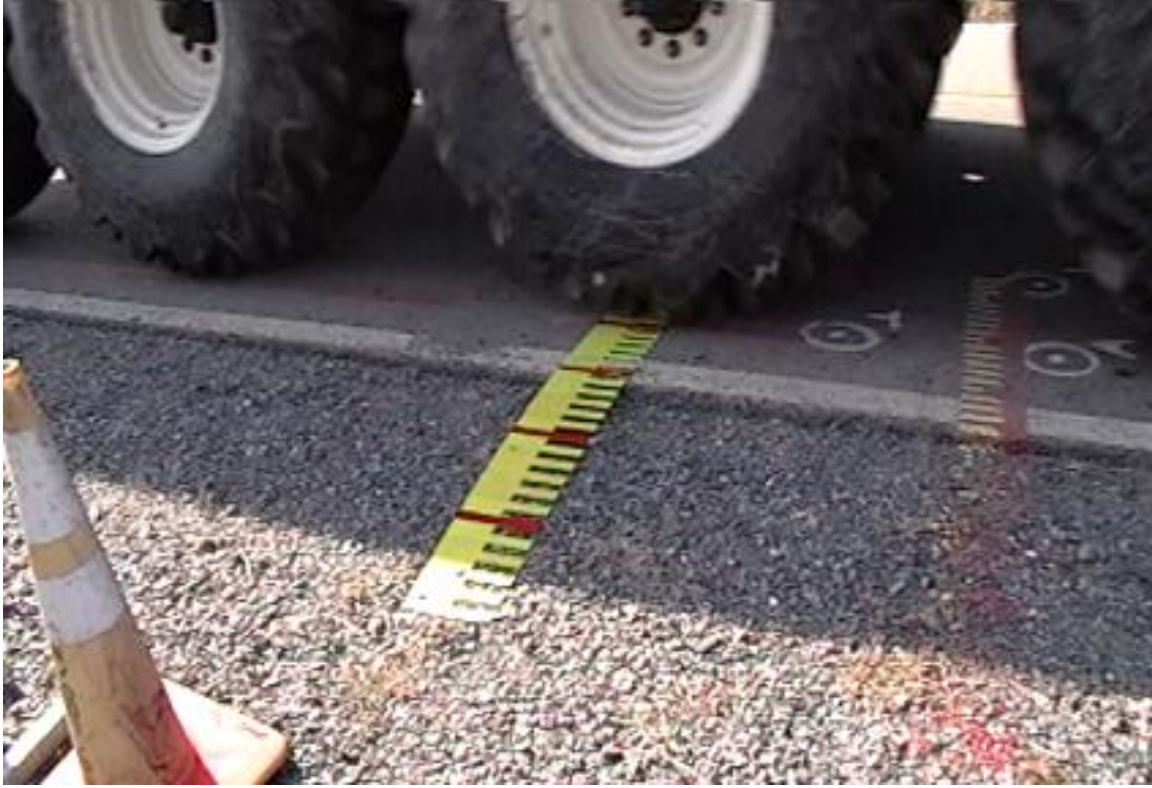
Figure 3-9. Illustration of Steel Scale Placement for Determination of Traffic Wander

To achieve this requirement, length scales were installed to help the vehicle drivers properly align the vehicle tires on the desired offset. As shown in Figure 3-9, a steel scale with one inch teeth spaced one inch apart was placed on the pavement surface at each of the test sections. The teeth and gap of the steel scale are both one inch. Red strips are marked every 12 inches. The red strip placed on the outer edge of the pavement edge line was designated as the origin. Wheel paths toward the centerline of the pavement are positive and wheel paths toward the shoulder are negative.

Although the vehicles were guided to have their wheel center of rear axle pass the desired offset (0 inch, 12 inches and 24 inches) shown on the steel strip, deviations from targeted offsets existed depending on the vehicle operators' ability and experience of heavy agricultural vehicle. Video cameras were placed at each of test sections to record the vehicles' actual position at the time each vehicle passing the scale. Videos were reviewed afterward and the exact traffic wander position (offset) of each vehicle pass was determined for data analysis.

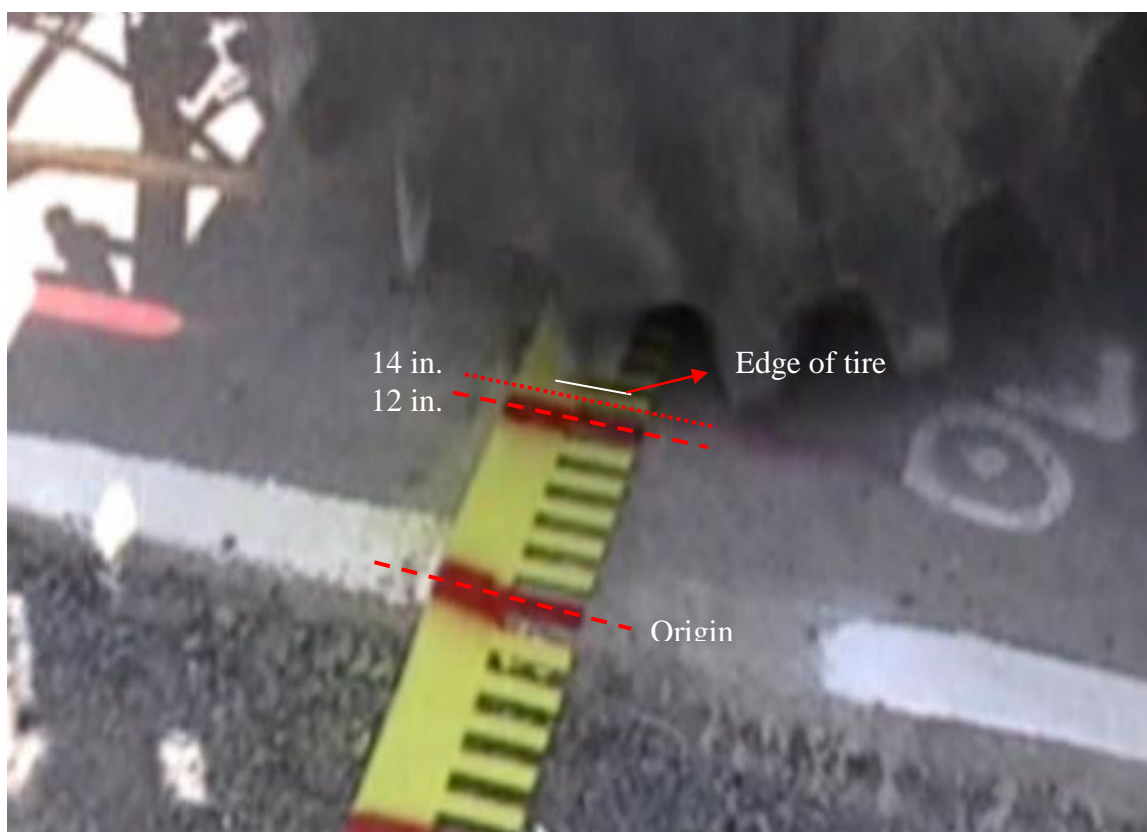
Figure 4-1. Determination of Vehicle Wheel Edge Offset

Videos taken at the time of each vehicle passing the steel scale were reviewed to determine actual wheel edge offset of last axle of a vehicle. The wheel edge offset could be obtained by counting the number of teeth and gaps from the origin to the last visible tooth or gap at the edge of the vehicle's last axle (See Figure 4-1). The wheel edge offset in Figure 4-1 is 14 inches.

The wheel edge offset value determined was recorded in the wheel edge offset column in offset table as shown in Table 4-1. The last column of Table 4-1 is the wheel center offset. Wheel center offset is simply the sum of the wheel edge offset and the half of tire width of last axle of the vehicle.

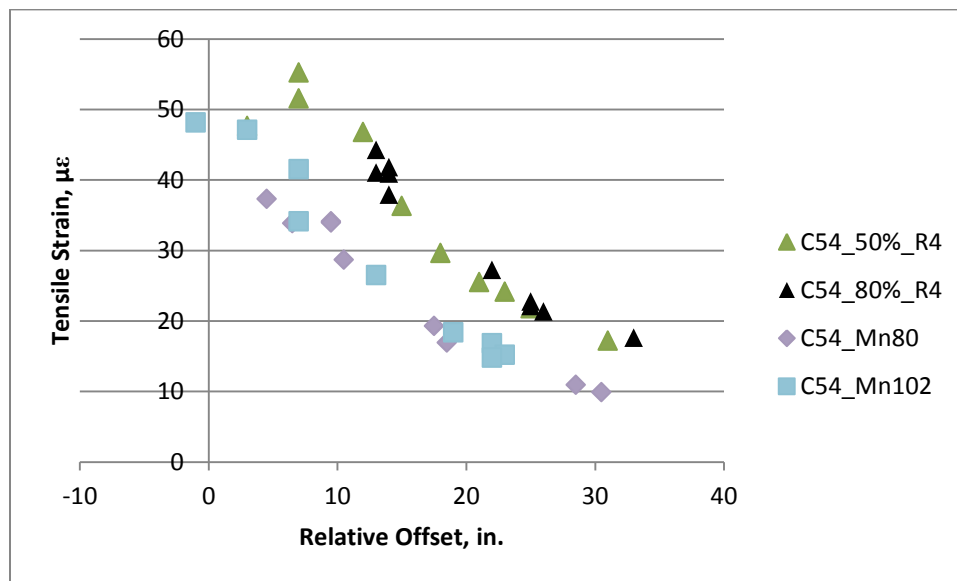
The effects of the load levels (50% and 80%) with relative offsets on the pavement strains introduced by various vehicles were investigated in Spring 2009 test program. The pavement strain responses at Cell 54 were plotted along with corresponding relative offset of each run of the tested vehicles in Figure 4-15. As shown in Figure 4-15, it is easily found that the strain responses decrease dramatically as the relative offset increases. Terra-gator R4 produced similar pavement strain when it was 50% and 80% loaded. In comparison to the Mn80, the higher pavement strains of R4 were observed as the relative offset changes. Please refer to Appendix B for the other vehicles tested since they produced similar trends.

Figure 4-15. Pavement Strain Comparisons Introduced by R4 on Cell 54 during Spring 2009 Field Testing

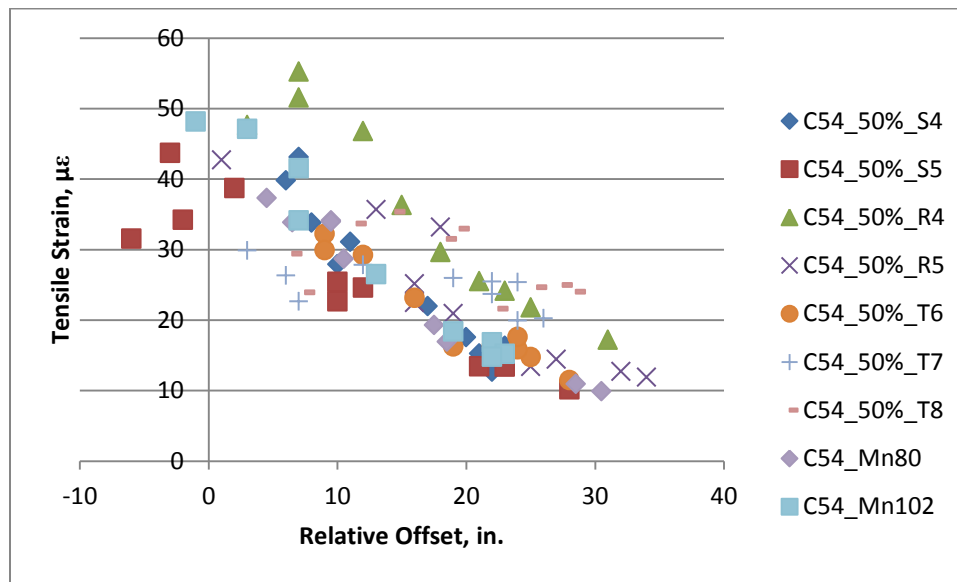
All the maximum strain responses generated by all tested vehicles at Cell 54 are plotted in Figure 4-16 for 50% of load level and Figure 4-17 for 100% of load level. As seen in Figure 4-16, the strain responses decrease dramatically as the relative offset increases. Strain responses for MnROAD vehicles (Mn80 or Mn102) at Cell 54 were used as a benchmark to compare responses for other vehicles. In comparison to strain responses of Mn80 under 50% of load level, higher strain responses were observed at the strain responses of R4 at less than 0 inches of relative offset and strain responses of T8 at higher than 0 inches of relative offset. Strain responses of T8 at higher than 0 inch of relative offset were even higher than those of Mn102. The strain responses of other farm vehicles tested were same as or less than those of Mn80 and Mn102.

Figure 4-16. Cell 54 Pavement Strain Responses during Spring 2009 Field Testing at 50% Load Level

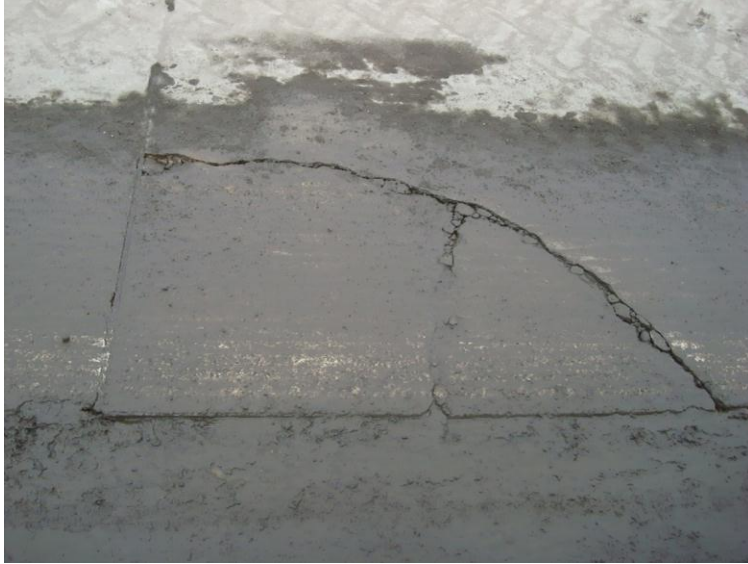
Figure 4-27. Aggravated Corner Break from Fall 2009 Testing Cycle

No visible distress was observed on Cell 54. On the Cell 32, the corner break observed during the Fall 2009 field testing cycle aggravated during the Spring 2010 test cycles as seen in Figure 4-27.

The crack width and depth are comparatively smaller compared with the one shown in Figure 4-27. However, this corner break could eventually become the one shown in Figure 4-27 if traffic continues to run.

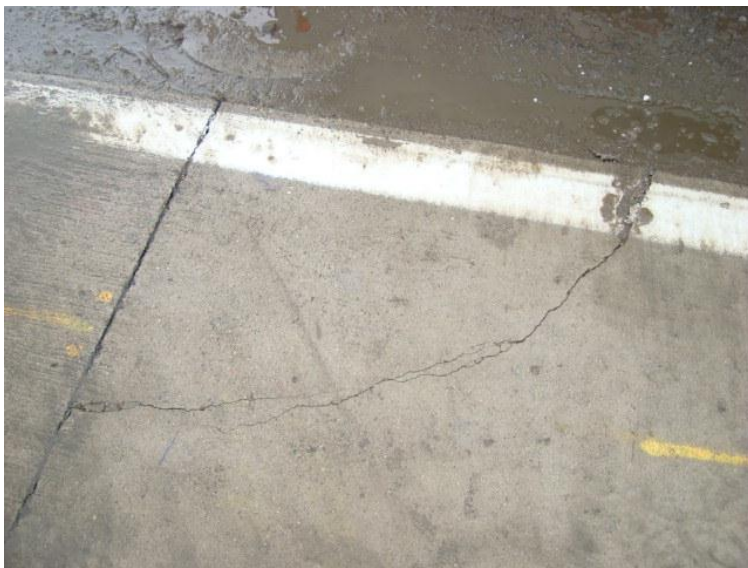
Figure 4-28. New Corner Break on Cell 32 during Spring 2010 Testing

Additional new corner cracks were observed on Cell 32 during Spring 2010. Figure 4-28 presents one of new corner breaks on Cell 32 during Spring 2010 field data collecting process.

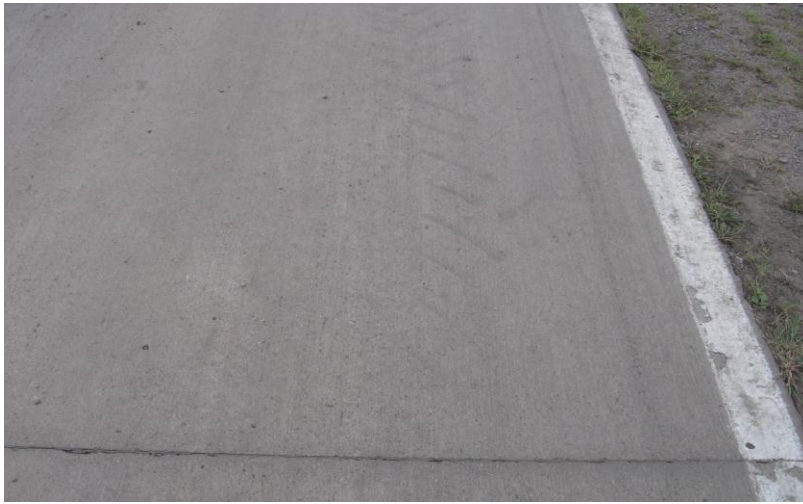
Figure 4-35. New Corner Break on Cell 32 during Fall 2010 Testing

In addition to previously occurred corner cracks, another corner crack as shown in Figure 4-35 occurred at seven slabs ahead of Cell 32 slab. The slab is located where testing vehicles speed up to achieve the planned speed requirement. The crack width is so tiny

that it is hardly to visualize. However, the crack length covered almost half of the slab width and length which is far greater than previous corner breaks.

Various factors including heavy loading of grain cart and large amount of load repetition might has contributed to this new corner break. However, it is not clear which vehicle is the dominating one to make this crack.

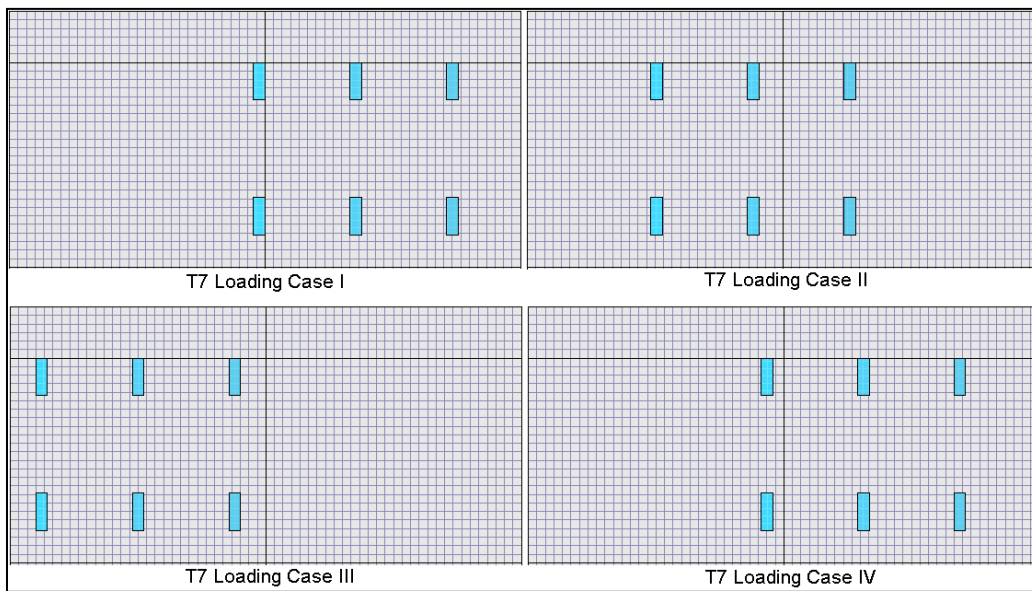
The spacing between the first axle and the last axle for T7 is 136 inches. Thus it would be enough for 15 ft. (180 in.) or 20 ft (240 inches) PCC slab to accommodate all three axles on the same slab. However, the critical loading and damage locations are still uncertain. Therefore, some typical loading scenarios of T7 were prepared and run on the ISLAB2005 to compare the maximum tensile stress at top and bottom of the slab. Four different loading cases are compared and shown in the following Figure 5-30.

Figure 5-30. Loading Scenarios for T7 on 15 Feet Slab
