The Marked Tree Site: Evaluation of Geosynthetic Reinforcements in Flexible Pavements

A thesis submitted in partial fulfillment
of the requirements for the degree of
Master of Science in Civil Engineering

Taylor M. Goldman
Arkansas State University
Bachelor of Science in Engineering with an Emphasis in Civil, 2010

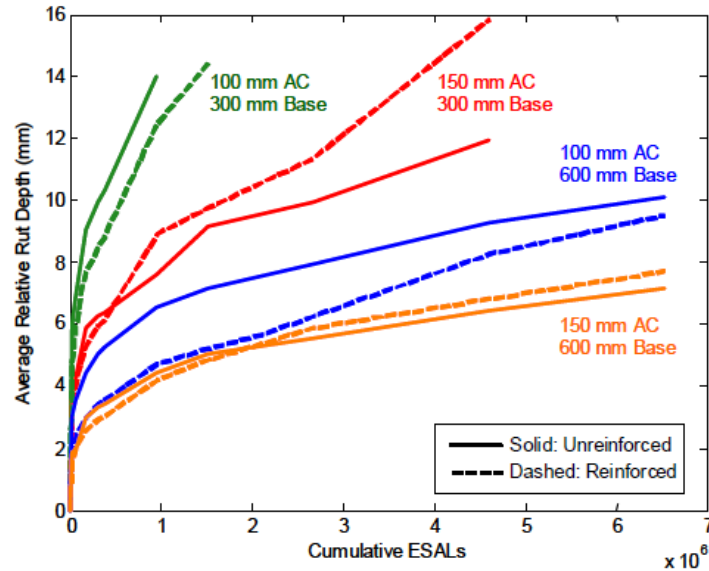
Figure 2.5. Average relative rut depth vs. cumulative ESALs (Henry et al. 2011).

It can be observed in Figure 2.5 that the section with 6 inches (150 mm) of asphalt and 12 inches (300 mm) of base performed contradictory of what would be expected. The unreinforced section resulted with less rut depth than the geosynthetic reinforced section after equivalent ESALs were applied. However, it must be noted that the base course in the unreinforced section was significantly softer, with a base modulus from FWD back calculations of approximately 30.6

ksi (281 MPa) (Henry et al. 2011). It should also be noticed that the thickest overall section, asphalt and base layers combined, resulted in negligible differences in rutting between the reinforced and unreinforced sections. This could represent a point of diminishing returns with regard to grid reinforcement (Henry et al. 2011). It could be possible that once a certain amount of base course is applied, the mobilization of the geosynthetic reinforcement is not reached until the pavement structure has reached the point of failure.

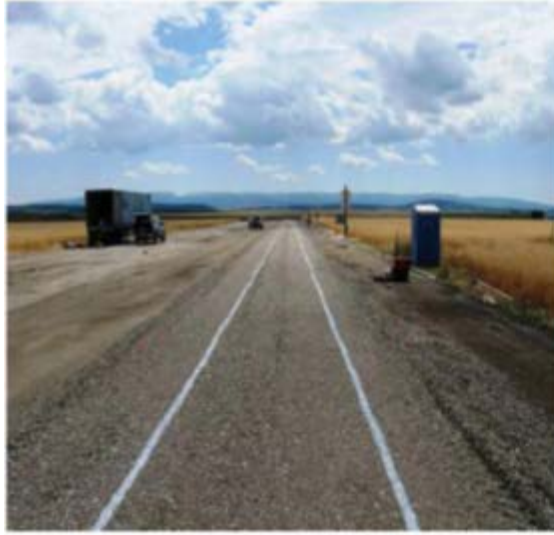
Figure 2.6. Full-scale field testing (Cuelho and Perkins 2009).

Full scale testing is typically performed to evaluate pavements under the actual traffic, environmental, and boundary conditions encountered in a given area, as shown in Figure 2.6. However, this can be inconvenient and uncertain as the environmental and loading conditions cannot be controlled. Field test sites also prevent control of uniform site conditions due to natural variations in the subgrade profile. Therefore, to be able to understand that contribution of the geosynthetic material in the pavement design, a uniform testing material must be used and often

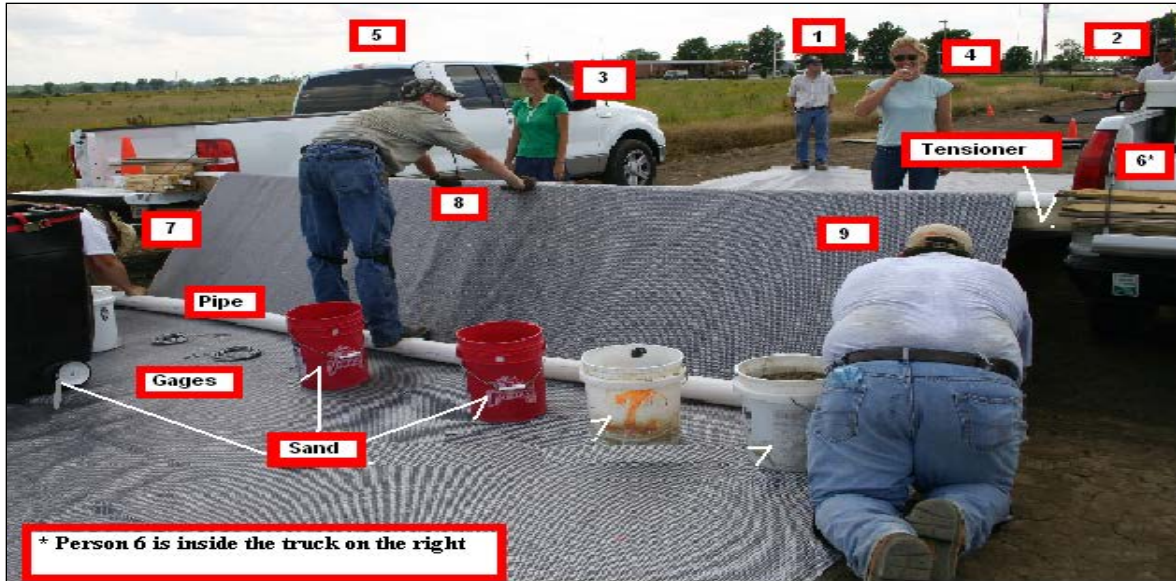
Figure 3.12. Geosynthetic tensioning technique (Howard 2006).

- 1) Locate the active gage over the center of the subgrade earth pressure cell and either unroll or unfold the entire geosynthetic.
- 2) Use standard surveying equipment to align the active geosynthetic strain gage and earth pressure cell center to within at most 1.2 in (30 mm).
- 3) Pull laterally (perpendicular to the traffic direction) on the geosynthetic at the gage location to remove all wrinkles and hold the material taut while driving six pins uniformly across the width of the geosynthetic, ensuring all pins are at least 12 inches (300 mm) from the gages.
- 4) Place full buckets of sand behind the gages to help them remain stationary.
- 5) Measure and place a mark every 8 feet (2.44 m) on the geosynthetic on both sides of the gage. These marks will be used for pin placement in the geosynthetics.

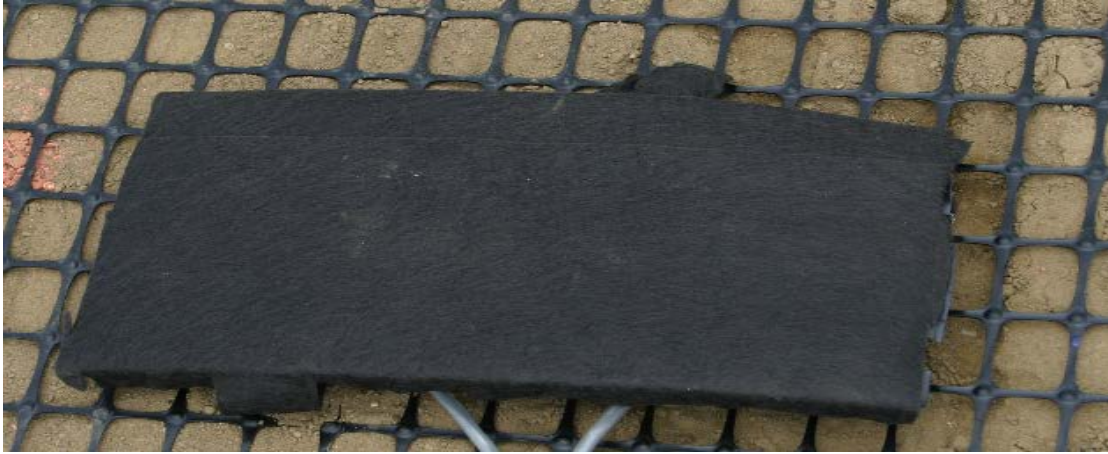
Figure 3.13. Geogrid strain gage protection, strip drain (Howard 2006).

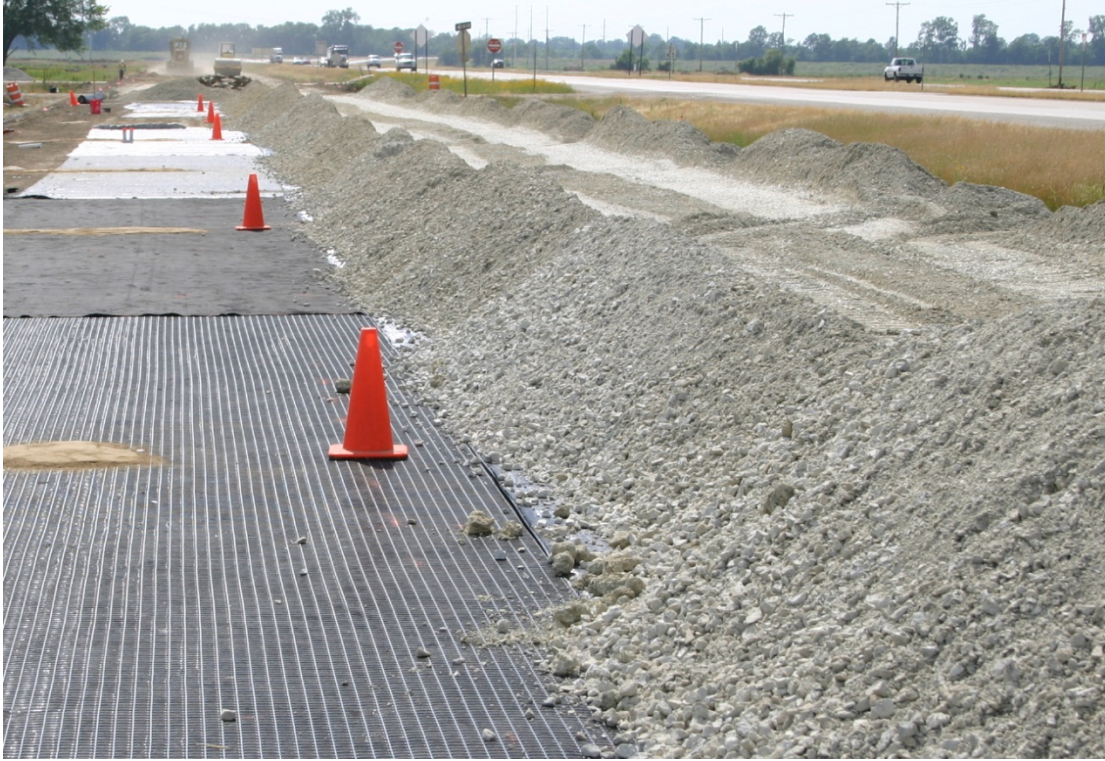
Figure 3.17. Base course placement on non-instrumented lane (Howard 2006).

lanes (Figure 3.17). Once sufficient material was present along the entire test section, aggregate was laterally bladed onto the test sections as shown in Figure 3.18. Until aggregate covered the instrumented test sections, all sensitive areas were continuously marked with fluorescent paint and/or traffic cones. This process was carefully observed and no movement of the geosynthetics occurred. After compaction of the first lift of crushed stone, the contractor proceeded as normal to bring the entire test section to the appropriate grade and density (Howard 2006).

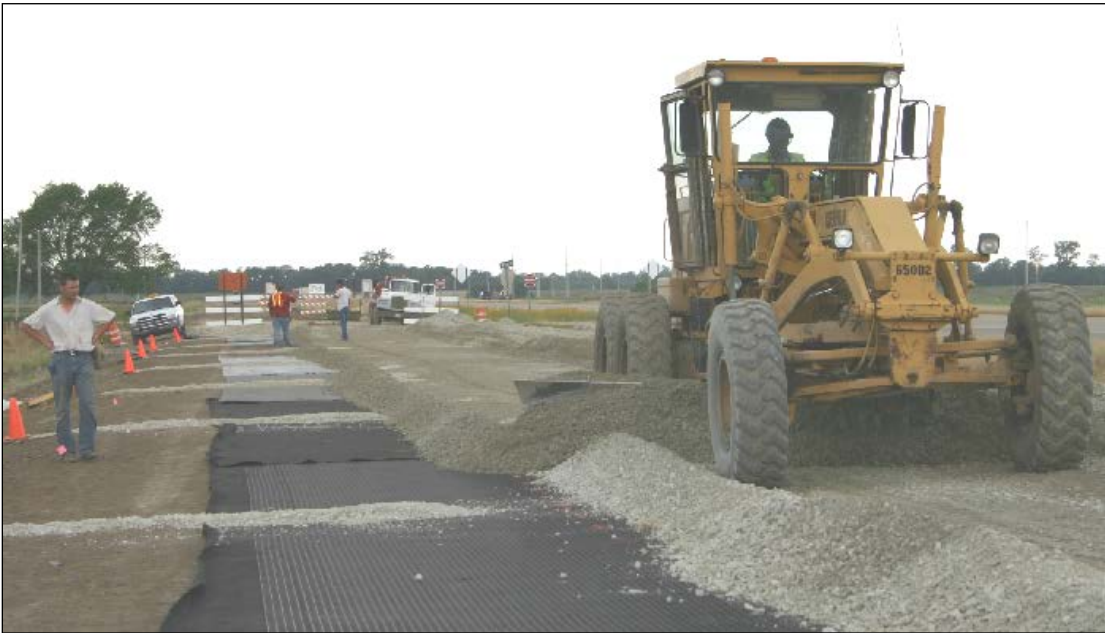
Figure 3.18. Lateral placement of crushed limestone on geosynthetics (Howard 2006).

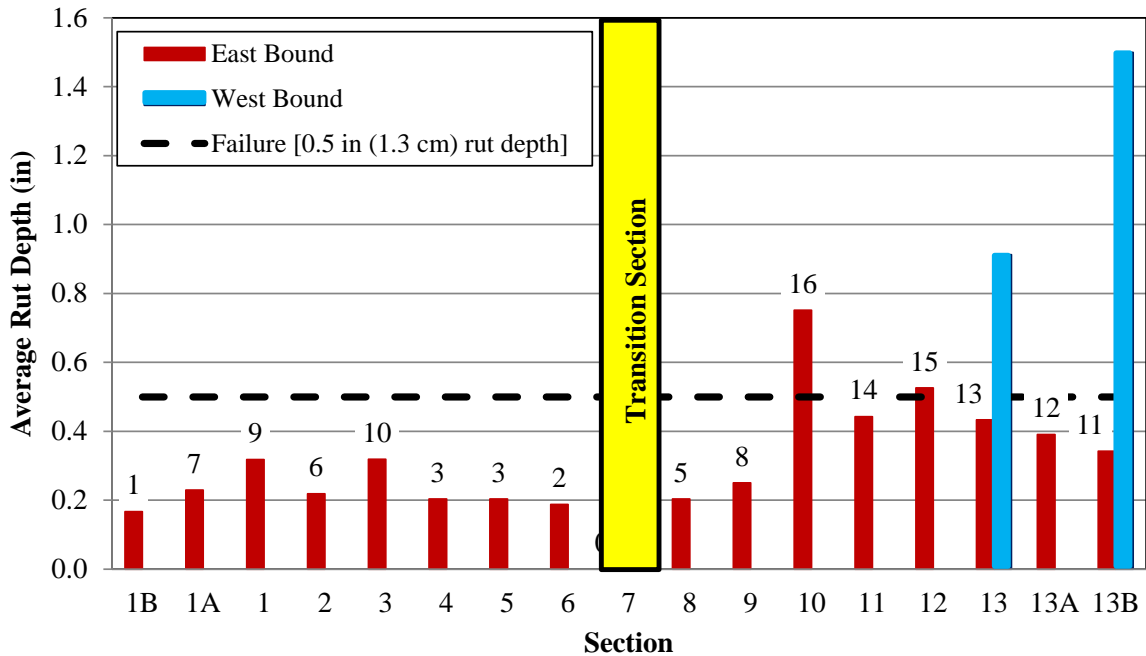
Figure 4.2. Average rut depths for measurements conducted in June of 2010.

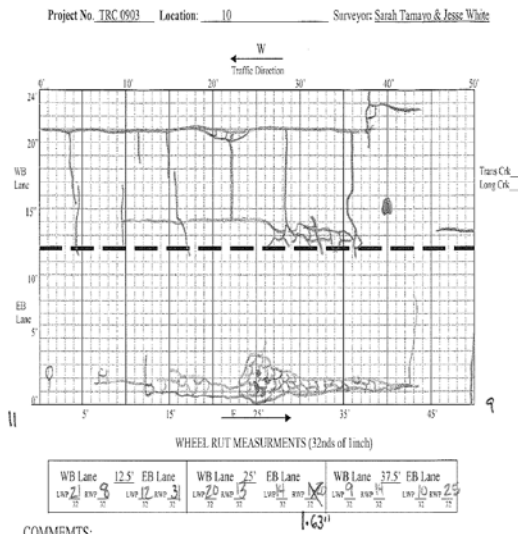
Figure 4.4. Section 10 June 2010 distress survey.

The distress survey for Section 10 for each date is presented in Figures 4.4 and 4.5 as an example of where the rut depth and cracking data were derived from. These distress surveys also show the growth of the pavement cracking over time within Section 10 (the poorest performing test section). Note that the alligator cracking in the eastbound lane began at the center of the test section in the righthand (outside) wheel path where the instrumentation was installed during

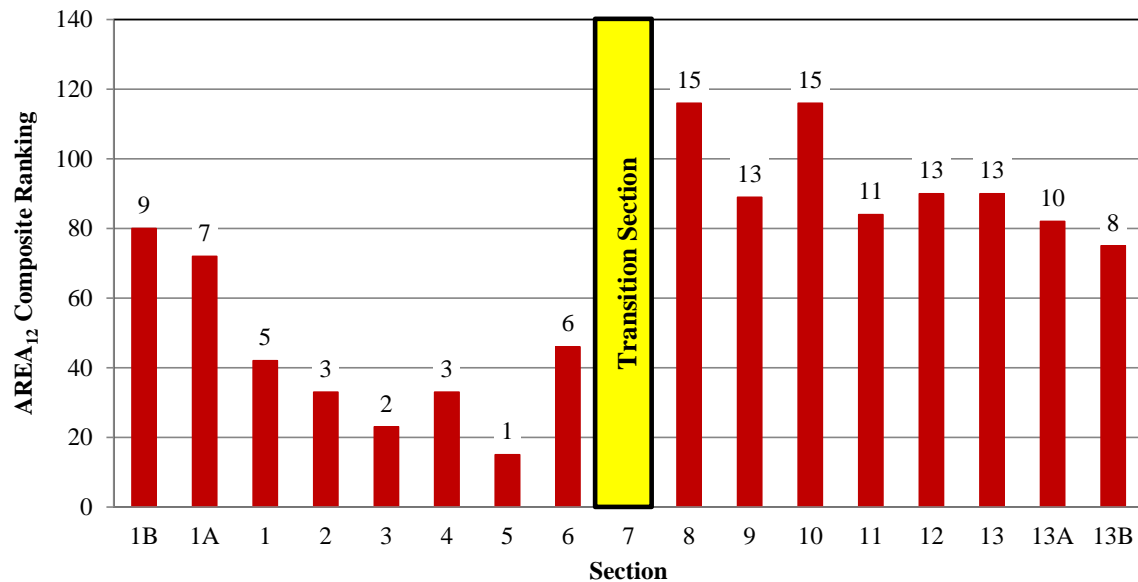
Figure 5.5. AREA₁₂ composite rankings from eight FWD tests conducted at the Marked Tree site.

The composite rankings were calculated by summing the total deflected area and the AREA12 values from each test date and ranking the sums accordingly.

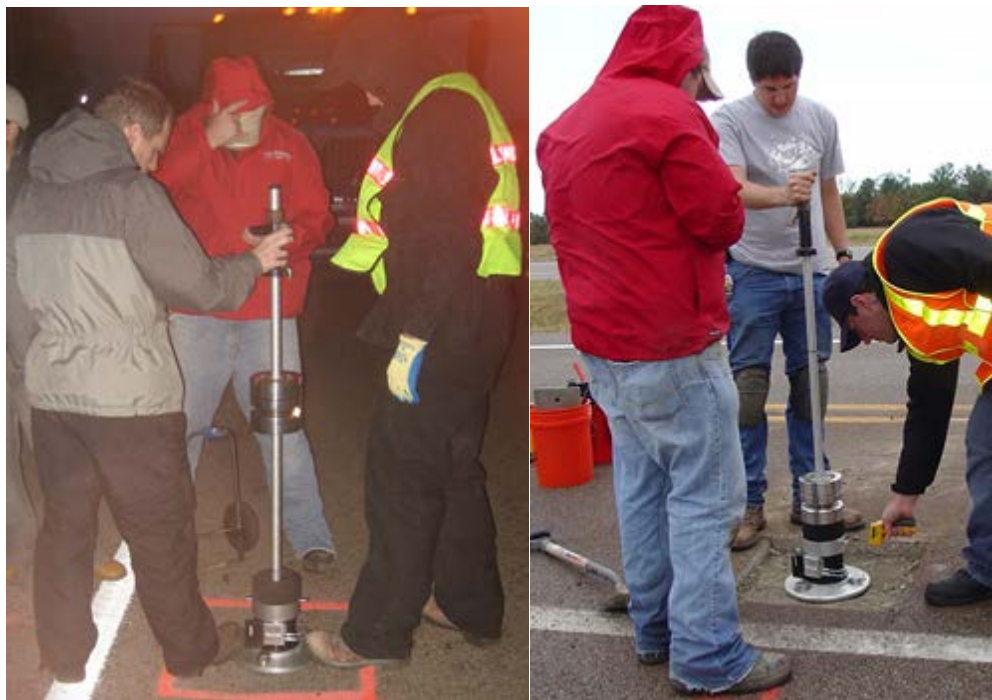
Figure 5.19. LWD tests conducted on asphalt and base course layers at Marked Tree site.

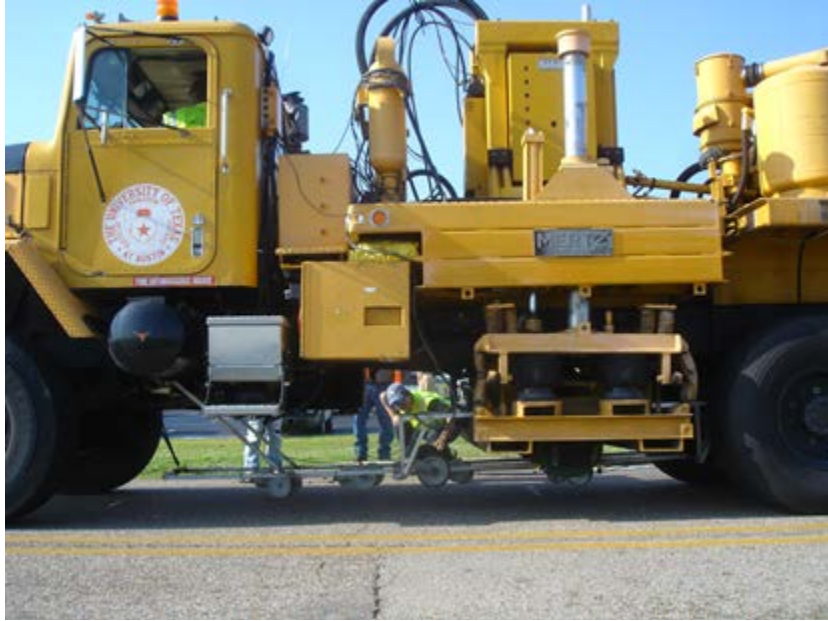
Figure 5.25. University of Texas’s RDD at the Marked Tree site.

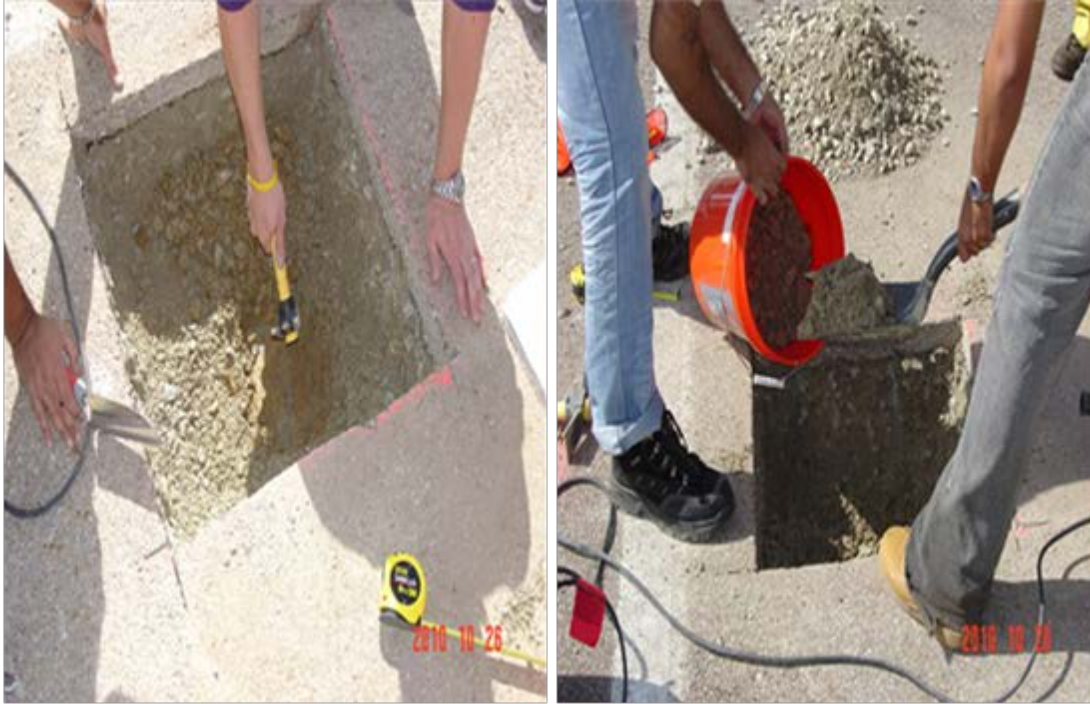
Figure 6.7. Base layer excavation and sampling at Section 2.

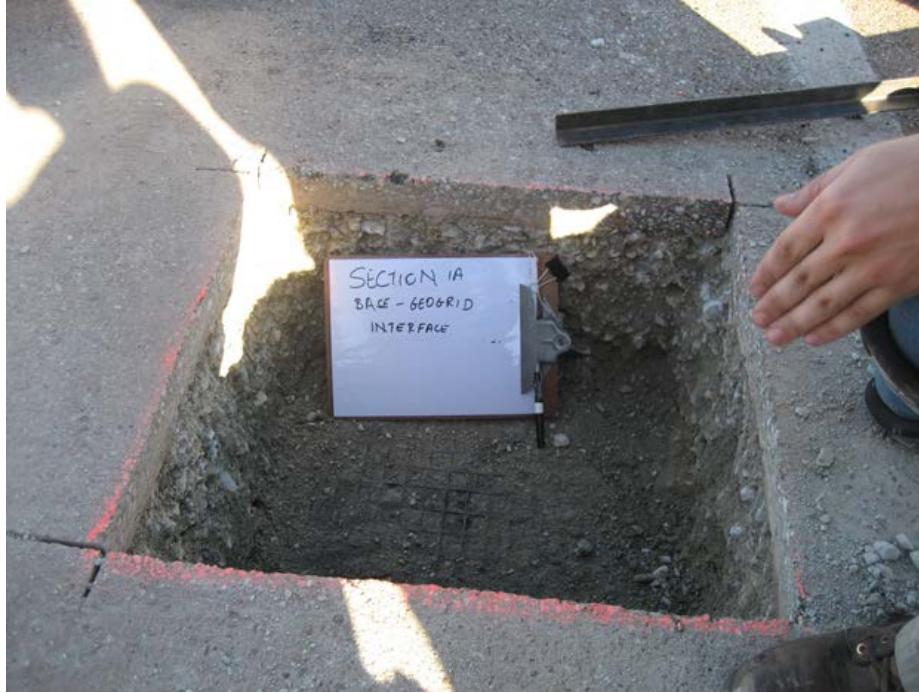
Figure 6.9. Subgrade-geosynthetic interface of Section 1A (Mirafi geogrid).

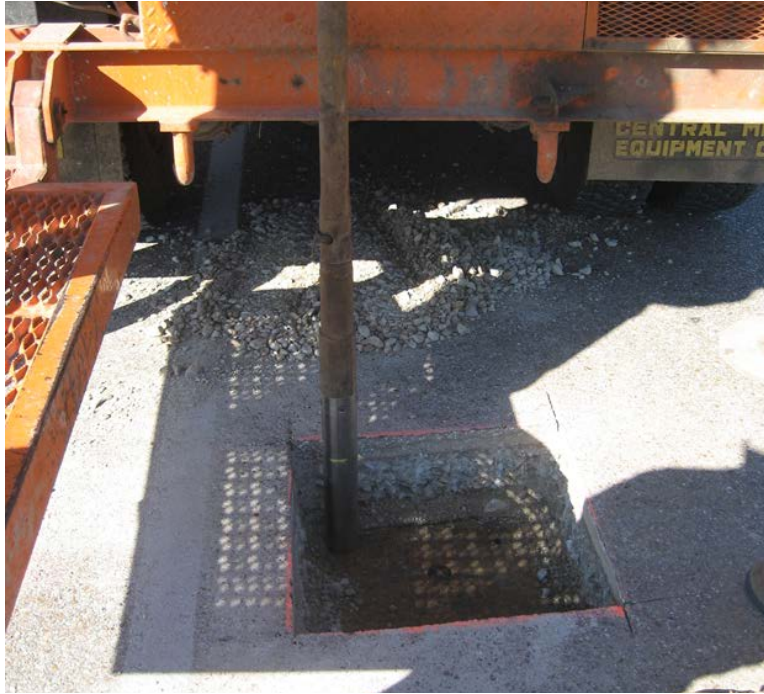
Figure 6.10. Shelby tube pushed in southwest corner of excavation area.

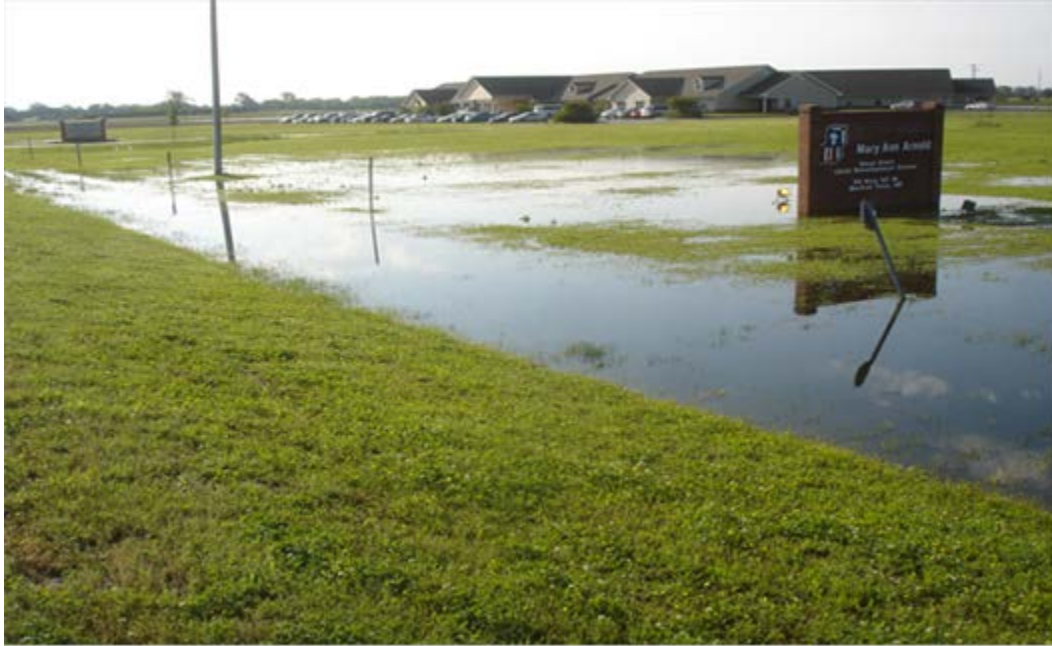
Figure 6.16. Standing water south of Sections 8 through 13B in May 2011.

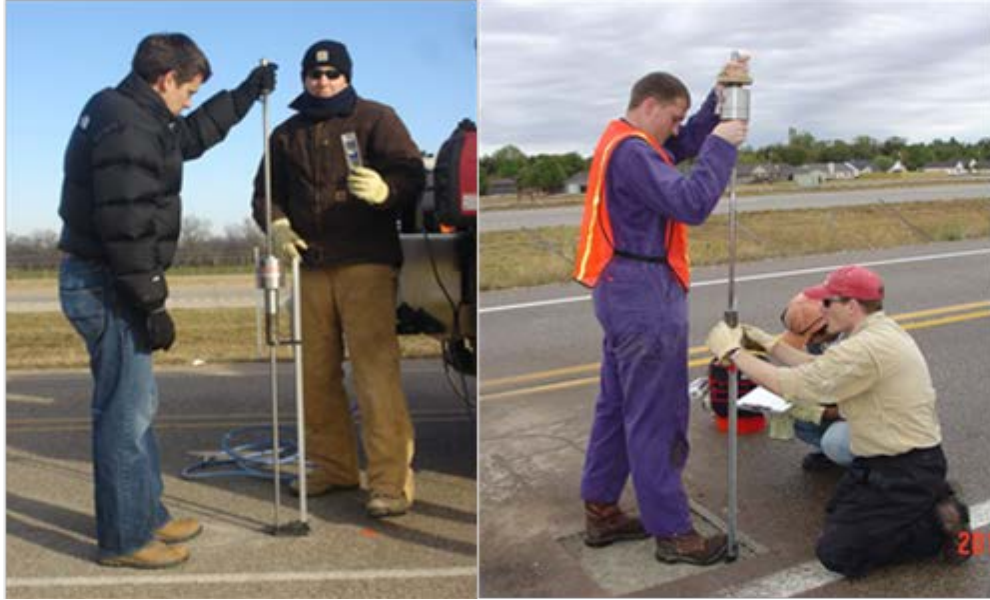
Figure 6.23. DCP testing at the Marked Tree site on December 2009 and October 2010, respectively.

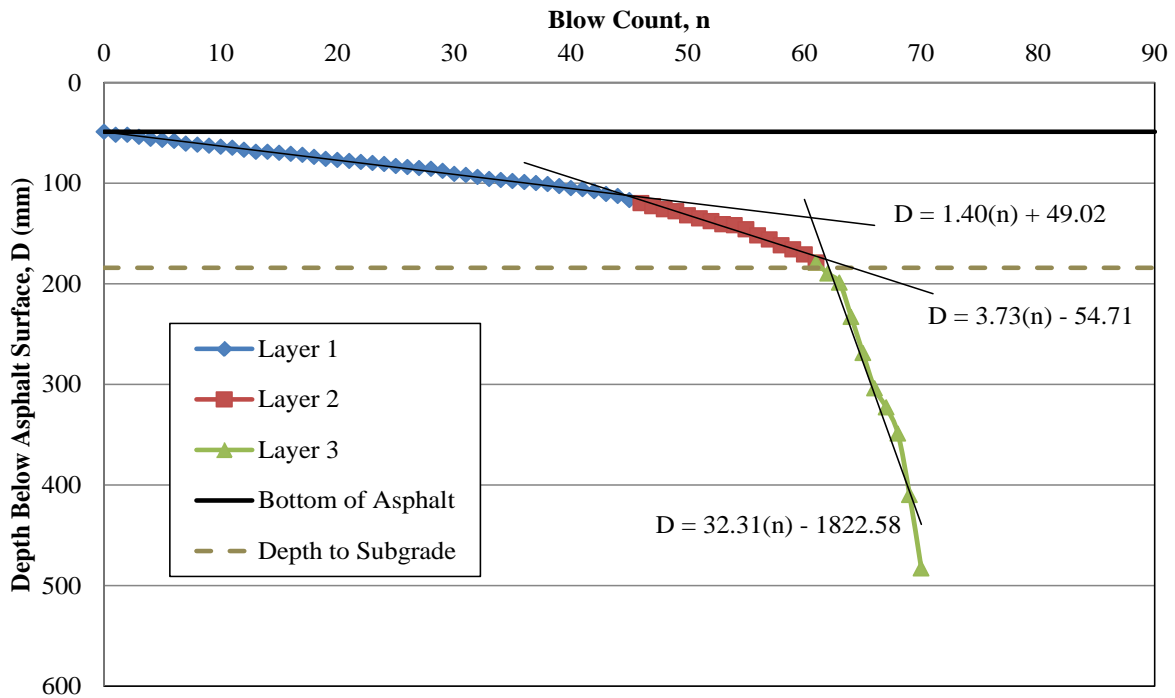
Figure 6.25. Typical DCP penetration curve for a 6-in (15.2 cm) nominal base thickness section (Section 13BW) from October 2010 site visit.

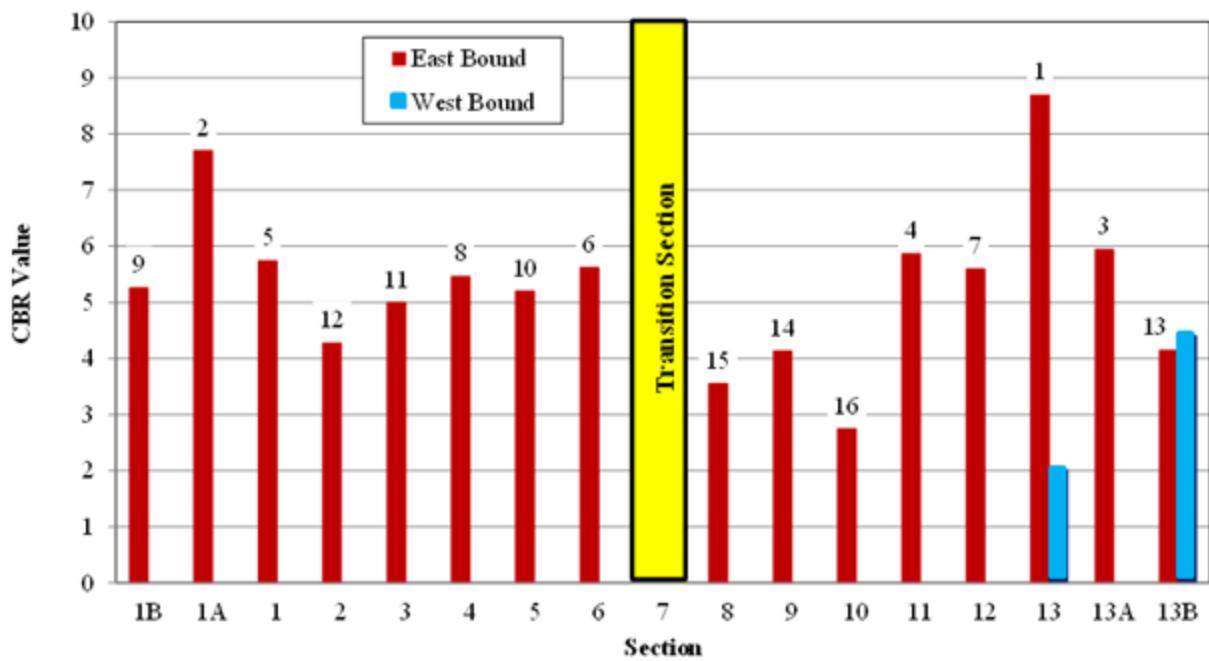
Figure 6.34. In-situ subgrade CBR values from the Marked Tree site during the October 2010 site visit.
