## The Origin and Nature of Flash Weld Defects in Iron-Nickel Base Superalloys

Ronald William Gunkel  
*University of Tennessee - Knoxville*

**A Thesis  
Presented for the  
Master of Science  
Degree  
The University of Tennessee**

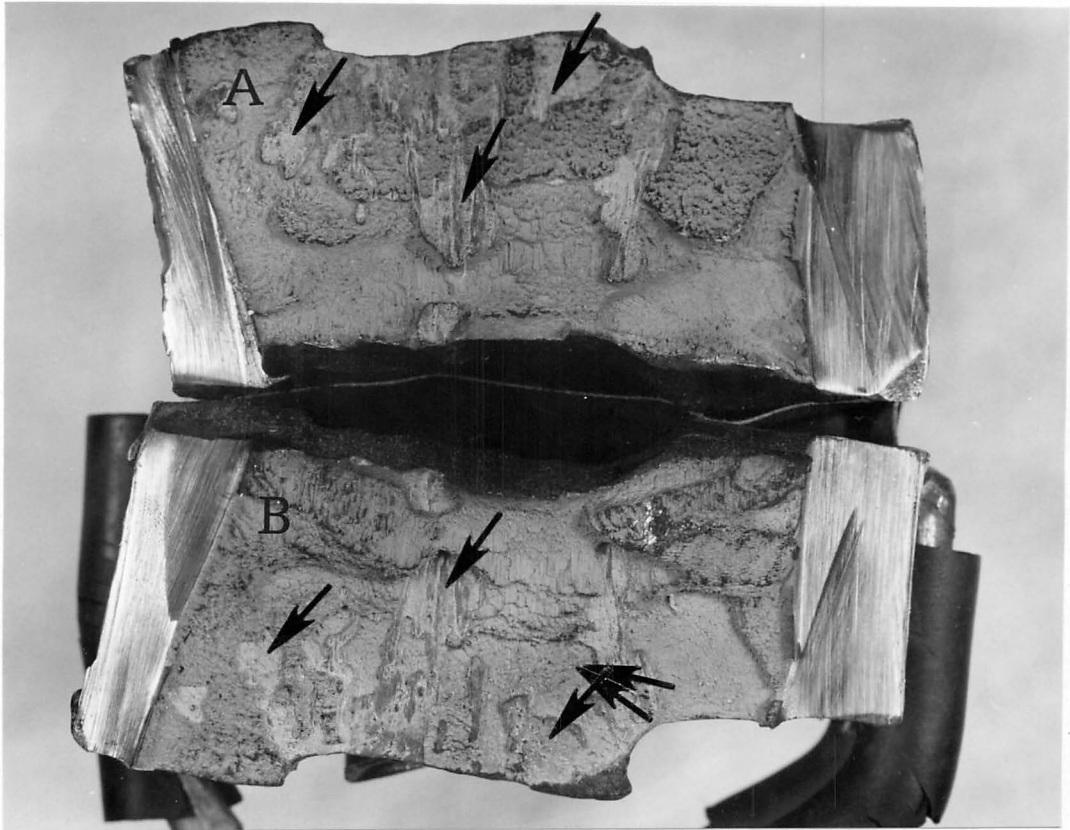
Figure 1. Macrograph of the mating fracture surfaces from a flash welded Hastelloy X sample. The arrows indicate the presence of flat spots. 1.5X

The cause and prevention of flat spots is not very well understood. In fact, the term itself is vague and is often used to describe several different features. These fracture features may be the result of a number of metallurgical phenomena having inherently different mechanisms. The smooth, irregular shaped areas indicated by arrows in Figure 1 are flat spots on the fracture surface of a flash welded Hastelloy X sample. Figure 2 is a 100X SEM micrograph which shows the variation in topography on the fracture surface. A plateau region can be seen which contains three relatively flat areas (A, B, and C) which are separated by rougher, more ductile areas. At higher magnification (Figure 3, 300X), it is apparent that for this alloy the flat spots are relatively featureless. However, in

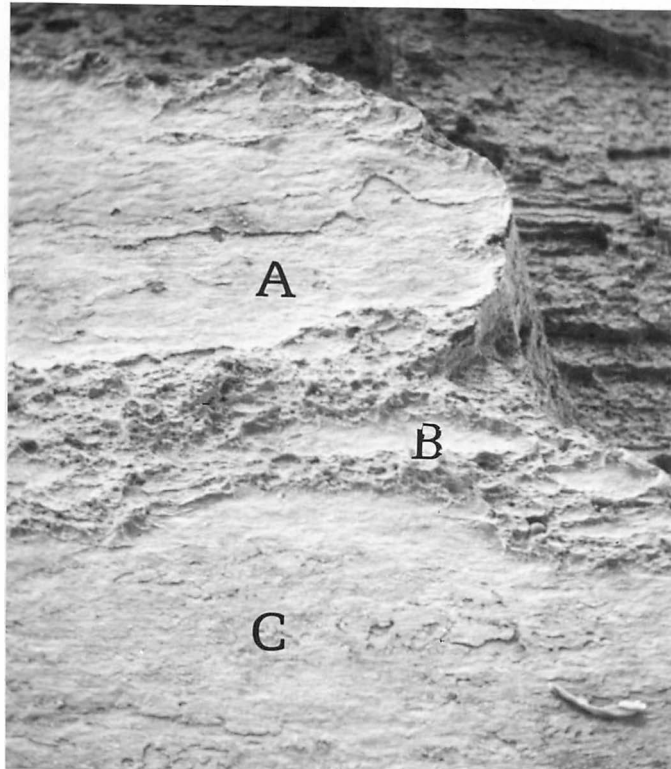
Figure 2. Scanning electron micrograph of some flat areas on the fracture surface of a flash welded Hastelloy X sample. 100X

other areas and in other alloys, numerous inclusions and very small dimples appear. This is in contrast to the rougher, larger dimpled area shown separating these flat areas. Barrett's metallographic investigation (15) of some flash welds made in large diameter, heavy wall alloy steel tubes revealed flat spots on fracture surfaces of numerous samples. He theorized that they were caused by oxidized craters on the faying interfaces which were not removed during upset. He stated that these oxides were complex and included silicates and aluminates. He did not mention his analytical technique. It was stated that higher chromium steels were more prone to contain chromium oxides and the resulting flat spots. In an effort to prevent the formation of these oxides, Barrett introduced shielding gas into the flashing region by directing the flow through one of the tubes to be welded. He found that the number and size of flat spots were reduced by the addition of the gas atmosphere, and that hydrogen was more effective than city gas. It appears that when a featureless flat spot occurs it probably is the result of flattened oxidized craters. This has been documented in this study also.

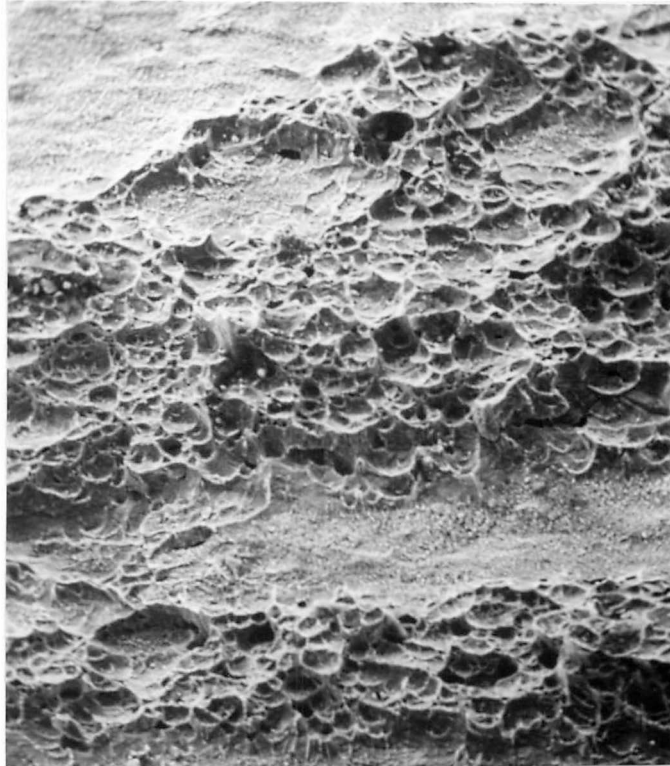
Figure 3. Higher magnification scanning electron micrograph of flat areas seen in Figure 2. 300X

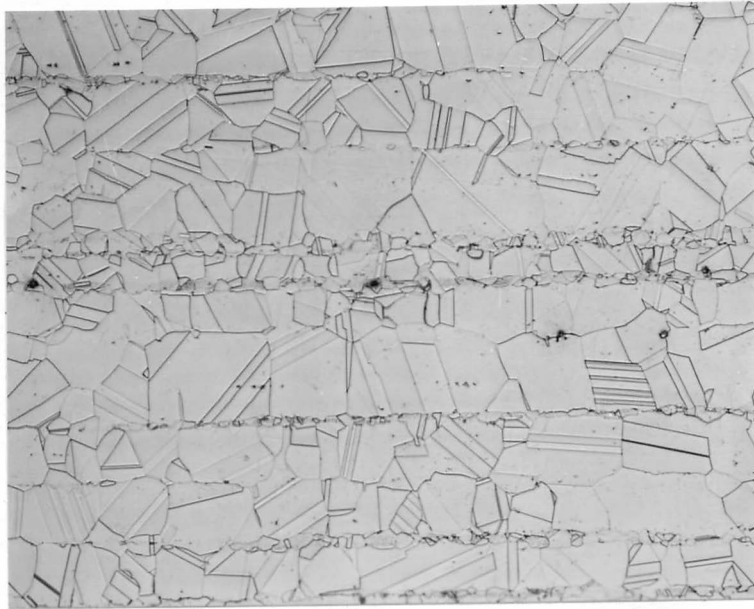
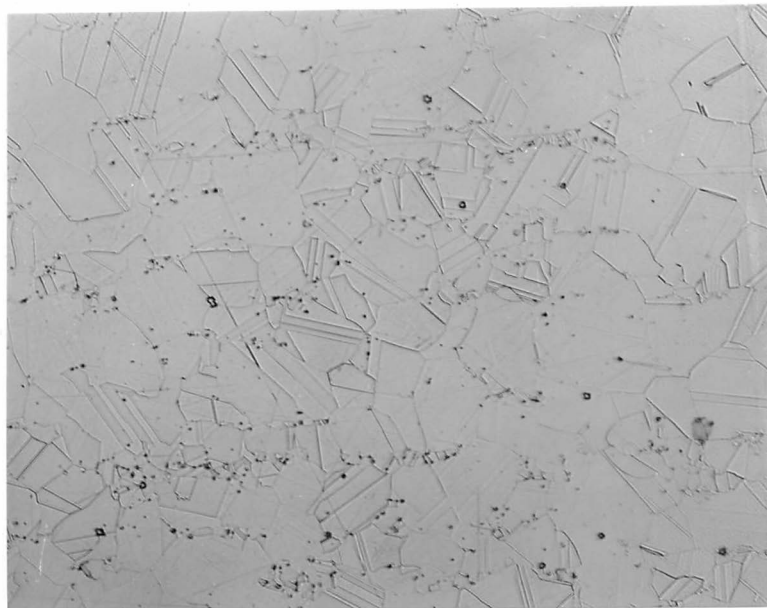
(A) Longitudinal section. 100X

(B) Transverse section. 100X

Figure 6. Micrographs of banding in Waspaloy base material.

Materials used in this study. The base materials used in this study exhibited the general type of elongated and banded microstructure which was discussed above. Figure 6 shows the microstructure of

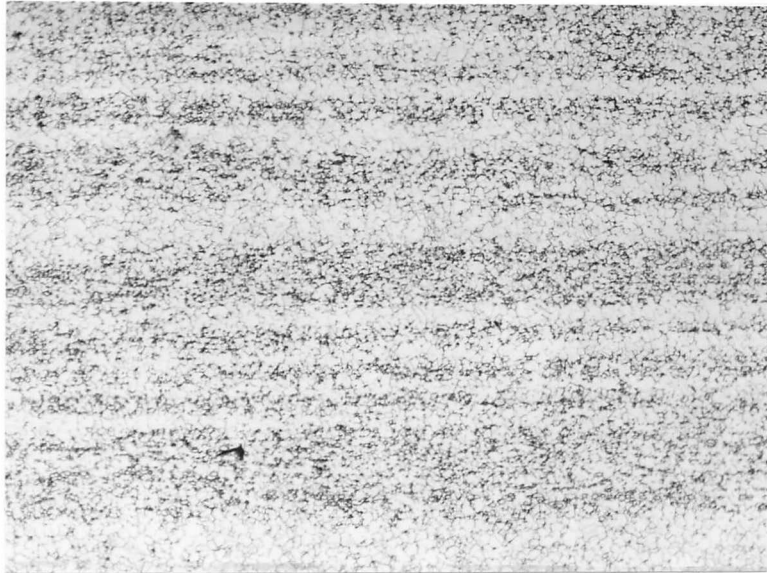
Figure 7. Micrograph of longitudinal section from Hastelloy X base material. 100X

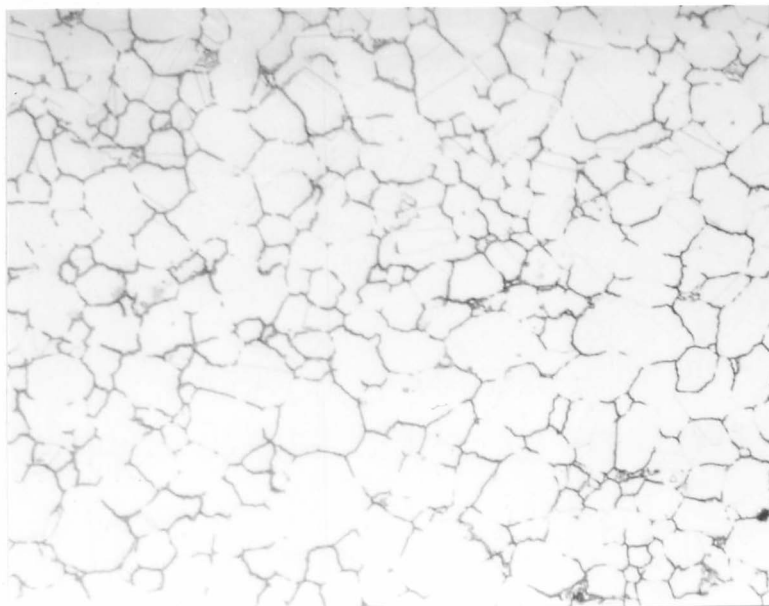
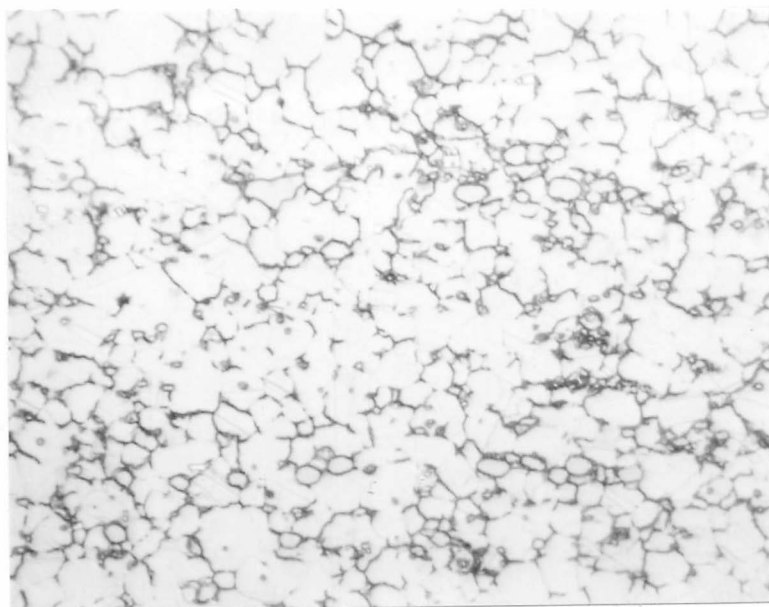
(A) Light band. 500X

(B) Dark band. 500X

Figure 8. High magnification micrographs of bands from Figure 7.

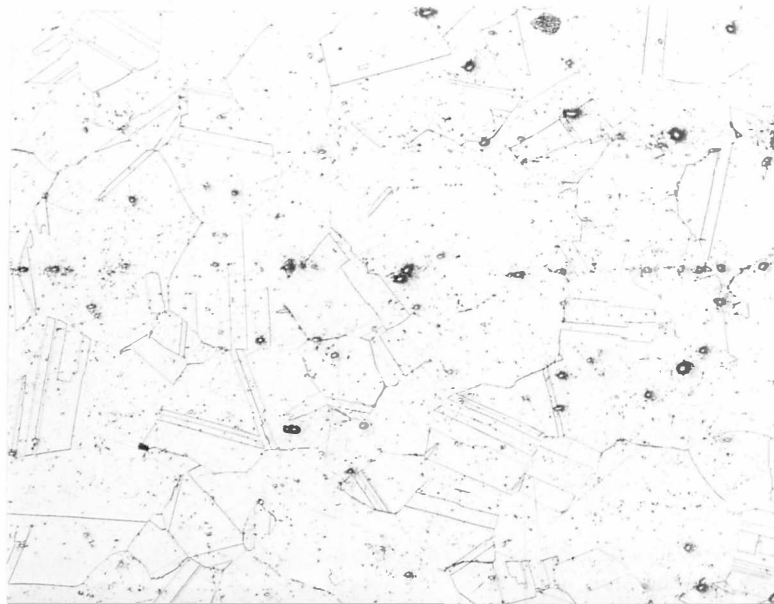
Figure 9. Longitudinal microstructure of Inconel 718 which is also representative of N-155 and Inconel 625. 100X

Figure 9 is a micrograph of a longitudinal section from the Inconel 718 base material used in this investigation. The microstructure shows little banding other than particle stringers. The grain size shows random variations. This microstructure is also closely representative of the N-155 and Inconel 625 base materials which were also investigated.

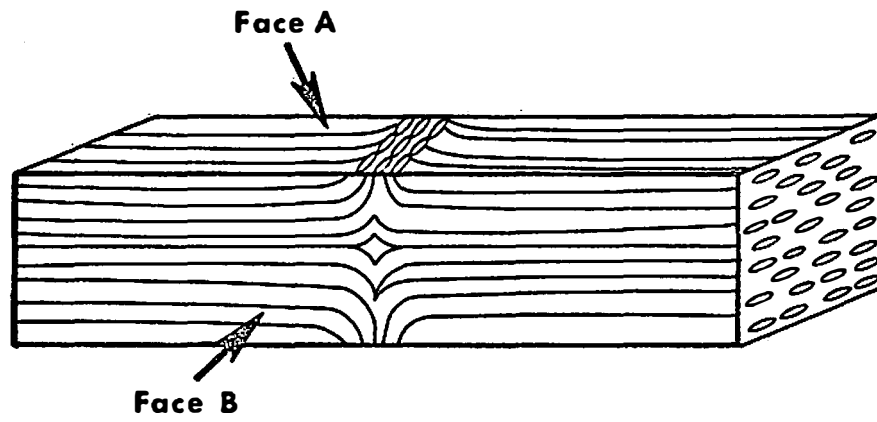
Figure 10. Schematic diagram of flash weld.

When the workpieces are upset during flash welding, the banded microstructure of the base material is forced to turn outward at the weld interface as shown schematically in Figure 10. In fact, some of the bands become almost parallel to the weld interface. When this happens, the

short transverse properties become, in essence, longitudinal properties at the weld interface.

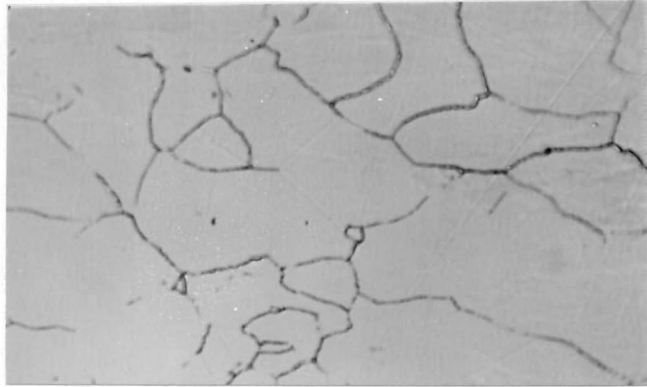
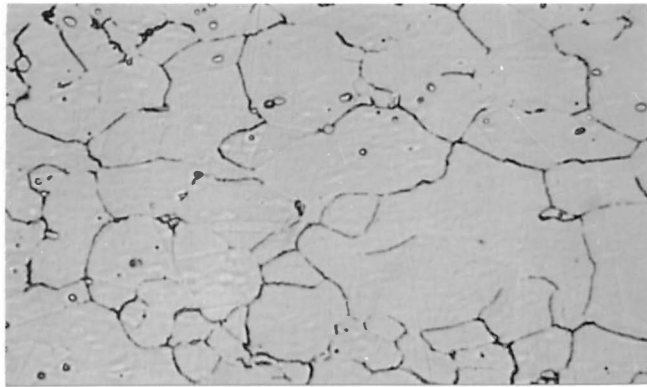
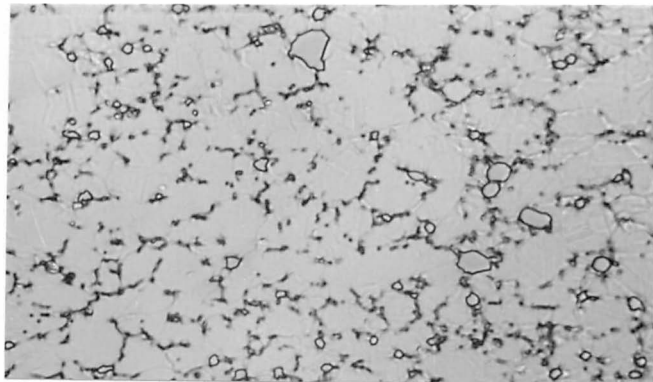
Figure 11. Carbide population at various distances from the weld interface.

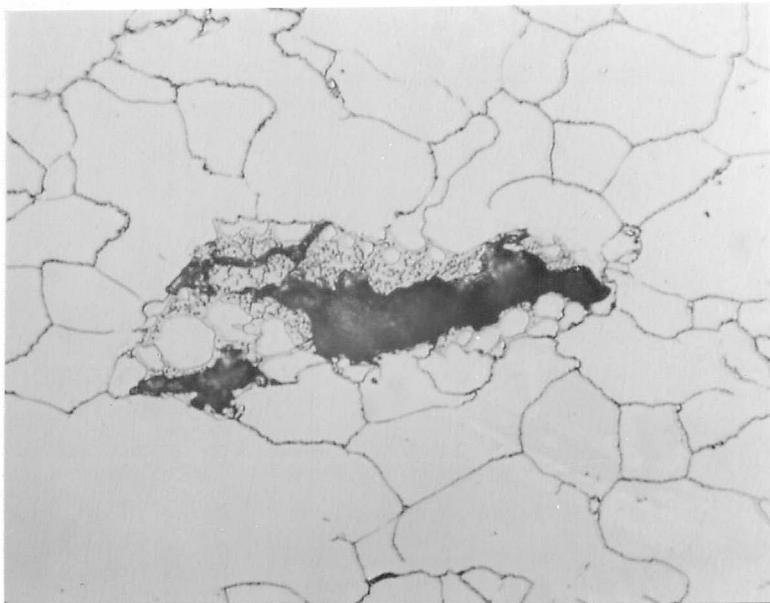
Figure 12. Constitutional liquation in flash welded Hastelloy X specimen. 750X

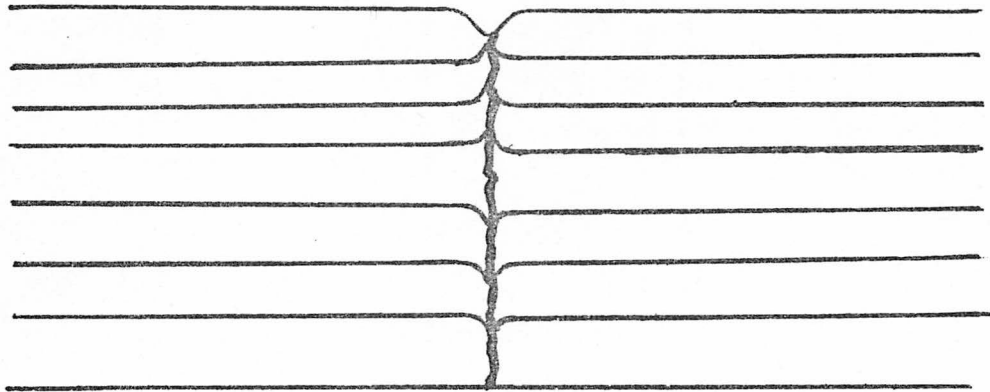
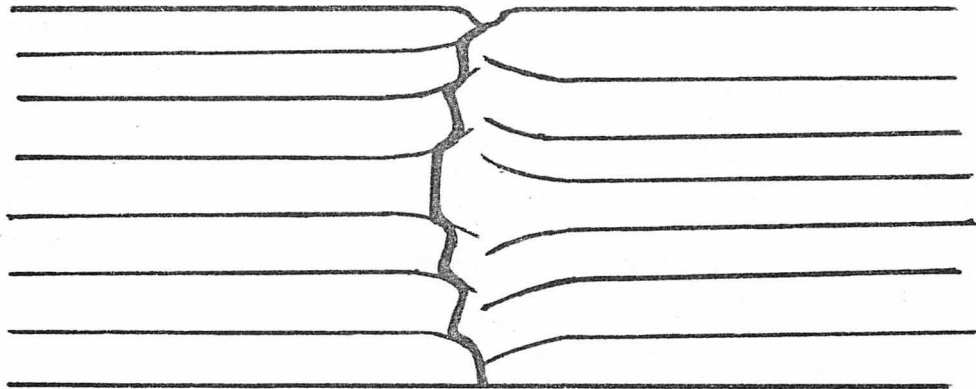
(A) Overly upset

(B) Proper upset

Figure 13. Effect of flash welding upset upon the fracture path for slow bend specimens having banded microstructures.

If the weld joint is properly upset, the deformed banded microstructure will appear similar to that shown schematically in Figure 13B. In this case, a crack which initiates from a notch in face A again propagates along a path of least resistance. This path is usually along the curved and banded structure for the same reasons stated above. As the propagating crack becomes almost parallel to the principal stress, it stops and then crosses the more ductile matrix regions between the inclusion/segregate bands. When the propagating crack reaches another favorably

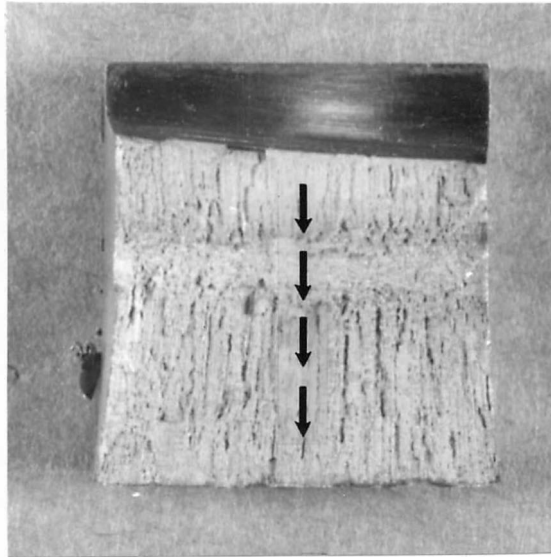
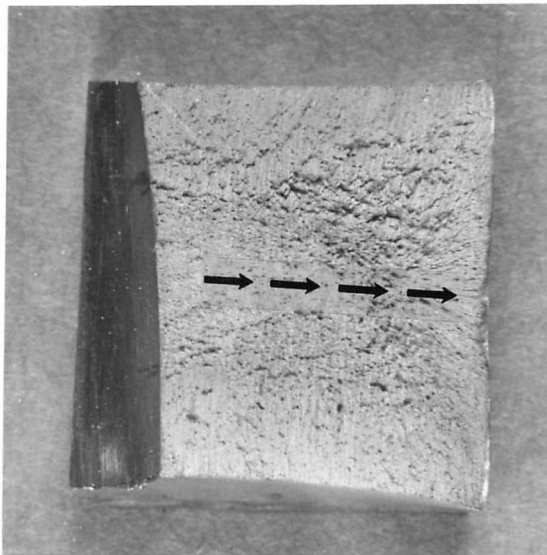
Figure 14. Effect of fracture propagation direction upon fracture face appearance.

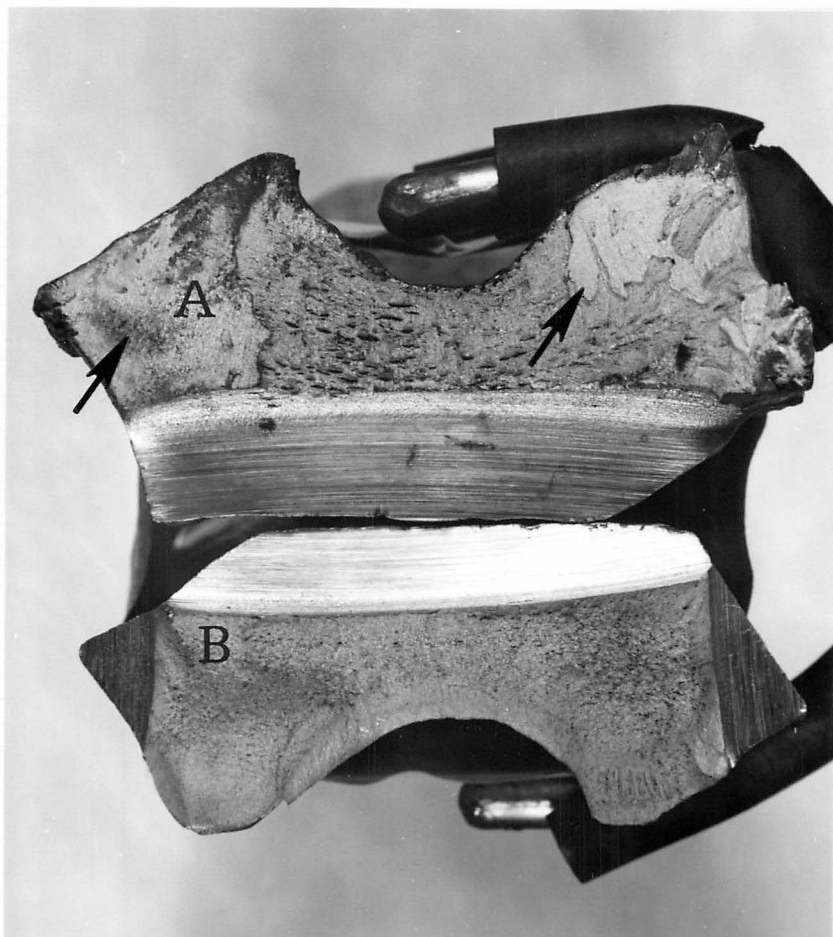
Figure 15. Fracture faces of two different flash welded joints made in Waspaloy.

Figure 15 shows the fracture faces of different flash welded joints made in Waspaloy. The flash weld fracture B exhibits a fine ductile appearance. The perimeter of the lower and right-hand sides is slightly streaked. In contrast the fracture surface appearance of the upper bar is very heterogeneous. Flat spots (indicated by arrows) can be seen on the left side and the upper right-hand corner. These flat spots appear shiny because the relatively smooth surface easily reflects light. The finely textured central area contains many small elongated crevices which are the result of delaminations along the banded regions of the microstructure. Figure 16 shows the fracture faces of two different flash welded joints in Inconel 625. The weld fracture B, which is representative of good welding practice, has a fine uniform texture. As indicated by the arrows, fracture face A contains several flat spots which are surrounded by finely textured material. The shiny smooth strip along the lower edge of weld fracture B is the result of arc gouging and is not related to the fracture. Figure 1, page 11, previously discussed, shows the fracture surfaces from a single Hastelloy X weld. (These are mating fracture faces.) The shiny flat spots on these surfaces are indicated by arrows. Relatively flat but shingled regions separate the majority of the flat spots. This fracture

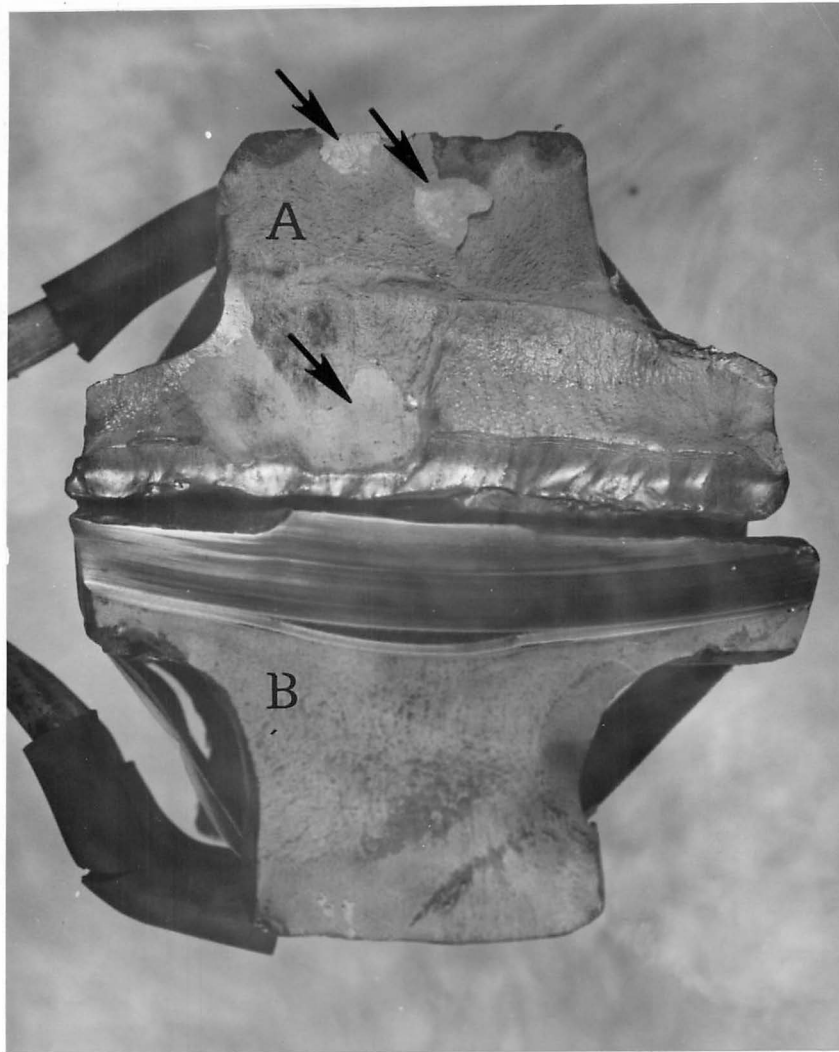
Figure 16. Fracture faces of two different flash welded joints made in Inconel 625.

was confined to the weld interface by notching the specimen with an abrasive cut-off wheel as can be seen on the right and left sides of the fracture. Streaks are also evident on these surfaces.

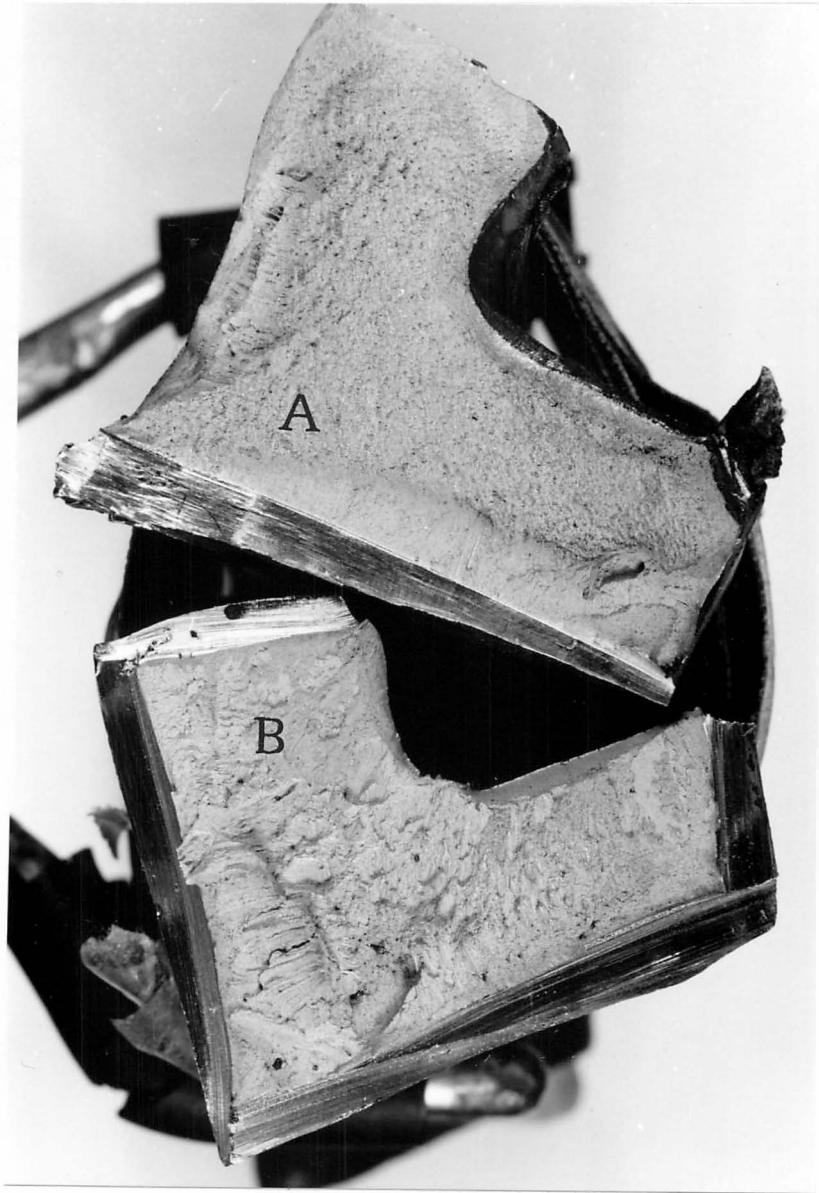
Figure 17. Fracture faces of two different flash welded joints made in N-155.

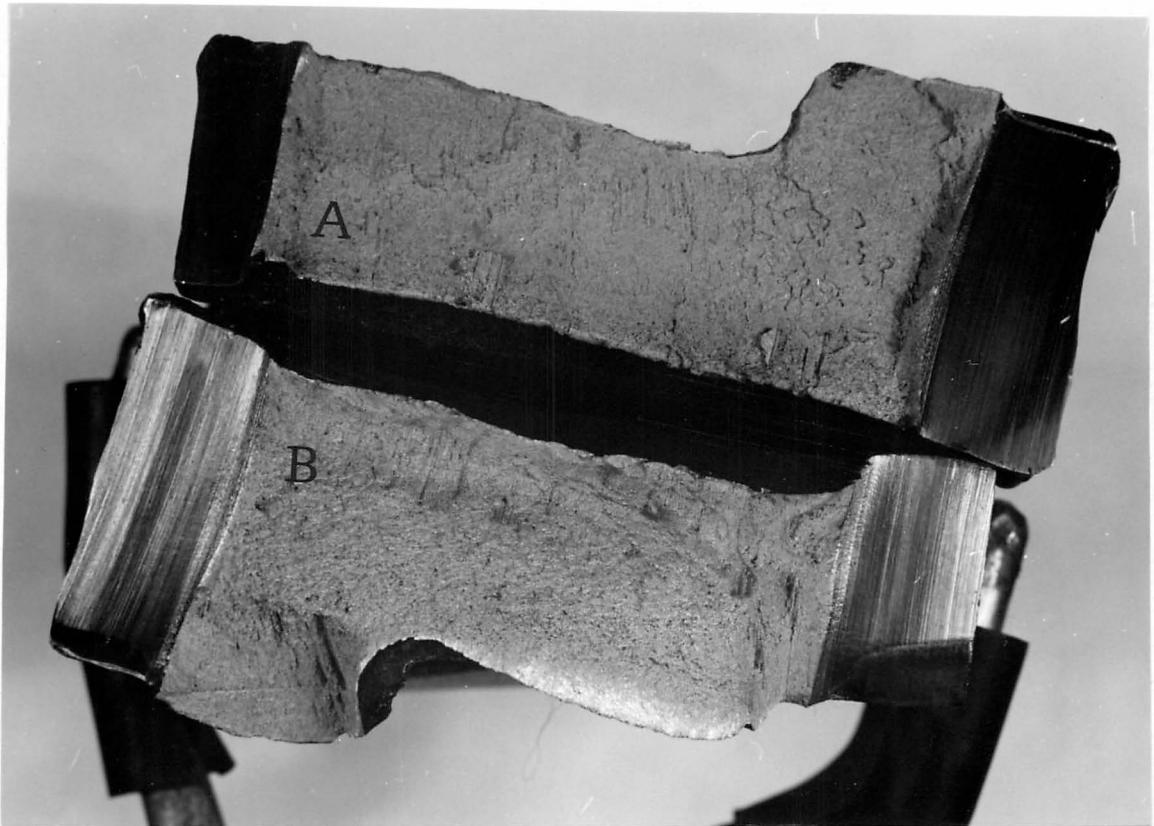
Figure 18. Fracture faces of two different flash welded joints made in Inconel 718.

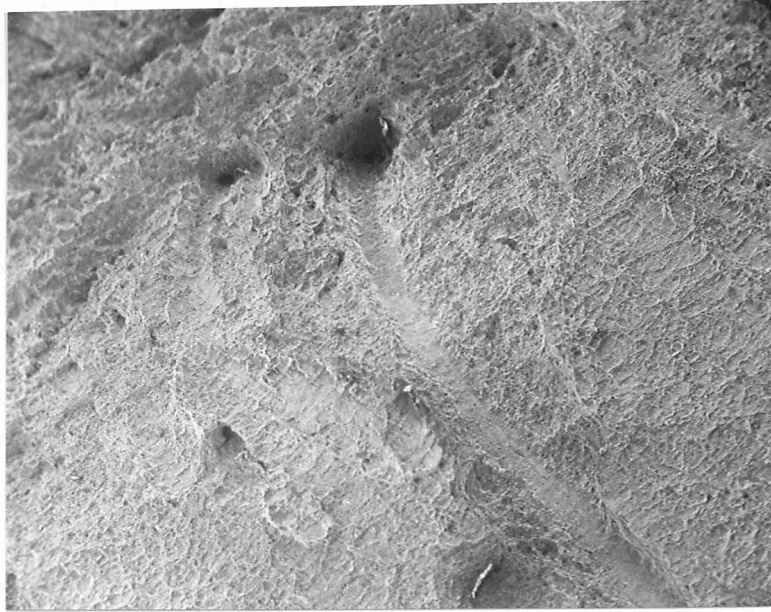
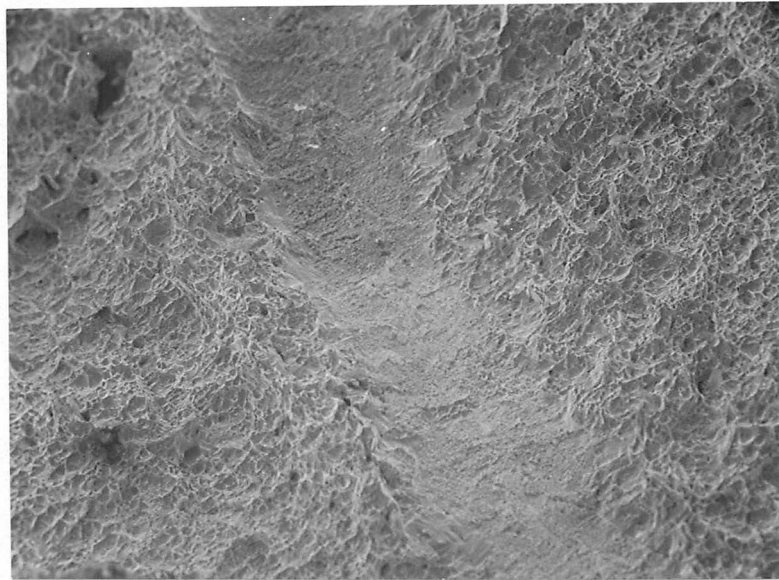
Figure 19. SEM micrographs of streak on Waspaloy fracture surface.

Figure 19A, an SEM micrograph at 20X, shows the central region of a fracture face from a weld in Waspaloy. A streak can be seen as one of the features on the fracture surface. The streaked region departs from the plane of the fracture face by literally penetrating the surface. This streak is a manifestation of a microstructural segregate band which was deformed during weld upset and then exposed by fracture during the slow bend screening test. The part of the streak which lies essentially on the fracture surface was originally located at or very near the weld interface. The streak is long and narrow and appears flat and smooth at low magnification when compared to the topography of the surrounding fracture surface. Figure 19B, an SEM micrograph at 100X, shows the streak to be relatively featureless although the surrounding area exhibits dimples characteristic of ductile fracture. However, when the magnification is increased to approximately 500X, features can be resolved in the streaked area. Figure 20, SEM micrographs at 500X, show that the topography of the streak is essentially a series of small dimples while the adjacent surface at the same magnification shows relatively large dimples. The dimple sizes are different by about a factor of 10. Figure 21 shows the streak at approximately 2000X. Many particles can be seen located within the dimples. These particles are the initiation sites for void formation and the resultant dimpled

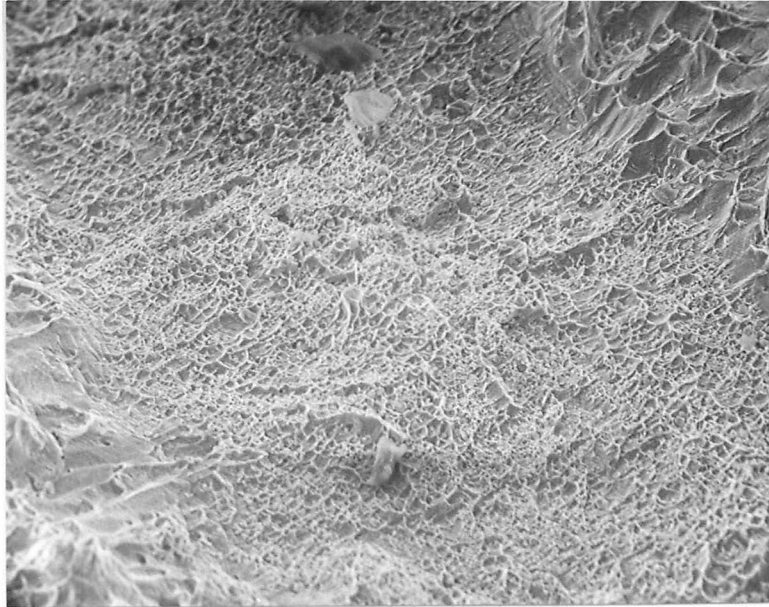
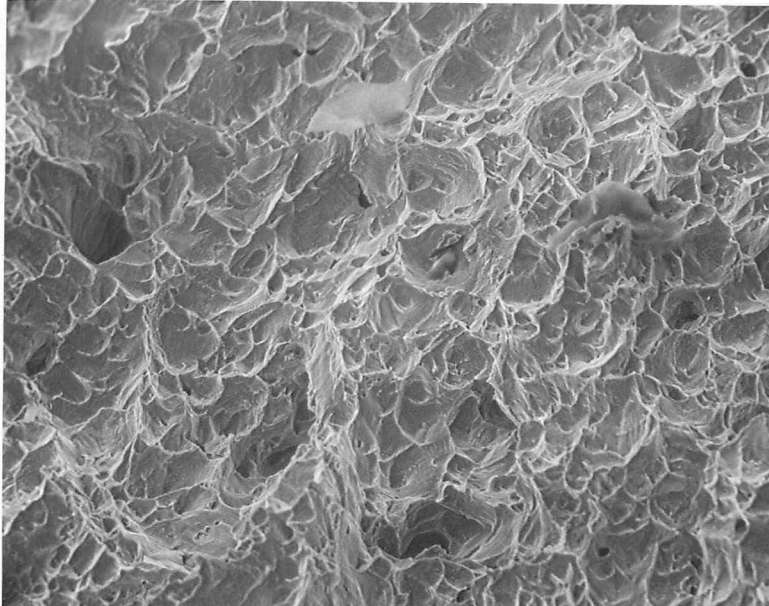
Figure 20. SEM micrographs comparing dimple size on the streak and adjacent area at 500X.

structure. As previously mentioned, the difference in dimple size means that the streaked region exhibited less ductility than the surrounding material.

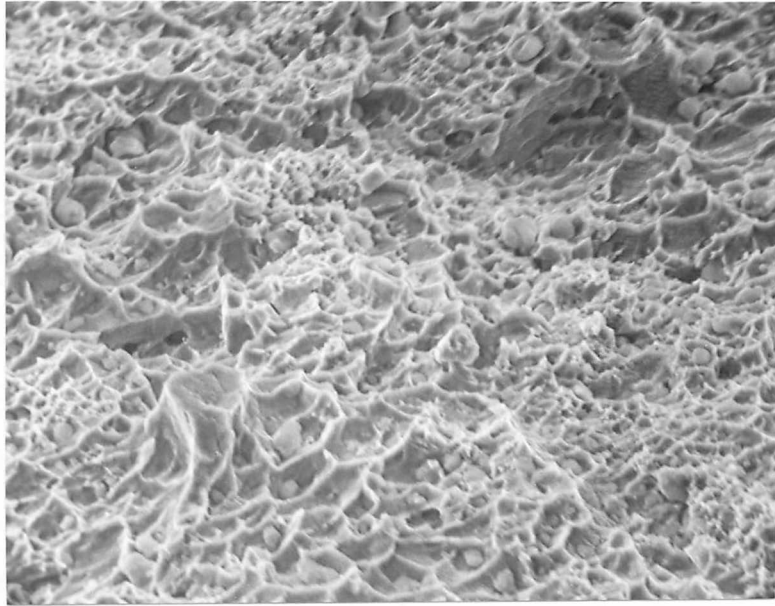
Figure 21. SEM micrograph of streak at 2000X.

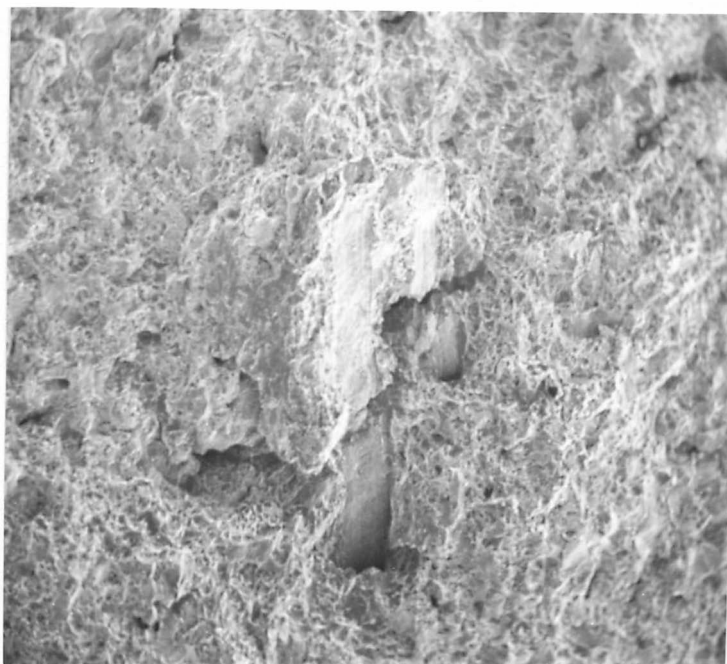
Figure 22. SEM micrograph of streaks on the fracture face of an Inconel 718 weld sample. 70X

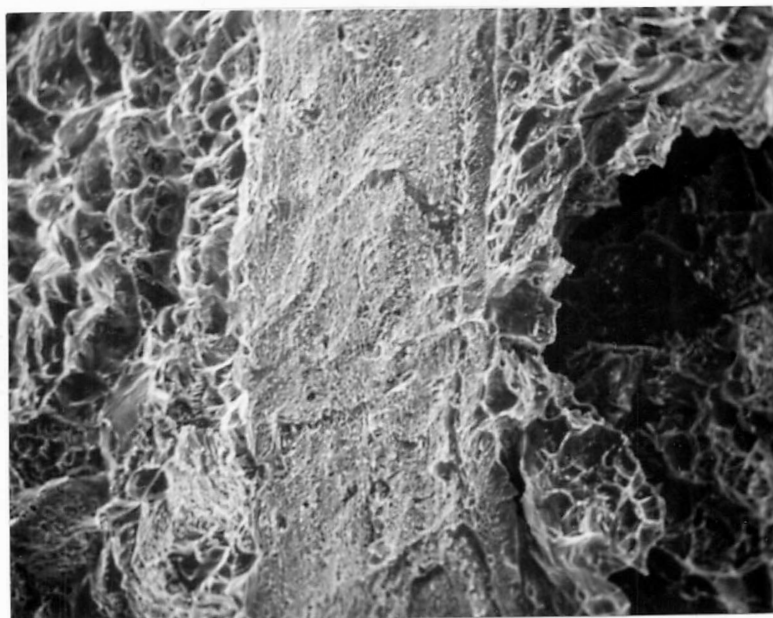
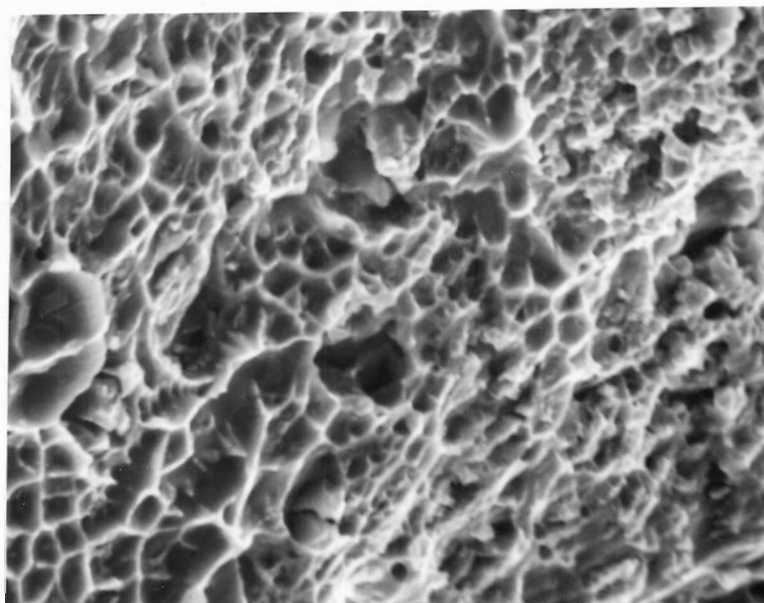
Figure 23. Higher magnification SEM micrographs of one streak shown in Figure 22 .

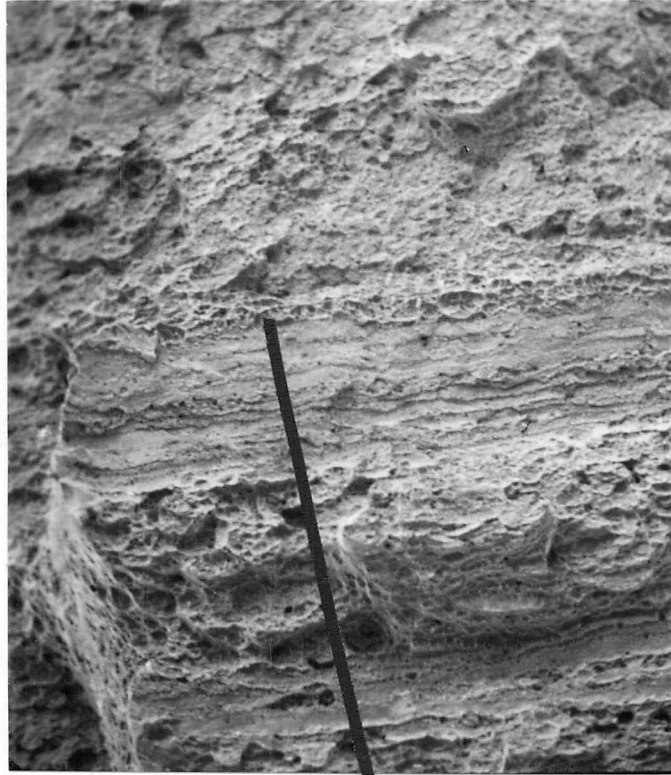
Figure 24. SEM micrograph of a fractured intermediate width particle/segregate band. 100X

Particle/segregate bands may take on a broad flat character rather than a thin pencillike configuration. The pencillike configuration results in streaks such as those just described above where the length to width ratio is large. As the particle/segregate bands become wider relative to their length, the streaks take on a more equiaxed shape intermediate between "streaks" and "flat spots". A region of this sort is shown in the SEM micrographs of Inconel 718 in Figure 24. The parallel, flat rectangular areas which are separated by rougher, more ductile regions resemble streaks although they are wider than most. They are also similar to flat spots since they form regions which are separated from the surrounding more ductile areas by differences of elevation and fracture appearance. Flat spots are invariably characterized by abrupt elevation changes from

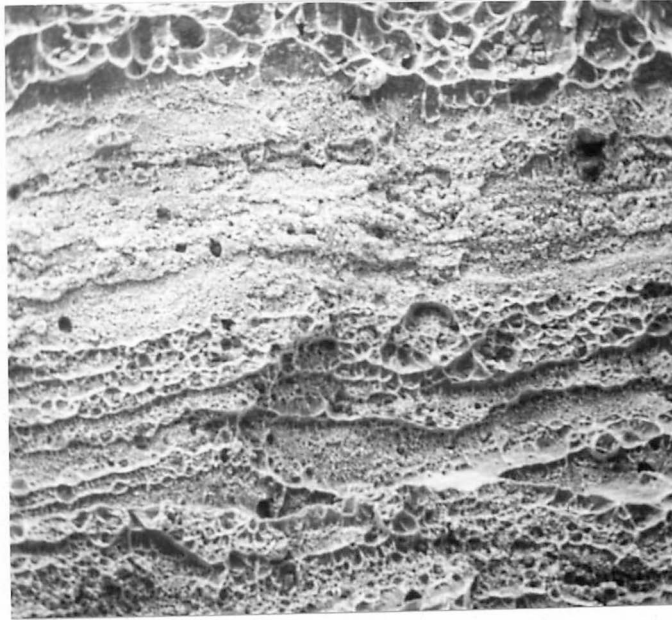
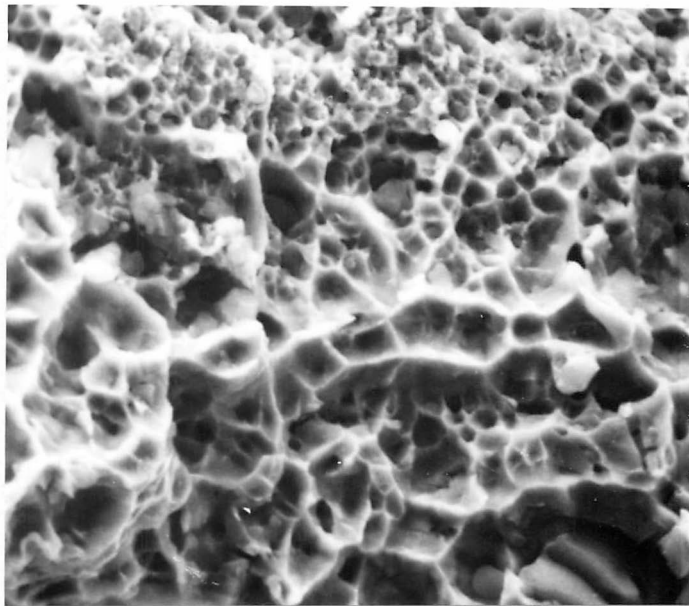
Figure 25. Higher magnification SEM micrographs of feature shown in Figure 24.

the surrounding more ductile regions. Figure 25, SEM micrographs, shows this feature at higher magnifications. Many dimples of varying sizes are visible. Like streaks, these areas fractured by the formation and coalescence of microvoids. The bands of particles which nucleated fractures in these areas were much wider than those resulting in streaks.

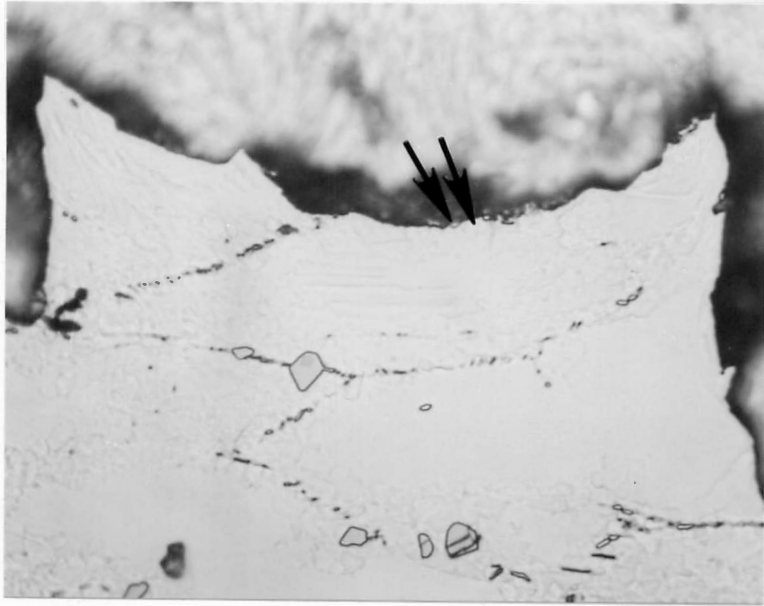
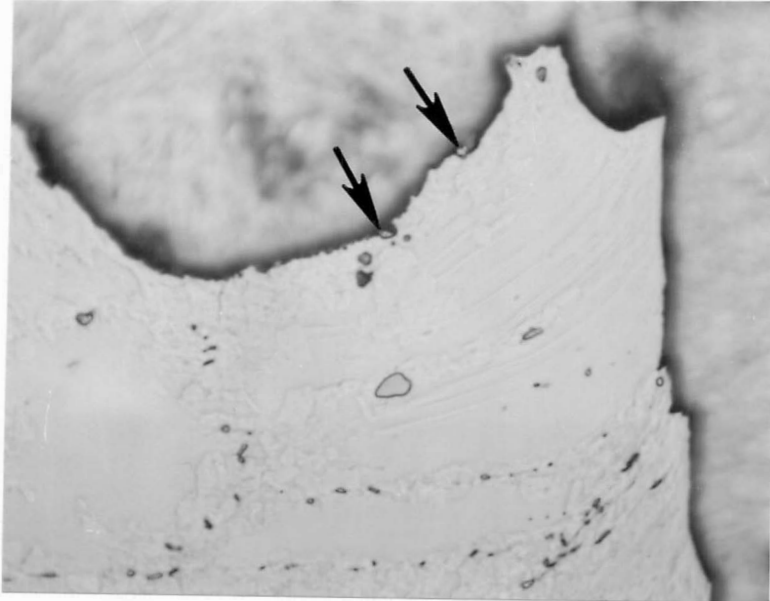
Figure 26. Microstructure at two locations along the sectioning line shown in Figure 24.

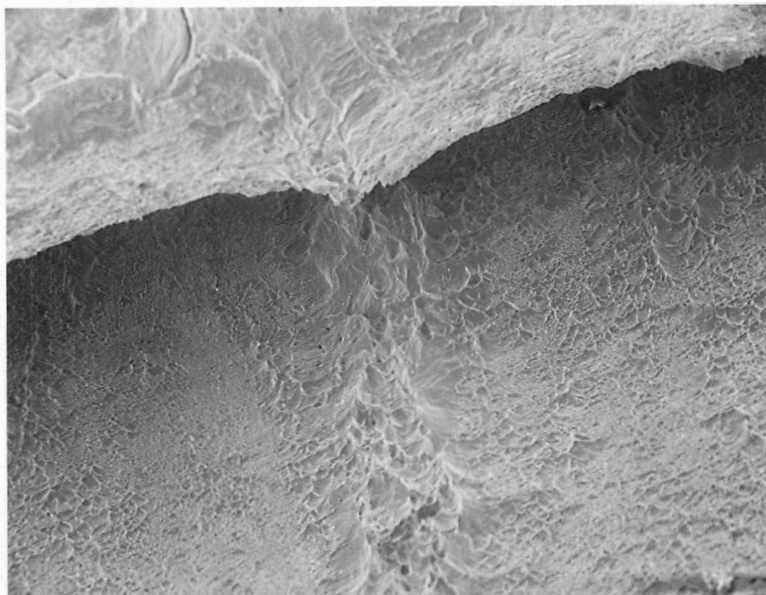
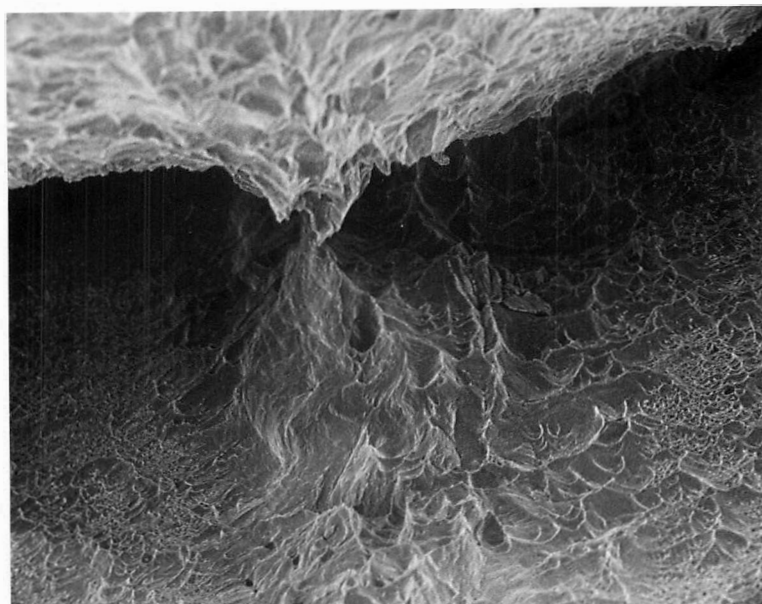
Figure 27. Flat spot caused by broad, flat microstructural particle bands.

If broad flat microstructural particle/segregate bands are oriented such that they are essentially parallel to the weld interface and thus perpendicular to the principal stress applied during bend testing, a large low ductility region will generally result from fracture propagation through these regions. A flat spot which formed by this process is shown in the SEM micrographs in Figure 27. The previously propagating but now arrested crack is shown. One should visualize that the fracture surfaces are created by crack propagation which separates one strata from another in much the same manner as peeling tape from a flat surface or removing the outer covering from a banana. When viewing Figure 27A, one should visualize that the material in the upper half of the micrograph is being peeled away from the lower flat portion thus creating two surfaces. The true leading edge of the fracture is seen at only one point along the crack front shown in Figure 27. This point is at the center of the micrograph and is characterized by the rough large dimpled region. The leading edge at the other locations is under the upper peeled portion. The crack front is thus scalloped while propagating. This is a result of the local variation in ductility as a smaller strain is required to separate low ductility regions than the high ductility regions. The broad flat areas exhibit low ductility because of the high particle density. Figure 27B shows that the overhang is still attached to the lower surface in the rougher areas. The two surfaces have already completely separated in the surrounding flat region. Figure 28 compares the dimple size in the rougher strip (Figure

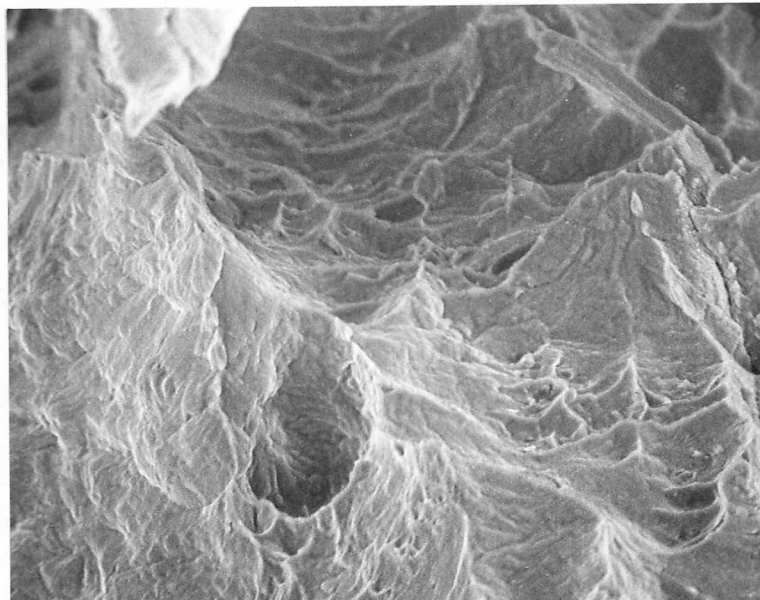
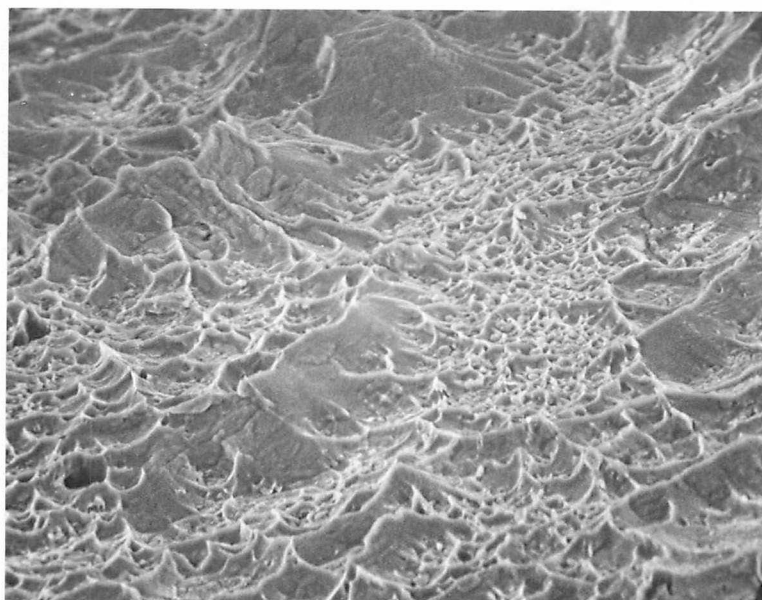
Figure 28. SEM micrographs comparing the dimple size on the rough and flat areas of Figure 27.
