## The Origin and Nature of Flash Weld Defects in Iron-Nickel Base Superalloys

Ronald William Gunkel  
*University of Tennessee - Knoxville*

**A Thesis  
Presented for the  
Master of Science  
Degree  
The University of Tennessee**

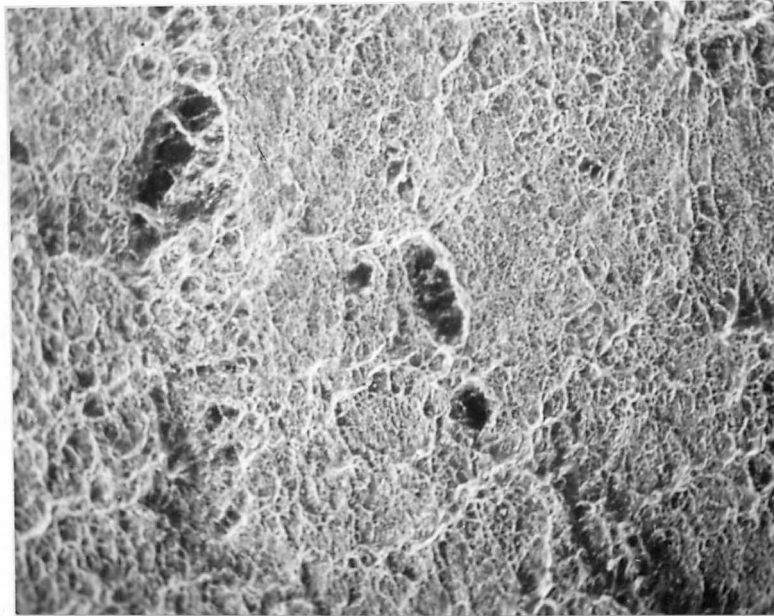
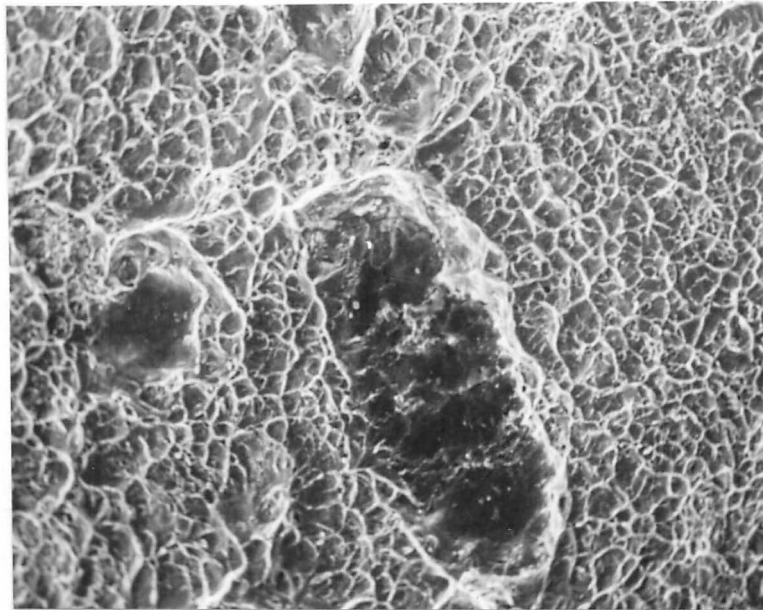
Figure 29. SEM micrographs showing dark areas on the fracture face of an Inconel 625 weld sample.

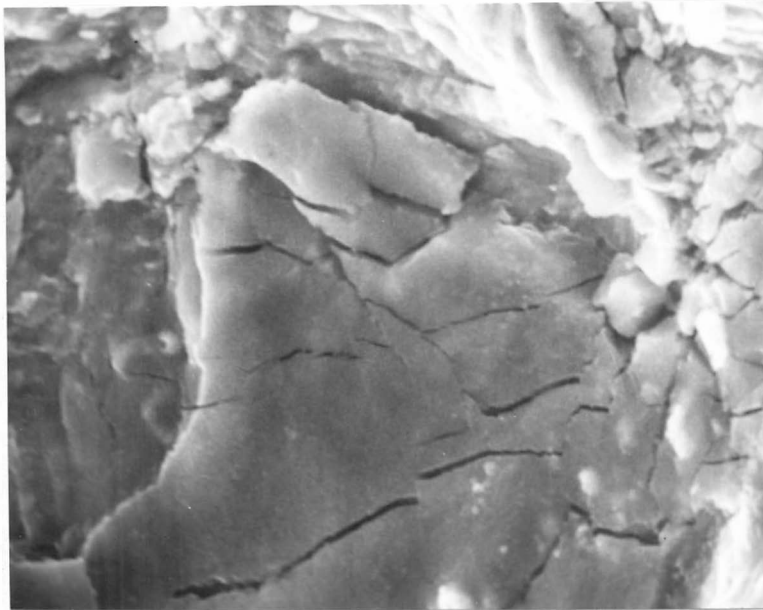
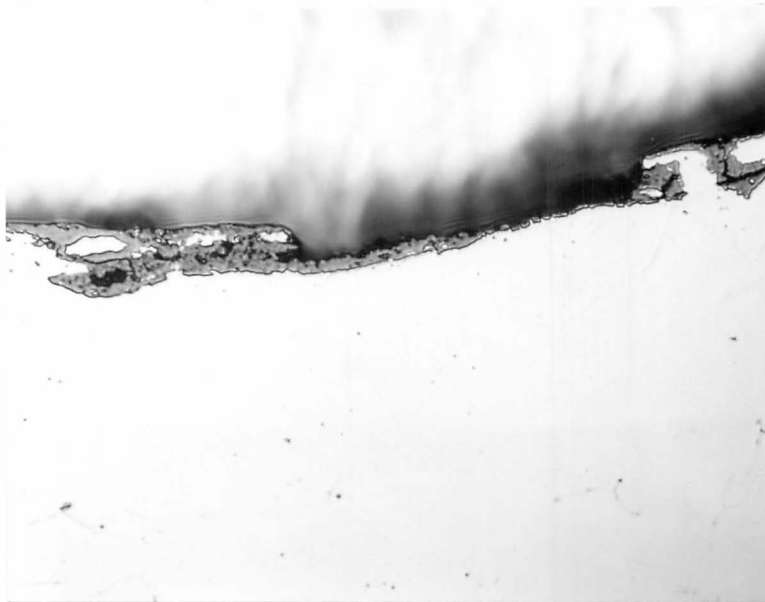
Figure 30. High magnification SEM and light micrographs of the dark area shown in Figure 29.

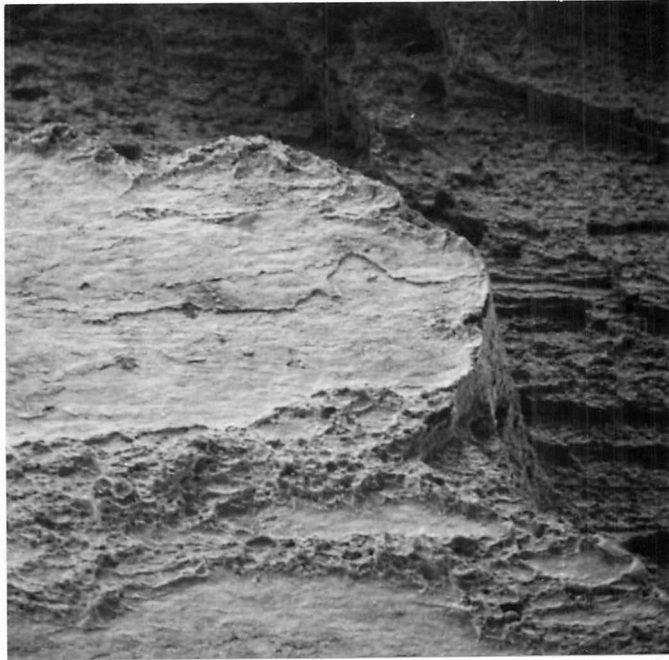
Figure 31. Flat spot on fracture face of a Hastelloy X flash weld.  
100X

Figure 31, an SEM micrograph at 100X magnification, shows a flat spot on the fracture face of a Hastelloy X flash weld. At this low

magnification, the flat spot resembles a mesa which is divided by a rougher region. Figure 32, SEM micrographs, shows this flat spot at successively higher magnifications. At 3000X (Figure 32C) the flat spot exhibits some dimples which appear to be partially filled by a scaly oxide. Although this brittle appearing oxide is not continuous over the affected area, its presence is deleterious enough to reduce the ductility of the welded joint. This specimen was sectioned perpendicular to the fracture face and through the flat spot. After polishing and etching, optical micrographs were obtained from the region at the fracture interface. Figure 33A and B, light micrographs at 500X and 750X, respectively, shows typical areas along the interface of the flat spot. (Note the sunburst effect which appears in the upper half of each micrograph. This is the nickel plating which was added for improved edge retention during polishing.) Oxide films can be seen along the interface and just below the surface of the flat spots. X-ray analysis indicated that aluminum was present in this oxide film, but it was not detected in the rougher, more ductile area which divided the flat spot into two distinct regions. Aluminum is not an intentional alloying element in this alloy, but it is often present in the scrap material which is added to complete a furnace charge.

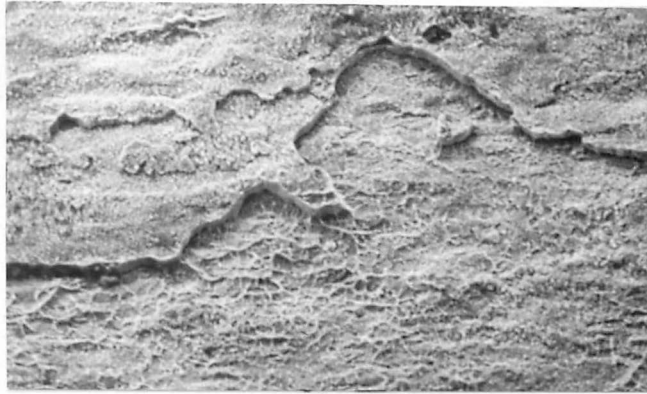
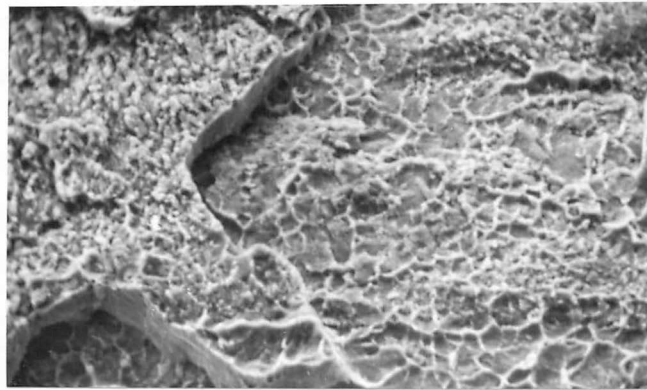
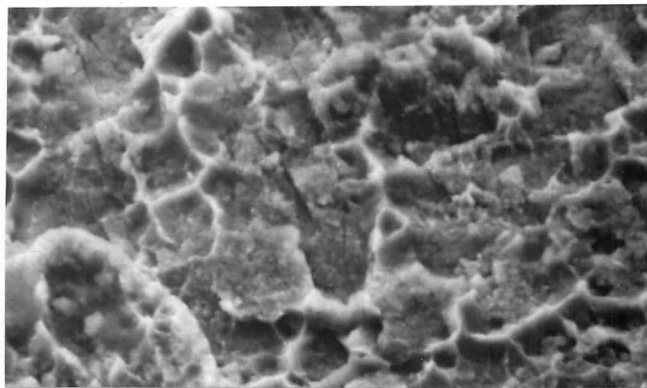
Figure 32. Flat spot shown in Figure 31 at higher magnifications.

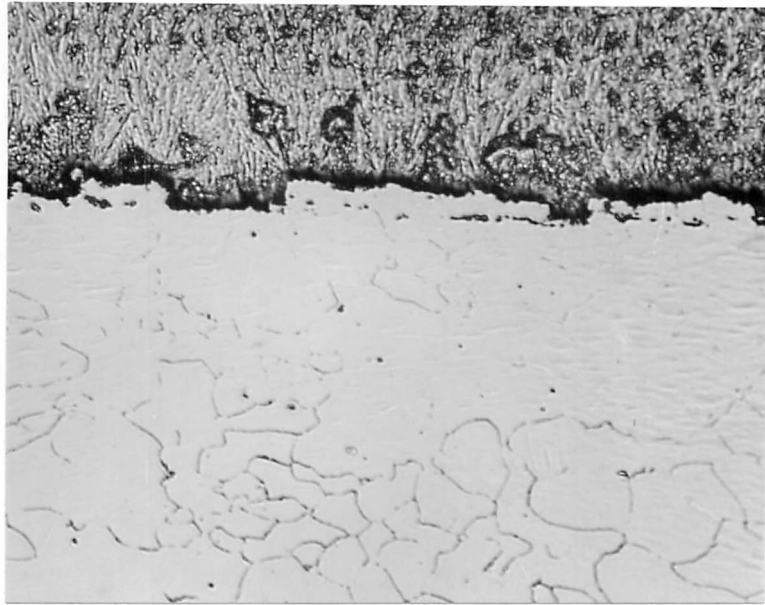
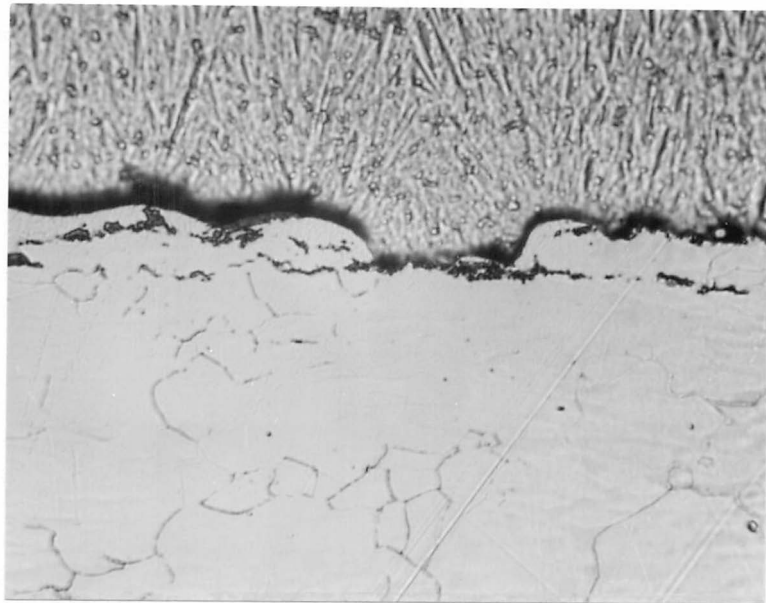
Figure 33. Light micrographs showing typical areas along the interface of the flat spot shown in Figure 31.

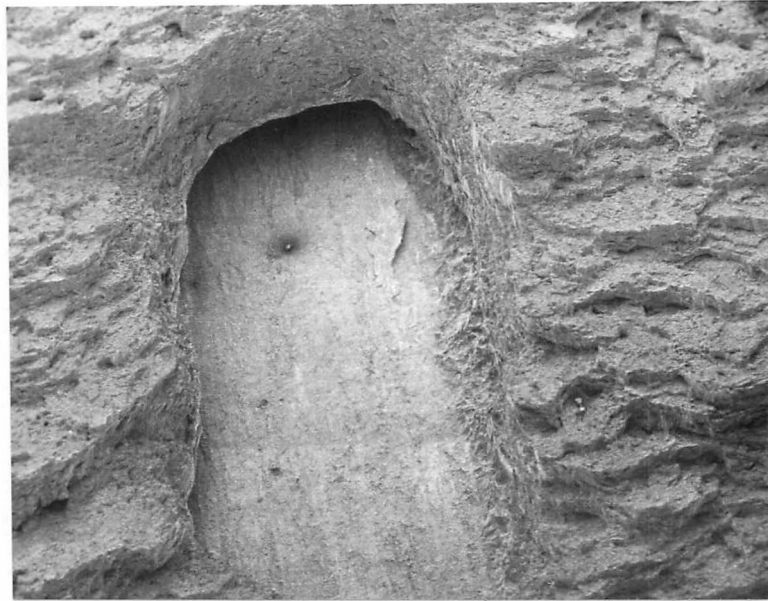
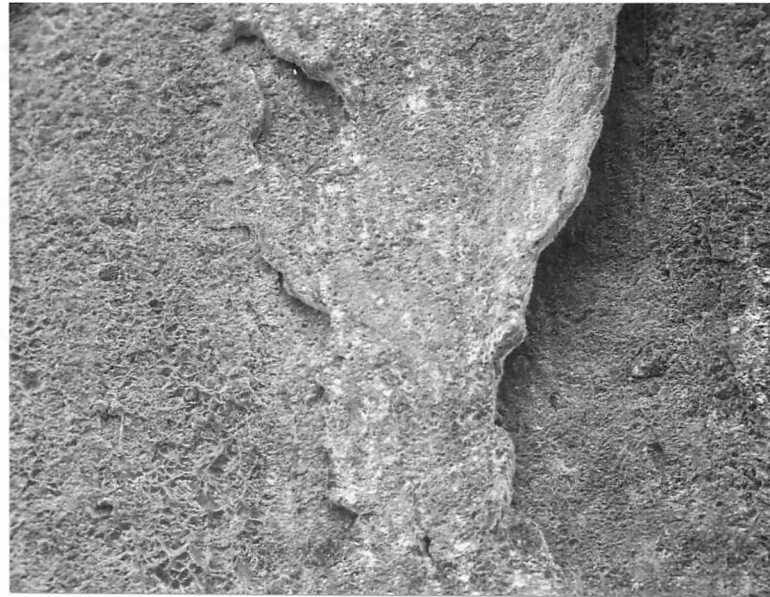
Figure 34. SEM micrographs of pockmarked oxide film on a flat spot.

Occasionally a flat spot indicates the presence of both an oxide film and an area exhibiting high particle density. Figure 34, SEM micrographs at 15X and 170X, illustrates such an occurrence. The peeled-up area is an oxide film which constitutes a portion of the flat spot. The

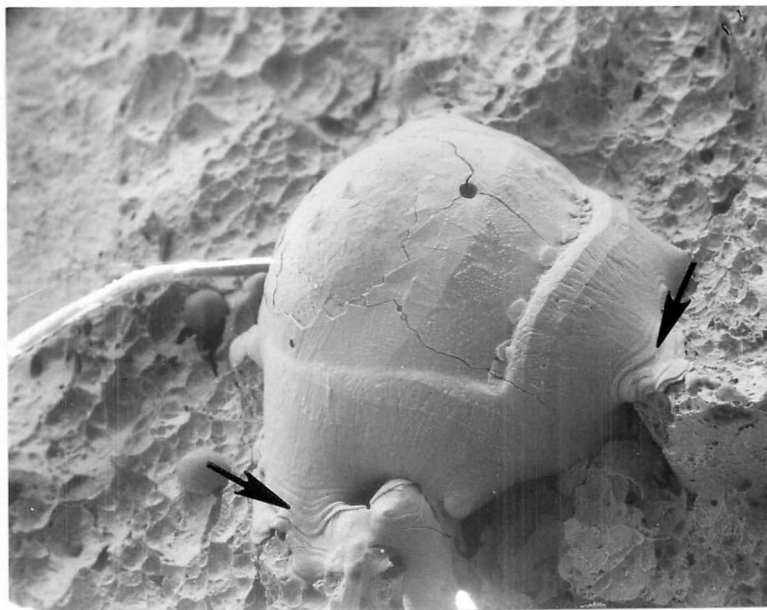
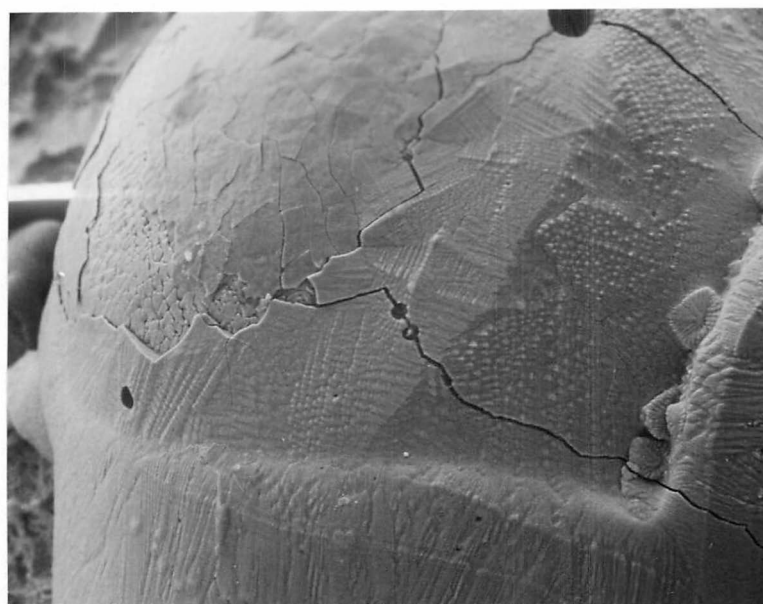
Figure 35. SEM micrographs of "blob" found on an N-155 fracture surface.

An example of one of these features can be seen in the SEM micrograph in Figure 35A. This feature is roughly hemispherical in shape but has a slight tendency to wet the fracture surface. The thick "collar" around the base of the "blob" in this figure resembles a taffy apple whose candy coating has begun to run from the surface. The arrows indicate ripples which probably formed as the "blob" struck the fracture surface and solidified. Some cracks are visible on the surface of the "blob". A bright fiber can be seen on the fracture surface. Similar bright "charged" fragments are often encountered in SEM microscopy. Figure 35B shows the "blob" at 500X magnification. At this magnification a solidification structure becomes evident. The cracks appear to be present only in the outer covering which is probably an oxide film. Where the covering has cracked and broken away, a coarser solidification structure is seen. This structure is apparently due to metallic solidification in the bulk of the "blob". Features such as these most probably result from molten particles produced during abrasive cutting of samples and specimens from the fractured

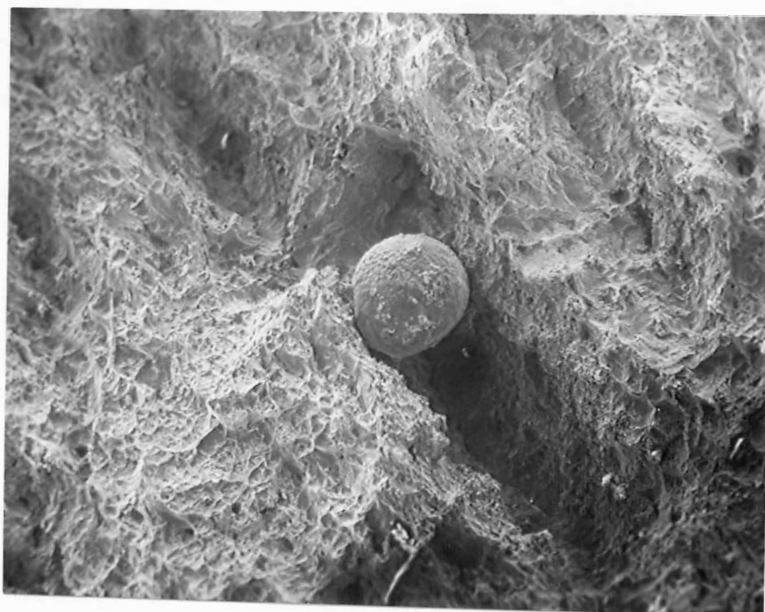
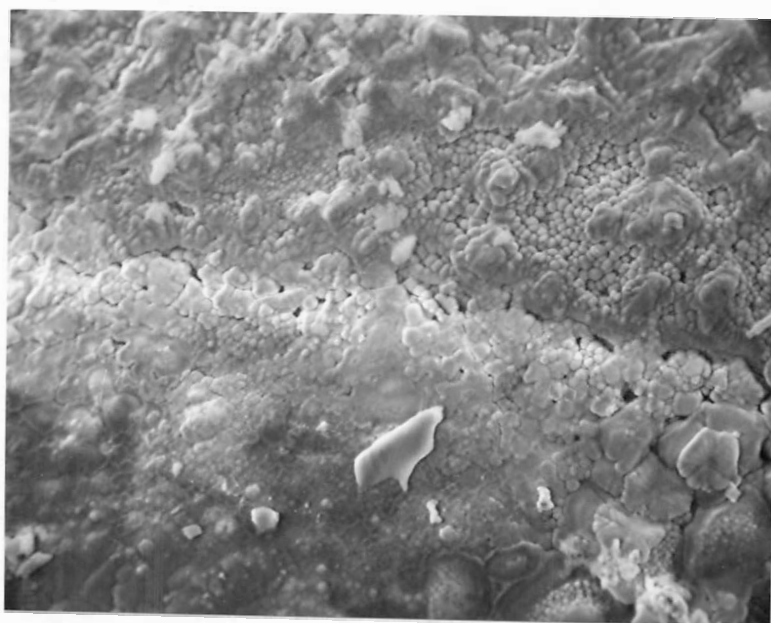
Figure 36. SEM micrographs of large spherical particle.

Often many completely spherical particles are found on the fracture surfaces. These spheres may range in size from 1 to 300  $\mu$ . The SEM micrographs in Figure 36 show one of the larger (300  $\mu$ ) spheres which is wedged in a crevice on a Waspaloy fracture surface. When viewed at higher magnification, the sphere appears as shown in Figure 36B. The surface appears to be oxidized. In an attempt to better understand these features, this specimen was nickel-plated and then carefully sectioned so that the internal structure of the sphere could be revealed. Figure 37A, a light micrograph at 100X, shows a cross sectional view of the sphere as it is located within the crevice. The surrounding gray material is the nickel-plating which was added to improve edge and sphere retention. The upper black region is a void space which is located entirely within the sphere. The black region is a void space where the nickel-plating did not completely fill the crevice. Figure 37B is a 500X magnification micrograph of the sphere. The arrow in Figure 37B indicates a thin oxide film which covers the sphere. The dark gray, circular areas within the sphere are probably oxide particles. ED spectrography indicated that some regions of the sphere contained high concentrations of chromium when compared to the base material. Again this feature is most

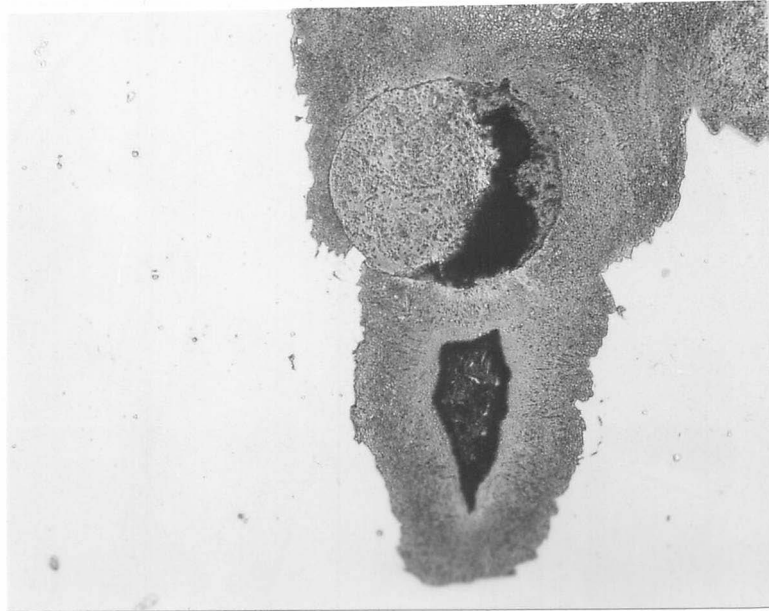
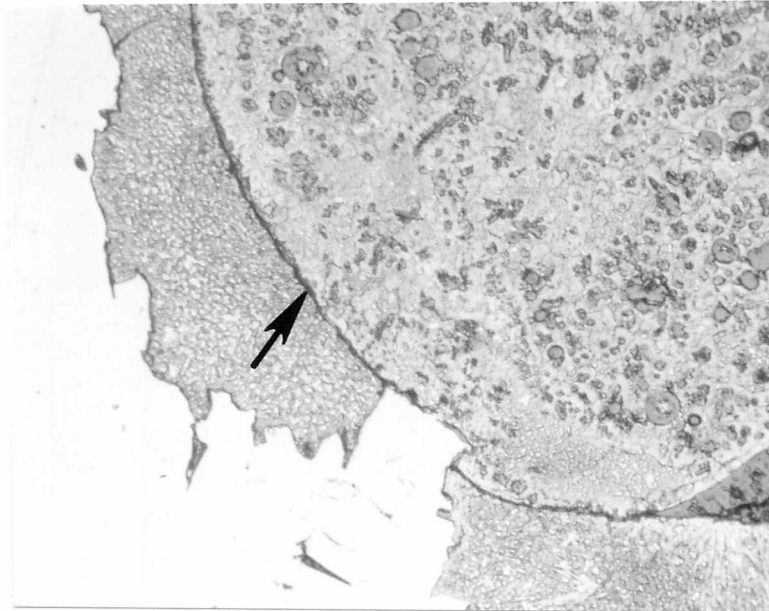
Figure 37. Light micrographs of sphere shown in Figure 36.

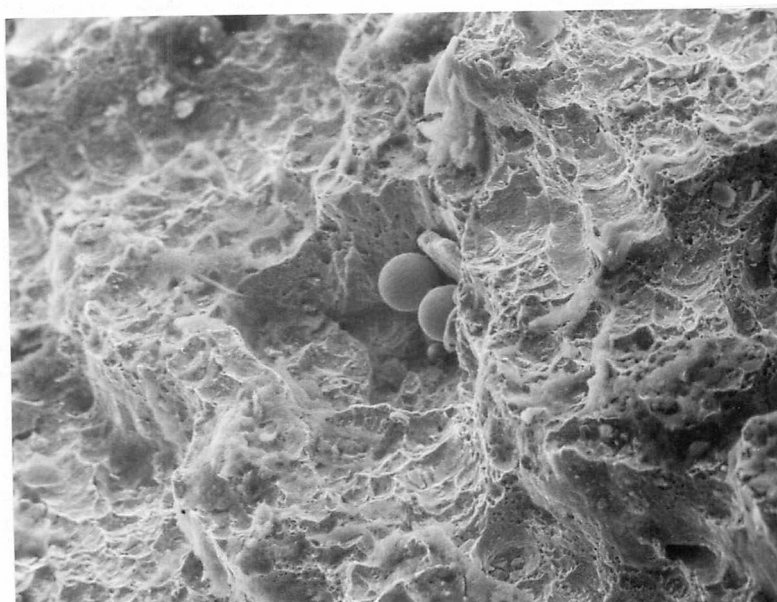
Figure 38. SEM micrograph of small spheres on fracture face of Inconel 625. 500X

spheres (1 to 10  $\mu$ ) were numerous and not characteristic of any particular fracture mode, thus it is felt that spheres in this size range are inclusions or are the result of particle formation due to thermal effects in the base material. They are exposed during the fracture process.

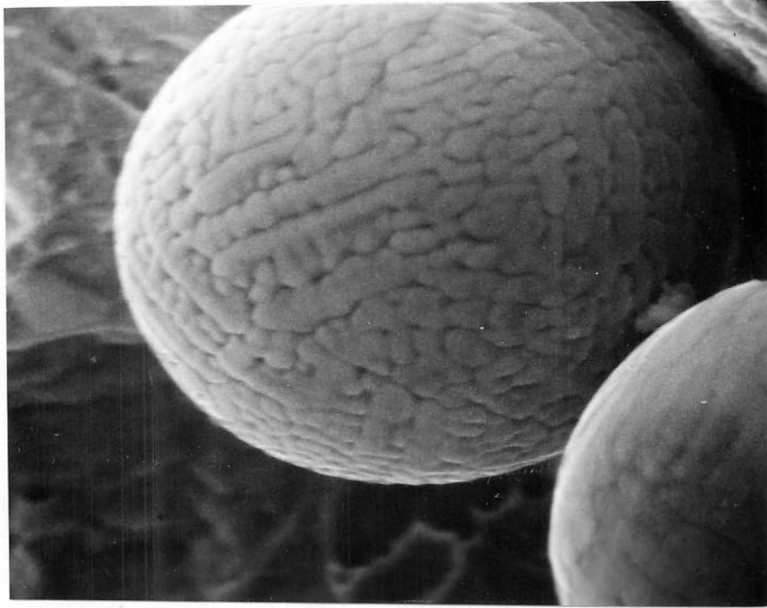
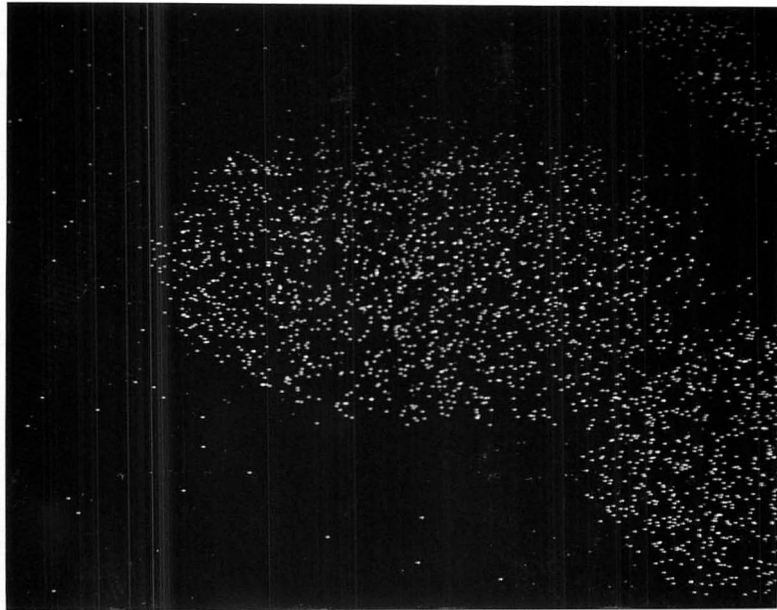
Figure 39. High magnification SEM micrograph and iron-K  $\alpha$  radiation area map of spheres shown in Figure 38.

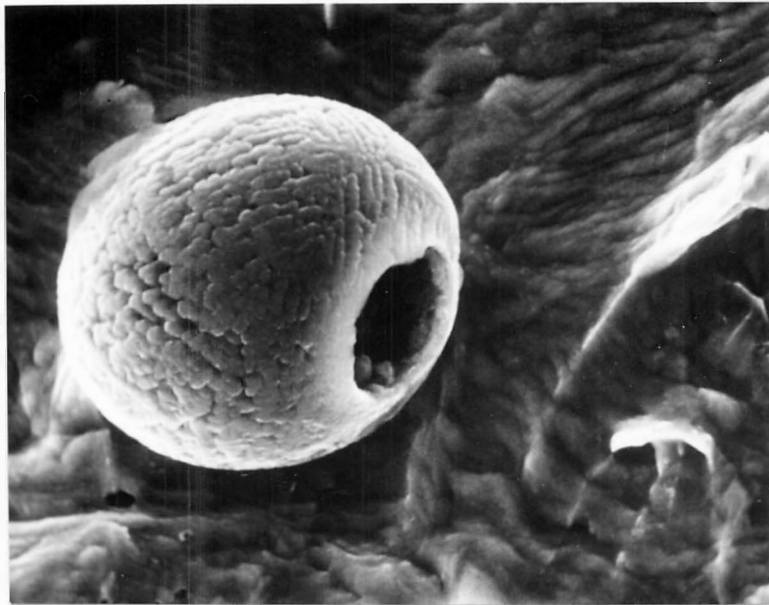
Figure 40. SEM micrograph of hollow sphere. 1000X

A slightly larger and hollow sphere is shown in the SEM micrograph in Figure 40. ED spectrography of this sphere indicates high iron as compared to the surrounding fracture surface. Many hollow spheres were encountered in this study. The cavity within the sphere suggests that a gas or vapor phase played a role in its formation. The smaller
