The Role of Inappropriate Outdoor Exhibition in the Biodeterioration of an Archaeological limestone Water Duct

Abstract

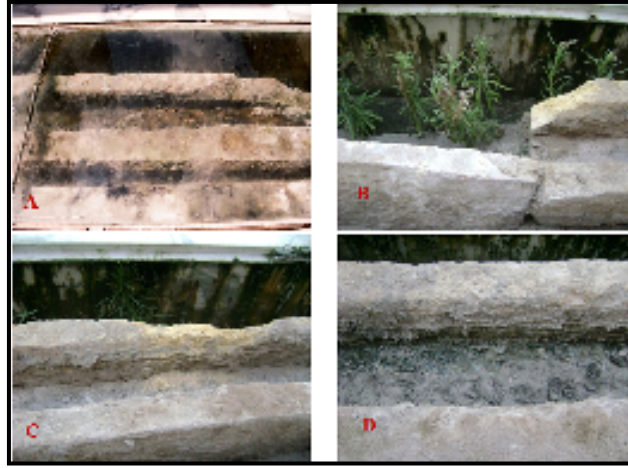
Fig. 4 Shows the degradation phenomena of the water duct. (A) Shows the discoloration of stone surface due to the accumulations of colored stains of microorganisms. (B) Shows the vascular plants growing in the bottom of the water duct. (C) Shows the eroded edges of the water duct due to the exfoliation and detachment of the superficial layer. (D) Show the black crust accumulated on the stone surface

The water duct is in very bad preservation state and shows typical decay phenomena of a surface subjected not only to the outdoor exposure but also to the unstudied human intervention. Very dense layers of biological colonization accumulated on the surface of the water duct [fig.3]. The accumulation of black, blackish brown, green and white stains of microorganisms caused the discoloration of stone surface [fig 4A]. Some vascular plants are growing in the bottom of the water duct [fig 4B]. The edges of the water duct are eroded because of the exfoliation and detachment of the superficial layer [fig 4C]. Salt efflorescence and incrustation are seen all over the surface of the water duct [fig 4D].

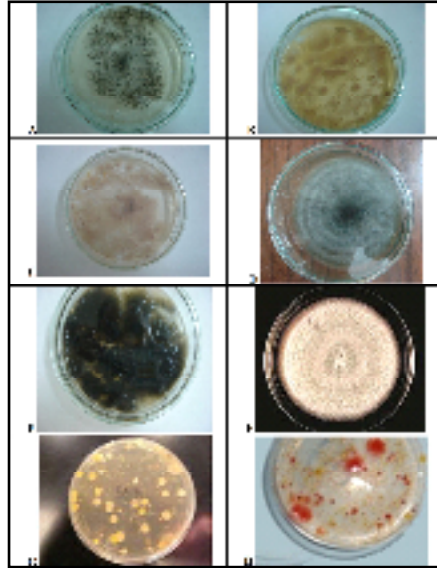
Fig.5 Shows the plates of the isolated fungi(A,B,C,D,E,F) and bacteria (G, H) from the water duct, (A) *Aspergillus niger*, (B) *Aspergillus terres* , (C)*Paecilomyces* , (D) *Alternaria* sp, (E) *Stemphylium* sp, (F) *Acremonium falciforme* , (G) *bacteria (Bacillus)*, (H) *bacteria (Coccus)*.

The pure culture of the developed microorganism shows the same morphology and colored stains that were seen on the limestone surface [fig.5]. The thin section examination showed the presence of six kinds of fungi; *Aspergillus niger*- *Aspergillus terrus* – *Acremonium* sp. *Alternaria* sp. *Paecilomyces* SP. *Stemphylium* and two kinds of bacteria *Coccus* (positive-gram) and *Bacillus*(negative-gram) [fig.6]. These groups of microorganisms living on inorganic substrates form more or less complex communities structured in biofilms or microbial mats. The development of specific biological species on a particular stone surface is determined by the nature and properties of the stone (mineral constituents, pH, relative percentage of various minerals, salinity, moisture content, texture). It also depends on certain environmental factors (temperature, relative humidity, light conditions, atmospheric pollution levels, wind and rainfall). In other words, the response of living organisms to a potentially colonizable surface depends on the ecological and physiological requirements of the biological species involved⁸. The ability of these organisms to cause serious damage to many kinds of stone has been well established. It was estimated that biological weathering is 100–1,000 times greater than inorganic weathering⁹. The interactions between these microorganisms and carbonate stone are very complex. The microbial growth can deteriorate the stone not only chemically or mechanically ways but also aesthetically way. In

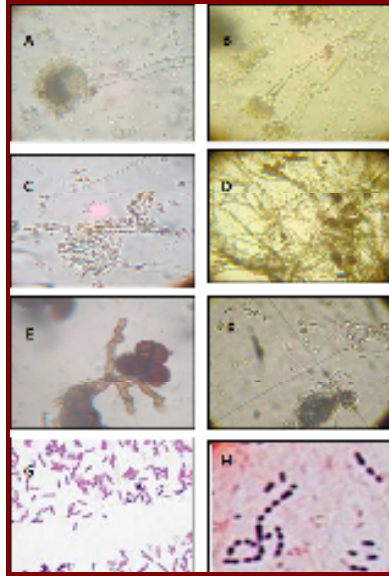
Fig. 6 Microphotographs of isolated fungi and bacteria, (A) *Aspergillus niger*, (B) *Aspergillus terreus*, (C) *Paecilomyces*, (D) *Alternaria* sp, (E) *Stemphylium* sp, (F) *Acremonium falciforme*, (G) bacteria (*Bacillus*), (H) bacteria (*Coccus*).

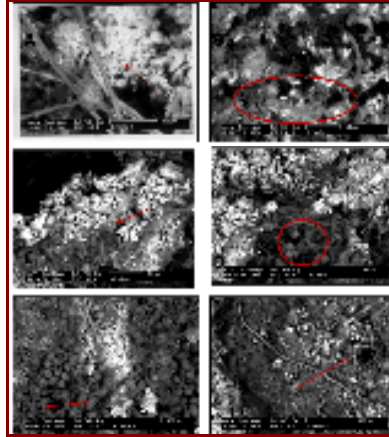
Fig. 7 shows the SEM images of the identified fungi and bacteria grows on and in the stone of water duct. (A) shows a complete body (hyphae and conidiophores) of *Aspergillus terreus* penetrating the crystals spaces of calcite (the arrow point to the corroded calcite crystal). (B) *Aspergillus terreus* growing within the stone. (C) Very dense growing of *Paecilomyces* (the hypha indicated by an arrow). (D) Shows the *Alternaria* sp. growing within the subsurface of stone. (E) shows very dense growing of *Stemphylium* sp., (the spores indicated by an arrow). (F) Shows the superficial growth of *Acremonium falciforme* on the stone.

some instances, the presence of microbial growth on stone is a purely aesthetic issue, since visible growth of pigmented microorganisms can alter the appearance of building and status¹⁰. According to the results received with the petri-dishes in this research five fungi (*Aspergillus niger*- *Aspergillus terrus* – *Alternaria* sp. *Paecilomyces* SP. *Stemphylium*) produce pigments [fig.6petri -dishes]. The pigments produced by the fungi are very often involved in the melanins¹¹. They are brown to black pigment that are formed in the cell wall and free in the substrate of cultured fungi¹². Many of fungi found on stone, especially on surfaces exposed to direct sunlight, do indeed exhibit a dark pigmentation due to the presence of melanin, which provides them with protection against physical agents (e.g., UV radiation, x- and γ -rays) and cellular lysis¹³. ESEM observation of the studied samples confirmed the data obtained by optical microscopy and verify the existence of bacterial and fungal biofilms on the stone surface and within the crystalline structure of the limestone [fig 7 and fig 8]. It was reported in many scientific researchs that the combination of bacteria and fungi, forming biofilms on the material surface, are involved in degradation of historic limestone materials.¹⁴ Eroded crystals of calcite and poorly crystalline mineral precipitates on fungal hyphae were observed to be a common feature in some studied samples [fig7A and fig 9].

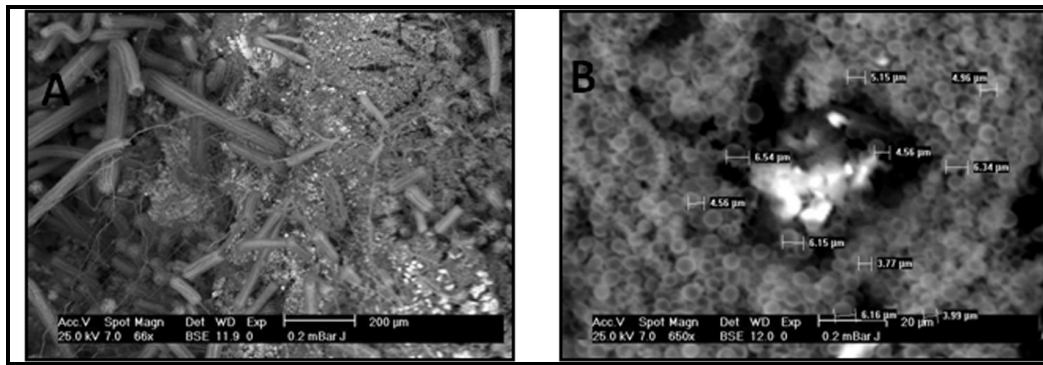
Fig. 8 SEM micrographs show (A) very dense bacteria (*Bacillus*) growth on the stone surface, (B) very dense bacteria (*Coccus*) growth on the stone surface (its dimension ranging from 3µm to 6µm).

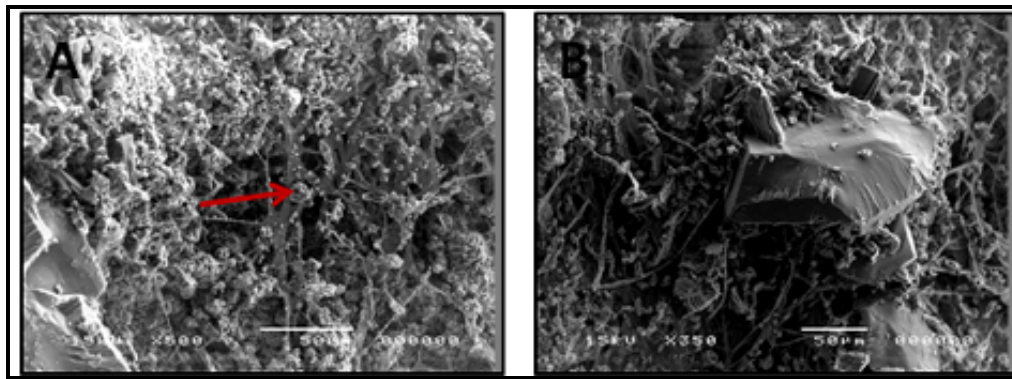
Fig. 9 SEM micrographs of (A) mineral secondary precipitates over fungal hypha, (B) shows calcite crystal embedded within the fungal growth.
