The effect of porosity on the fatigue life of 8630 cast steel

THE EFFECT OF POROSITY ON THE FATIGUE LIFE OF 8630 CAST STEEL

A thesis submitted in partial fulfillment
of the requirements for the Master of
Science degree in Mechanical Engineering
in the Graduate College of
The University of Iowa

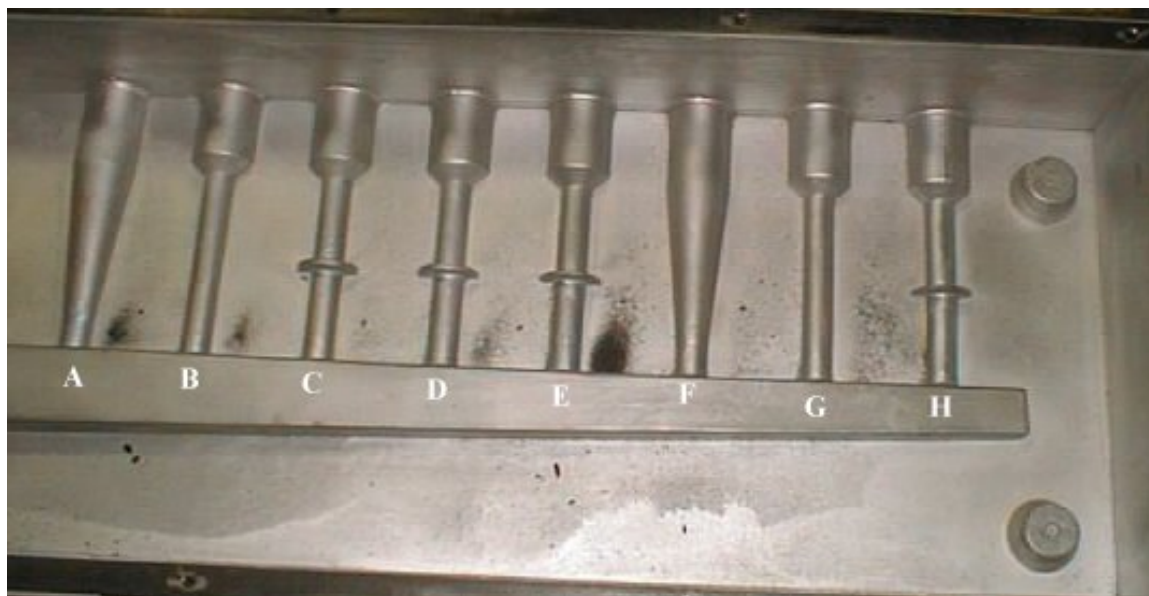
Figure 2.1 - Photograph of Pattern with Individually Labeled Blanks

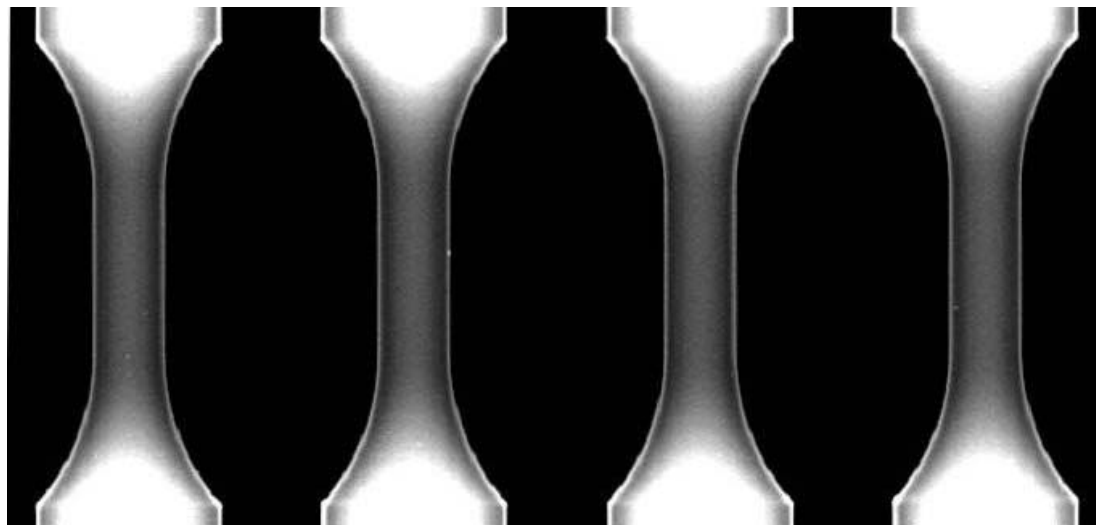
Figure 2.5 - Representative Radiographs of Truncated Cone Specimens

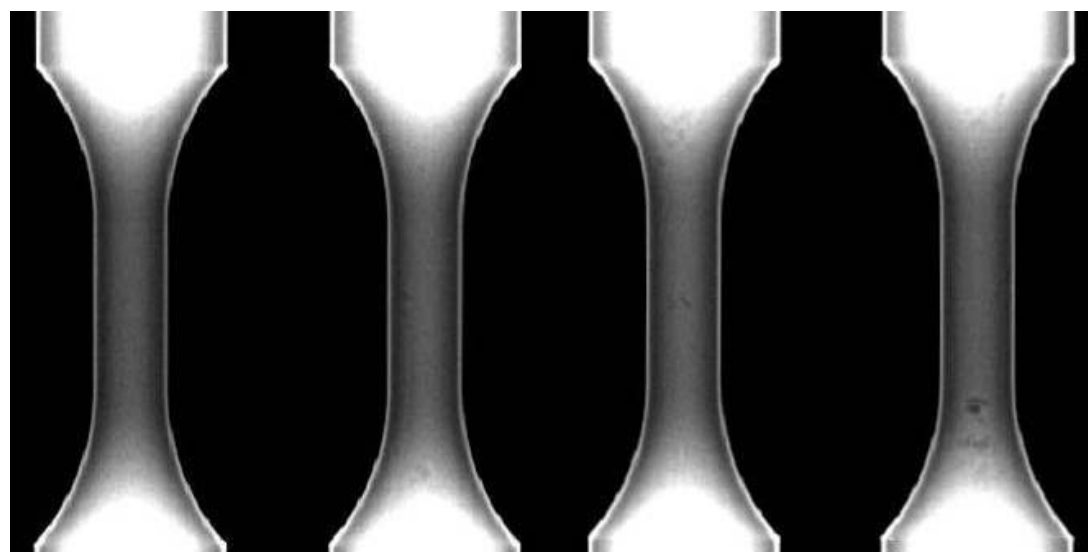
Figure 2.6 - Representative Radiographs of Cylinder with 3 and 4 mm Disc Specimens

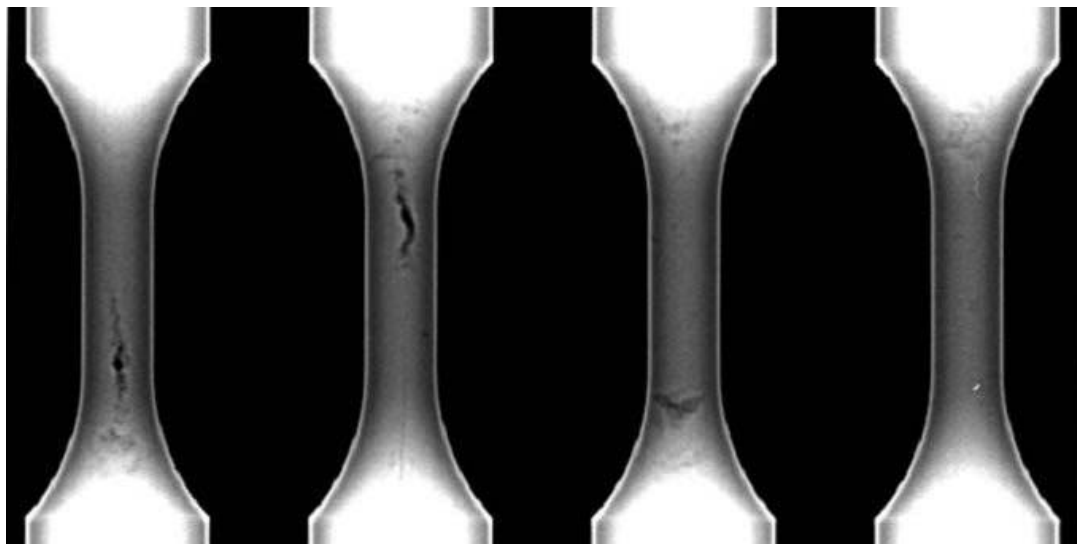
Figure 2.7 - Representative Radiographs of Cylinder with 5 mm Disc Specimens

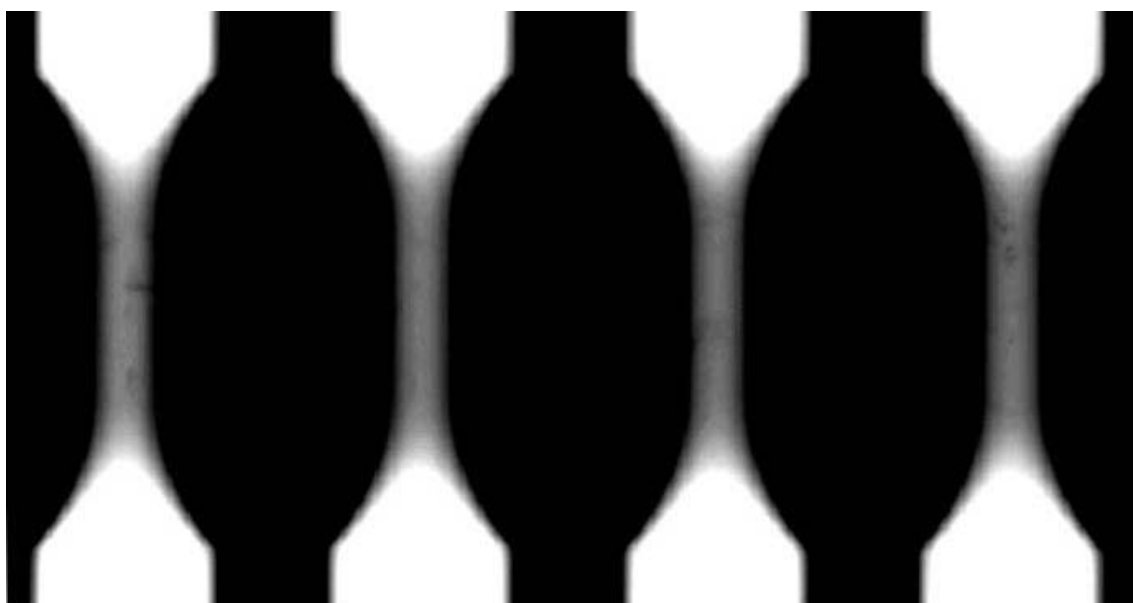
Figure 2.8 - Representative Radiographs of Straight Cylinder Specimens

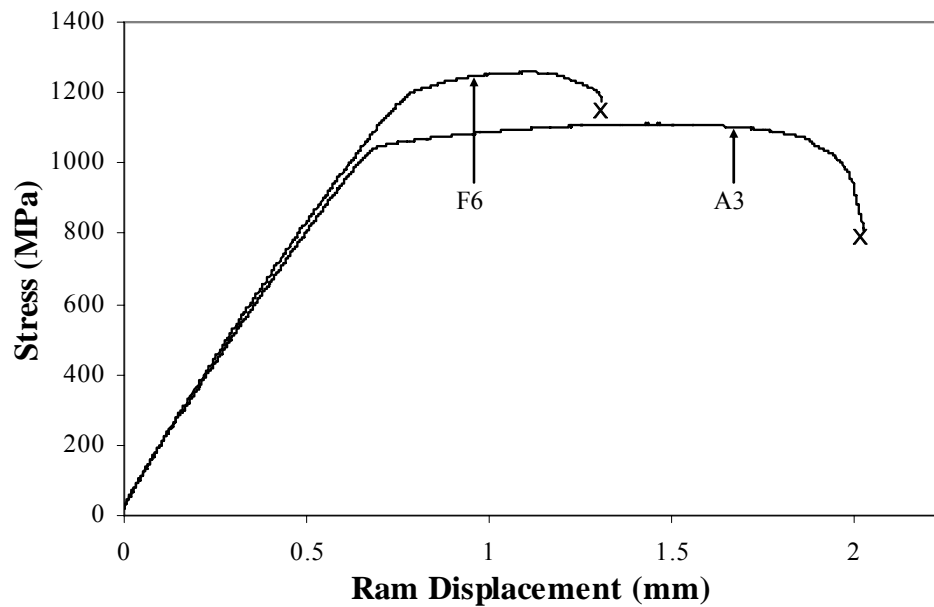
Figure 4.1 - Monotonic Stress-Ram Displacement Curve of Truncated Cone Specimens

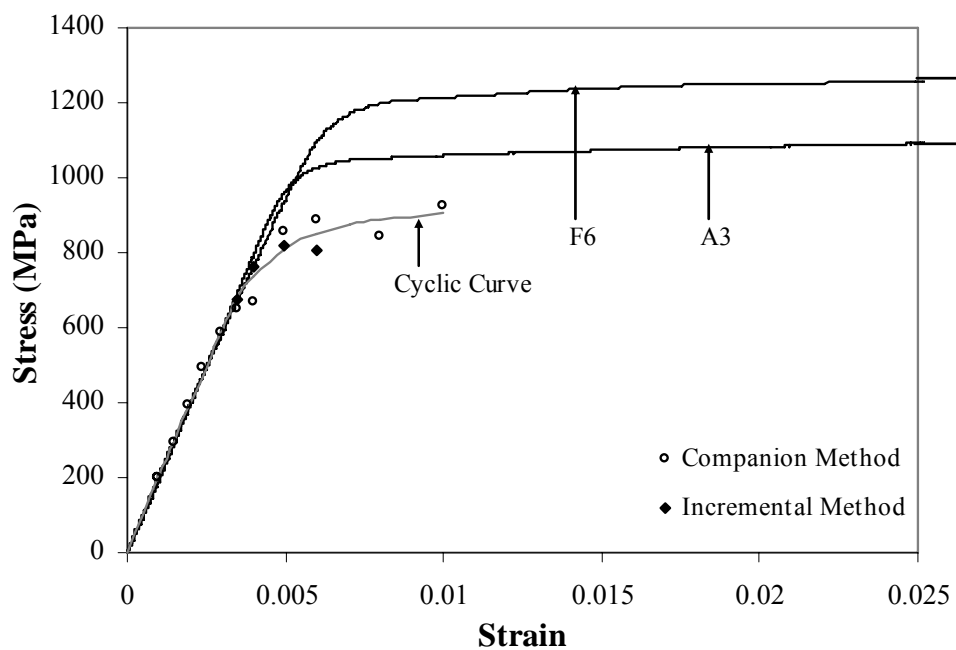
Figure 4.2 - Monotonic and Cyclic Stress-Strain Curves of Truncated Cone Specimens

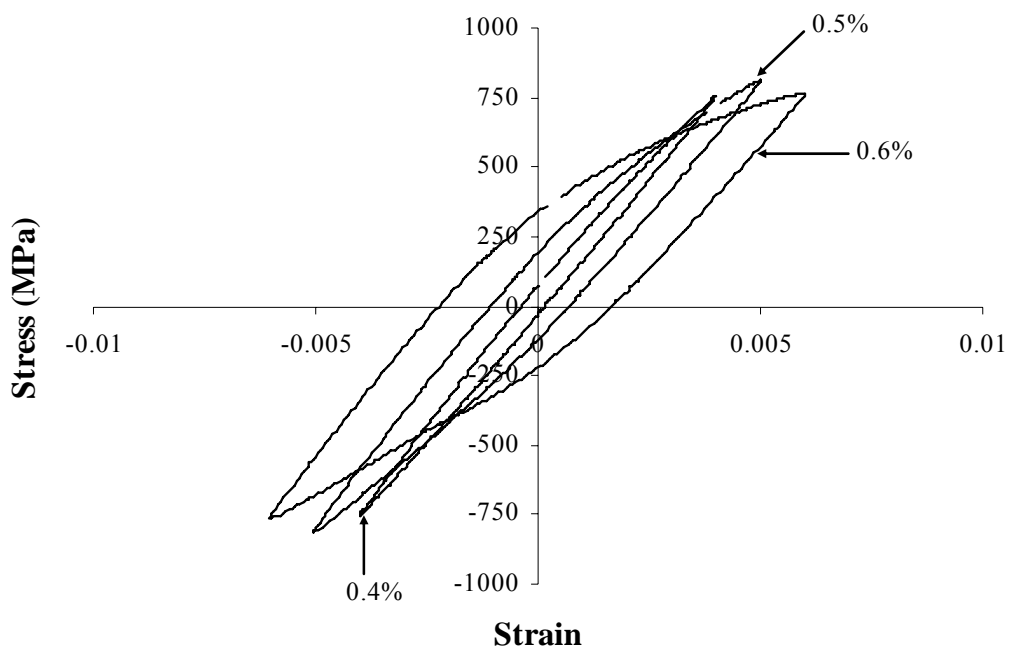
Figure 4.5 - Stress-Strain Hysteresis Loops for LCF Testing (Incremental Method)

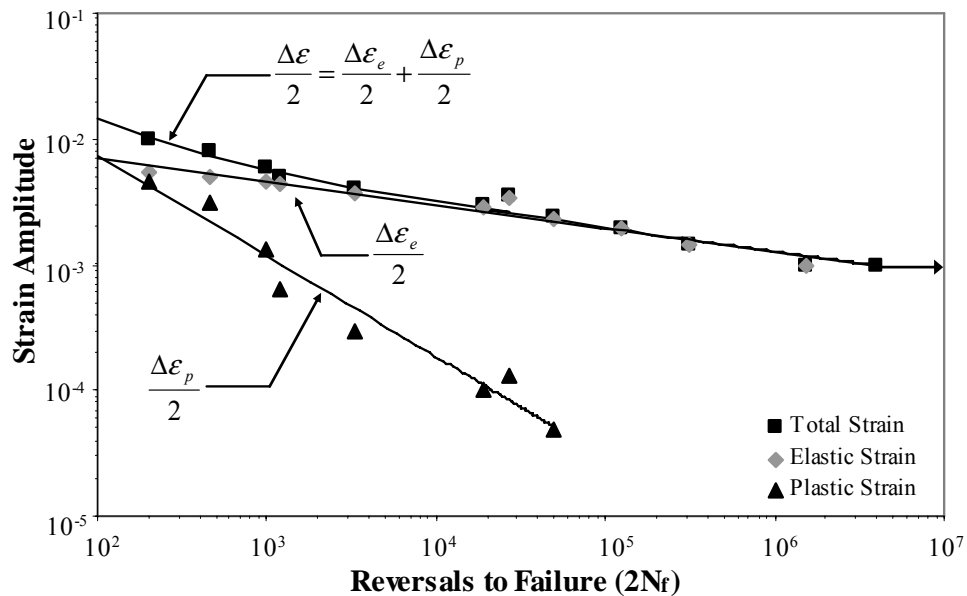
Figure 4.7 - Total, Elastic, and Plastic Strain-Life Data of Truncated Cone Specimens

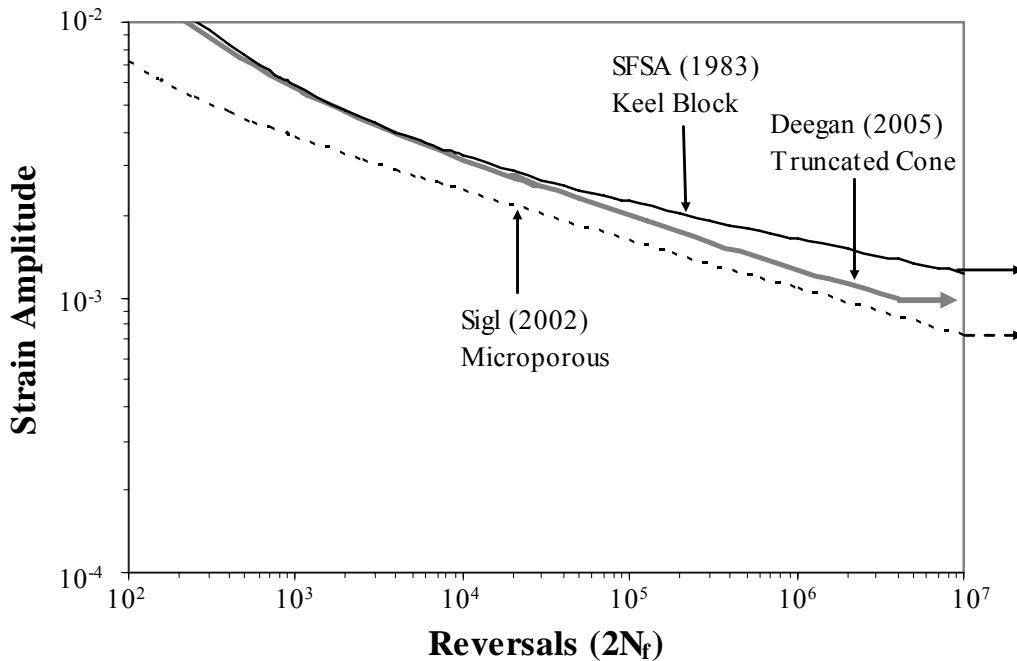
Figure 4.8 - Comparison of Strain-Life Curves

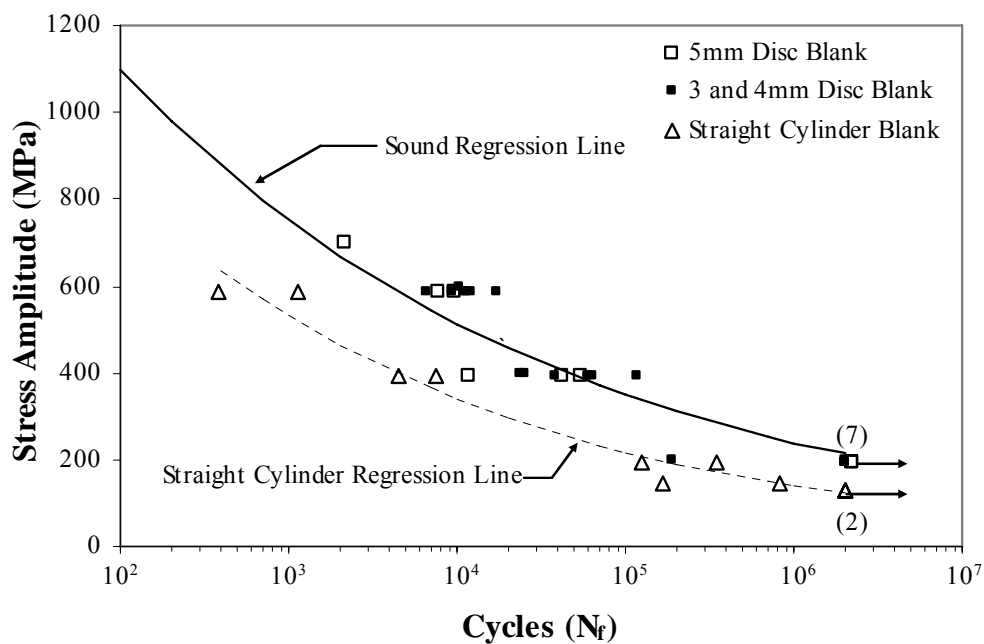
Figure 4.10 - Cylinder with Disc Specimen and Straight Cylinder Specimen Data Superimposed on Sound S-N Curve
