The effects of intersection collision warning systems on gap selection and stopping characteristics

A thesis submitted to the graduate faculty
in partial fulfillment of the requirements for the degree of
MASTER OF SCIENCE

Major: Civil Engineering (Transportation Engineering)

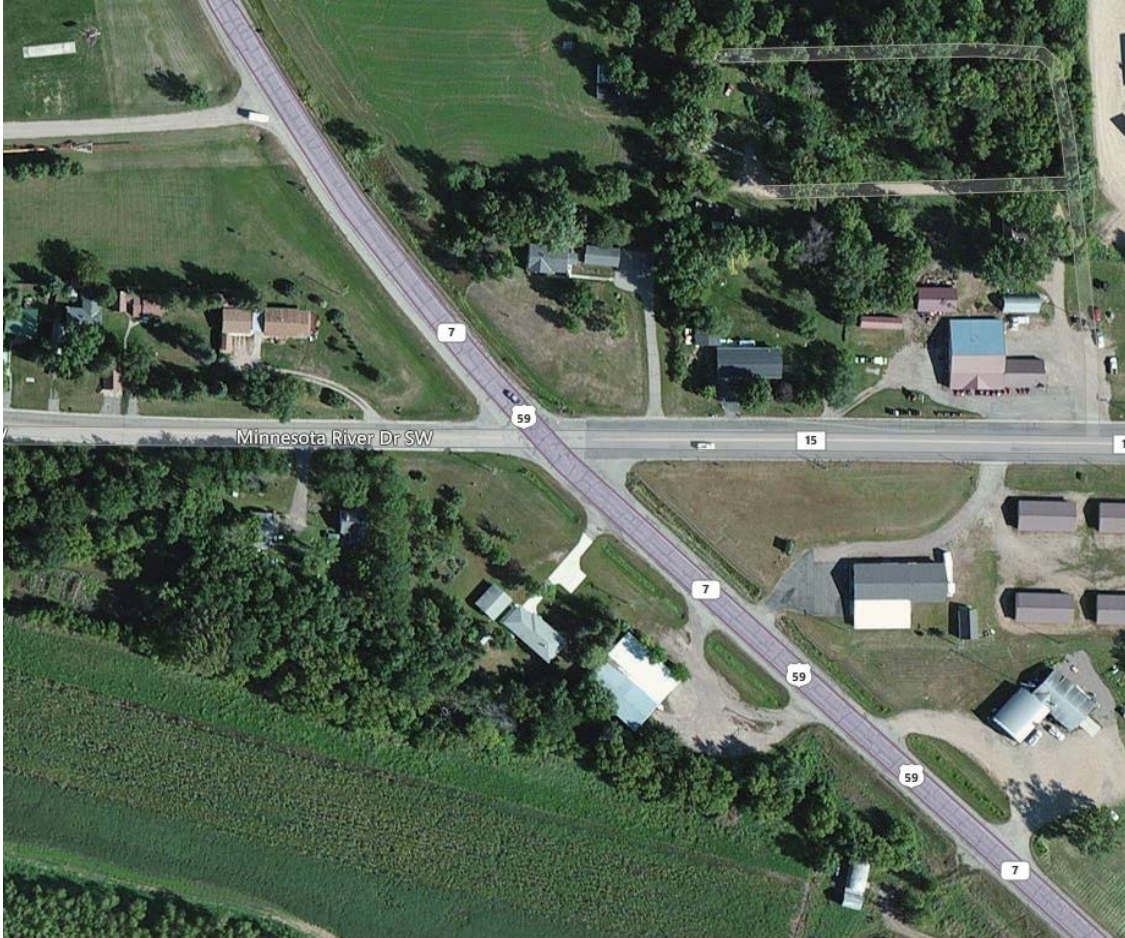
Figure 2: Chippewa County treatment site (Bing Maps. Bing, 2015.)

The second treatment site which was evaluated is the intersection of Minnesota State Highway 7 (MN7) and County Road 15 (Co15). The site is located in Chippewa County near the city of Montevideo and is approximately 120 miles west of downtown Minneapolis and 35 miles east of the South Dakota border. MN7 acts as the major roadway, while Co15 is the minor roadway and has a stop control. Both MN7 and Co15 are two lane undivided roadways. There is a significant skew between the two roadways, which can be seen in Figure 2. There is also a vertical curve on the north leg of MN7 that may cause site distance issues. There are no turning lanes at any of the four approaches of the intersection. However, many cars were observed using the shoulder of the Co15 east leg as a right turning lane. The traffic patterns are based on the city of Montevideo, with many of the cars coming from the town, or going towards the town.

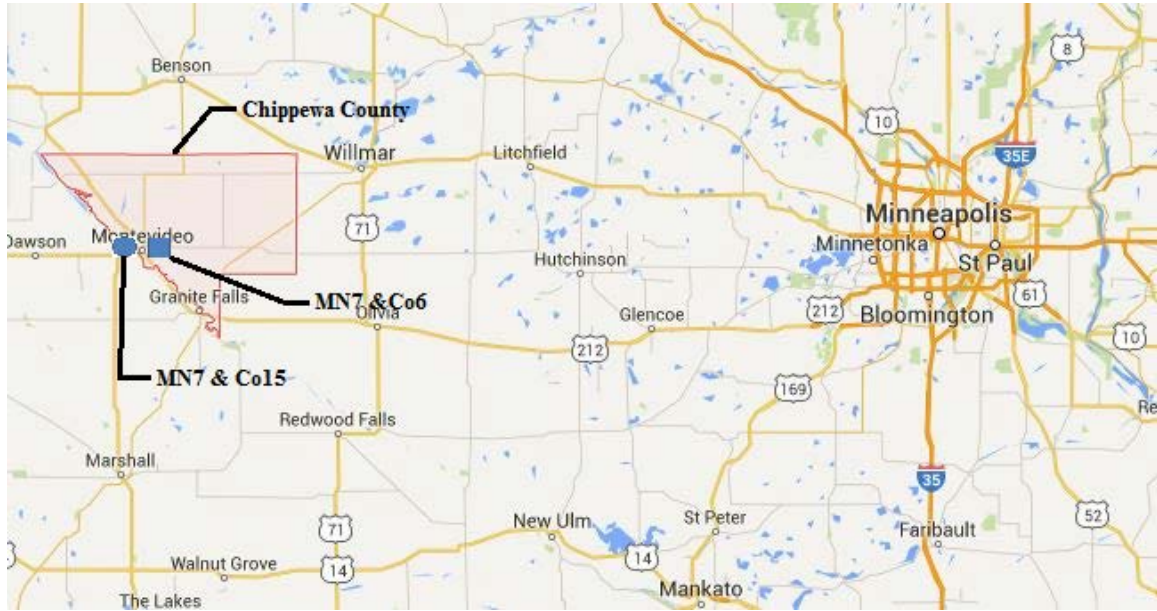
Figure 3: Chippewa County intersections (Google Maps. Google, 2015.)

The AADT for MN7 is 1,800 vehicles, with the majority of this traffic turning left from the north leg to the east leg. On Co15, the AADT is 2,950 vehicles, with most of the vehicles turning right from the east leg onto the north leg of MN7. This intersection is on the outer portions of Montevideo, with lower speeds than the Isanti County sites. The speed limit on Co15 is 30 miles per hour on the east leg in the direction of Montevideo and turns to 50 miles per hour on the west leg. MN47 has a speed limit of 50 miles per hour in both directions. Chippewa county and the intersection location can be seen in Figure 3.

The control intersection for MN7 & Co15 was selected to have similar characteristics as the treatment intersection and is located approximately seven miles east of the treatment site at the intersection of Minnesota State Highway 7 and County Road 6 (Co6). MN7 is again the major roadway for this location while Co6 is the stop-controlled minor roadway. Similar to the treatment location, both roadways are two lane, undivided roads. Unlike the treatment location, this these roadways meet at a 90-degree angle. This location is also comparable to the treatment intersection in that no legs of the intersection utilize turning lanes. While still near Montevideo, the control site is located in a rural setting with speed limits of 55 miles per hour in all directions. MN7 has approximately 3,200 vehicles per day in this location while Co6 has fewer than 1,000 vehicles daily.

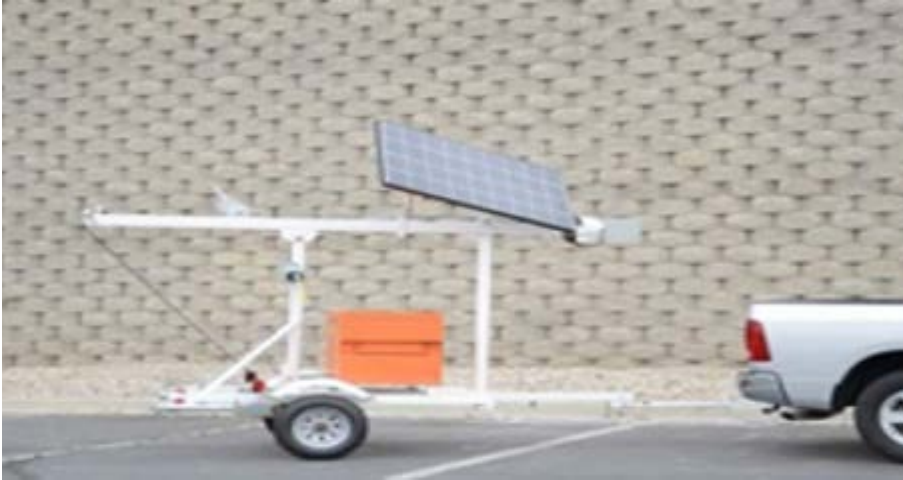
Figure 6: Mobile camera trailer (Live View Technologies, 2014.)

Video data were collected at each location before and after installation of the ICWS. An array of video trailers/cameras were used and video collected at each intersection for one week during the before period and one week during the after period. The cameras were recording the intersection continuously for the week period, which required an effective answer to video storage. With the video recording process lasting a week at a time, and multiple sites throughout the state of Minnesota, a decision was made to find a camera to be moved between locations. The solution to these problems came through Live View Technologies in supplying mobile cameras on trailers. Figure 5 displays the trailer with the camera set up and Figure 6 displays the trailer ready to be moved.

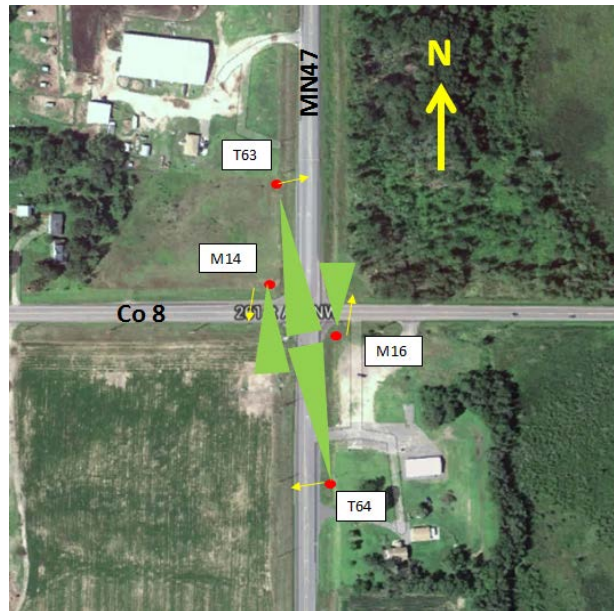
in Appendix A. Cameras T63 and T64 are mobile trailer cameras in the ditch of MN47. These cameras are used to view all aspects of the intersection. The vehicles approaching the stop signs are visible and the videos from these cameras are used to determine the stopping motions of the vehicles and the gaps between cars on MN47. In addition to the two mobile trailer cameras, each intersection utilizes two post-mounted cameras. These cameras are identical to the ones used on the trailer but are attached to a post in the ground at approximately the same height as vehicle windows. The cameras are facing the vehicles stopped at the stop sign in an attempt to see what the drivers are looking at while they are stopped.

Figure 7: Isanti treatment intersection camera layout

Each intersection utilizes four cameras to make all approaches available for viewing. The camera setup at the intersection of MN47 and County Road 8 in Isanti County is displayed in Figure 7. The camera layout of the other 3 intersections are found

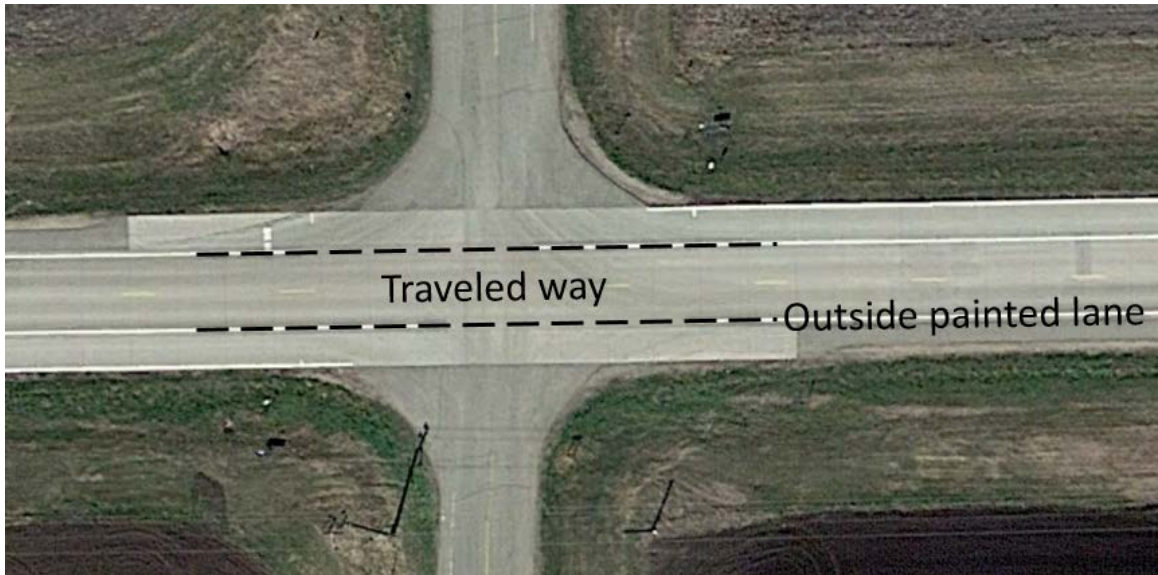
Figure 9: Departure time location (Google Maps. Google, 2015)
