# ULTIMATE SHEAR STRENGTH OF REINFORCED HIGH STRENGTH CONCRETE CORBELS SUBJECTED TO VERTICAL LOAD

Dr. Omar Qarani Aziz

Zrar Sedeeq Othman

Assistant Professor  
Civil Eng. Department, College of Engineering, University of Salahaddin - Hawler

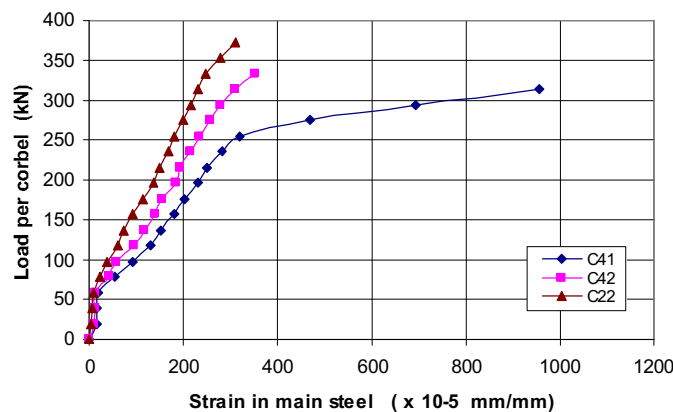
Fig.(13) Effect of concrete compressive strength on main steel strain for corbels with  $\rho_r f_{yh} = 2.305$ .

Fig.(14) Effect of  $\rho_r f_{yh}$  on main steel strain.

Fig.(15) Effect of  $\rho_w$  on main steel strain.

For all the tested corbels the main steel bars yielded before the maximum load was reached. Figs.(13) through (15) show the effect of various parameters which is studied in this research on the main bar strain. As shown in the figures for all the tested corbels first the curves was steepest, terminated at the occurrence of the first flexural crack. After the initiation of the first crack, the strain increased rapidly for a small load increment.
