Understanding Soil Liquefaction of the 2016 Kumamoto Earthquake

A thesis submitted to the faculty of
Brigham Young University
in partial fulfillment of the requirements for the degree of
Master of Science

Department of Civil and Environmental Engineering
Brigham Young University

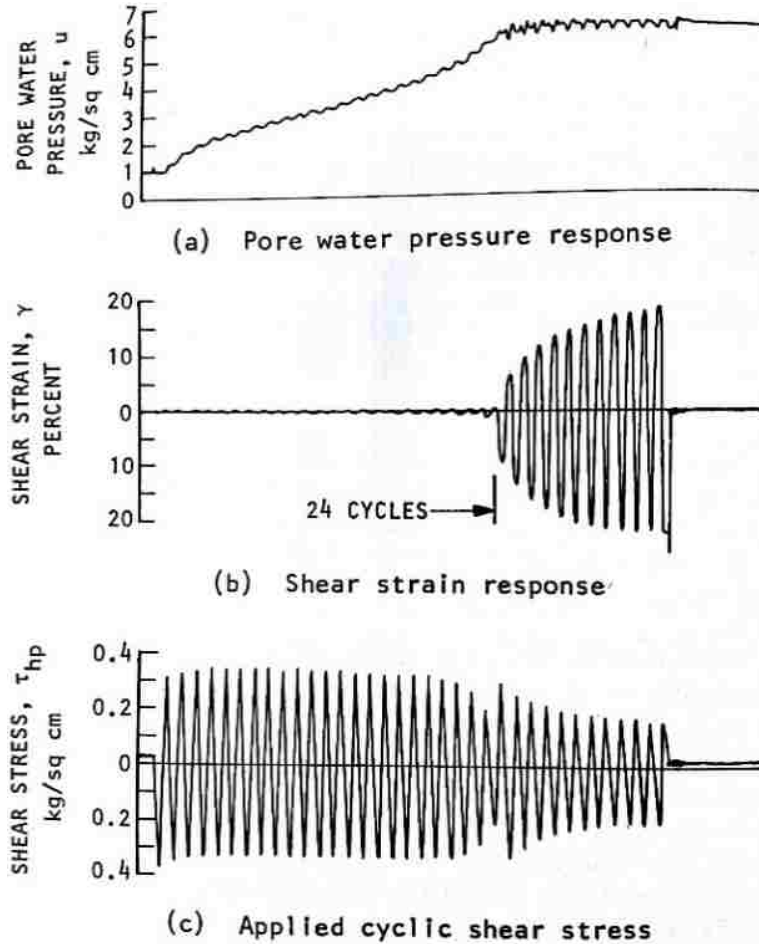
Figure 2-7: Cyclic loading test of loose sand (Seed and Idriss, 1982)

Soil liquefaction was first reported during the 1964 Niigata, Japan and Alaska earthquakes, and has been extensively studied since. Although earthquake engineering has significantly advanced with the advent of the seismograph, these earthquakes caused the soil, not steel and concrete, to fail. Not all earthquakes result in major liquefaction, but some liquefaction typically occurs in every sizeable earthquake. Minor liquefaction in earthquakes is not surprising. Some recent earthquakes with major liquefaction are the 2011 Tohoku, Japan and 2011 Christchurch, NZ earthquakes. Figure 2-7 provides an illustration of a soil that has liquefied (Seed & Idriss, 1982). There is a gradual increase in pore pressure followed by an abrupt change in shear strain and strength (Seed & Idriss, 1982).

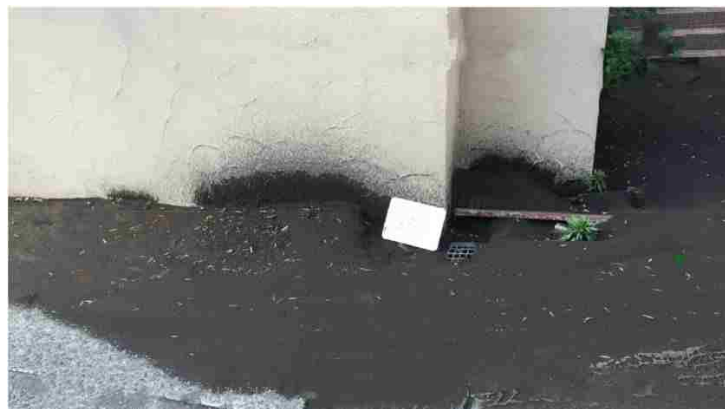
Figure 2-9: Sand boils on side of house in Kumamoto, showing volcanic material that was plastic and pumiceous in origin (Kayen 2017)

Perhaps the most common liquefaction hazard is the sand boil, a phenomenon in which a liquefied soil layer releases pore pressure by cracking through a surface layer and leaving behind a sand volcano or gaping hole. Sand boils are often accompanied by large depressions filled with water and soil from layers that were eroded. Oftentimes, the edges of foundations are perfect exits for water and will have sand boils. See Figure 2-9 for an picture of a sand boil from Kumamoto City that was dark and contained pumiceous materials (Kayen et al., 2017). The dark color of the soil is typical of the Kumamoto volcanically derived soils.

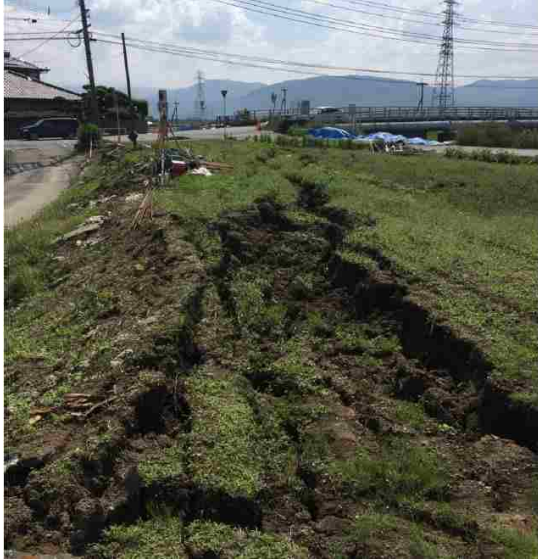
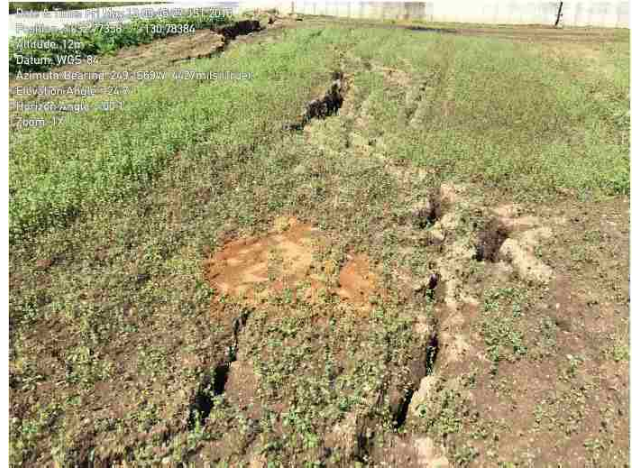
Figure 6-26. Hypothesized lateral spread at site 4 and observed fissures and ejecta (Kayen et al., 2017)

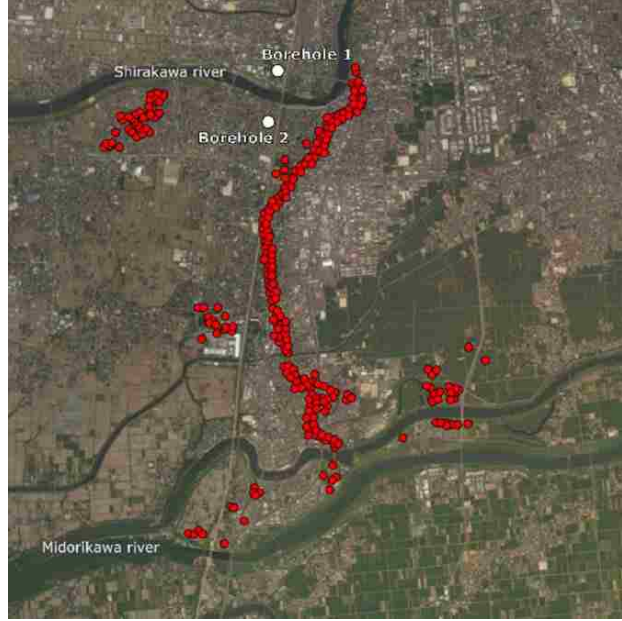
Figure A-7: Observed soil liquefaction in Kumamoto City (Bhattacharya et al., 2018)
