## Understanding Strawberry Plains Through Landscape Archaeology

A Thesis  
presented in partial fulfillment of requirements  
for the degree of Master of Arts  
in the Department of Anthropology  
The University of Mississippi

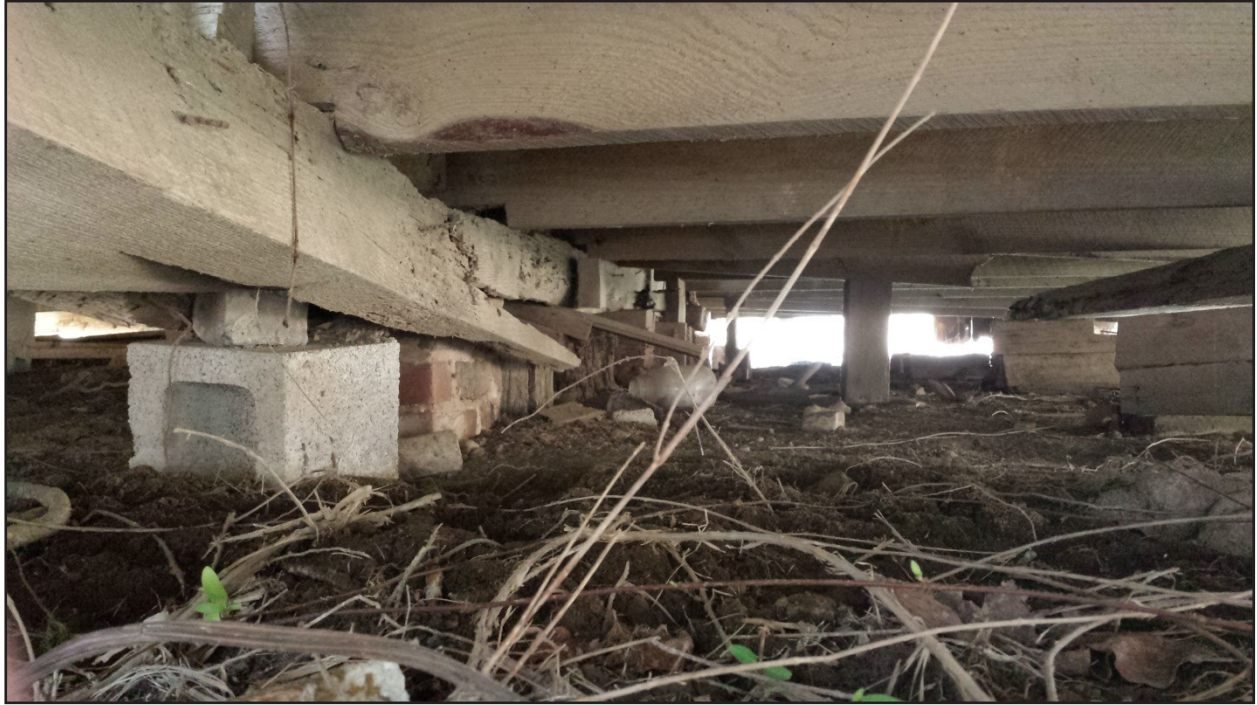
Figure 16. View of different types of piers used for foundation (cement blocks, bricks and mortar, and wood).

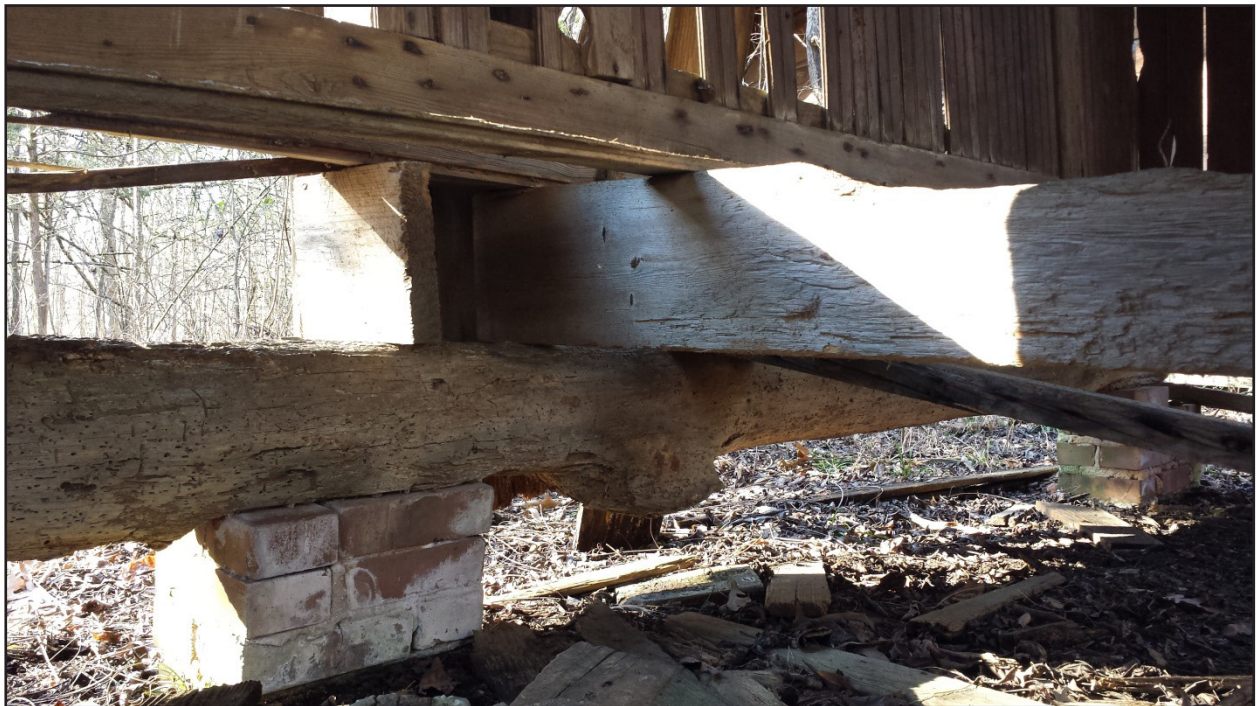
Figure 17. Types of sills used to hold up frame of structure (milled wood beams and an unmodified tree).

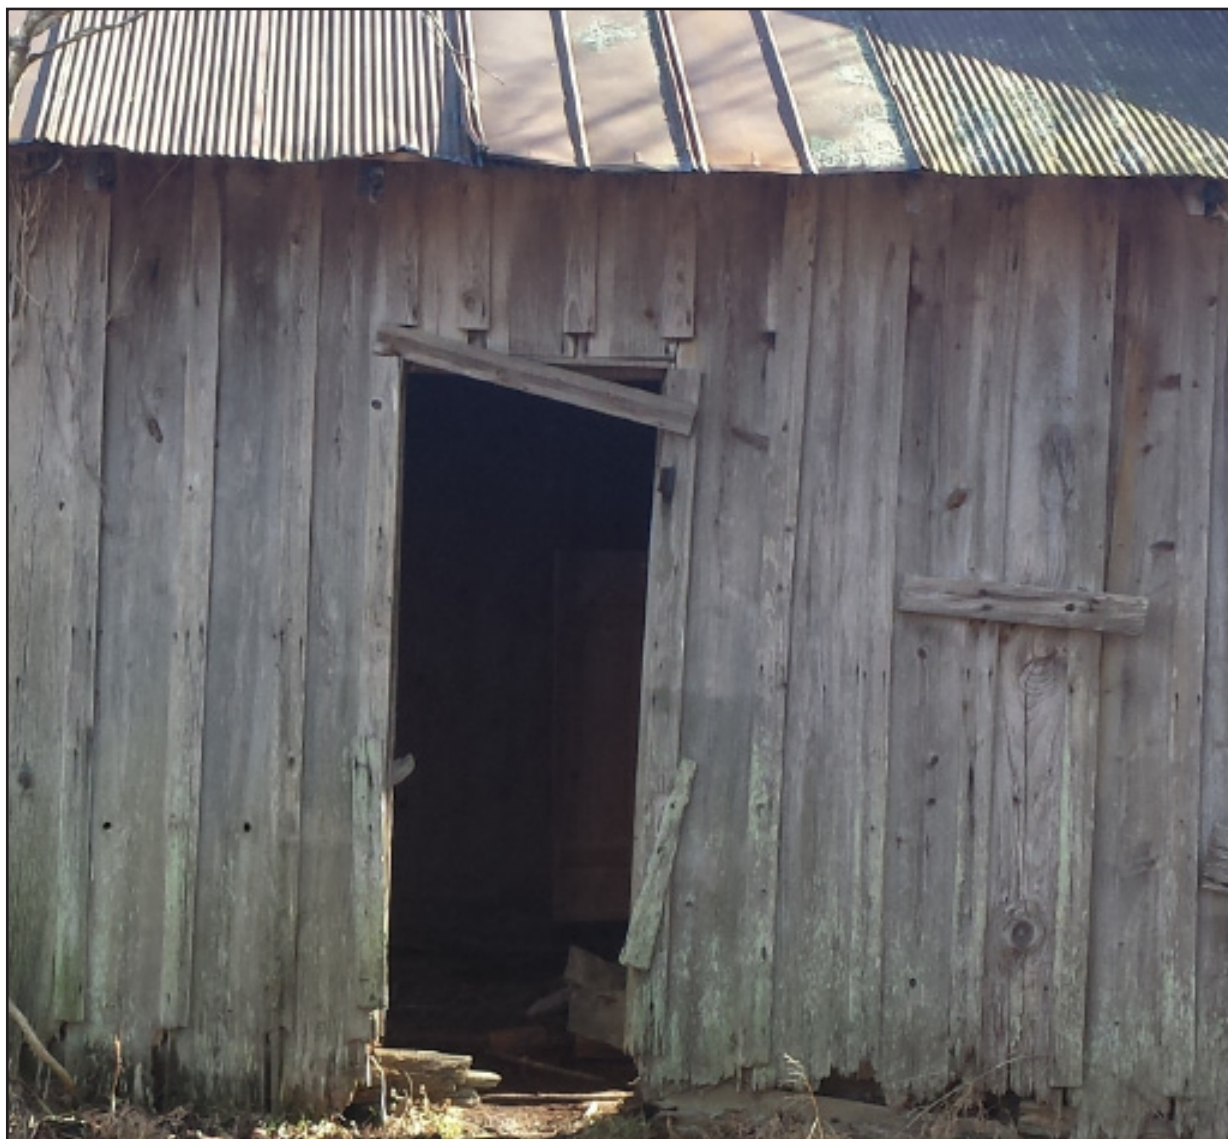
Figure 18. Board and batten siding.

Exterior finishes consist of the type of siding placed on the structures. The exteriors of each structure were clad in board and batten siding (Figure 18). This type of siding consisted of

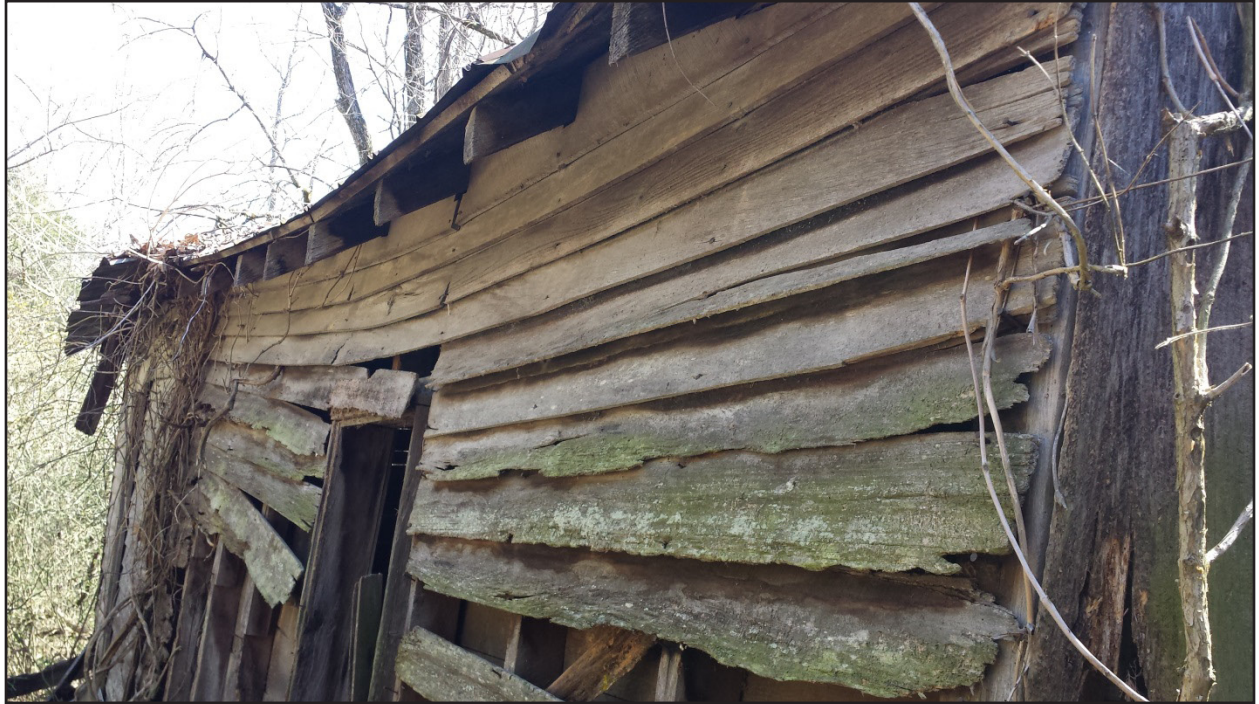
Figure 19. Clapboard siding.

Another type of siding that was found in limited quantities on three of the structures was clapboard. Clapboard siding is situated on the framing of the house horizontally and overlays each board (Figure 19). Also to note, many of these exterior walls within these structures have

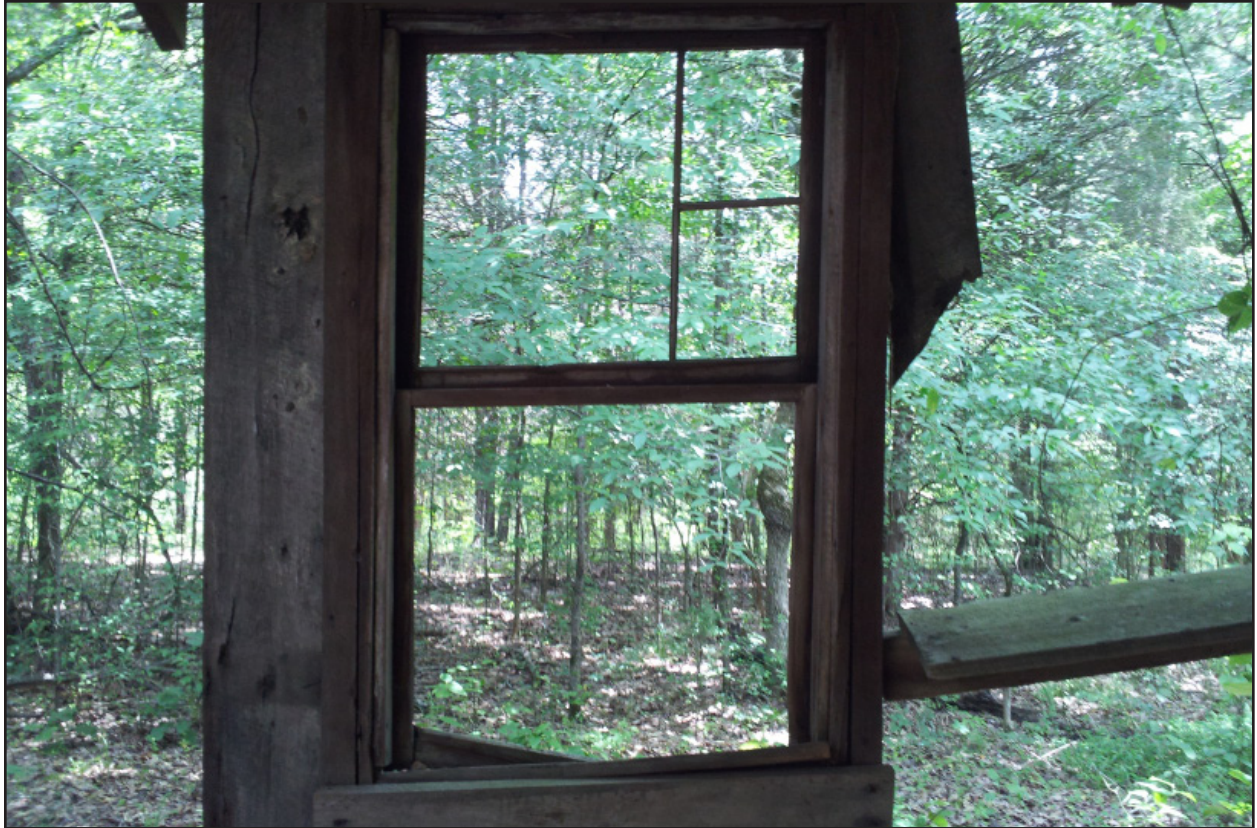
Figure 21. Single hung sash window in SCH #7.

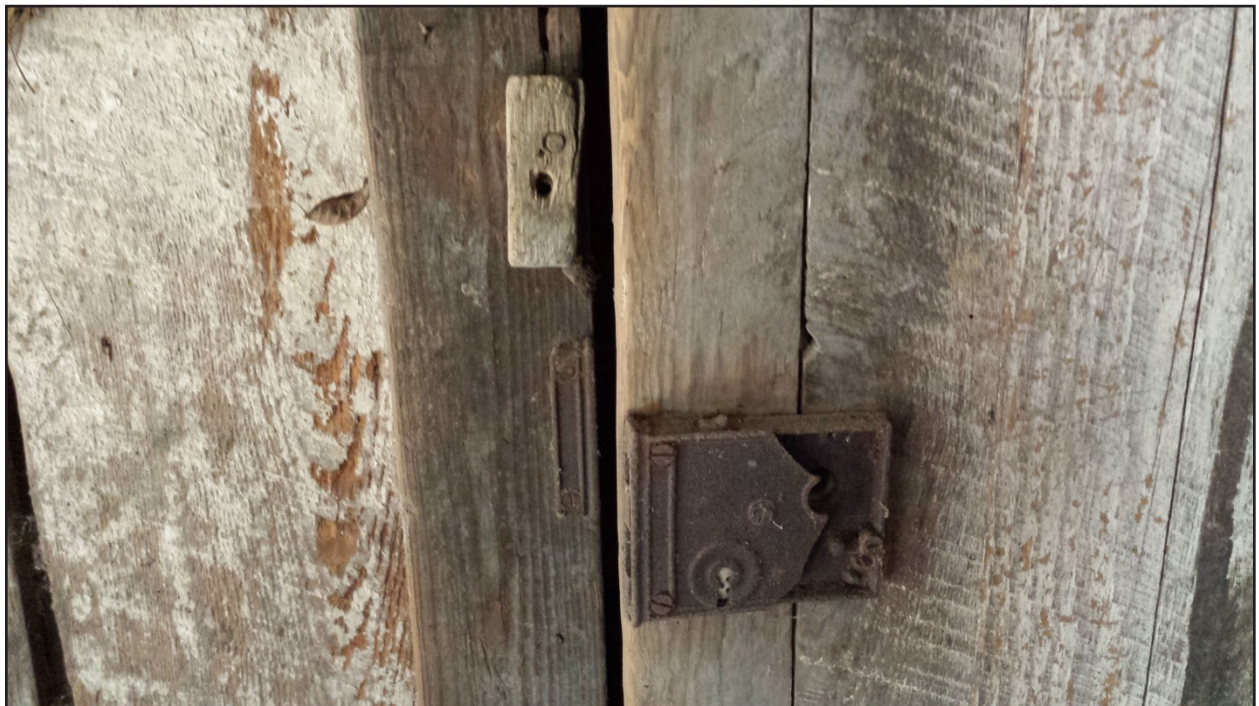
Figure 22. Metal lock and a wooden closure on the interior of a door.

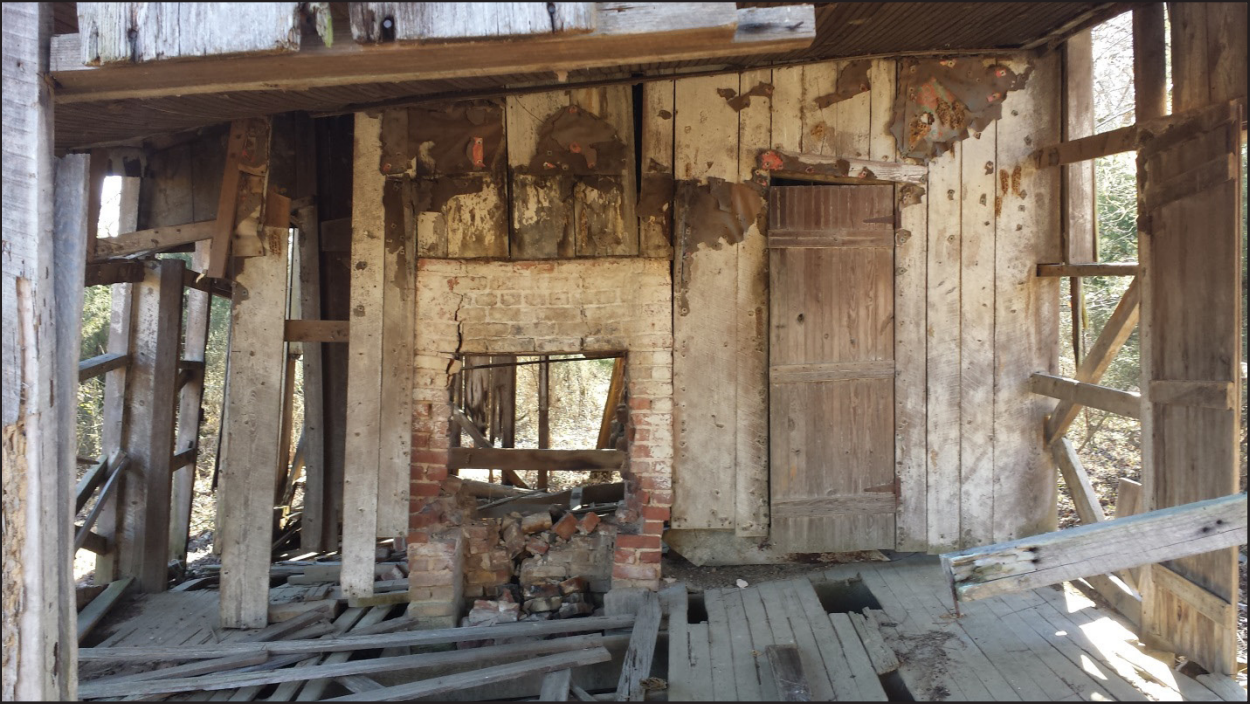
Figure 24. Central chimney with a double fireplace.

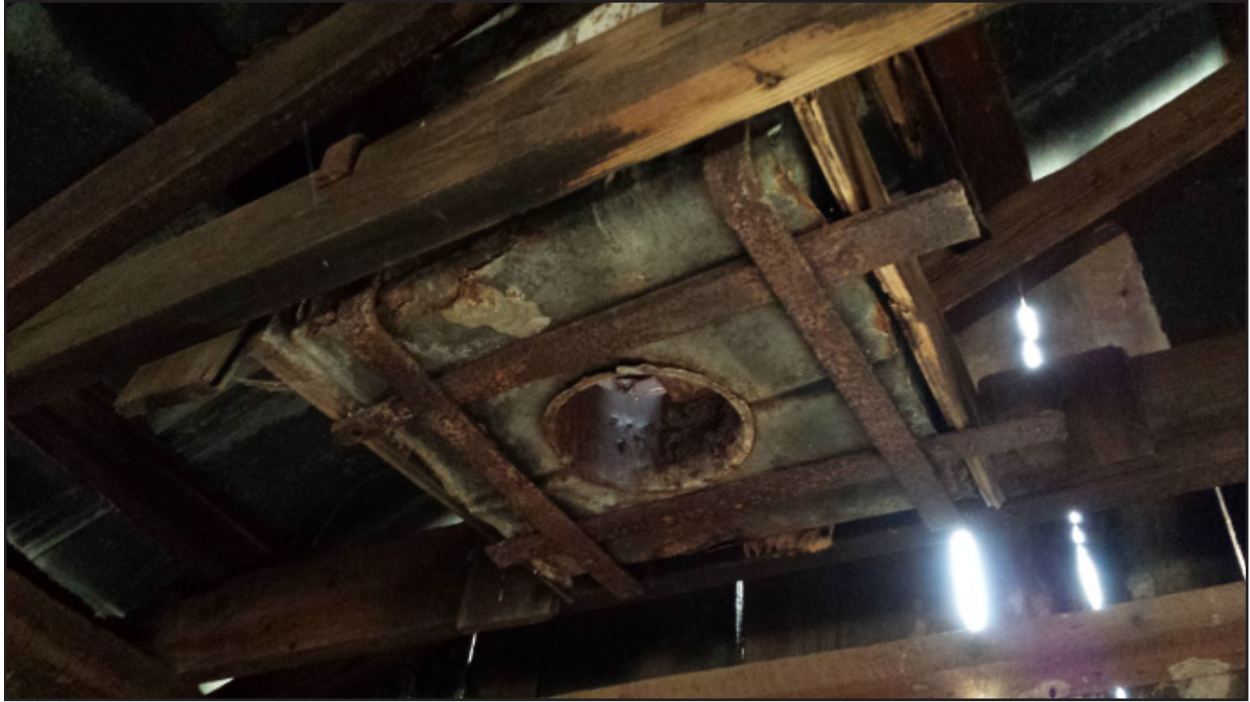
Figure 25. Wood stove chimney.

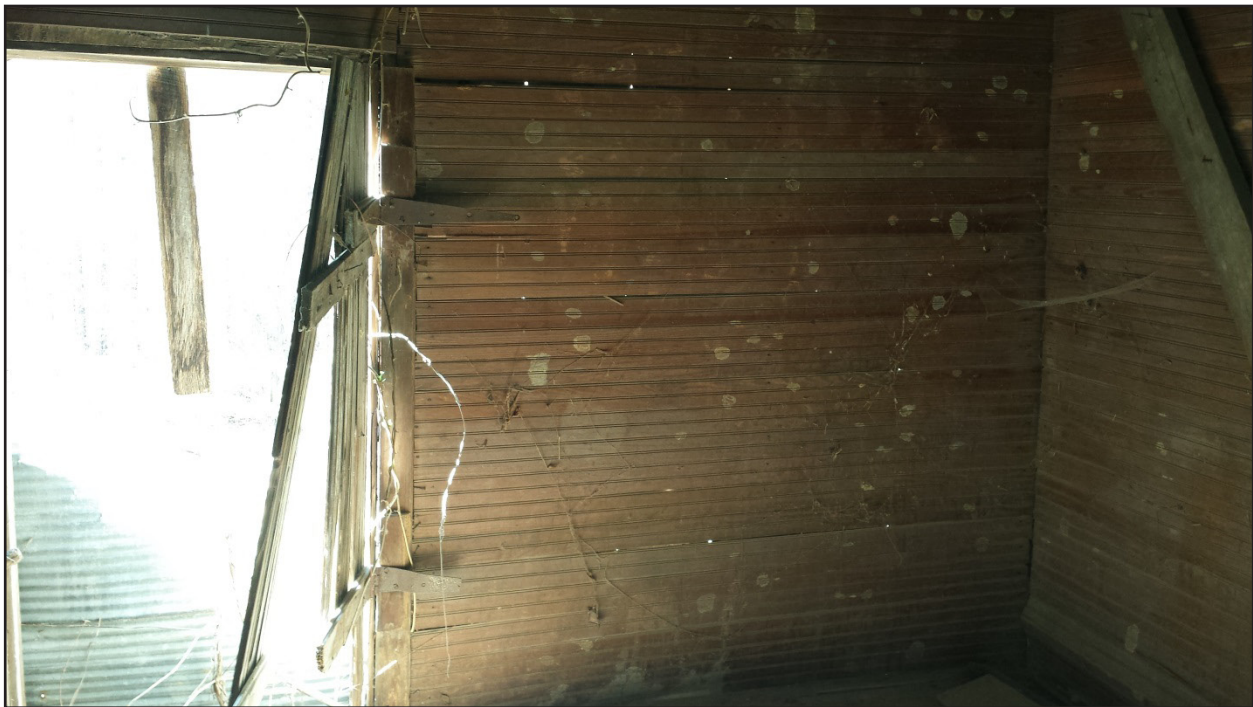
Figure 26. Bead board on the interior walls of a structure.

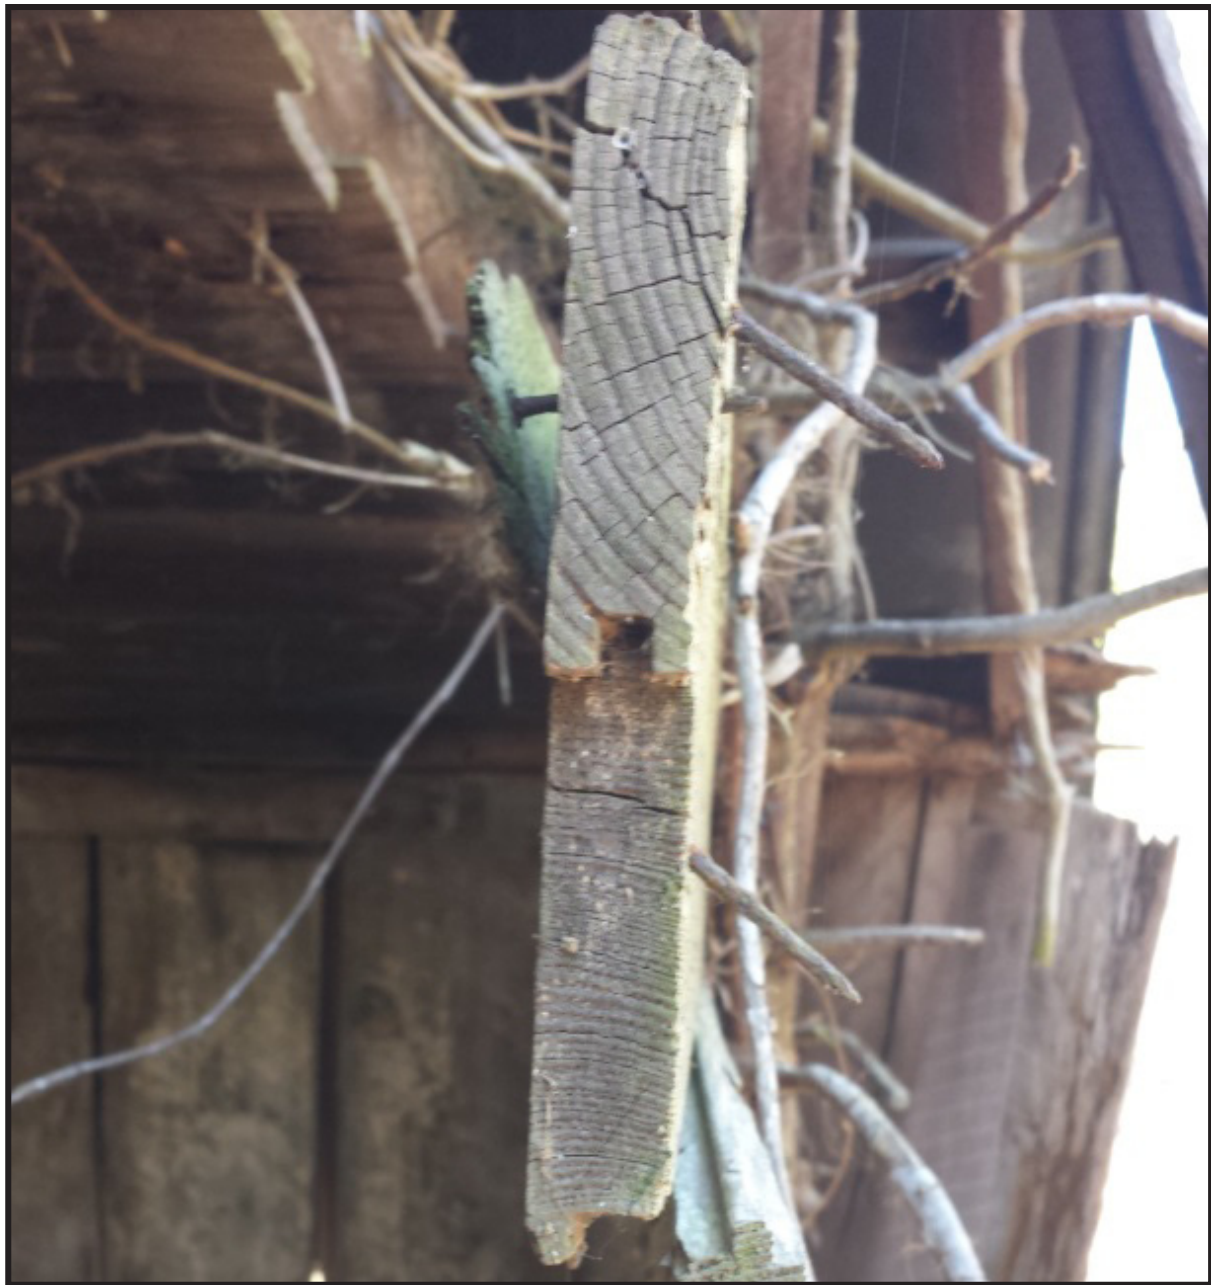
Figure 27. Tongue and groove boards used in the construction of interior walls of a structure.

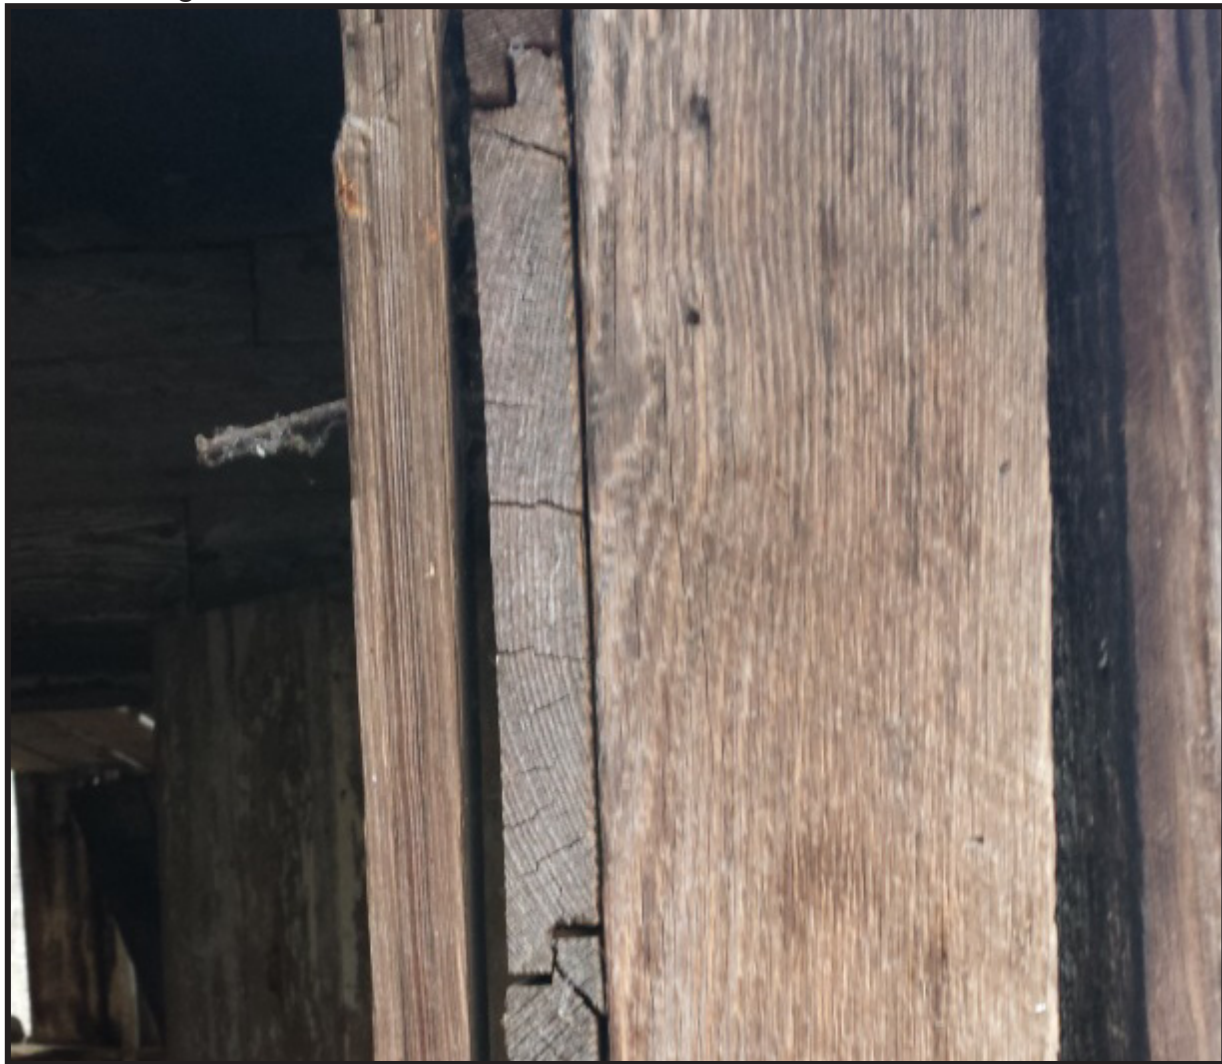
Figure 28. Boards with lap joints used in the construction of interior walls of a structure.

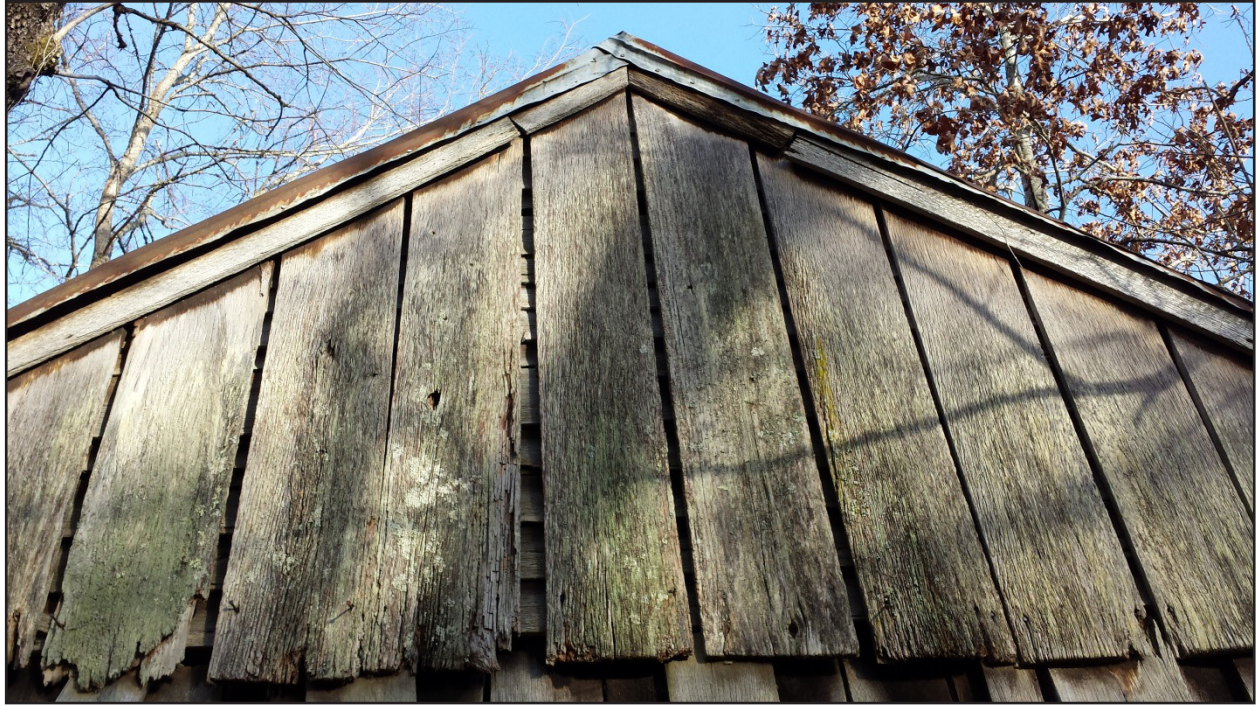
Figure 30. Clapboard siding underneath the board and batten on the gable of SCH#6.

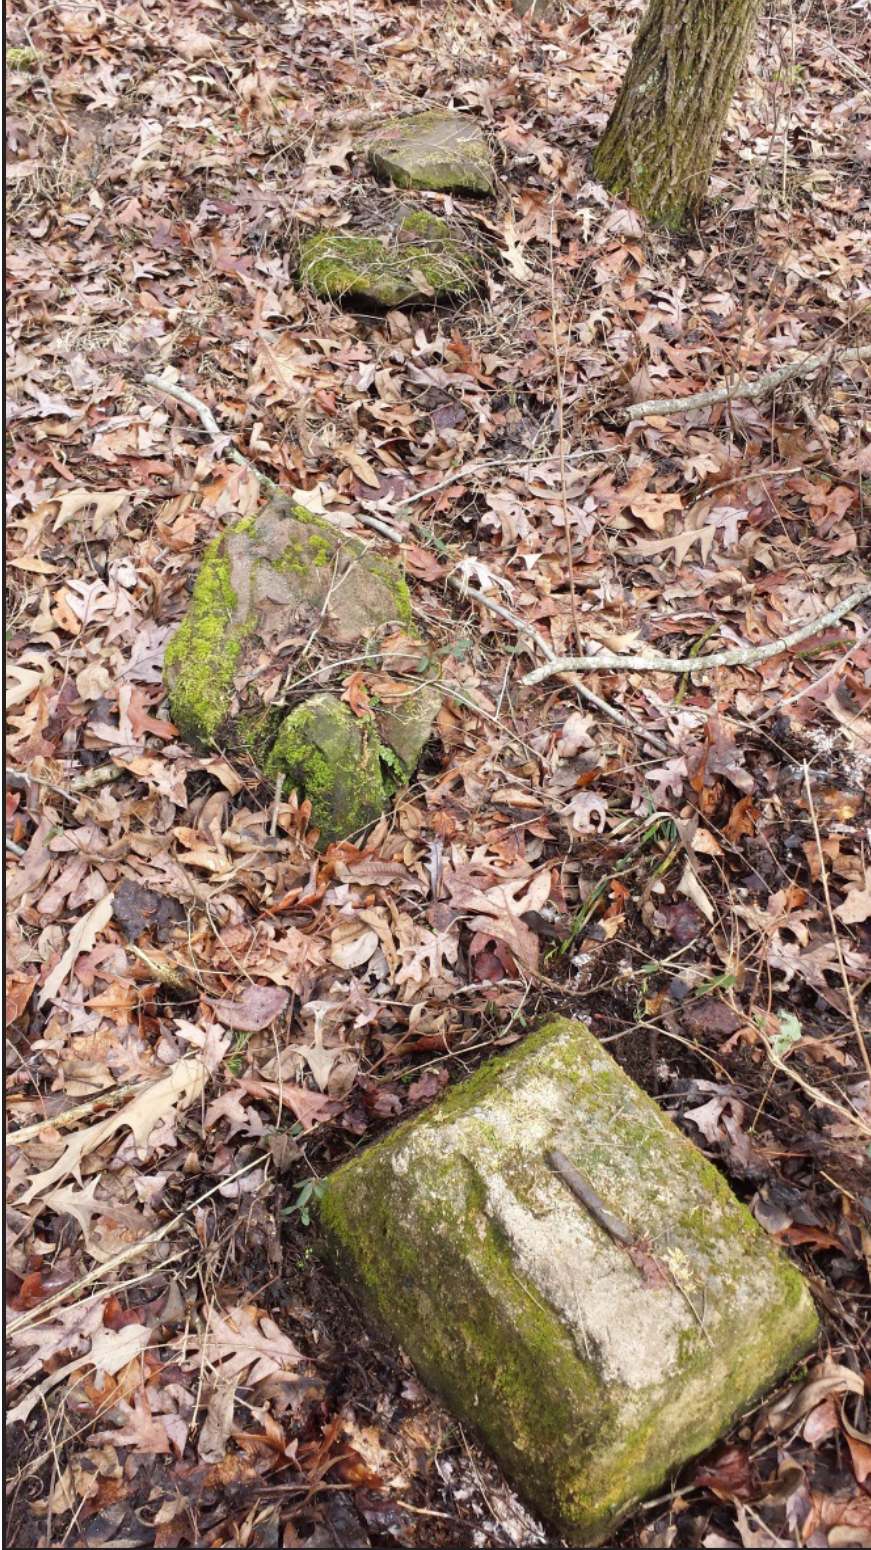
Figure 42. Concrete block and sandstone used as a foundation for SCH#14.

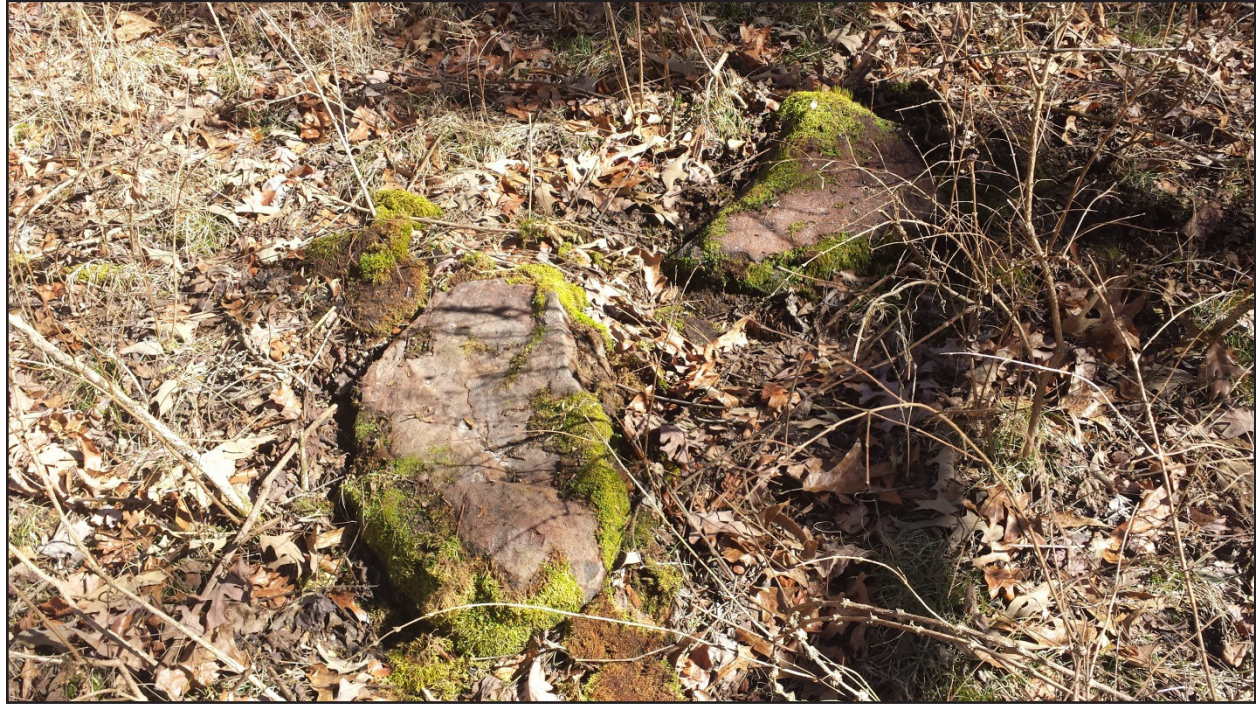
Figure 45. Sandstone foundations found at the area for SCH#15.

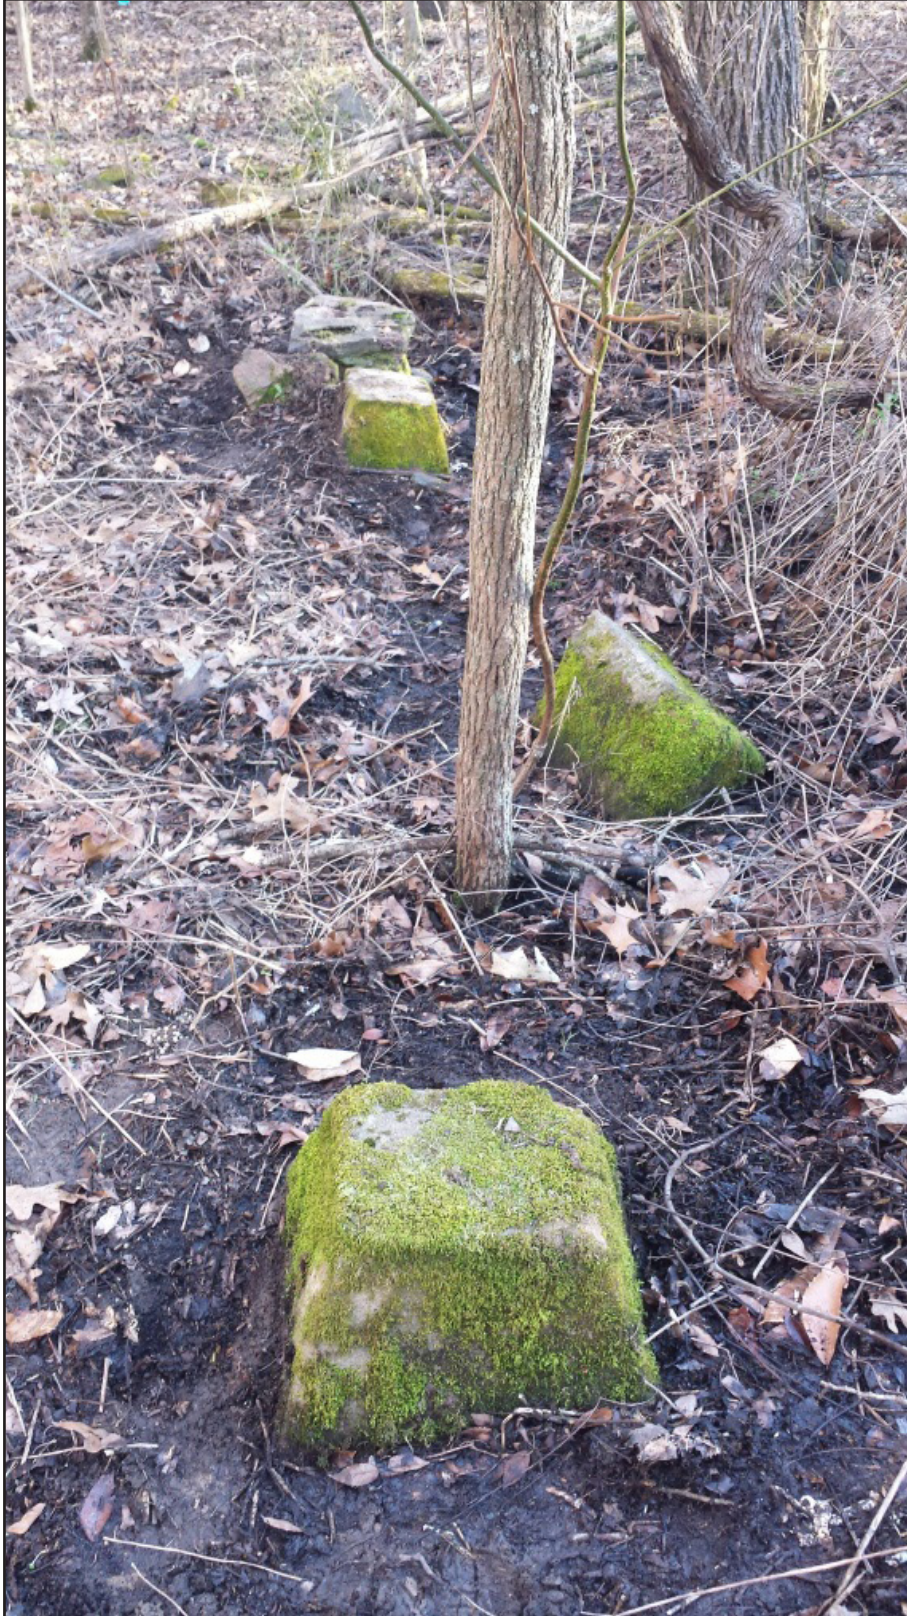
Figure 48. Concrete blocks and sandstone used as foundations for SCH#16.
