Utility cut repair techniques – Investigation of improved utility cut repair techniques to reduce settlement in repaired areas, Phase II

A thesis submitted to the graduate faculty
in partial fulfillment of the requirements for the degree of
MASTER OF SCIENCE

Major: Civil Engineering (Geotechnical Engineering)

Iowa State University

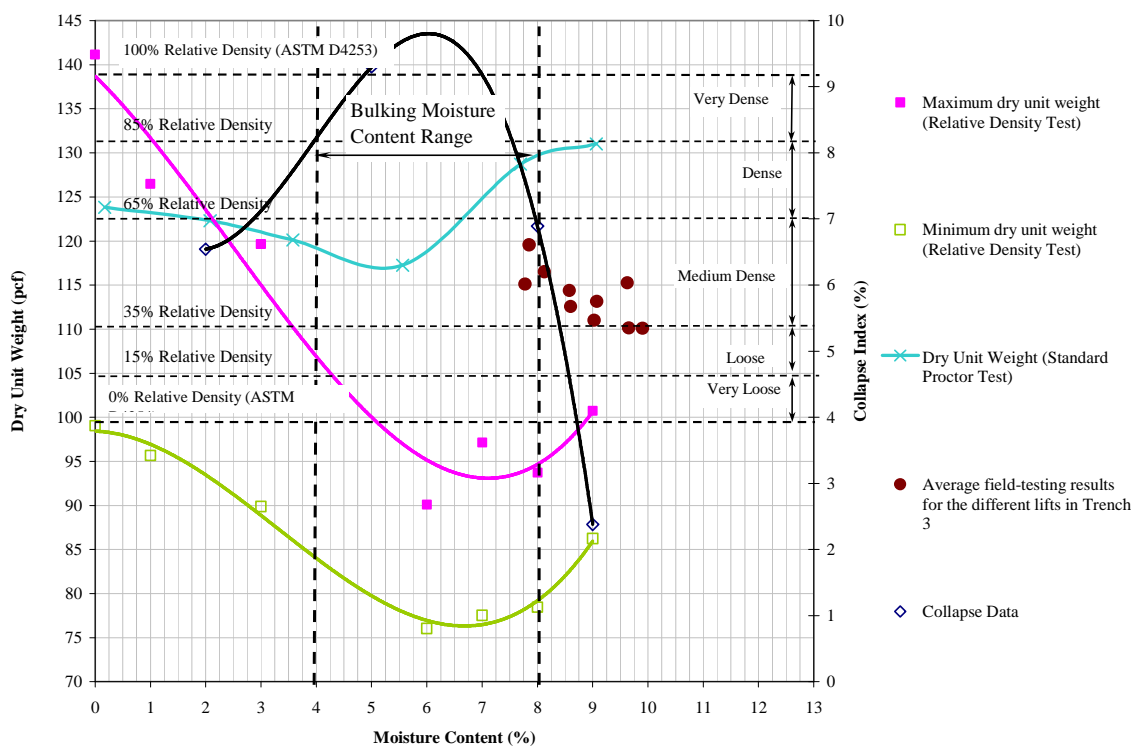
Figure 3 -- Measured densities compared with maximum and minimum densities, showing loose backfill material after compaction

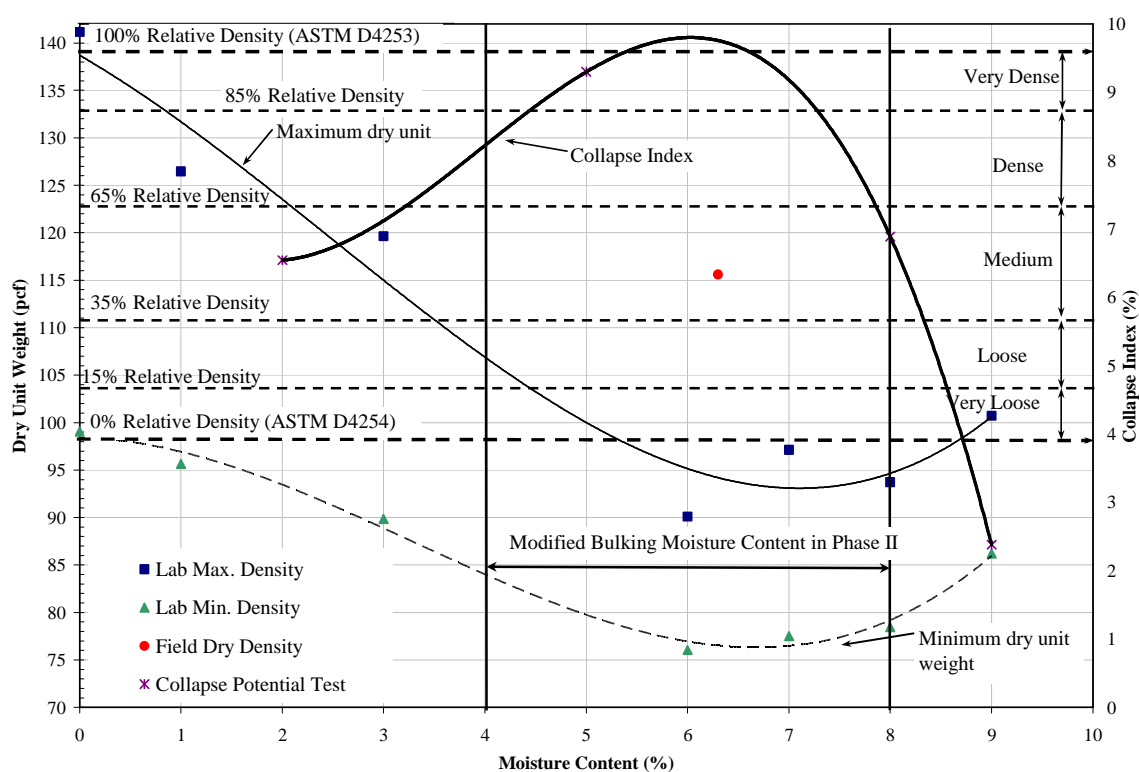
Schaefer et al.. 2005 stated that CBR values from the Clegg Hammer ranged from 5.8% to 7.6% with an average CBR value of 6.7%. The reported CBR values from the DCP test ranged from 3.7 % to 17.4% with an average CBR value of 11.3%. The CBR values from the DCP and Clegg Hammer tests were below the typical CBR values of 20% to 40% indicated by NAVFAC in Table 5. Complete CBR data is in Table 15 of Schaefer et al.. 2005 (Phase I). Schaefer et al.. 2005 concluded that the CBR values indicated that that the strength of the backfill was constant with depth.

Figure 19-- Relative density and average field-testing results for the trench backfill material for the Ames site (modified from Schaefer et al.. 2005)

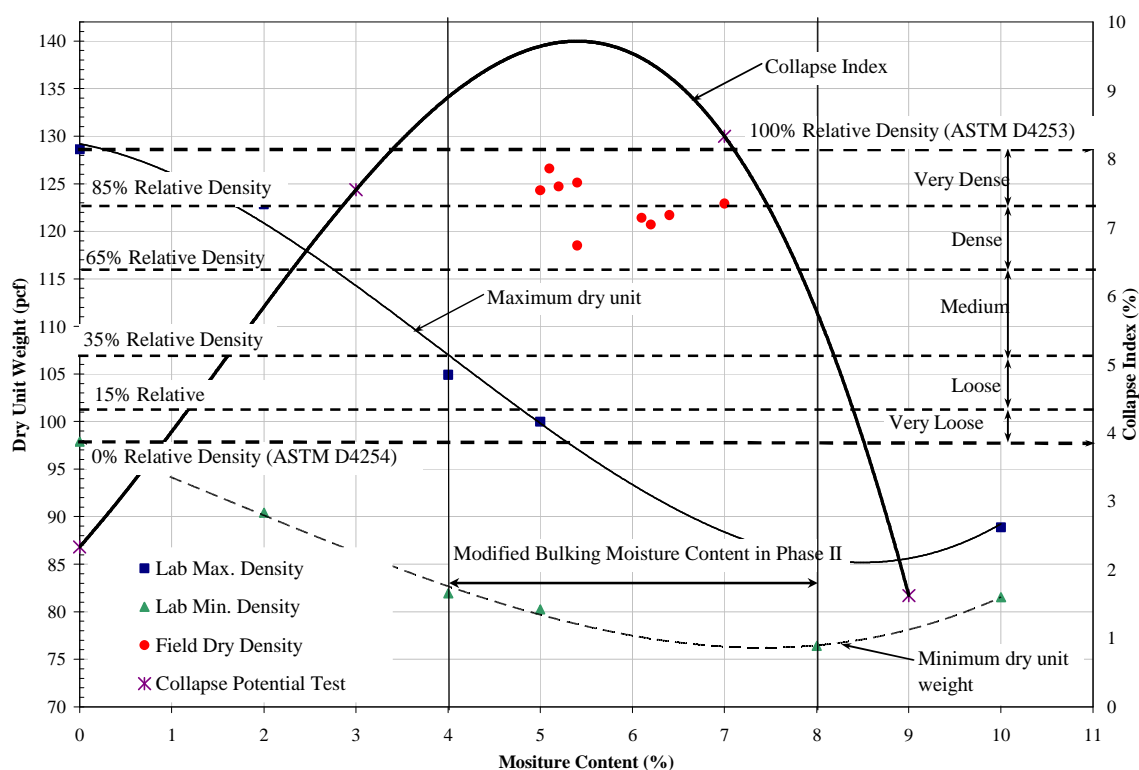
Schaefer et al.. 2005 reported that the CBR values obtained from the Clegg Hammer test ranged from 8.2% to 12.9% with an average CBR value of 12.9%. The CBR values from the DCP tests ranged from 4.9% to 25.0% with an average CBR value of 13.3%. Schaefer et al.. 2005 stated that these values were “just above to below the typical CBR values of 10% to 20%.” Complete CBR data is in Table 15 of Schaefer et al.. 2005 (Phase I final report).

Figure 26 -- Relative density and average field-testing results for the trench backfill material for the Cedar Rapids site (modified from Schaefer et al., 2005)

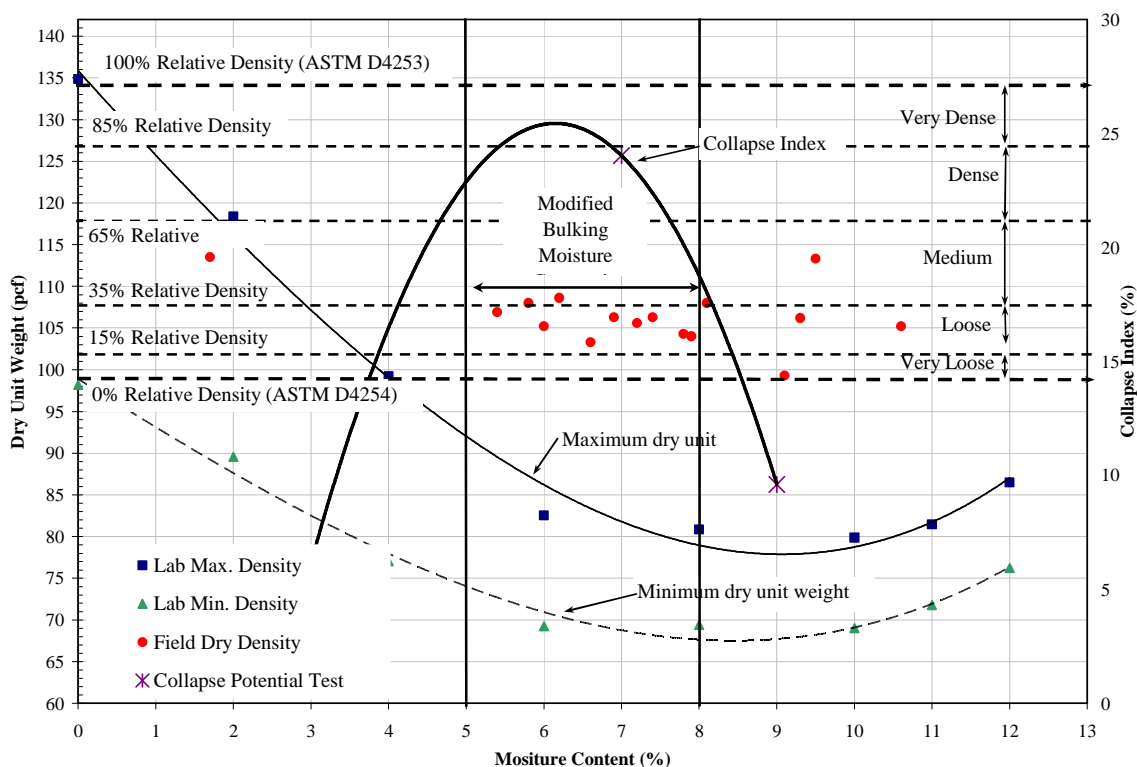
Schaefer et al.. 2005 reported the following CBR results from the Clegg Hammer nad DCP test. The CBR values from the Clegg Hammer ranged from 4.6% to 15.1% with an average CBR value of 8.6%. The CBR values from the DCP test ranged from 2.7% to 34.9% with an average CBR value 12.5%. Schaefer et al.. 2005 were below the typical range of 20% to 50%. Complete CBR data is in Table 15 of Schaefer et al.. 2005 (Phase I final report).

Figure 33 -- Relative density and average field-testing results for the trench backfill material for the Des Moines site (modified from Schaefer et al.. 2005)
