Validation of Ndesign in Iowa

Validation of N_{design} in Iowa

Major: Civil Engineering (Civil Engineering Materials)

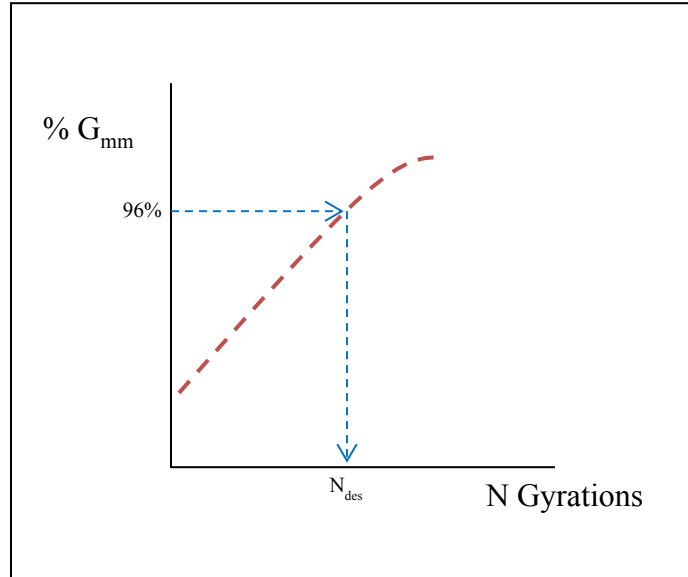
Figure 7: Concept of N_{design}

AASHTO R 35 were significantly higher than the ultimate pavement density, primarily at ESAL levels greater than 0.3 million. Figure 7 displays the general concept of N_{design} .

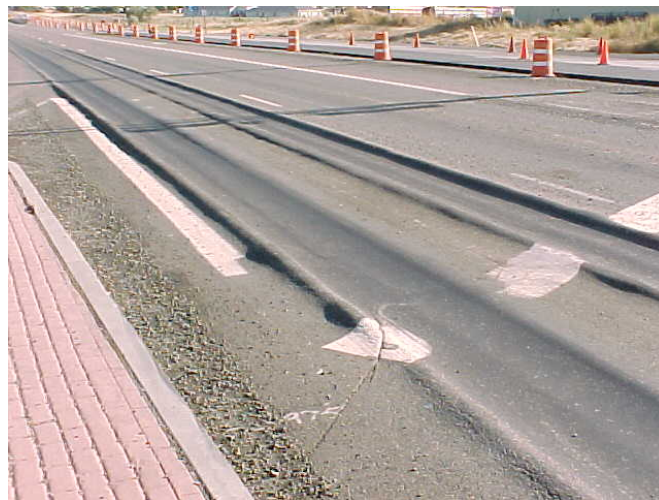
Figure 9: Severe rutting in flexible pavement [19]

Rutting occurs due to an accumulation of permanent deformation along the wheelpaths caused by excessive traffic loading (rut depth) and/or high temperature; and as a result causes compressive strain at the top of each layer, see Figure 9. Rutting can also occur due to inadequate compaction during construction [5]. The severity level can be detected by following the *Highway Pavement Distress Identification Manual for LTPP*. High severity rutting, if left untreated can lead to hydroplaning caused by the build-up of water and therefore may lead to structural failures [11]. Additionally, excessive rutting can cause serviceability issues because the ride quality becomes inadequate for travelers [5]. About 32% of rutting occurs in the surface layer and 14% and 45% in the base and subbase respectively [11]. Generally, with the existing N_{design} used in Superpave, rutting resistance has not been reported to cause major inadequacies to the pavement structure. Thus, reducing the N_{design} value can negatively affect the rutting resistance and consequently increase permanent deformation in the structure due to higher asphalt content [15].

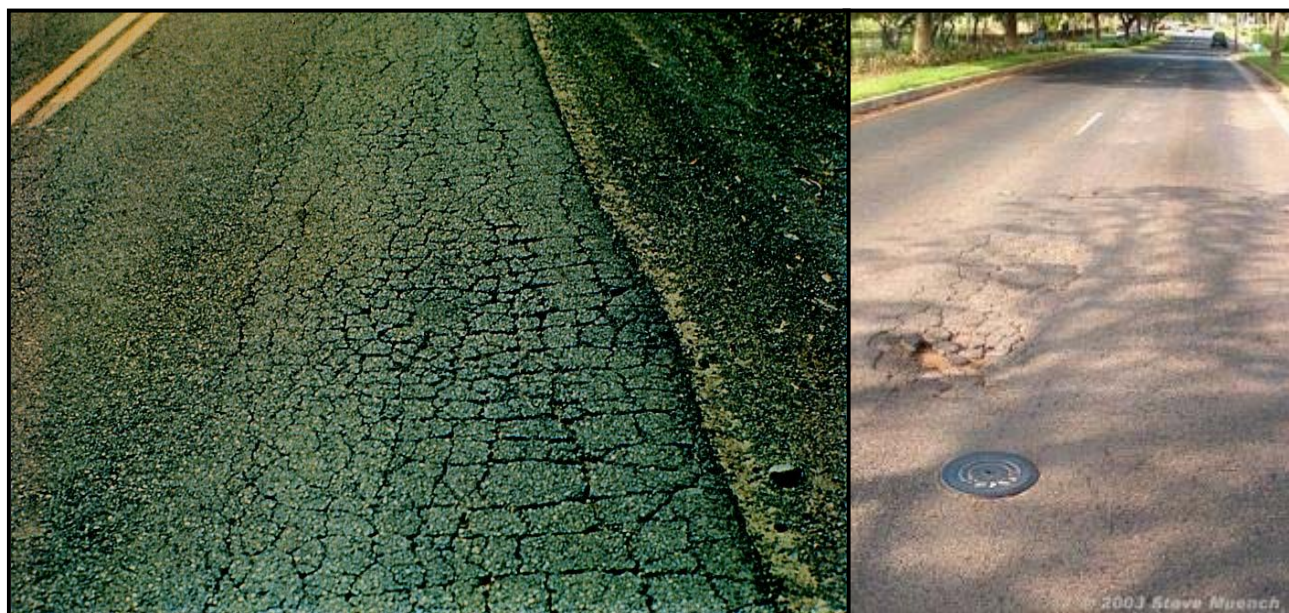
Figure 10: Fatigue cracking (left). Pothole caused by fatigue cracking (right) [20]

Fatigue cracking in flexible pavements causes horizontal tensile strain at the bottom of the asphalt or base layer under repeated traffic loading, see Figure 10(a). The small cracks start at the bottom of the asphalt or base layer and propagate to the surface layer resulting in a series of interconnecting cracks caused by fatigue failure [11]. There are many factors that contribute to fatigue cracking, such as improper design (QC/QA), pavement material characteristics, weak subgrade soil, traffic loading, moisture due to poor drainage and temperature. While too much

If left untreated excessive fatigue cracking will result in loose surface materials that will ultimately lead to potholes, as shown in Figure 10(b). Pavement rehabilitation is required in order to restore pavement conditions and increase serviceability. However, the underlying pavement layers in addition to the traffic loads must be evaluated and considered in design prior to the rehabilitation process because weak layers do not provide sufficient support to accommodate or withstand traffic loads [5]. Previous studies have shown that mix design using Superpave showed early signs of fatigue cracking. In order to reduce the fatigue cracking, different agencies suggested adding enough binder to reduce/delay cracking.

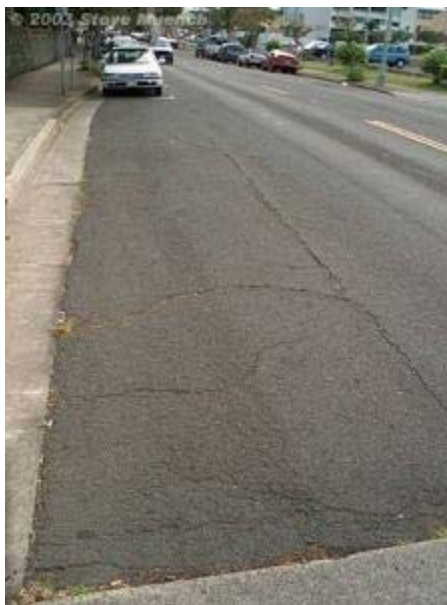
Figure 11: Block cracking, type of thermal cracking [21]

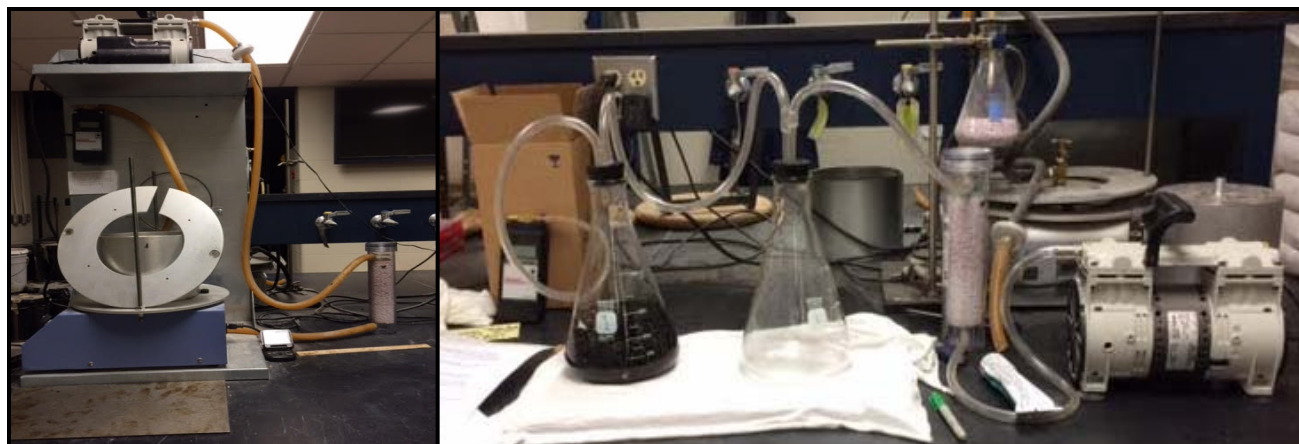
Figure 18: Metal bucket method (left) and flask method (right)

The theoretical maximum density (G_{mm}) was initially estimated per project milestone based on the closest stationing from the G_{mm} measured from the QC/QA hotbox of loose mix recorded by the Iowa DOT at construction. The actual G_{mm} for each core sample was then verified in accordance to AASHTO T 209. Two methods in AASHTO T 209 were used to determine the G_{mm} in the laboratory; the flask and metal bucket methods, as shown in Figure 18. The surface mix samples was heated in the oven at $105 \pm 5^\circ\text{C}$ for 30 minutes or until the core is tender enough to break apart. For the flask method, a total of 2000 grams of sample was tested [24]. Similar to the bulk specific gravity, the flask method is known to produce accurate values for G_{mm} . Both methods yielded the same results.

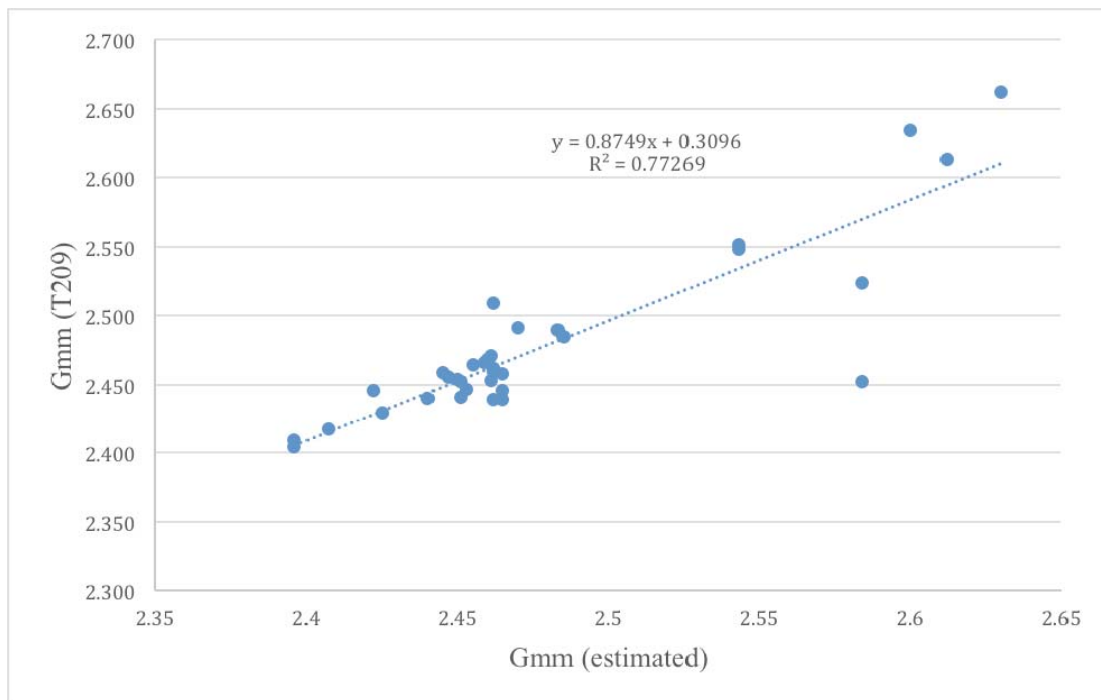
Figure 24: G_{mm} estimated or QC/QA versus actual G_{mm} or G_{mm} tested with AASHTO T209

The $G_{mm(QC/QA)}$ is the G_{mm} measured during QC/QA at construction and was used initially to estimate the field air voids at construction with the actual calculated G_{mb} from the field cores. It is expected that the values for $G_{mm(QC/QA)}$ would yield equivalent values of G_{mm} directly measured from the core. To verify, G_{mm} testing was carried out to validate if QC/QA G_{mm} values matched actual field core G_{mm} values. As shown in Figure 24 and Figure 25, based on the results, the percent air voids for $G_{mm(QC/QA)}$ yielded similar results to G_{mm} tested using AASHTO T209. The $G_{mm(QC/QA)}$ was also plotted against actual field G_{mm} with a linear fitted regression line. Figure 24 show that G_{mm} values 2.50 and below displayed better correlation between the observed values and predicted ($G_{mm(QC/QA)}$). Thus, for evaluating future air void information, the G_{mm} can accurately be used from QC/QA as opposed to conducting additional laboratory testing to validate the G_{mm} directly from field cores.

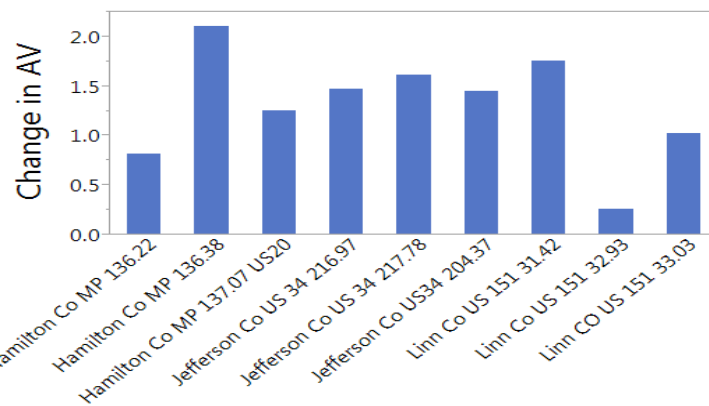
Figure 26: Change in percent air voids per ESAL level, (a) 100-300K, (b) 1M, (c) 3M, and (d) 10M

The average air voids four years post-construction for 100-300 ESALs was about 4.0% air voids, which indicate that the pavements under this specific ESAL level range reached ultimate pavement destiny. At construction, the air voids were compacted to an average of 6.0% at this ESAL level range. At 1M ESALs, although the average air voids at construction reached the initial target air voids of about 7.0%, the average air voids 4 years post-construction was about 5.0%. The results for 3M ESALs varied, specifically for projects paved in IA 160 in Polk Co (project 8). The overall average air voids four year post-construction and at construction was approximately 5.0% and 6.50% respectively. In project 8, the air voids at construction was roughly 5.0%, significantly lower than the desired initial target air voids compared to the other two projects. Pavement density for project 8 4 years post-construction reached to about 4.0% air voids, a 2 percent change in air voids. At 10M ESALs, the average air voids at construction for projects located in Hwy US 20 in Hamilton Co and Hwy US 34 in Jefferson Co (Projects 12 and 11 respectively) was about 7.30% air voids, which is above the initial target air voids; and the project located in Hwy US151 in Linn Co (Project 10) was overcompacted to about 5.0% air voids at construction. The air voids four years post-construction for projects 12 and 11 did not densify to 4% and final density was determined to be in the range of 6.20 – 6.80%, whereas in project 10, the air voids were approximately 3.0%. See Figure 28 for the average air voids per ESAL level 4 years post-construction and at construction.

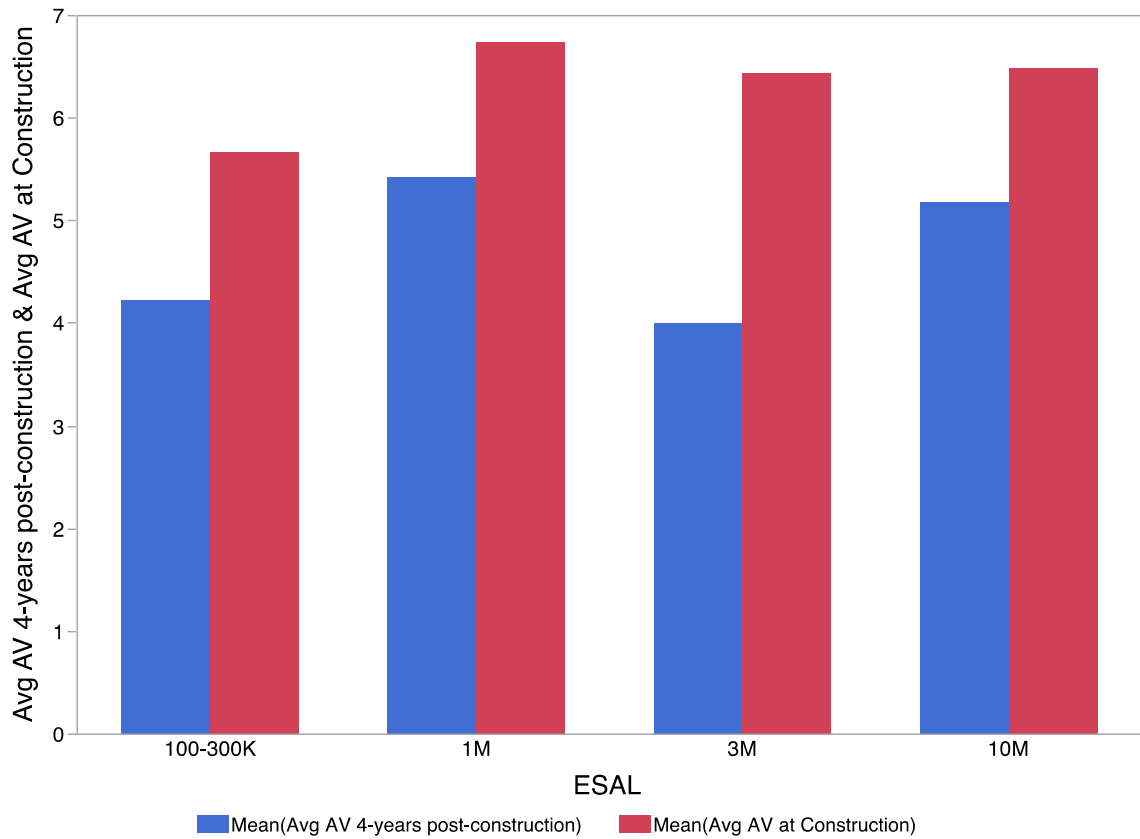
Figure 28: Average AV at construction and four years post-construction

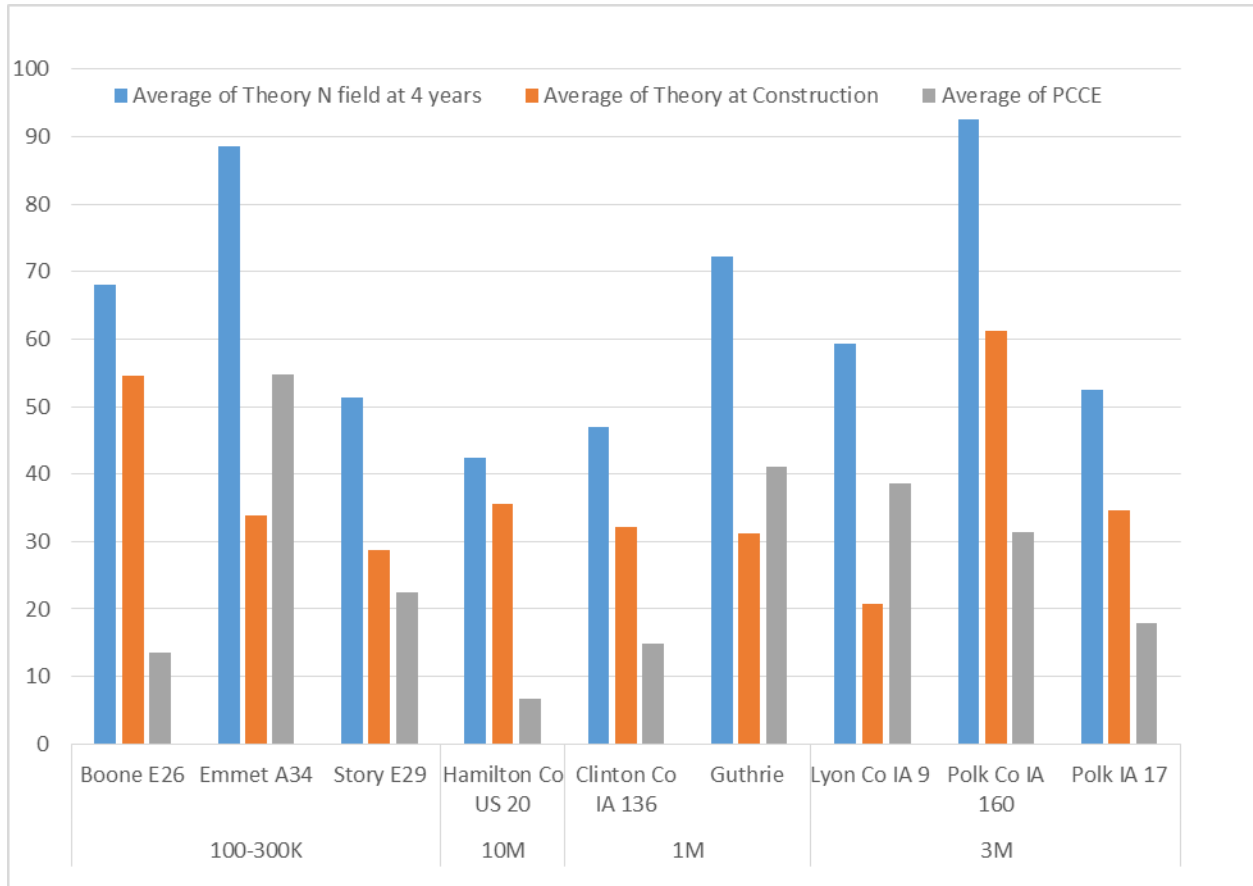
Figure 31: Average Theory N@4yrs, N@const., and PCCE for each ESAL level
