## Mechanical Behavior of a Fuselage Stiffened Carbon-Epoxy Panel under Debonding Load

The present project sets out the analysis of mechanical behaviour of a carbon-epoxy stiffened panel under bending load. For this purpose, the National Polytechnic Institute of Mexico counts with a non-airworthy B727-200 as experimental platform. The first step was to calculate the aerodynamics loads and flight envelope of the aircraft. Secondly, the selection of the fuselage section is performed in order to identify an adequate stiffened panel for the study. The structural elements of the panel, skin and stiffeners were manufactured by VARTM and glued with high strength adhesive. The load, in bending condition, was imposed by a structural testing machine in order to emulate, at lab scale, the flight conditions responsible for debonding the stiffeners from the skin. The displacement field was determined by Digital Image Correlation (DIC) and the strains values at key zone of the fuselage by gages measurements. Finally, the failure mechanisms were analyzed with the goal to improve the knowledge of the stiffened-skin glued joint solution.

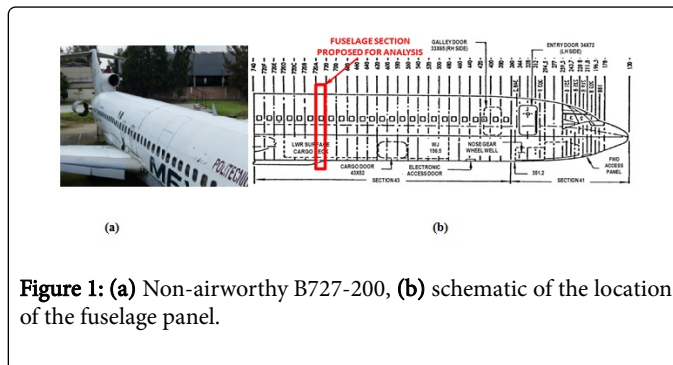
Figure 1: (a) Non-airworthy B727-200, (b) schematic of the location of the fuselage panel.

The IPN of Mexico has a non-airworthy B727-200 aircraft, which can be used as scale-one experimental platform (Figure 1a). This

aircraft offers the opportunity to study representative scenarios for designing, repairing and replacing large zones on the nose radome, fuselage, wing and elevators. As initial study case, the approach was to select a fuselage panel candidate, first to be reproduced at lab scale, and then, to be evaluated in-situ on the aircraft. The selected panel belongs to section 43, between the 720 and 720-A frames (Figure 1b) [17].

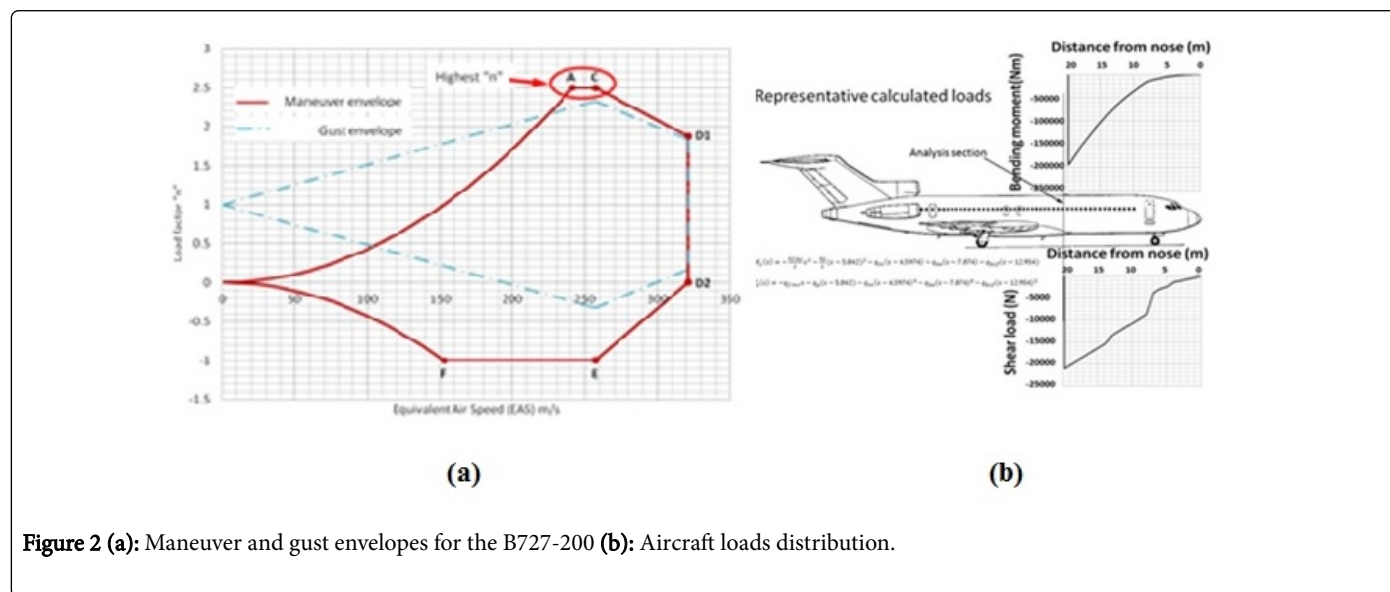
Figure 2 (a): Maneuver and gust envelopes for the B727-200 (b): Aircraft loads distribution.

Previous work has been done to calculate the aerodynamic and structural forces acting on the selected fuselage panel. The loads relevant to the fuselage are caused by three sources: 1) aircraft maneuvers, 2) aircraft weight distribution and 3) cabin pressurization. Following the weight fractions method [18], the weight for all components of the aircraft was estimated using the maximum take-off weight. The basic engineering criterion to design a fuselage is to consider it as a balanced beam under distributed load with only one middle support. For the aerodynamic forces, the maneuver and gust envelopes were calculated to identify the critical design scenario for the fuselage panel, resulting on cruiser speed and maximum load factor (Figure 2a). Additionally, the cabin differential pressure at cruiser altitude is taken into account for the stress calculation. The effect of all these loads can be summarized in a load distribution diagram through the length of the fuselage (Figure 2b).

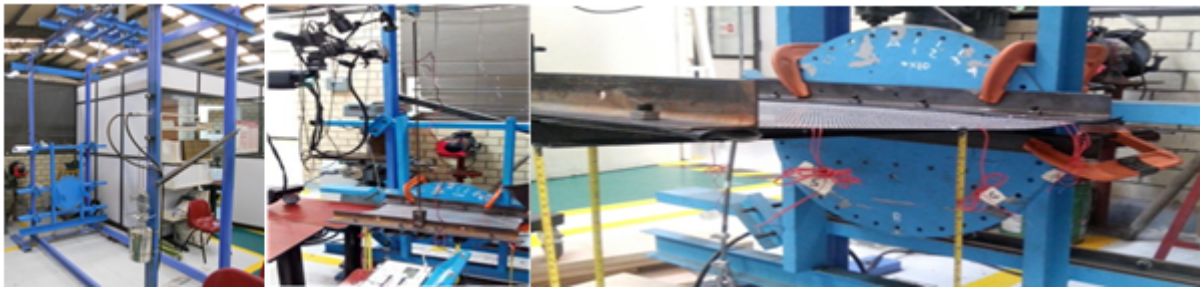
Figure 5: Mechanical test of the composite panel (a) in-house testing banc, (b) and (c) DIC setup.

As first approach, the stiffened composite panel was tested in an in-house built representative structural testing banc (BESTER) designed for the test of UAV's structures (Figure 5a).

In order to represent at lab-scale the stress condition calculated (cf. section 2), the composite panel is constrained in cantilever condition, fixing one side of the panel and applying the bending load on the other side with one servo-hydraulic actuator through a metallic brace (Figure 5b).

The instrumentation of the composite panel consists in three strain gauges; two located on the stiffener-skin zone near the fixed side and one located at the center of the fuselage panel. Additionally, the skin was painted with a white speckle pattern with the aim to employ Digital Image Correlation (DIC) during the test (Figure 5c). A set of two CCD cameras is placed and calibrated for making image acquisition without visual alterations.

The CCD cameras had lens with 2.4 mm of diameter and 70 mm of focal distance. The region of interest selected (ROI) is the total surface of the skin of the panel. Once the images are captured, the software GOM-Aramis is used for the images post-treatment.

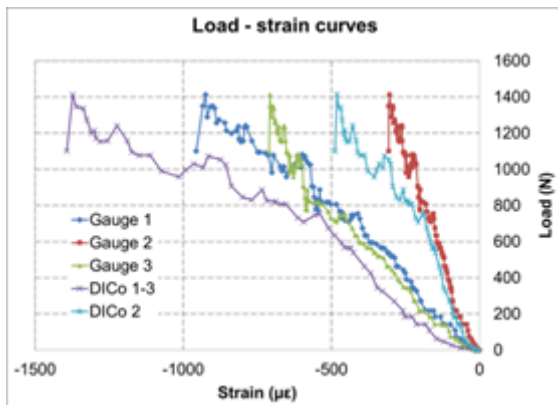
Figure 6: Load-strain curves for the fuselage panel by strain gauges measurements.

The fuselage stiffened composite panel subject to bending condition presents a linear behavior prior to failure, caused by debonding of the stiffener-skin interface. The load-strain curves, obtained by strain gauges measurements, show that the stiffener-skin zones near the fixation (Gauges 1 and 3) are the most constrained when the composite panel is under bending moment.

The skin zone (gauge 2) is less deformed; as the mid-zone of the panel carries a lower load compared to the stiffeners reinforced zones (Figure 6). As it can be seen, strain values from digital image correlation are over-estimated compared with the strain values obtained from strain gauges. As stiffener-skin zones are symmetrical, only one DIC strain-load curve is showed.

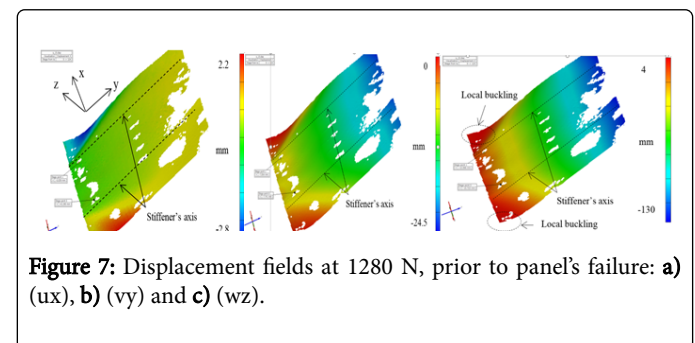
Figure 7: Displacement fields at 1280 N, prior to panel's failure: a) (ux), b) (vy) and c) (wz).

For all displacement fields obtained by DIC, the most elongated areas are the zones between the stiffeners and the two free-edges of the composite panel, near the fixation. On first place, the displacement field perpendicular to the stiffeners (Figure 7a) shows a small displacement variation between the two free-edges zones, which can be related to in-plane shear strains caused by a misalignment between the fixation's center and the metallic tensile brace.

On second place, the displacement field parallel to the stiffeners (Figure 7b) reveals a negative displacement on the loading side, inherent to the compression stresses that the composite panel suffered during the bending test. This displacement field also reveals that the

zones between the stiffeners and the panel's free-edges are the most constrained. Because the panel is under compressive stress state, the skin between the stiffeners and the free-edges presents local buckling. On third place, the panel's out-of-plane displacement field (Figure 7c) proves that the fixed side exhibits a lower displacement than the loaded side, as expected.

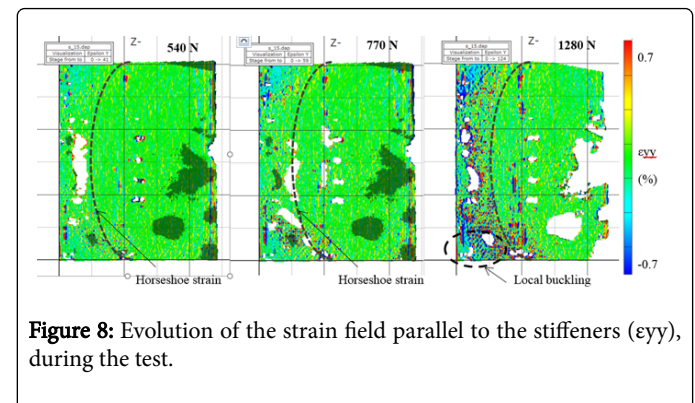
Figure 8: Evolution of the strain field parallel to the stiffeners ( $\epsilon_{yy}$ ), during the test.

As the skin is mostly submitted to compressive stresses, the analysis of the strain field ( $\epsilon_{yy}$ ) parallel to the stiffeners (Y-axis) is the more relevant for this study. The evolution of the strain field (Figure 8) clearly shows that the fixed side of the panel is the most strained, where strain concentrations appear between the stiffeners and the panel's free-edges.

The strain field shows a horseshoe type morphology which is related to the skin's local buckling due to the combined shear and bending condition to which the upper surface of the fuselage panel is submitted. The skin being under compressive stress causes the panel's geometric instability, leading to stiffeners-skin interface's debonding which results in a complete loss of the panel's load-carrying capacity.
