The Matas "barn", Robin Plantation (16SL66), St. Landry Parish, Louisiana-history and archaeology of a nineteenth century milk house

**THE MATAS “BARN,” ROBIN PLANTATION (16SL66),
ST. LANDRY PARISH, LOUISIANA—
HISTORY AND ARCHAEOLOGY OF A
NINETEENTH CENTURY MILK HOUSE**

A Thesis

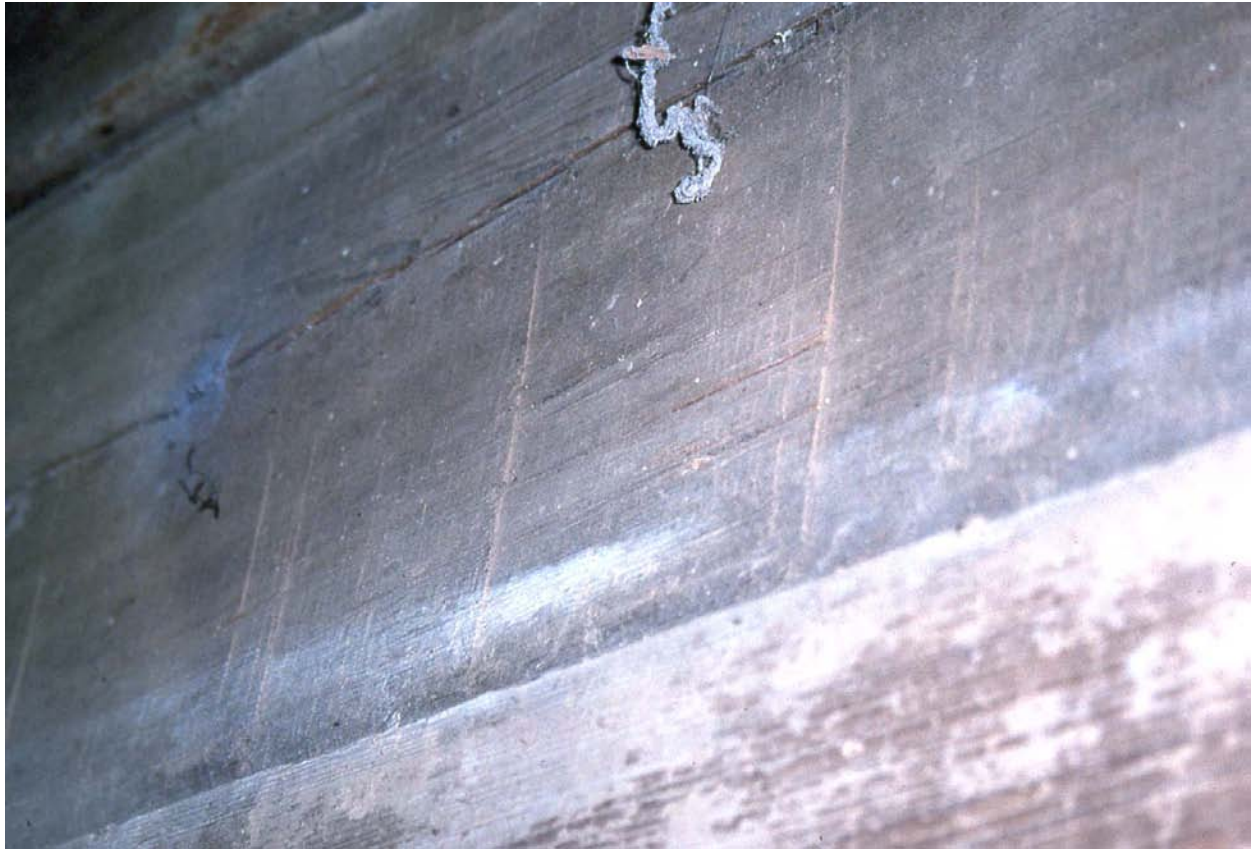
Figure 5.1. Faint sawmarks are visible on the cypress timbers of Room 1.

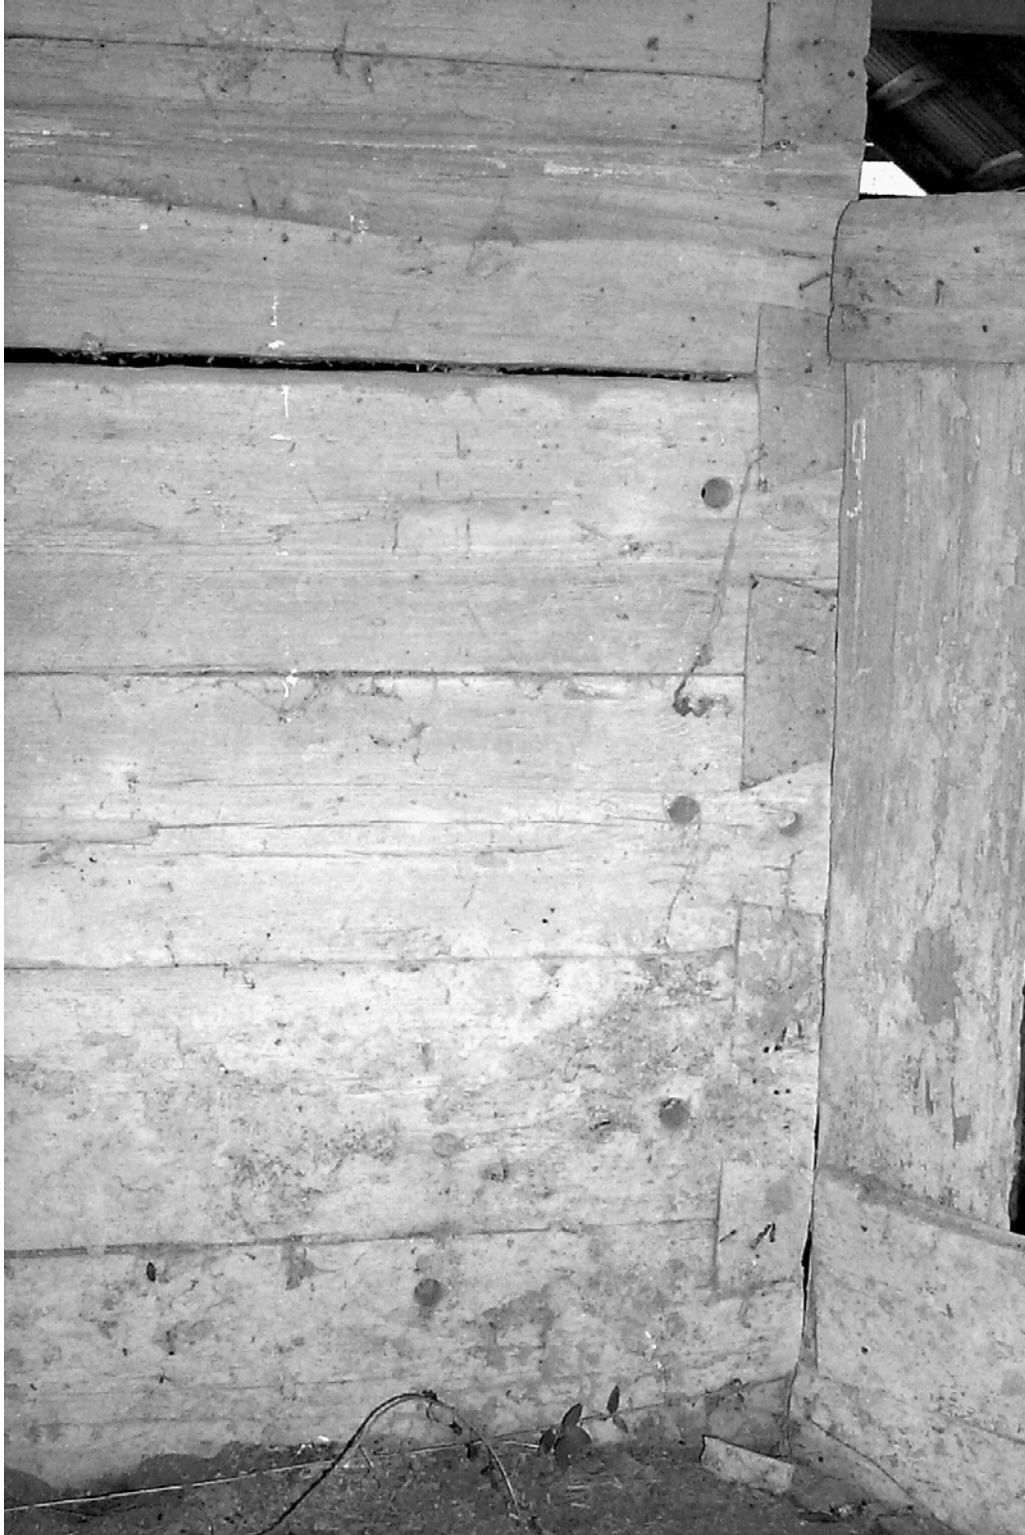
Figure 5.2. Some of the holes in the timbers seen here may have been created to construct timber “rafts,” which were floated from the mill to their final destination.

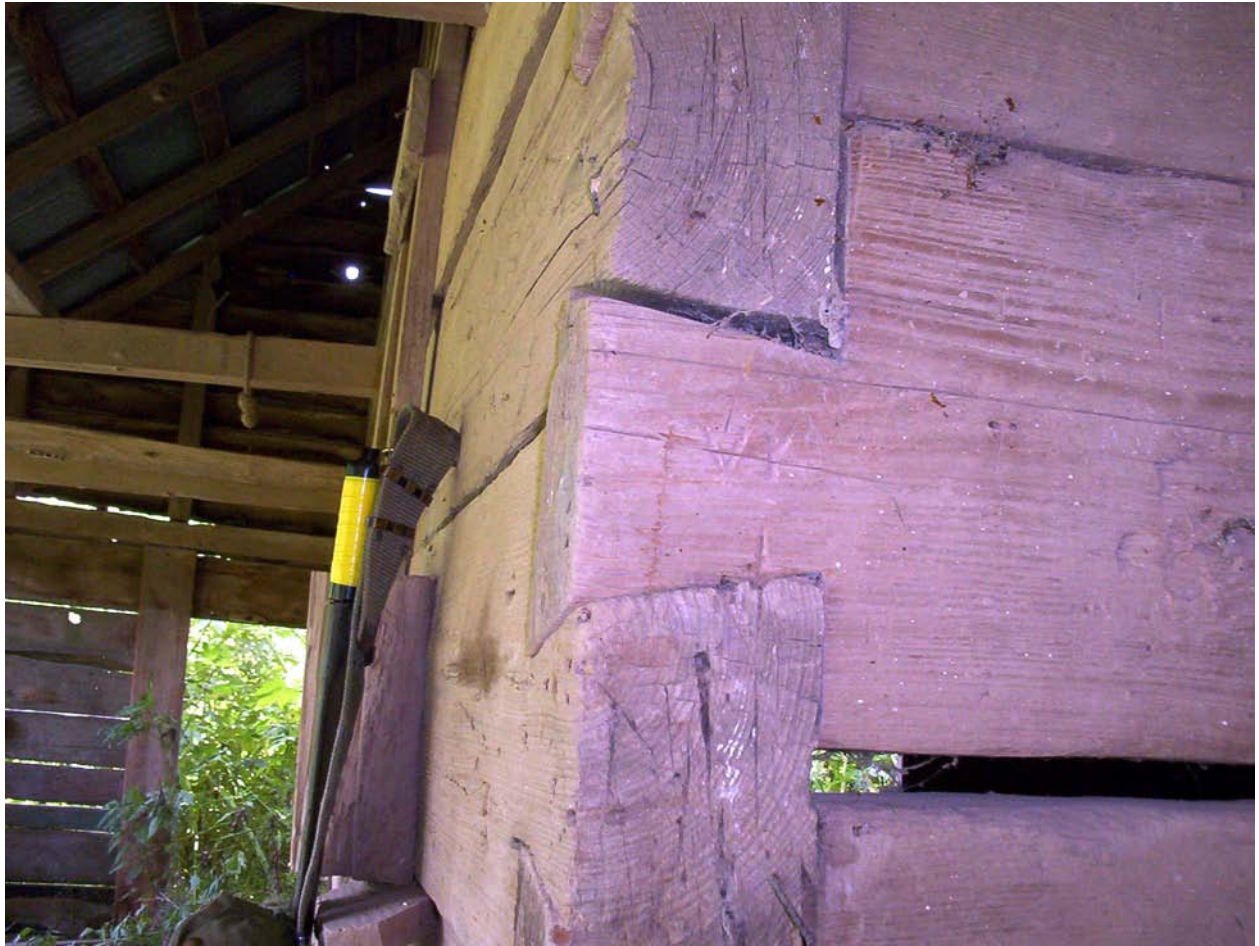
Figure 5.3. The carpenter's mark "VI" is visible on the end of this timber. This mark was used to insure easy assembly after notching the timbers.

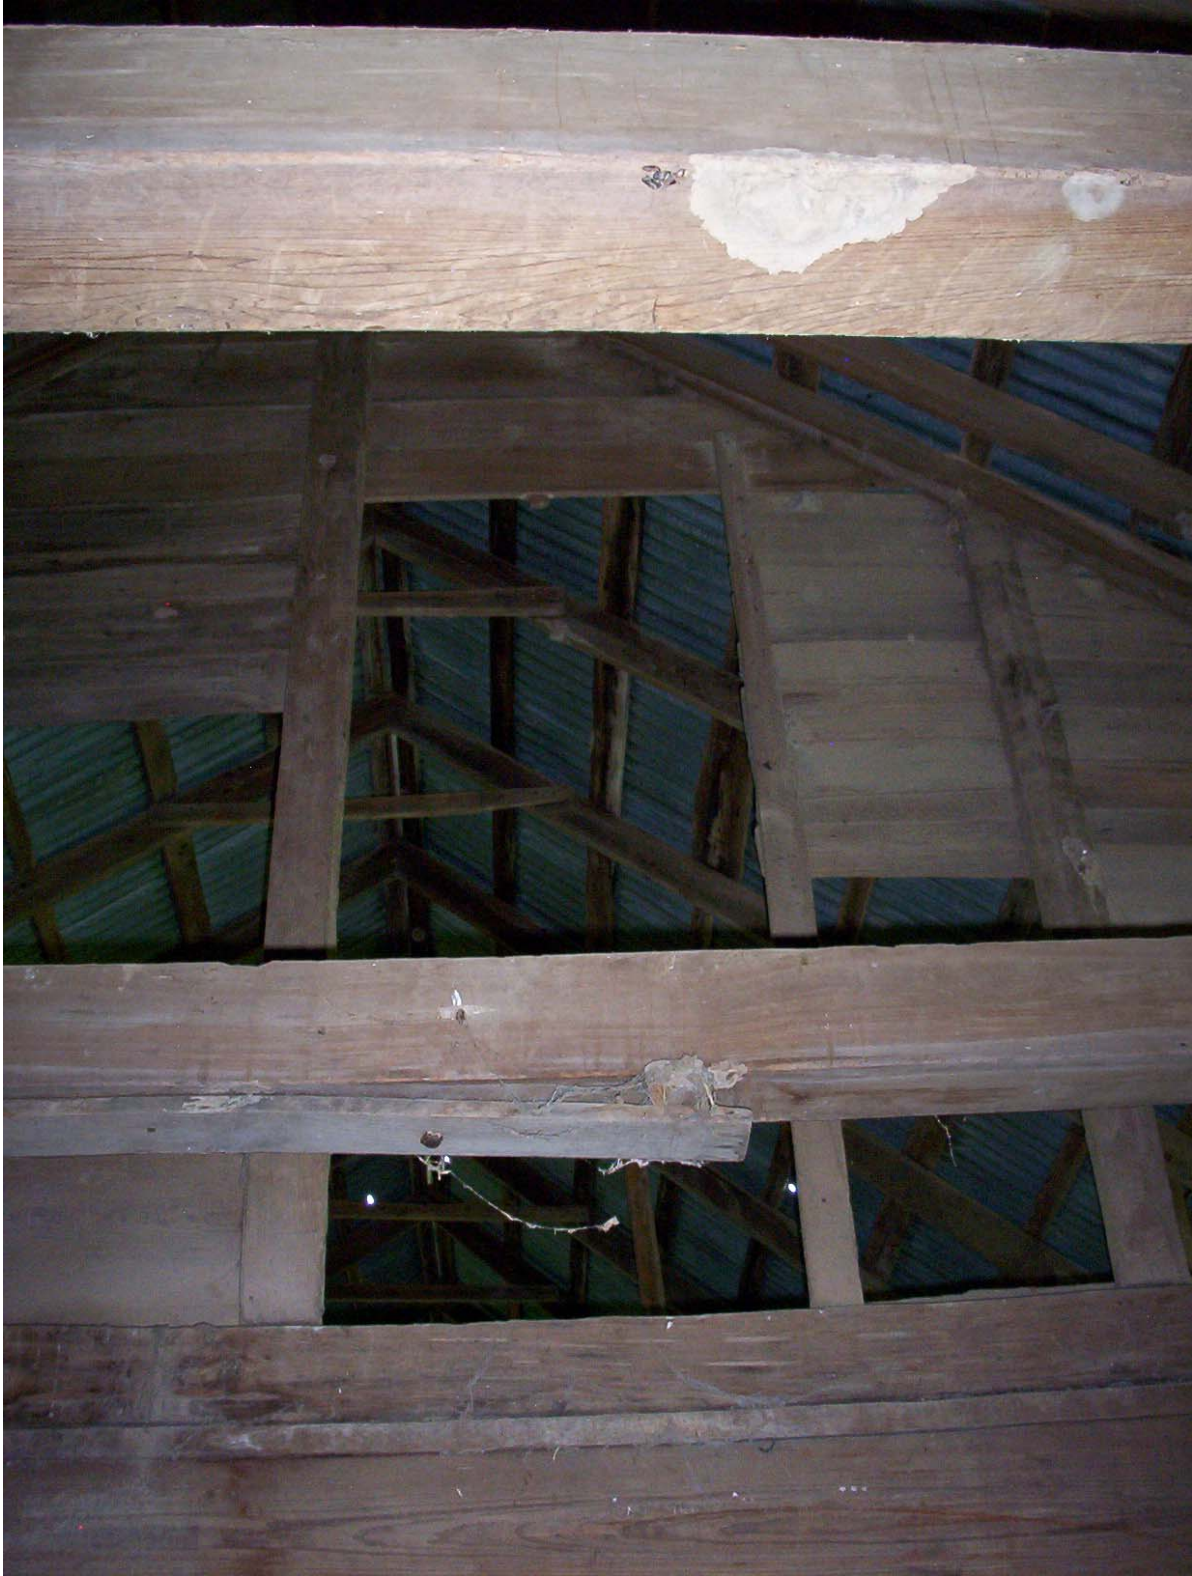
Figure 5.5. Ceiling joists measuring 3.5 by 5 inches are still present in Room 1.

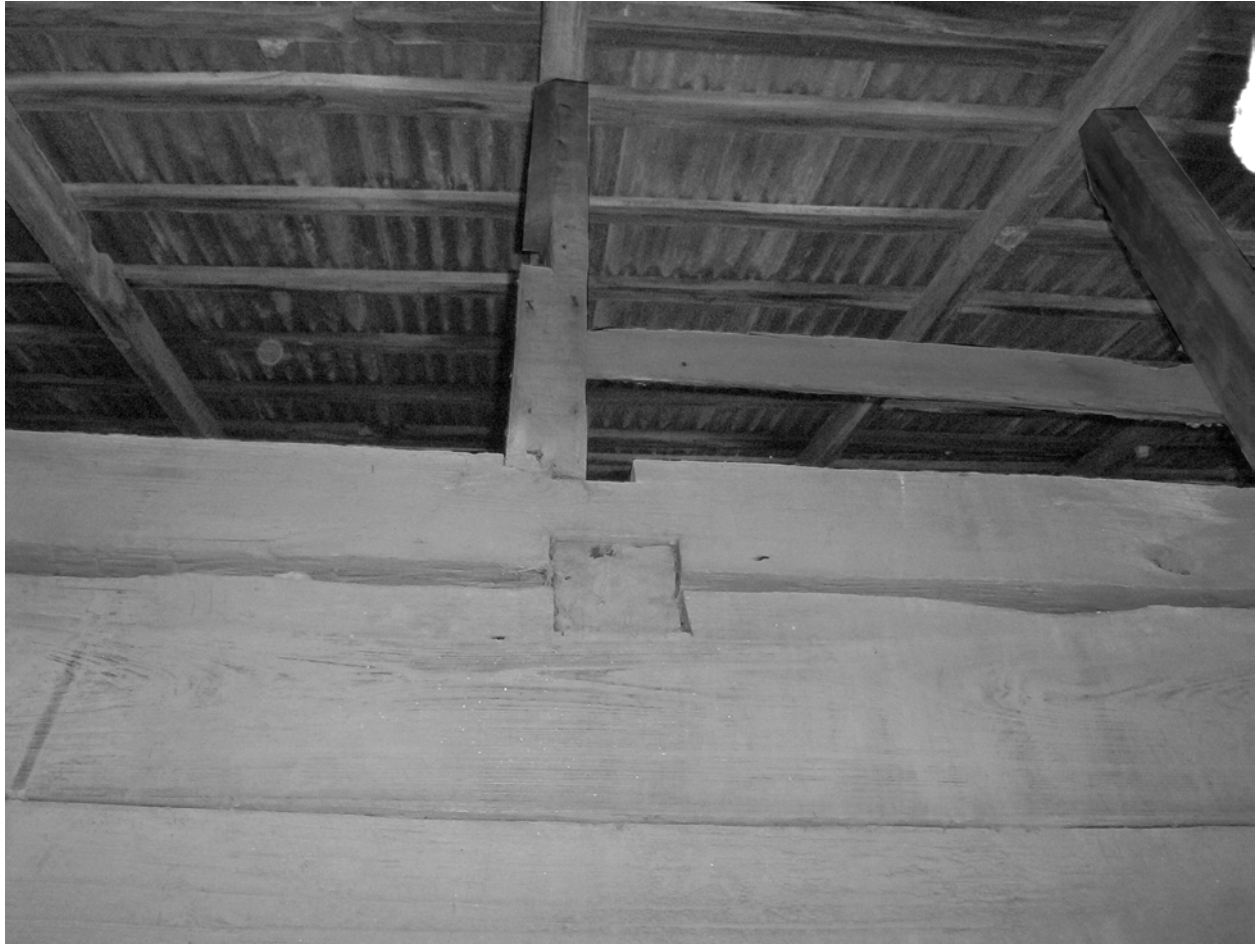
Figure 5.6. Ceiling joists are mortised through the two topmost timbers of the west and east walls of Room 1. Notches from the original roof joists are still visible (above the ceiling joist) and were partially reused for the uprights used to support the new roof. These uprights were created from used timbers, possibly from the original roof structure.

Uprights, to which the present roof is attached, are attached to the top plate of the room (see Figure 5.6). Whether these uprights were original to Room 2 or whether they were added when the two rooms were combined under a common roof is unknown. These mortises may have once held the substrate of the original roof and were reused to hold the uprights of the current roof.

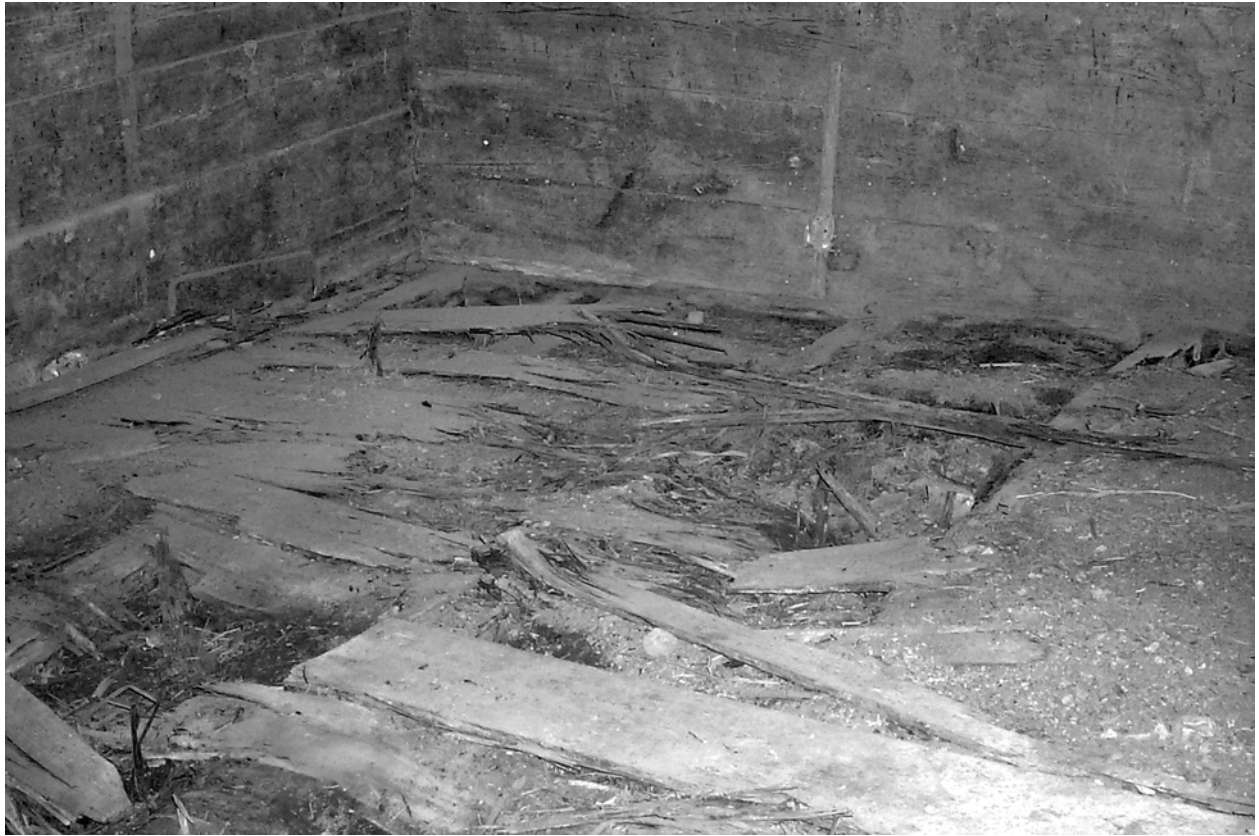
Figure 5.7. The tongue-and-groove floor is nailed to the floor joists and sills of Room 1.

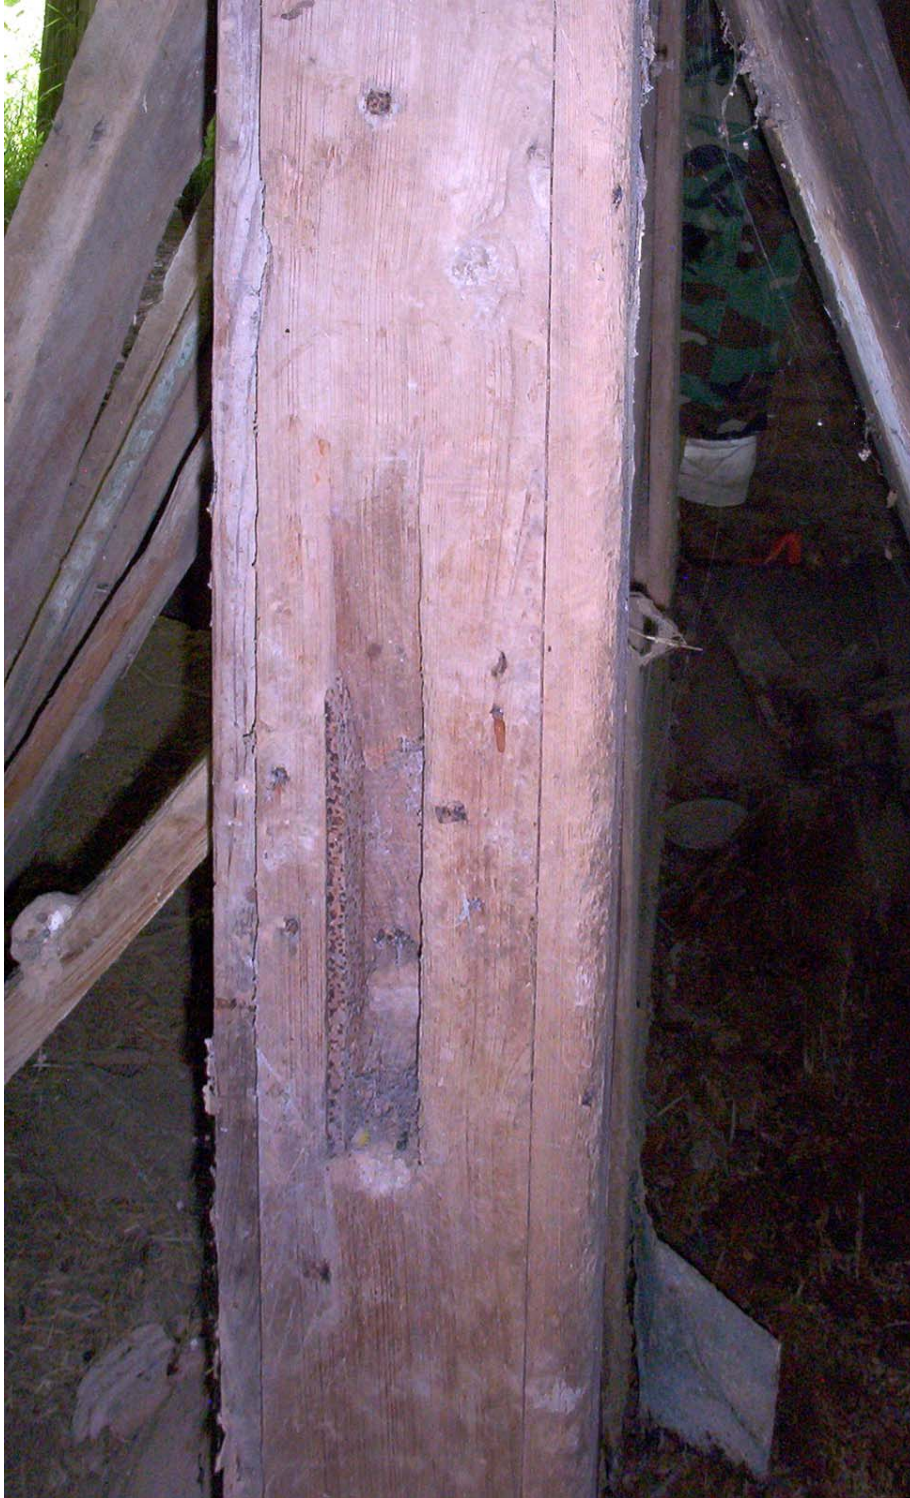
Figure 5.8. Most of the original openings in Room 1 were locked by bar-type latches. Only the notches that the bars slid into remain.

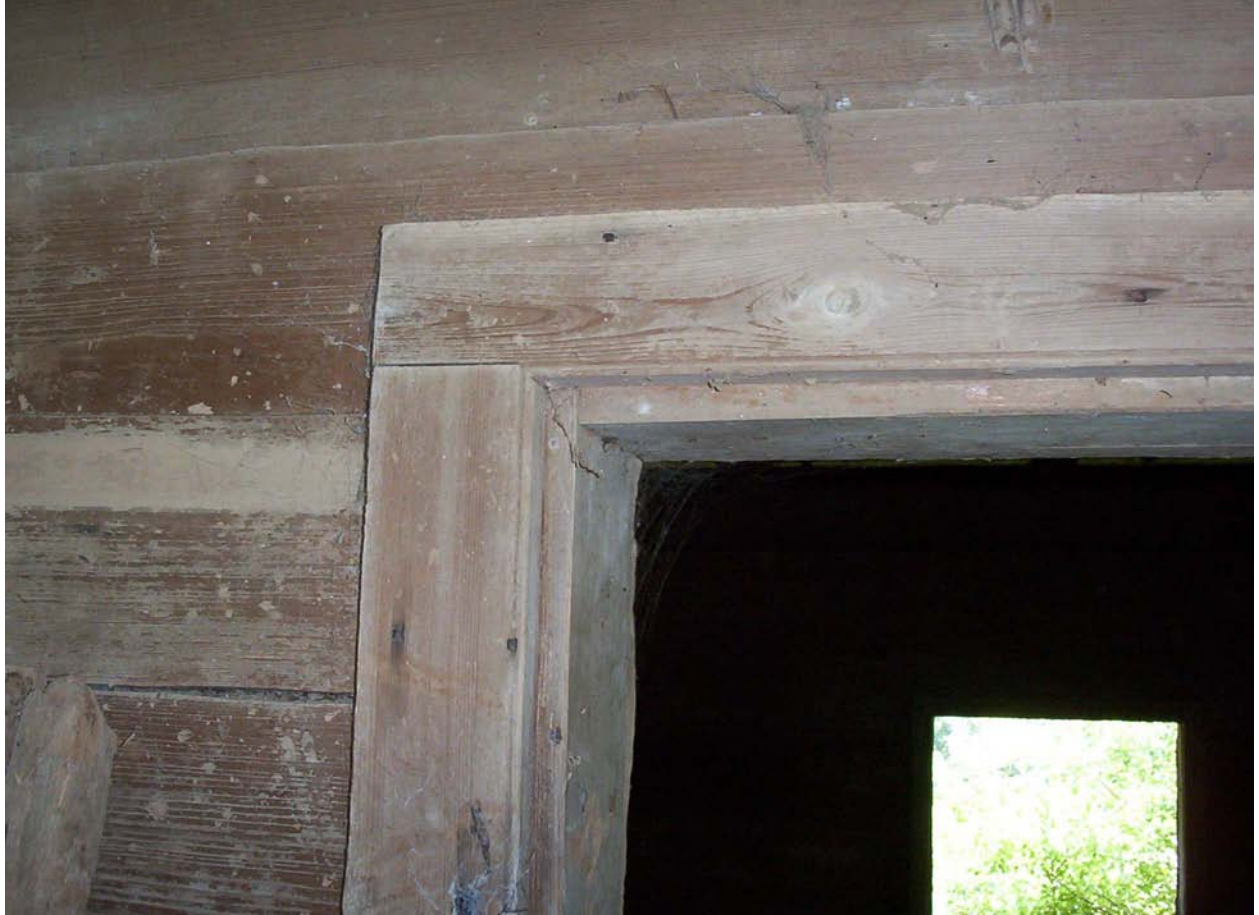
Figure 5.9. The original openings of Room 1 are surrounded by beaded trim.

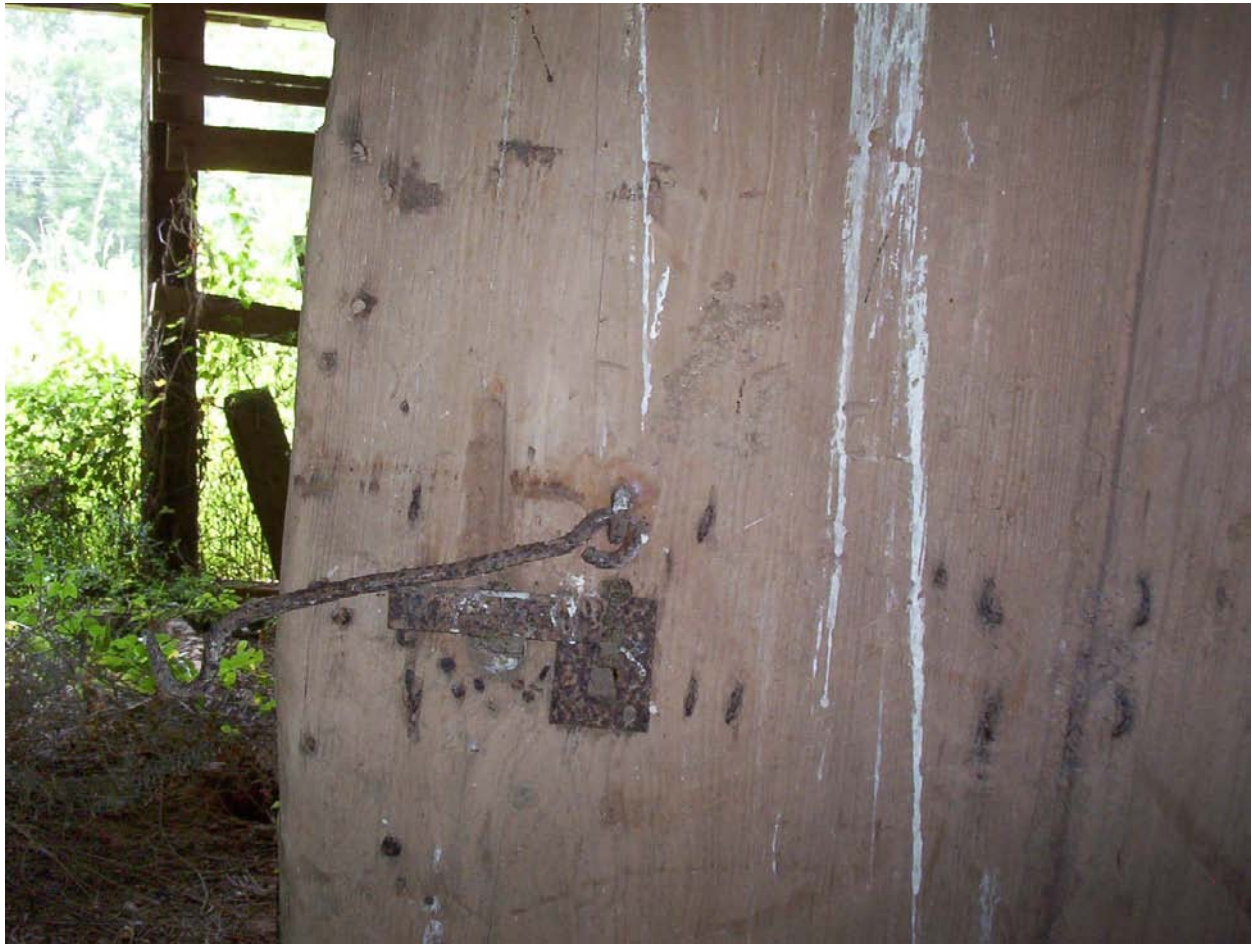
Figure 5.10. All that remains of the mortise-type lock of the southern door of the building is the keyhole.

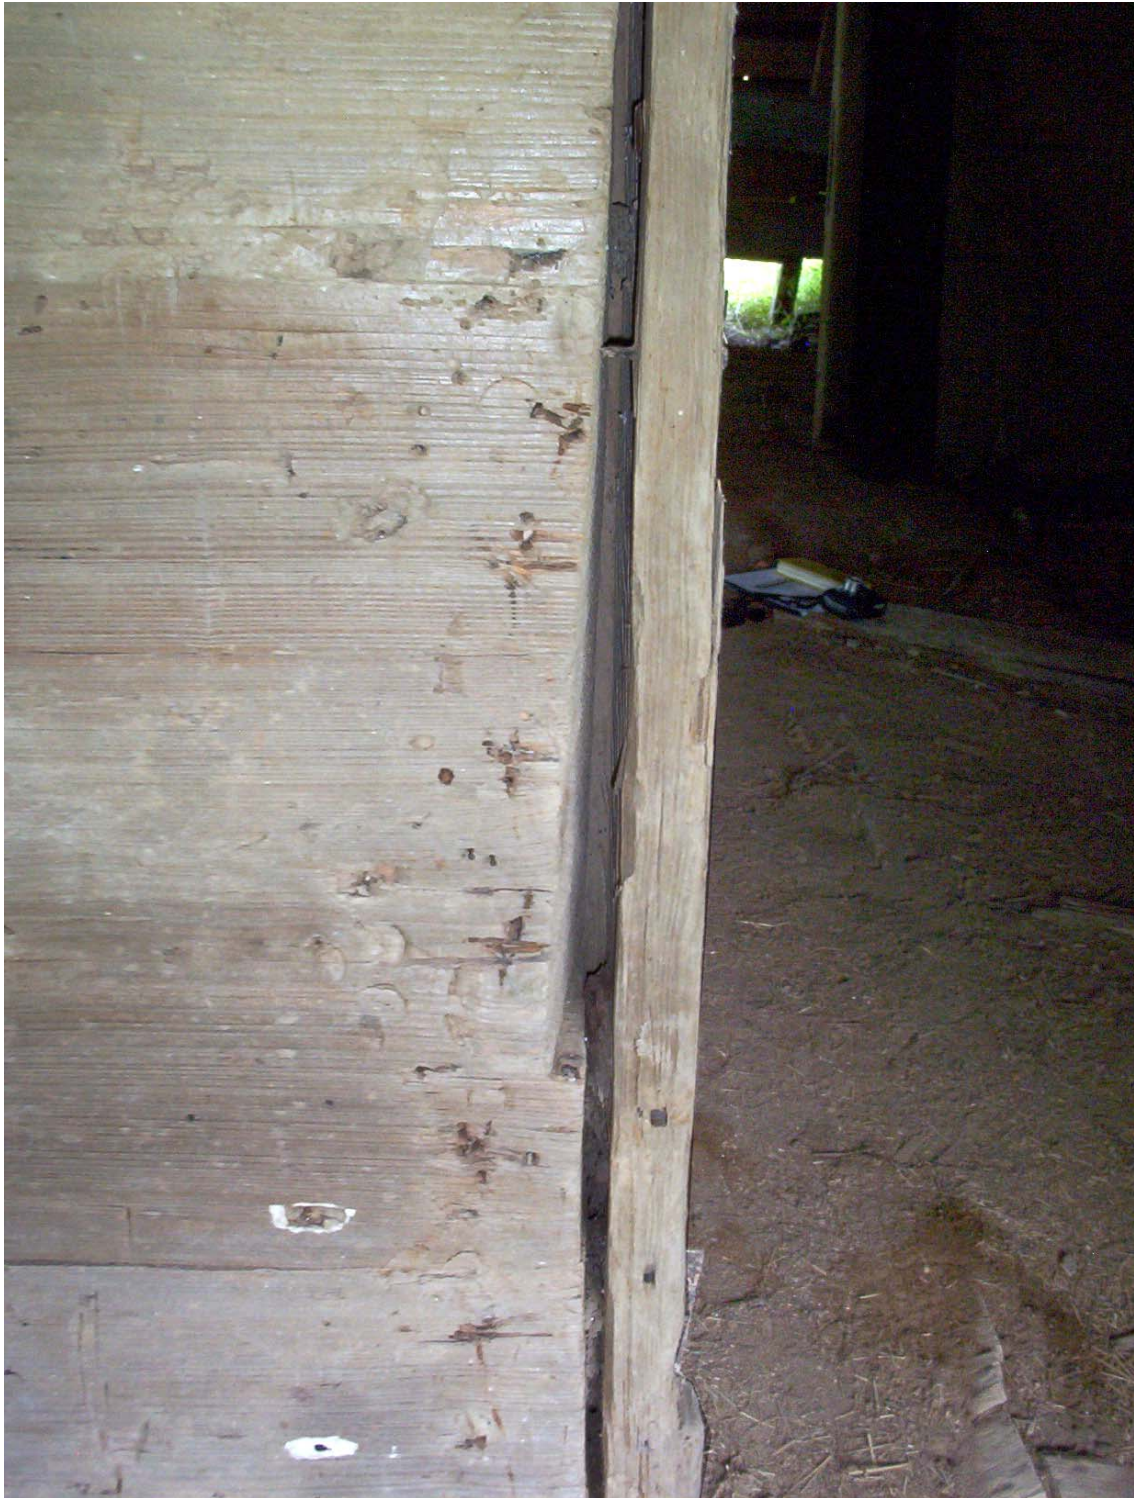
Figure 5.11. The western door opening was added at a later date and was crudely cut into the building.

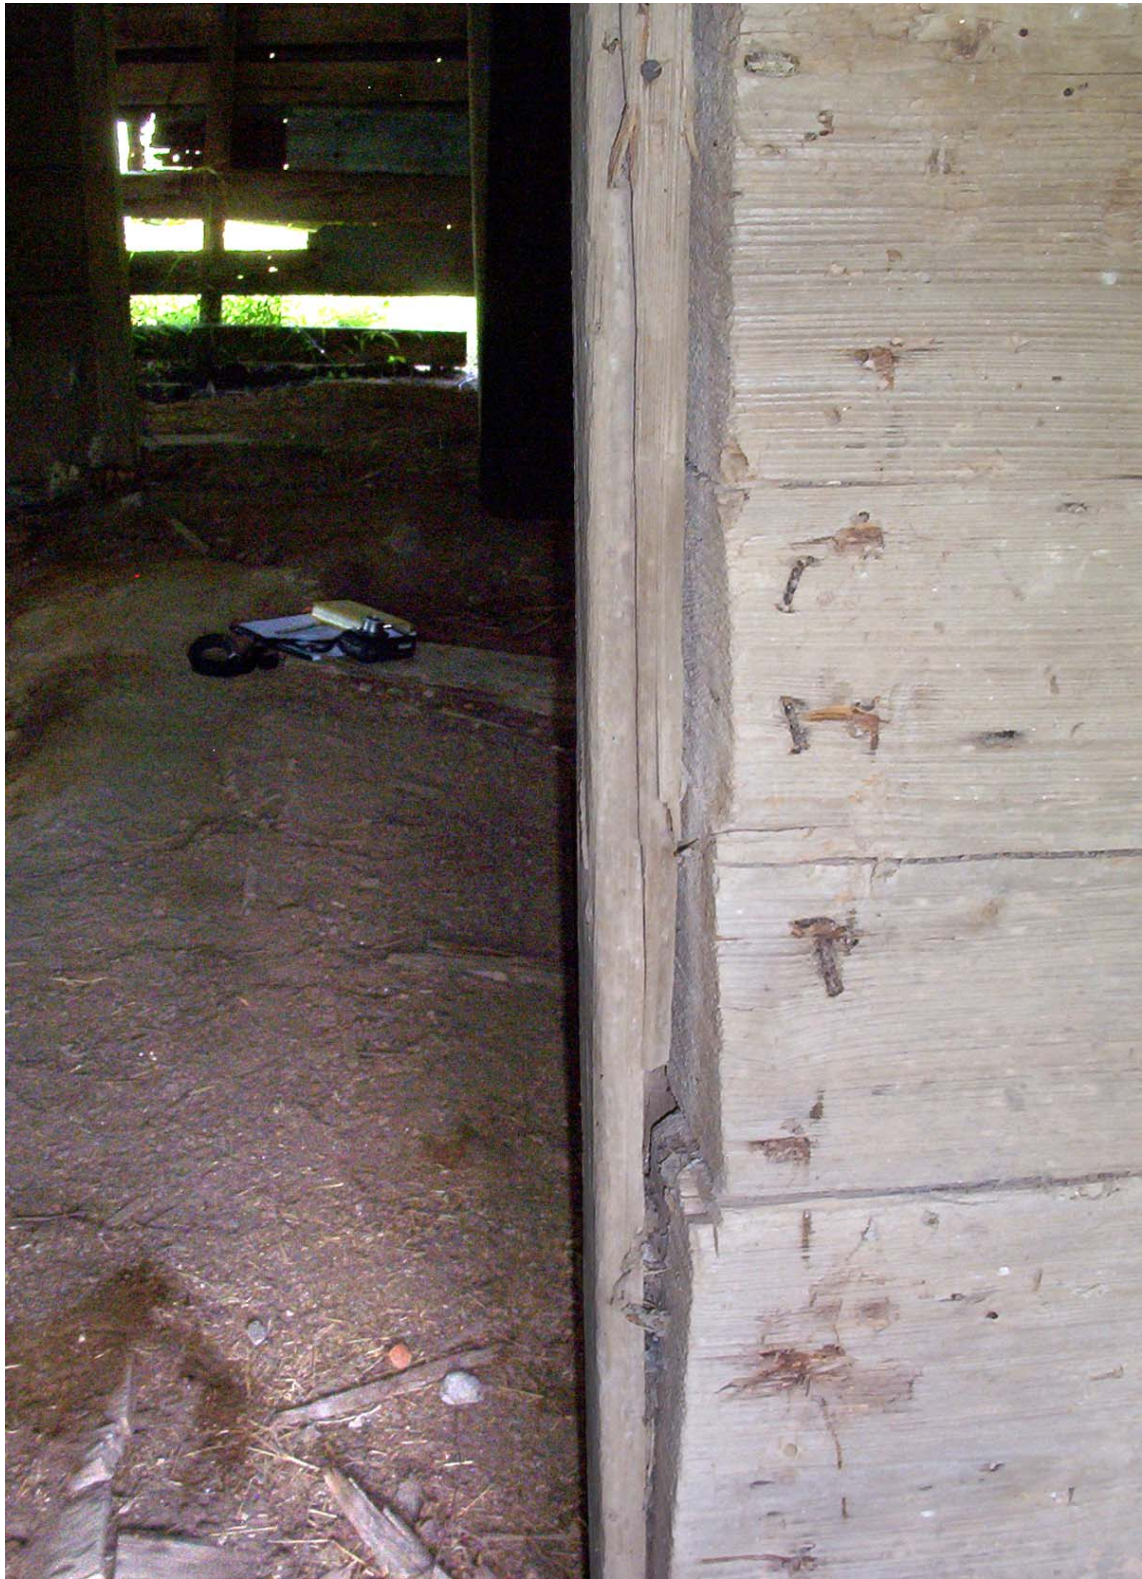
Figure 5.12. Thin boards were scabbed onto the new door opening.

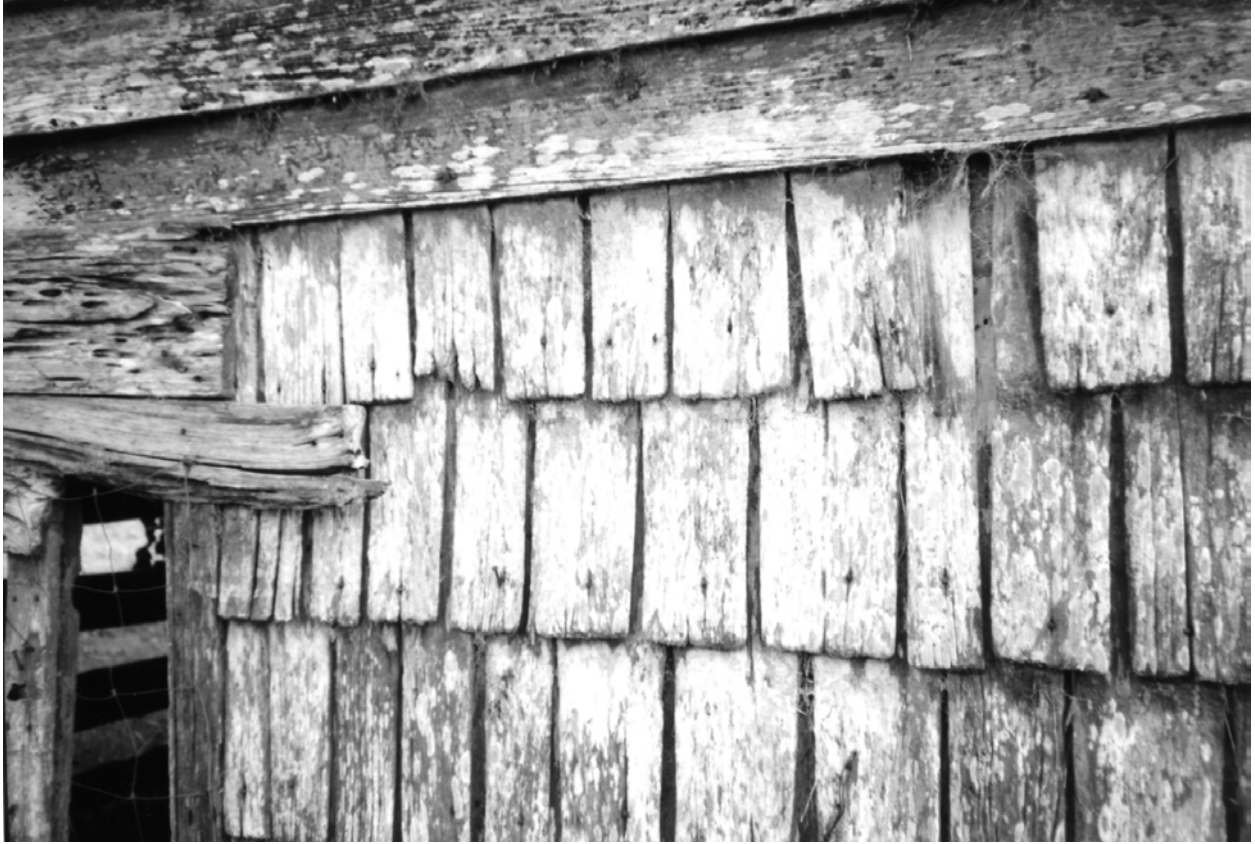
Figure 5.13. Wooden shakes or shingles cover a portion of the north exterior of Room 1.

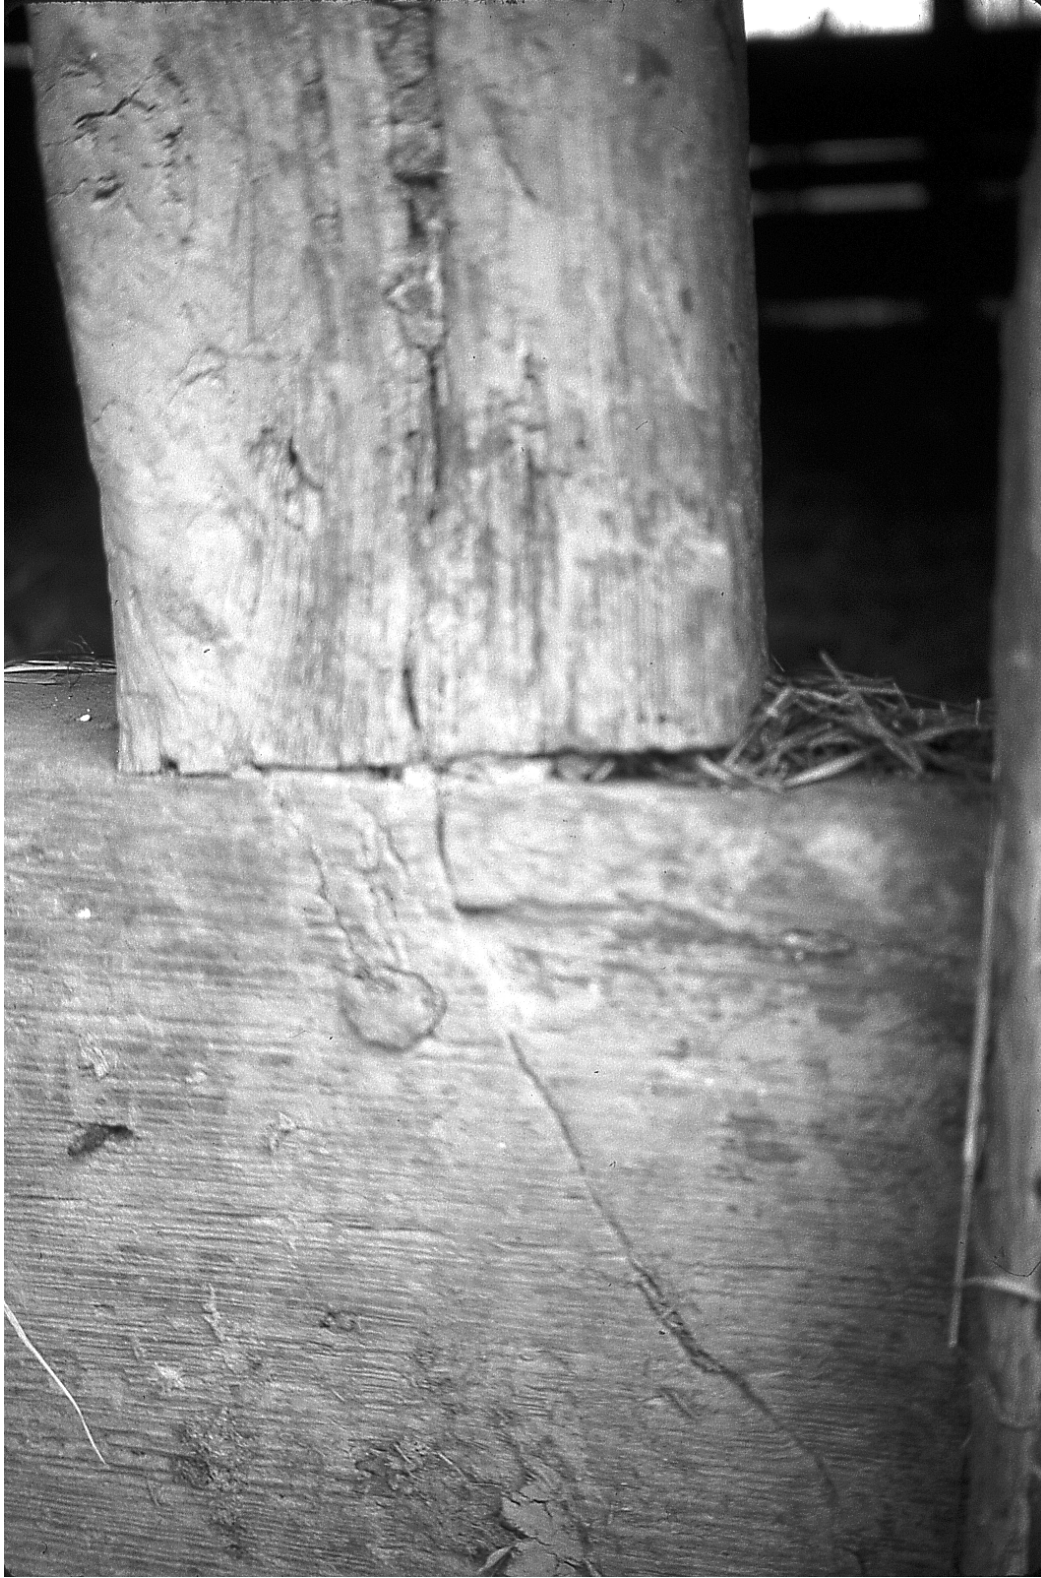
Figure 5.14. Posts are mortised into a sill in Room 2 of the “barn.”

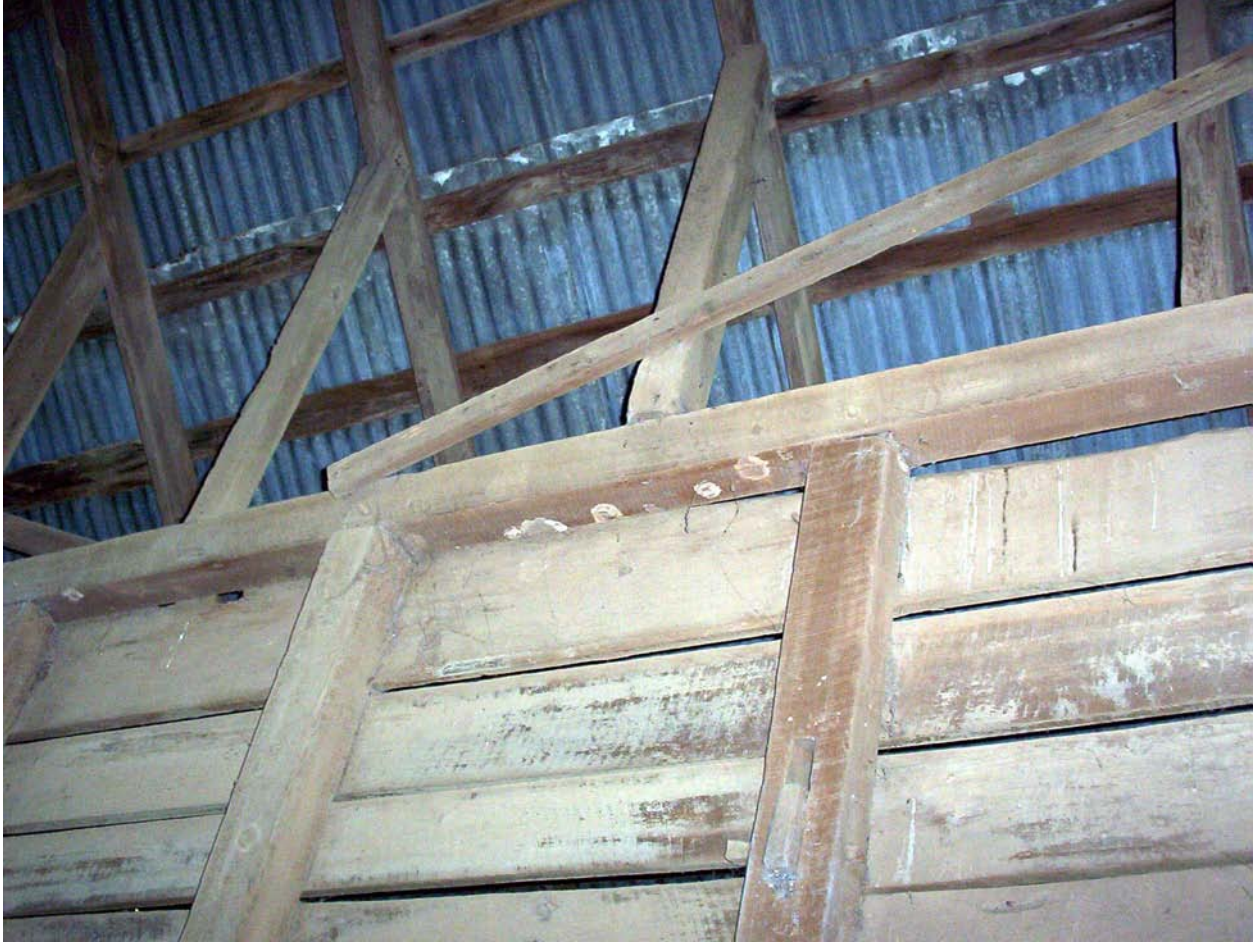
Figure 5.15. The same posts of Figure 5.14 are also mortised into a top plate.

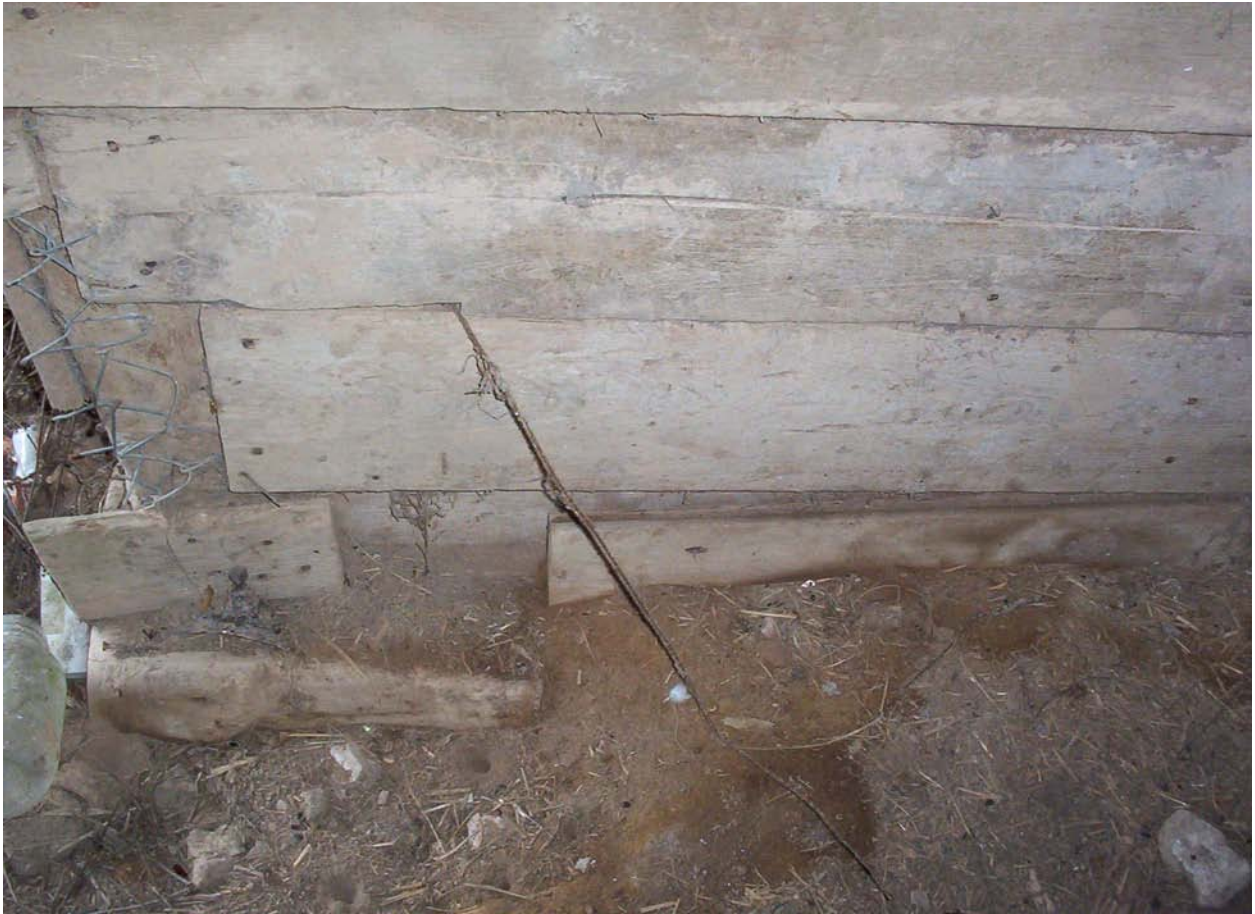
Figure 5.16. Room 2 rests on wooden piers shown in the lower left-hand corner of this photograph.

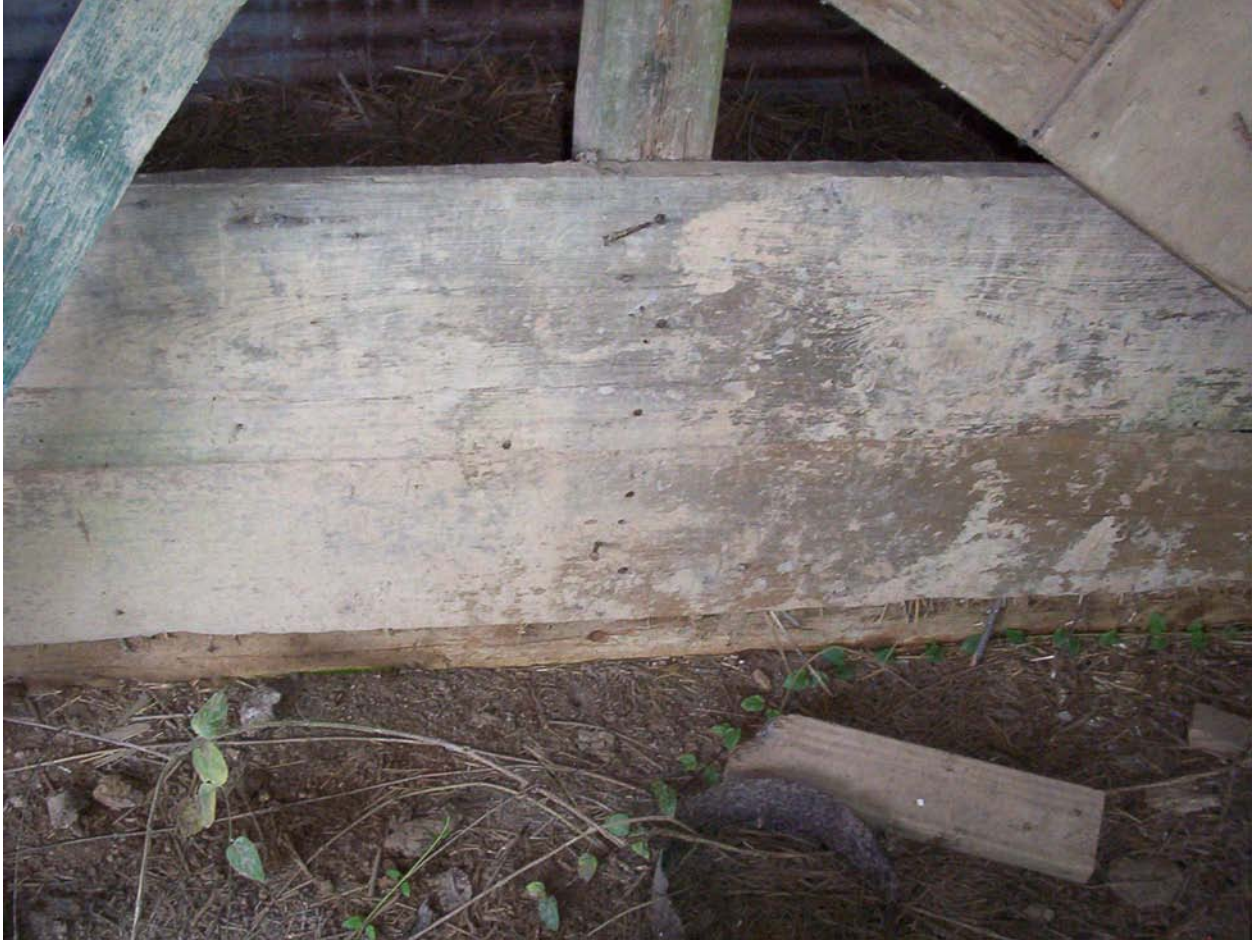
Figure 5.17. Planks cover the exterior of the walls of Room 2.
