The Matas "barn", Robin Plantation (16SL66), St. Landry Parish, Louisiana-history and archaeology of a nineteenth century milk house

**THE MATAS “BARN,” ROBIN PLANTATION (16SL66),
ST. LANDRY PARISH, LOUISIANA—
HISTORY AND ARCHAEOLOGY OF A
NINETEENTH CENTURY MILK HOUSE**

A Thesis

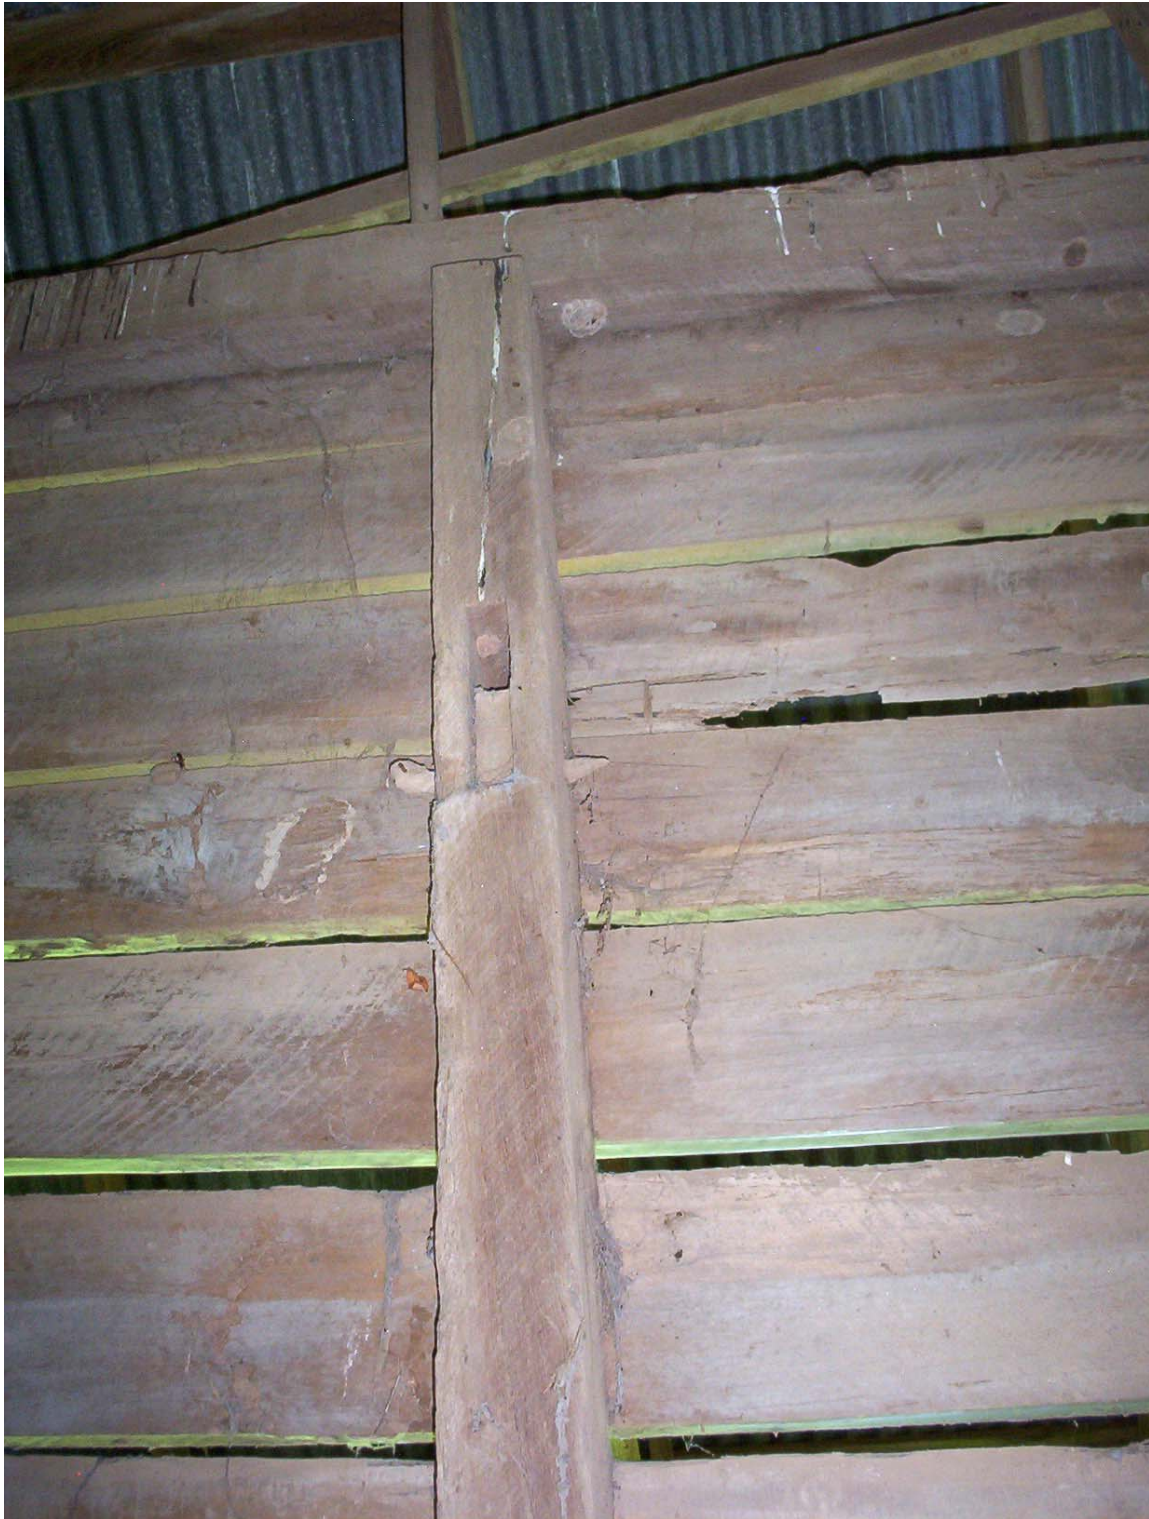
Figure 5.18. The planks that cover Room 2 were circular sawn.

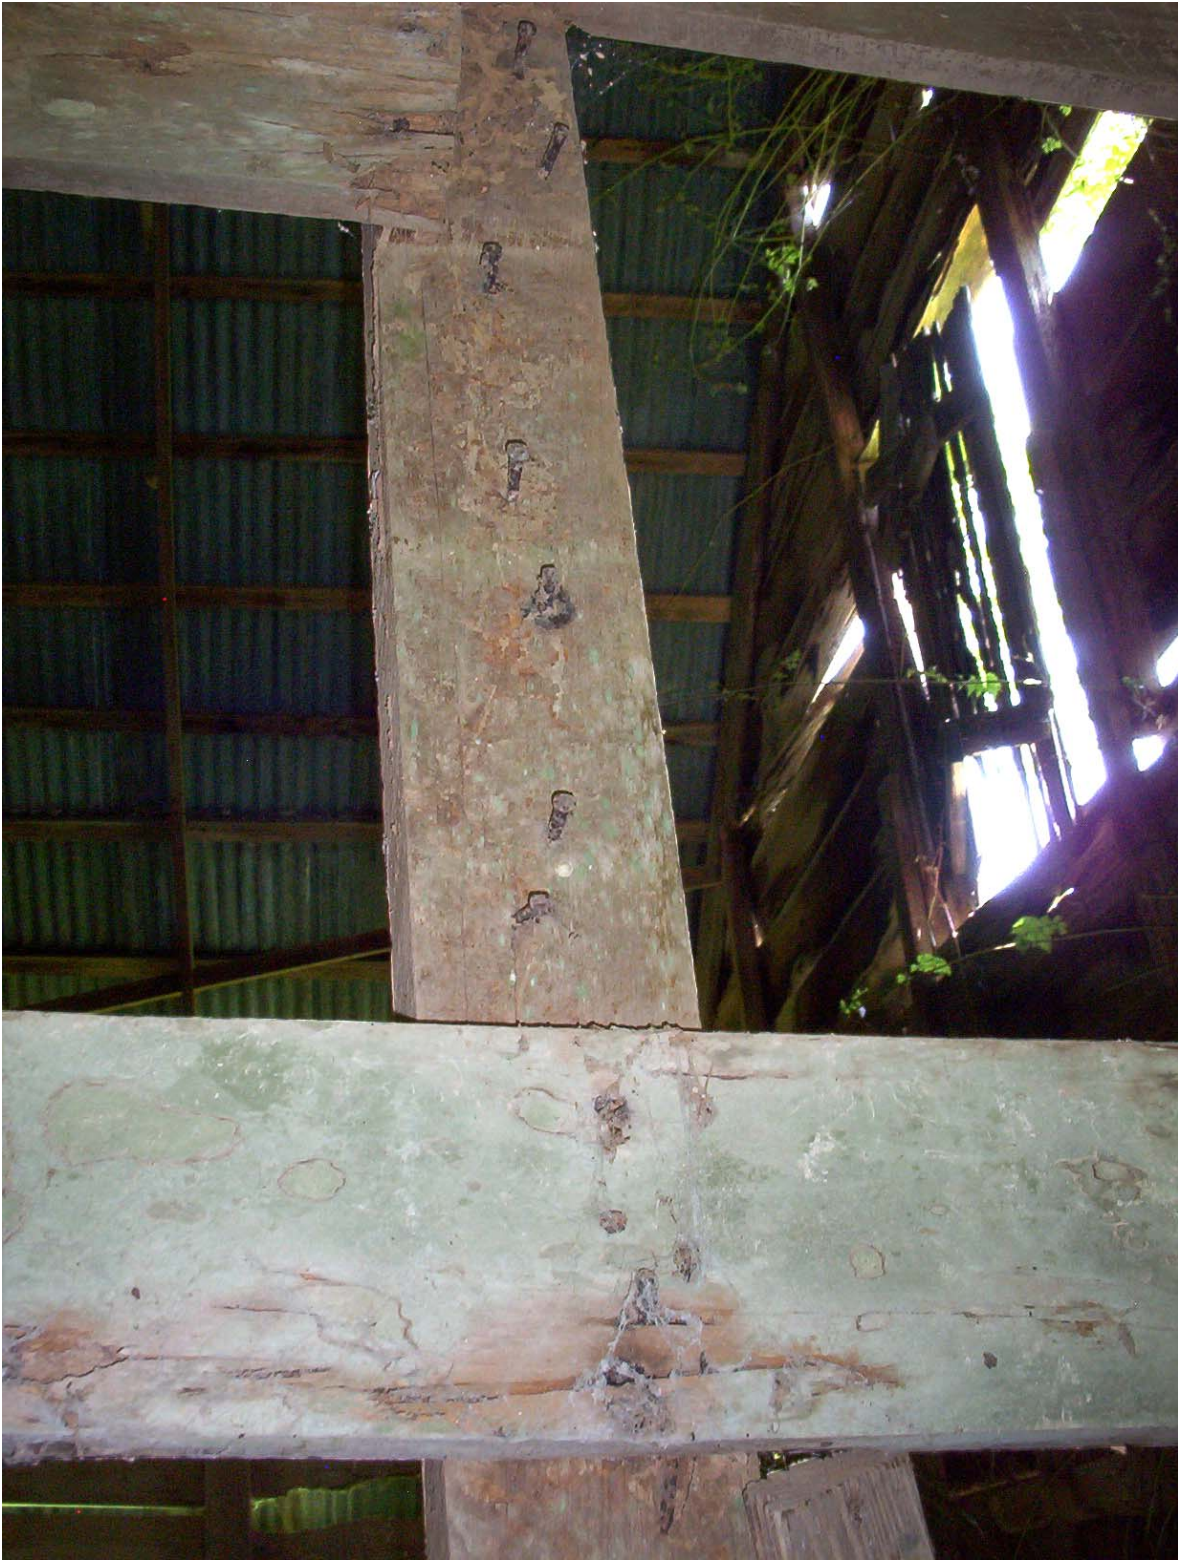
Figure 5.19. Modern machine cut nails hold the planks in place.

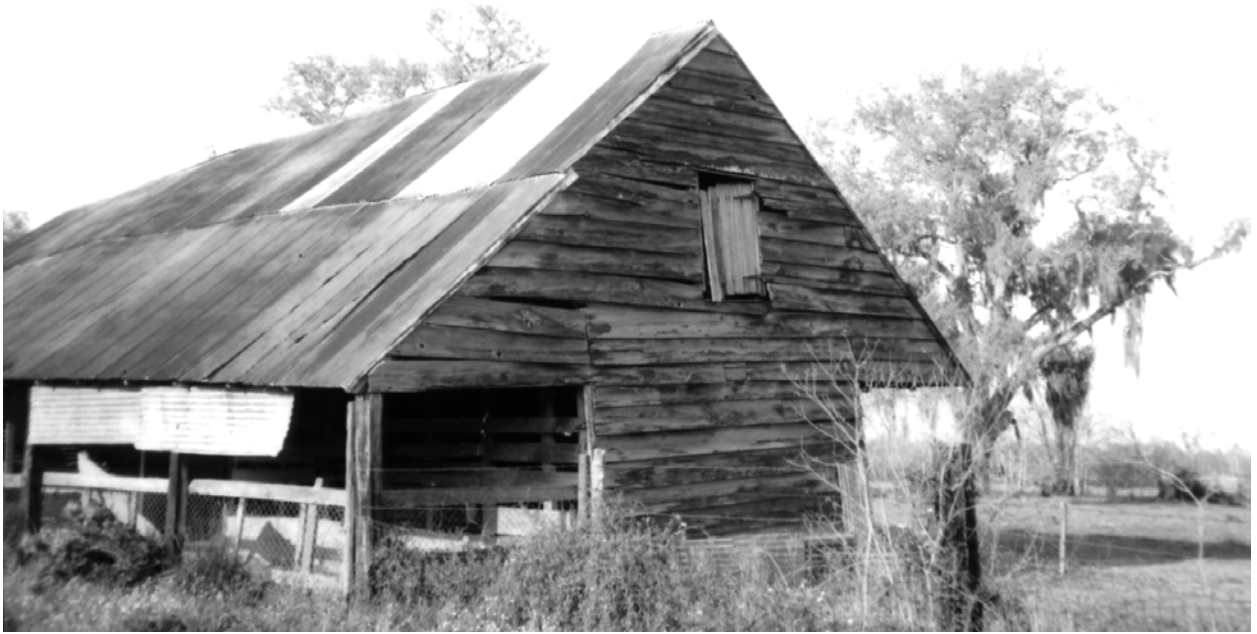
Figure 5.20. Clapboards cover the exterior wall of Room 2.

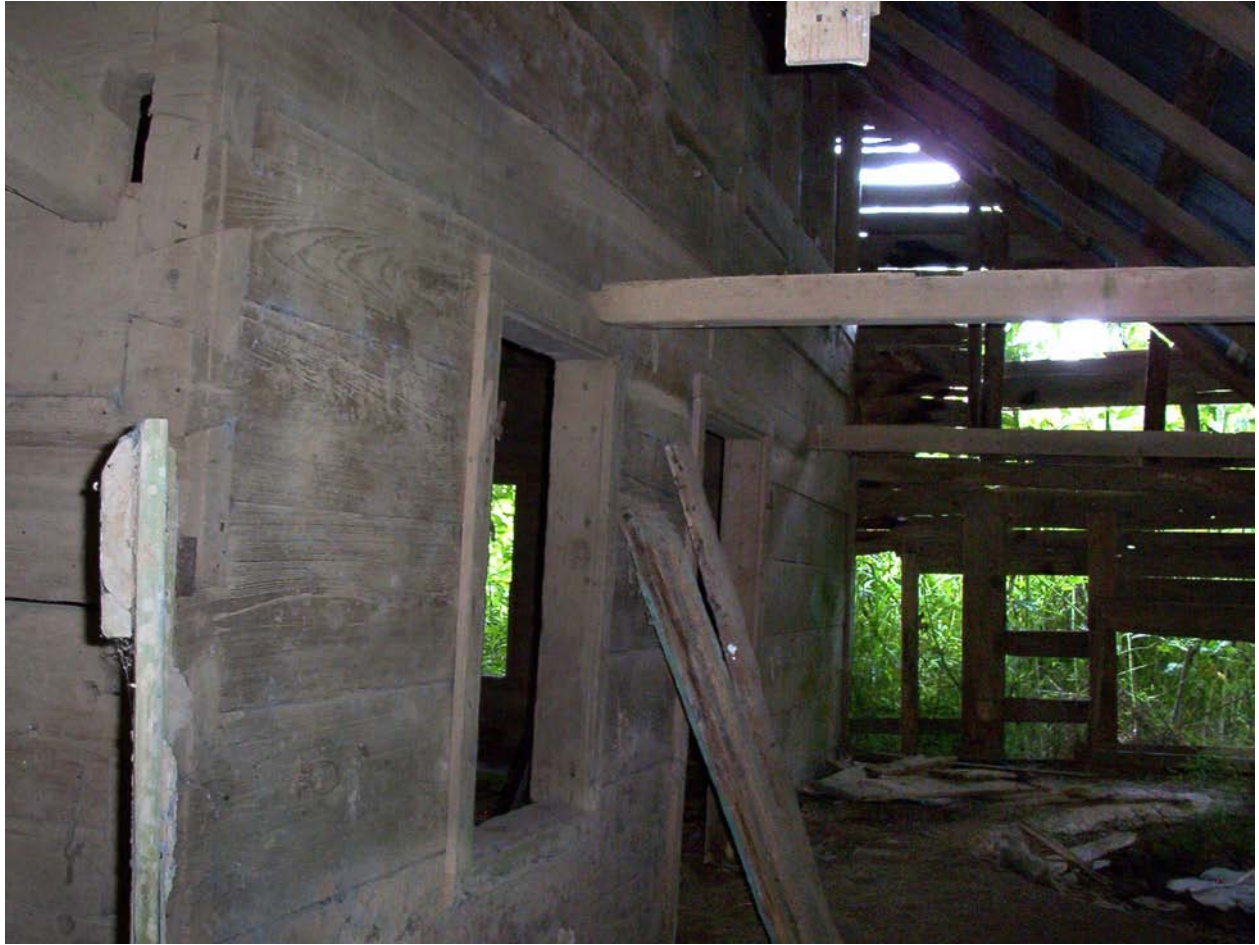
Figure 5.21. Ceiling joists were added during the Phase III construction of the “barn.”

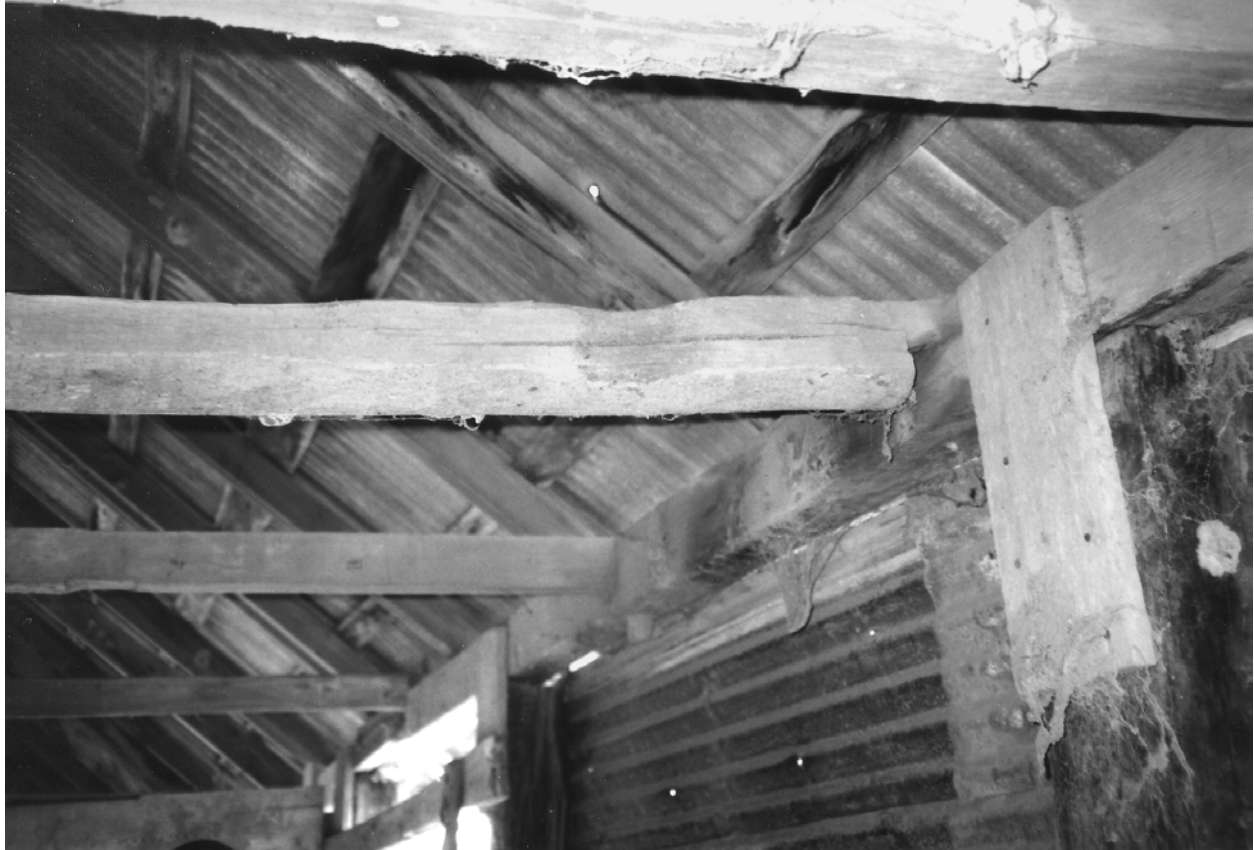
Figure 5.23. Some of the ceiling/roof joists were reused from another structure (see joist in background) and others were made with whatever was available. Note the tree in the foreground of the photograph that has been planed on two sides, but the bark remains on the bottom.

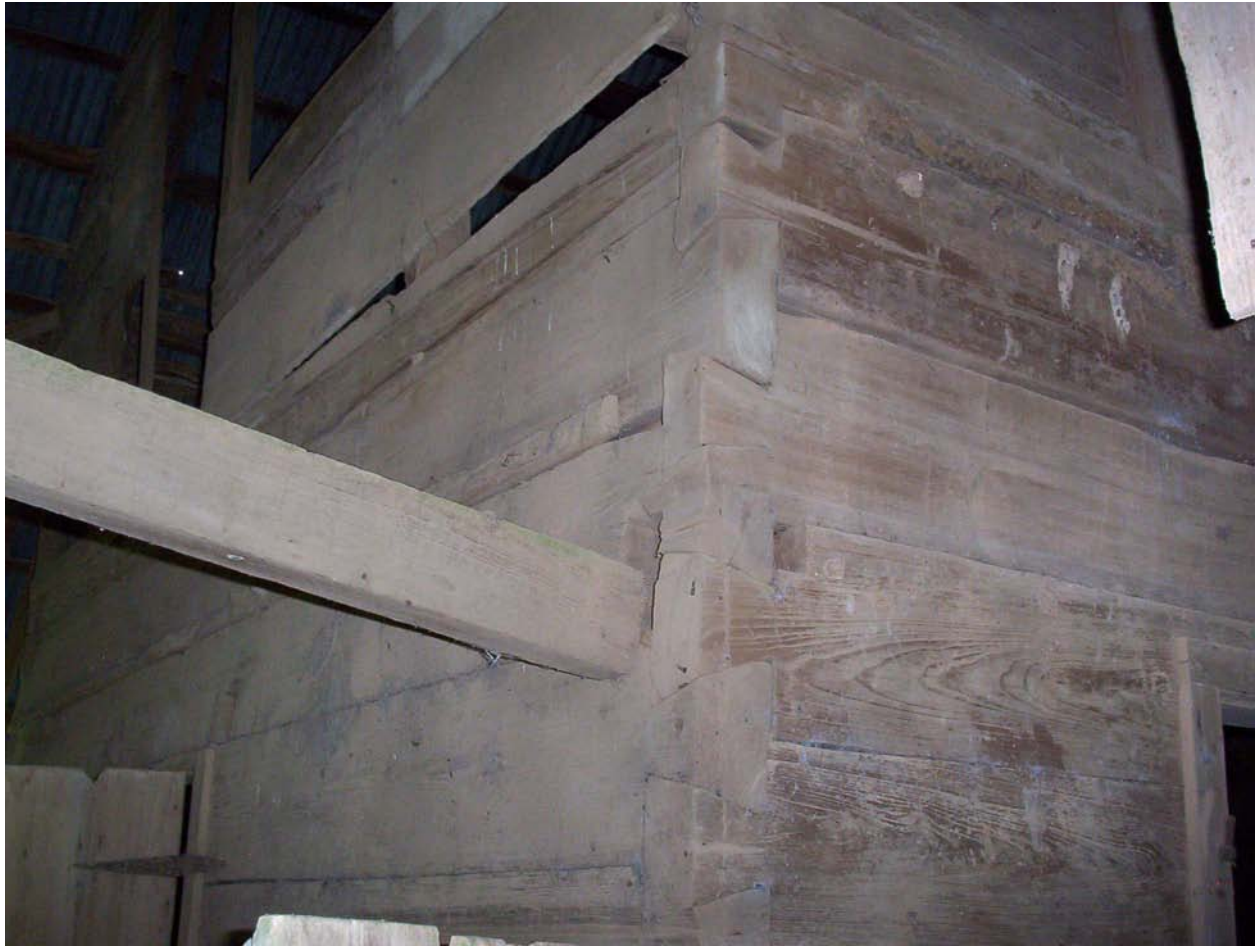
Figure 5.24. Joists were added between the two rooms of the “barn” to join the two ceilings and further stabilize the building. The joist shown here has slipped out of its hole because the northern room has shifted.

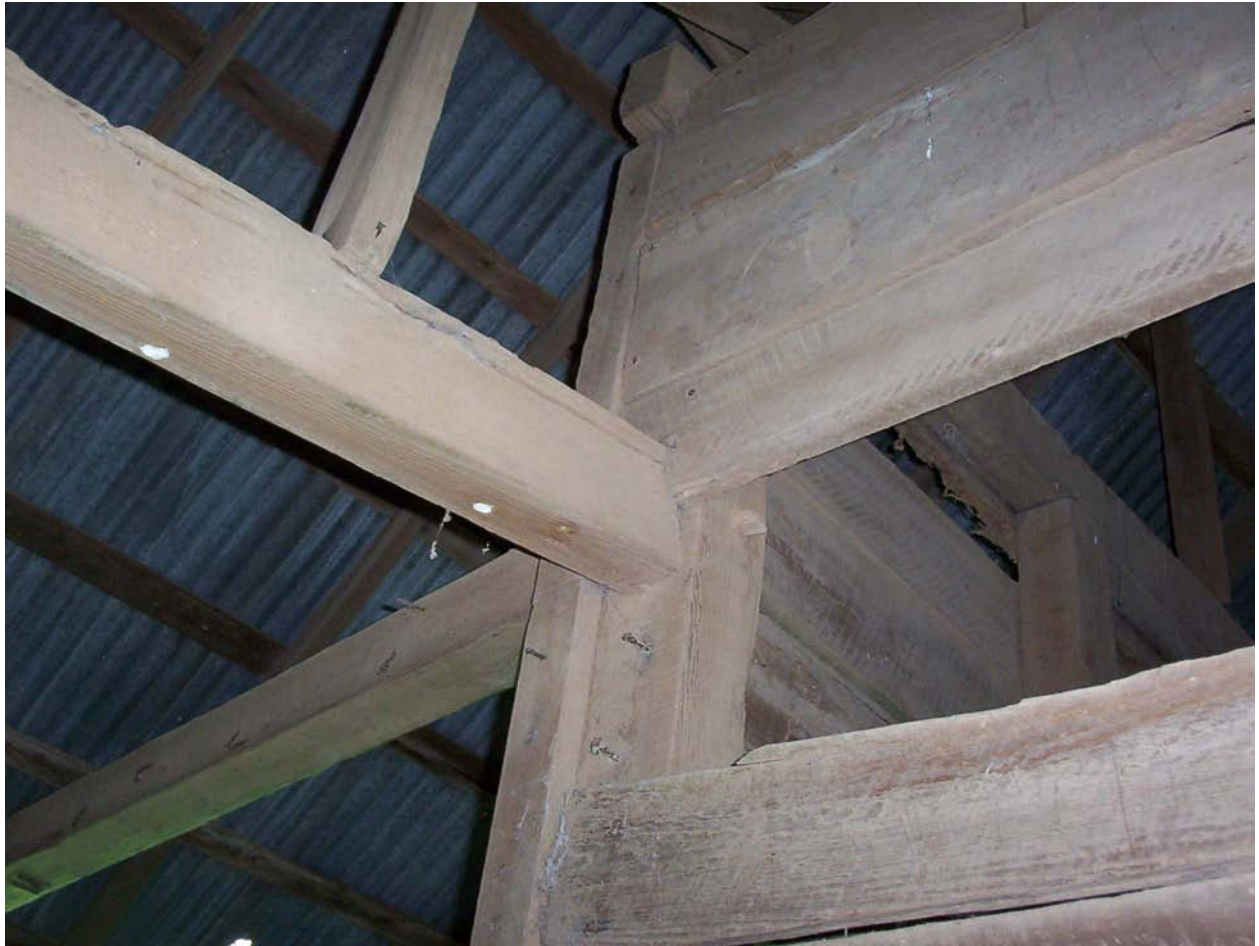
Figure 5.25. The same joist depicted in Figure 5.24 connects to Room 2 of the structure shown here.

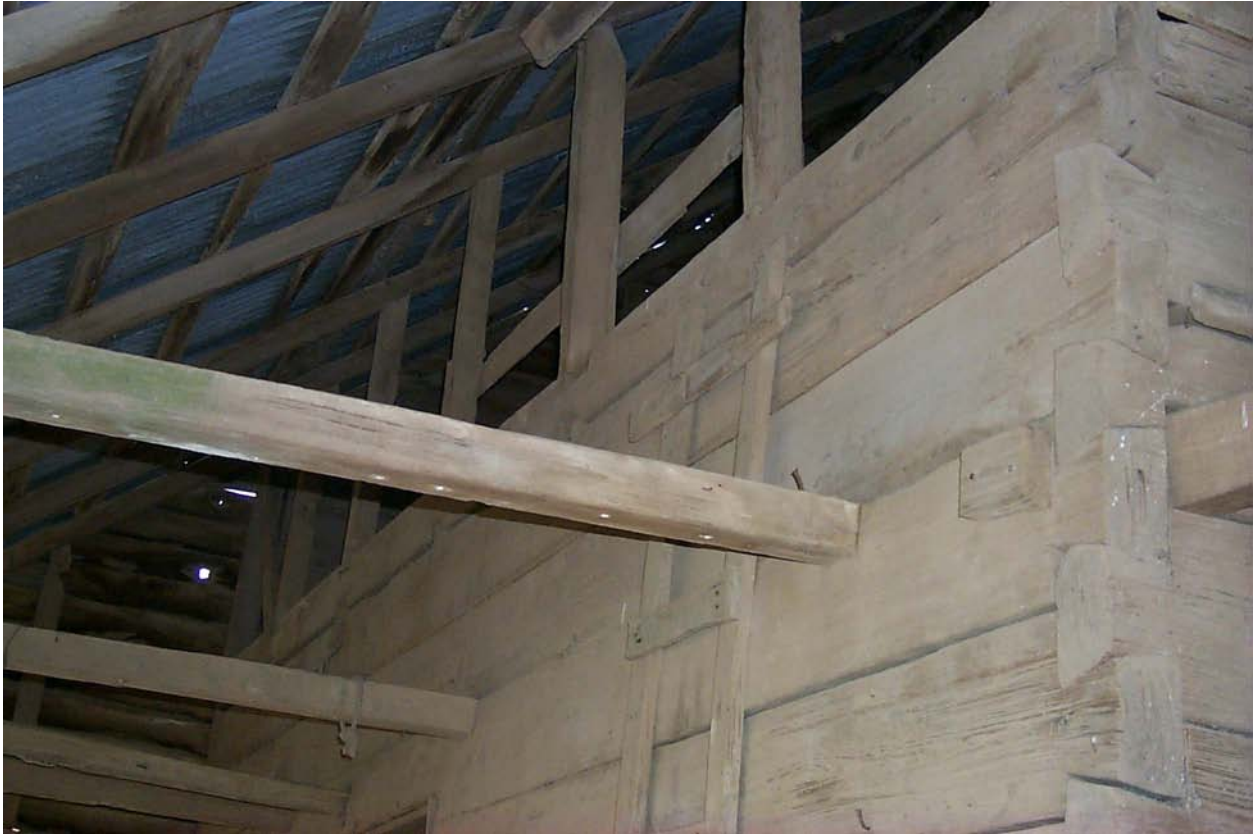
Figure 5.26. This ladder, on the western wall of Room 1, once led to a loft door.

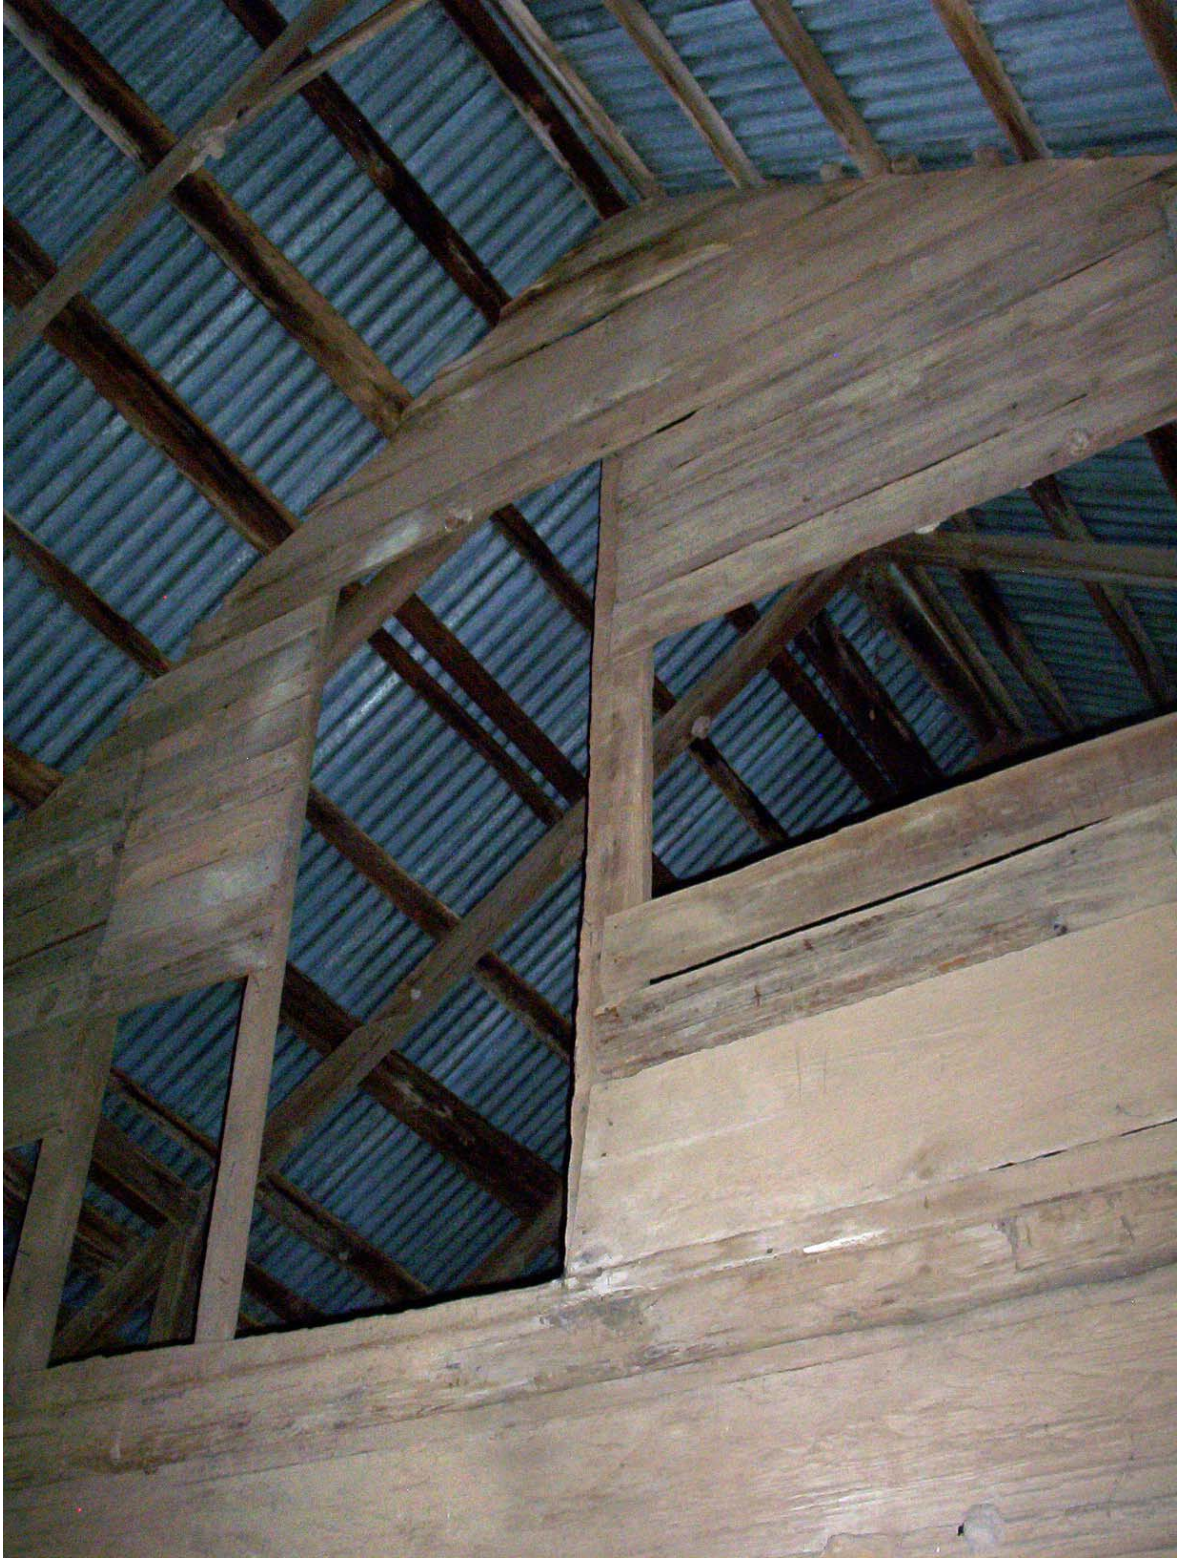
Figure 5.28. This opening may have once held another door to the loft.

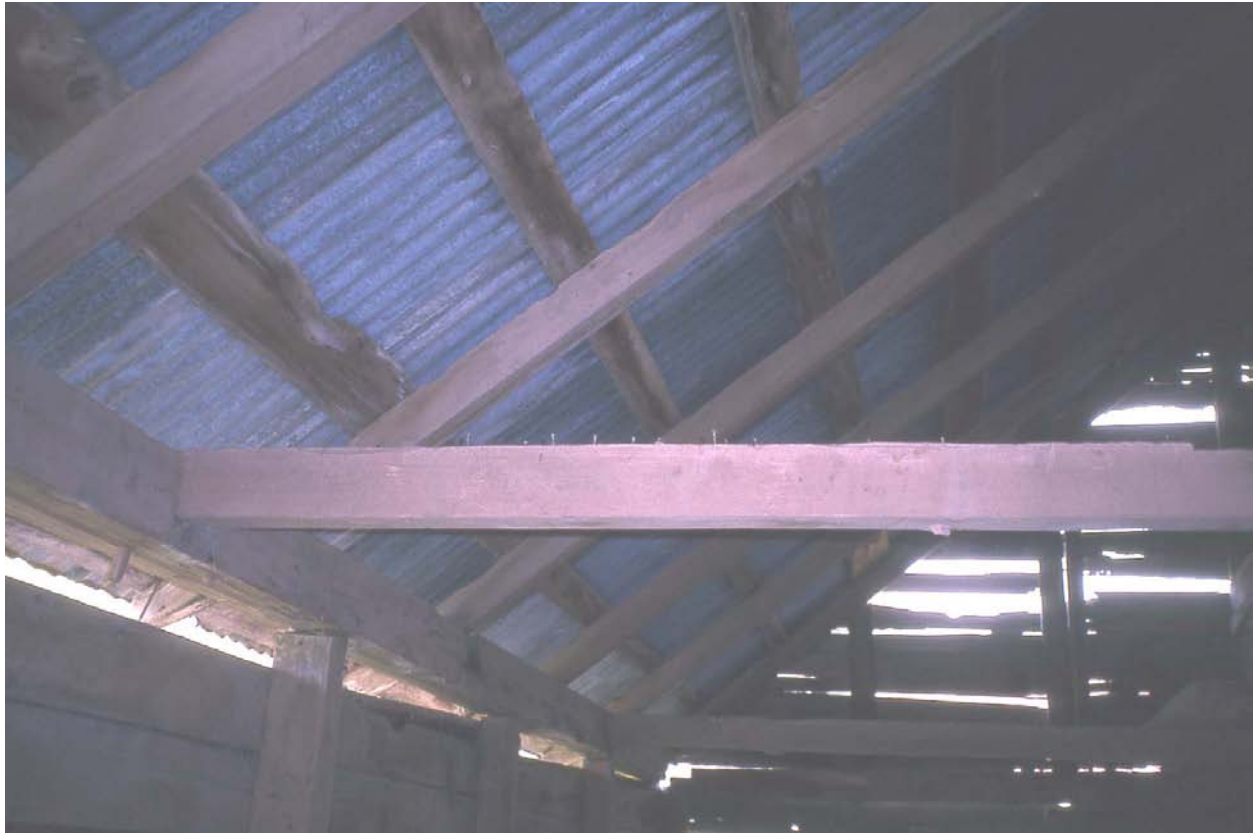
Figure 5.29. The nails shown here on the top of the joist once held wooden planks. This space was probably used for extra storage space.

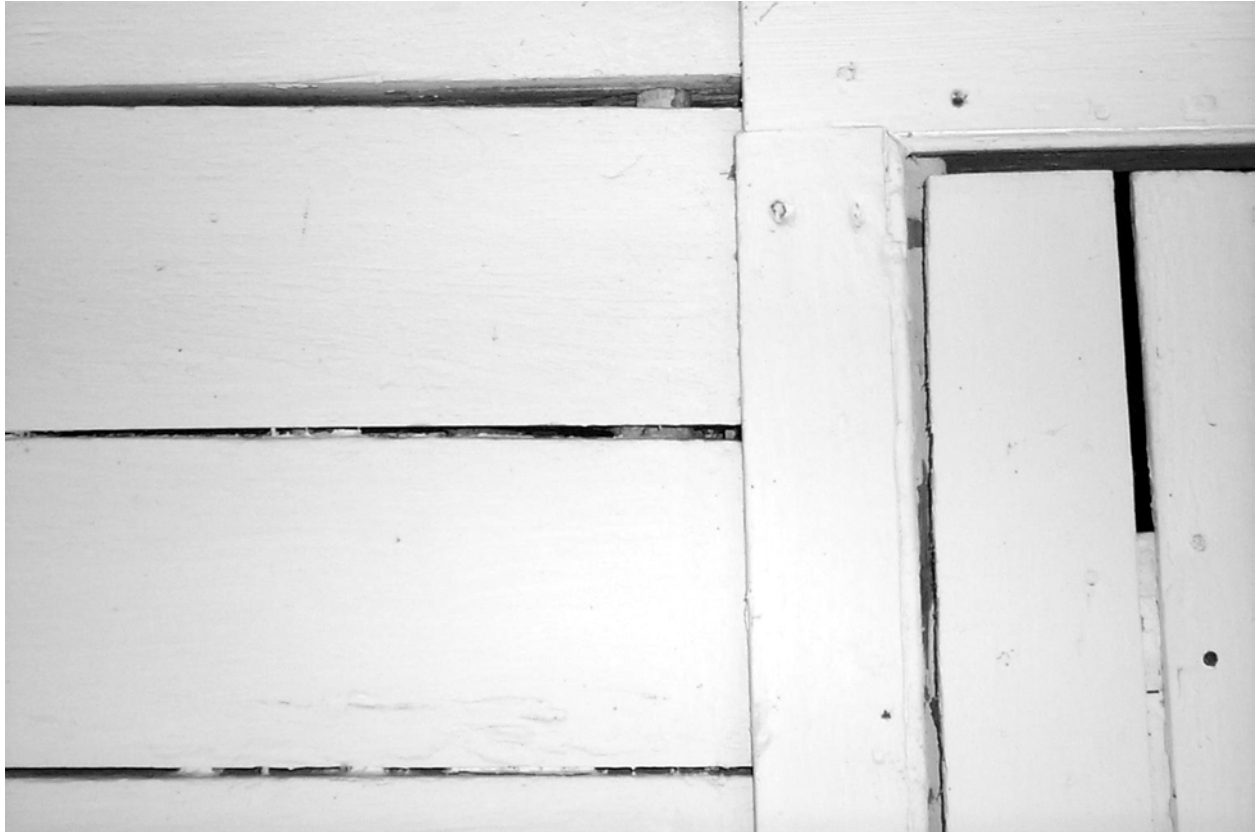
Figure 5.34. The timbers of the Rosedown Milk House are pegged above and below for more stability around the door and window openings. The pegs are visible above and below the second timber shown in the photograph.

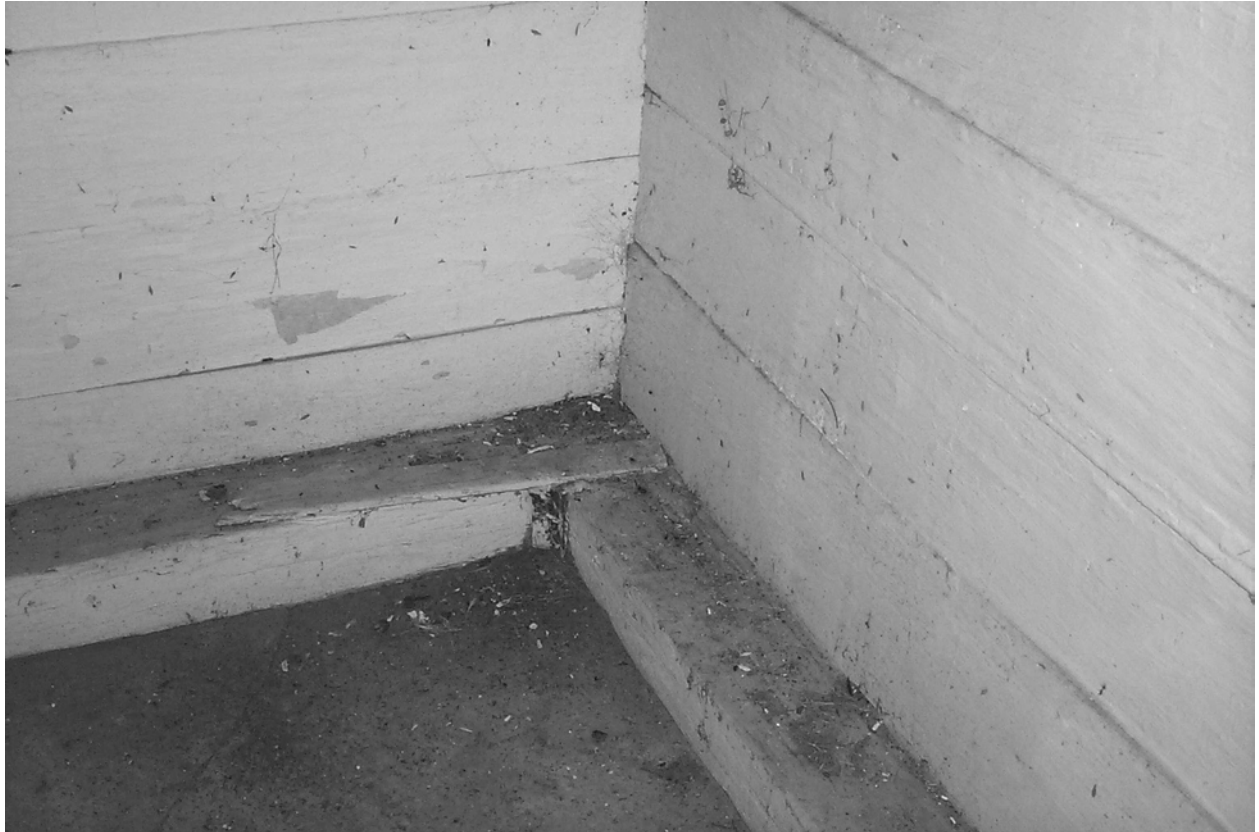
Figure 5.35. The sills of the Rosedown Milk House extend out into the structure. A floor was probably attached to the sill at one time.

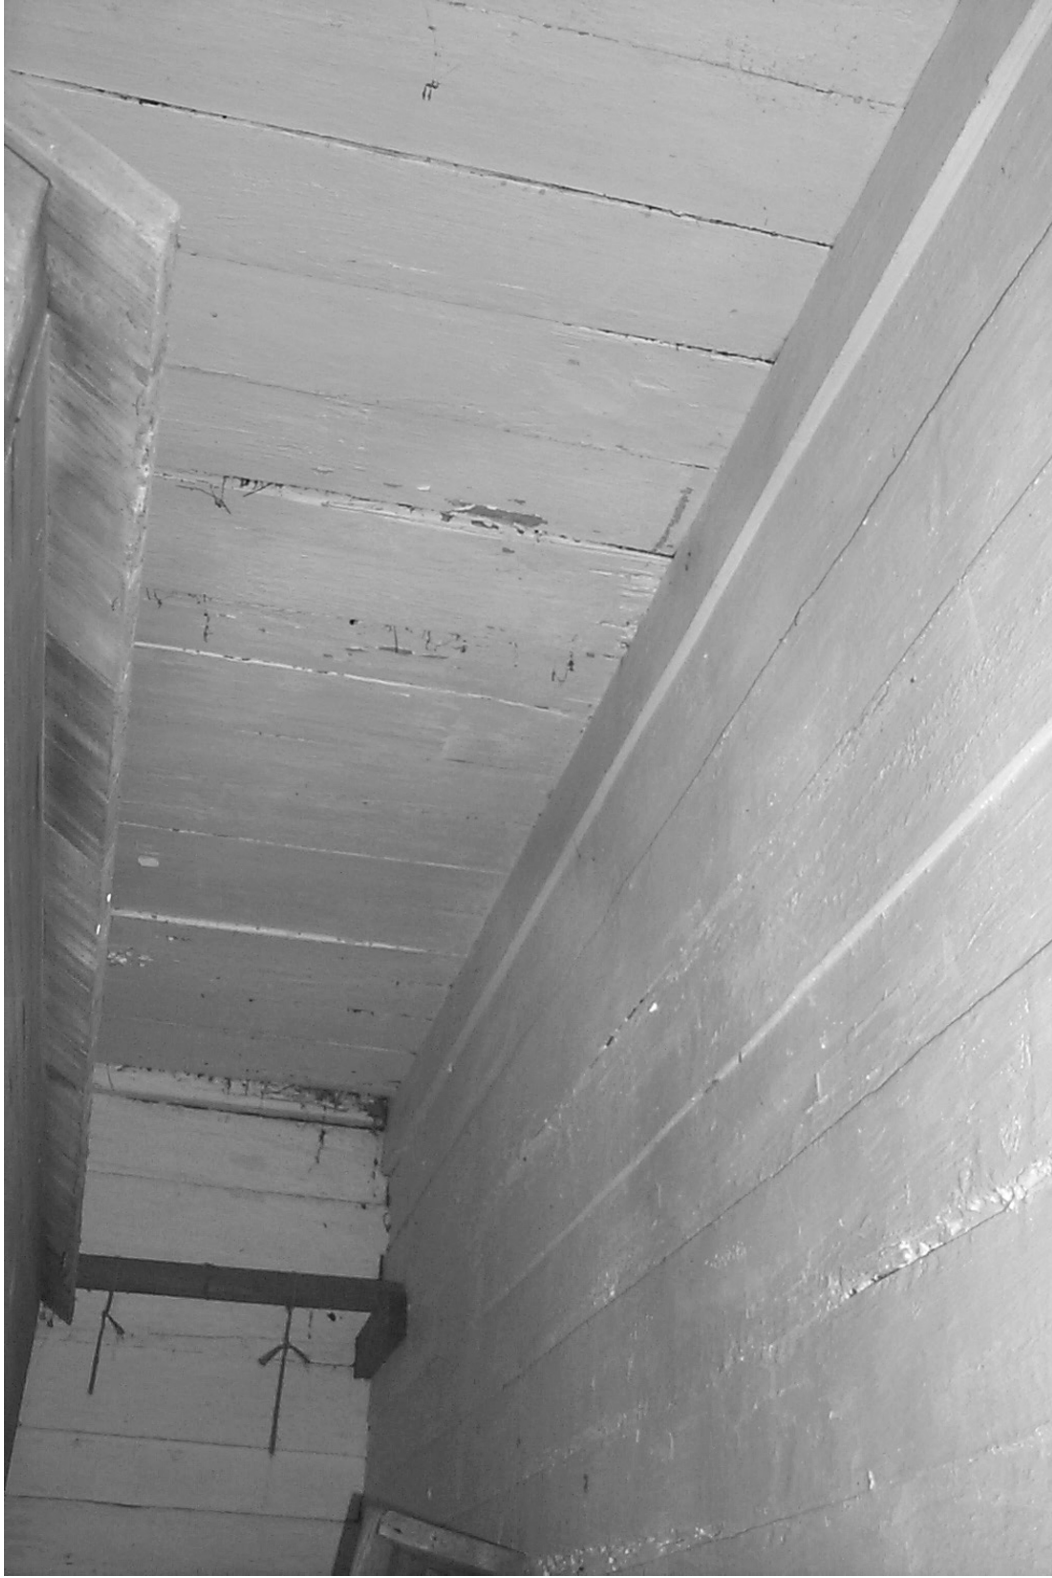
Figure 5.36. The ceiling of the Rosedown Milk House is still present, whereas the ceiling of Room 1 has been removed.

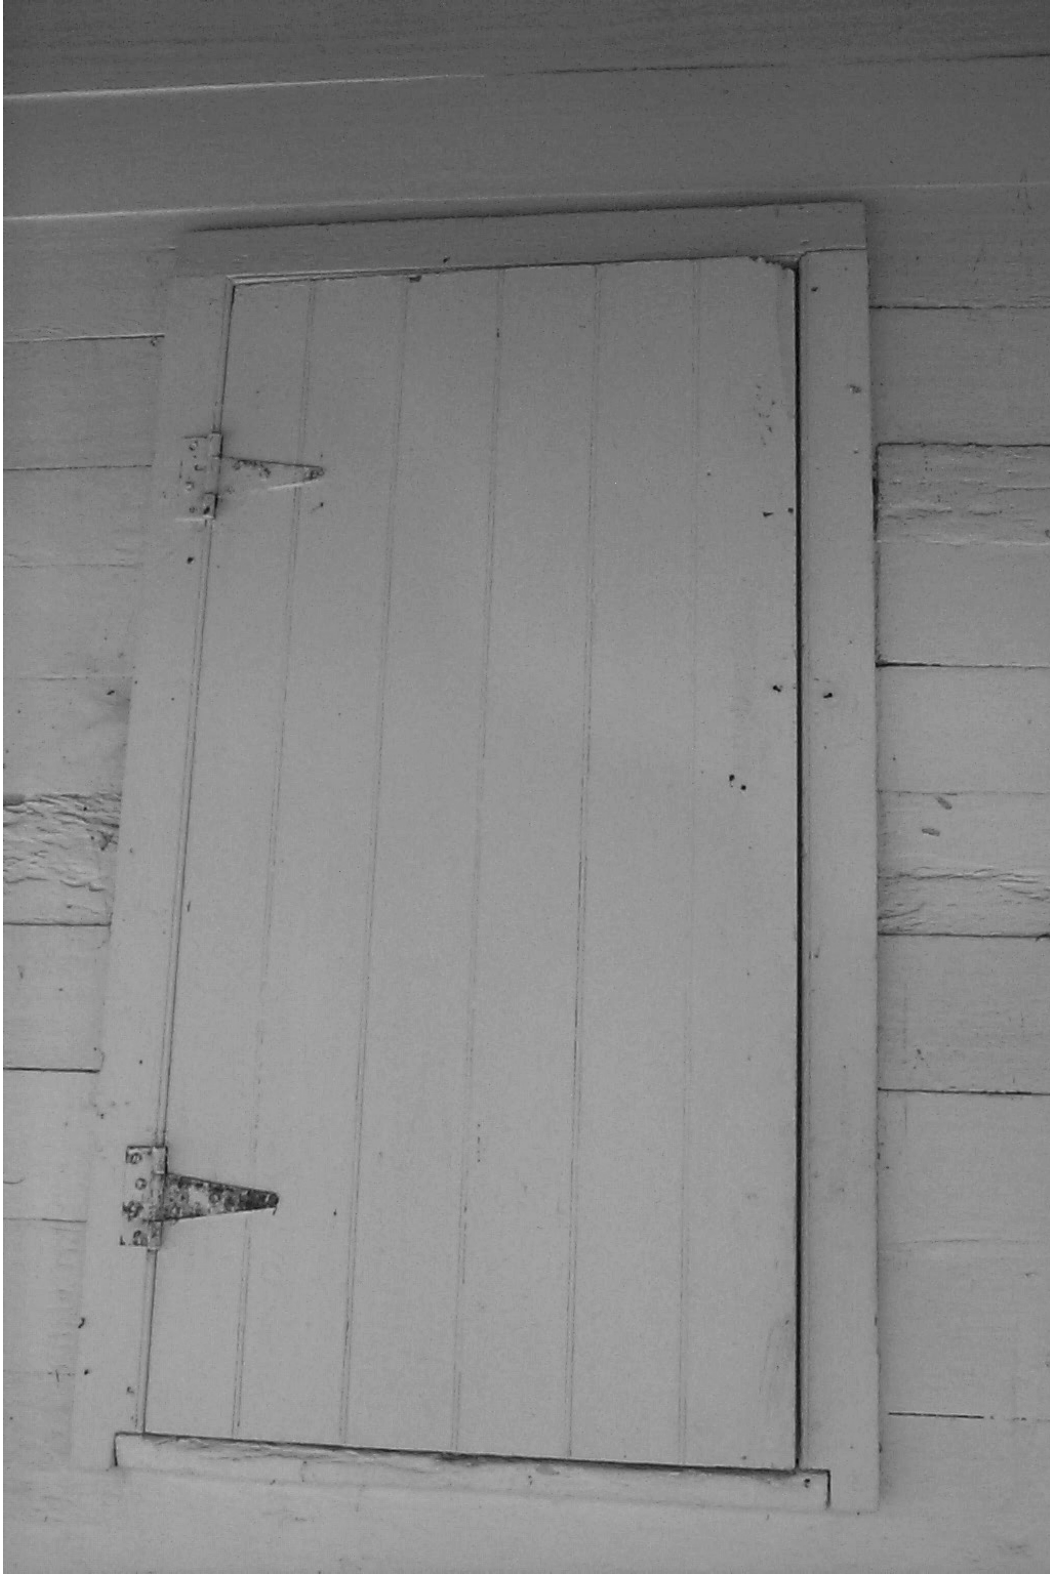
Figure 5.37. The windows and door of the Rosedown Milk House are batten with beaded shutters.

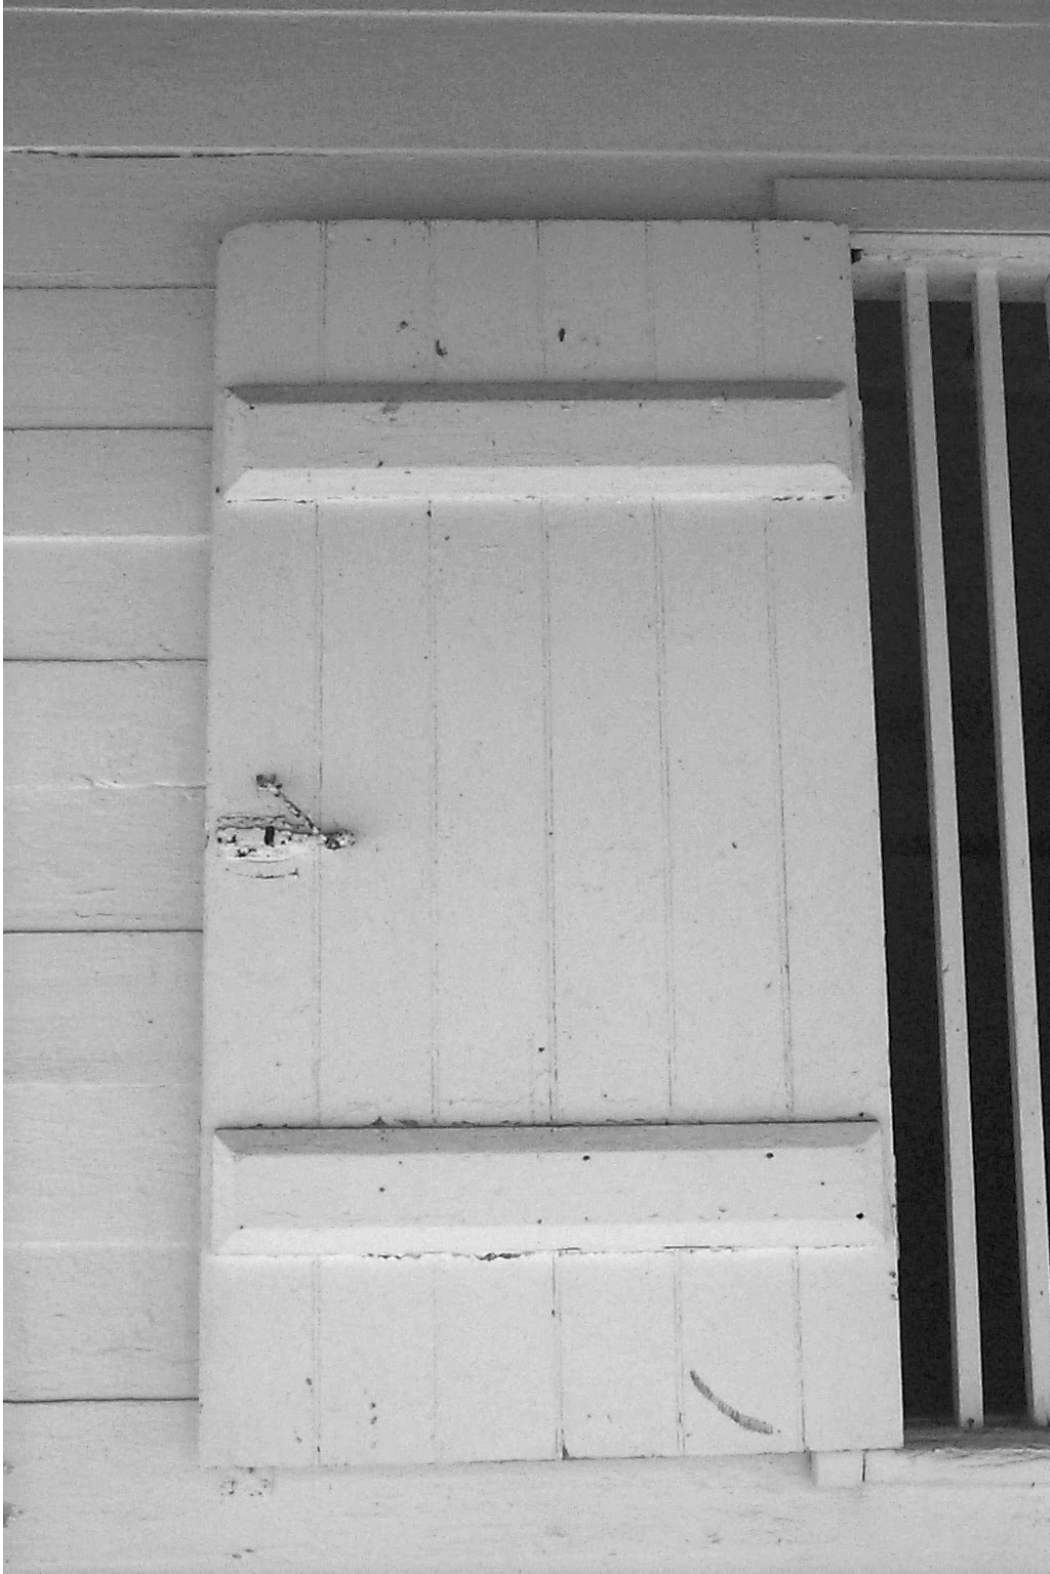
Figure 5.38. Metal latches lock the windows from the inside of the building.

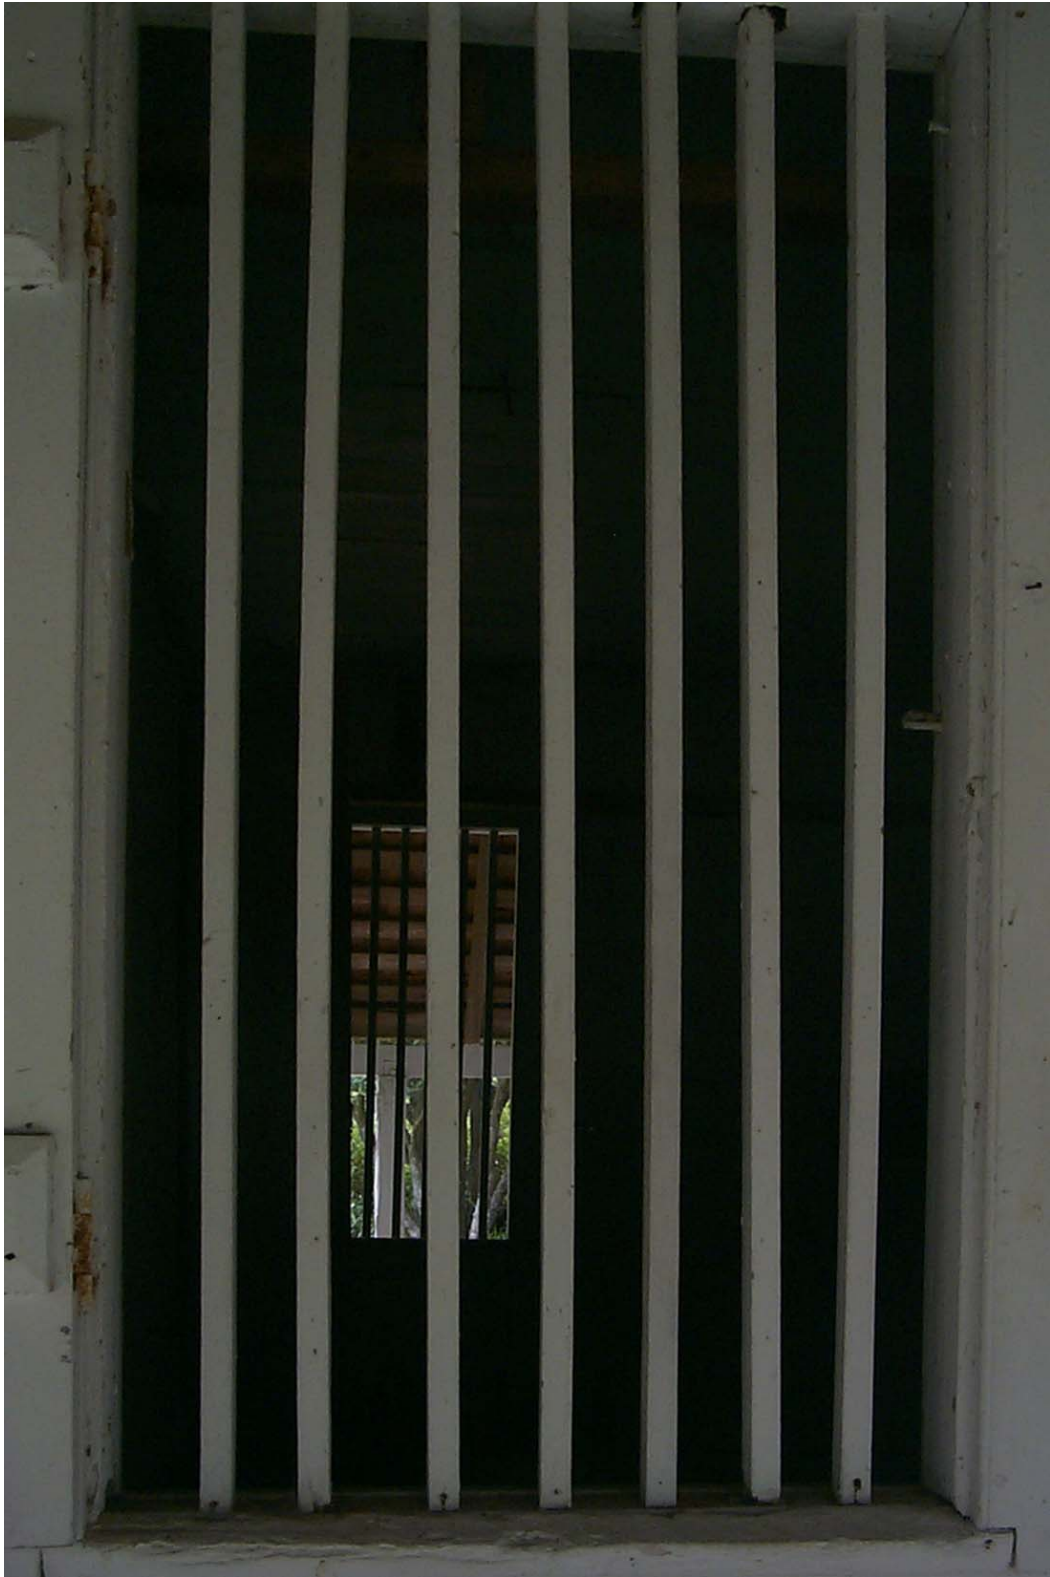
Figure 5.39. Wooden bars keep varmints out but allow the air to circulate.

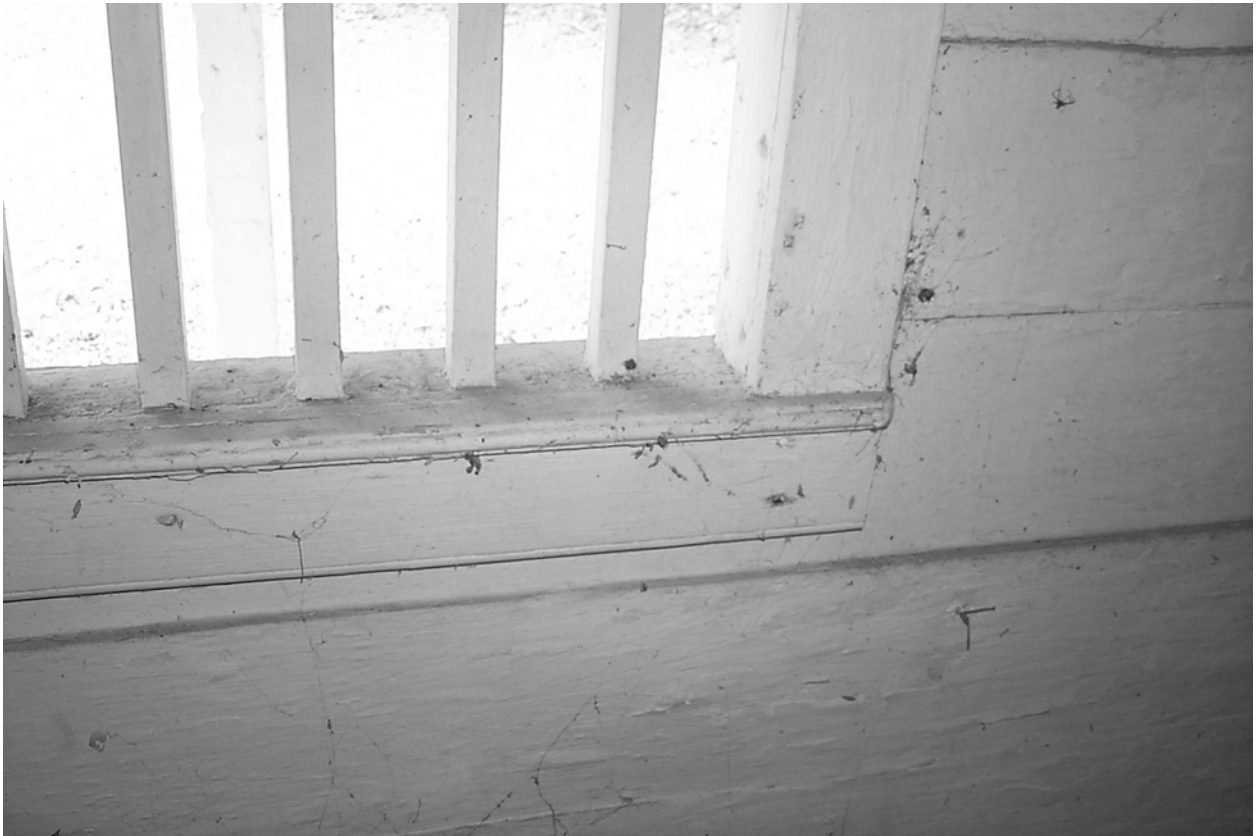
Figure 5.40. Similar to Room 1, the Rosedown Milk House has beaded trim.
